Development and Implementation of Hydromodification Control Methodology

Watershed Characterization Part 2: Watershed Management Zones and Receiving-Water Conditions

Central Coast Regional Water Quality Control Board
895 Aerovista Place, Suite 101
San Luis Obispo, CA 93401

October 14, 2011

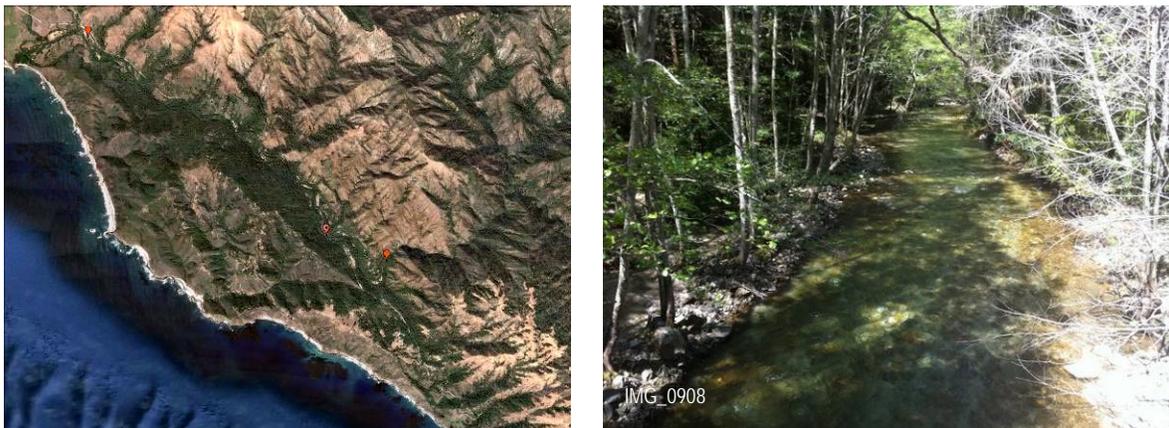
Figure 4-6. Big Sur River (left panel, from GoogleEarth), with the downstream and upstream BML sites (red pins, upper left corner and middle right). Photo in right panel taken at red pin with black dot; the two BML stations are about 5 miles apart.

Big Sur River drains approximately 46 square miles, dominated by a granitic geology. The Big Sur watershed is relatively unimpacted through most of the area (Figure 4-6), with moderate levels of human land use only close to the mouth. Monitoring for benthic macroinvertebrates and water quality by both Central Coast Long-term Environmental Assessment Network (CCLEAN) and Monterey Bay National Marine Sanctuary (MBNMS) has been conducted at two sites over the past decade. The upstream-most biological monitoring station lies above the development in the basin at the USGS gage. The lower site lies below several developments, including a state park and the section of the river adjacent to the coastal highway. The upstream site shows predictably high-quality conditions, with 14–19 EPT taxa in 2002 and 2003. Our field visit to this locale revealed a free-flowing cobble-bed river with clear water and stable channel boundaries. Even the lower site showed between 6–15 EPT taxa between 2002 and 2007, with comparative values for tolerant and intolerant taxa; they suggest measurable impacts from even this low level of human disturbance, but with significantly less consequences than seen in the more urban or agricultural landscapes elsewhere in the region. Somewhat counterintuitively, CRAM assessment scores for these two sites report an inverse relationship between them, with the downstream site reporting significantly better conditions than the upstream site.

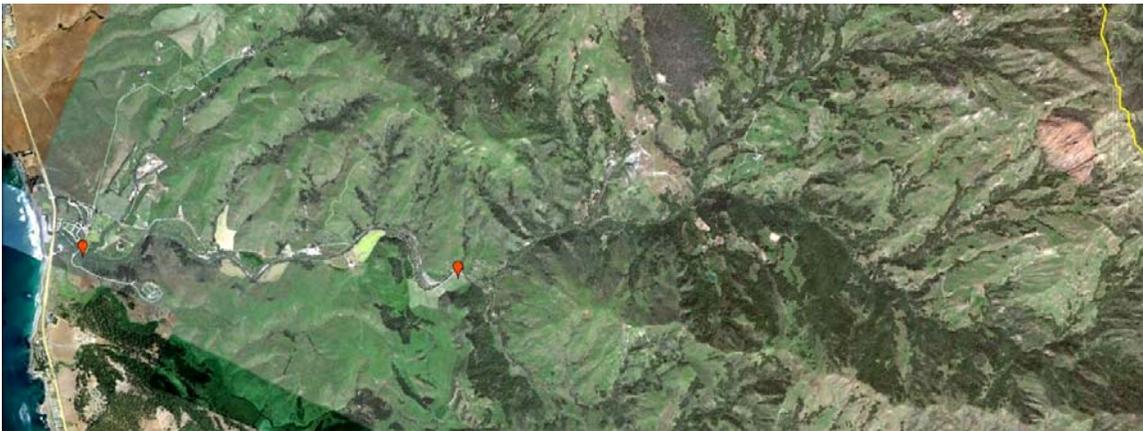
Figure 4-7. Watershed of San Simeon Creek (from GoogleEarth; upper boundary marked by yellow line, upper right corner). The two BMI sites (red pins) are about 4 river miles apart, with only modest disturbance occurring between them.

San Simeon Creek drains a 35-mi² watershed originating in the Santa Lucia Range, just north of the coastal town of Cambria (Figure 4-7). The watershed is primarily underlain by Franciscan *mélange*, a rock mixture that allows little infiltration and is prone to erosion. Human land uses are limited to roads and ranching in the upper watershed, although some agriculture in the form of grape growing occurs in the South Fork San Simeon Creek. The nearest population center, Cambria, is in the neighboring watershed of Santa Rosa Creek. The creek has two main forks, the north and south, which converge at about stream mile 6.2. There is no USGS gage in the basin. A BMI monitoring station is located in the upper watershed that drains an area mostly used for ranching and grazing; the lower BMI station is located downstream of both grazing, but also some fields with row crops and very low-level residential development. Sampling results from the two stations are similar: EPT taxa were 15 for both; percent intolerant averaged 32% at the upper (310SSU) and 22% at the lower (310SSC). Tolerant taxa, however, differed more—10% at the upper and 29% at the lower. CRAM evaluations in the vicinity of the two sites also returned similar scores to each other, but identified the lower as having slightly better conditions than the upper one.

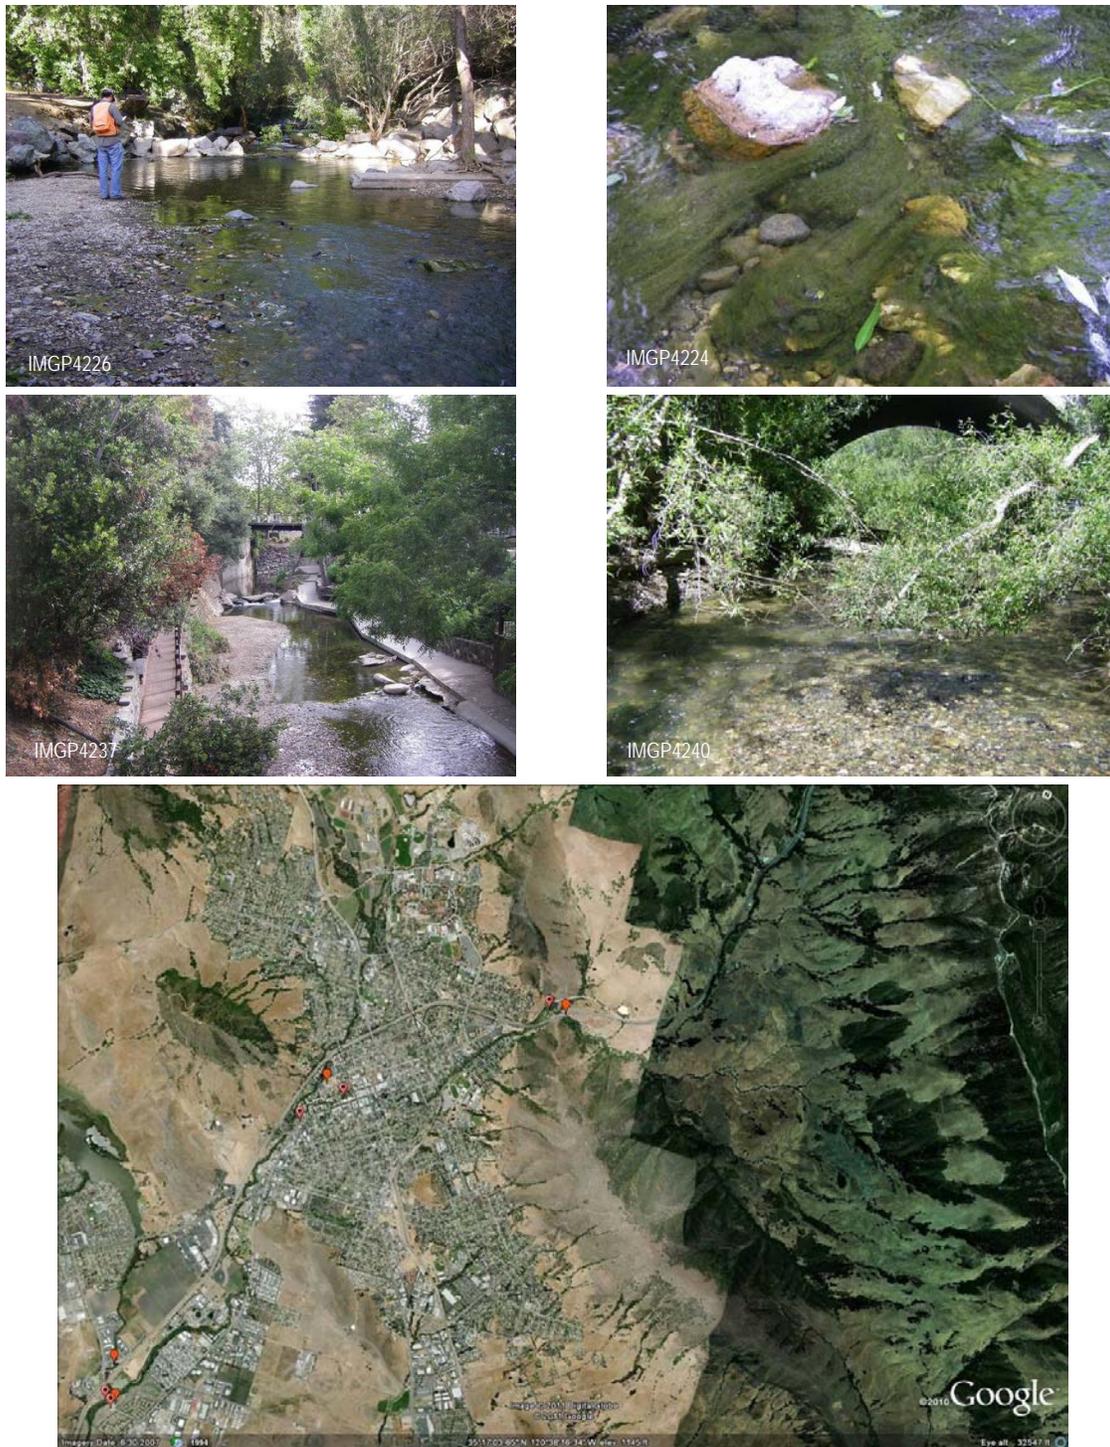
Figure 4-8. San Luis Obispo Creek, from its headwaters (ridgeline at extreme right in the GoogleEarth image) downstream through the town of San Luis Obispo (the large urban area at left-center). BMI stations shown with red pins, photo locations are red pins with black dot. Upper photos, upstream-most site (310SLC) with no upstream urbanization but significant grazing through Cuesta Park; lower left, through center of town (site 310SCN); lower right, below most urbanization (site 310SLV). Distance from upstream to downstream site is about 4 miles; downstream site is ~6 miles from Pacific Ocean.

Conditions recover marginally at the BMI station at the mouth of the creek (310SLB, not shown in Figure 4-8), with the most extensive monitoring history. It has shown relatively few EPT taxa (1–6), low intolerant taxa (one sample at 22%, the others at 0%), and up to 35% tolerant taxa. The creek still has a Southern California IBI rating of "very poor" at this location, however, which provides a curious contrast with a CRAM assessment score that is close to the calibration data set's average here and is higher than every other site on the stream, including one upstream of nearly all urban development.

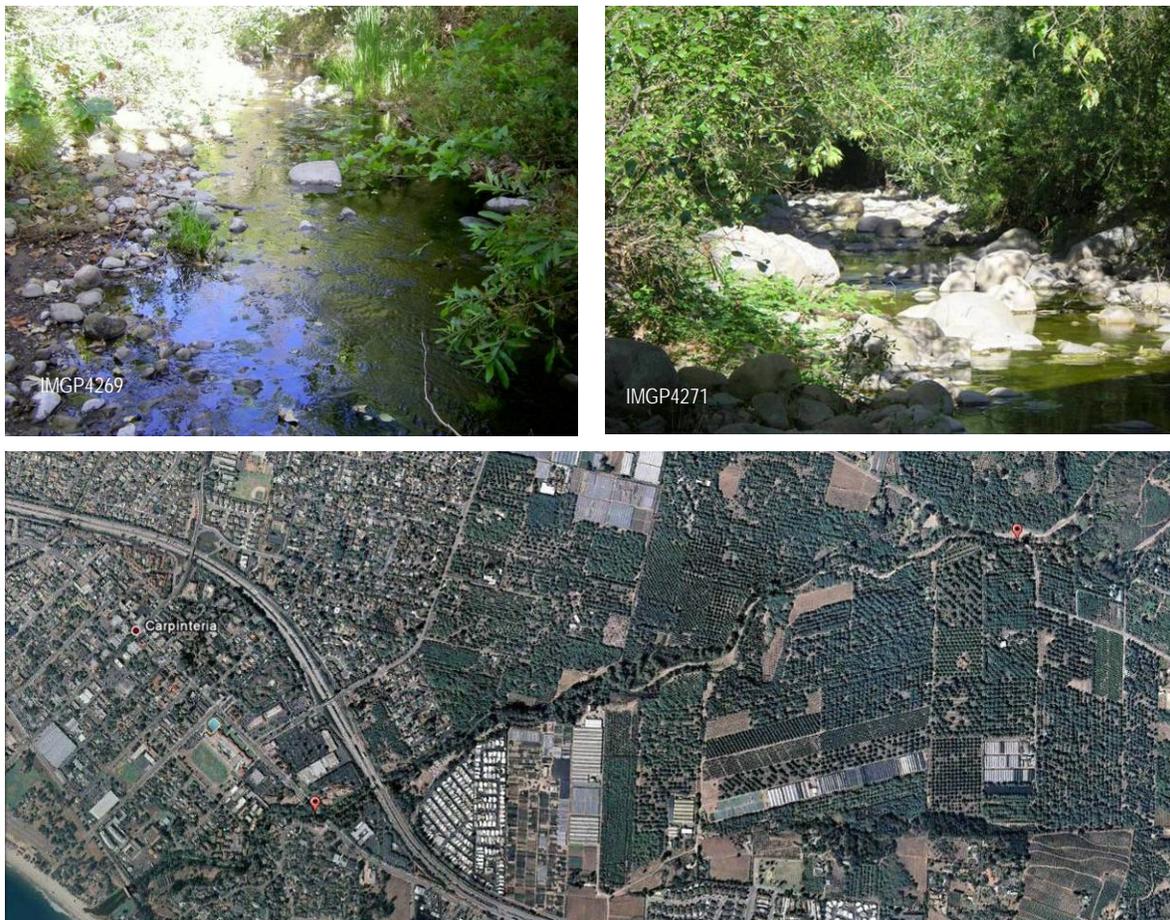
Figure 4-9. Carpinteria Creek, downstream (upper left) and upstream (upper right) of the town of Carpinteria and US Highway 101. Lower image from GoogleEarth shows the location of the two photos (red pins) relative to the surrounding land cover; they are about 1.5 miles apart from each other.

Carpinteria Creek lies about 8 miles east along the coast from Mission Creek and occupies a similar physiographic setting, with headwaters in the steep uplands of the mountains above the southern Central Coast Region, flowing through agricultural and then urban development before reaching the Pacific Ocean. In contrast to Aptos Creek discussed above, Carpinteria Creek displays a classic relationship between biological conditions and urban development (Figure 4-9): City of Santa Barbara site 315CAU lies at the Highway 192 crossing, above all but scattered large-lot residential development and orchards; sampling in 2001 and 2008 found 11–13 EPT taxa. Site 315CRP, a few hundred yards upstream of the coastline and below US 101 and the town of Carpinteria, found between 1 and 4 taxa over the same period. Using the index scoring ratings from Ecology Consultants (2011), the biological condition of the lowermost site (C1 in their report) is “Very Poor”; the upper site (C3), “Good.”

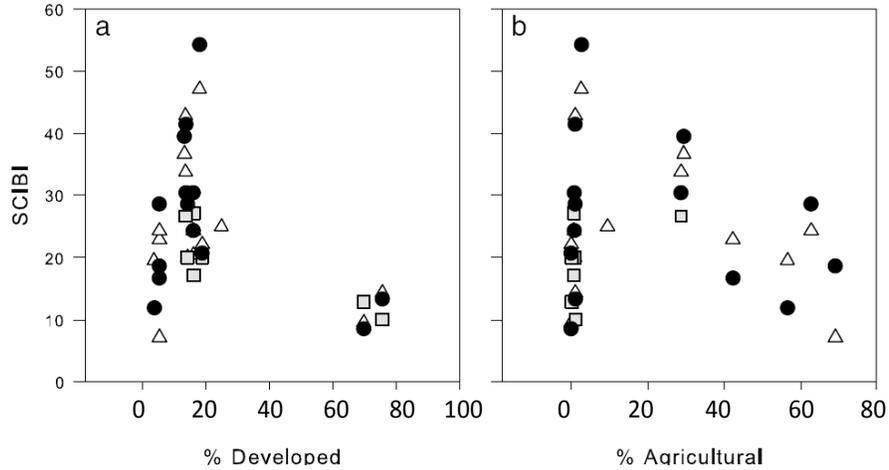
Figure 4-10. Southern California IBI scores versus land-cover metrics (each point represents the mean of all samples collected by each of three sampling protocols at each site). Note that the relationships do not suggest a classic linear regression but rather a factor-ceiling distribution (Thompson et al. 2007), wherein any result is possible below an upper threshold for a given level of land cover (reproduced from Figure 4 of Mazor et al. 2010).

Mazor et al. (2010) evaluated the utility of existing bioassessment protocols at 21 low-gradient California stream sites, including 6 within the Central Coast Region. They found a minimum detectable difference between scores using the Southern California IBI between 19 and 22, allowing discrimination of the 100-point index into at most five discrete categories. Their data also showed classic relationships between typical environmental stressor variables (urban and agricultural land cover in the contributing watershed) and biological health (Figure 4-10). As with other studies of urbanization’s effects (e.g., Booth et al. 2004), a low percentage of disturbed land does not guarantee high-quality biological conditions but, conversely, high percentages of disturbed land assure poor conditions regardless of other stream and watershed attributes.

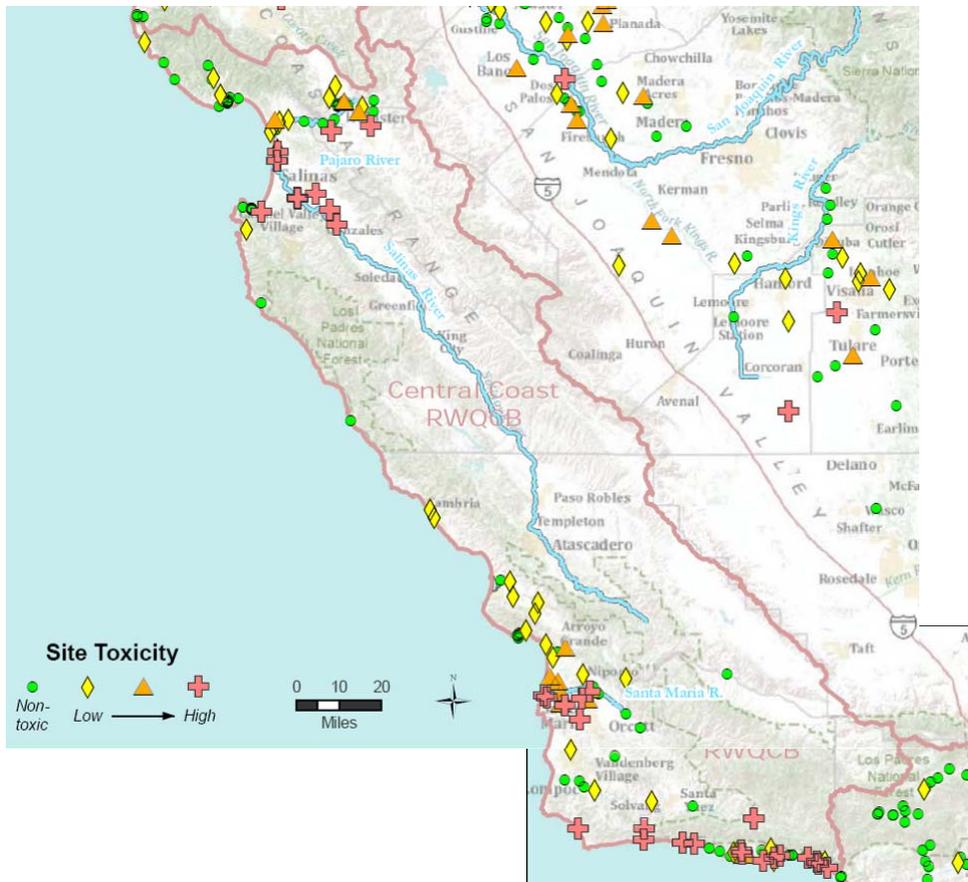
Figure 4-11. Magnitude of toxicity at sites in the Central Coast Region, based on the most sensitive species in either water or sediment samples at each site (reproduced from Hunt et al. 2010, their Figure 5). Areas with multiple sites showing severe toxicity are (north-to-south) the Pajero River, the lower Salinas River, the Santa Maria valley, and multiple points along the Santa Barbara coast.

SWAMP has compiled multiple data sources into a statewide review of sediment and water toxicity, primarily from rivers, streams and the marine nearshore (Hunt et al. 2010). Overall, they found about 80% of sites were non-toxic where the “local” land use (defined as land use within 1 km of the site; whole-watershed land use was not assessed) was less than 25% agriculture and less than 10% urban. For the sites with either or both of these land uses above their respective threshold, 47% (urban) and 58% (agricultural) of sites had results of at least “low” toxicity, with more than half of those rated “highly toxic” in the study. Sites from the Central Coast Region are illustrated in Figure 4-11.
