# TMDLs for Nitrogen Compounds & Orthophosphate *in* Streams of the Pajaro River Basin

## Agenda Item 13

**TMDLs and an associated implementation strategy addressing nutrient pollution in streams of the Pajaro River basin**

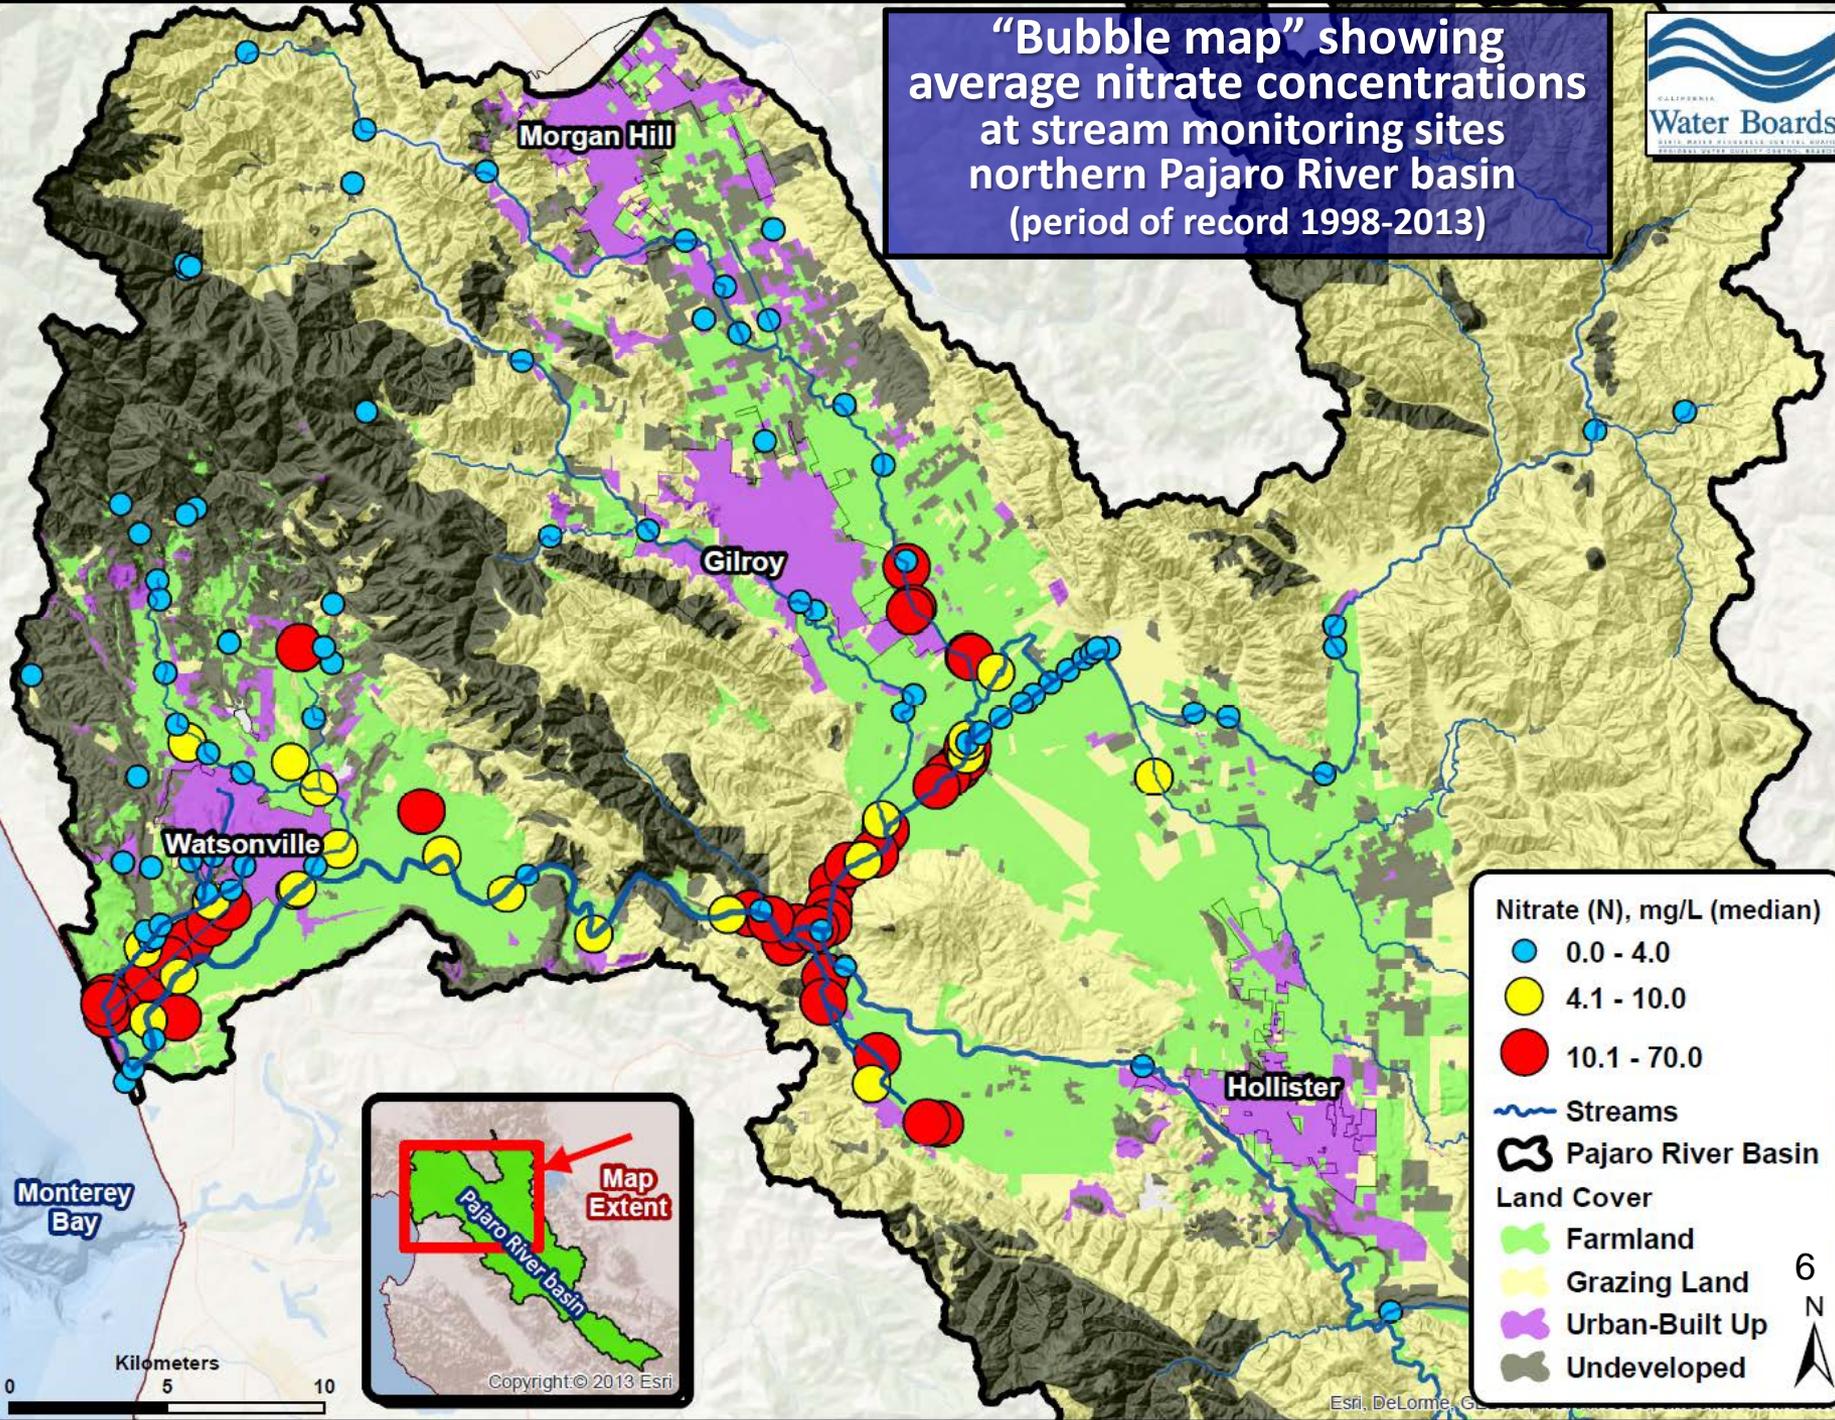
**“Bubble map” showing average nitrate concentrations at stream monitoring sites northern Pajaro River basin (period of record 1998-2013)**

**Nitrate (N), mg/L (median)**

- 0.0 - 4.0
- 4.1 - 10.0
- 10.1 - 70.0

- Streams
- Pajaro River Basin
- Land Cover
  - Farmland
  - Grazing Land
  - Urban-Built Up
  - Undeveloped

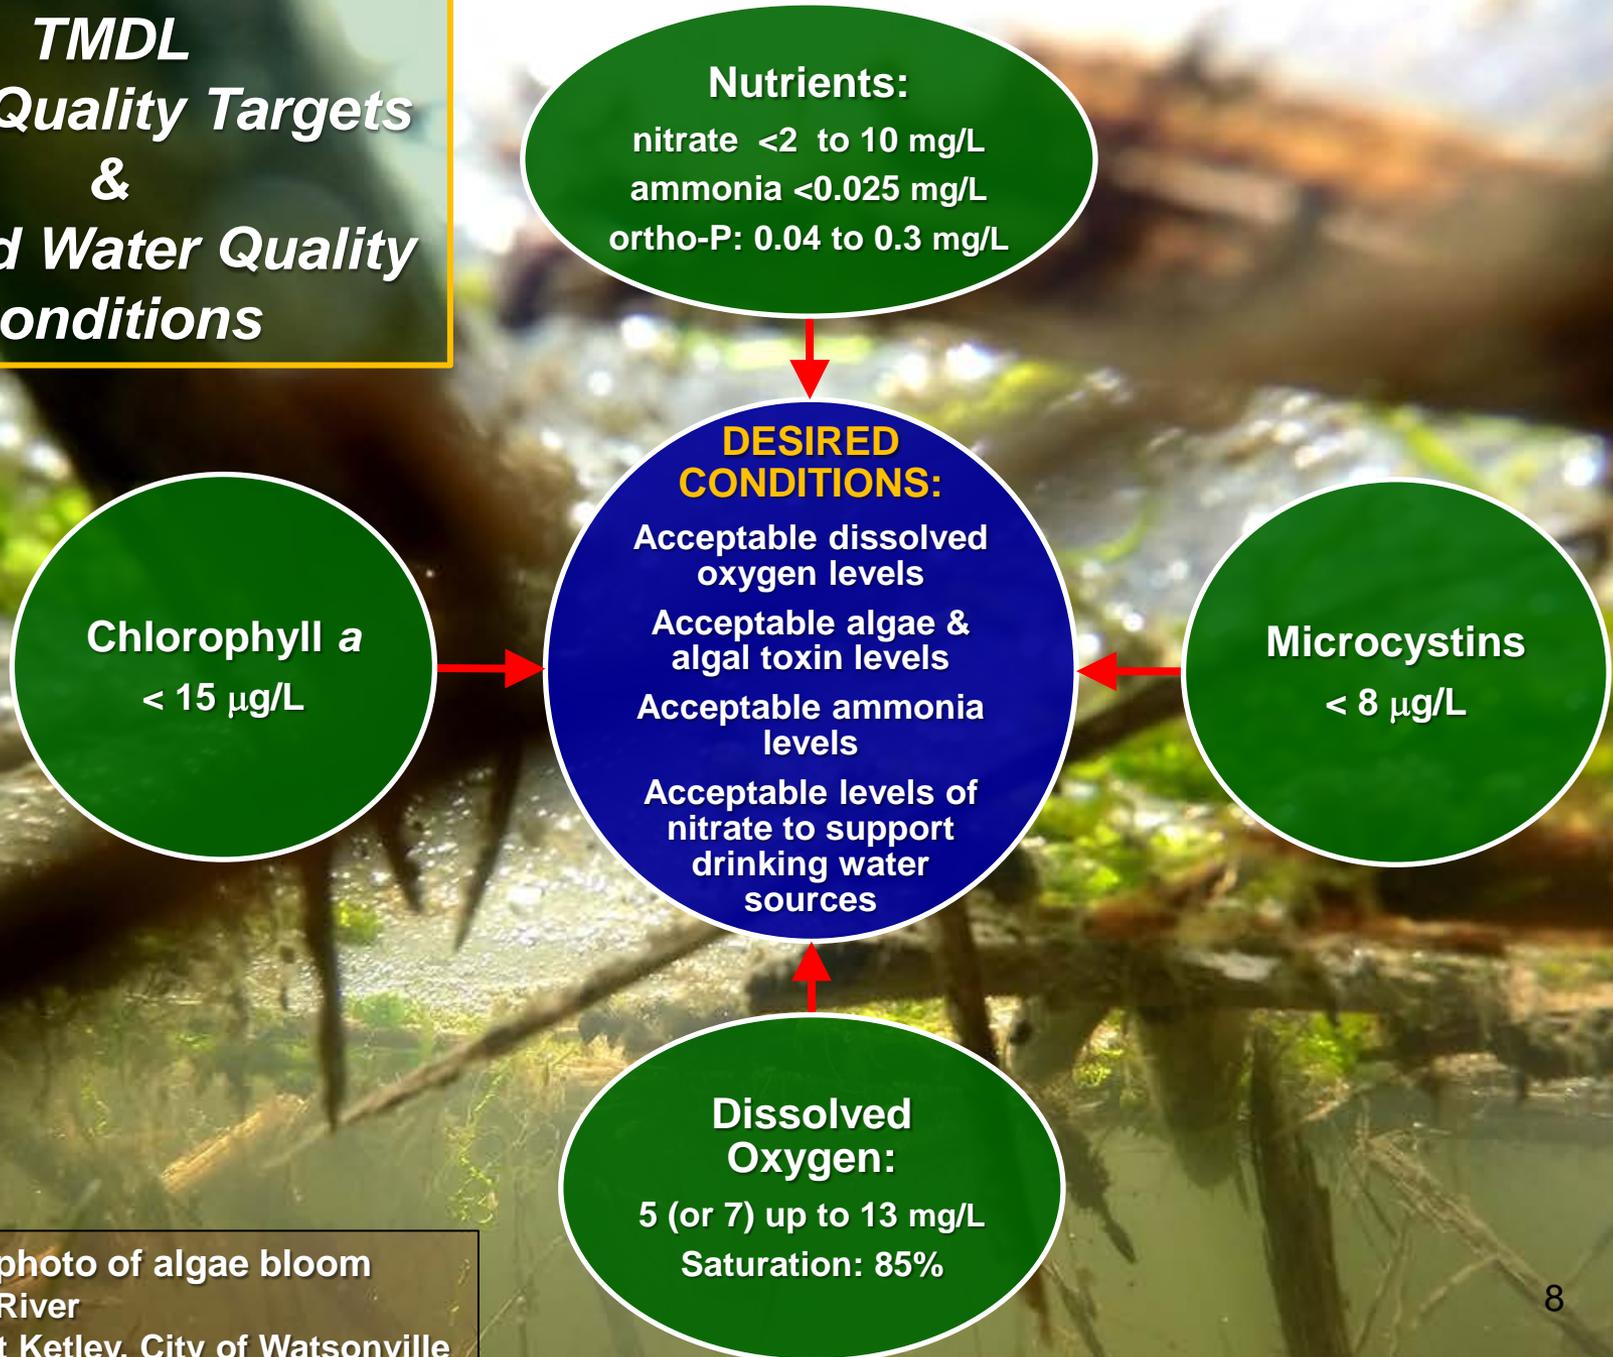
**Nutrients:**  
nitrate <2 to 10 mg/L  
ammonia <0.025 mg/L  
ortho-P: 0.04 to 0.3 mg/L

**Chlorophyll a**  
< 15 µg/L

**Microcystins**  
< 8 µg/L

**Dissolved Oxygen:**  
5 (or 7) up to 13 mg/L  
Saturation: 85%

Underwater photo of algae bloom lower Pajaro River  
photo: Robert Ketley, City of Watsonville
