Appendix C – Assessment of Biostimulation

C.1 Water Quality Standards and Screening Criteria

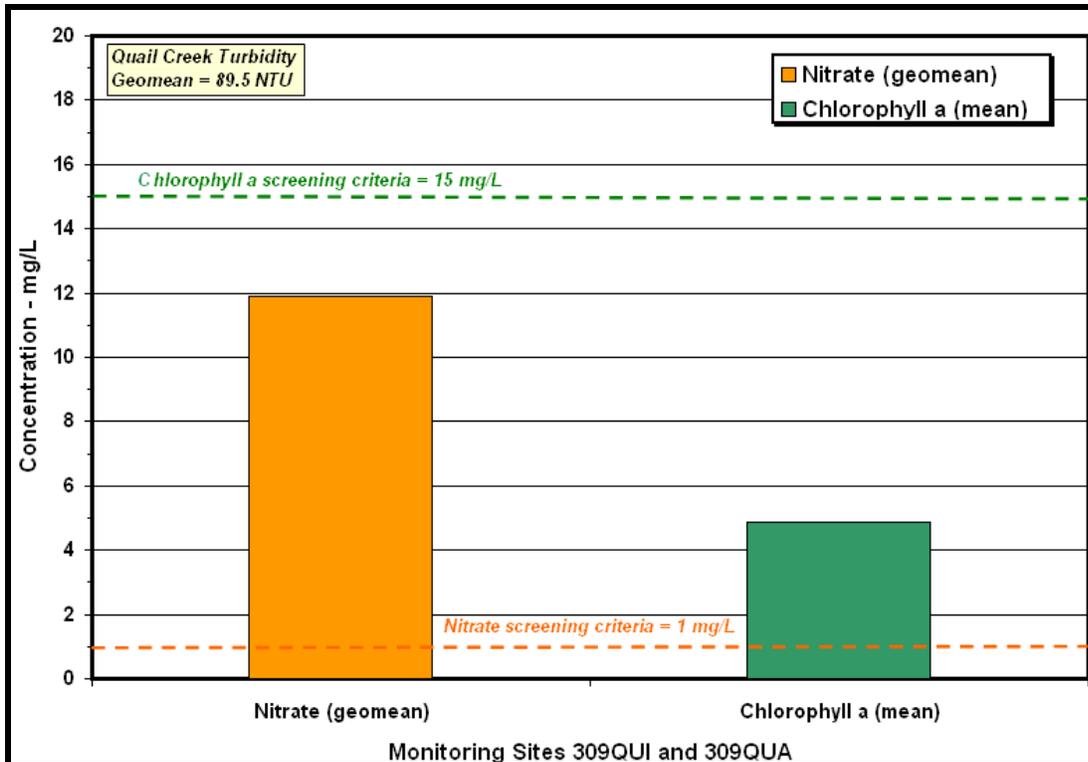
Figure 17. Nitrate and Chlorophyll a average concentrations, Quail Creek; and percent algal cover statistics.

309QUI and 309QUA % Algal Cover	
Mean	14.81
Median	0
Range	100
Minimum	0
Maximum	100
Observations	26

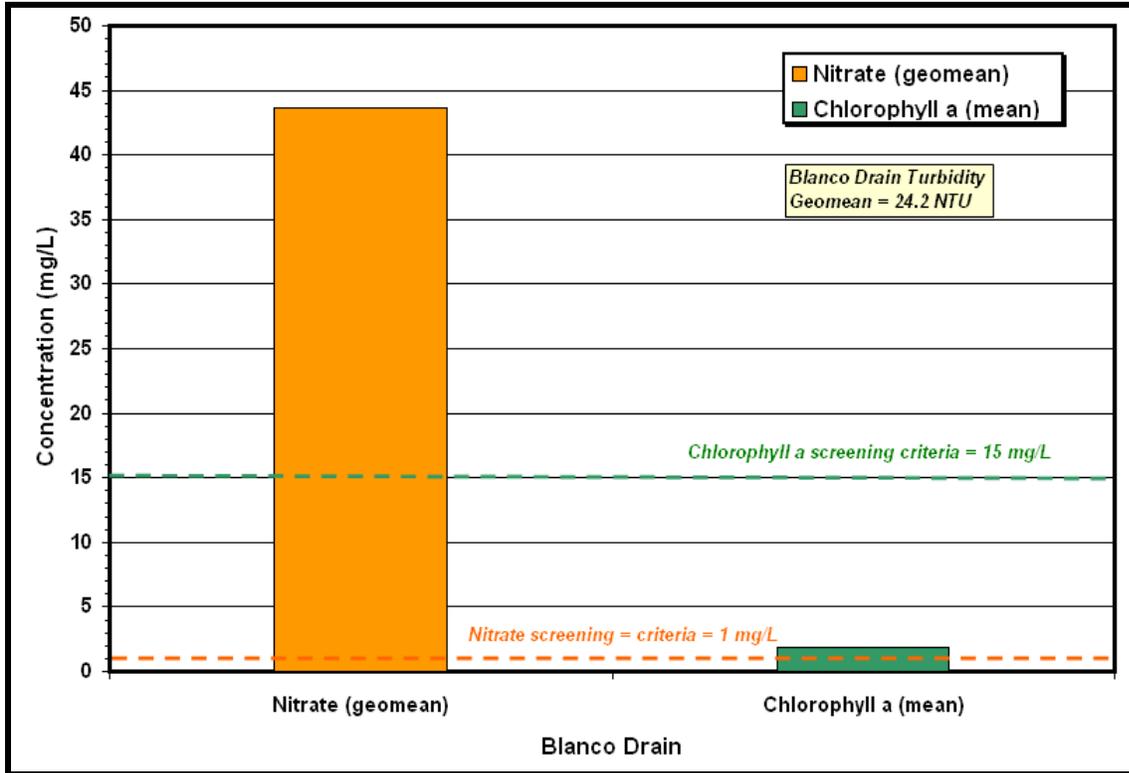
Figure 21. Nitrate and Chlorophyll a average concentrations, Blanco Drain; and percent algal cover statistics.

Site BLA-PUM % Algal Cover	
Mean	64.64
Median	90
Range	100
Minimum	0
Maximum	100
Observations	14

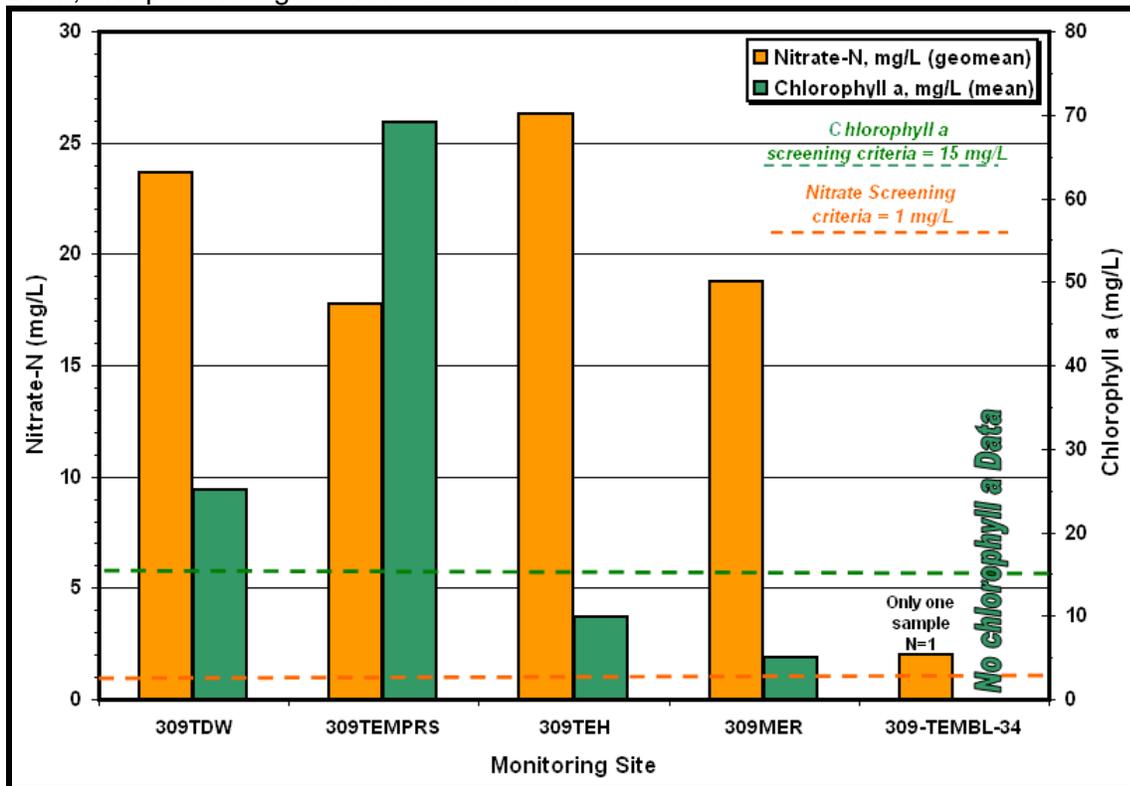
Figure 31. Nitrate and Chlorophyll a average concentrations, Tembladero Slough and Merritt Ditch; and percent algal cover statistics.

309TDW-Algal Cover	309TEM-Algal Cover	309TEH-Algal Cover	309MER-Algal Cover
no data	Mean 0.00	Mean 0.00	Mean 35
	Range 0	Range 0	Range 100
	Minimum 0	Minimum 0	Minimum 0
	Maximum 0	Maximum 0	Maximum 100
	Observations 14	Observations 11	Observations 13

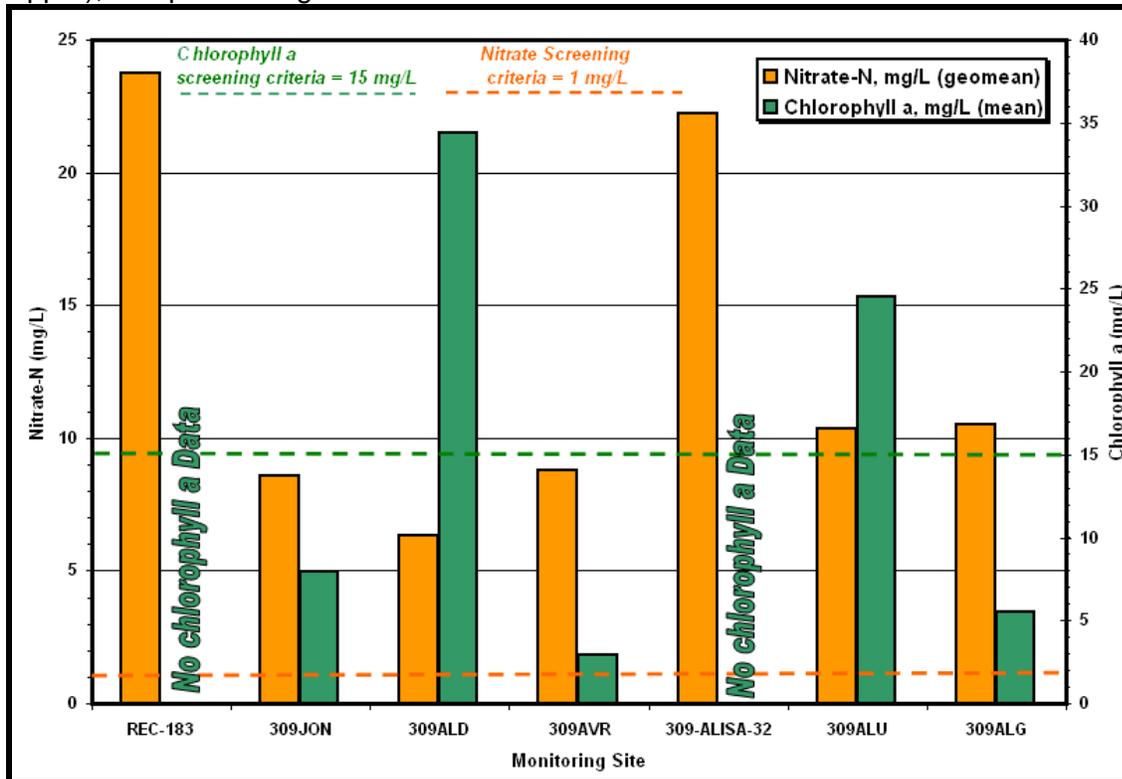
Figure 32. Nitrate and Chlorophyll a average concentrations, Reclamation Canal (Lower and Upper); and percent algal cover statistics.

309JON-Lower Rec Canal	309ALD-Lower Rec Canal	309ALU-Upper Rec Canal	309ALG-Upper Rec Canal
Mean	23.75	Mean 0.92	Mean 0.14	Mean 13.57
Range	75	Range 10	Range 2	Range 50
Minimum	0	Minimum 0	Minimum 0	Minimum 0
Maximum	75	Maximum 10	Maximum 2	Maximum 50
Observations	12	Observations 13	Observations 14	Observations 14

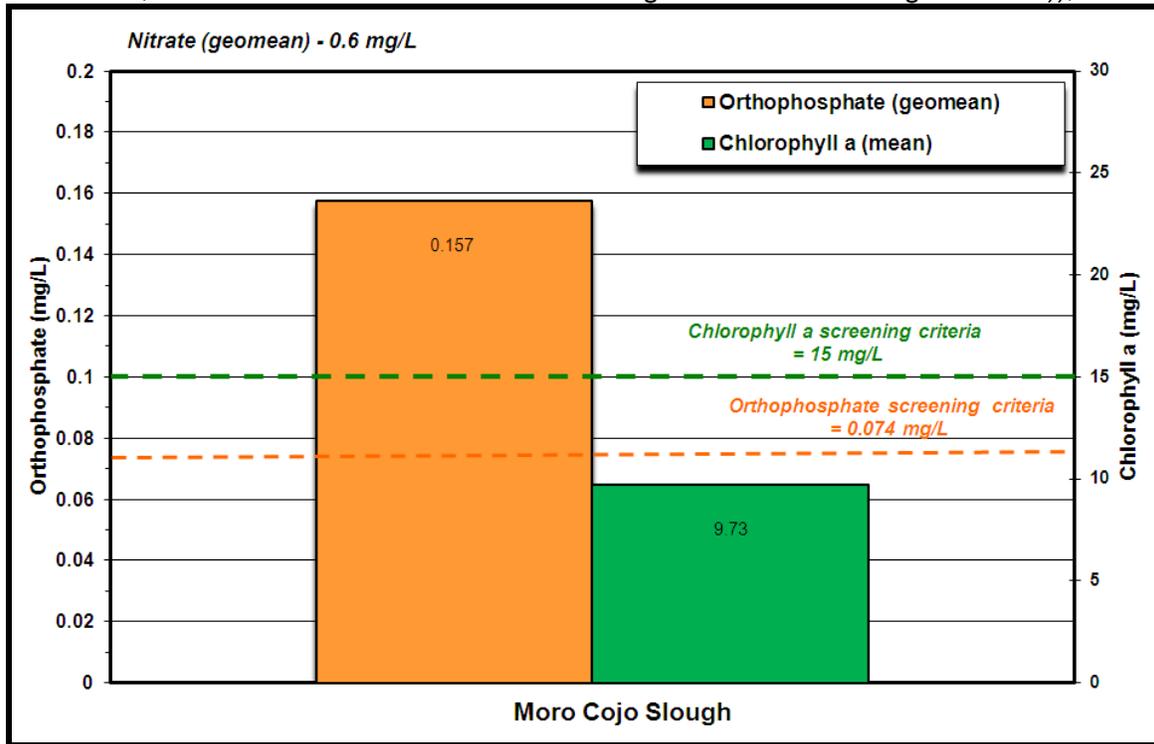
Figure 46. Nitrate and Chlorophyll a average concentrations, Moro Cojo Slough (sites 306MORMLN, 306MOR and 306-MOROC-32 – Slough Mile Zero to Slough Mile 1.7), .

Moro Cojo - % Algal Cover	
Mean	10.42
Range	80
Minimum	0
Maximum	80
Observations	24

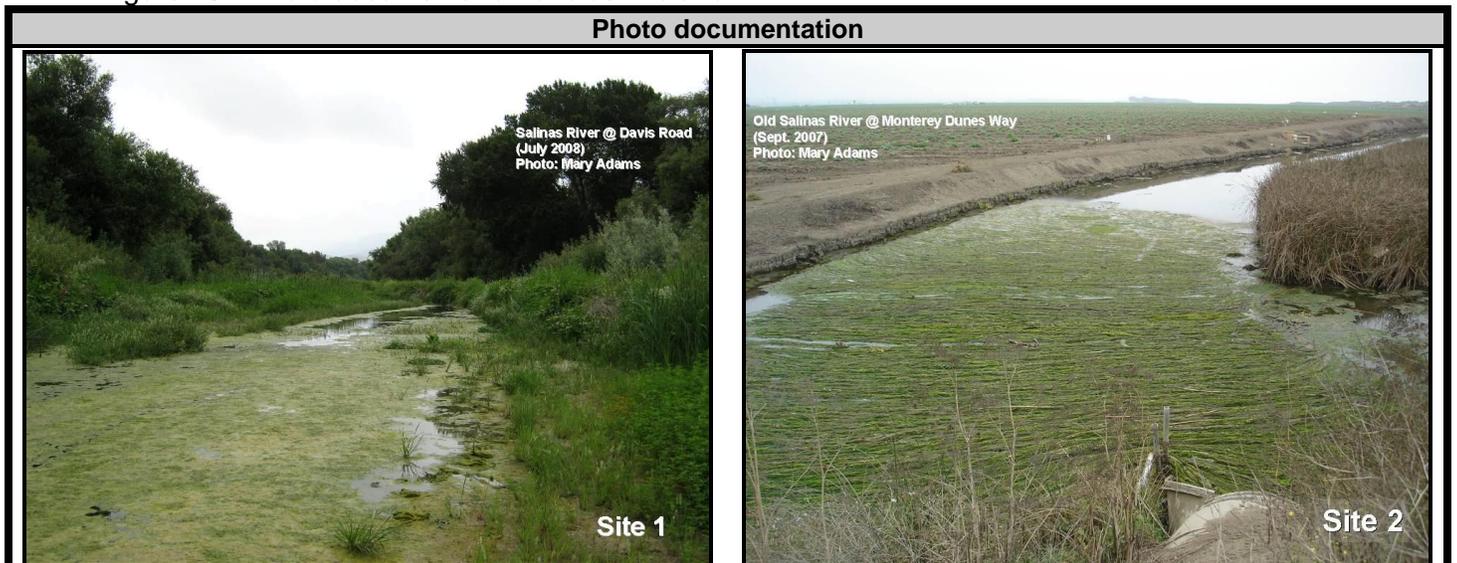
Figure 48. Photo documentation of biostimulation.

CCAMP staff periodically photo-document evidence of biostimulation and excessive algal growth at water quality monitoring sites in the Project Area Figure 47. shows the location of photo monitored sites. The photographic documentation for these sites is presented in Figure 48
