**Total Maximum Daily Loads to Address  
Organophosphate Pesticides and Aquatic Toxicity  
Impairments within the Lower Salinas River Watershed**

**Monterey County, California**

**Draft  
Water Quality Data Analysis Report**

**October 2020**

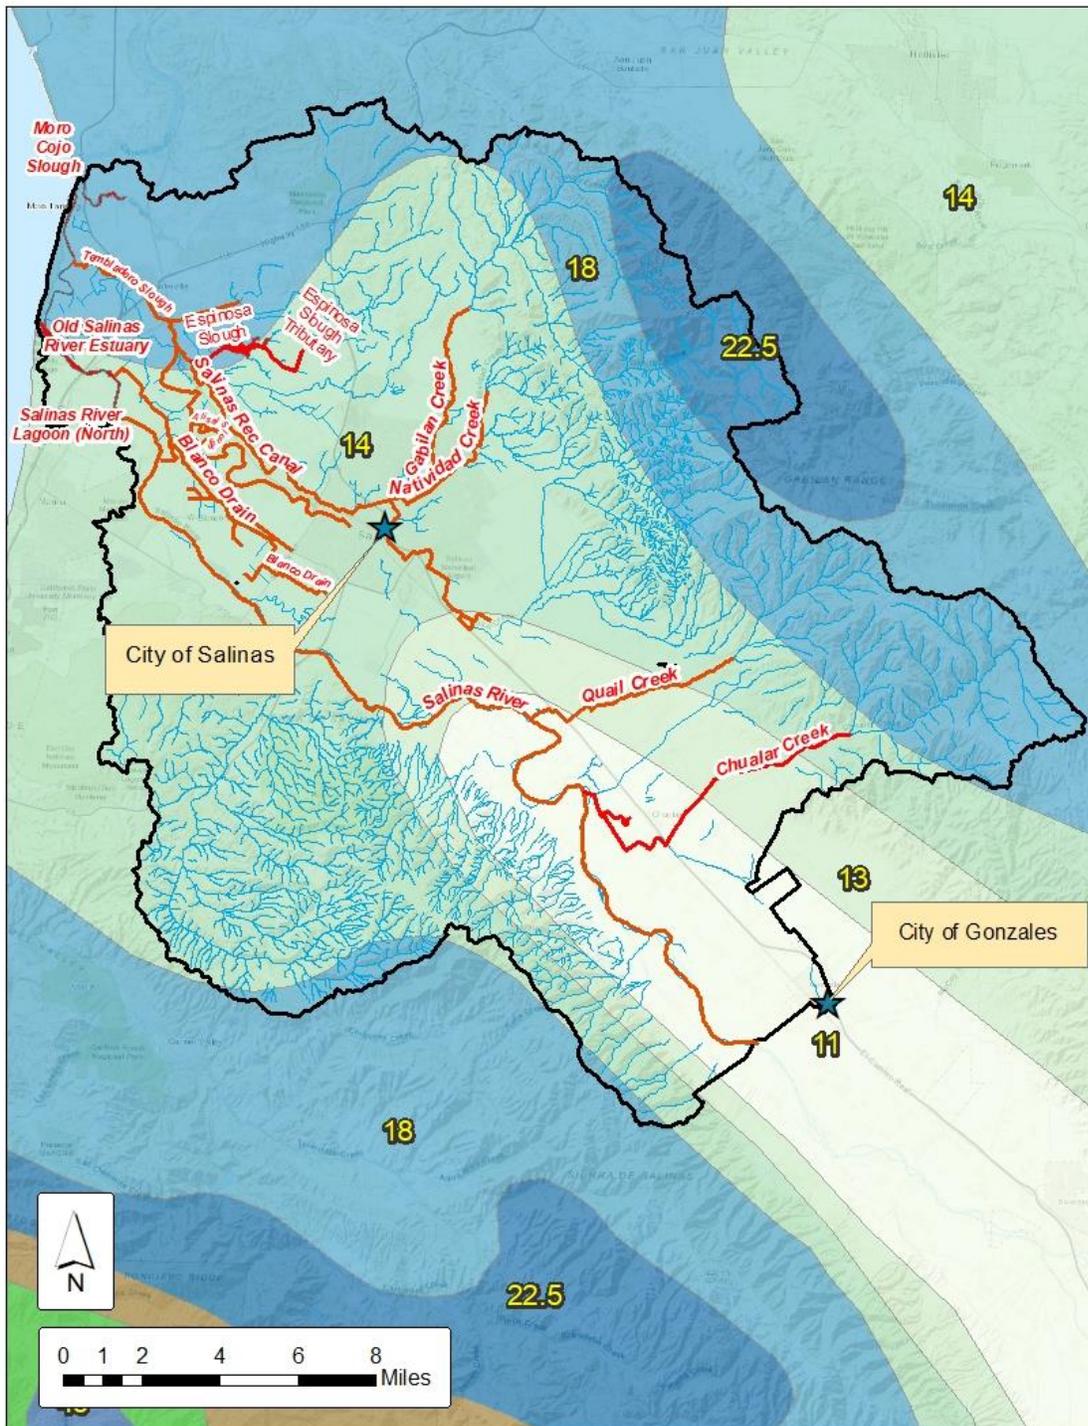
Figure 4-2. Map of precipitation isohyets (inches).  
Source: United States Average Annual Precipitation (1981-2010). The PRISM Climate Group at Oregon State University (2006).

Precipitation is concentrated in winter. Rain totals range from about 10 inches in drier locations to near or slightly above 22 inches in the mountains. Snowfall in the county is generally insignificant, although a limited amount may be observed each winter at the higher elevations.

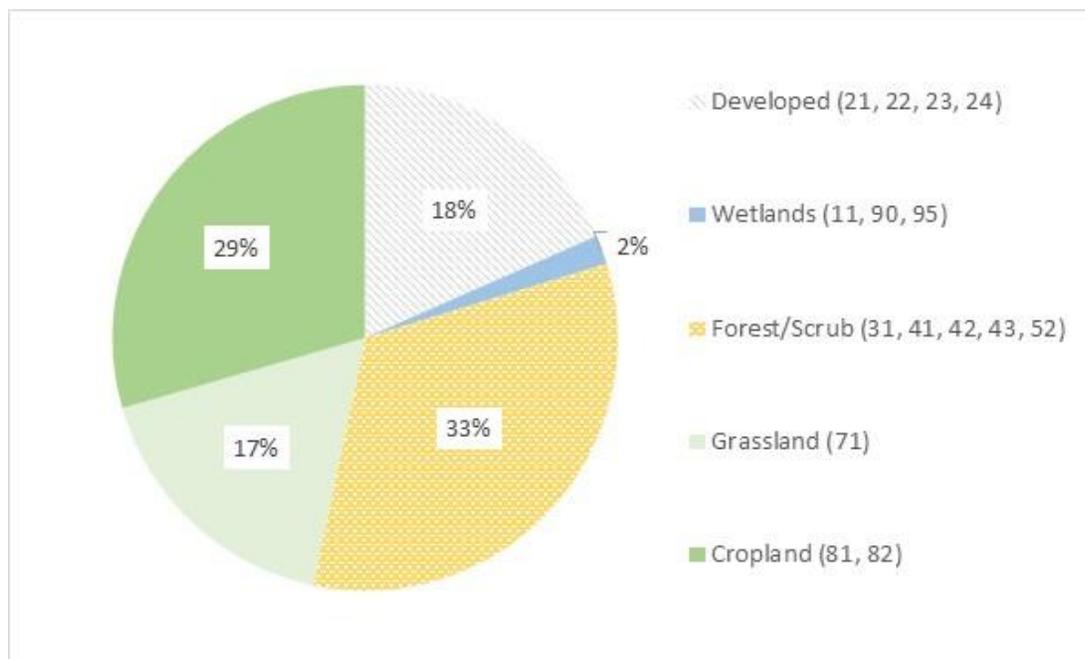
Figure 4-4. Pie chart of percent NLCD 2011 land cover and aggregated land cover type.

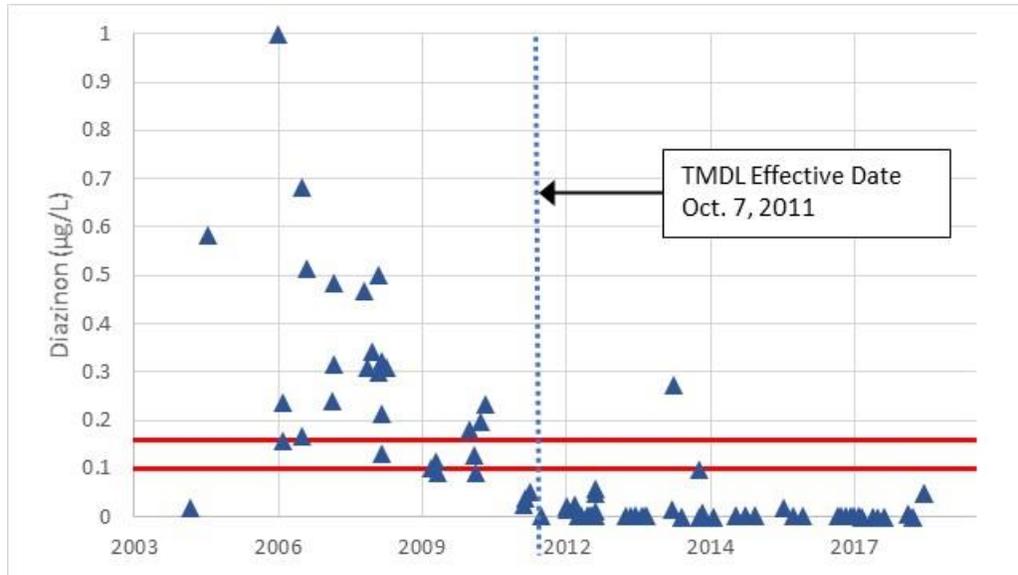
Figure 6-4. Graph of diazinon concentrations for all Salinas Reclamation Canal monitoring sites.

Note: Red horizontal lines represent diazinon criteria of 0.16 µg/L (acute) and 0.1 µg/L (chronic). Not shown are concentrations of 1.16 µg/L (9/13/2004) and 3.16 µg/L (8/23/2006) for 309JON and 1.68 µg/L (3/22/2007) for 309ALG.

Following approval of the previous TMDL on October 7, 2011, a total of 59 diazinon samples were collected from the Salinas Reclamation Canal which included monitoring sites 309ALD (n=5), 309ALG (n=8), 309ALU (n=4), 309JON (n=28), and 309SLRC66 (n=14). Only one of the 59 samples from the Salinas Reclamation Canal exceeded the acute and chronic evaluation criteria for diazinon. Figure 6-4 shows diazinon concentrations over time for all Salinas Reclamation Canal monitoring sites (309ALD, 309ALG, 309ALU, 309JON, and 309SLRC66).

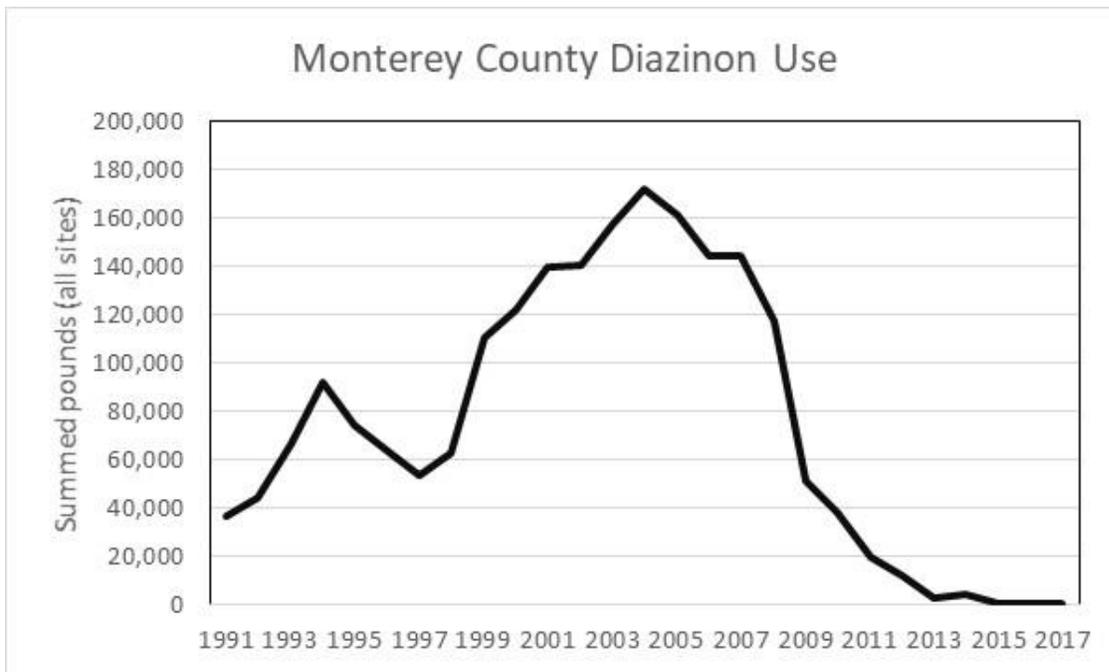
Figure 6-5. Graph of Monterey County diazinon use (1991 to 2017).

Diazinon use in Monterey County has been declining rapidly since 2007. Pesticide use reporting provided by CDPR indicates that peak diazinon use in Monterey County occurred in 2004, where 171,840 pounds of diazinon was used. The most recent year of pesticide use reporting for diazinon is 2017, where 107 pounds of diazinon was used. Figure 6-5 depicts the total amount of diazinon used each year in Monterey County from 1991 to 2018 and its' rapid decline since 2004.

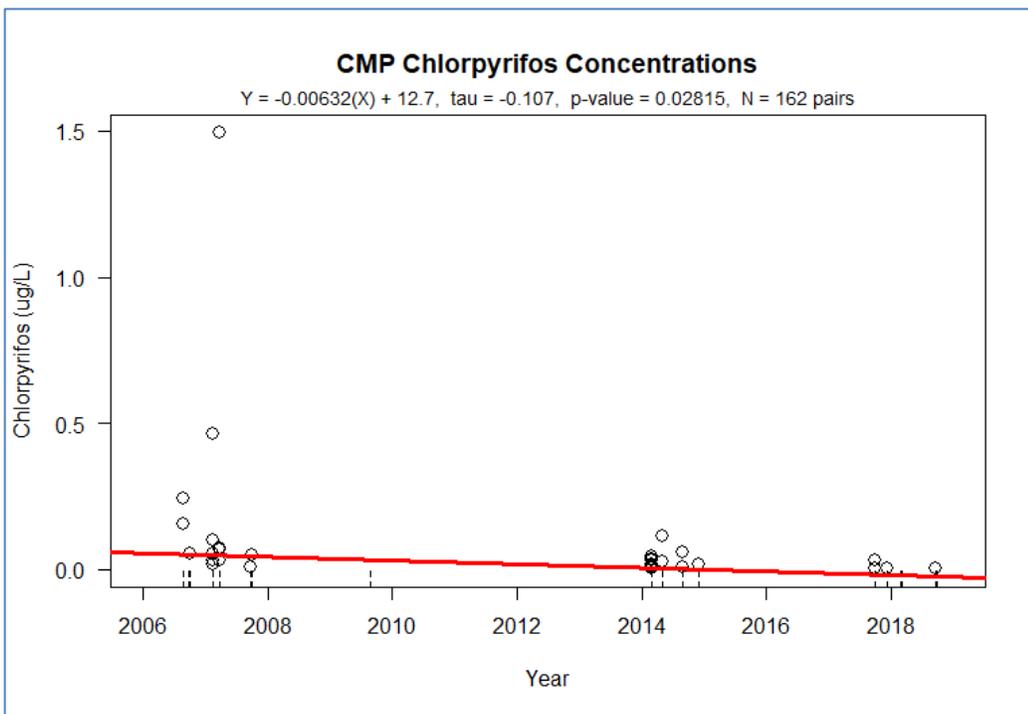
Figure 6-6. Time series graph of chlorpyrifos concentrations (µg/L) from 17 CMP monitoring sites in the project area.

Figure 6-6, Figure 6-7, and Figure 6-8 show time series plots for chlorpyrifos, diazinon, and malathion, respectively. The plots also show the computed Akritas-Theil-Sen nonparametric line in red, which estimates the median of slopes of all lines through pairs of censored points.
