CALIFORNIA REGIONAL WATER QUALITY CONTROL BOARD  
CENTRAL VALLEY REGION

CLEANUP AND ABATEMENT ORDER R5-2015-0705

CALIFORNIA DEPARTMENT OF CORRECTIONS & REHABILITATION  
DEUEL VOCATIONAL INSTITUTE DAIRY

SAN JOAQUIN COUNTY

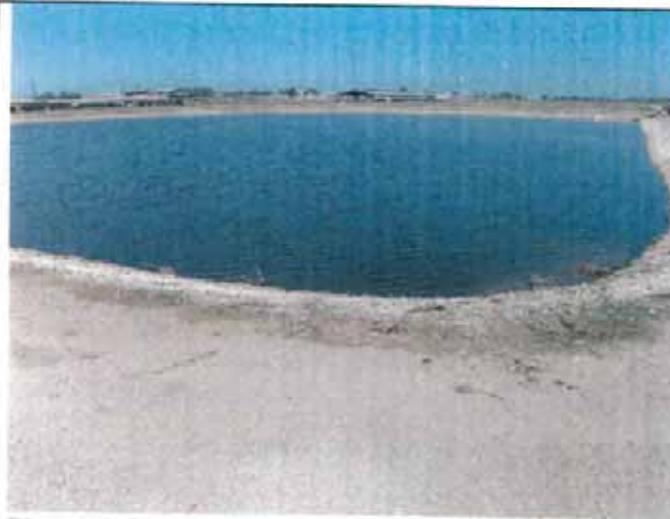
The facility utilizes a total of 7 lagoons (settling and storage combined). All lagoons and settling basins had 3'-6' freeboard (Photo 1) and were free of animal burrows and/or signs of berm erosion except the "Big Reservoir" located southwest of the production area and immediately east of Kasson Road; staff observed a large hole on the outside of the eastern lagoon embankment (Photos 2-3) that appeared to staff to compromise berm integrity. The lagoons are cleaned out as needed with manure being directly applied to the field from the lagoon.

**Photo 1:** Typical condition of all storage lagoons at the facility. No signs of berm erosion and/or animal burrowing. Note 3'-5' freeboard.

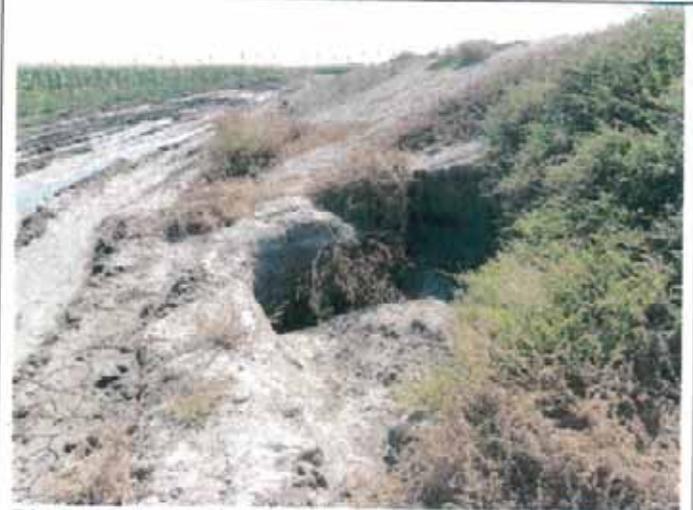
**Photo 3:** Large hole on the eastern embankment of the 'Big Reservoir.'

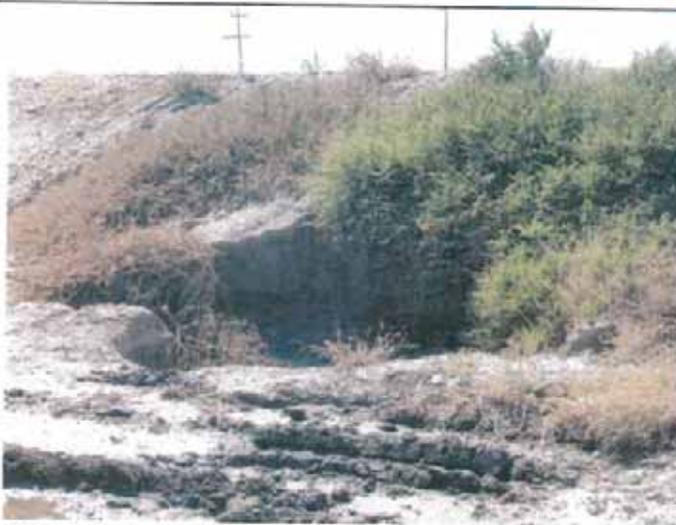
**Photo 2:** Large hole on the eastern embankment of the 'Big Reservoir.' It appeared to staff this hole compromises berm integrity.

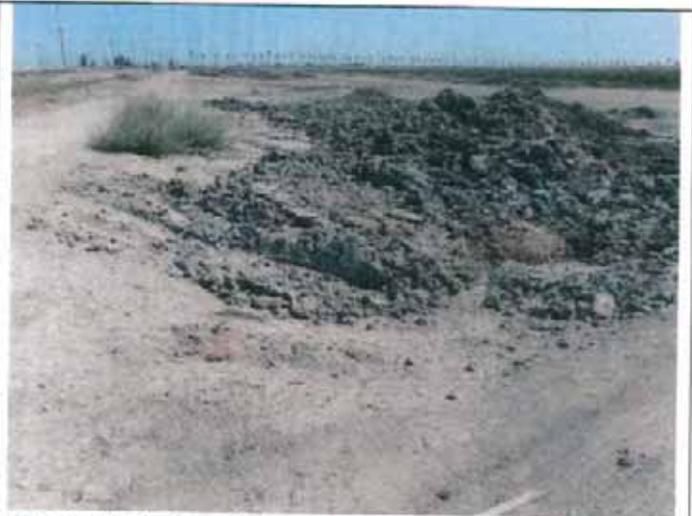
**Photo 4:** Designated manure drying / storage area. No control to convey manure leachate to wastewater lagoon.

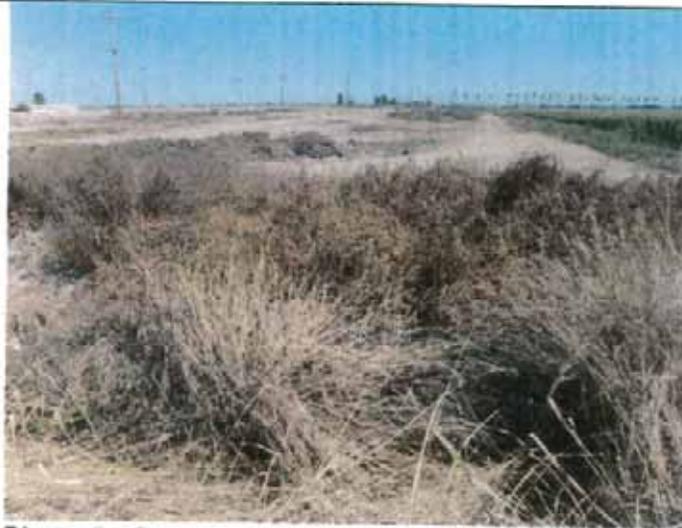
**Photo 5:** Same Designated Manure Drying Area as seen in Photo 4. No control to convey manure leachate to the wastewater storage lagoon.

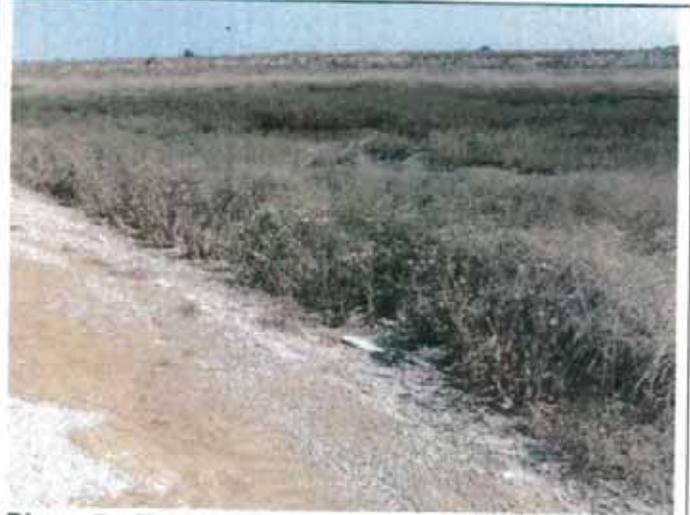
Staff observed considerable ponding of wastewater in a weed filled shallow basin east of the wastewater lagoons and north of the prison shooting range. According to an employee of the dairy / prison (Jag) the conveyance ditch that helps to convey tailwater overflowed into this shallow basin. The electrical conductivity of the water contained in the basin was 2200  $\mu\text{s}/\text{cm}$  (Photos 6-7). Jag didn't know when the overflow occurred; the wastewater needs to be pumped out to the wastewater lagoons as soon as possible.

**Photo 7:** The same low spot pictured in Photo 6.

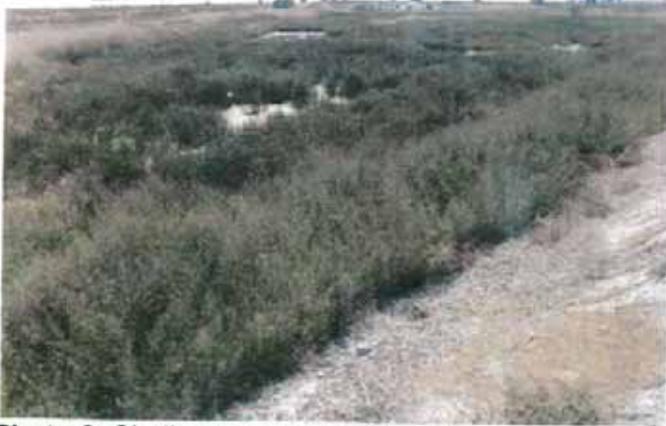
**Photo 6:** Shallow basin containing standing wastewater located east of the wastewater lagoons and north of the facility shooting range.

- c. Ponding east of the lagoons: If ponds are leaking, new liners may need to be installed. Alternatively, clay or soil additives may need to be added. If water from the ditch along the eastern perimeter is seeping, the berms on either side of the ditch may need to be reconstructed with steps taken to prevent gopher holes and future seepage. It may be necessary to install a drain and lift pump in this area to redirect any water back to the ponds. Re-grade the ground and build or reinforce berms to prevent runoff from entering this area in the future.

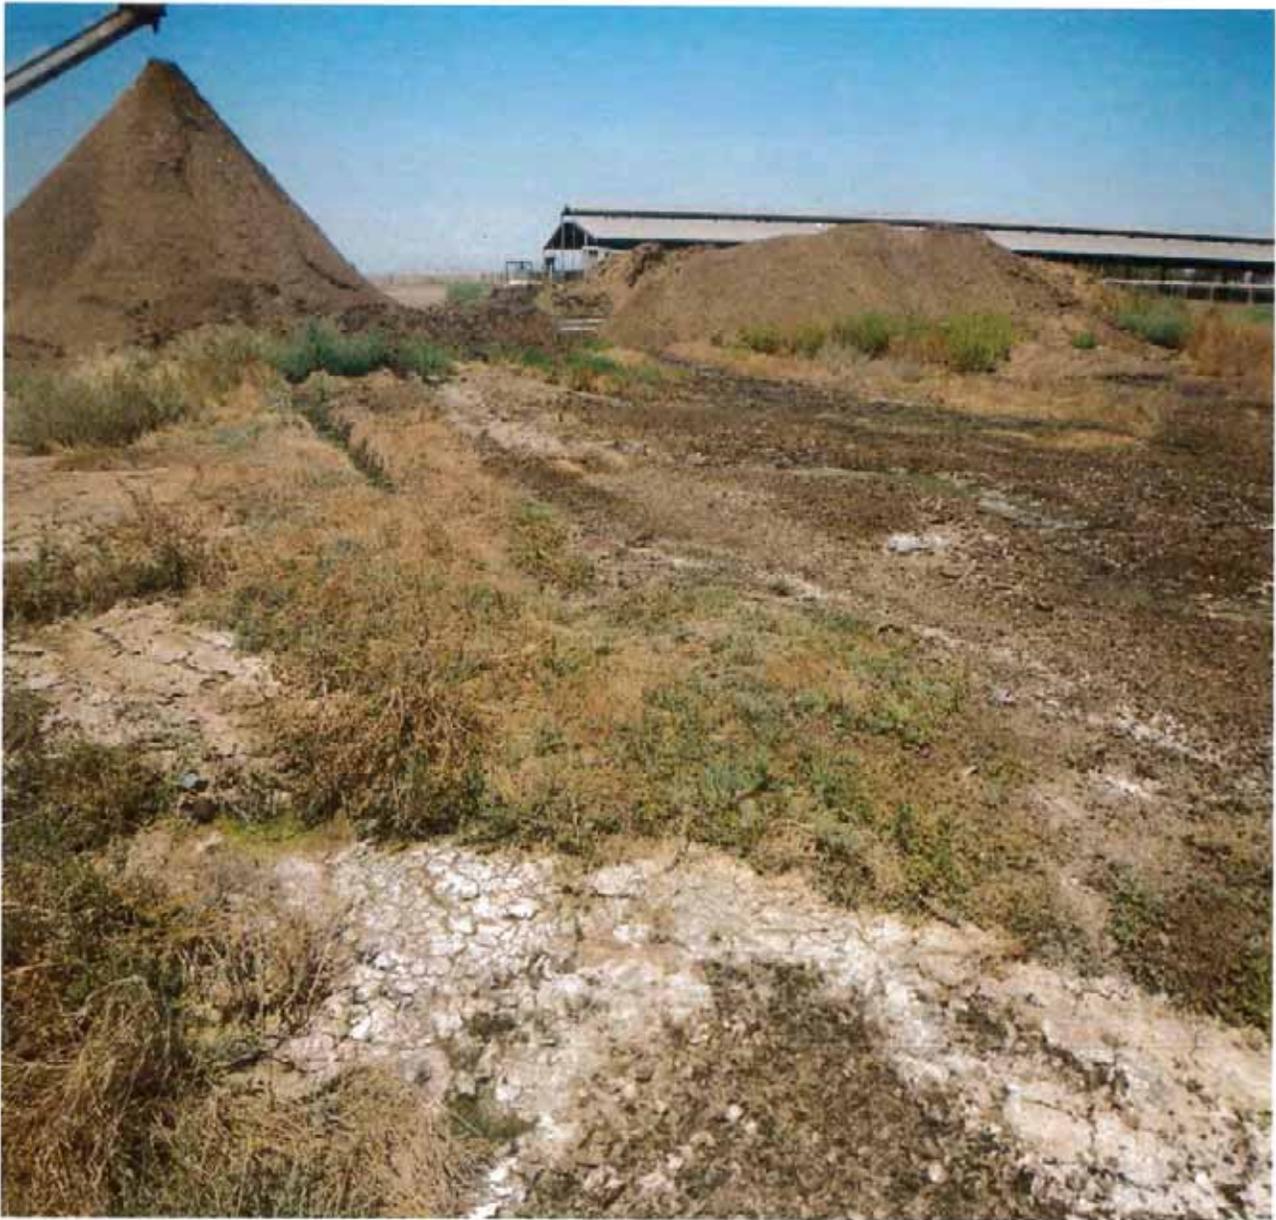
Photo 1: Photo of the uncontained manure stacking area without proper drainage.

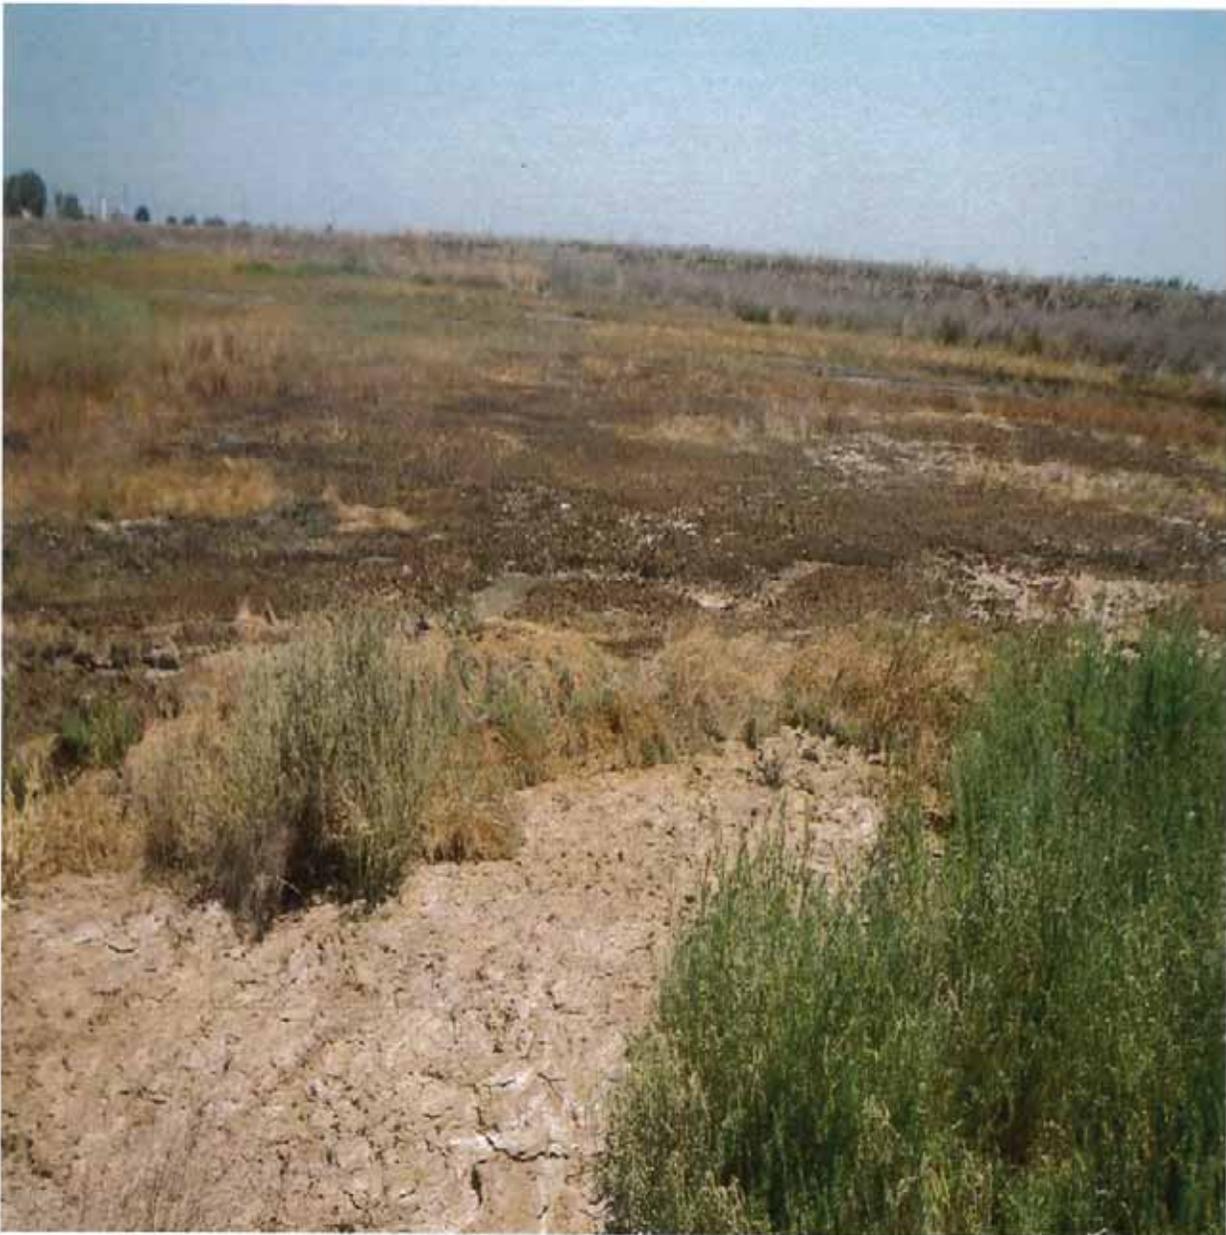
- C. Staff then observed a one-acre area located north of the manure solid separator where manure (liquid & solids) had been discharged (see Photo 2). The one-acre area had significant wastewater ponding issues created by a dysfunctional manure solid separator. The manure separator had been discharging wastewater into the one-acre area every time the separator was turned on (see Photo 3). Mr. Silva told staff someone had been called out to repair it, but the repairmen had found nothing was wrong with it. Staff observed a temporary berm made of manure had been placed to redirect discharging wastewater from the separator to the lagoon; staff was informed the berm was placed prior to the inspection. This is only a temporary fix rather than a permanent one. Staff suggested wastewater bypass the separator until it was repaired properly.

Photo 2: Photo of the one-acre area, north of the separator, where manure (liquid & solid) had been discharged.

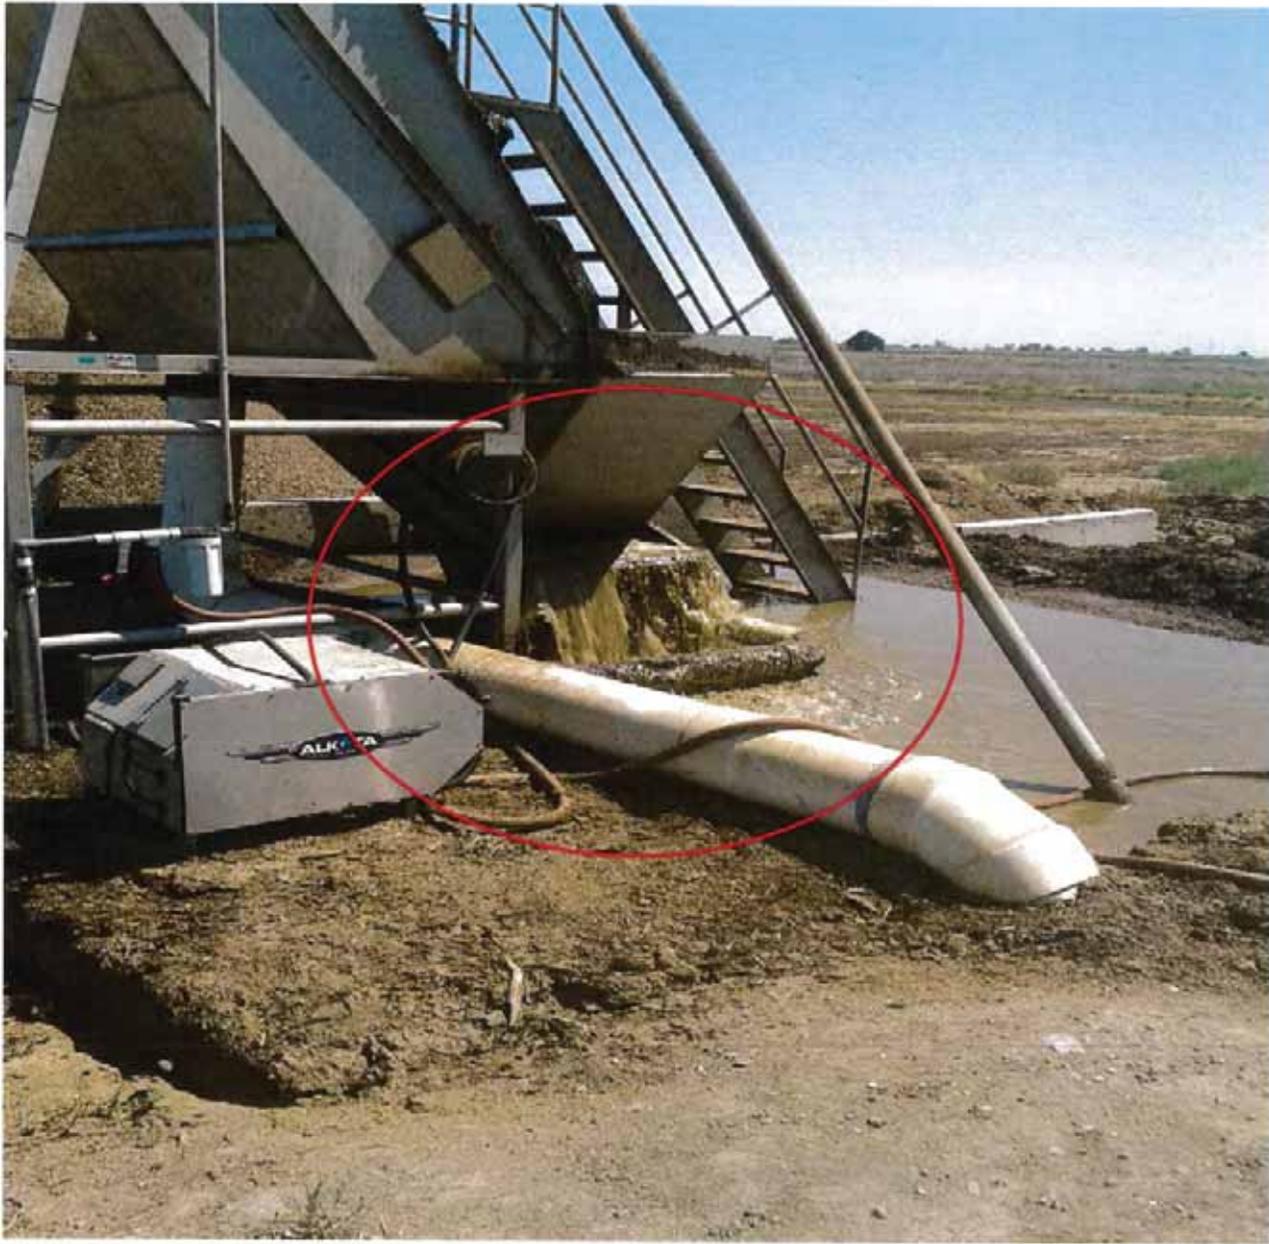
Photo 3: Photo of wastewater spilling from the broken manure solid separator during the inspection.

5. If steps in item number four are taken, discharge to the area around the separator will cease, and all water from the separator itself and from solids leaching will be redirected back to the ponds. It will be necessary to provide documentation of the repair and maintenance of the separator.

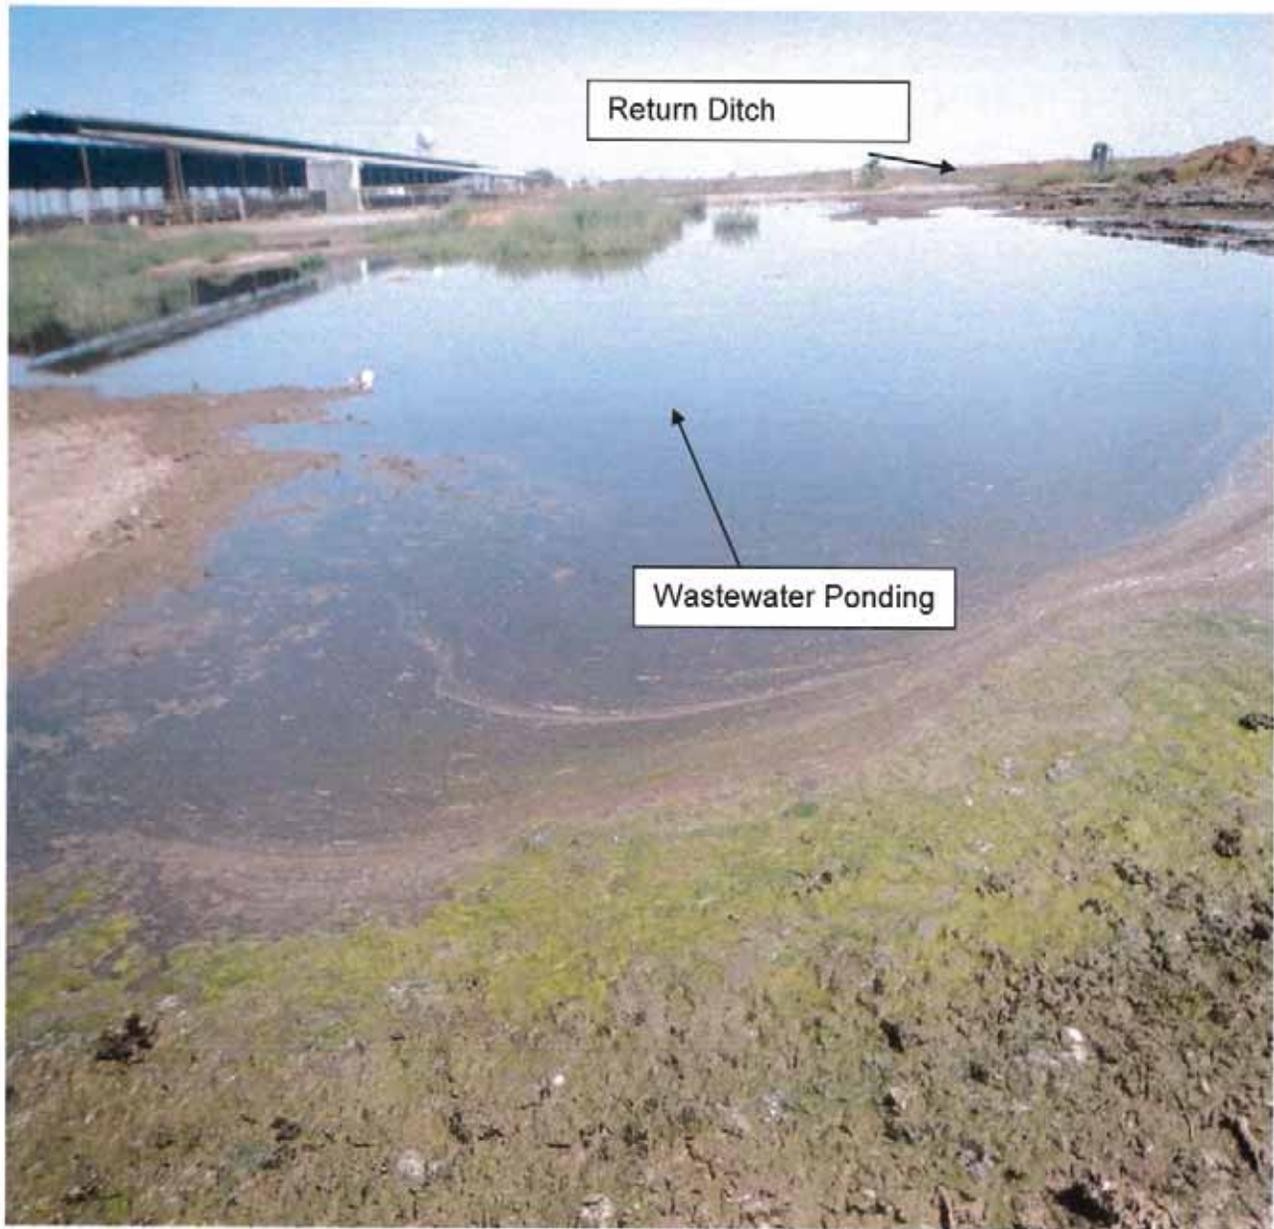
Photo 4: Photo of wastewater ponding in the one-acre area; wastewater from this area appears to have flowed into the return ditch along the east property perimeter.

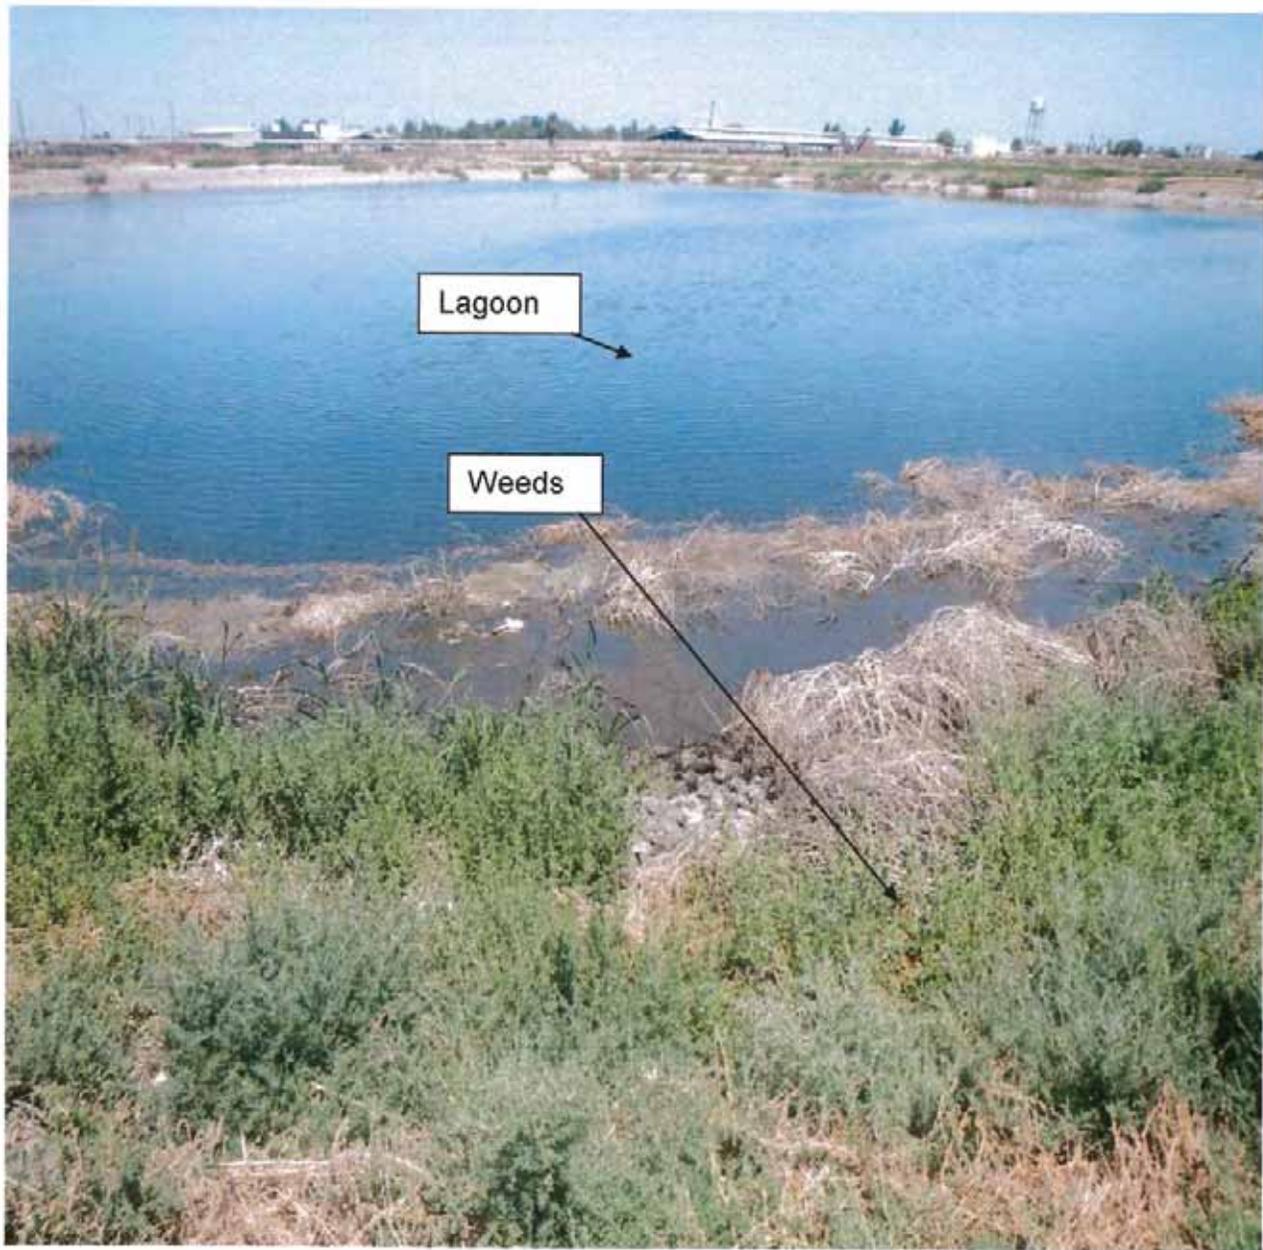
Photo 5: Photo of a lagoon with excessive vegetation on its inner and outer embankments.

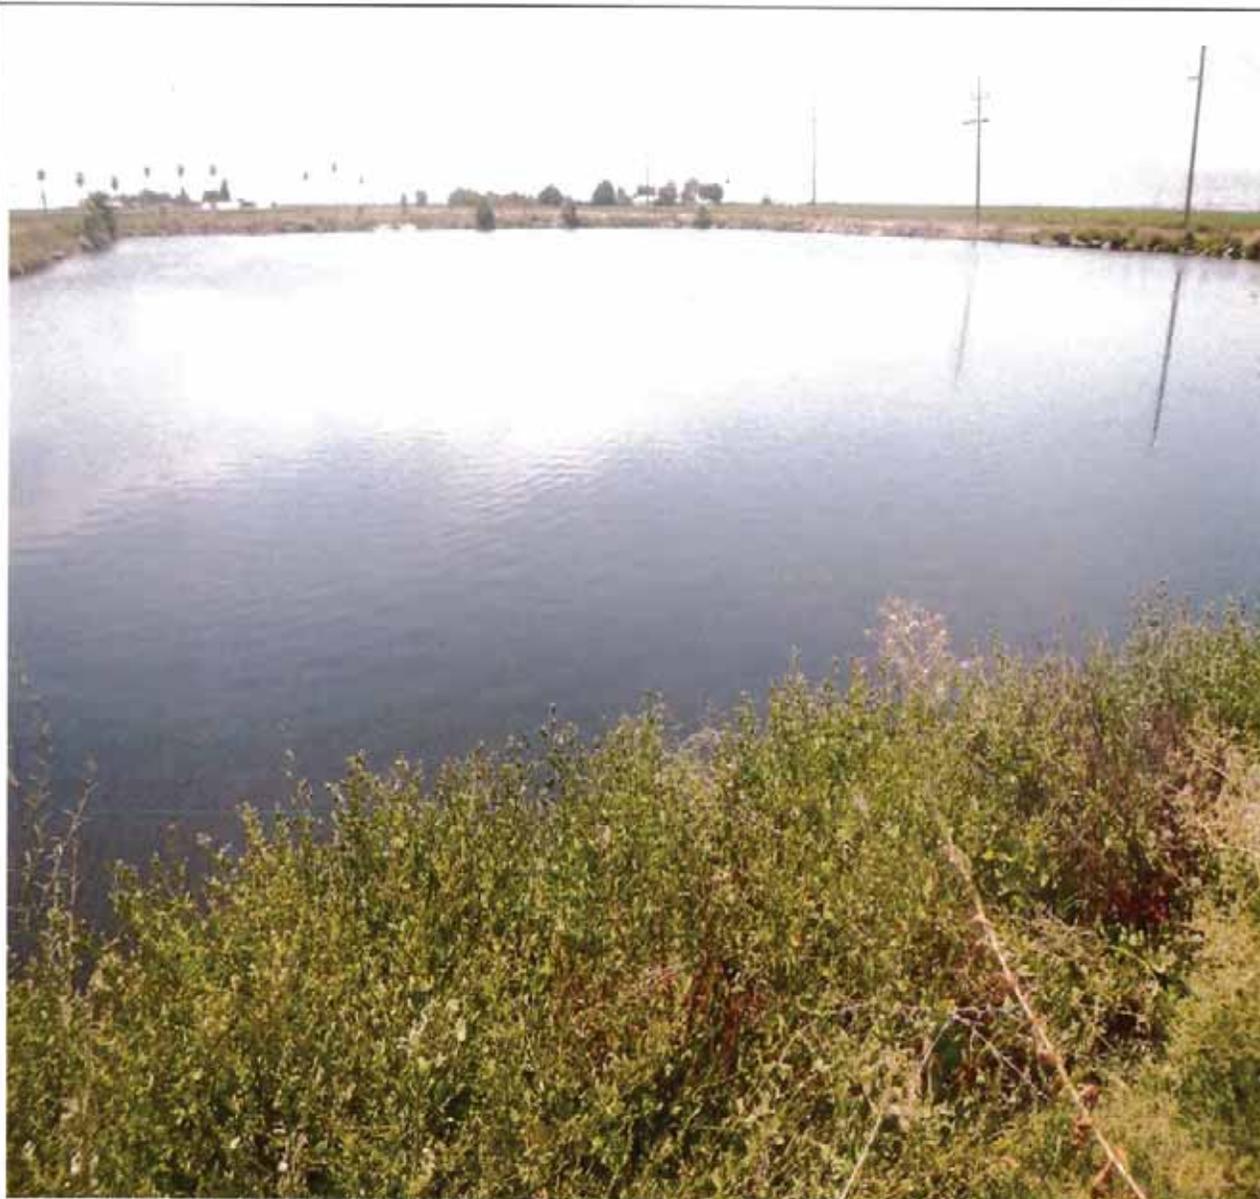
Photo 6: Photo of the "freshwater pond" containing wastewater blended with fresh water.

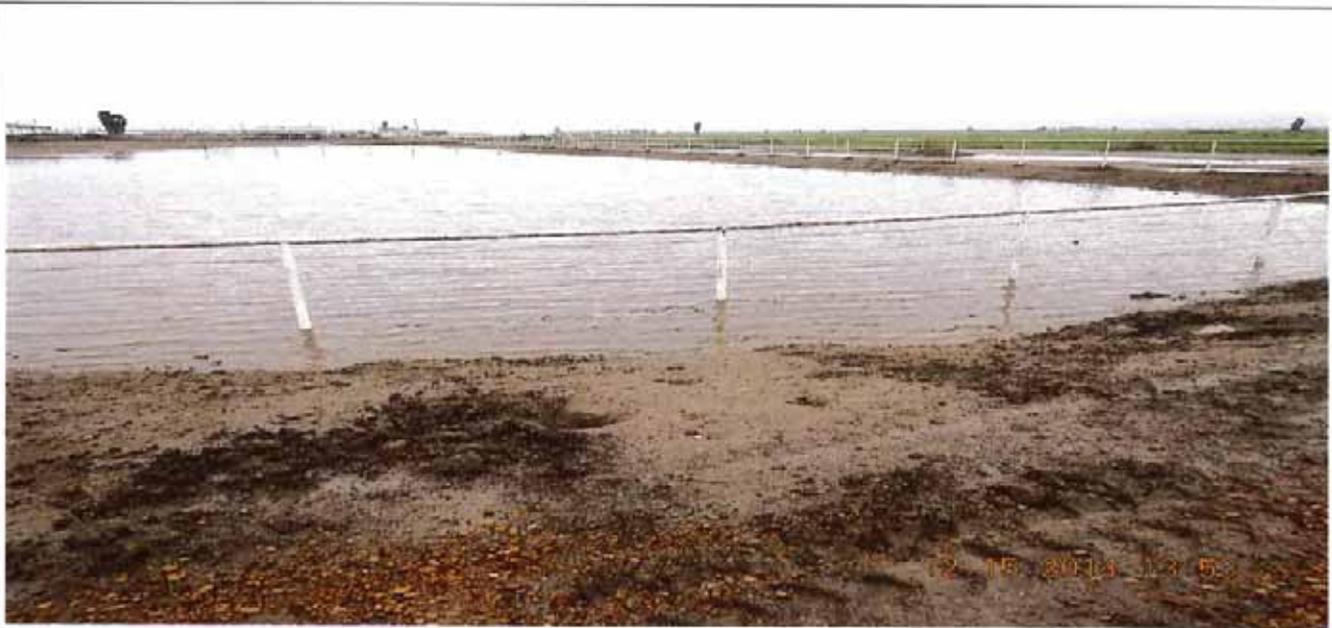
Photo 1: Photo of major corral ponding without proper drainage capabilities.

**In the short term, water will be pumped from the feed storage area and from the corrals within 36 hours after a rain event. In the long term, it will be necessary to locate all the drains and repair any malfunctioning lift pumps on site so that the drainage can be returned to the dairy ponds. In addition, the entire silage pit will be reconstructed. The expected completion date for this retrofit is approximately 18 months from today (July 9, 2016).**

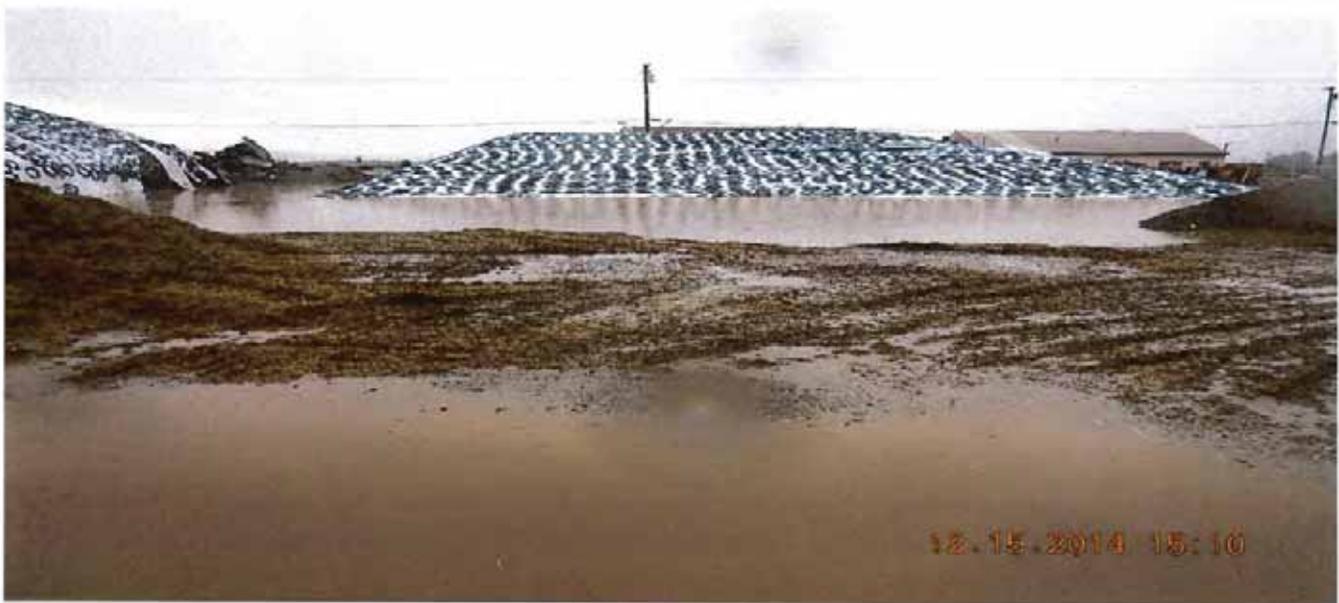
Photo 2: Photo of major ponding at the feed storage area.

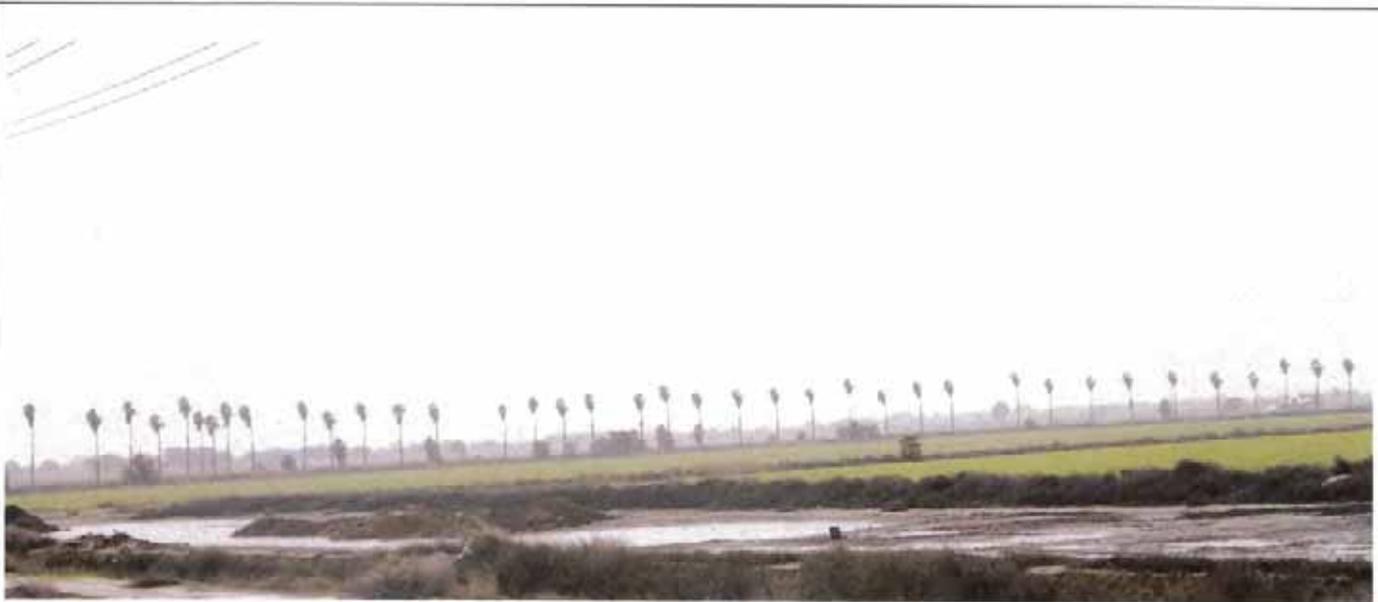
Photo 3: Photo of major wastewater ponding at the manure staking area.

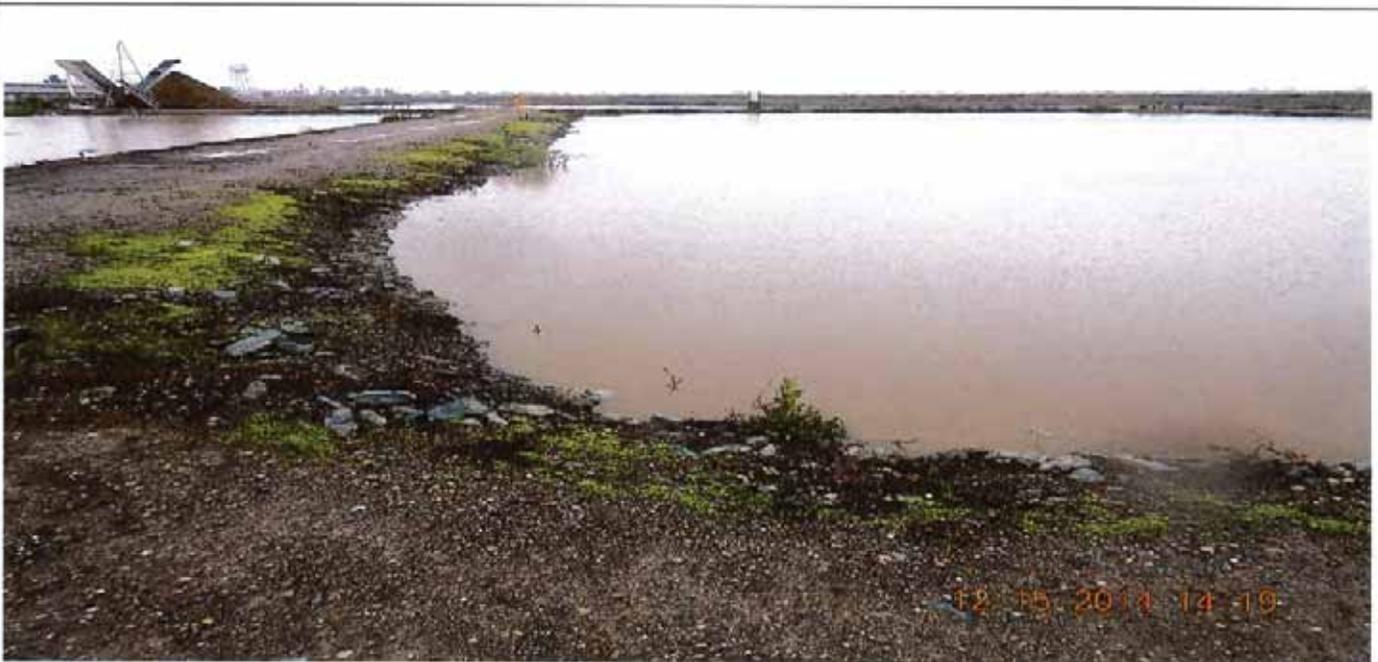
- c. Dairy lagoons had less than the two feet of freeboard required for above-grade lagoons under the Reissued Dairy General Order.

*The failure to maintain the required minimum amount of freeboard is a violation of Pond Specification 1 of the Reissued Dairy General Order.*

Photo 4: Photo of the lagoons onsite at capacity without the required freeboard.

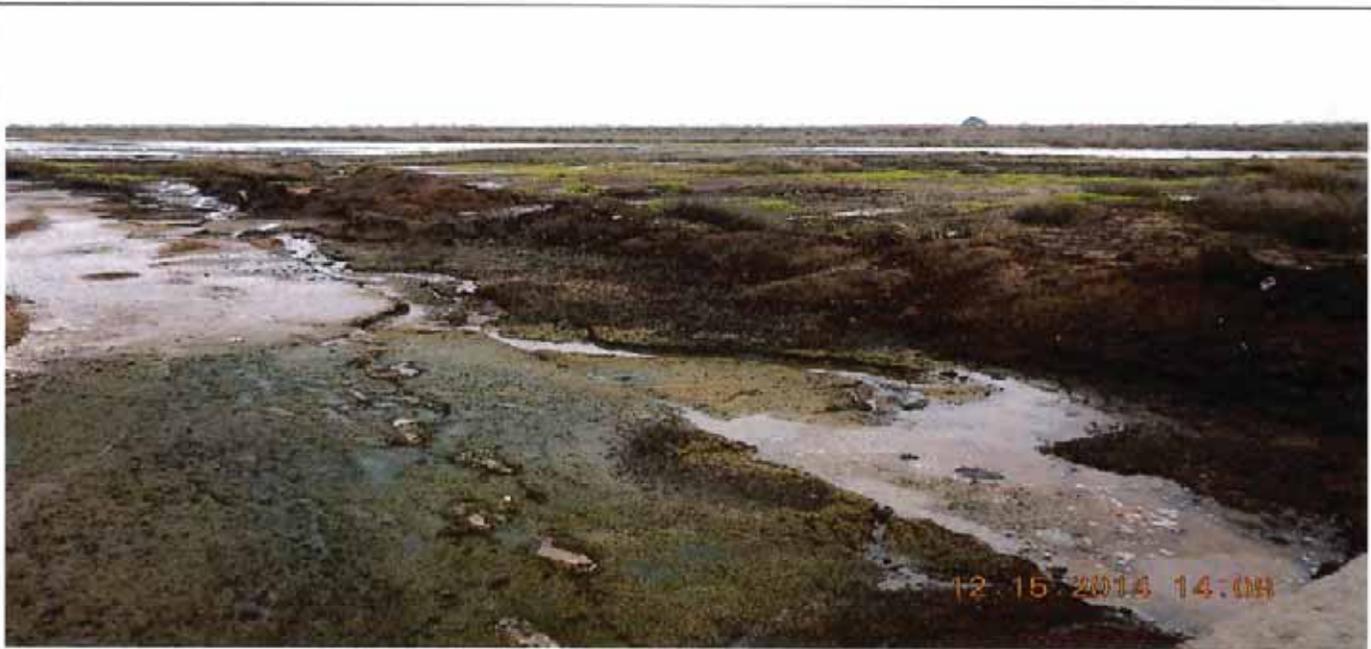
Photo 5: Photo of uncontained manure at the one-acre undefined area north of the manure separator.

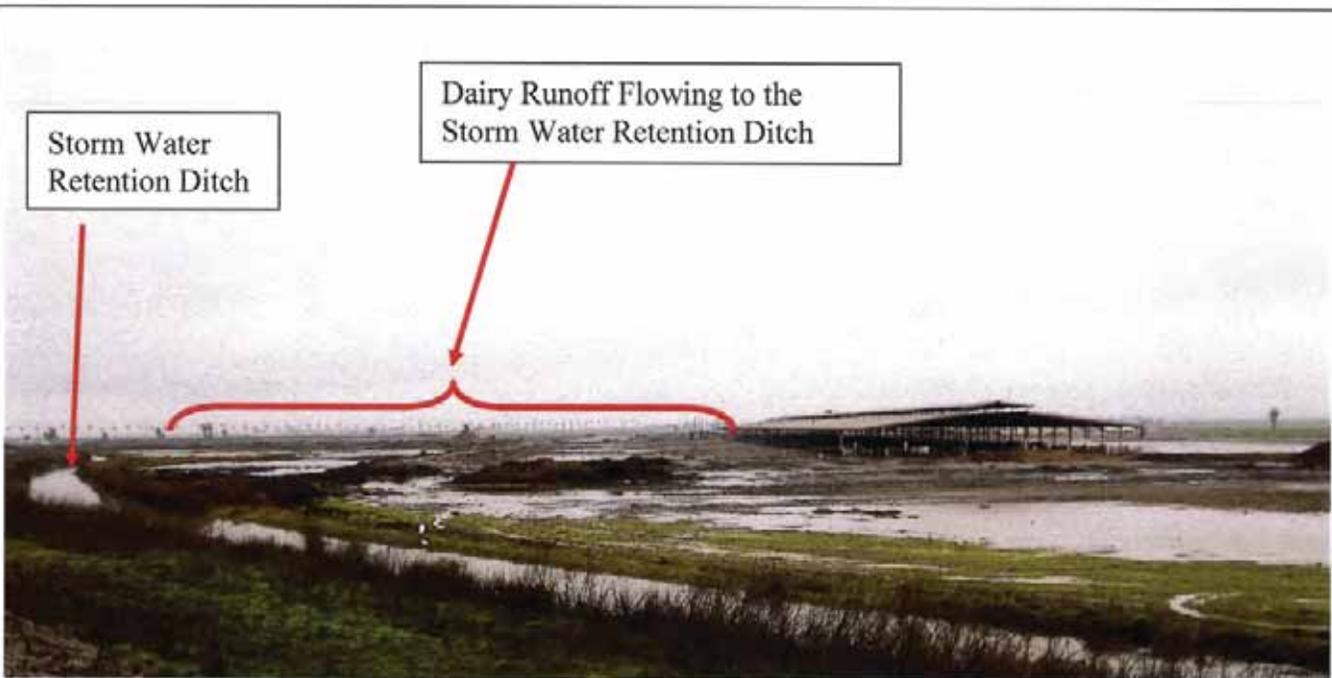
Photo 6: Photo of the dairy production area east perimeter with lots of runoff flowing into an on-property storm water retention ditch.
