**VAUGHN, LLC  
RESPONSE TO RWQCB SECTION 13267 ORDER  
POND INFORMATION AND SAMPLING RESULTS**

**MIDWAY-SUNSET OIL FIELD  
USL 15 LEASE  
SECTION15 T32S/R23E MDB&M**

**May 28, 2015**

#### **INSPECTION REPORT – VAUGHN, LLC, USL 15 LEASE, MIDWAY – SUNSET OIL FIELD, KERN COUNTY**

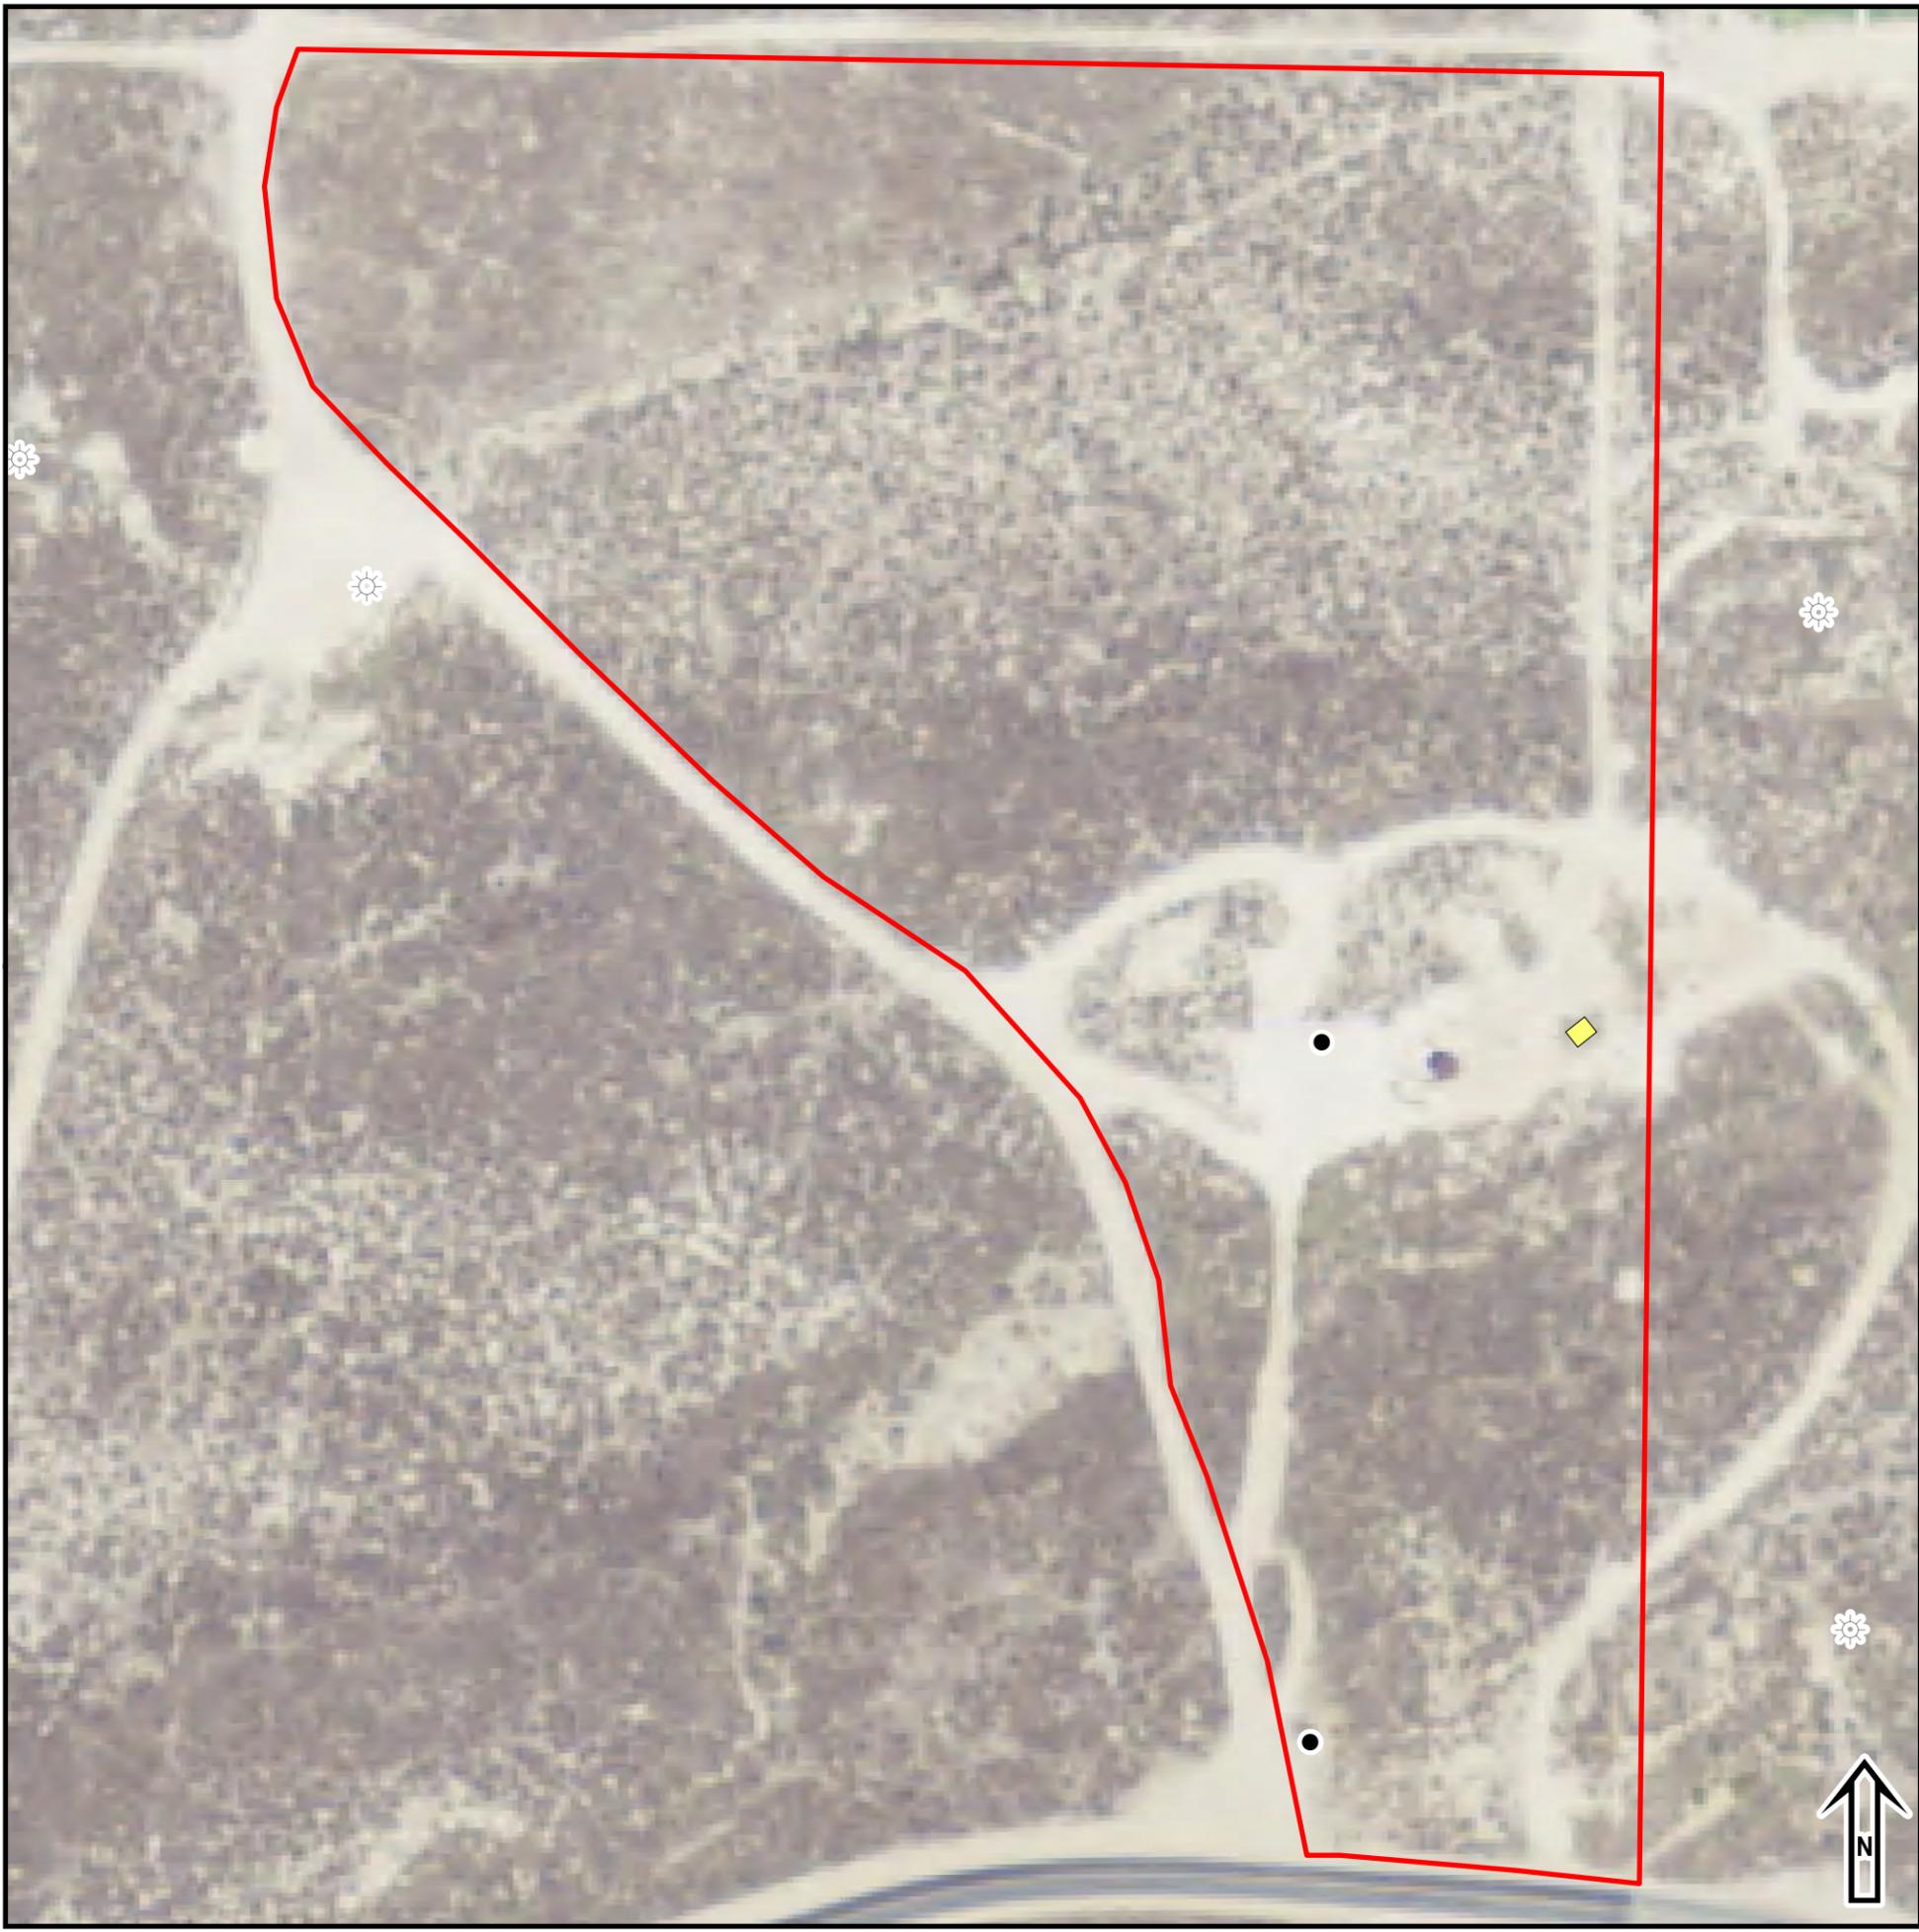
USL 15 POND MAP

One pond was identified containing discharges of produced water. A map of the pond and surrounding lease is included as Attachment A.

USL 15 Lease	<b>DOGGR Wells</b>
USL 15 Pond (6ft Deep)	Active
	Plugged

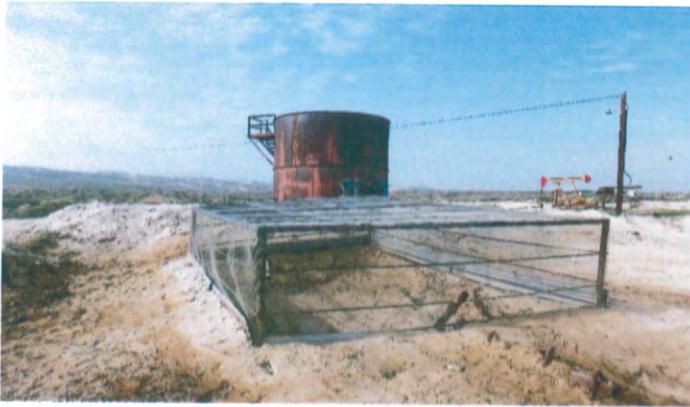
- An active unlined earthen pond with netting.
- Pond bottom had wet soil but no oil was present.
- Pond area soil had very sandy-soil

Photo 1. A tank and small earthen pond

If Vaughn plans to close the pond, please submit closure plans prepared by a California registered professional. In addition, please submit a history of waste discharge (volumes & dates) to the ponds.

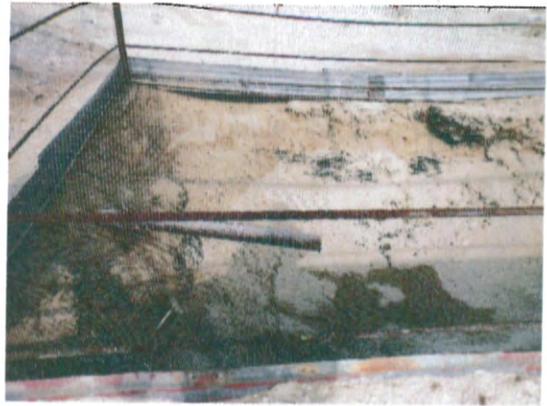
Staff observed an unlined earthen pond that had wet soil in the pond bottom. Discharge to the pond was the only method of wastewater disposal.

Photo 2. Wet soil at pond bottom

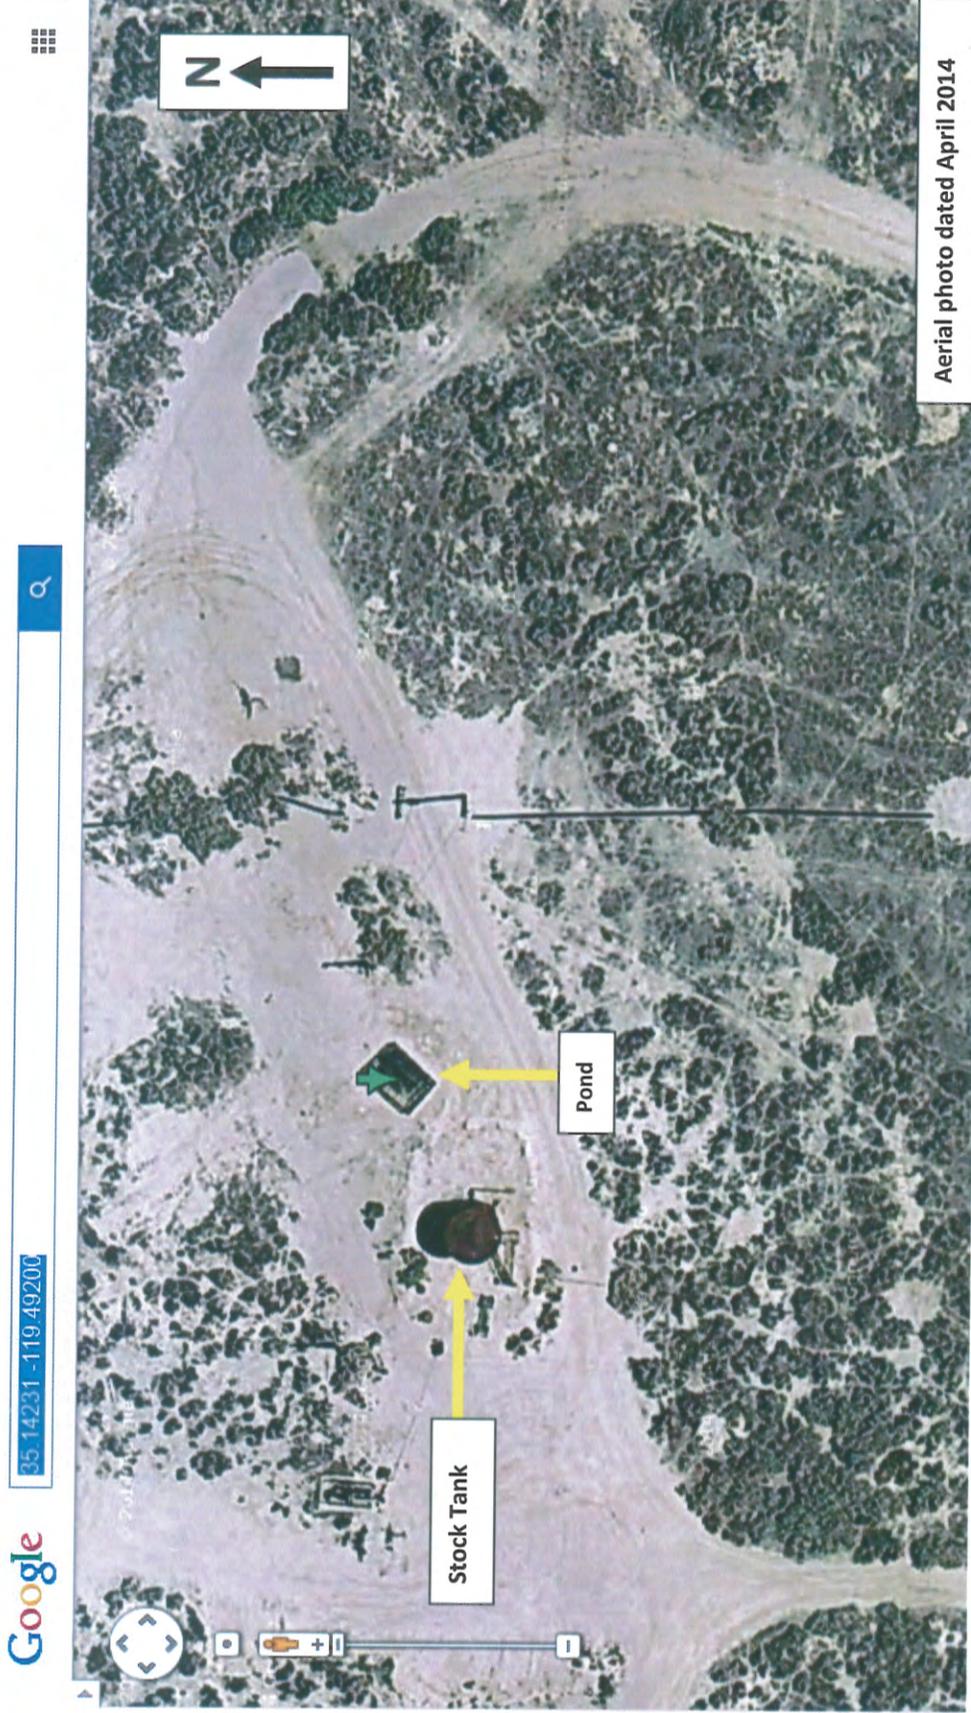
# ATTACHMENT 1 - Facility Map

See Attachment 1 for an aerial photo of the facility area with a tank and one pond.
