GROUNDWATER FLOW DIRECTION Second Quarter 2010 to Third Quarter 2015*

Comments on Proposed Cleanup and Abatement Order No. R6T-2015-PROP Lake Tahoe Laundry Works South Lake Tahoe, California

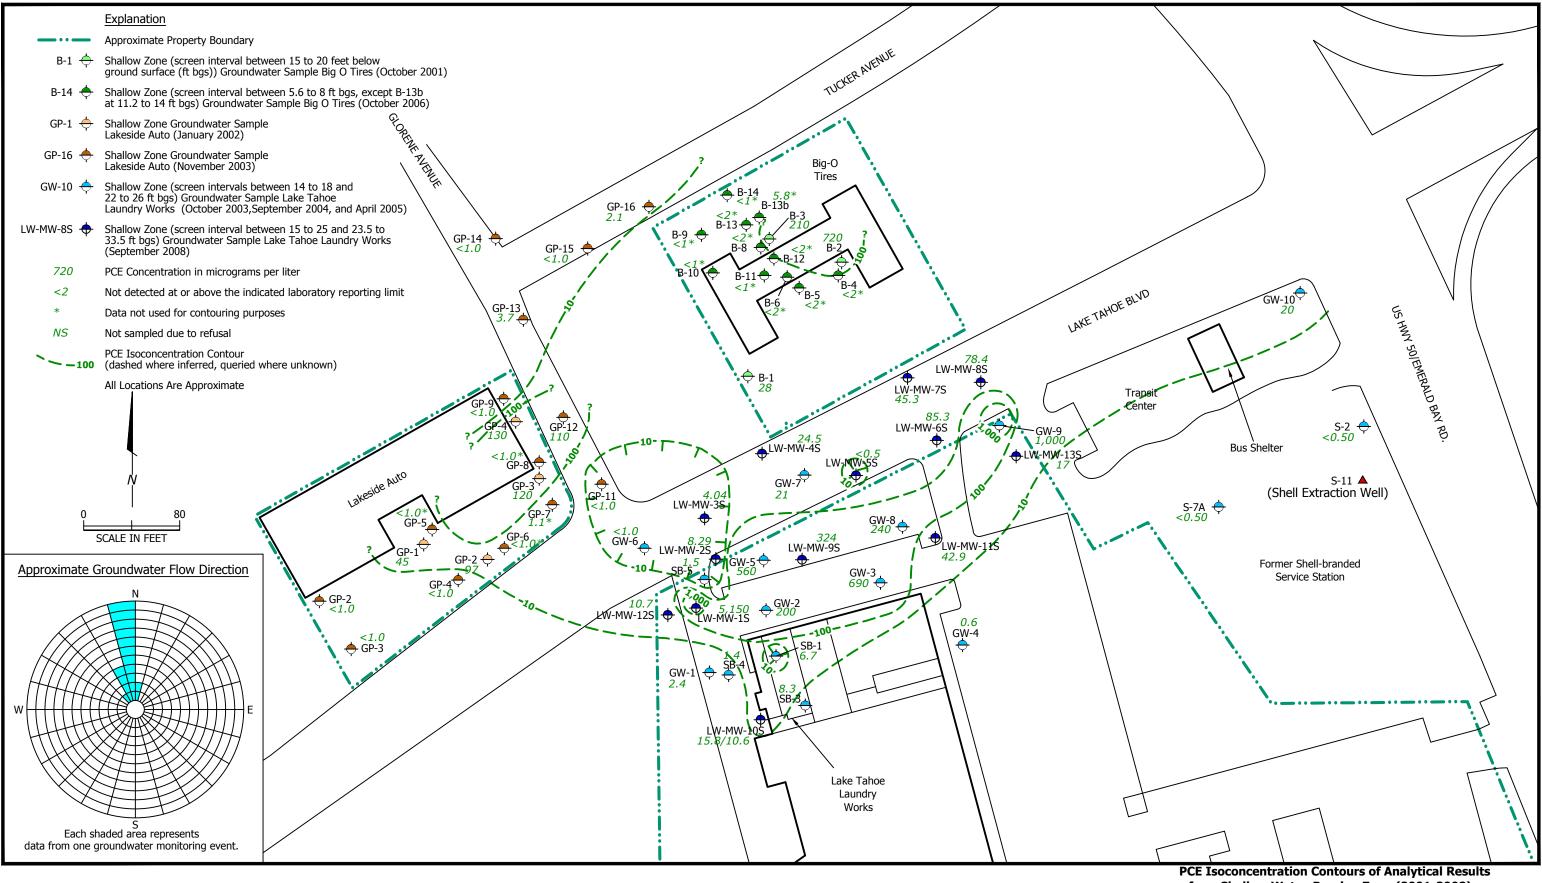
PLATE

from Shallow Water-Bearing Zone (2001-2008)

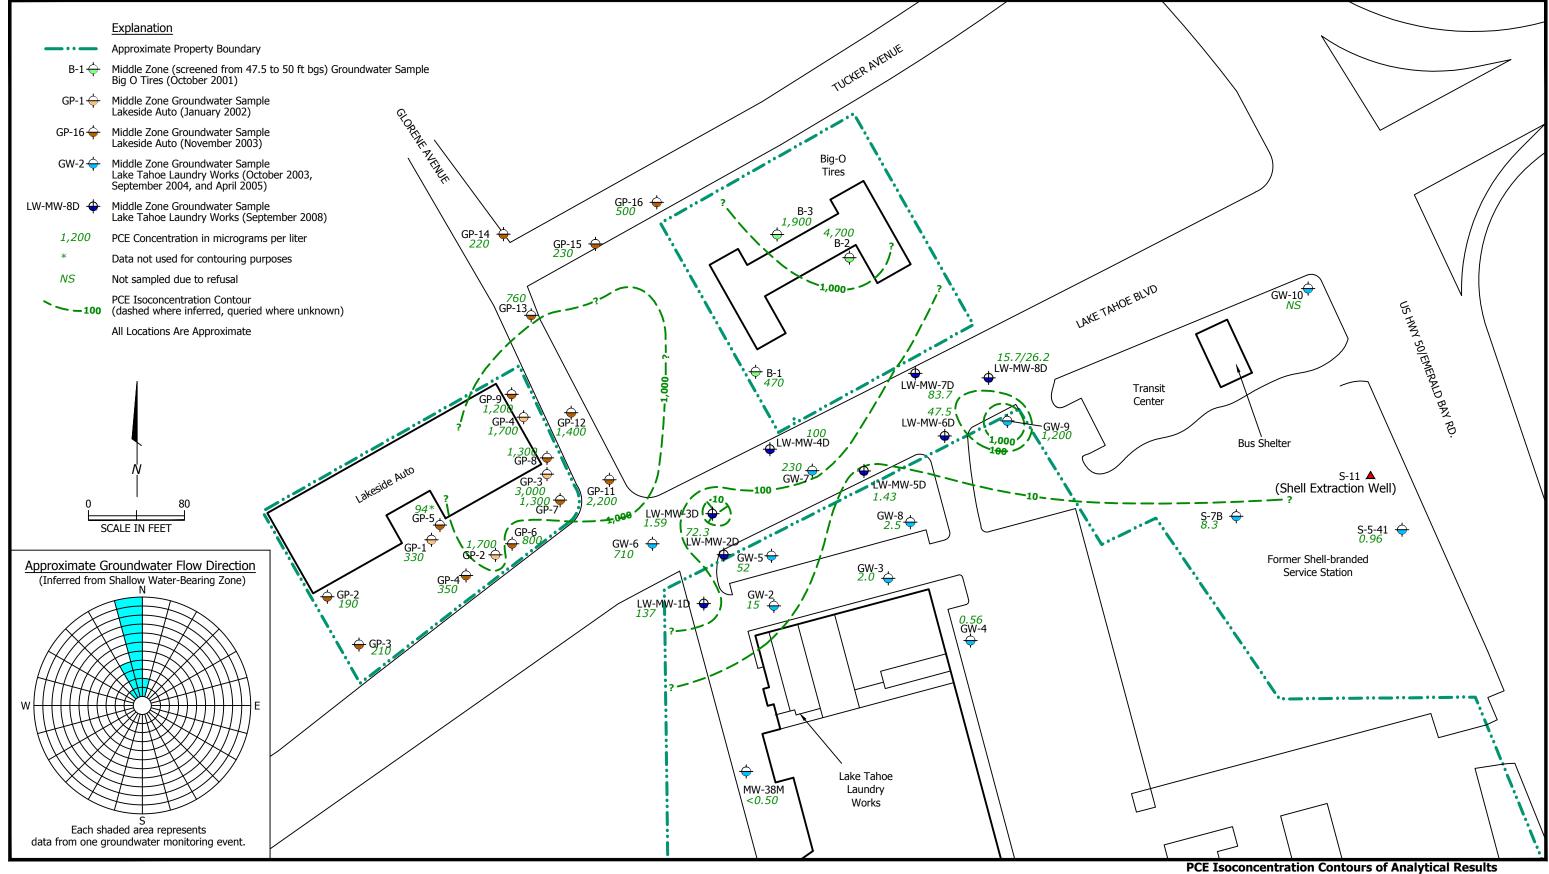
Lake Tahoe Laundry Works South Lake Tahoe, California PLATE

from Middle Water-Bearing Zone (2001-2008) Comments on Proposed Cleanup and Abatement Order No. R6T-2015-PROP
