# SWANSON HYDROLOGY + GEOMORPHOLOGY

draft final report

## Upper Truckee River Upper Reach Environmental Assessment

for the Bureau of Reclamation, Tahoe Resource Conservation District, and  
Regional Water Quality Control Board - Lahontan Region

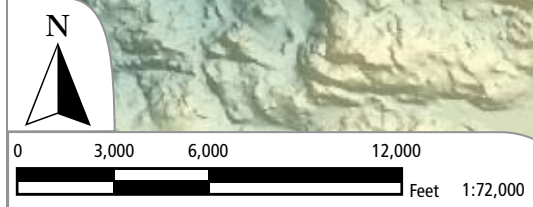
FIGURE 1.1: Project Location Map.

The Upper Truckee River (UTR) is the largest, longest water course, draining over 54 square miles in the Lake Tahoe Basin (Figure 1.1). The UTR originates in undeveloped wilderness, ten miles south of Lake Tahoe along the Sierra Nevada crest at Red Lake Peak (elevation 10,063 feet), then flows northward through a spectacular alpine terrain of lakes, meadows, forests and volcanic and granitic bluffs. It cascades down multiple waterfalls into the narrow, glacially-formed Christmas Valley and at that point enters the urban lands of Meyers and South Lake Tahoe. From South Upper Truckee Road crossing to Lake Tahoe, the UTR becomes more affected by roads, houses, bridges and other elements of urban landscape. The River flows over 15 miles through neighborhoods, old quarries, a golf course, an Airport and grazing lands before flowing away from its original delta lagoon system in the Barton Meadow. It then flows into a channelized section past the Tahoe Keys Project before discharging into Lake Tahoe.

The Upper Truckee River flows from Red Lake Peak near Carson Pass to Lake Tahoe near the Tahoe Keys Marina, a distance of over 20 miles. The watershed can be segmented into five distinct areas as shown in Figure 1.1:

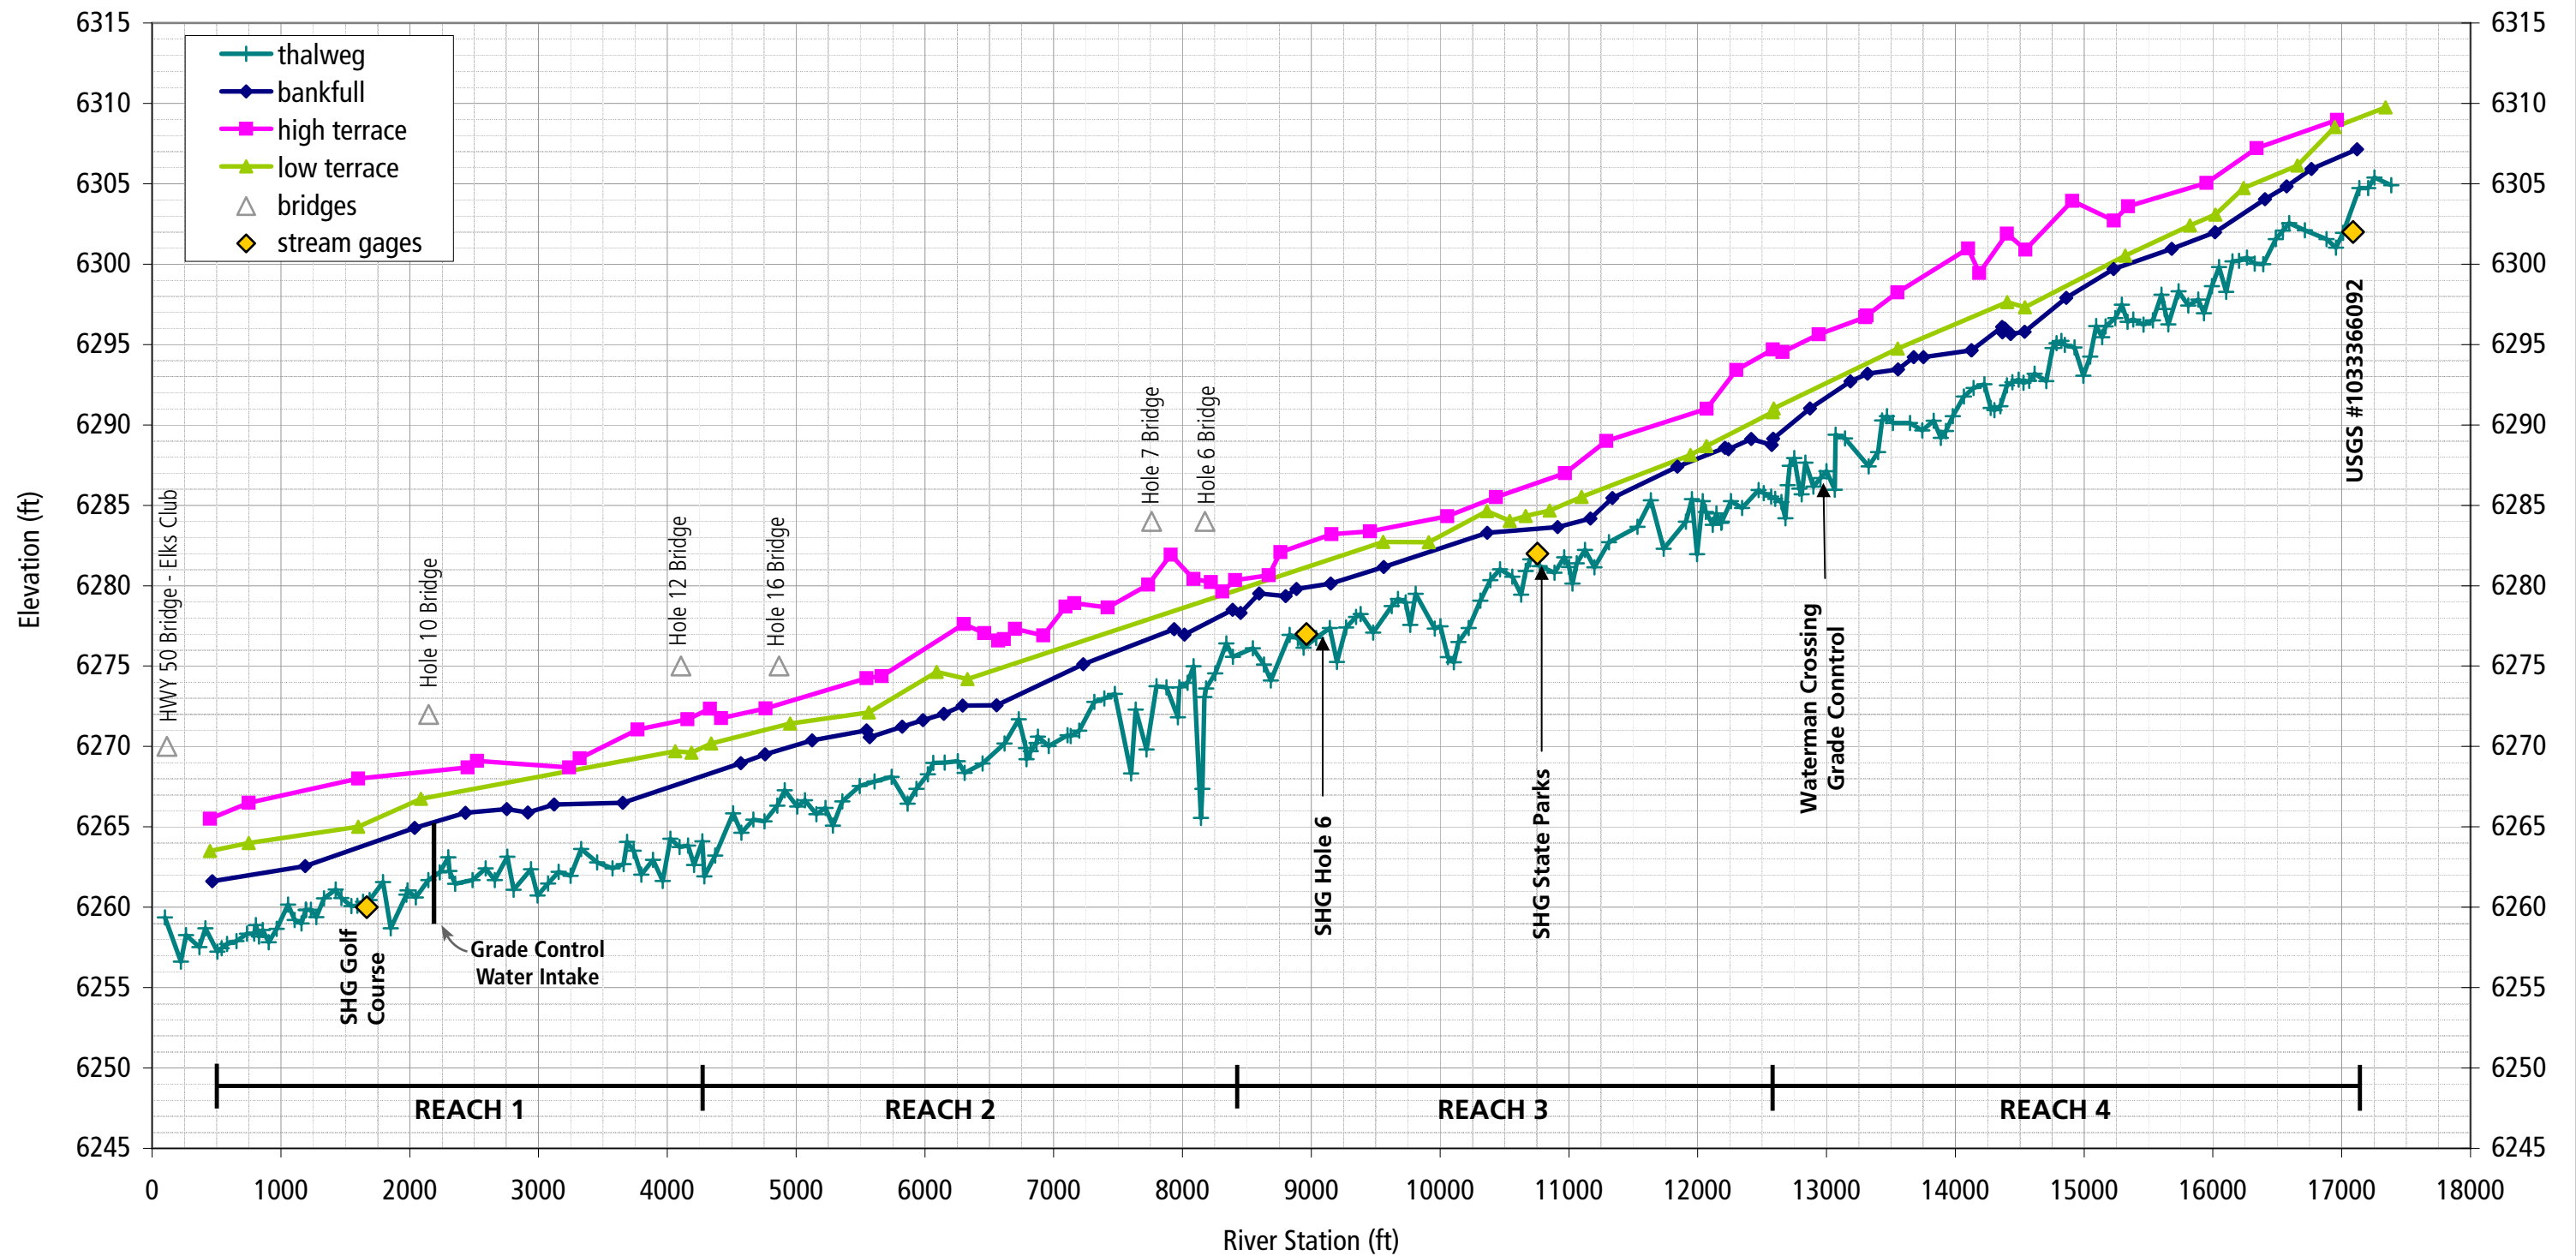
FIGURE 2.5: Longitudinal profile of Upper Truckee River from Elks Club Highway 50 crossing to Meyers Highway 50 crossing (Reaches 1-4). Bankfull, low terrace and high terrace features were also surveyed in the field.

The 2003 longitudinal profile for the Elks Club Highway 50 crossing to Meyers Highway 50 crossing reach reveals several key features (Figure 2.5), including a flattened area in the lowermost reach, where meander cutoffs and channel deepening have been pronounced, followed by gradually steeper sections upstream. Two prominent grade control structures are found at station 2100 and 13000; the 2003 profile also reveals several significant active headcuts or knickpoints in

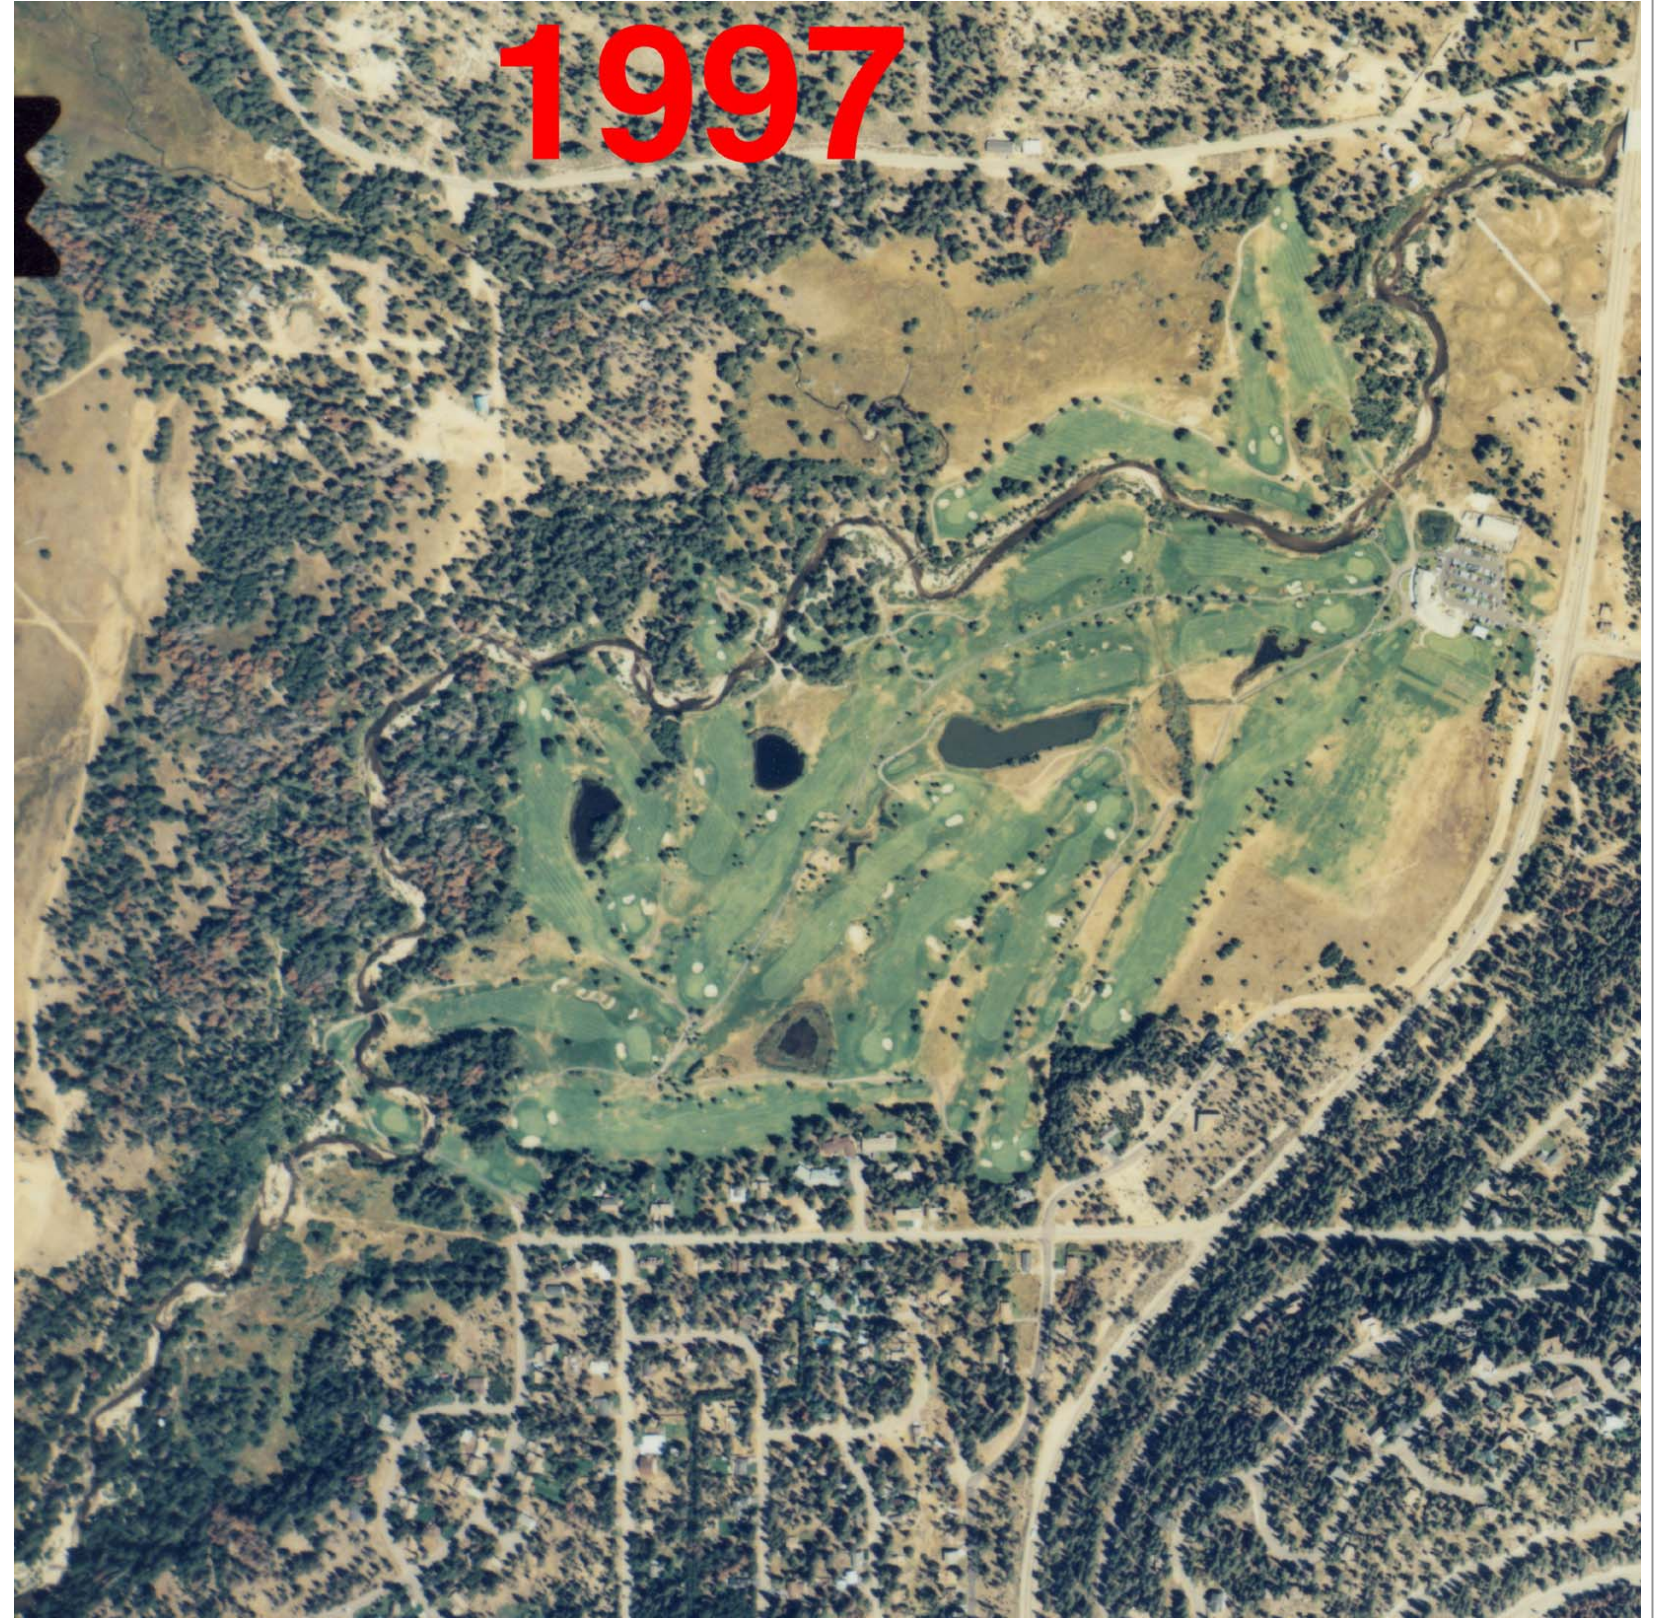
FIGURE 2.6: Aerial photographs of the Upper Truckee River from 1940 and 1997.

The earliest aerial photograph available of the UTR is 1940 (Figure 2.6), which is 80 years following the introduction of intensive European land use during the Comstock Era. These photos show the river system already affected by grazing, reclamation, logging and roads and bridges. In order to estimate pre-1860 conditions, other indirect evidence must be used. Using a combination of aerial photographs and recent topographic data (1-foot contour LIDAR Map supplied by TRPA) an “original” channel pattern was developed (Figures 2.7A-D) along with the channel pattern shown in 1940 and 2003 aeriels. The “original pattern” is that represented by drawing and connecting visible meander scars on Holocene floodplain areas, the 1940s from the 1940 aerial photographs, and 2003 from the LIDAR image and topographic map. The resultant channel pattern plot reveals an overall loss of pattern sinuosity of 20 percent in the Meyers Reach from 1.70 to 1.35; the loss in the Christmas Valley Reach is less, but measurable and significant in discrete reaches. A comparison of sinuosity of Reaches 1 – 4 in the original, 1940 and 2003 channels can be found in Table 2.1.

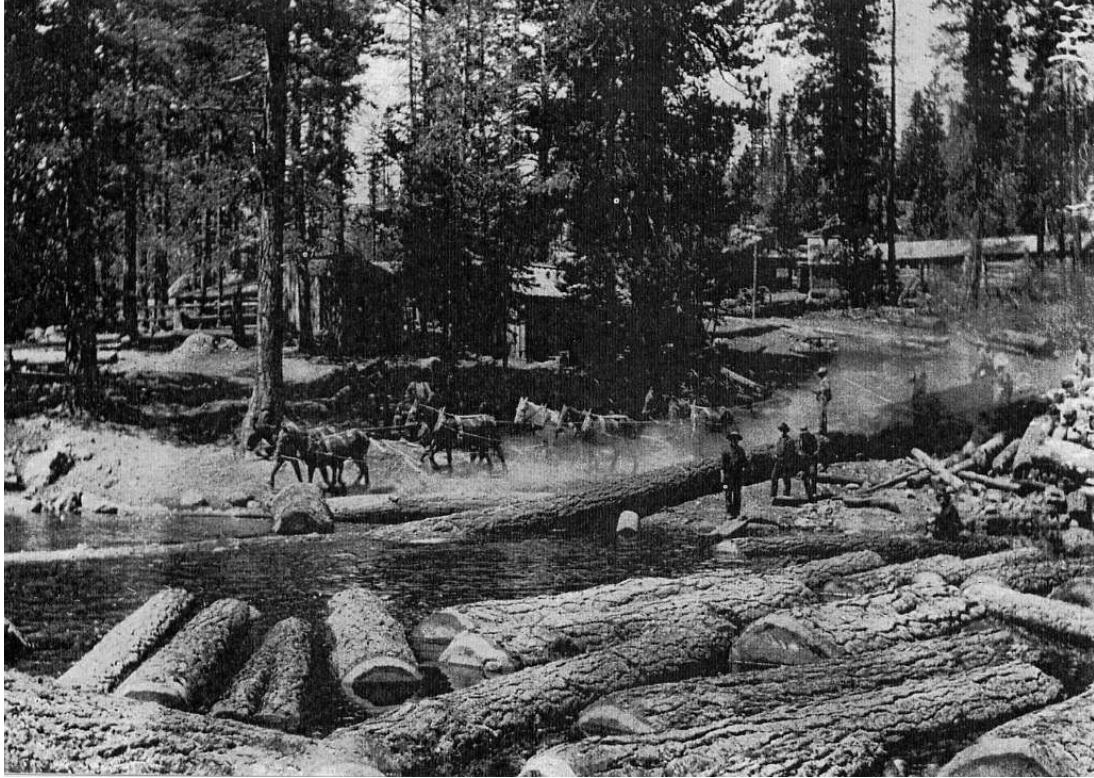
**FIGURE 2.9:** Photo of loggers using splash dam to transport logs. Saw logs were floated down the Upper Truckee River to Lake Tahoe. The site may be near the confluence of Angora Creek and the Upper Truckee River. (Photograph courtesy of Special Collections Department, University of Nevada, Reno.)

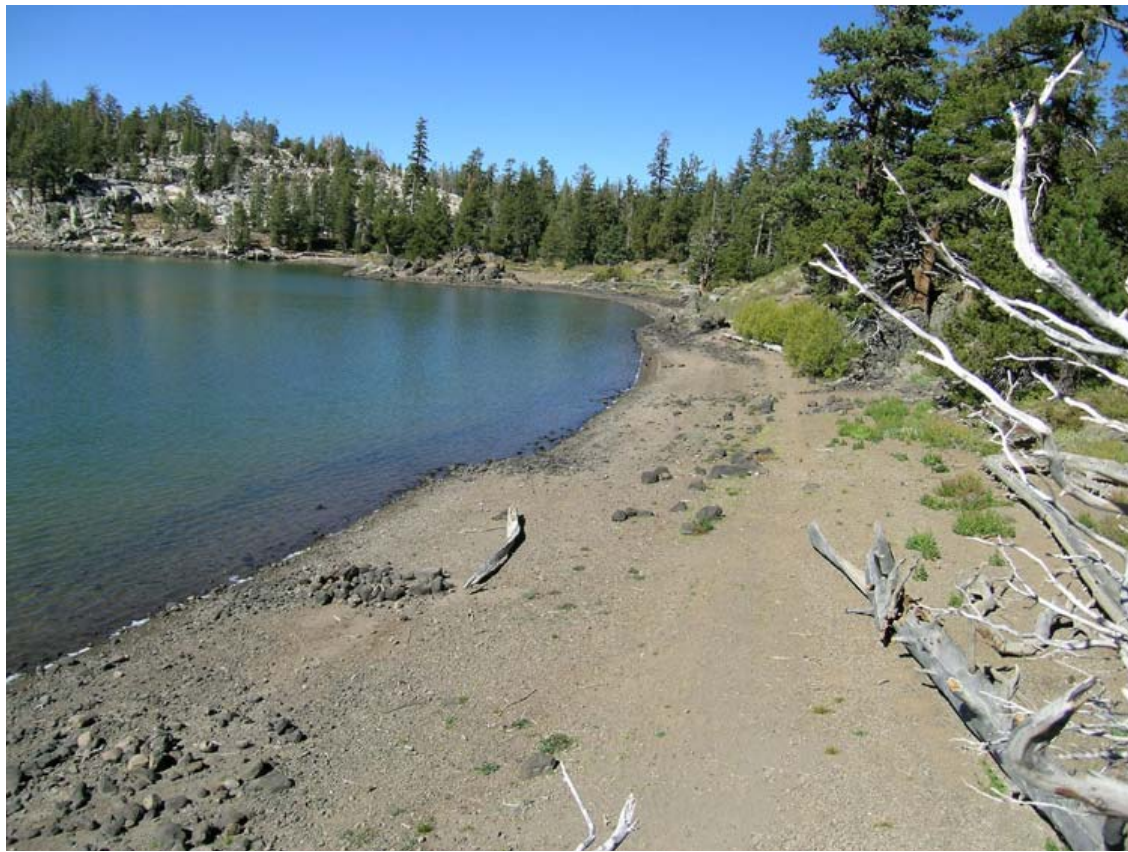
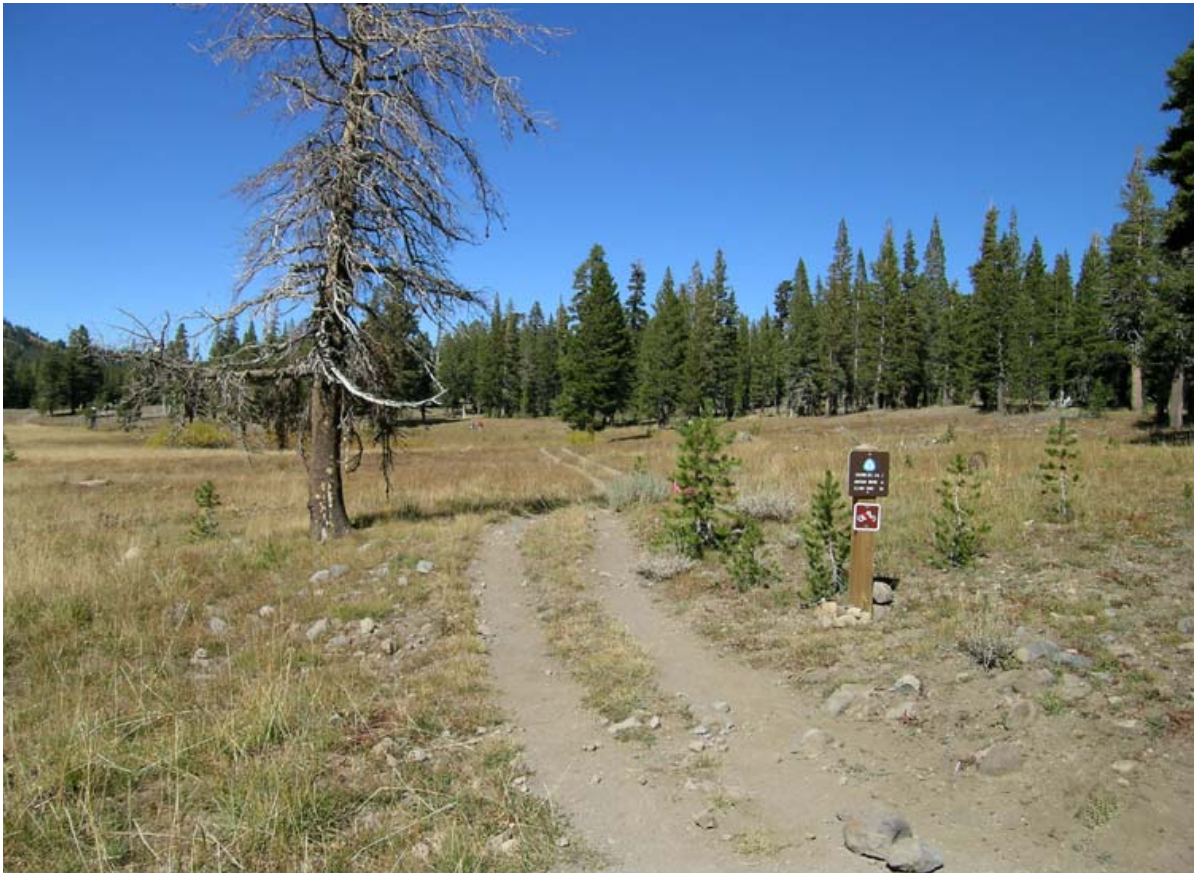
**FIGURE 2.11:** Photos of Meiss Meadow taken in 1910 and 2003. Notice the heavy cattle grazing in the 1910 photo.

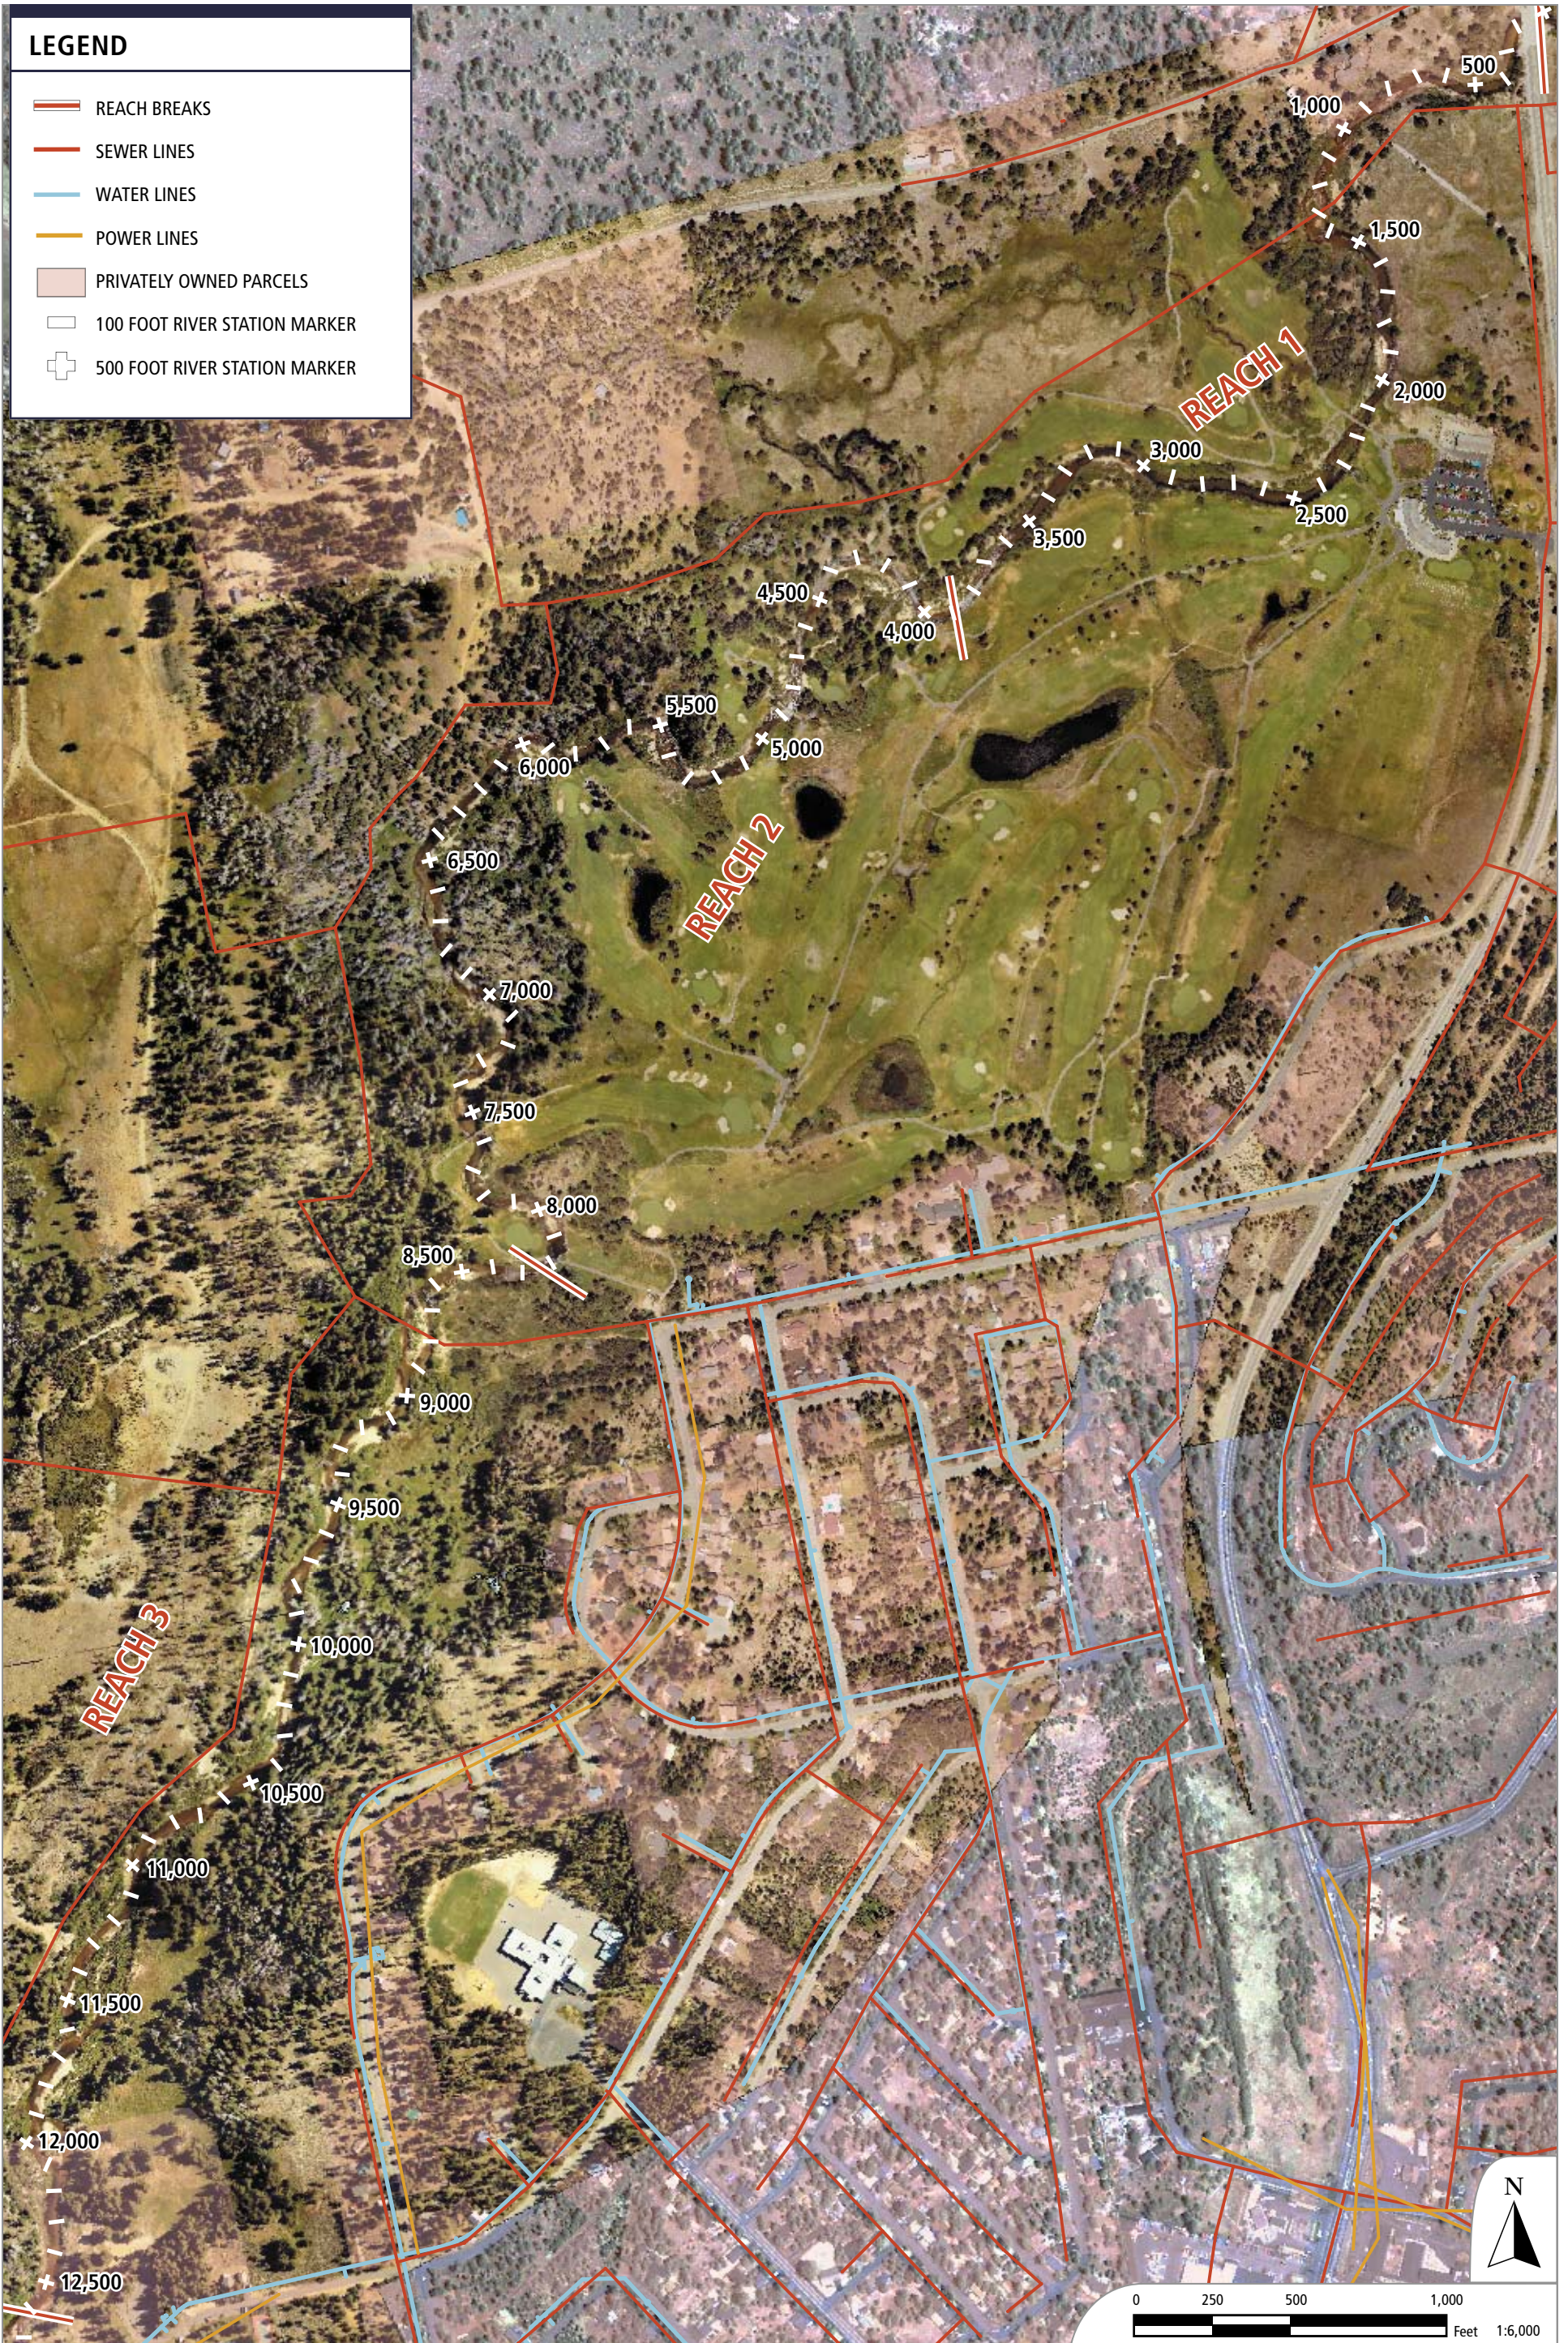
FIGURE 3.13A: Map indicating the location of underground utilities relative to the Upper Truckee River (Reaches 1-3).

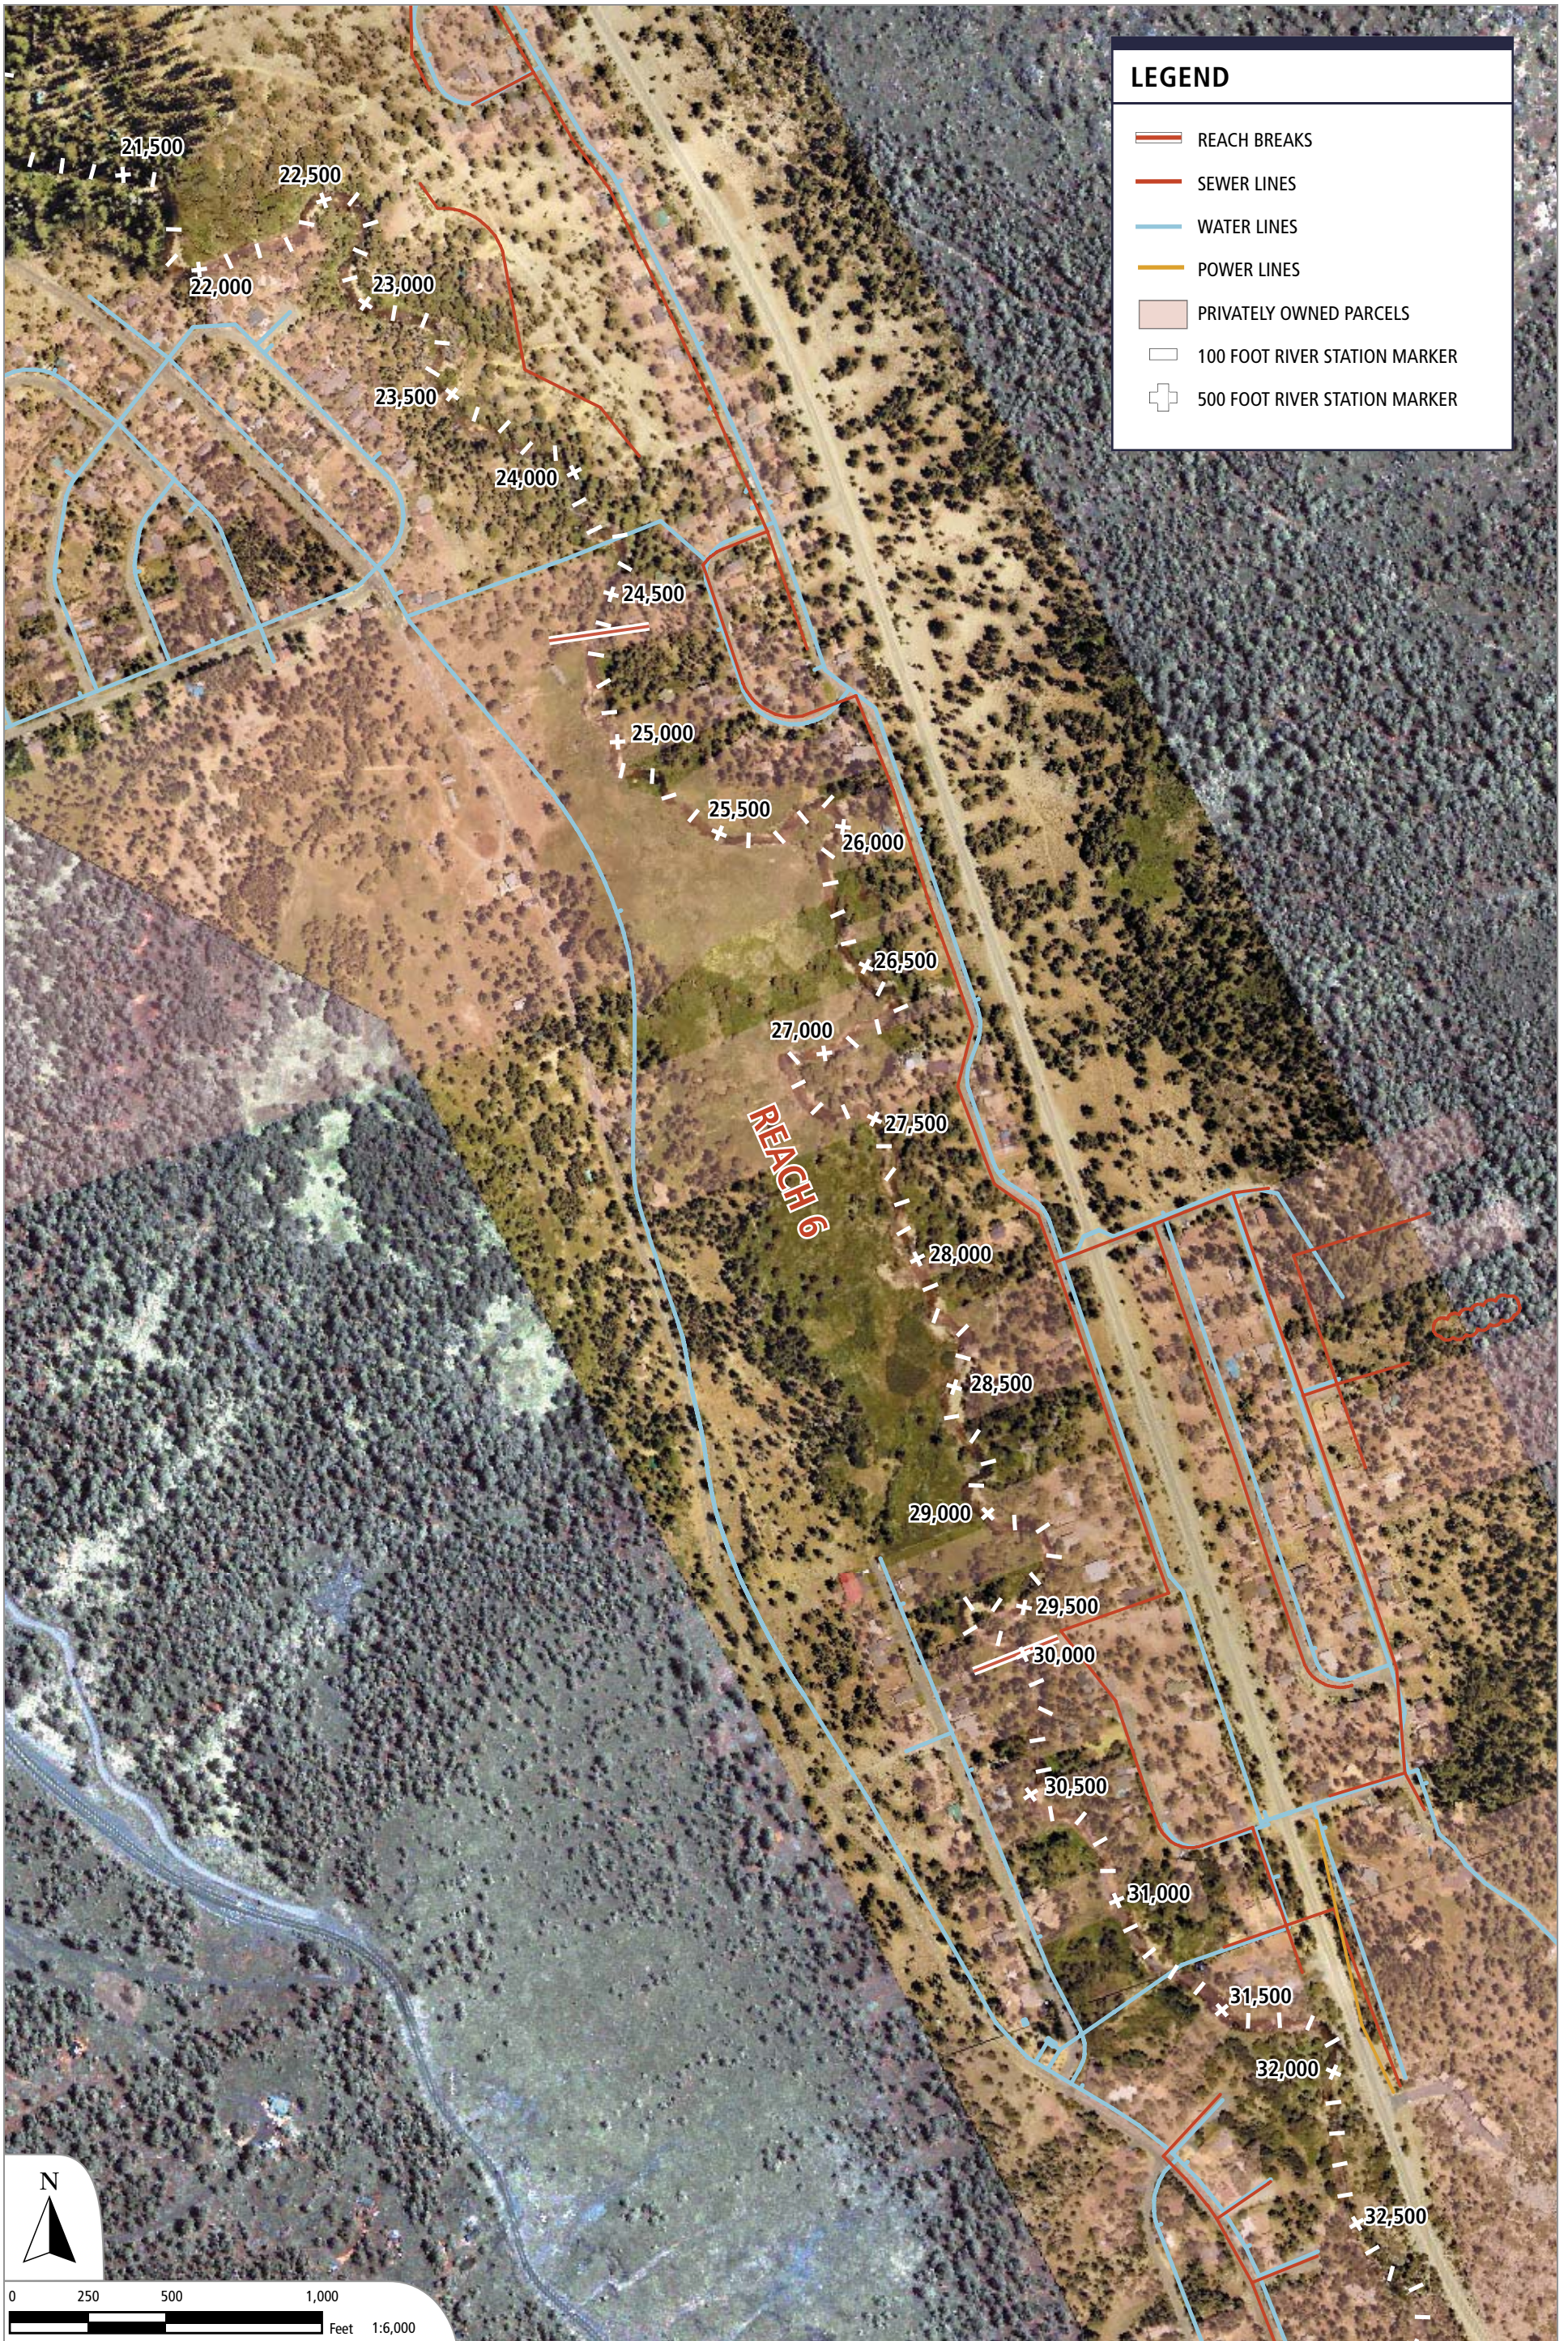
FIGURE 3.13C: Map indicating location of sewer and water lines relative to the Upper Truckee River (Reach 6).

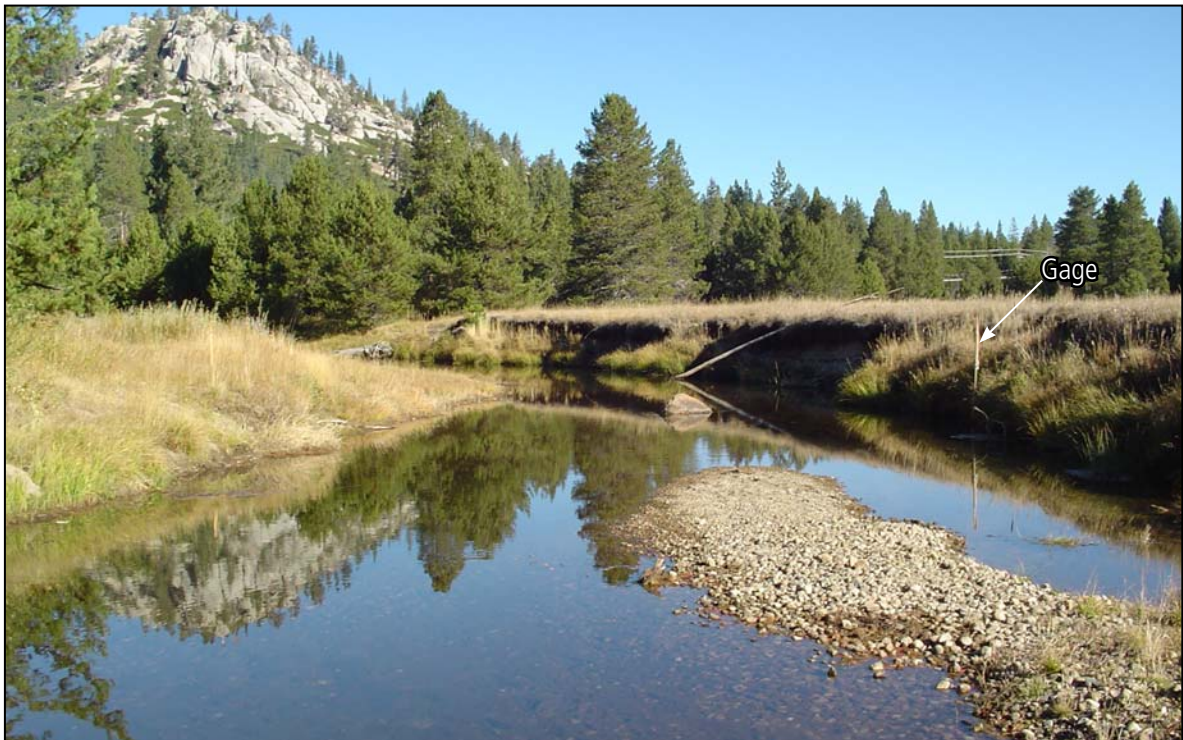
### Photo of Channel at Gage Looking Downstream

**FIGURE 3.16B:** Channel cross-section surveyed at location of SH+G Golf Course gage by California State Parks in September, 2003. Key channel features were identified in the field and associated discharge was calculated using depth gage data.

Channel hydraulic geometry relationships for the UTR were developed for multiple locations. Channel geometry was measured at repeated cross sections set up by CDPR, in addition to several other locations established by SH+G. Three stage recorders were installed in Reaches 1 through 4 and one in Christmas Valley from March through July 2003 to record the stage and water surface elevations of various flows occurring during the 2003 snowmelt (Figure 3.1). The instrument installed in Christmas Valley failed and no useful data was obtained from that station. Stage measurements at each cross section were correlated with the continuous flow measurements taken at the USGS stream gage Upper Truckee River near Meyers (#106633092). Rating curves were created to relate water surface elevation to streamflow. Based on cross-sectional area measurements, channel geometry and water surface elevation for key discharge values for channel forming features (bankfull stage, terrace elevations) were calculated for each of the three gage locations. Additionally, during the longitudinal profile survey, measurements of channel forming features were taken, including the elevation of bankfull indicators and terraces. The results of this monitoring are shown in Figures 3.16A-C through 3.18A-C.

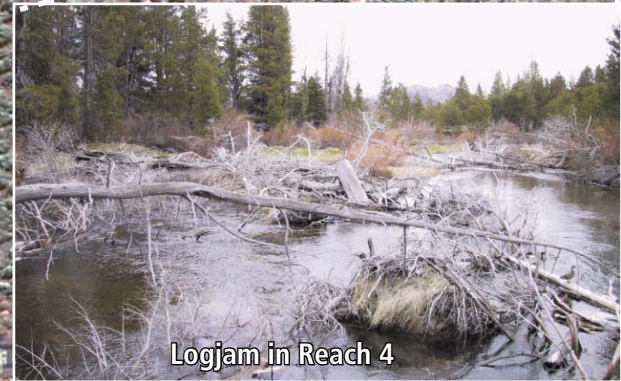
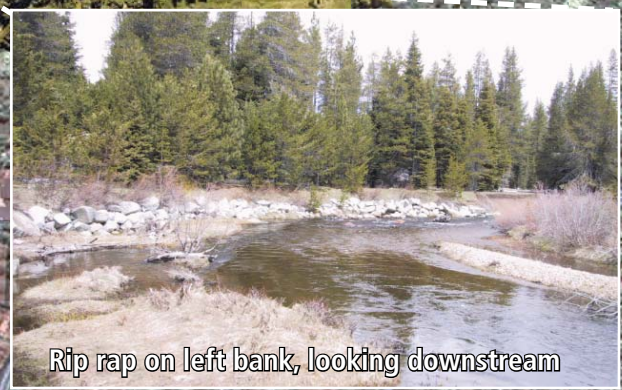
**FIGURE 3.20B:** Bank erosion potential ratings for Reaches 3 and 4.

The results of the mainstem UTR bank erosion survey are presented in Figures 3.20A-F and 3.21 and summarized in Table 3.4 (the complete database is presented in Appendix B). The data reflect the recent history of channel incision, with many reaches of unstable banks undercutting bank vegetation, especially in Reaches 1-4. High erosion hazards are also found in the alluvial reaches of Christmas Valley, especially the meadow areas of Reaches 5, 7, 10 and 11. The erosion hazard rating also reflects the fact that many of the banks rating high erosion potential or above are chronic sources of fine sediments. Areas exhibiting low or moderate erosion hazards occur in reaches lined in boulders or bedrock. An interesting exception occurs in the lower end of Reach 3, where it appears that the stream bed is being held nearly at grade with adjacent valley flat similar to the relief that would have been expected prior to disturbance; this appears to be the result of an erosionally resistant layer of older glacial outwash cobble and small boulder underlying the stream bed.

**TABLE 3.4:** Summary of channel bank erosion survey in the Upper Reach Study Area for the left and right banks. Ratings range from very low bank instability to extreme bank instability. See Figures 3.20A-F for maps showing exact location of instabilities.

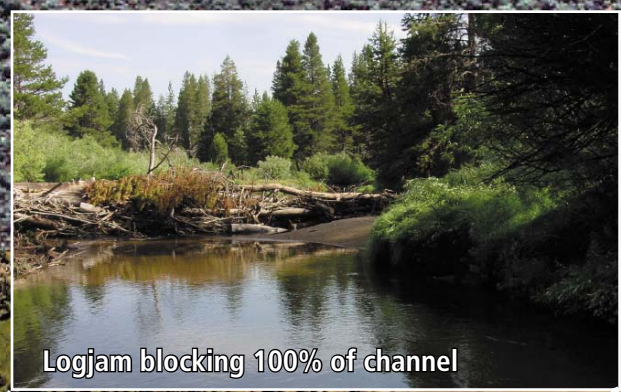
Reach 6 Statistics							
Stream Bank	Bank Erosion Potential	Linear Feet	% of Reach	Stream Bank	Bank Erosion Potential	Linear Feet	% of Reach
Right Bank	Very Low	577	11.1%	Left Bank	Very Low	177	3.3%
	Low	0	0.0%		Low	0	0.0%
	Moderate	932	17.9%		Moderate	987	18.7%
	High	607	11.6%		High	961	18.2%
	Very High	2703	51.9%		Very High	2637	49.9%
	Extreme	394	7.6%		Extreme	525	9.9%
Total	5212	100.0%	Total	5287	100.0%

FIGURE 3.20D: Bank erosion potential ratings for Reach 6.

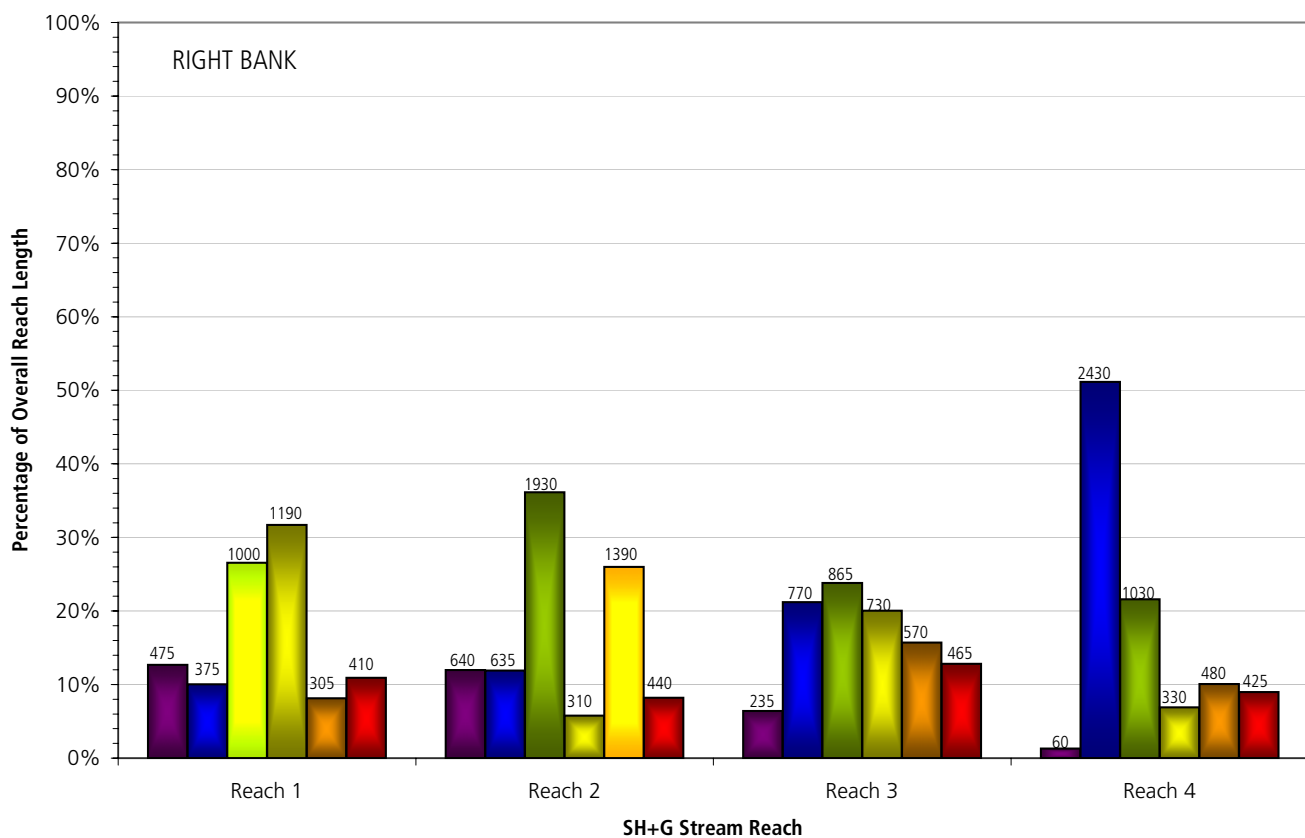
**FIGURE 3.21A:** Histograms illustrating the bank erosion potential for the left and right banks of Reaches 1-4 by percentage of overall reach length. See Figures 3.20A and B for locations.
