# SWANSON HYDROLOGY + GEOMORPHOLOGY

draft final report

## Upper Truckee River Upper Reach Environmental Assessment

for the Bureau of Reclamation, Tahoe Resource Conservation District, and  
Regional Water Quality Control Board - Lahontan Region

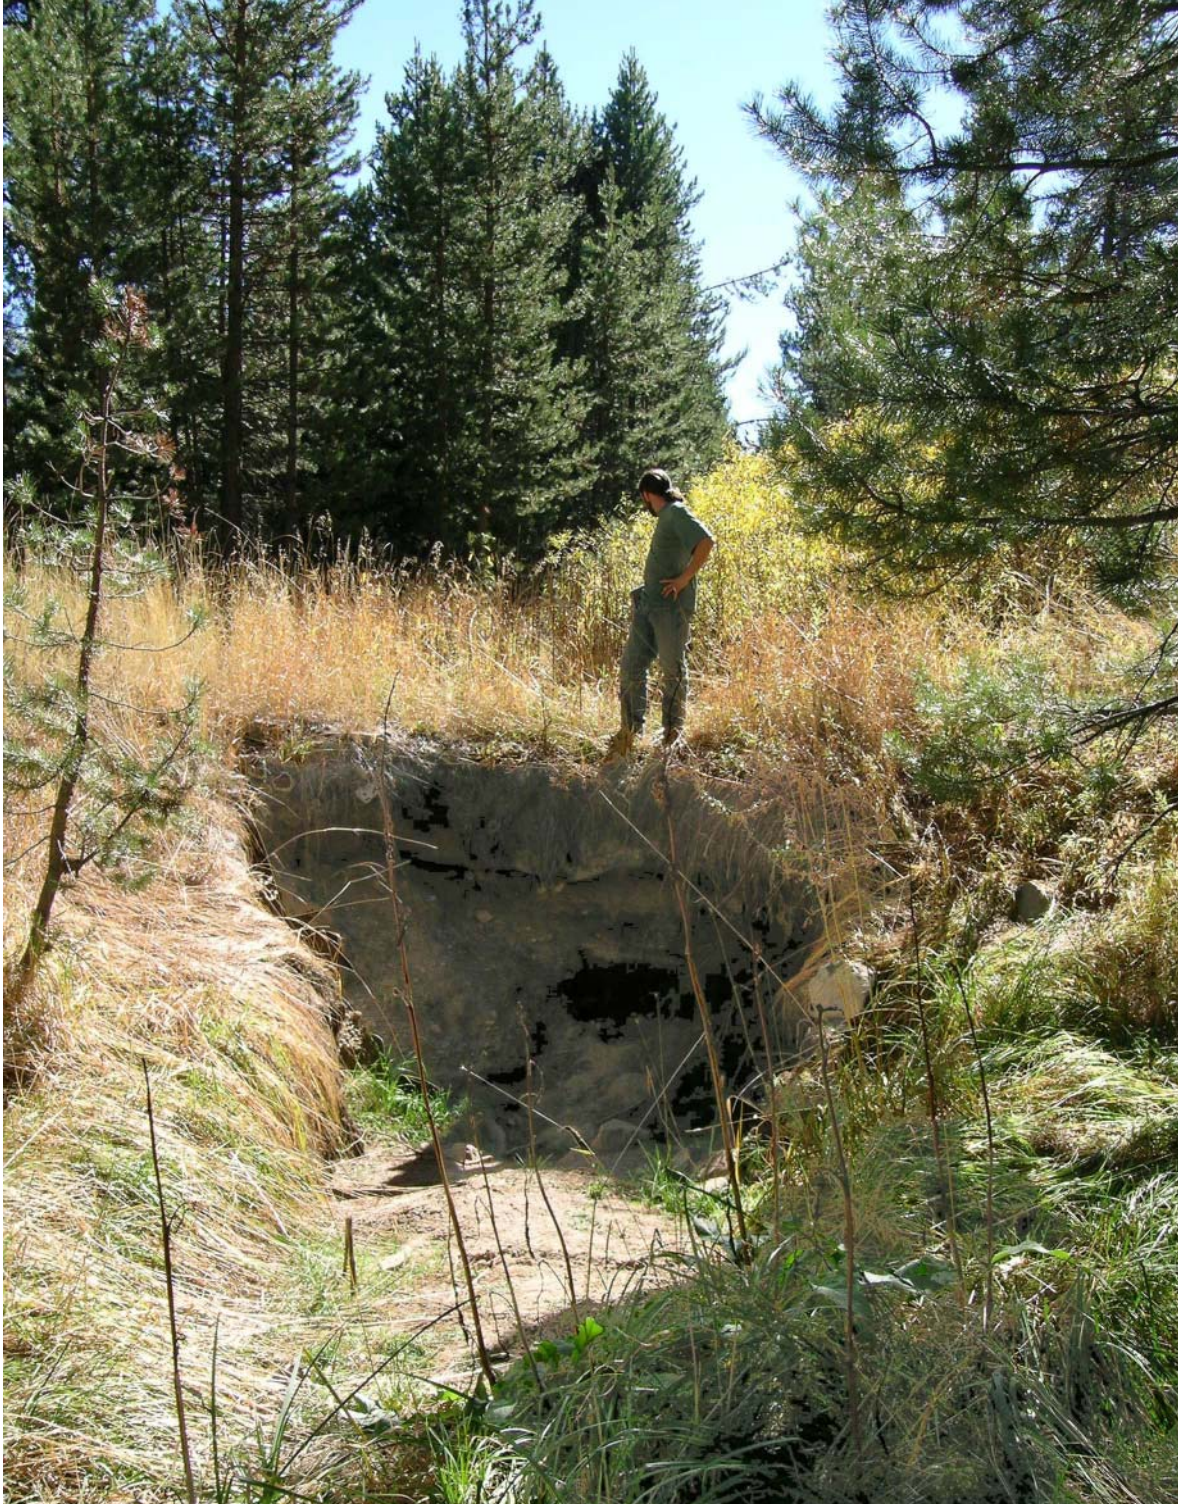
**FIGURE 3.25:** Photo of the unnamed tributary near Meyers downstream of the Santa Fe Road crossing. A berm was placed across the channel to divert flow from the channelized creek back to the adjacent floodplain. Subsequent flows have overtopped the berm, creating the large scour hole shown in the photo above.

Downstream of the Santa Fe Road crossing, the tributary has been channelized away from a historic wet meadow between Arrowhead Drive and Highway 50. This channelization likely occurred to make room for development of a commercial area along Highway 50. A recent attempt has been made to divert flow out of the channelized section of creek and back into the meadow. To do this a berm was placed across the channel. Subsequent storm flows have overtopped the berm, resulting in a large scour hole downstream that may have initiated or exacerbated downcutting and channel widening within that reach (Figure 3.25). Given the absence of development on the historic wet meadow, there may be an opportunity to restore this feature, providing flow attenuation for downstream residents and water quality treatment for the Paradise Golf Course and adjacent neighborhoods. This and other restoration opportunities are discussed in great detail in Chapter 5.

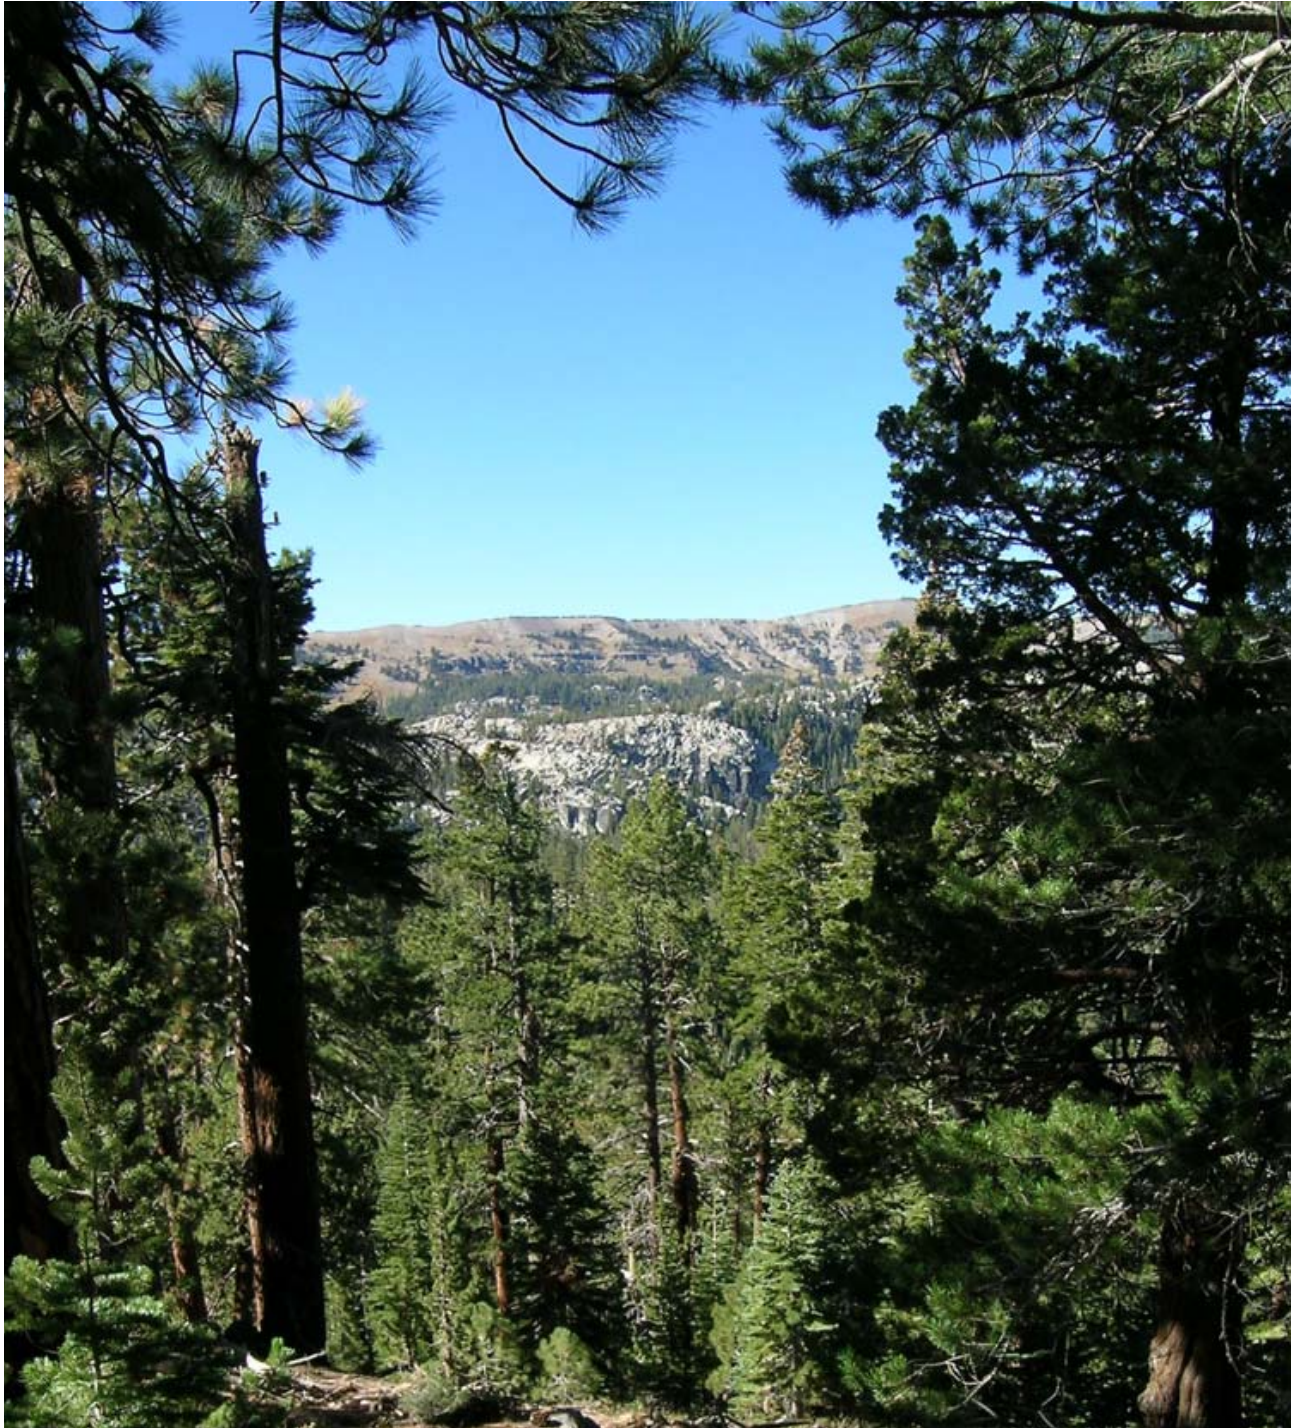
**FIGURE 3.28:** View of Upper Truckee River, upper southwest watershed divide showing Tertiary Volcanic (Tv) rocks overlying granitic rocks.

One striking feature of the Upper Watershed is the observed erosion and sediment production rates of the Tertiary volcanic rocks (Tv) that form the rim of the Upper Watershed. These are predominately volcanoclastic rocks (breccias) that form cliff faces (Figure 3.28), but are readily weathered and eroded. The erosion rates of the volcanic bluffs were demonstrated by the immense volume of post-glacial alluvial fans formed below the bluffs and the recent evidence of debris-flow landslides that occurred with the severe thunderstorm event of August 21, 2003 (Figure 3.29). Beyond the shear volume and erodibility of the Tertiary volcanics, the erosion and weathering products include fine sediments and clays that may be dispersive in nature and an important factor for Lake Tahoe clarity. It is doubtful that the areas underlain by Tertiary volcanics, or the alluvial deposits derived from them, were ever impacted heavily by historic grazing, given the fact that little forage occurs under the predominately old growth Jeffrey pine and red fir

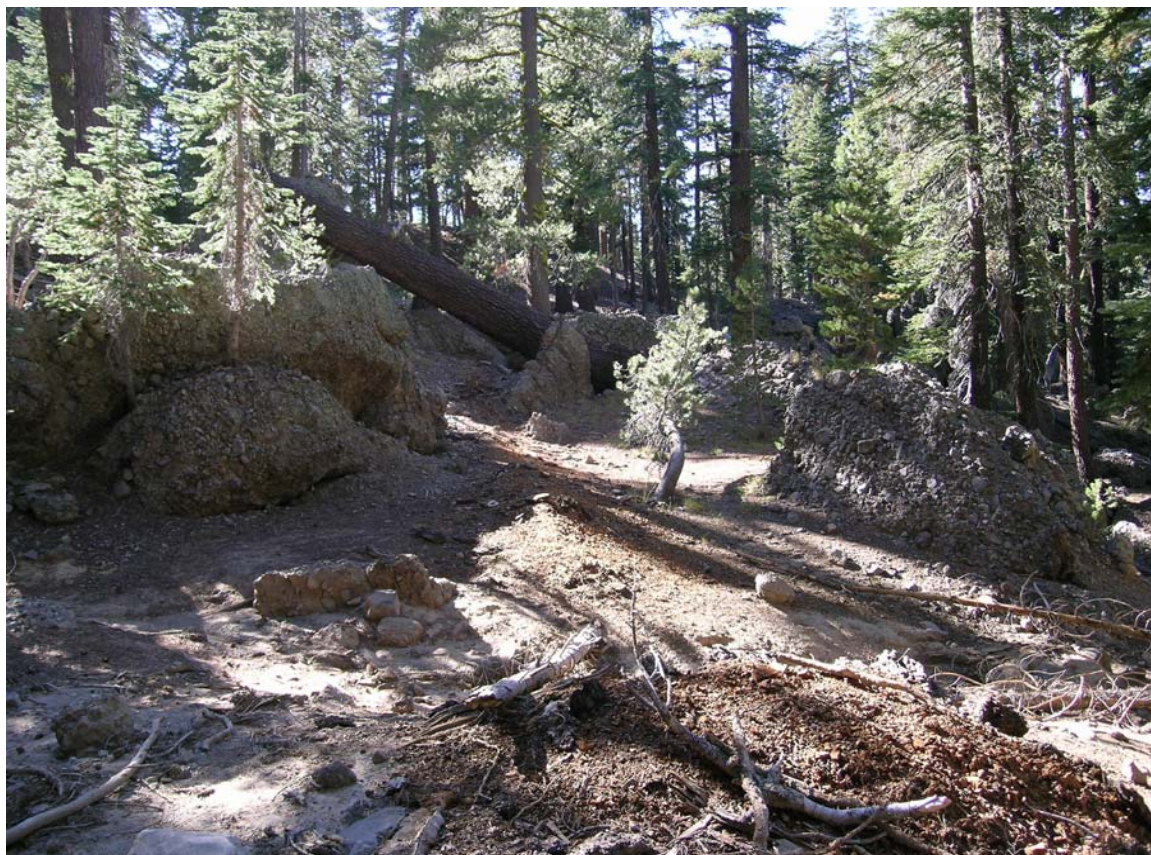
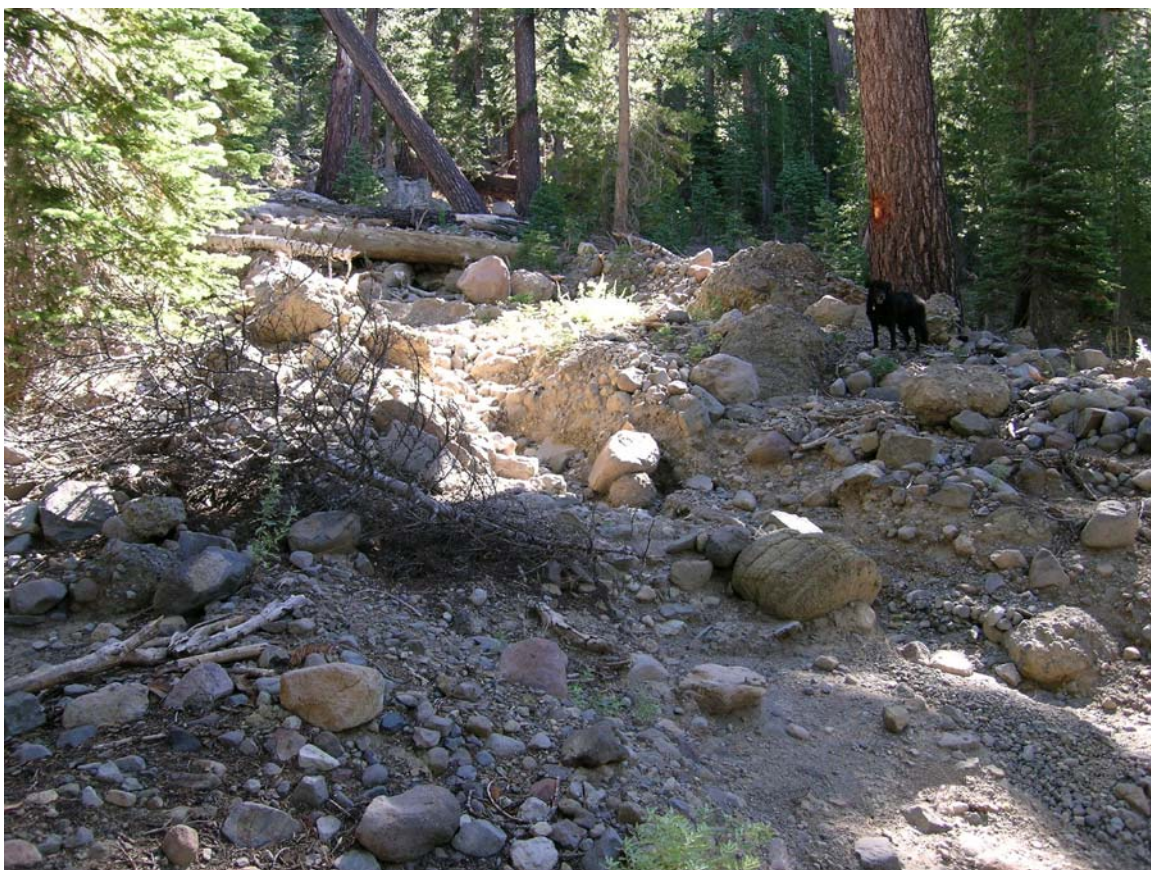
**FIGURE 3.29:** The upper photo shows recent sediment generated on hillslopes of tertiary volcaniclastic (Tv) rocks. Photo taken south of Round Lake in Upper UTR watershed (10/03). The lower photo shows debris flow chute emanating from Tv terrace near Round Lake in the Upper Watershed.

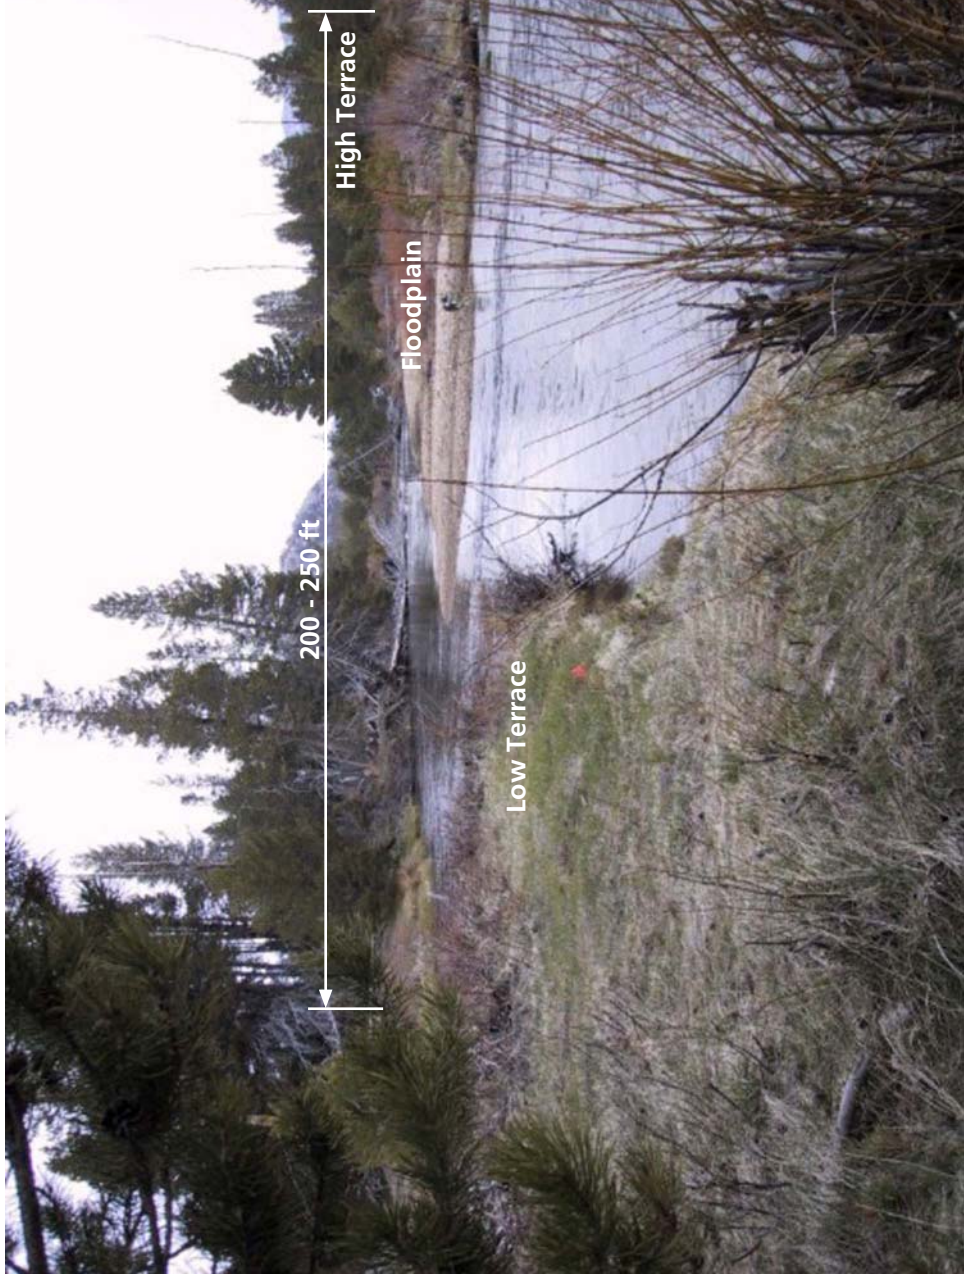
**FIGURE 4.1:** Photo depicting portion of Upper Truckee River in Reach 3 with wide, quasi-stable channel geometry.

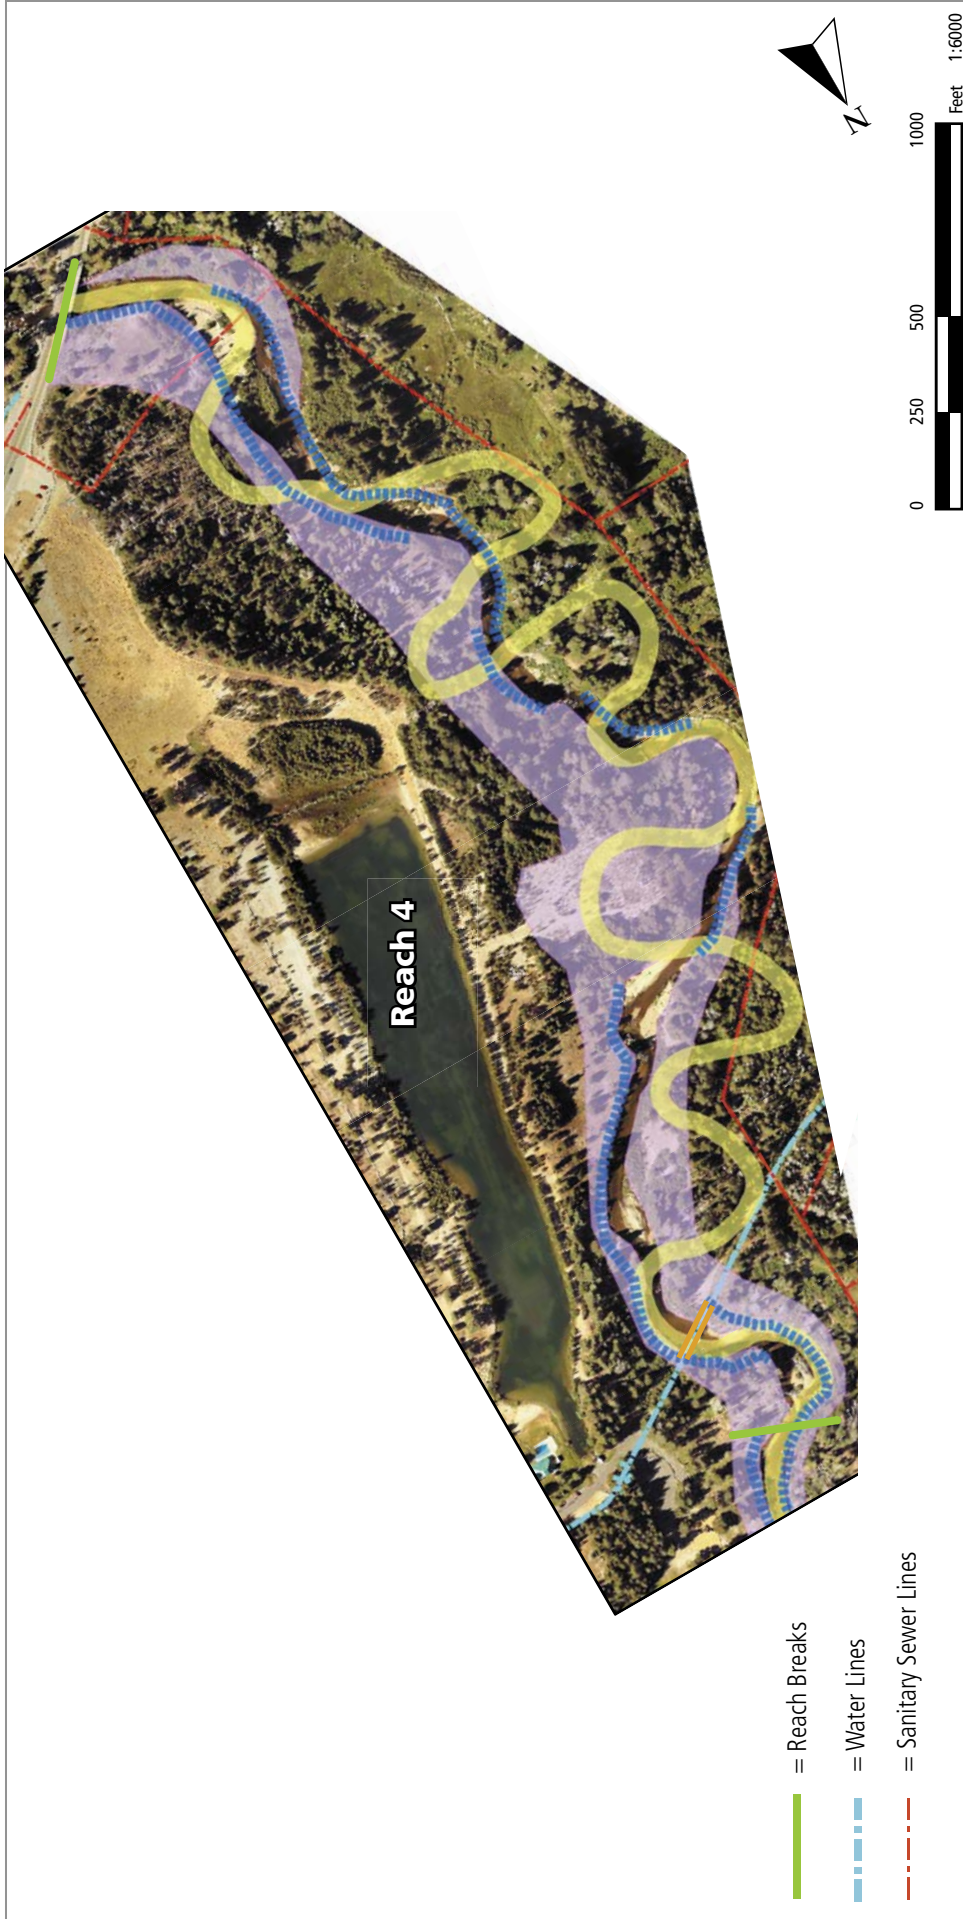
<p><b>Alternative #1</b> - No Action</p>			
<p><b>Alternative #2</b> - Provide Rip Rap Protection along banks and Grade Control in channel.</p>	  = proposed Rip Rap   = proposed Grade Control	<p><b>Alternative #3</b> - Excavate incised banks to create Floodplain Terraces.</p>	  = proposed Floodplain Terraces
<p><b>Alternative #4</b> - Restore channel to its original planform and profile. Fill existing channel.</p>		  = proposed Channel Alignment
