**Analysis of Impacts of Blackwood Creek Reach 6 Stream Channel
and Floodplain Restoration on Sediment Loading to Lake Tahoe
during the 2009 and 2010 Water Years**

**USDA Forest Service
Lake Tahoe Basin Management Unit
Ecosystem Conservation Department**

January 19, 2012

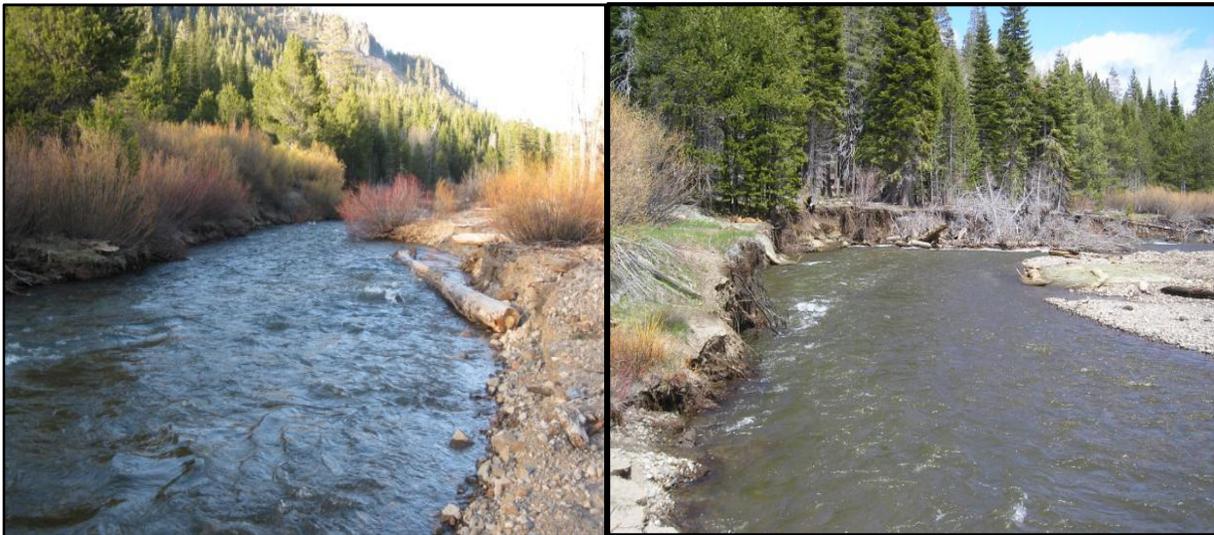
Figure 1: Looking downstream at avulsed channel reach (left photo) and high terrace cutbank (right photo), eroded during spring of 2009.

Next we estimated the volume of SS that was eroded from the Reach 6 project as a result of a channel avulsion that occurred in the spring of 2009, within the alluvial substrate below the constructed reach. During this event, the streamflow was diverted out of the main channel,

cutting a new channel through the adjacent coarse-grained alluvial deposits in the lower floodplain. This avulsion occurred as a result of the project, because the grade control constructed at the bottom one third of the restored reach constructed in 2008, failed during the 2009 spring peak flows (USFS, 2009a). We estimate that during spring peak flows in 2009, the SS lost from the reach through this avulsion may have been 10% of the total annual SS load in 2009.

We then estimated the volume of SS that was eroded from a high terrace cutbank during that same spring runoff period, located approximately 300 meters downstream of the restored reach. This high terrace cutbank erosion, consisting of primarily fine grained sediments, was unrelated to restoration project activities, and typified the type of erosion exhibited in this reach prior to restoration. We estimate that during spring peak flows in 2009, the SS lost from this section of high terrace cutbank erosion may have been 8% of the total annual SS load in 2009.

** Area of eroded high terrace cutbank 91m long, by 1.2 to 2.4 m wide (ave 1.8 m), by 2.4 m deep.			
** Area of avulsed channel, calculated in AutoCAD. Approximate dimensions, 92 m length, 9.5m wide, and 1.5 m deep.
