Moonlight Beach Urban Runoff Treatment Facility Final Report

City of Encinitas
Clean Water Program
February 2006

Prepared for
State Water Resources Control Board

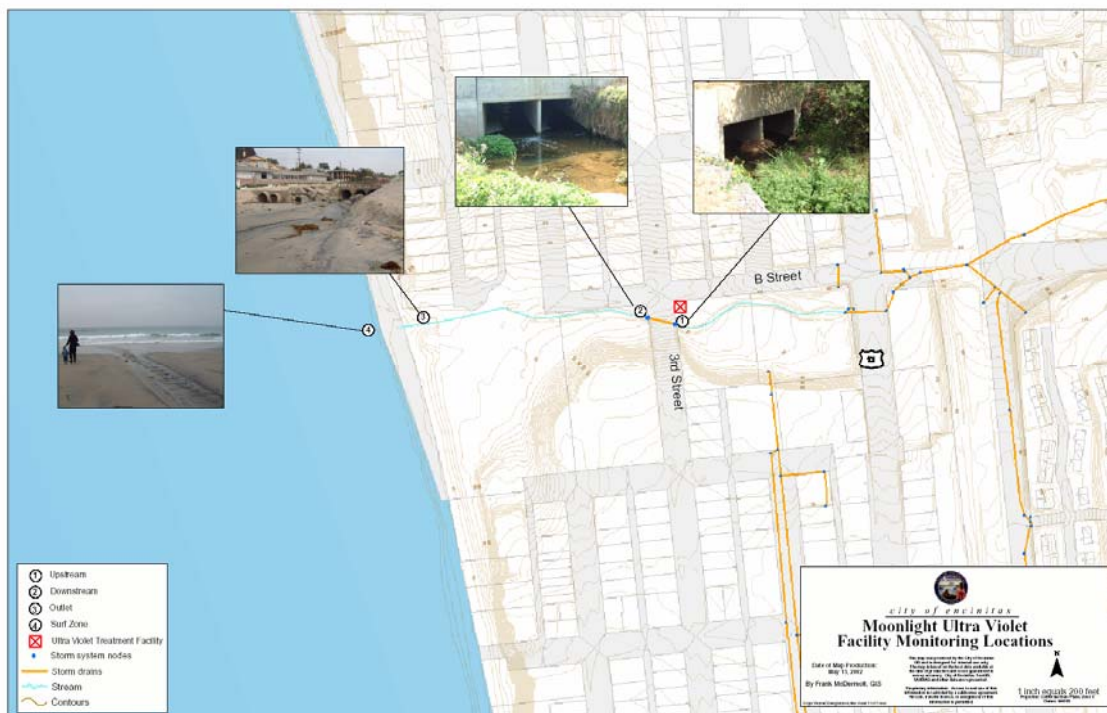
Figure 3.0 Routine Monitoring Locations

1. UV Influent – Upstream of the treatment facility, collected at the influent port prior to filtration.
2. UV Effluent – Downstream of the treatment facility, collected at the effluent port, after filtration and UV treatment.
3. Cottonwood Creek Mouth (EH-420 (-20)) – At the creek mouth prior to discharge to the surf zone.
4. Moonlight Beach Mixing zone (EH-420 (0M)) – In the mixing zone where Cottonwood Creek enters the Pacific Ocean.

A map of the routine monitoring locations is included as Figure 3.0.

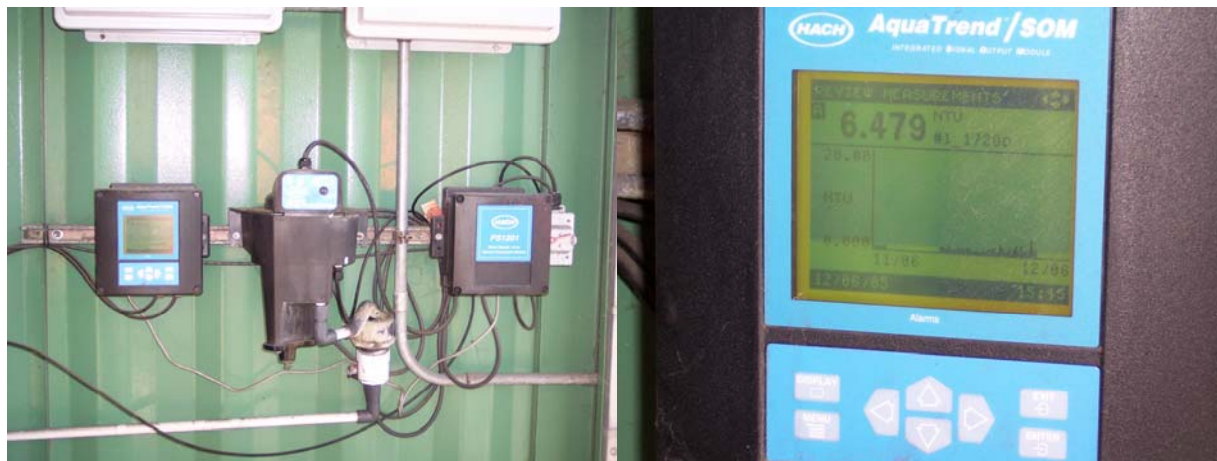
Figures 3.1 and 3.2 Hach 1720D Nephelometer used to analyze turbidity in influent water.

Water from Cottonwood Creek is analyzed for turbidity near the influent sampling port within the facility. The nephelometer selected for the facility is plumbed inline with the intake structures and analyzes the creek water prior to filtration by the multimedia filters. The water entering the facility is continually analyzed for turbidity. See figures 3.1 and 3.2 above.

Turbidity data was also collected to assist in process control. An inline Hach 1720D nephelometer was utilized to continually monitor turbidity in the influent. Water in Cottonwood Creek is clear, with turbidity <5 NTU. An increase in the turbidity over 5 NTU was considered abnormal and was most often attributable to rain or to an illicit discharge upstream. Turbidity data was collected continually and is available for the past 30 days on the Hach instrument. This was used primarily for process controls. During each monitoring event, the turbidity was noted on the field data sheet. This data is provided in Appendix I. The mean turbidity for the influent in Cottonwood Creek is 3.60 NTU over the since the startup of the facility. This is based on a sample size of 126 and includes data from rain events and illicit discharges when the facility was online. Maintenance issues with the nephelometer occasionally prevented data collection, hence a smaller data set than used in the bacteria monitoring.

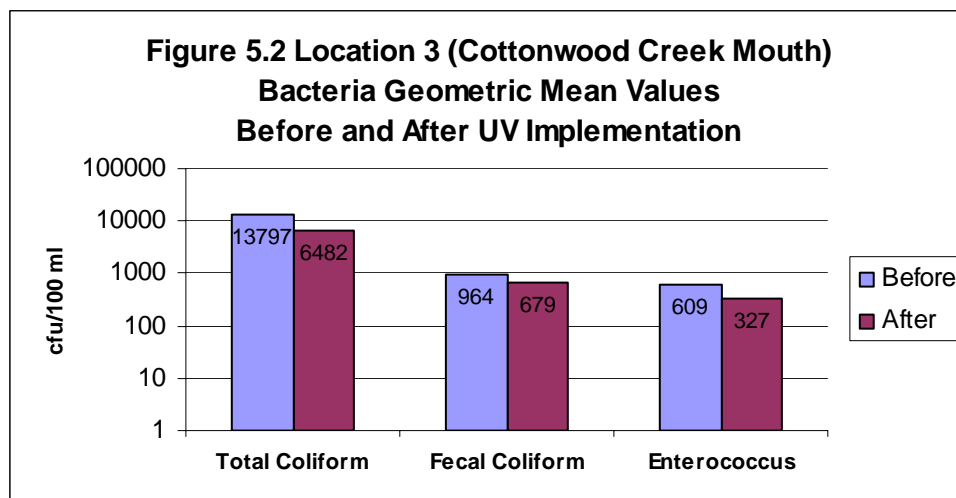
There are significant reductions in FIB at monitoring locations 3 and 4 as well, as shown in Figures 5.2 and 5.3. Each location is affected by reductions in bacteria upstream of the UV Facility and reductions at the UV Facility. The elimination of the bacteria in treated water at the treatment facility is effective in reducing bacteria concentrations at the creek mouth and in the mixing zone.

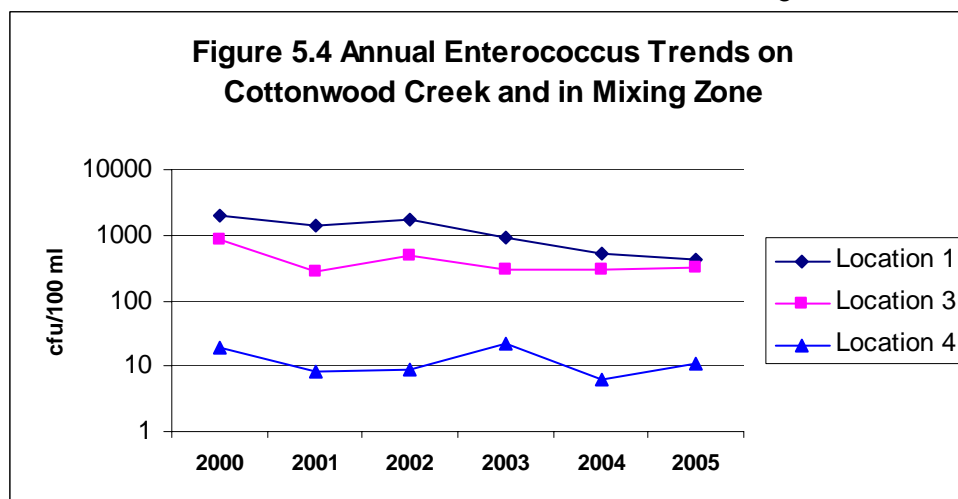
In order to further understand the effects of the structural BMPs implemented during the study time period, annual FIB concentrations for each indicator at each sampling location were calculated and graphed. Because the majority of water quality exceedances are caused by enterococcus, these figures are presented first. Figure 5.4 illustrates the reduction in concentrations of enterococcus at the influent, creek mouth, and mixing zone.

These reductions in enterococcus at the influent and at the creek mouth led to a reduction in FIB concentrations in the mixing zone, also illustrated in the figure. Of note is the spike in enterococcus concentrations in the mixing zone in 2003 that is not present in the sampling locations on the creek. This suggests that factors other than the creek may be responsible for the increases in FIB concentrations in the mixing zone.

Figure 5.4 shows annual reductions in enterococcus concentrations at monitoring location 1. The construction of Cottonwood Creek Park began in 2003 and was complete in 2004. In the park, urban runoff is collected in a detention basin prior to flowing into an open natural channel. Prior to the construction of the park, the creek flowed directly into a 96" underground storm drain through this section. Improvements in water quality are observed by the decrease in bacteria concentrations over the study period upstream of the facility, likely attributable to the new park.

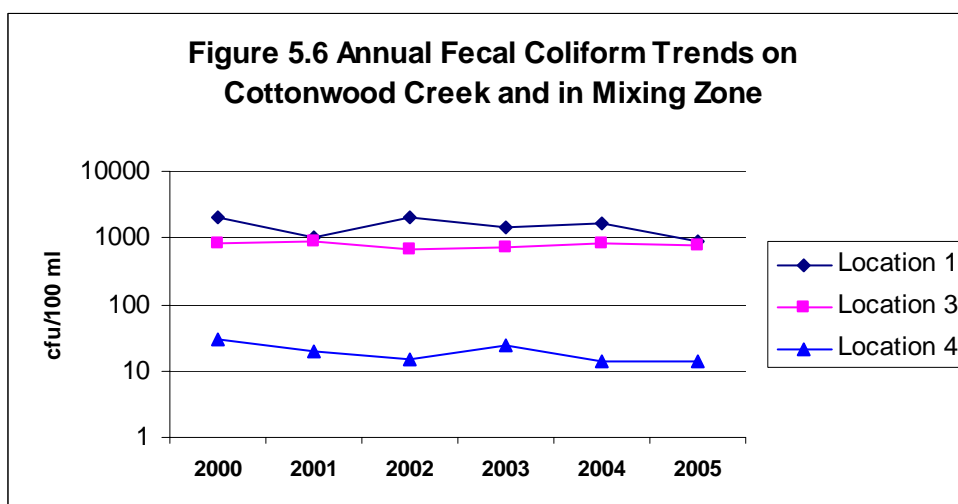
Figures 5.5 and 5.6 correspond to Figure 5.4 above. These are similar graphs using total and fecal coliform data trends in Cottonwood Creek and in the mixing zone and show similar results.

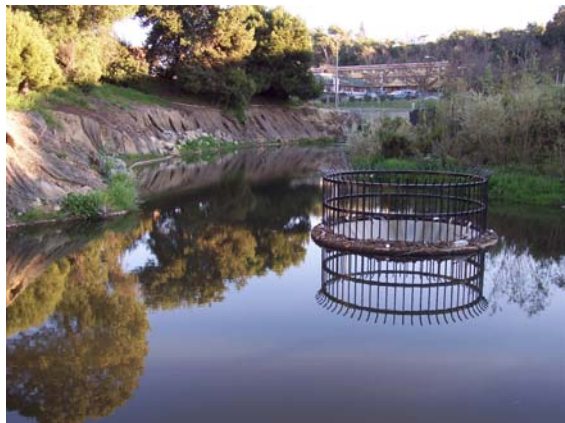
Figure 5.7 Detention Pond at Park.

Photographs of Cottonwood Creek Park are included below as Figures 5.7 and 5.8.

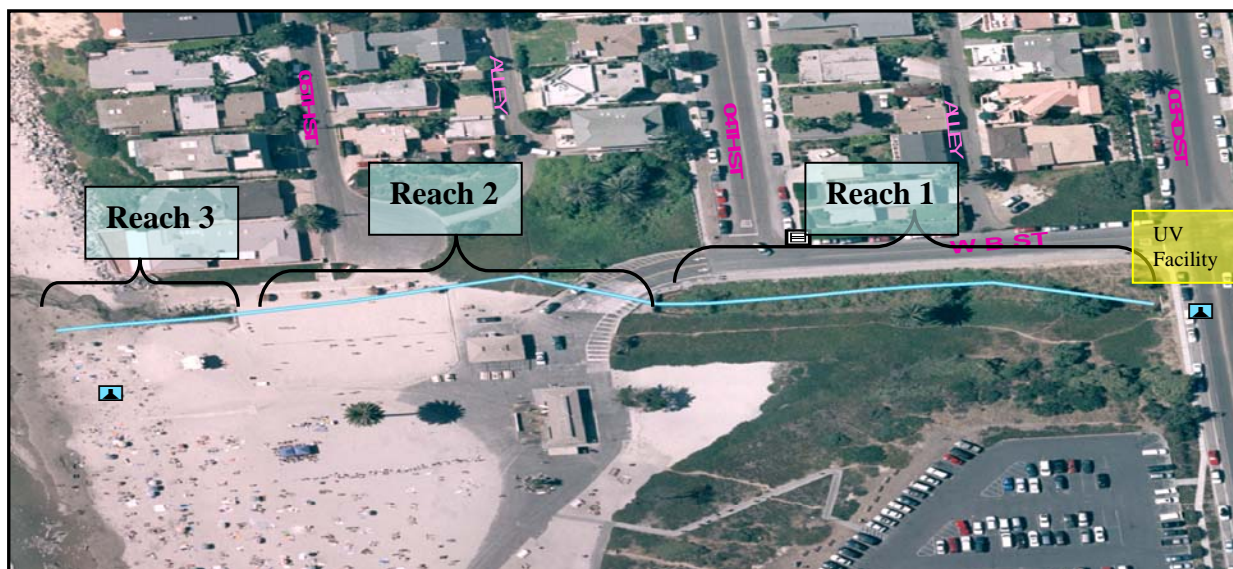
Figure 6.0 Special Bacteria Study Area

Because of these spikes in bacteria concentrations in the mixing zone, the City of Encinitas initiated this study to further understand the bacteria influences in the western portion of Cottonwood Creek. This special bacteria study consisted of five intensive monitoring events from October 2003 to December 2004 in an effort to characterize possible bacterial sources impacting water quality in Cottonwood Creek downstream of the UV Facility, prior to discharge to the Pacific Ocean. Figure 6.0 illustrates the study area downstream of the UV Facility.

The distance from the UV Facility to the beach is approximately 230 yards. In an attempt to identify and characterize the observed increase in bacteria, a series of intensive monitoring events supplemented the routine monitoring at the facility. The goal of this special study was to identify any possible sources of bacteria downstream of the UV Facility. Samples were collected at approximately 15 locations downstream of the facility along the creek. This last stretch of the creek was divided into three reaches.

This formula does not take into account any additional sources of bacteria which may be present downstream. The expected FIB concentrations downstream of the treatment facility are slightly lower than the average of samples collected in Reach 1 of this study. Bacteria concentrations continue to rise as the water is conveyed to the beach, from R1 to R3. Figure 6.5 illustrates the rising bacteria concentrations at the creek flows from east to west, with Stations 2-9 in R1 (natural creek), Stations 10-11 in R2 (72" storm drain pipes), and Stations 12-15 in R3 (on sand at Moonlight Beach). These reaches are illustrated in Figure 6.0.

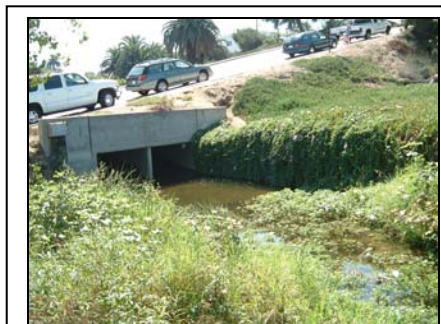
The first reach begins at the box culvert under Third Street, just downstream of the UV Facility, to the entrance of the three 72" pipes leading to Moonlight Beach. This reach of the creek is an open natural channel and has two pipes entering from the north bank that flow during dry weather. There are also two pipes entering the channel from the south that flow only during storm events. The two flowing pipes are the only other sources of water downstream of the UV Facility. Samples were collected at various intervals in the channel according to changes in channel topography. Both flowing pipes entering the channel were isolated and sampled, and samples were collected up and downstream of each pipe. Figure 6.1 and 6.2 show Reach 1 (R1) characterized in the special study.

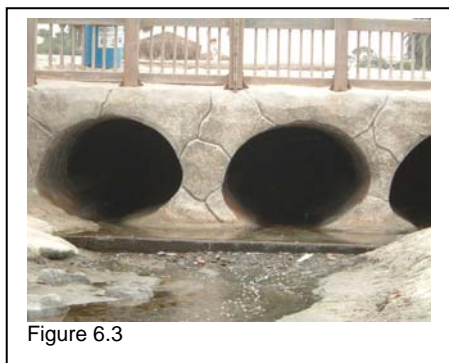
The second reach (R2) monitored in the special study is in the three 72" pipes leading to the beach. There are no inputs into these pipes. Samples were collected upstream and downstream to characterize changes in bacteria concentrations occurring in the pipes. Figure 6.3 is of the three 72" pipes in R2 as they flow to the beach.

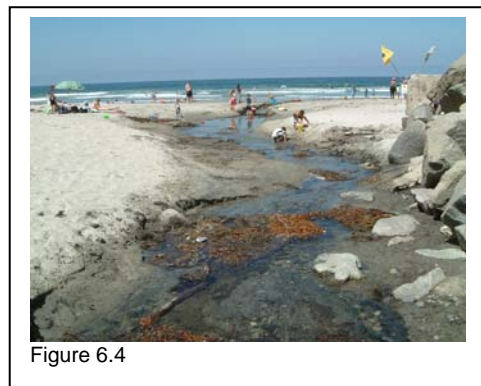
The third reach (R3) of the special study was from the outlet of the 72" pipes, off of the headwall, and across the beach to the ocean. Samples were collected periodically across the stretch of beach in an attempt to isolate bacteria contributors along the shoreline. Figure 6.4 illustrates the Third Reach monitored in the special study.
