OIL WELL SUMP RECONNAISSANCE AND INVESTIGATION REPORT

**Southern California Gas Company
Aliso Canyon Gas Storage Facility
12801 Tampa Avenue
Northridge, California 91326**

October 4, 2007
Project No. Eco-05-205

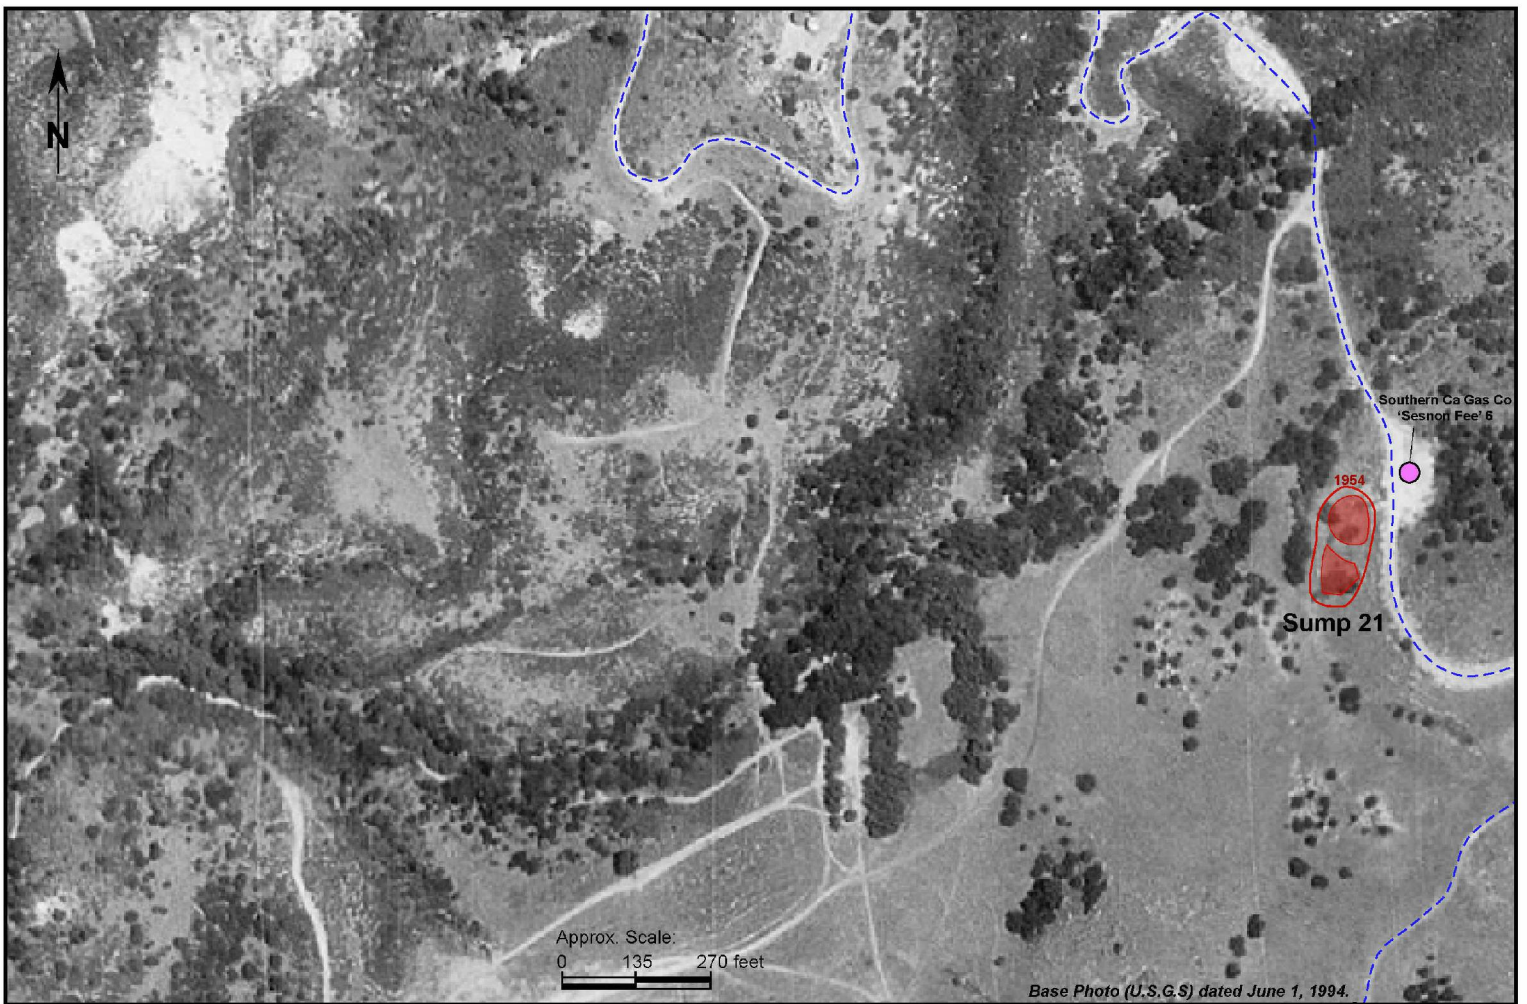
7

Sump 21 - Two adjoining sumps were formerly located at the Sump 21 location (Figures 2 and 7). A well (*Southern Ca Gas Co 'Sesnon Fee' 6*) is located northeast of this sump location. The Sump 21 area is relatively flat and covered with a light to heavy growth of grasses and brush. Depressions marking the location of these former sump locations are not visible. Stained soil or possible oil seepage was not encountered within or adjacent to this sump location.

An ascending slope is located along the eastern side of this sump area. A paved roadway is located at the top of this slope, immediately east of the sump area. Historic access roads from the sump to this roadway were not encountered during the site reconnaissance. Pipelines were not observed within this sump area.

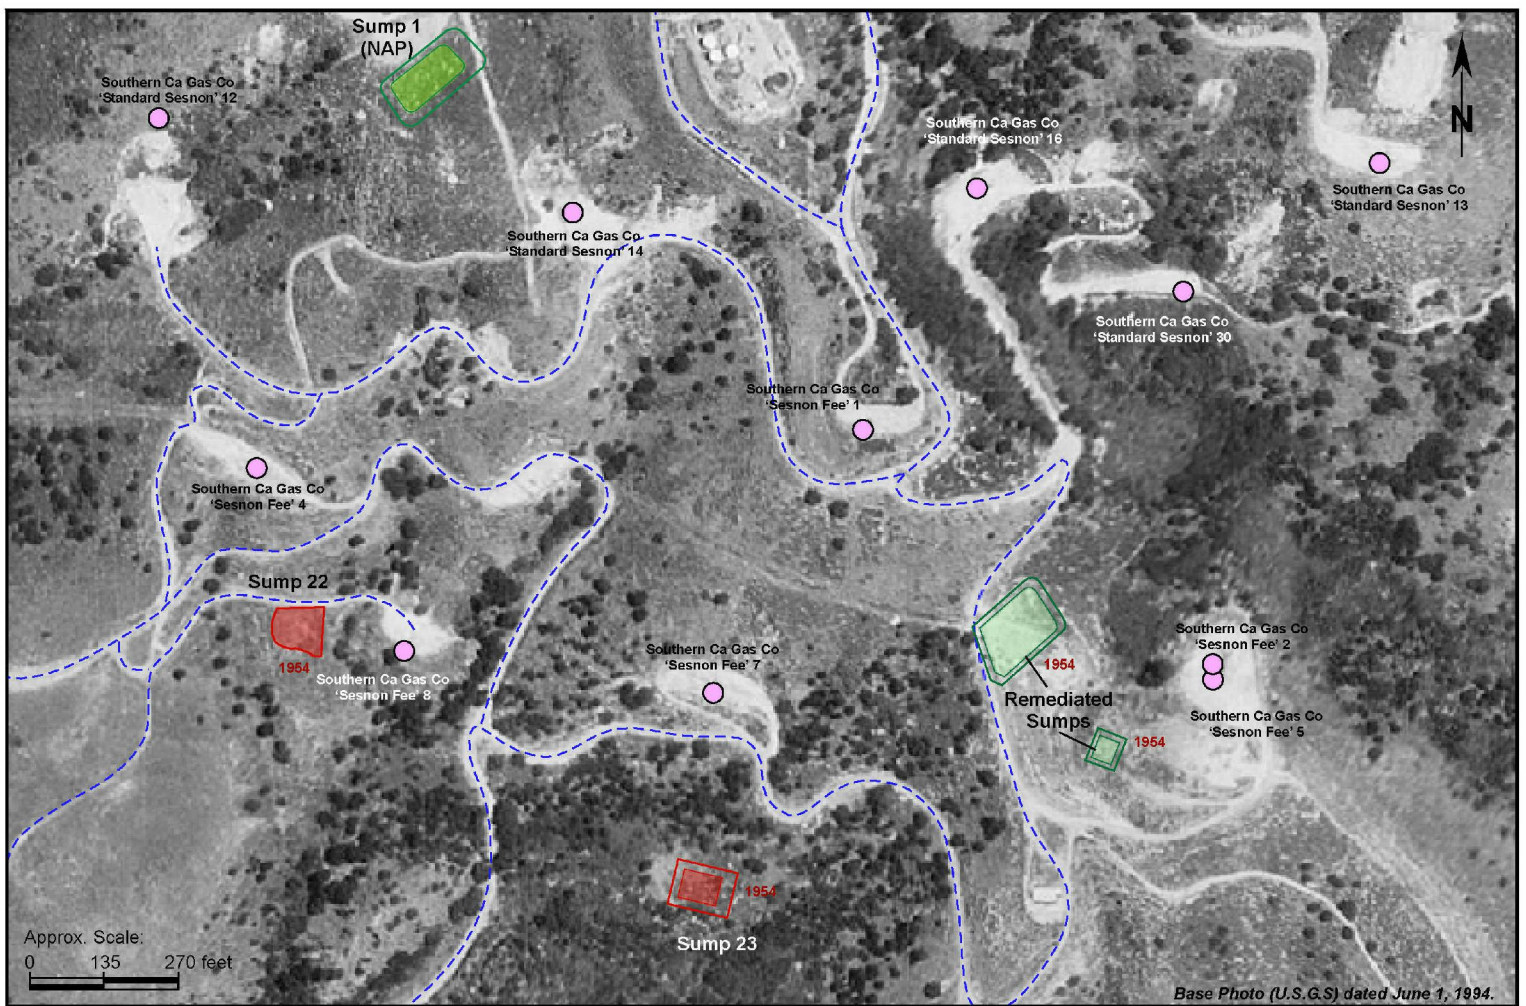
8

Sump 22 - Sump 22 is located within a relatively flat area immediately south of the access road to Well "*Southern Ca Gas Co 'Sesnon Fee' 8*" (Figures 2 and 8). This sump area is covered with a moderate growth of coastal shrub. Evidence of the former sump was not encountered at the time of the site reconnaissance. Stained soil or possible oil seepage was not encountered within or adjacent to this sump location.

Sump 23 - Sump 23 is located within a relatively level area at the south end of an overgrown road (Figures 2 and 8). This sump area is covered with a moderate growth of coastal shrub. Fences border a portion of the former sump area. No other evidence of this former sump location was encountered at the time of the site reconnaissance. Stained soil or possible oil seepage was not encountered within or adjacent to this sump location.

It is recommended that impacted soil within Sumps 15 and 22 be remediated to appropriate cleanup levels provided by the RWQCB (for VOCs and TPH). Prior to remedial activities, it is also recommended that a comprehensive remedial action plan be developed and approved by the SCG.

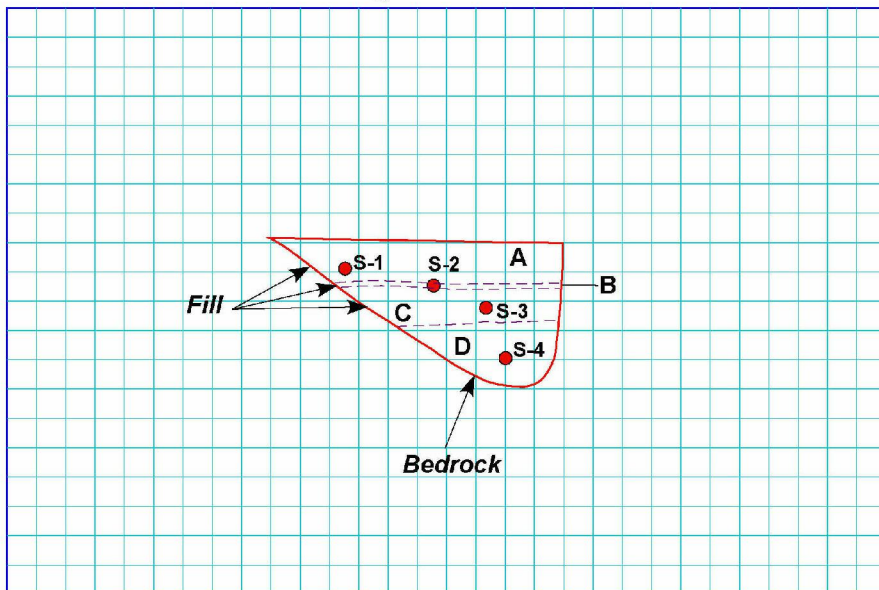
- A. Very dark gray silty clay with trace fine to coarse sand, damp, oil staining, slight odor.
- B. Gray clay (bentonite) with some black oil stained nodules, no odor.
- C. Gray to pale brown silty fine sand, damp, few oil stained nodules, no other staining, no odor.
- D. Dark yellowish brown, yellowish brown, and gray weathered siltstone, MnO staining, fractured, no oil staining, no odor.

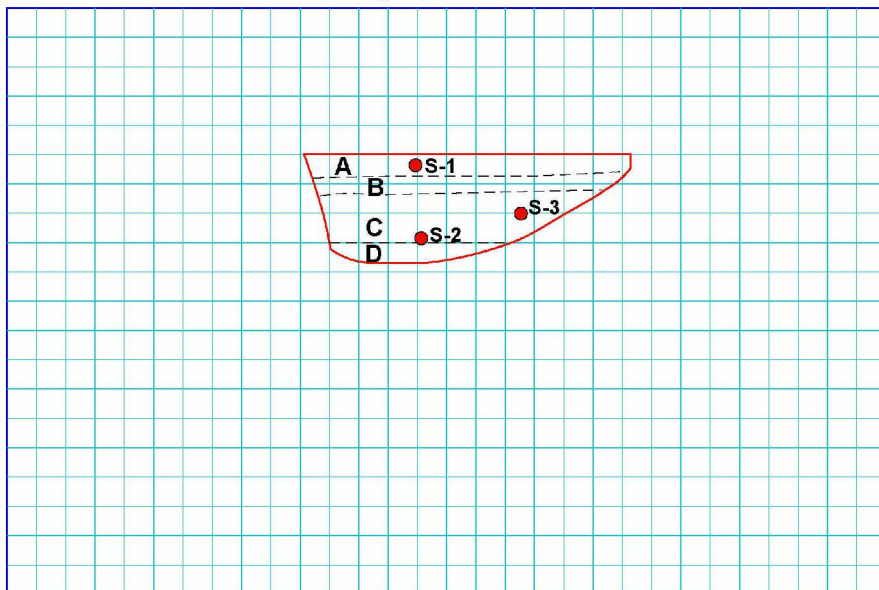
- A. Black to very dark gray fine sandy silt, oil stained, no odor.
- B. Yellowish brown and gray silty fine sand, damp, no visible staining or odor.
- C. Gray, dark gray, and yellowish red silty clay, moist, trace black oil-stained nodules, no odor.
- D. Yellowish brown siltstone (weathered), damp, no visible staining or odor.

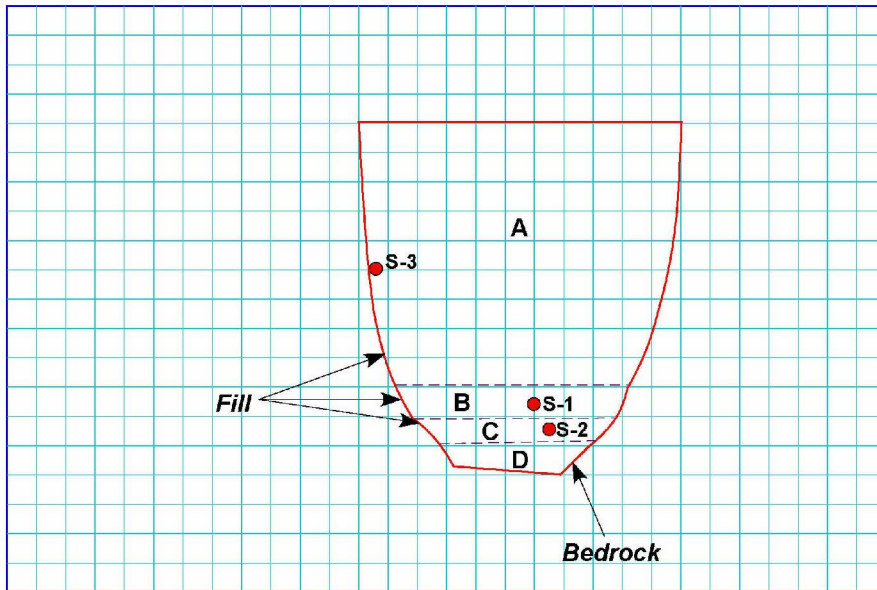
A. Brown to olive brown silty clay with abundant gravel- to cobble-size angular rock fragments, moist, locally stained with oil, no odor.

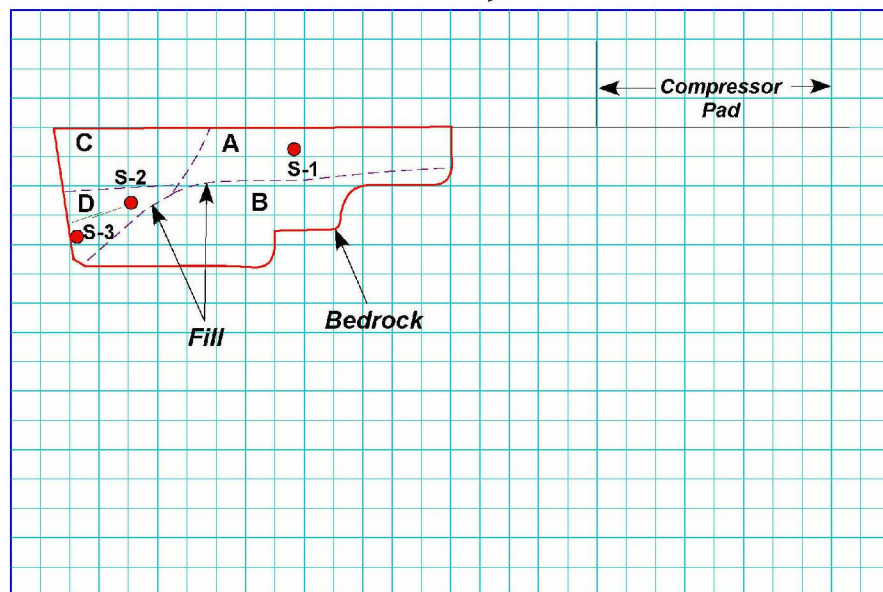
- A. Dark yellowish brown to dark brown fine sandy silt with trace gravel- and cobble-size angular rock fragments, damp, few oil stained areas, no odor.
- B. Dark brown gray to yellowish brown siltstone, fractured, oil stained fracture faces, no odor.
- C. Yellowish brown fine sandy to clayey silt, damp, no odor or visible staining.
- D. Gray and dark gray brown clay to silty clay, some very dark gray oil staining, moist, petroleum hydrocarbon odor, bentonite rich, few sandy silt laminae.

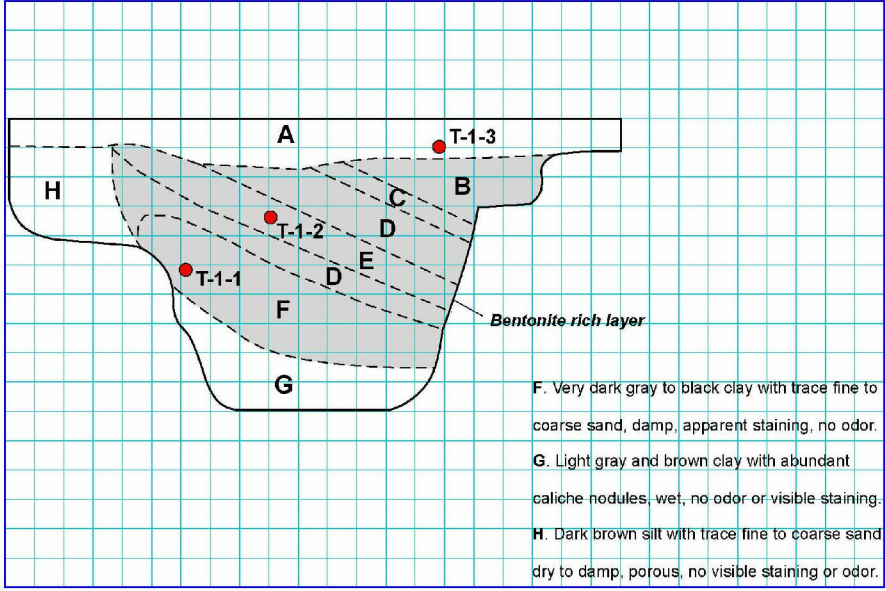
F. Very dark gray to black clay with trace fine to coarse sand, damp, apparent staining, no odor.
 G. Light gray and brown clay with abundant caliche nodules, wet, no odor or visible staining.
 H. Dark brown silt with trace fine to coarse sand dry to damp, porous, no visible staining or odor.

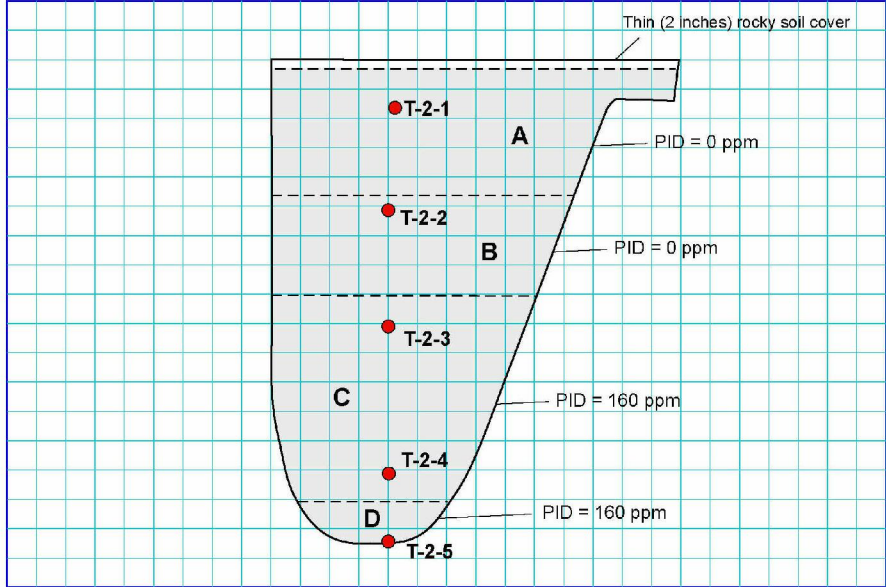
A. Very dark gray fine to coarse sandy silt with gravel- to cobble-size rock clasts, dry to damp, stained, no odor.

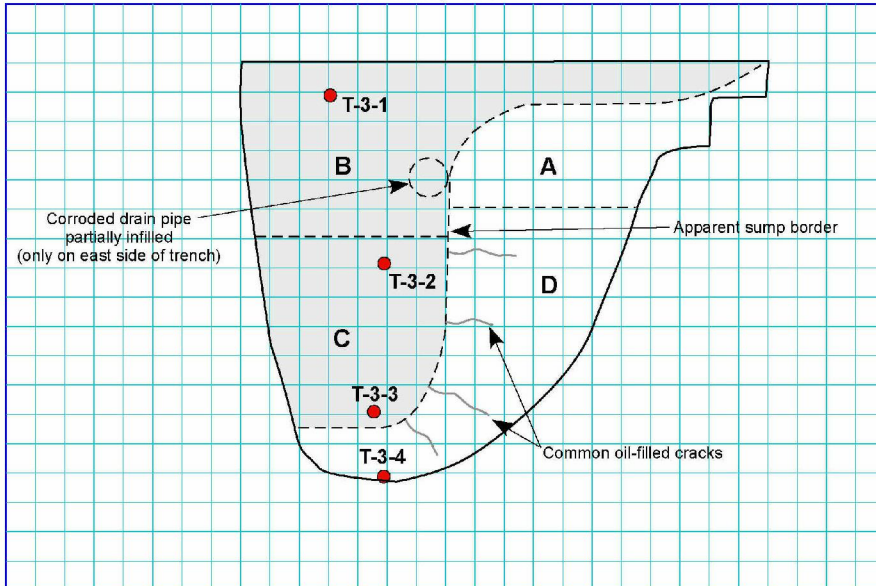
North-South Trench, East View

A. Light yellowish brown fine to coarse sand with abundant gravel- to cobble-size rock clasts, dry, trace staining, no odor.

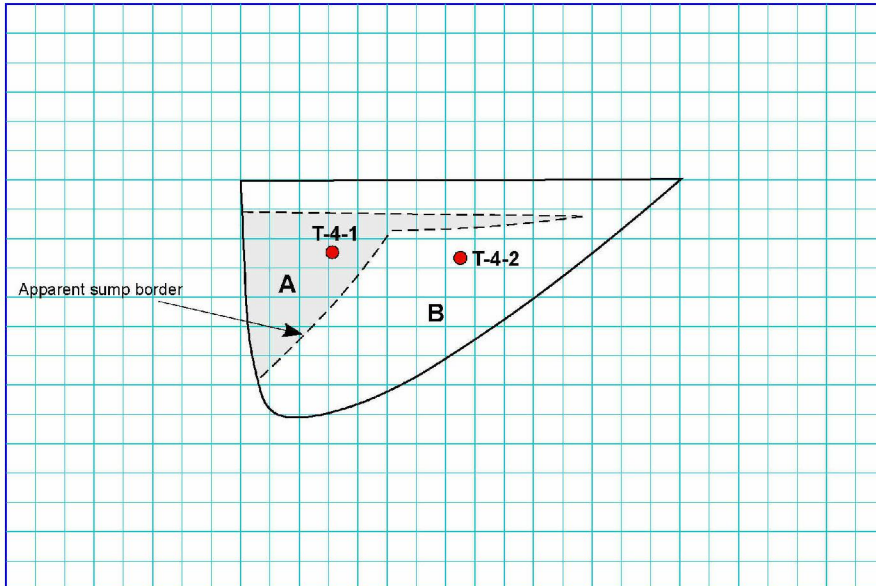
A. Very dark gray to black fine to coarse sandy silt with some yellowish brown gravel-size rock clasts, dry, stained, no odor.
