Technical Report

Response to Investigative Order No. R4-2015-0413 California Water Code Section 13267

16 February 2016

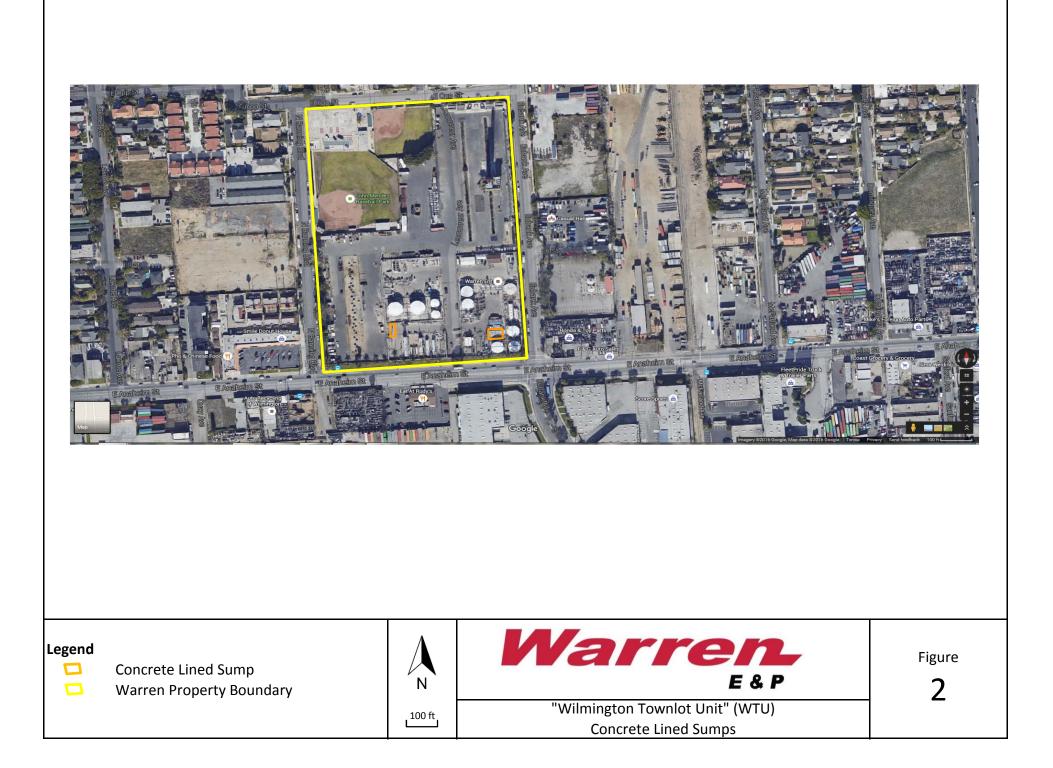
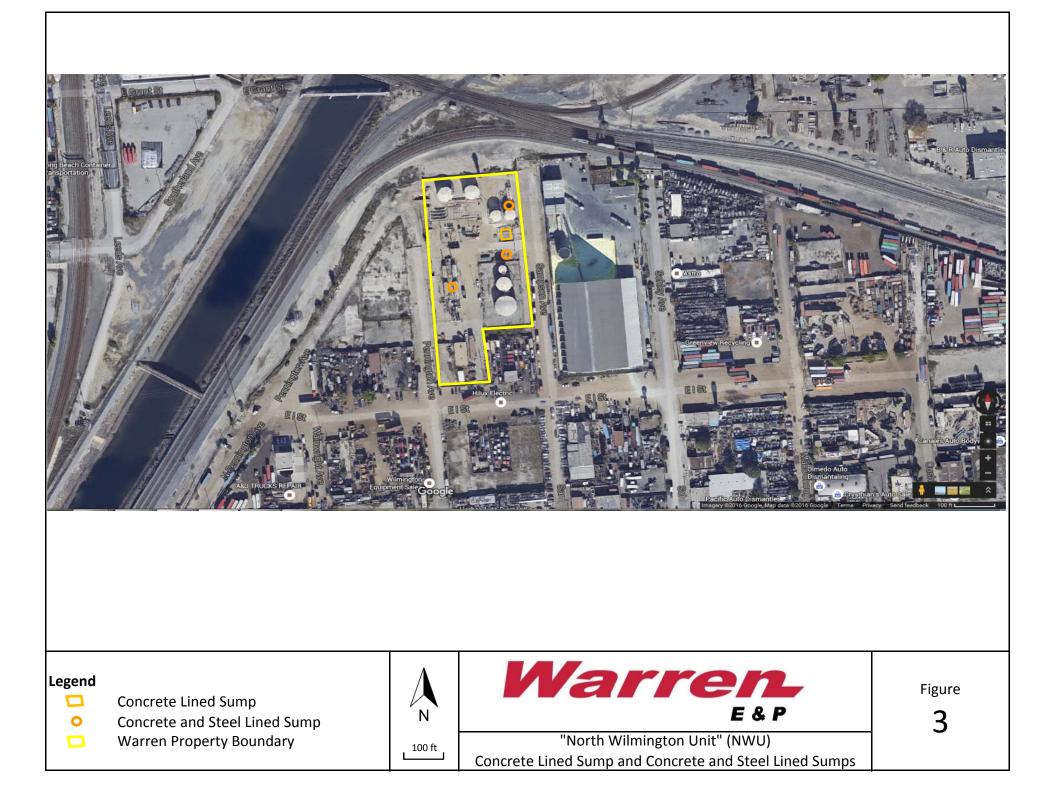
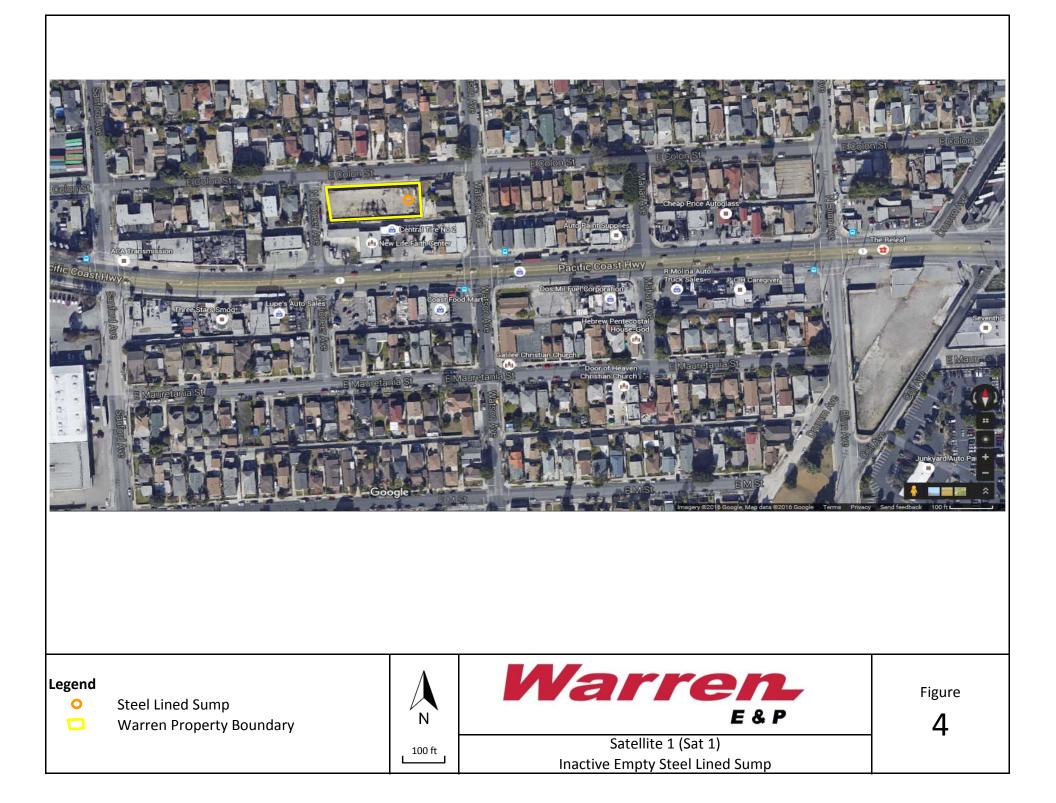
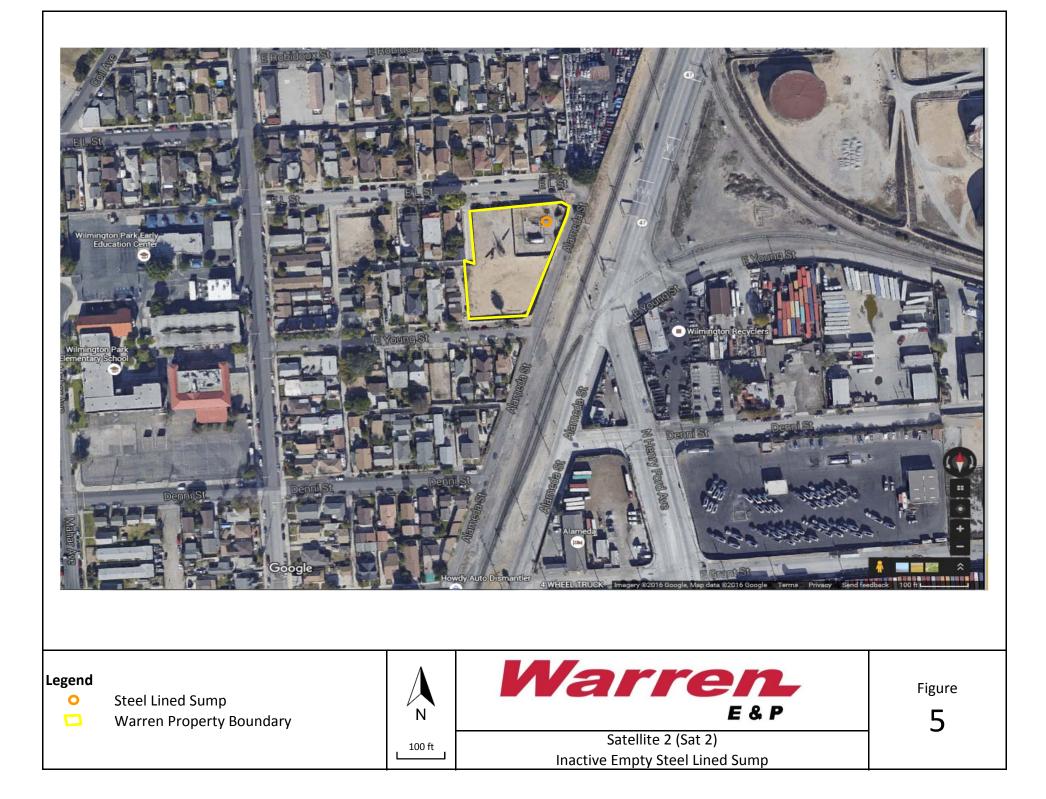
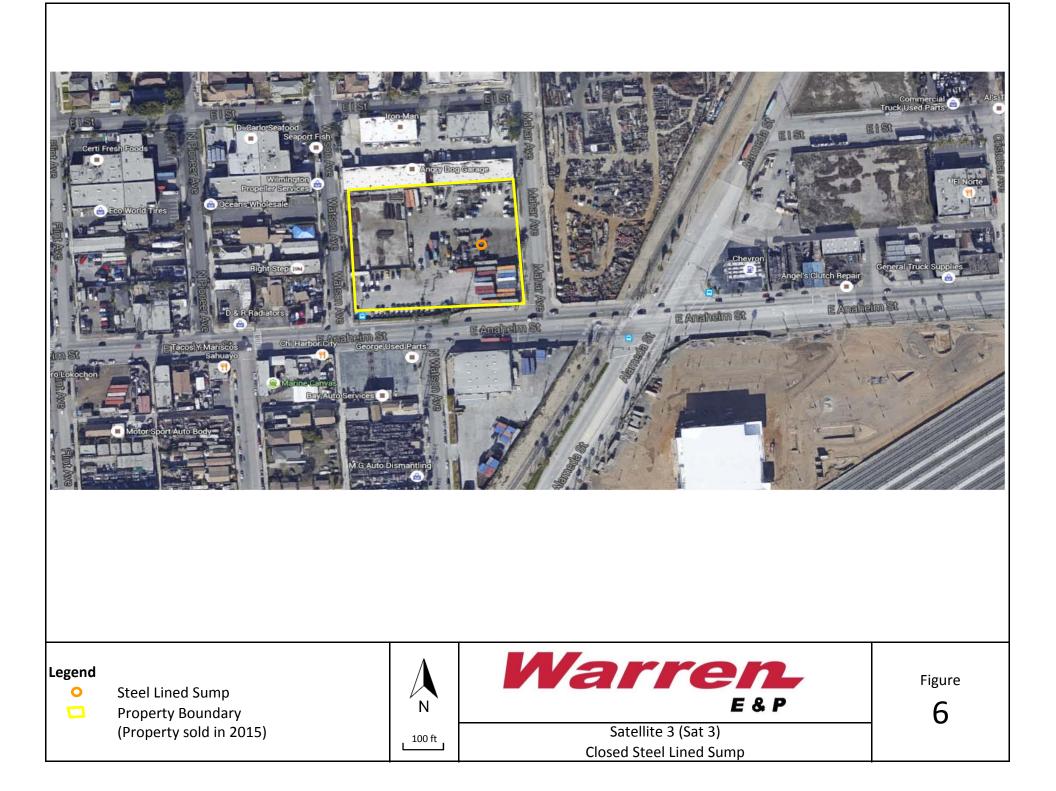
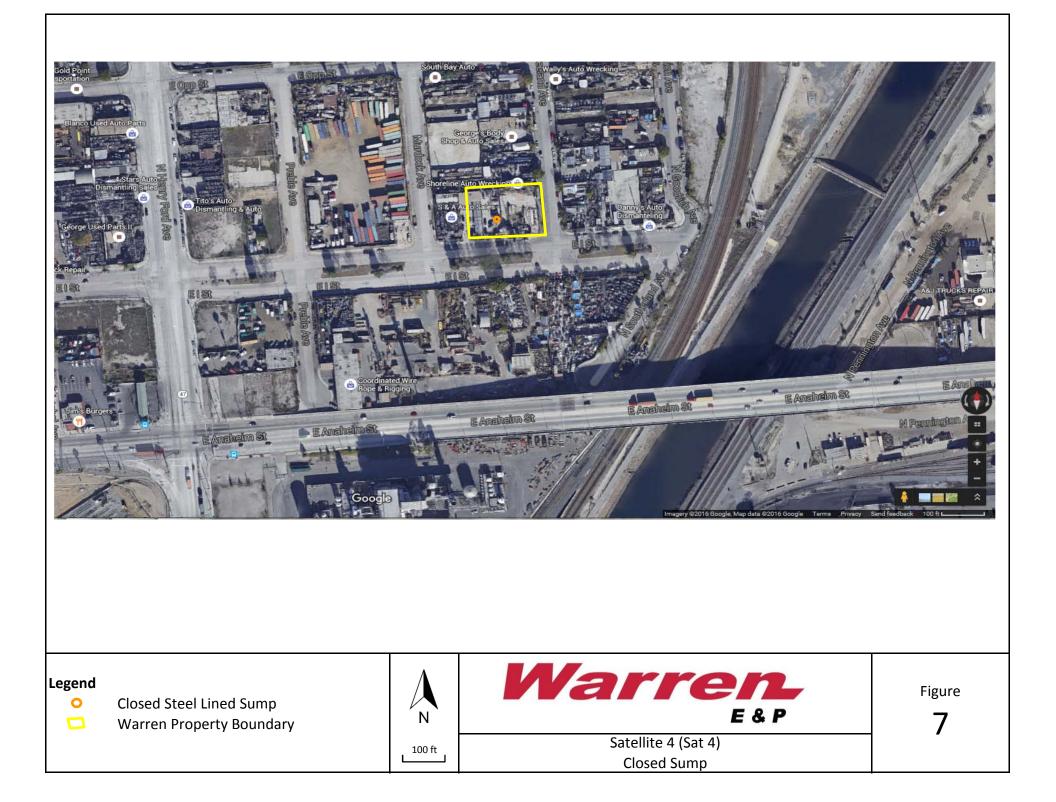
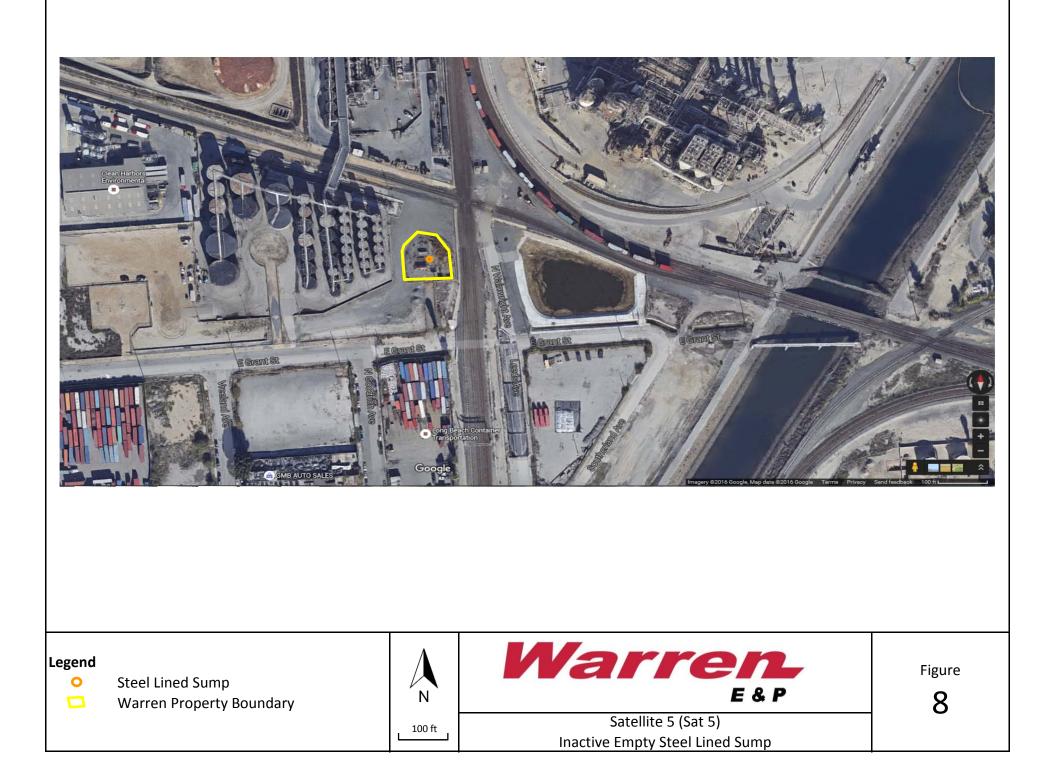
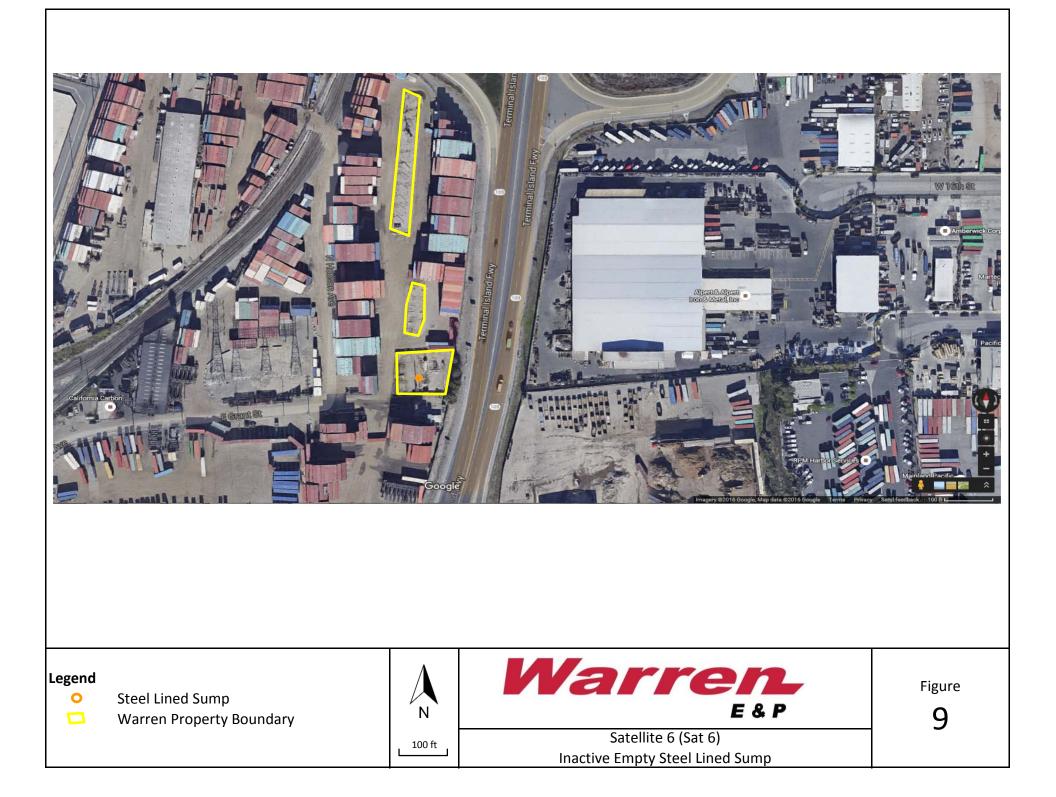
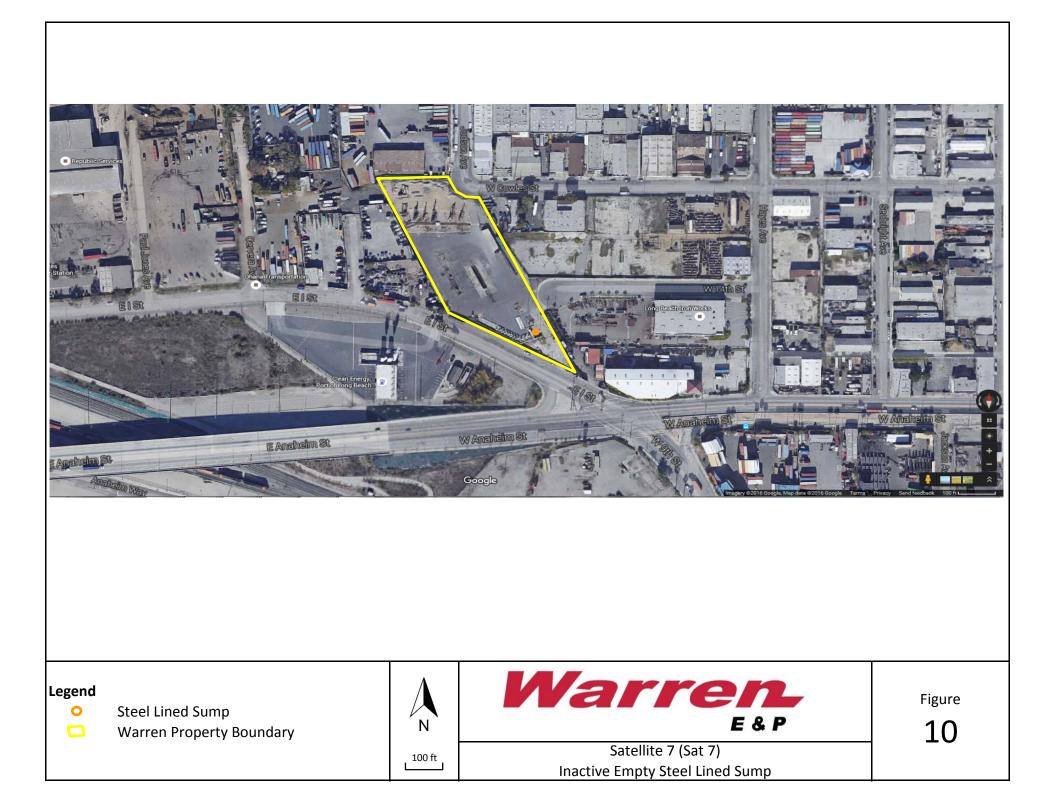
Figures and Maps

Please refer to Attachment B and Figures 1-10 that follow for additional information.
