CALLEGUAS CREEK WATERSHED TREATMENT – PHASE III FINAL REPORT

March 22, 2006

CALLEGUAS CREEK WATERSHED, VENTURA COUNTY, CA

COVER CROP, MULCHING, STREAMBANK STABILIZATION AND PERMIT COORDINATION PROGRAM

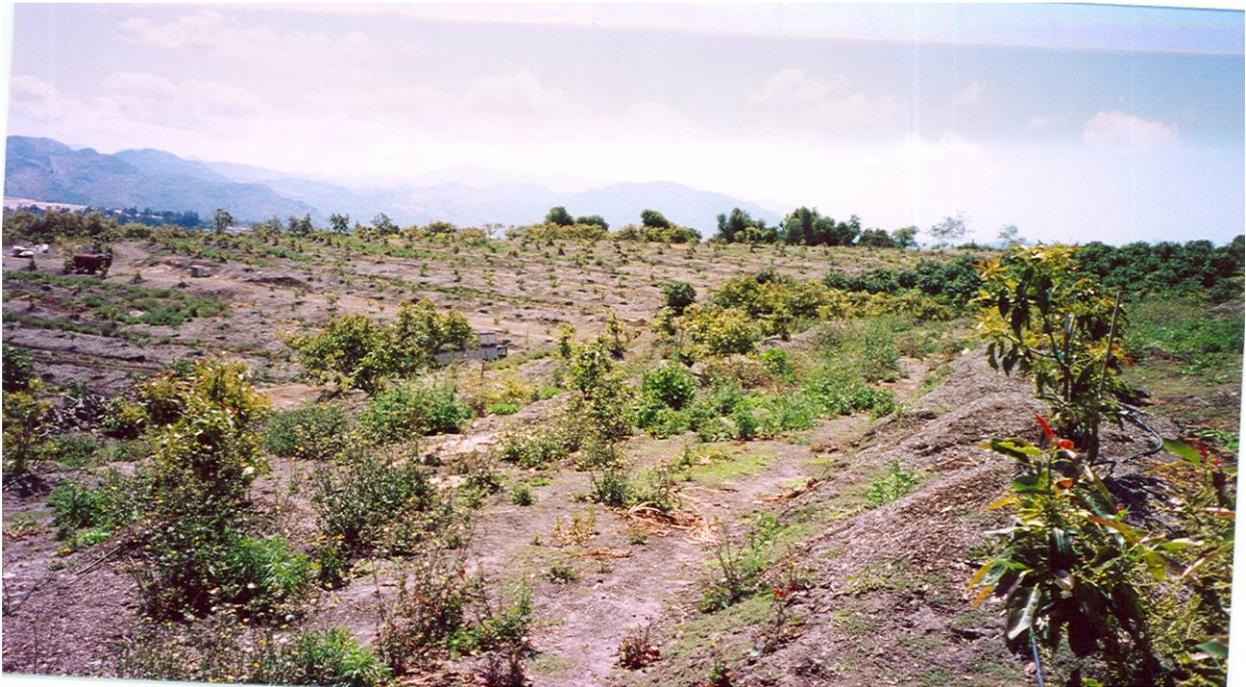
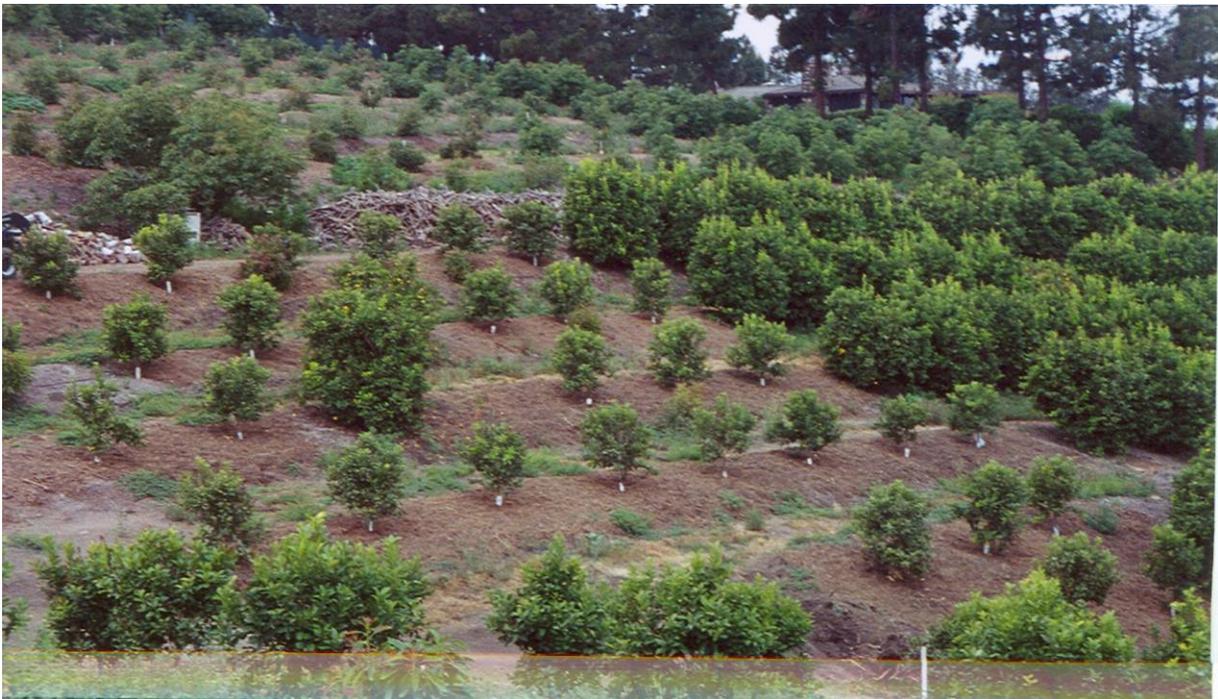
GENE BAKER

Mr. Baker's ranch is located on a hillside, which has potential for erosion. He was a very enthusiastic participant in this program and secured copious amounts of mulch, which he applied liberally to his grove. Because of this program and the benefits derived from mulching, Mr. Baker has continued to add material to his ranch even though he will no longer be reimbursed.

Before

After

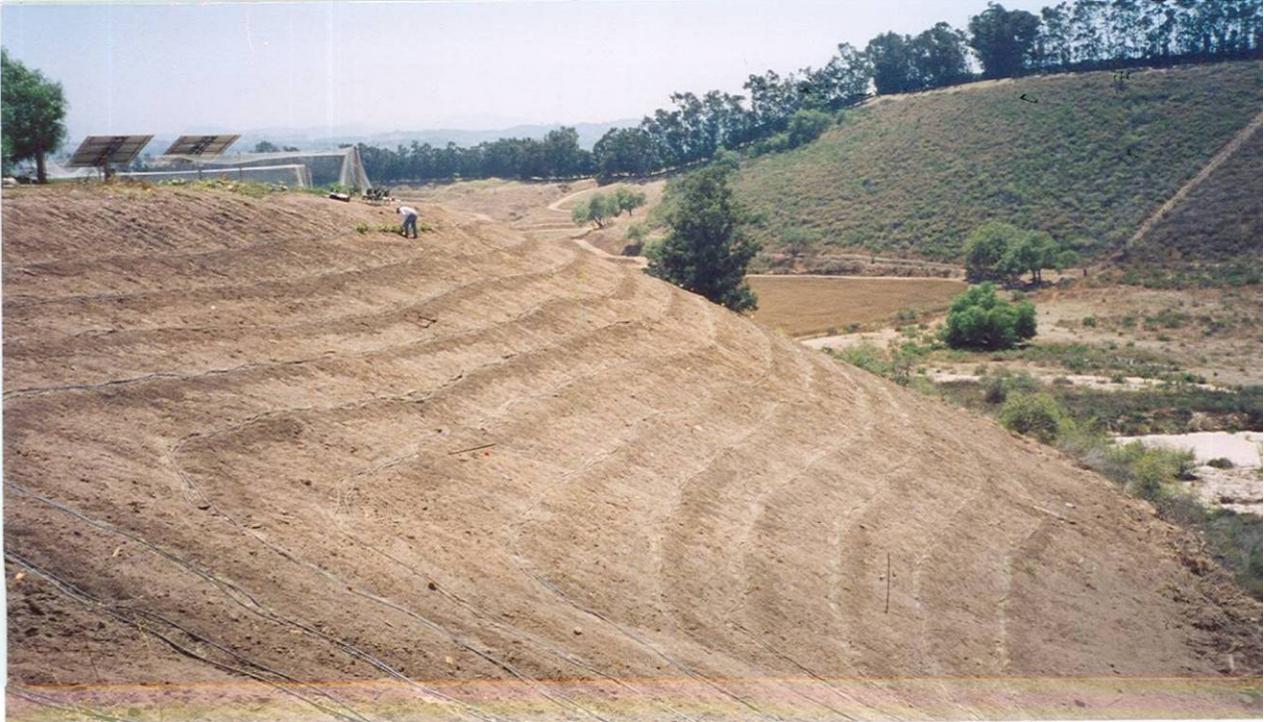
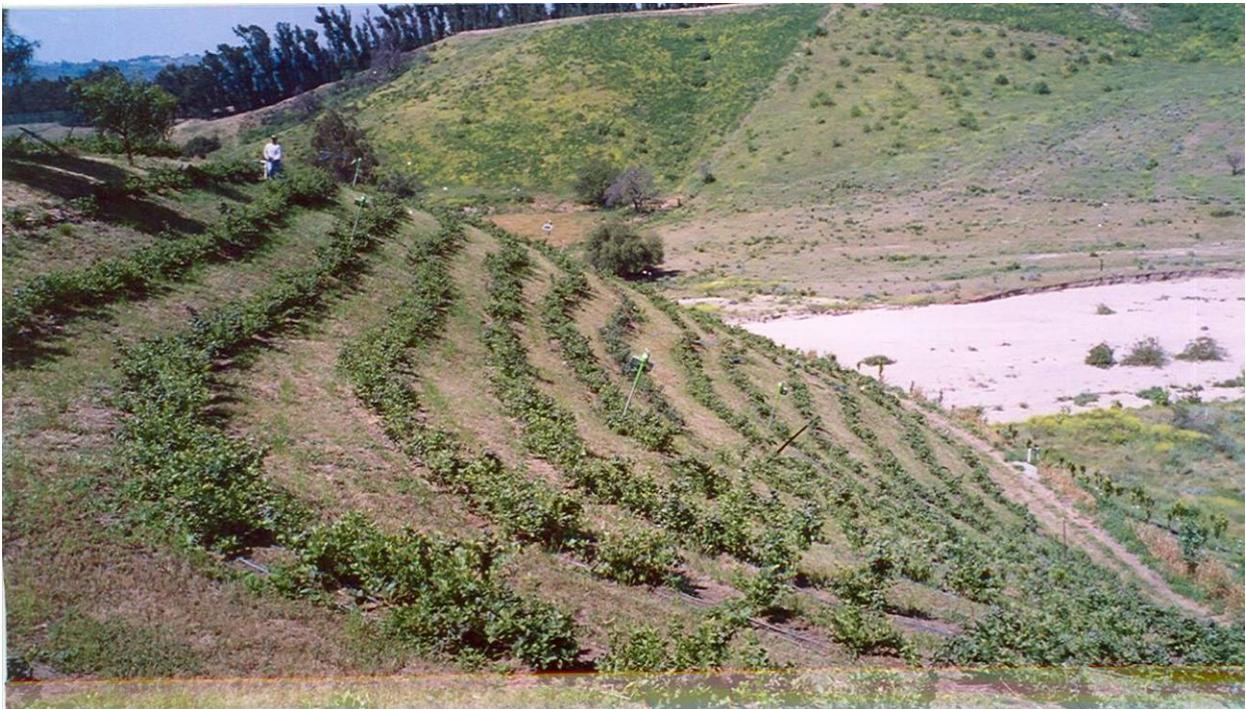
GREG BERRY

Mr. Berry grows blueberries in an area with moderate to very steep hillsides as can be seen from the accompanying pictures. In the areas with moderate sloping mulch was applied. However, the steep hillsides had to be cover cropped.

Before

After

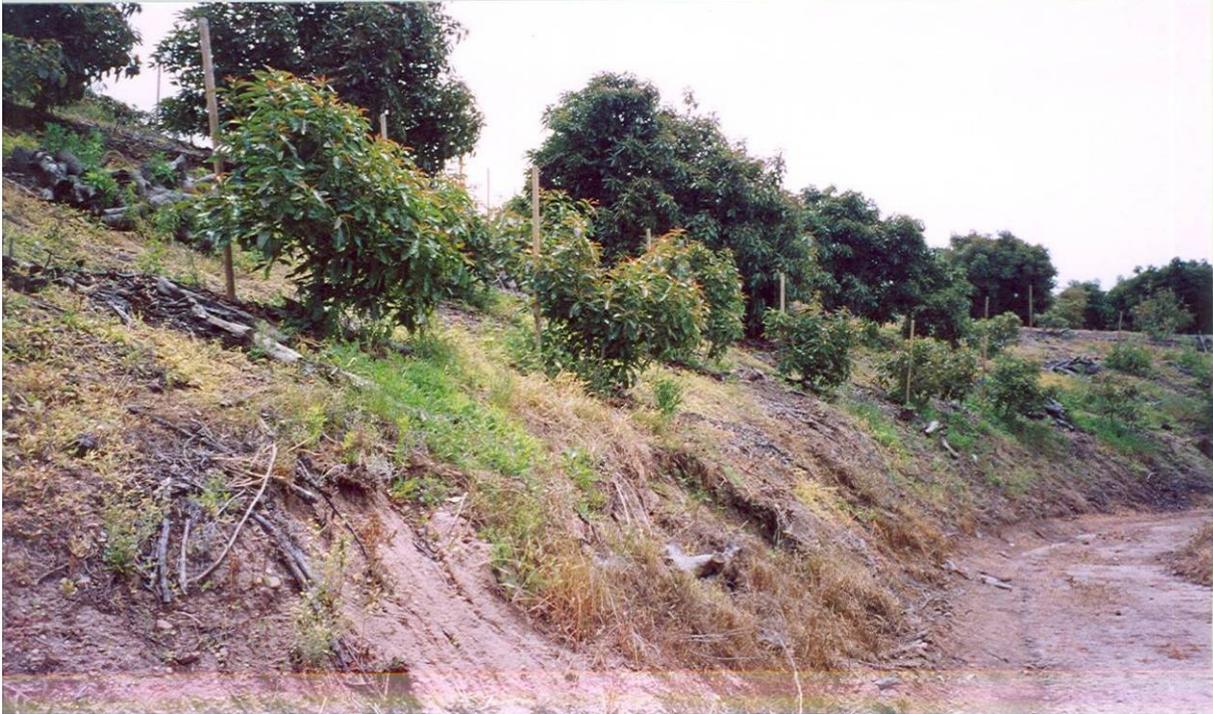
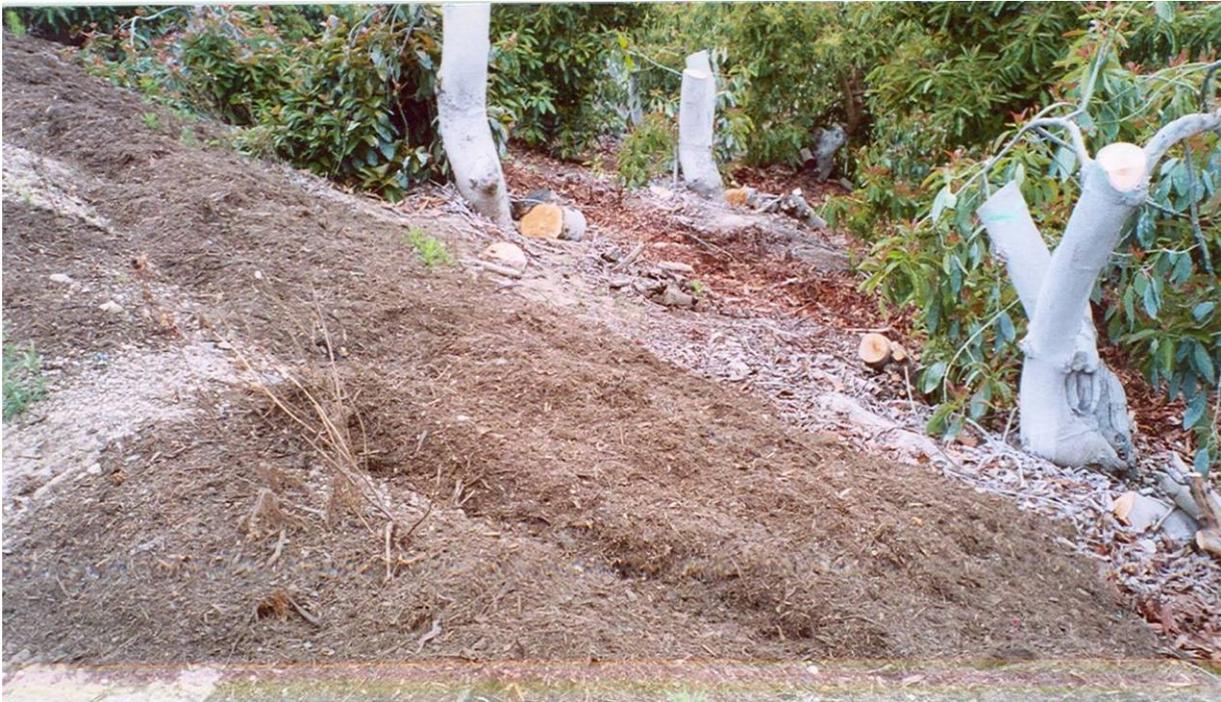
CHARLES BLANC

Mr. Blanc used both an outside contractor to apply the mulch and ranch labor on the very steep areas of his ranch.

Before

After

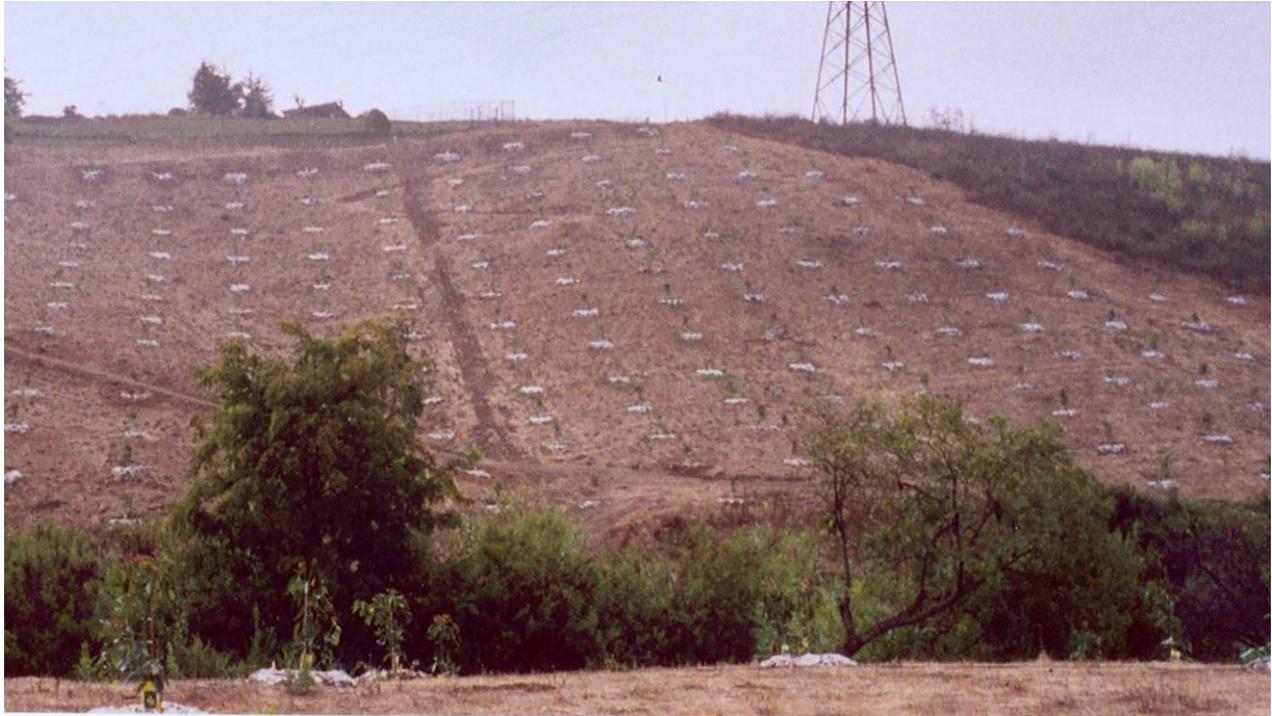
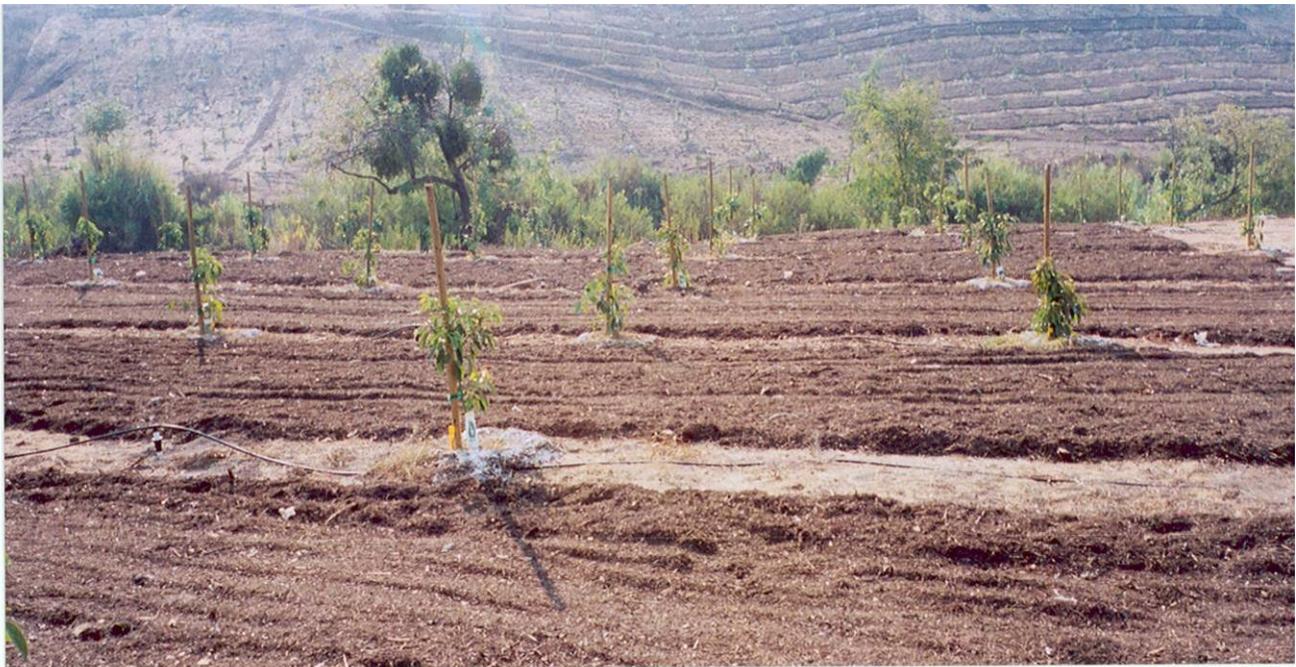
TOM FIELDS

Mr. Fields has recently planted avocados on his hillside property. With the addition of mulch, these hillsides will be protected from eroding into the streambed below his property. Mr. Fields had the mulch applied by a ranch management company and met our requirements.

Before

After

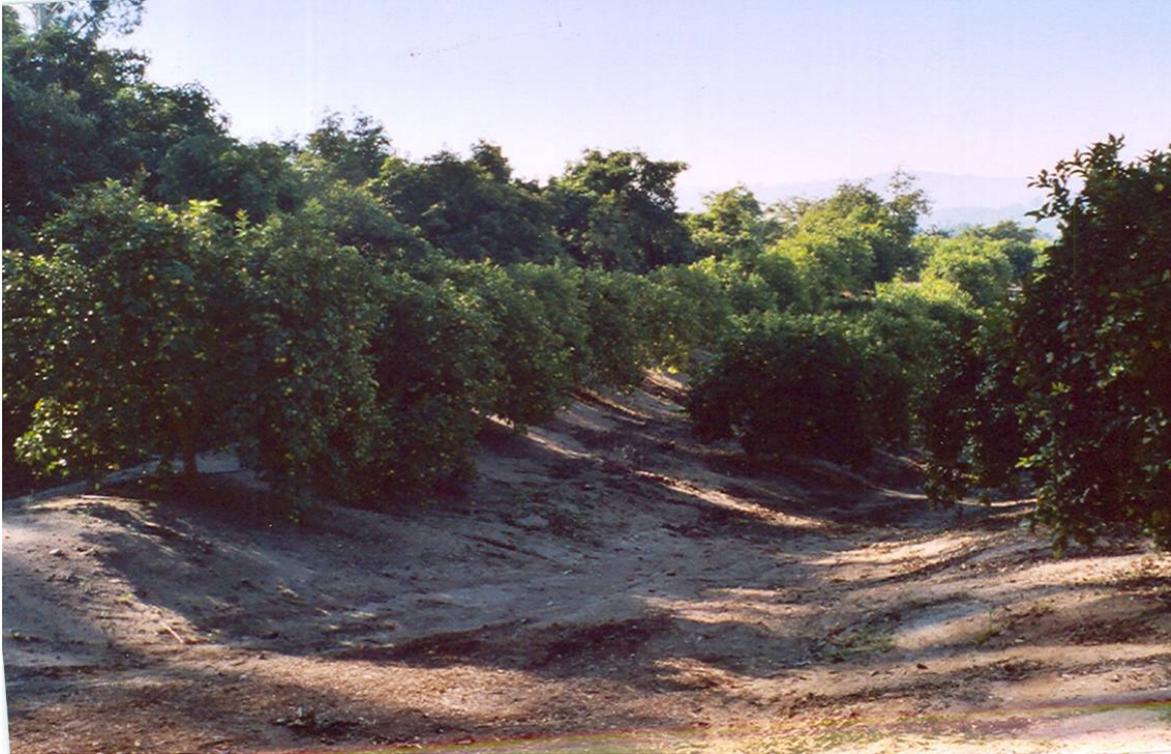
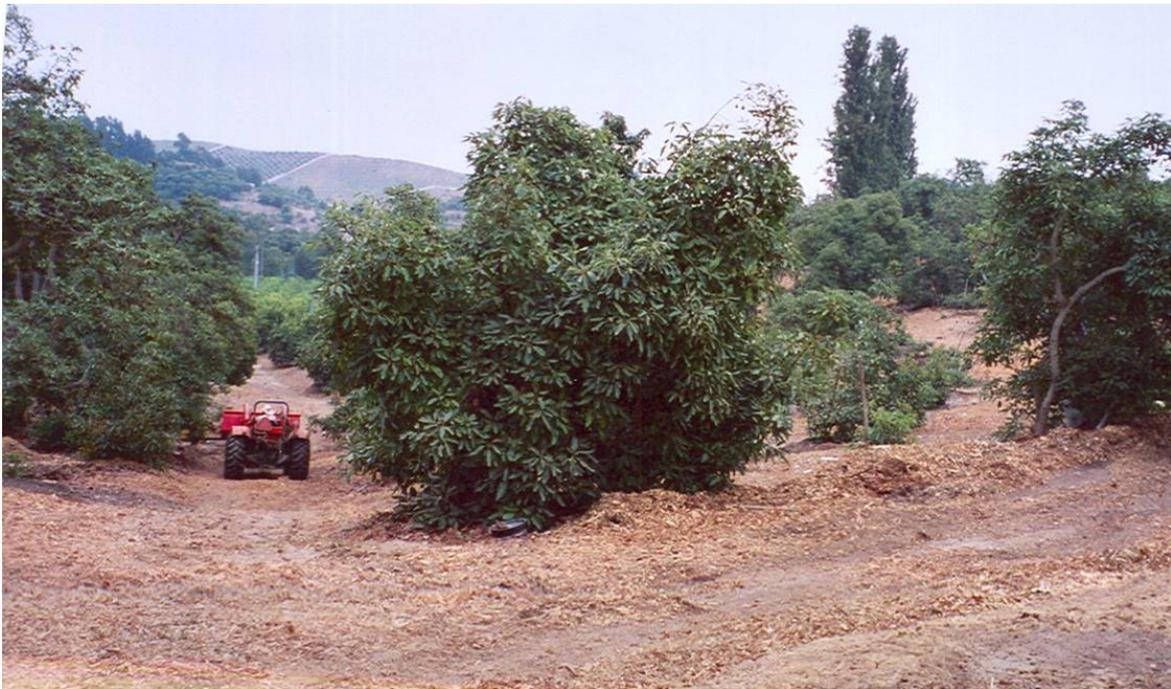
BRIAN LEE

Mr. Lee is a young grower new to this profession and is very cost-conscious. After qualifying for our program, the grower was able to expand his mulching project in a larger way and over the hillsides where his ranch is located. The grower has secured large amounts of mulch material and in order to mitigate cost he is using ranch labor to apply the material. This method takes longer due to other obligations, but he has been able to cover a majority of his ranch under our time table.

Before

After

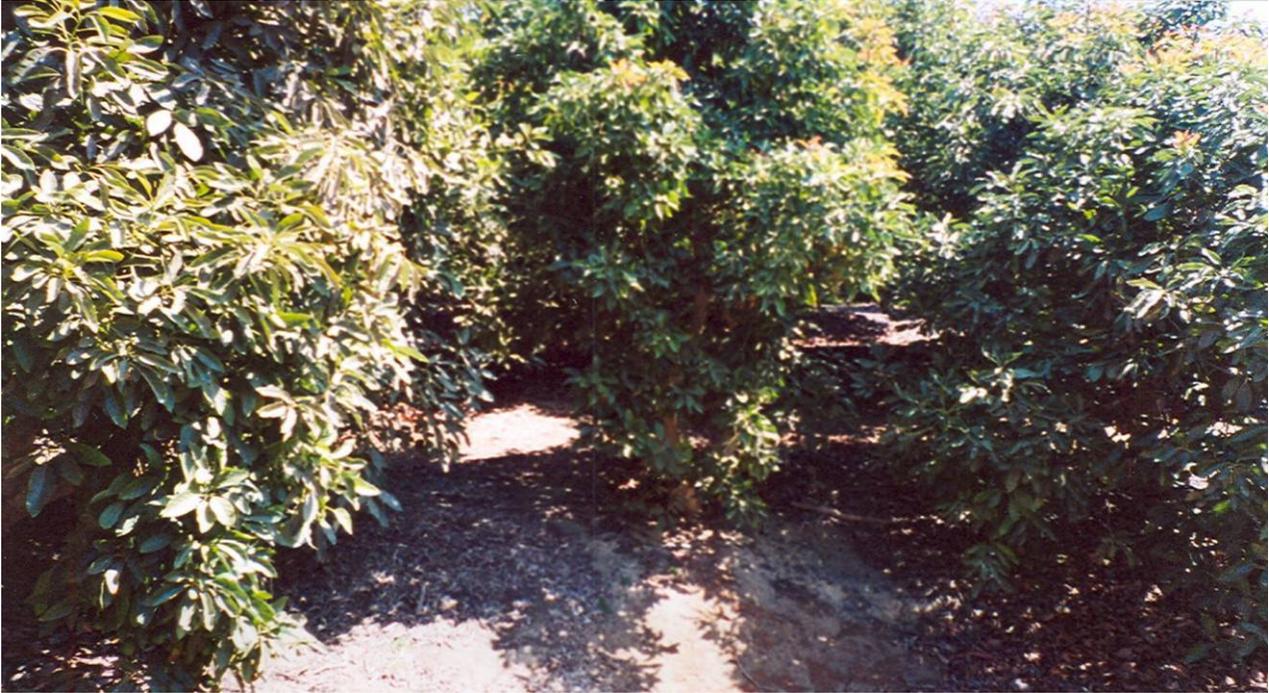
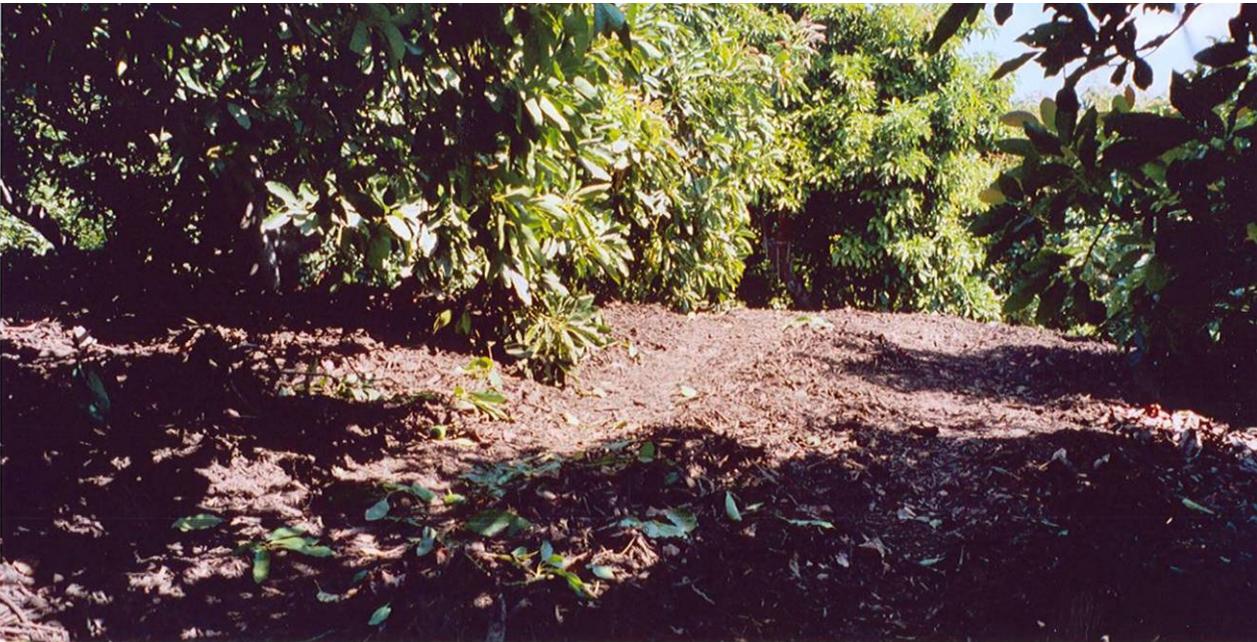
JIM LLOYD BUTLER

The grower was very selective in the type and quality of mulch using primarily lemon wood. The mulch was applied by an outside contractor, until he purchased his own spreaders and is now applying the mulch. The mulching was completed.

Before

After

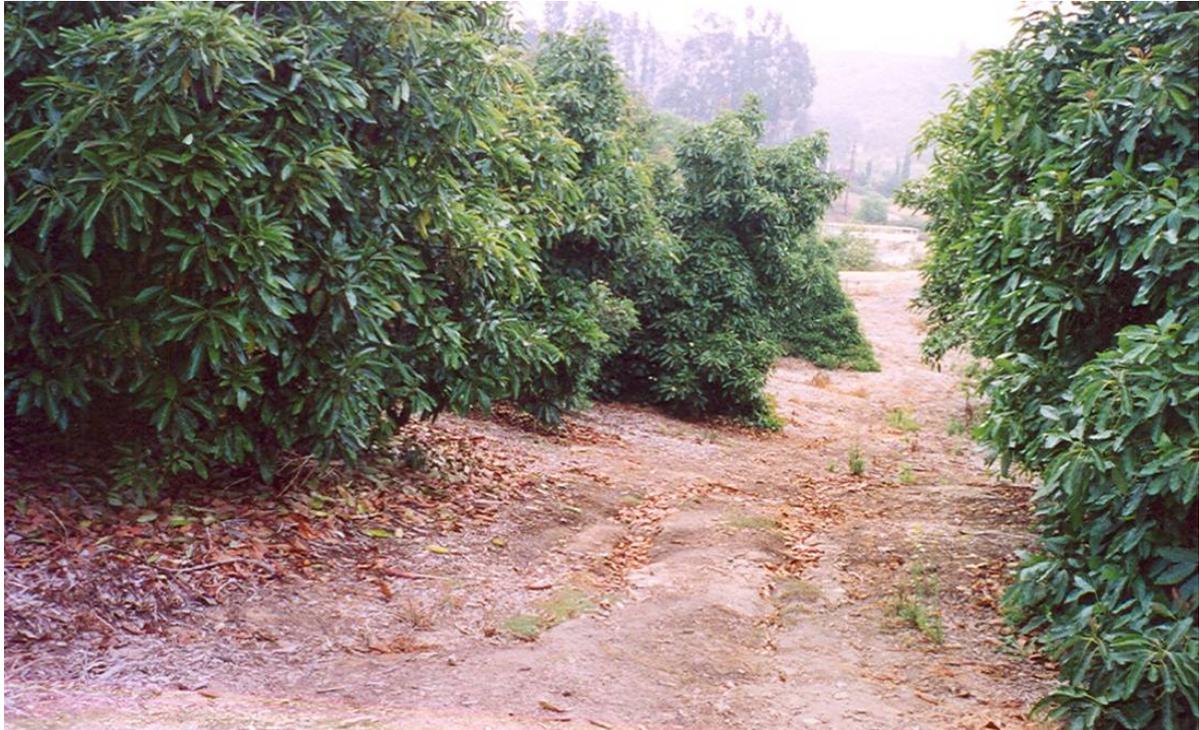
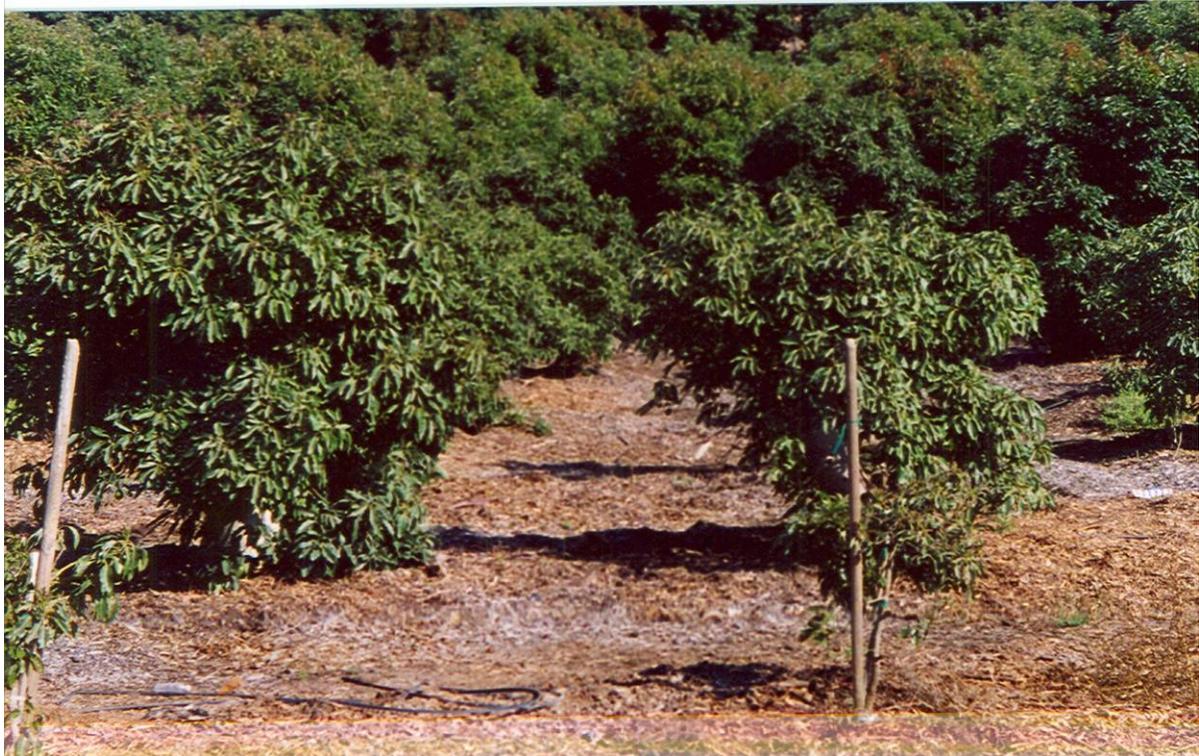
GENE MABRY

Mr. Mabry raises both lemons and avocados on his ranch. The ranch consists of areas with moderate to steep slopes.

Before

After

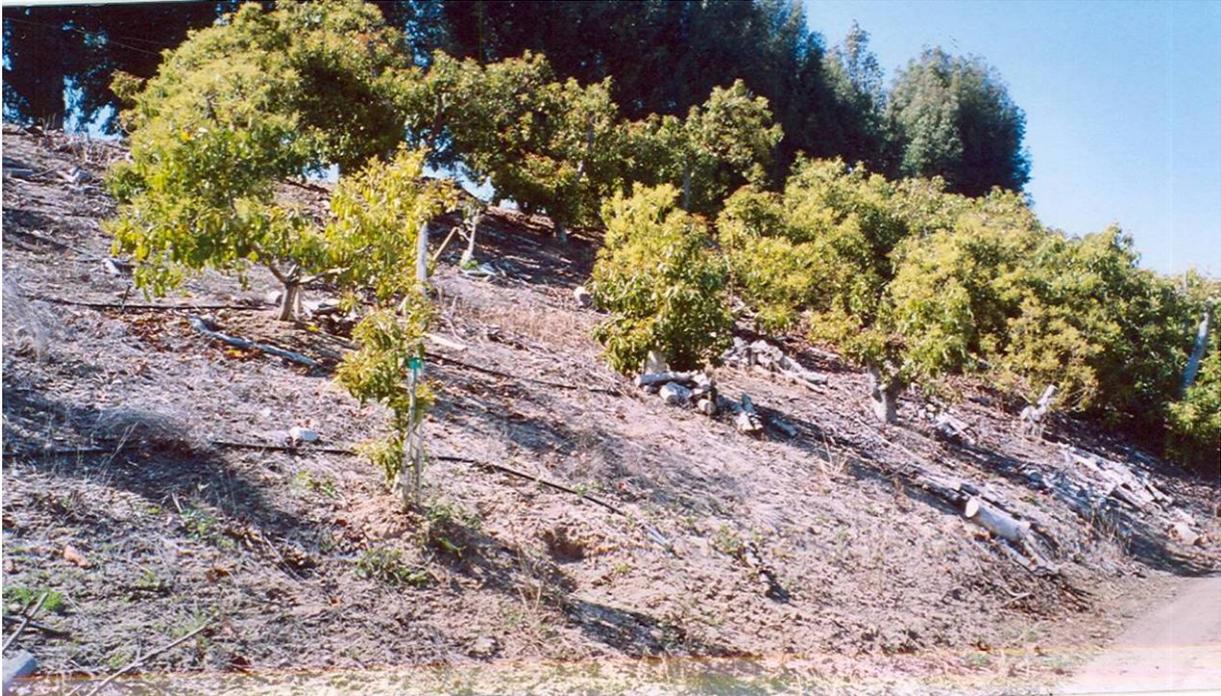
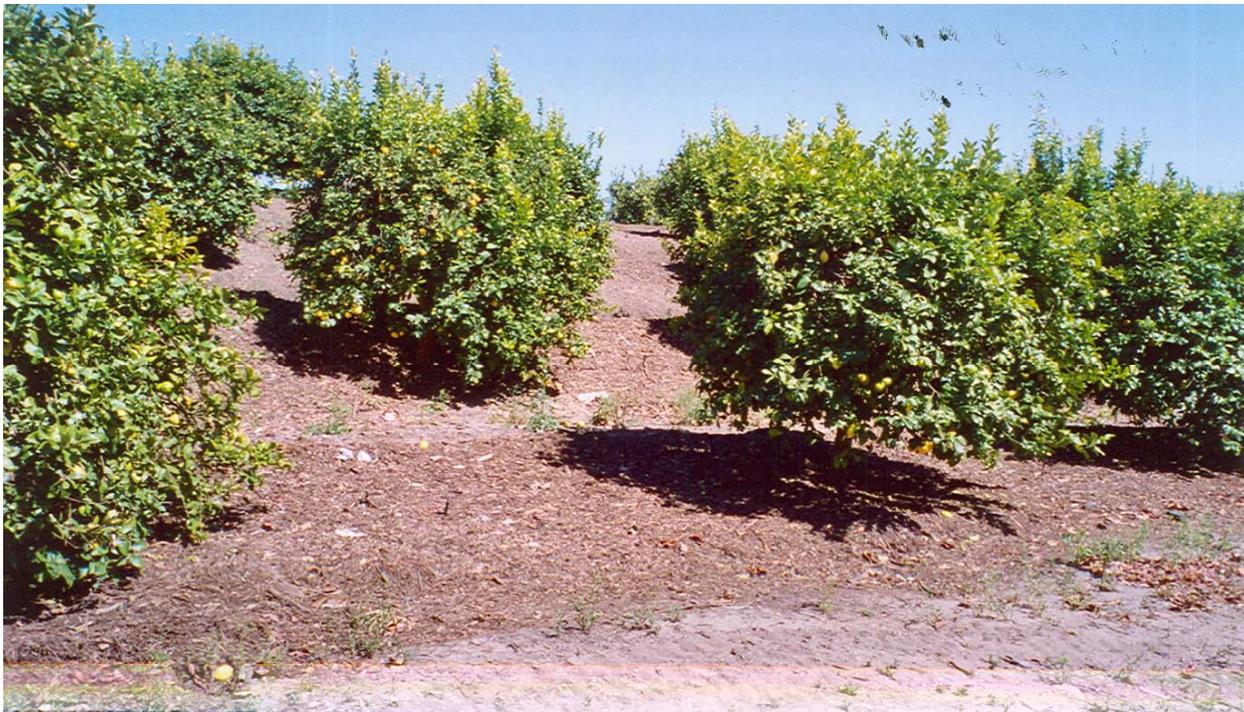
RON PARTAIN

Mr. Partain is an absentee farmer, therefore he employs a grove management company to maintain his lemon and avocado grove. The mulch was applied by an outside contractor with little concern for cost. The mulch was applied liberally with all hillsides covered as required.

Before

After

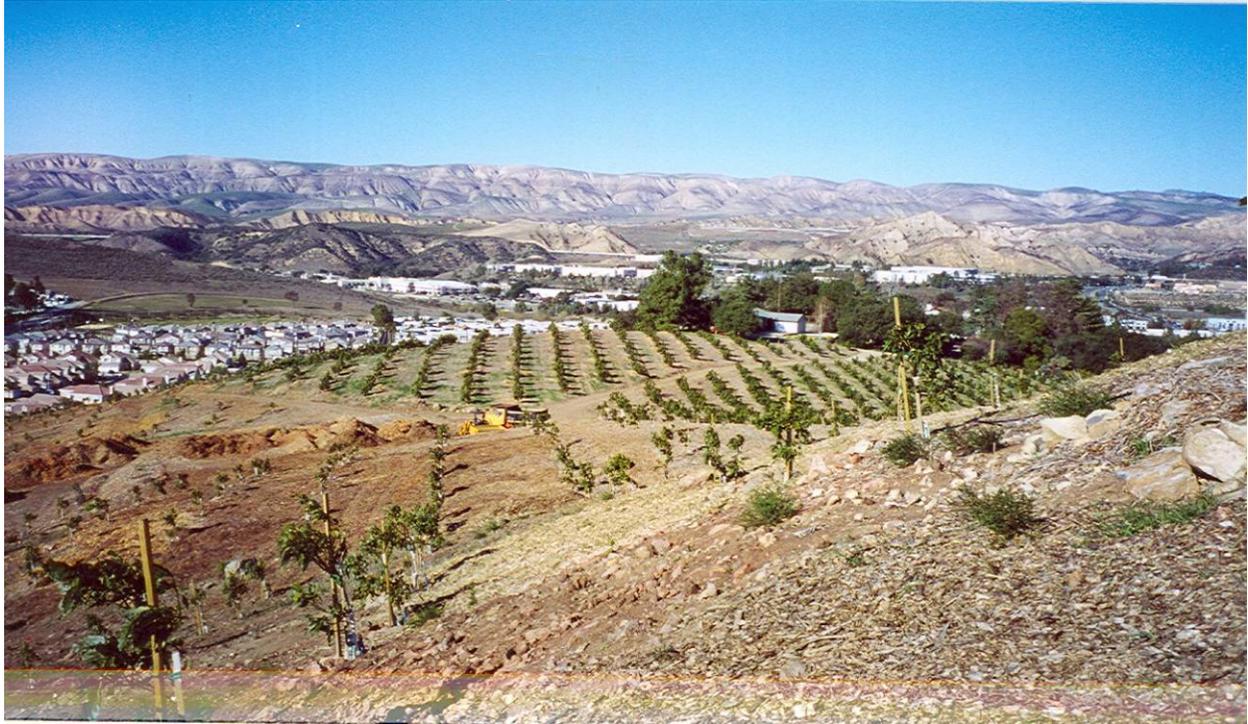
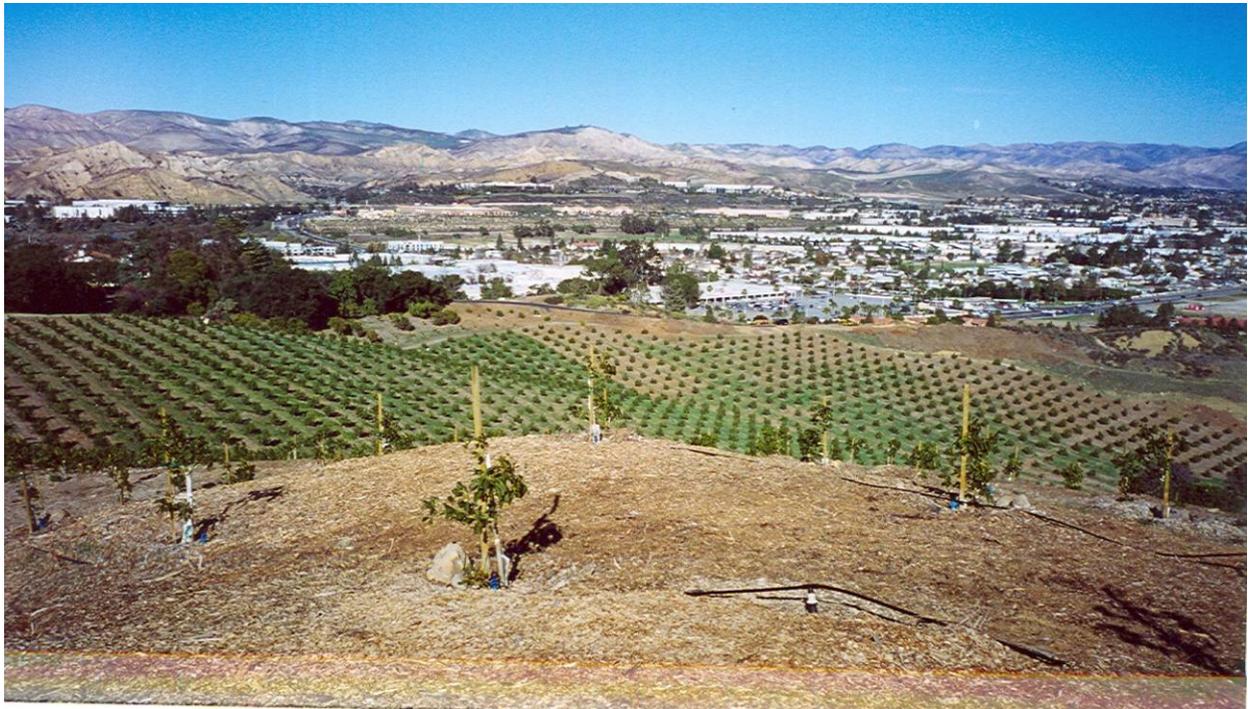
GARY SEATON

Mr. Seaton was just beginning to explore the benefits of applying mulch to his avocado grove but was holding back due to the cost. After being accepted into our program, he was able to apply mulch to all areas of his grove. This ranch qualified for our program as it is situated on steep hillsides directly above two housing tracts. Due to the amount of mulch applied just prior to the heavy rains we sustained in the winter of 2004-2005, he experienced little or no soil erosion. Even though he is no longer in the program, Mr. Seaton is continuing to apply mulch.

Before

After

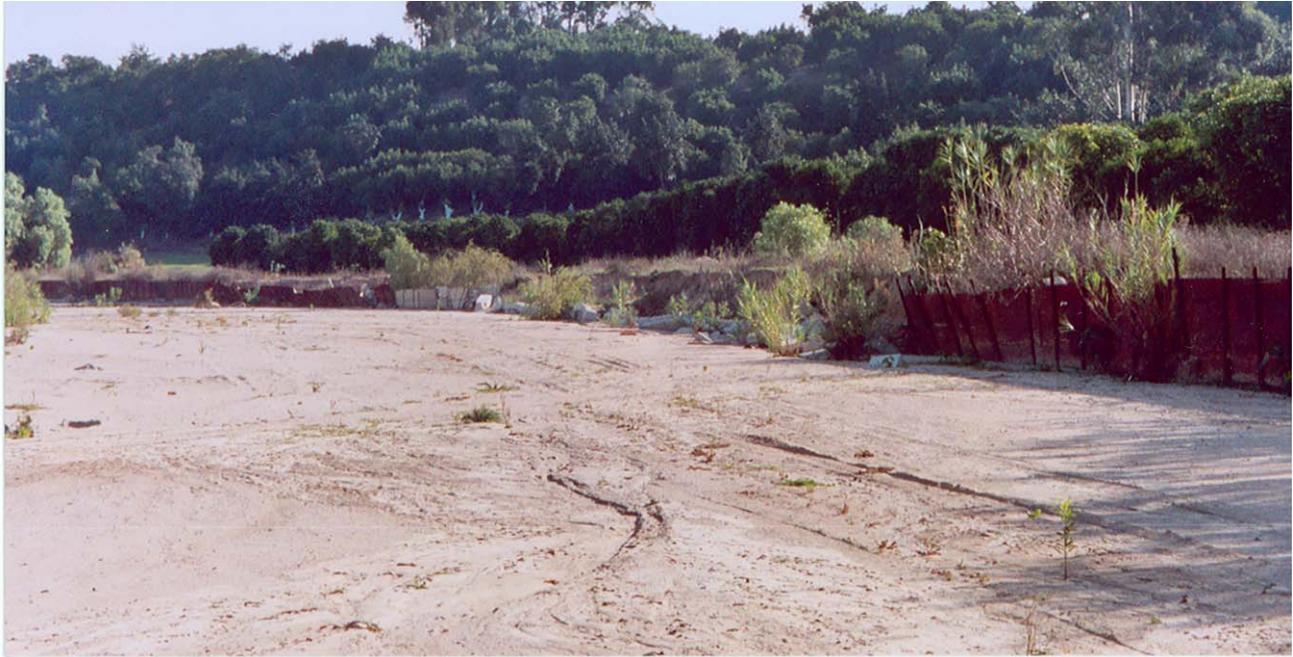
Proposed repair of concrete block-lined streambank.

Staff visited 12 potential project sites over the course of two years. Only two growers were either interested in moving forward with designs or qualified for the program. Pictures of some of the proposed project sites are attached. Two projects moved forward with designs and both growers have spent funds for surveying and engineering. One project proponent submitted plans to the VCRCD in October. Staff will be preparing permit applications for the project, but the project implementation will be done with private funds next year. The other landowner hired an engineering firm in July 2005 to work on his design. Staff was contacted by the engineer in February 2006 to talk about design requirements as they were just beginning to work on the design.

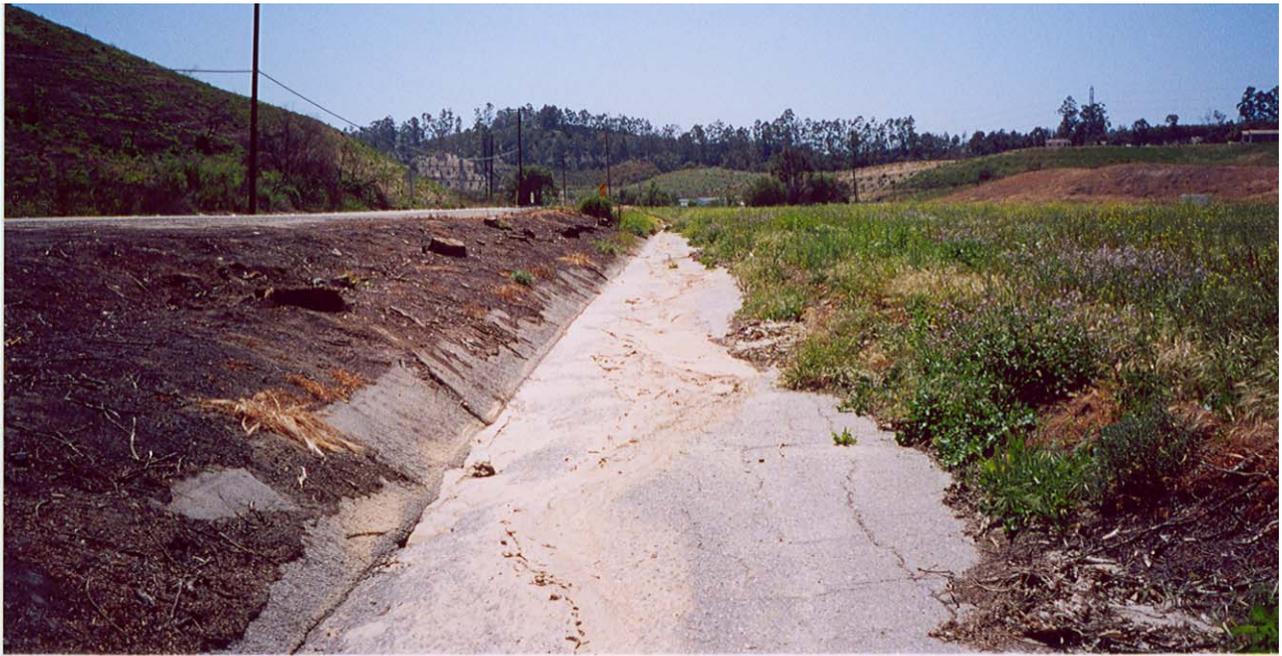
Proposed re-lining of downstream eroded area.

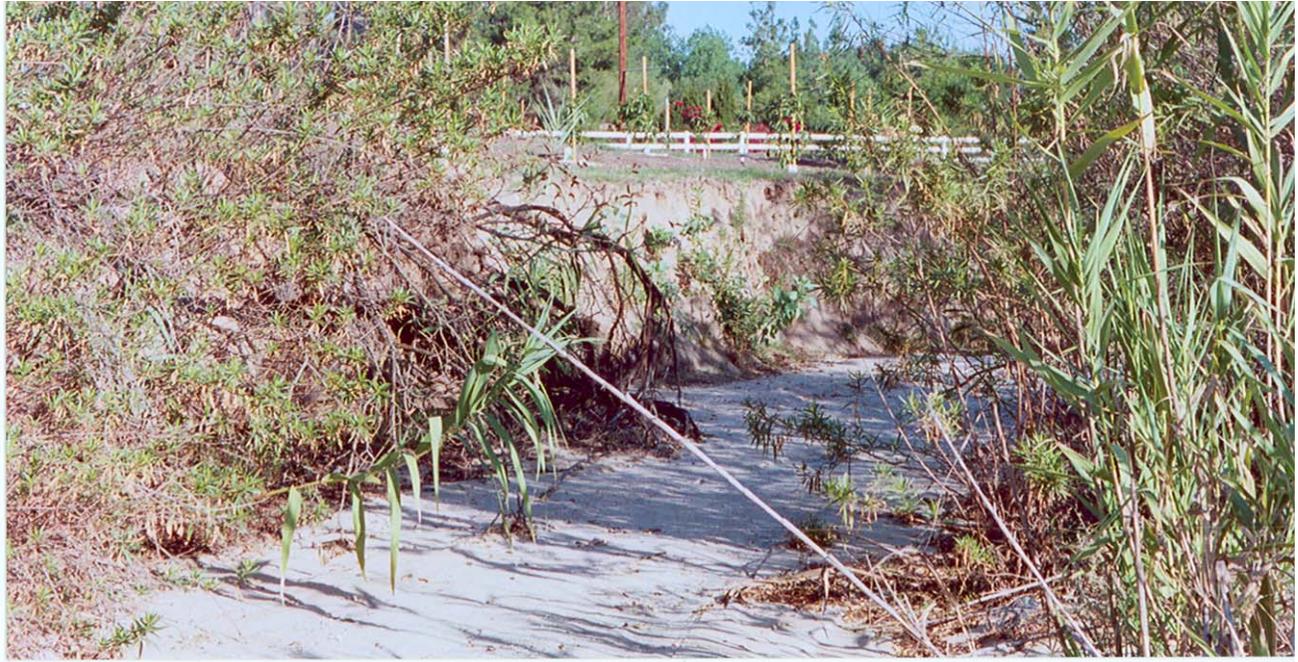
Proposed bank repair using bioengineering and removal of invasive plants.

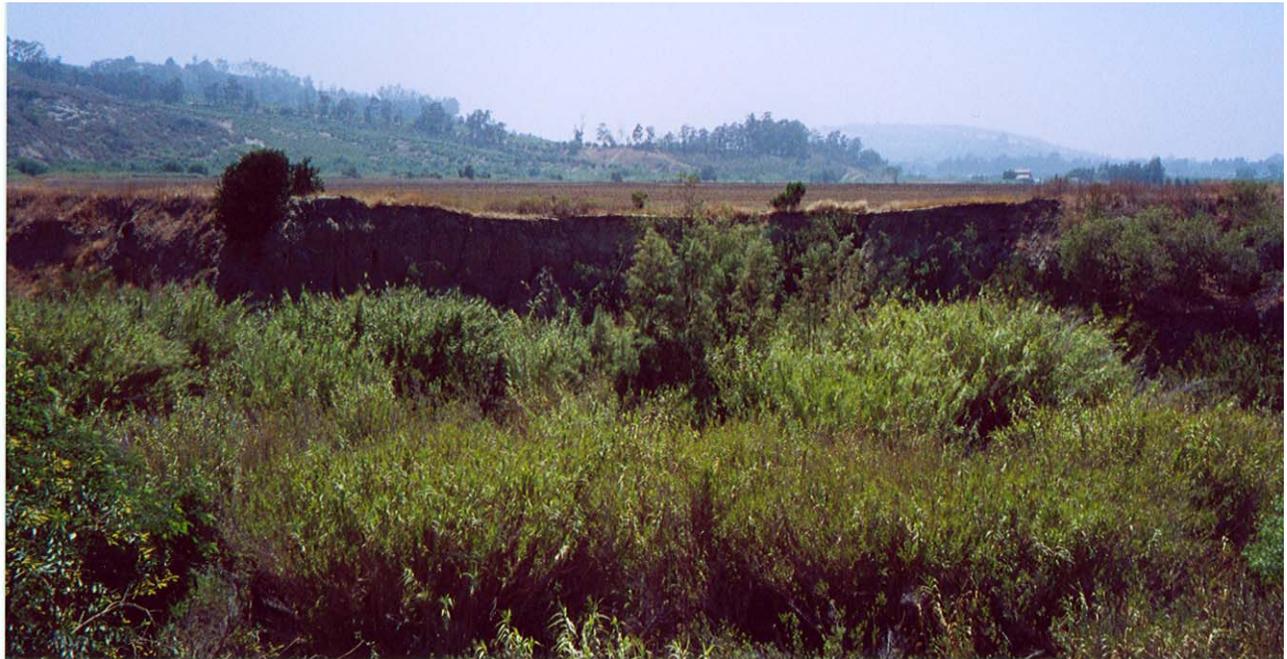
Proposed repair included laying back the slope, planting native grasses on the slope and willows and mule fat at the toe.
