California Regional Water Quality Control Board  
North Coast Region

Cleanup and Abatement Order No. R1-2004-0077

Windsor Oaks Associates LP

**Enclosure 2 – Site Photos taken May 21, 2004 and June 14, 2004.**

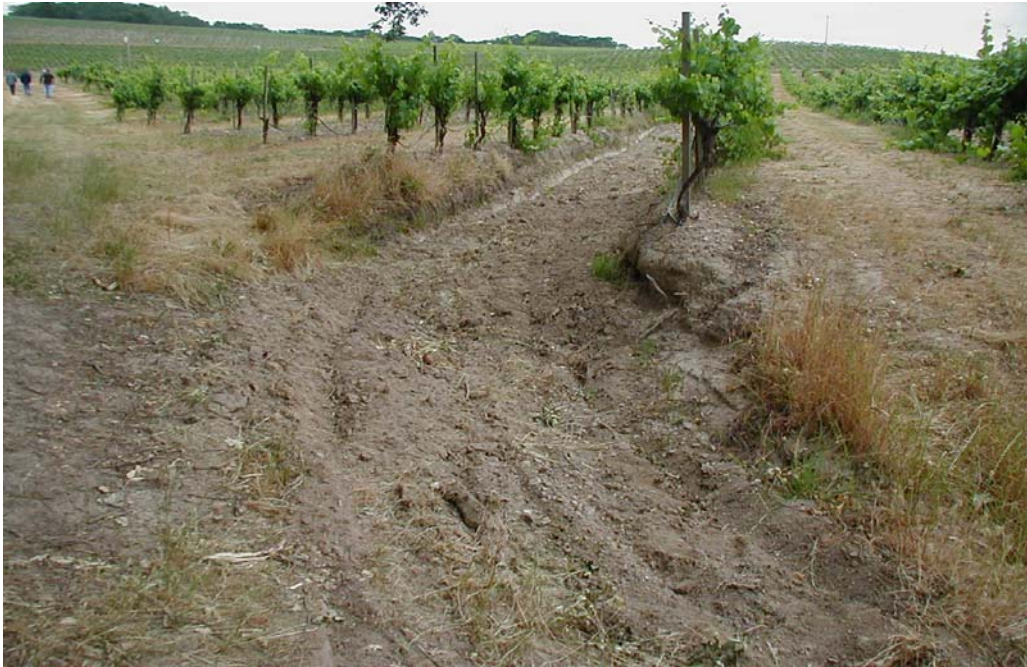
There was an historic waterway that runs through an existing historic vineyard, which was converted in the 1970's, that has been altered yearly through disking. The drainage feature lacks any riparian and offers no real habitat value. There is evidence of erosion associated with the continuous disking of the drainage feature. Staff recommended that the Discharger not disc the row that contains the drainage feature, and to implement some erosion control Best Management Practices (BMPs) to help control erosion from the feature. The Discharger agreed to the recommendations (Photo 1).

**Photo 1.** View of impacted drainage feature that flows through Field 1. 5/21/04.

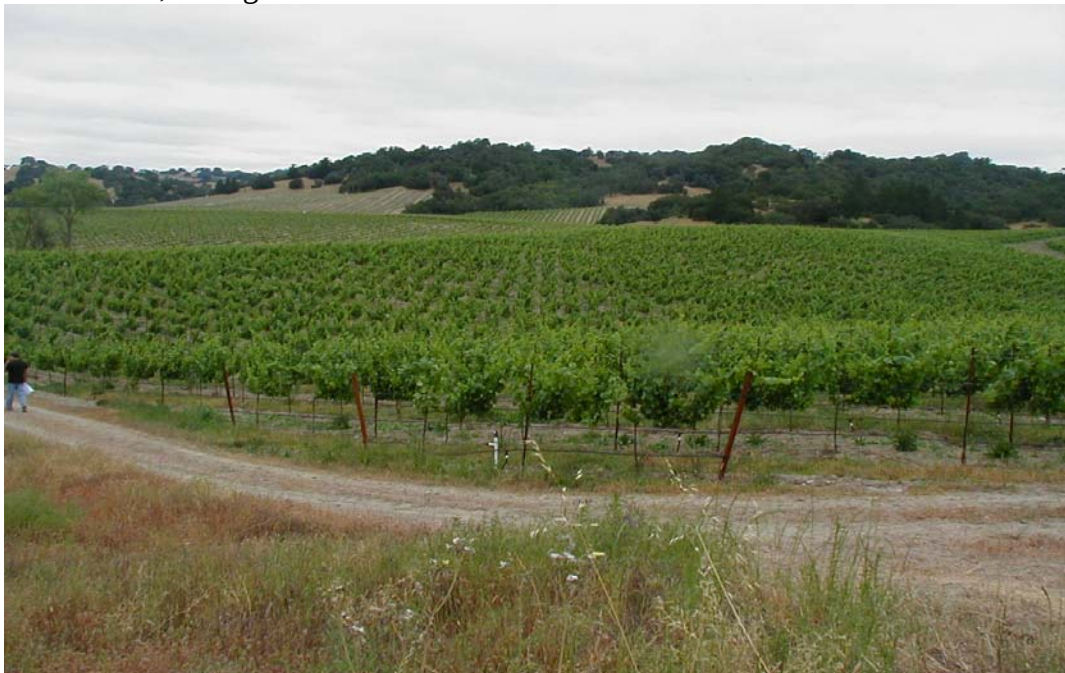
Field 8 is located up gradient of an existing reservoir. It appeared that an intermittent drainage feature had been culverted and filled during a vineyard conversion in 2001. The group reviewed aerial photographs of the area, and determined that a small water feature was present above the pond feature, and had been culverted and filled over to facilitate vineyard plantings (Photo 2).

**Photo 2.** View of intermittent drainage feature had been culverted and filled during a vineyard conversion in 2001, through Field 8. 5/21/04.

- a. A Workplan for removing the linear culverts and fill material from the intermittent tributaries that have been filled on the Site. The Workplan shall include information regarding the location and suitability of a chosen disposal site for the excavated fill material;

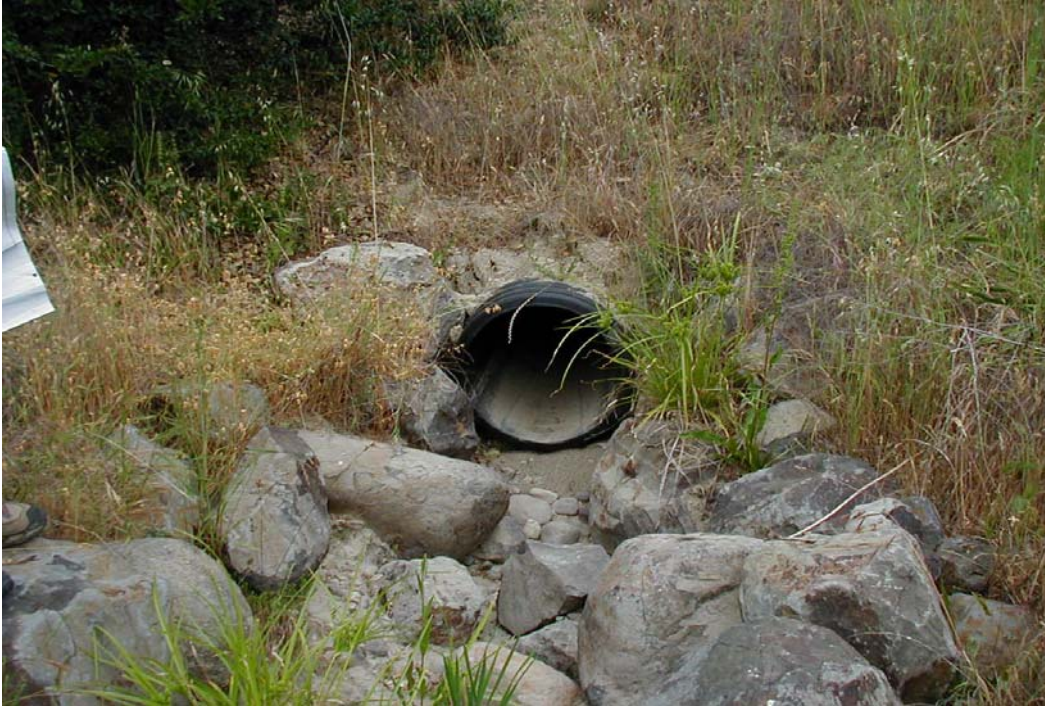
An existing culvert was replaced apparently during the summer of 2001 with a corrugated plastic pipe, without the necessary resource agency approvals, to facilitate a road crossing. The intermittent tributary that the culvert was installed in is identified as Starr Creek Tributary #8 (T-8) on the improvement plans prepared by Kenneth Carr and Associates, November 17, 2002. Staff notified the Discharger of the permitting requirements and stated that an “after-the-fact” permit would be required for the crossing. The Discharger agreed to submit an application for an after-the-fact permit (Photo 3).

**Photo 3.** View of the unauthorized corrugated plastic pipe crossing that was installed in Starr Creek Tributary #8 (T-8), for a road crossing. 6/29/04.

4. Submit an application for a Water Quality Certification and/or Waste Discharge Requirements for Dredge/Fill Projects (Enclosure 3), and appropriate processing fees, to the Regional Water Board, for Executive Officer concurrence, to cover activities associated with the restoration Workplan and for the unauthorized stream crossing on Starr Creek T-8, by November 30, 2004.

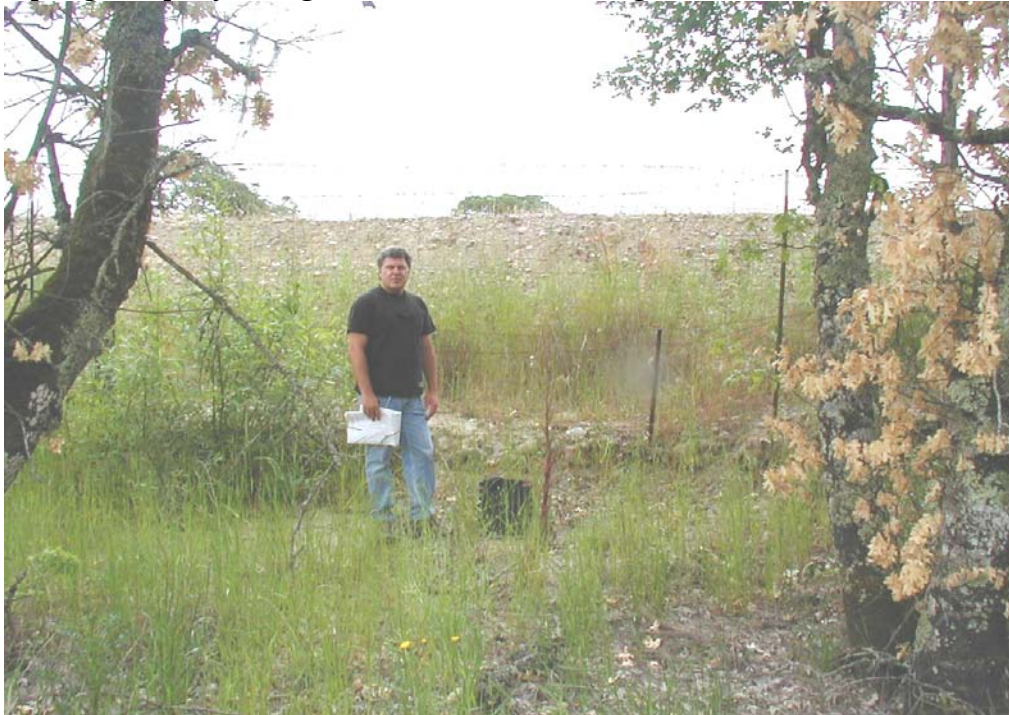
Mr. Martel of the ACOE determined that there was a wetland feature at the base of Field 6 that had been impacted by the vineyard conversion performed sometime between 2001 and 2003. Mr. Martel identified another wetland area below the road and Field 6, which has been impacted by the installation of culverts. In addition, the Discharger gave permission to the adjacent property owner, Mr. Rich Carnation and Brookfield Investors, LLC, to extend a culvert from the Diamond Springs Property onto the Site, to capture flow of Starr Creek T-3, which was culverted through Field 6, as described below, and subsequently through the Diamond Springs Property. In addition, at the top of Field 6 an intermittent tributary of Starr Creek, identified as Starr Creek Tributary #3 (T-3) on the improvement plans prepared by Kenneth Carr and Associates dated November 17, 2002, had been culverted and filled to facilitate the planting of the vineyard unit. Mr. Martel also determined that an ordinary high water channel was evident above Field 6, which was culverted and filled through Field 6. Another small intermittent tributary appears to have been filled directly to the west of T-3. The Discharger did not obtain any resource agency approvals for the culverting and filling of the intermittent tributary or to impact the wetland habitat. Staff requested copies of pre-project and post-project aerial photographs from the Discharger to help determine the extent of impacts (Photo 4-5).

**Photo 4.** View of a culvert that has been installed in a designated wetland area on the Site. Diamond Springs Property filling activities shown in background. 5/21/04.

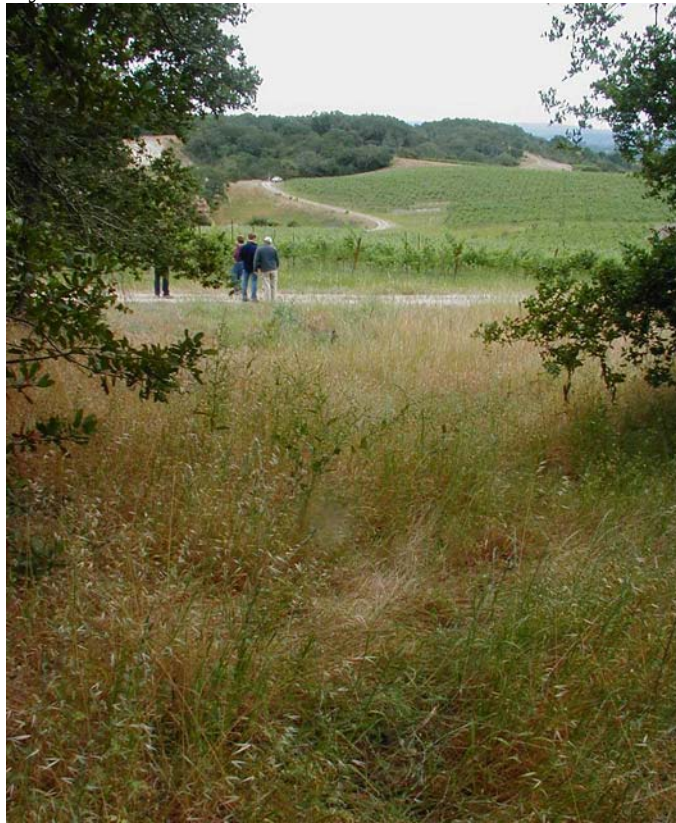
**Photo 5.** View of intermittent tributary, facing downstream, that has been culverted and filled through the Field 6 vineyard unit. 5/21/04

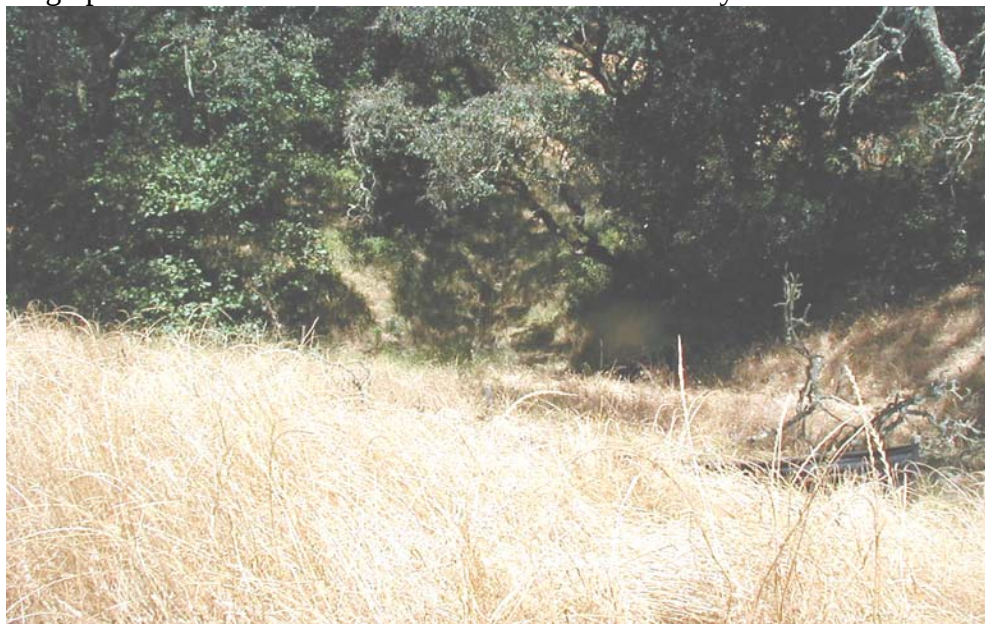
The ACOE determined an intermittent tributary of Starr Creek T-8 to be Waters of the U.S. during the site inspection. The small intermittent tributary has a defined channel above Field 7, but has been culverted and filled with a 20-foot fill prism, through Field 7 to facilitate vineyard development. Above Field 7 the intermittent tributary has a well-established riparian zone and appears to provide some high quality habitat. Below Field 7, the culverted tributary daylights and flows into Starr Creek T-8. Staff requested copies of pre-project and post-project aerial photographs from the Discharger to help determine the extent of impacts (Photos 6-7).

**Photo 6.** View of intermittent tributary of Starr Creek T-8 that had been culverted and filled with a 20+-foot fill prism, through Field 7, to facilitate a vineyard conversion. View from the fill prism, looking upstream at the remnant of the intermittent tributary. 6/14/04.

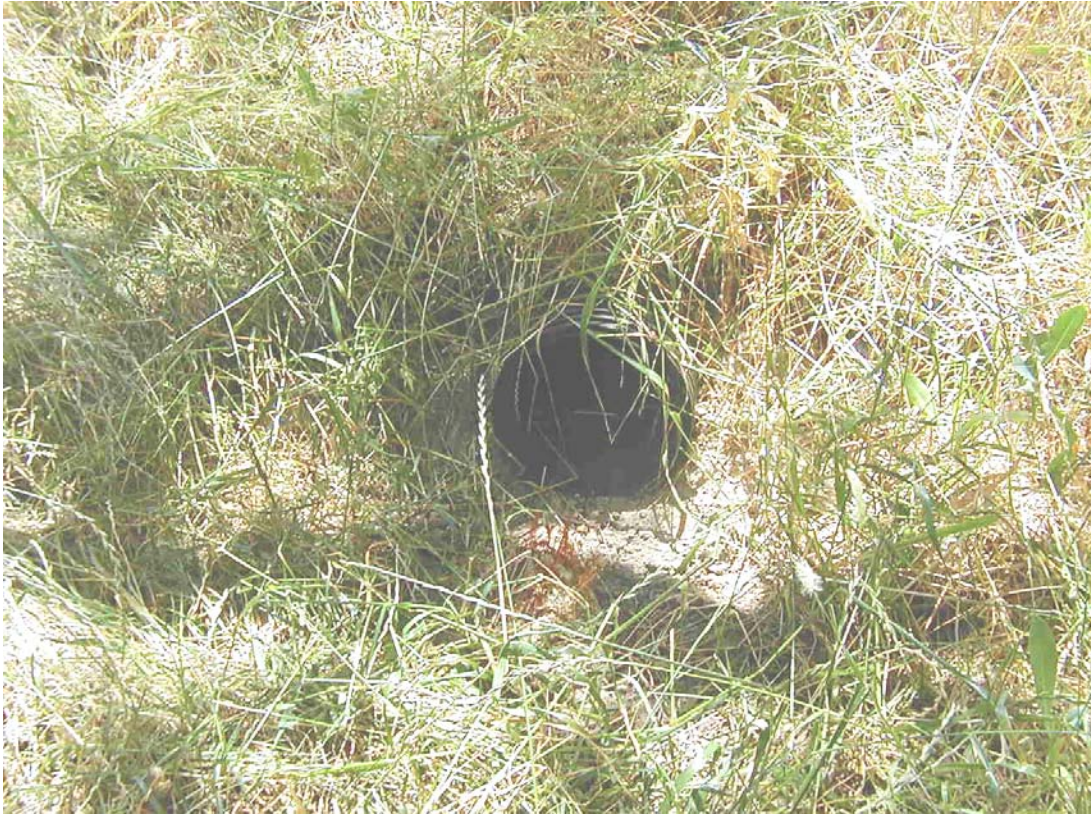
**Photo 7.** Photo of the outfall of the culverted intermittent tributary shown in Photo 6, that flows through Field 7. Outfall daylights the intermittent tributary approximately 30 feet upslope of Starr Creek T-8. 6/14/04
