## North Coast Regional Water Quality Control Board

Subject: **Notice of Violation** of State Water Resources Control Board Order No. 2014-0057 DWQ *General Permit for Storm Water Discharges Associated with Industrial Activities* (Industrial General Permit); and **Confirmation of Corrective Actions**

File: Mark West Quarry, 4611 Porter Creek Road, Santa Rosa, Sonoma County, WDID No. 149I009813

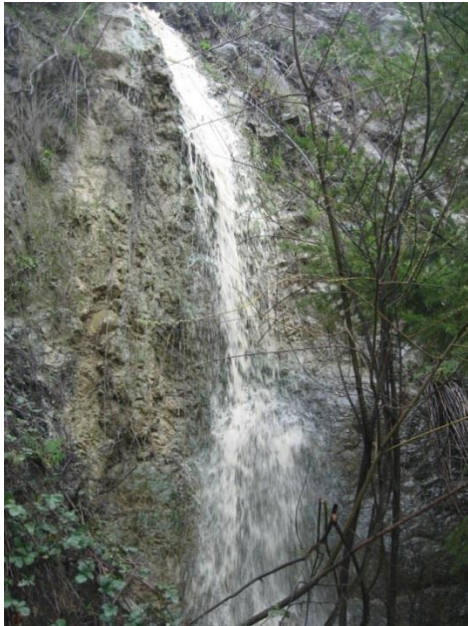
The Permittee violated Provision III. C of Section by discharging storm water runoff from a relatively newly mined area on the Site without adequate soil stabilizing and sediment control BMPs, which resulted in a turbid discharge emanating from a settling basin (Attachment 1, Photo 1A, B) from a rainfall event of 0.40 inches, as recorded at the Site. Based on the duration of the rain event, including the prior two days of moderate to heavy rain, time of concentration for runoff, and settling basin holding capacity, Regional Water Board staff estimates the discharge likely occurred for a duration of less than 3 hours and totaled approximately 81, 000gallons of storm water.

February 19, 2016 –Photo 1A. Turbid discharge emanating from newly mined area into the settling basin. Paul Keiran, Regional Water Board staff photograph

The Permittee has taken corrective actions by both immediately removing a large pile of overburden which was the source of the turbid discharge, and subsequently mining rock out of the area over the past several months. This has created a large depression which now retains the storm water that drains into this area of the quarry.

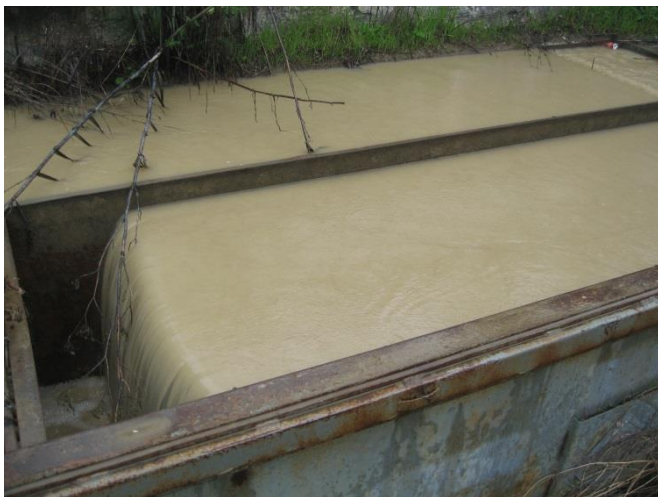
February 19, 2016 – Photo 1B. Turbid water within settling basin. Paul Keiran, Regional Water Board staff photograph.

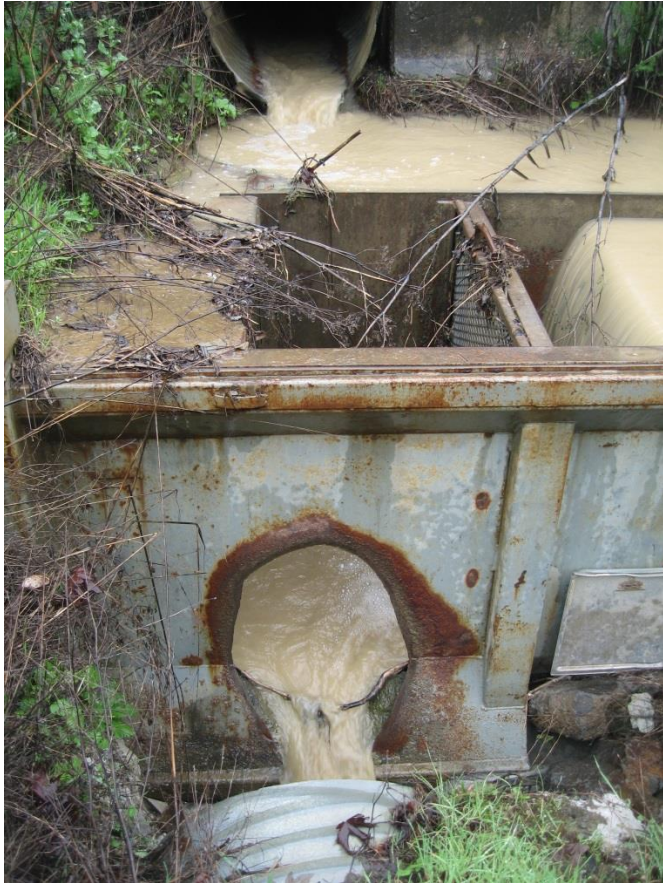
The Permittee violated Provision V. A of Section D by failing to implement appropriate BAT/BCT BMPs, which resulted in a turbid discharge to Mark West Creek (Attachment 1, Photo 1C). The turbid discharge was noticeable as it discharged into Mark West Creek (Attachment 1, Photo 1D).

February 19, 2016 – Photo 1C. Point of discharge of turbid runoff to culvert that discharges into Mark West Creek. Paul Keiran, Regional Water Board staff photograph.

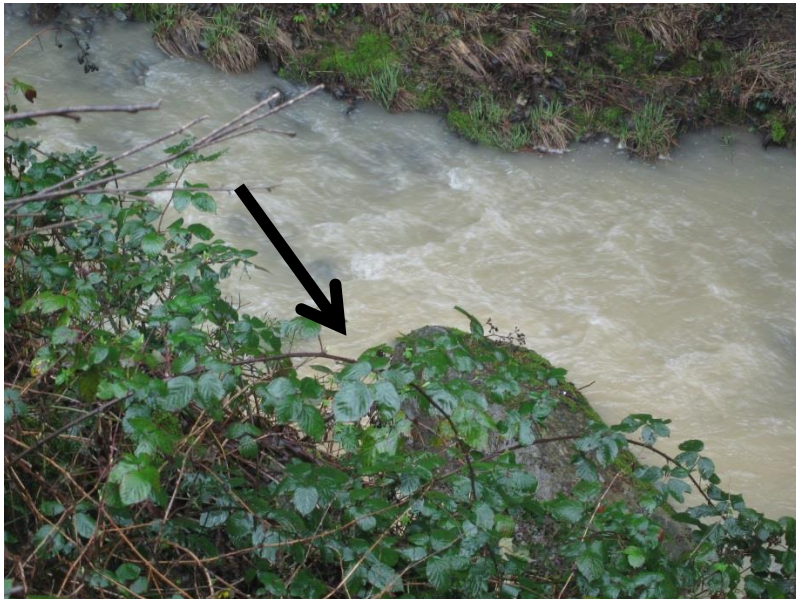
February 19, 2016 – Photo 1D. Point of culvert outfall into Mark West Creek. Paul Keiran, Regional Water Board staff photograph
