North Coast Regional Water Quality Control Board

Subject: **Notice of Violation** of Order No. R1-2011-0046 Waste Discharge Requirements for Redway Community Services District, Redway Wastewater Treatment Facility, Humboldt County (NPDES No. CA0022781)

Supporting Photographs from the December 14, 2016, inspection

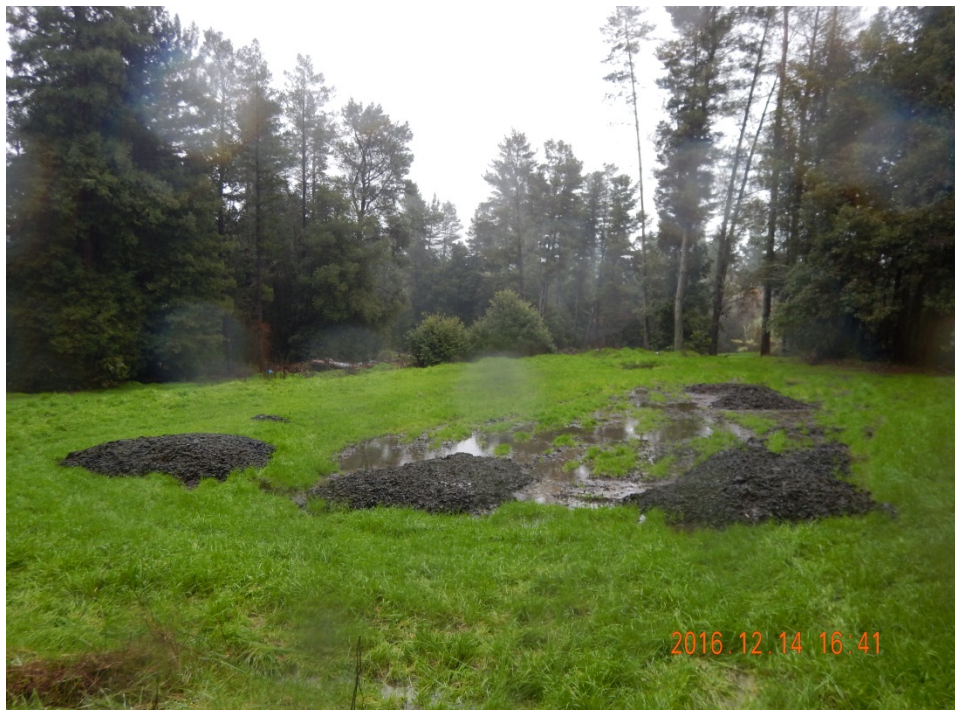
During a December 14, 2016, inspection, Regional Water Board staff observed four mounds of sludge piled approximately 10 inches above the ground surface. The mounds were wet from the rain. The area around the sludge mounds had ponded water that was visibly discolored by sludge material (see Attachment A: Photos 1-5). At an adjacent sludge disposal area, staff observed runoff flowing downhill from the sludge disposal site in the general direction of the Eel River which is approximately 2200 southwest of the sludge application area. The runoff was carrying eroded sediment with it (see Attachment A: Photos: 6).

Photograph 1. Redway CSD – 12/14/16: Evidence of ponding water below sludge mounds on forested property northwest of the treatment plant. Photograph by Cathleen Goodwin, Regional Water Board staff

In accordance with Provision VI.C.2.b of the newly adopted Order, the Permittee is required to submit a preliminary work plan by **August 1, 2017**, to reevaluate existing sludge management practices in order to comply with applicable portions of 40 CFR 57, 258, and 503, and General Waste Discharge Requirements for Small Domestic Water Treatment Systems (Order WQ 2014-DWQ). The preliminary work plan shall include a schedule of initial tasks the District will implement to bring sludge handling, storage, and disposal practices into compliance with federal and State regulations. Additionally, the Permittee shall prepare and submit a final work plan that contains the recommended long-term sludge management practices, and a time schedule leading to implementation of the selected alternative practices. The Permittee shall submit the final workplan for review and approval to the Regional Water Board Executive Officer by **May 1, 2018**.

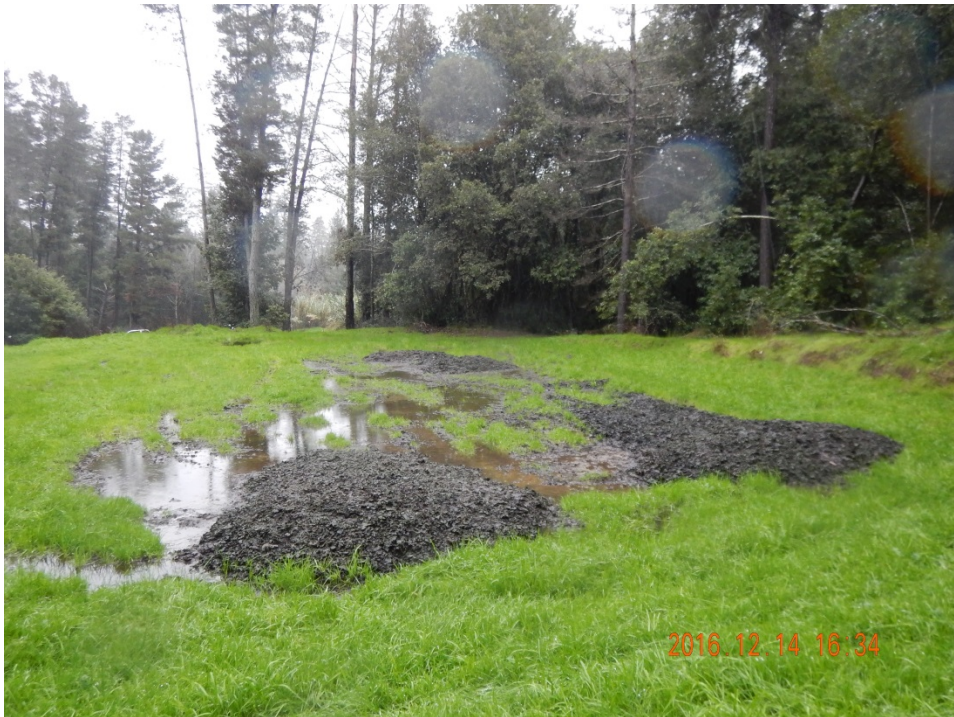
Photograph 2. Redway CSD – 12/14/16: Evidence of ponding water below sludge mounds on forested property northwest of the treatment plant. Photograph by Cathleen Goodwin, Regional Water Board staff

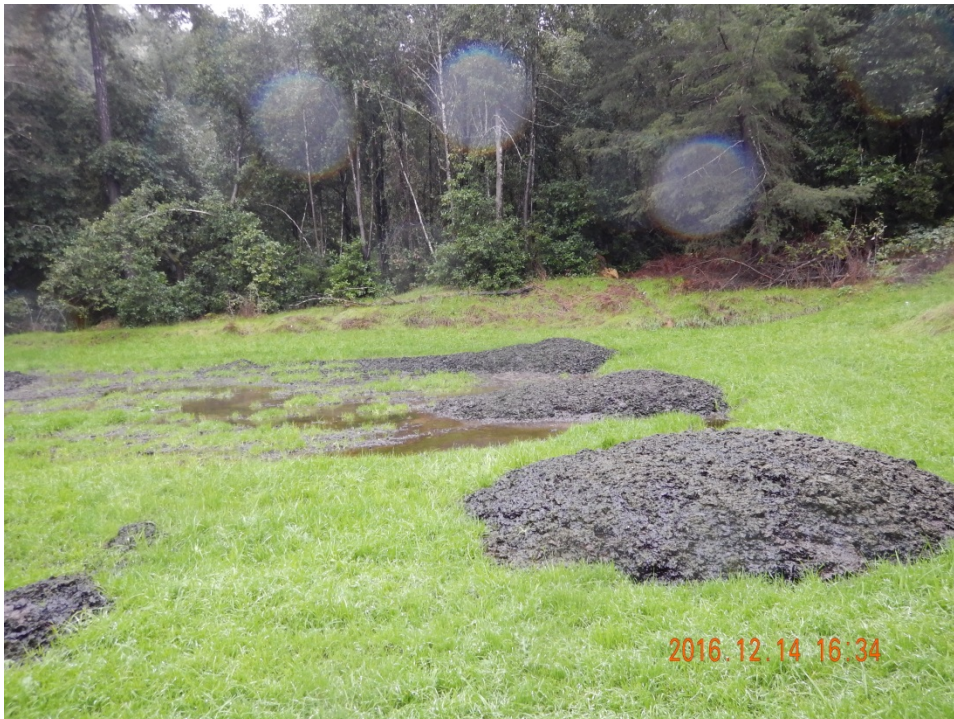
Photograph 3. Redway CSD – 12/14/16: Evidence of ponding water below sludge mounds on forested property northwest of the treatment plant. Photograph by Cathleen Goodwin, Regional Water Board staff

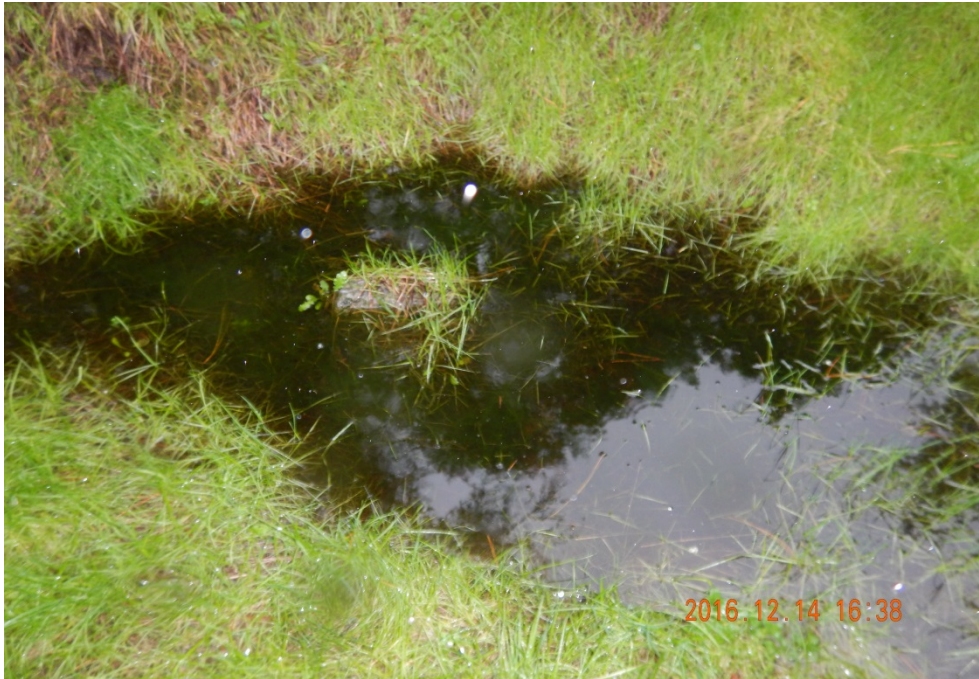
Photograph 4. Redway CSD – 12/14/16: Discoloration of water on the forested property northwest of the treatment plant. Photograph by Cathleen Goodwin, Regional Water Board staff

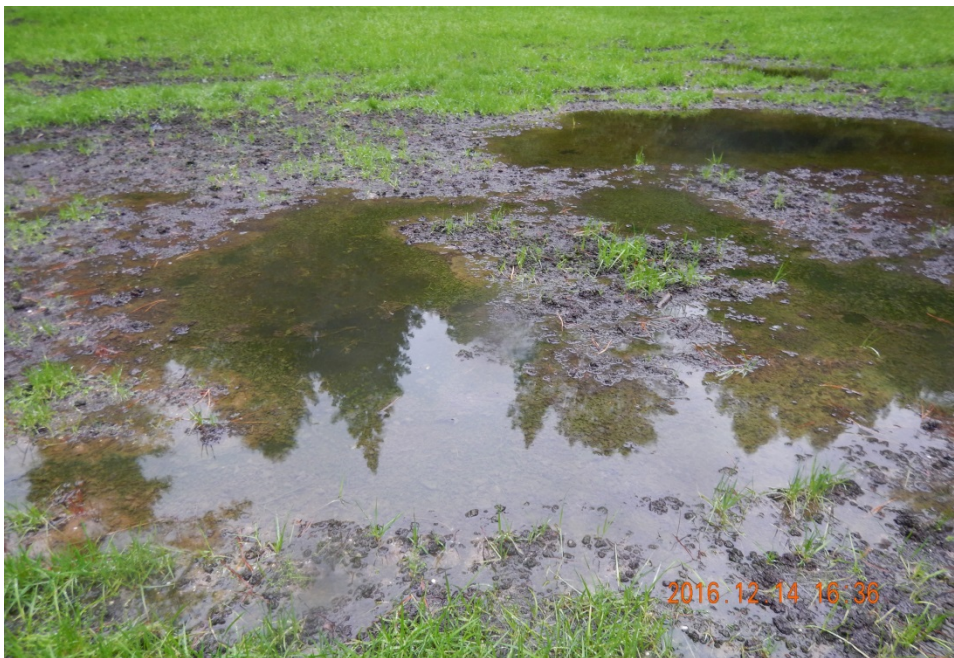
Photograph 5. Redway CSD – 12/14/16: Discoloration of water on the forested property northwest of the treatment plant. Photograph by Cathleen Goodwin, Regional Water Board staff

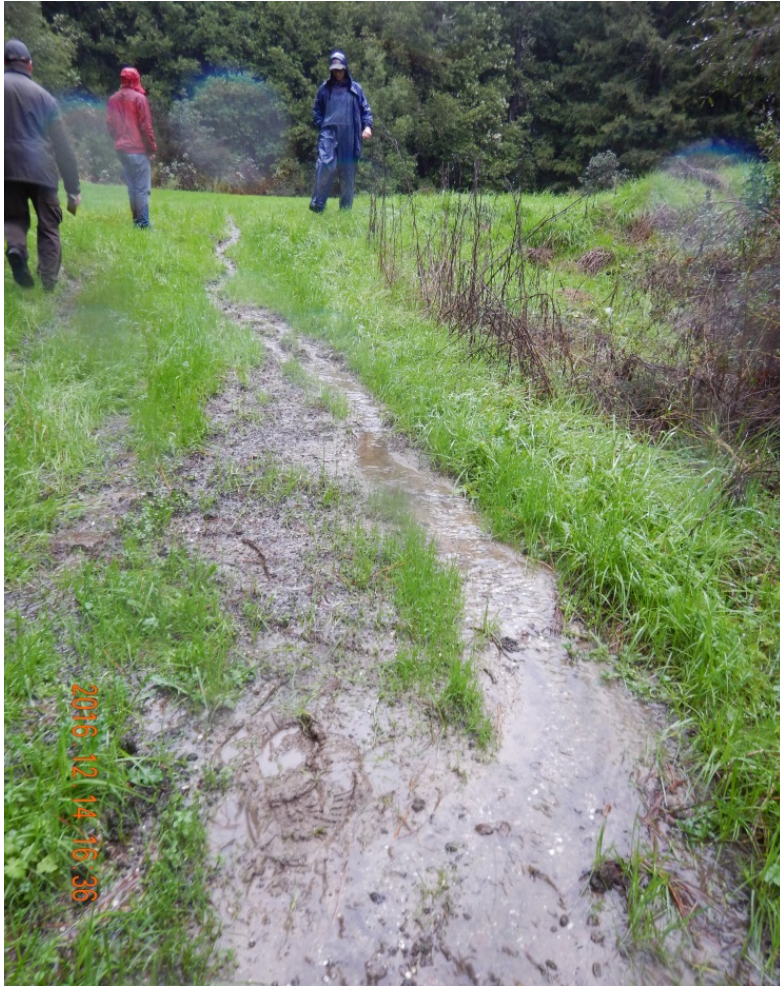
Photograph 6. Redway CSD – 12/14/16: Evidence of sediment laden runoff occurring from sludge disposal area on the forested property northwest of the treatment plant. Photograph by Cathleen Goodwin, Regional Water Board staff
