## North Coast Regional Water Quality Control Board

Subject: *Notice of Violation* for Activities Associated with Non-Industrial Timber Management Plan (NTMP) 1-96NTMP-016 HUM NTO#6

File(s): 1-96NTMP-016 HUM, Janes Creek Unit  
Humboldt County, CA

### **December 28, 2016 Site Inspection Compliance Issues**

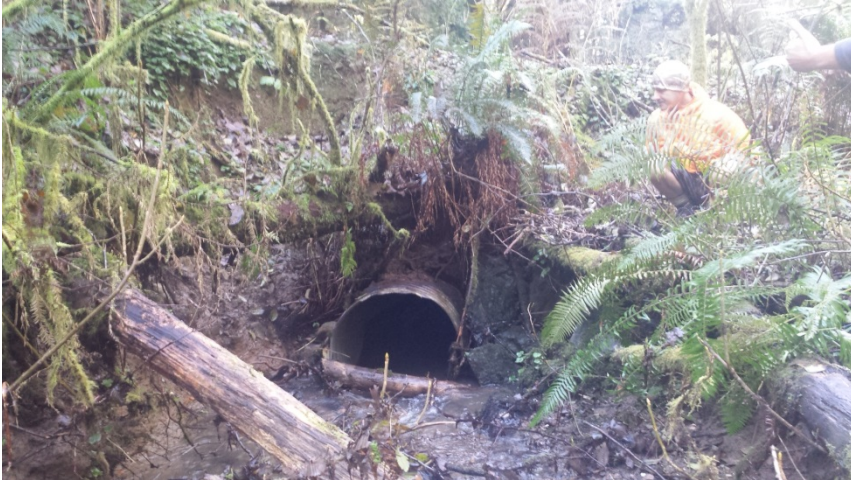
1. WQ Site 1 (Figure 1) is an existing 48" culvert on a Class I, fish bearing segment of Janes Creek. The culvert is showing signs of active failure such as erosion of the fill material above the culvert inlet. It appears that the culvert is fully submerged at high flows as is evident by the accumulation of debris on the upstream right bank near the inlet (See photos below). The channel upstream of the culvert is at least 6-feet wide. The culvert

outlet is perched above the stream channel and is torn and is likely a barrier to all stages of fish species. Based on these observations, this culvert is not properly functioning and is negatively impacting sensitive beneficial uses of water. The culvert must be replaced with a properly functioning drainage structure as soon as possible, but no later than October 15, 2017. The replacement structure must be designed to ensure fish passage for all life stages. The RPF is encouraged to consult with DFW regarding criteria and methods to ensure the design meets applicable current standards.

Figure 1. WQ1- View looking downstream to inlet of 48" diameter culvert on Class I tributary of Janes Creek. Photo taken by RWB staff Joelle Geppert December 28, 2016.

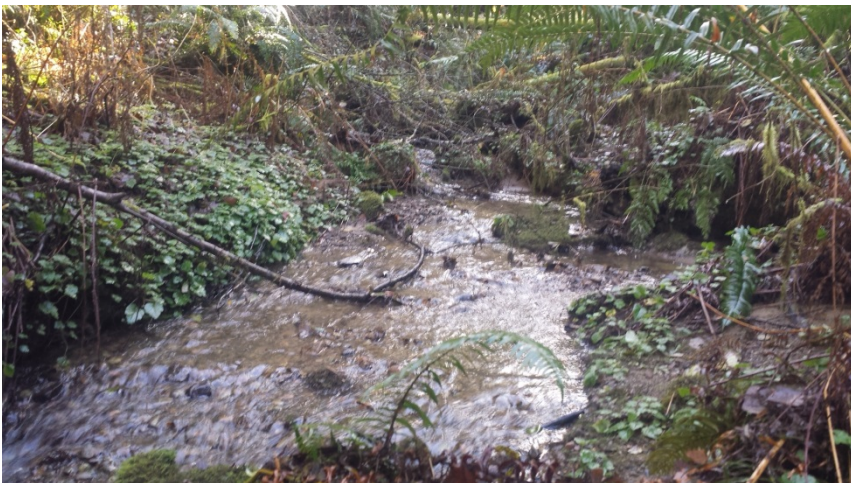
Figure 2. WQ1 - View looking upstream from near the culvert inlet on Class I tributary of Janes Creek. Photo taken by RWB staff Joelle Geppert December 28, 2016
