North Coast Regional Water Quality Control Board

Subject: **Notice of Violation** of the *Water Quality Control Plan for the North Coast Region* and Order No. R1-2004-0030, *General Waste Discharge Requirements for Discharges Related to Timber Harvest Activities on Non-Federal Lands in the North Coast Region*; and
13267 Investigative Order Pursuant to California Water Code section 13267, for Sierra Pacific Industries

File: THP 2-15-021 TRI "YESMON" (CW-814600)

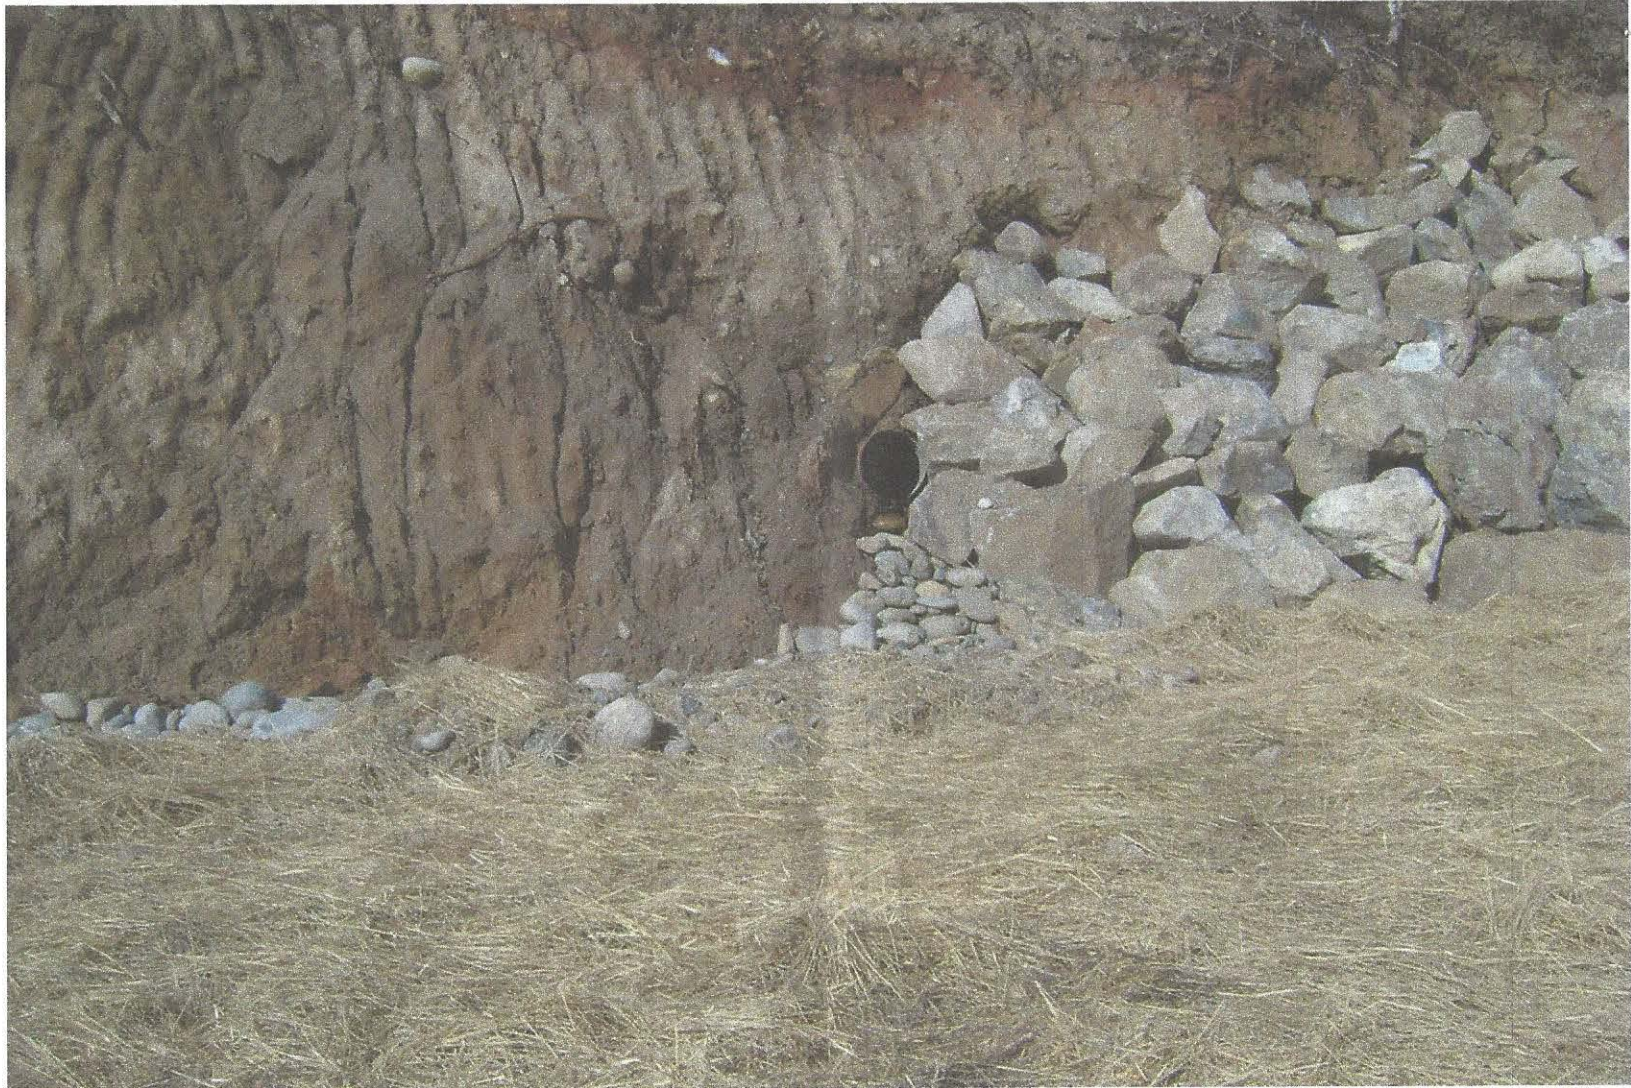
DSC01926- Culvert crossing above P1 and P2.

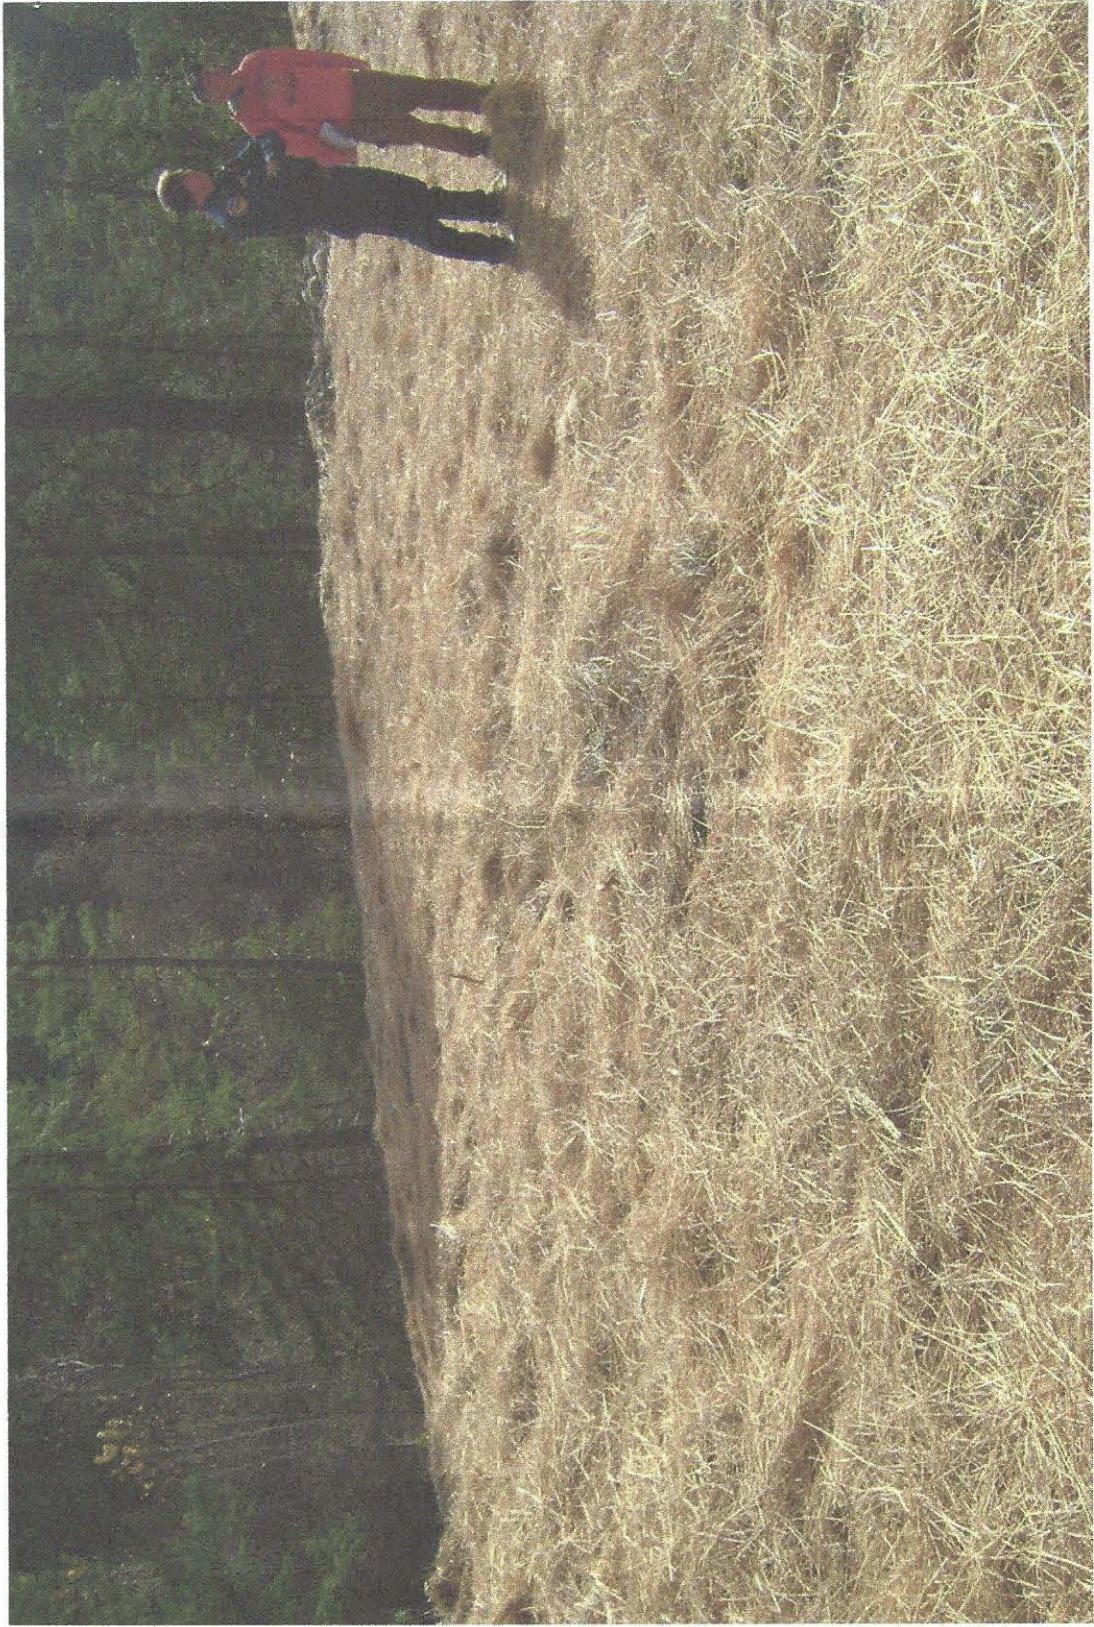
DSC01927- Location of P1 and P2.

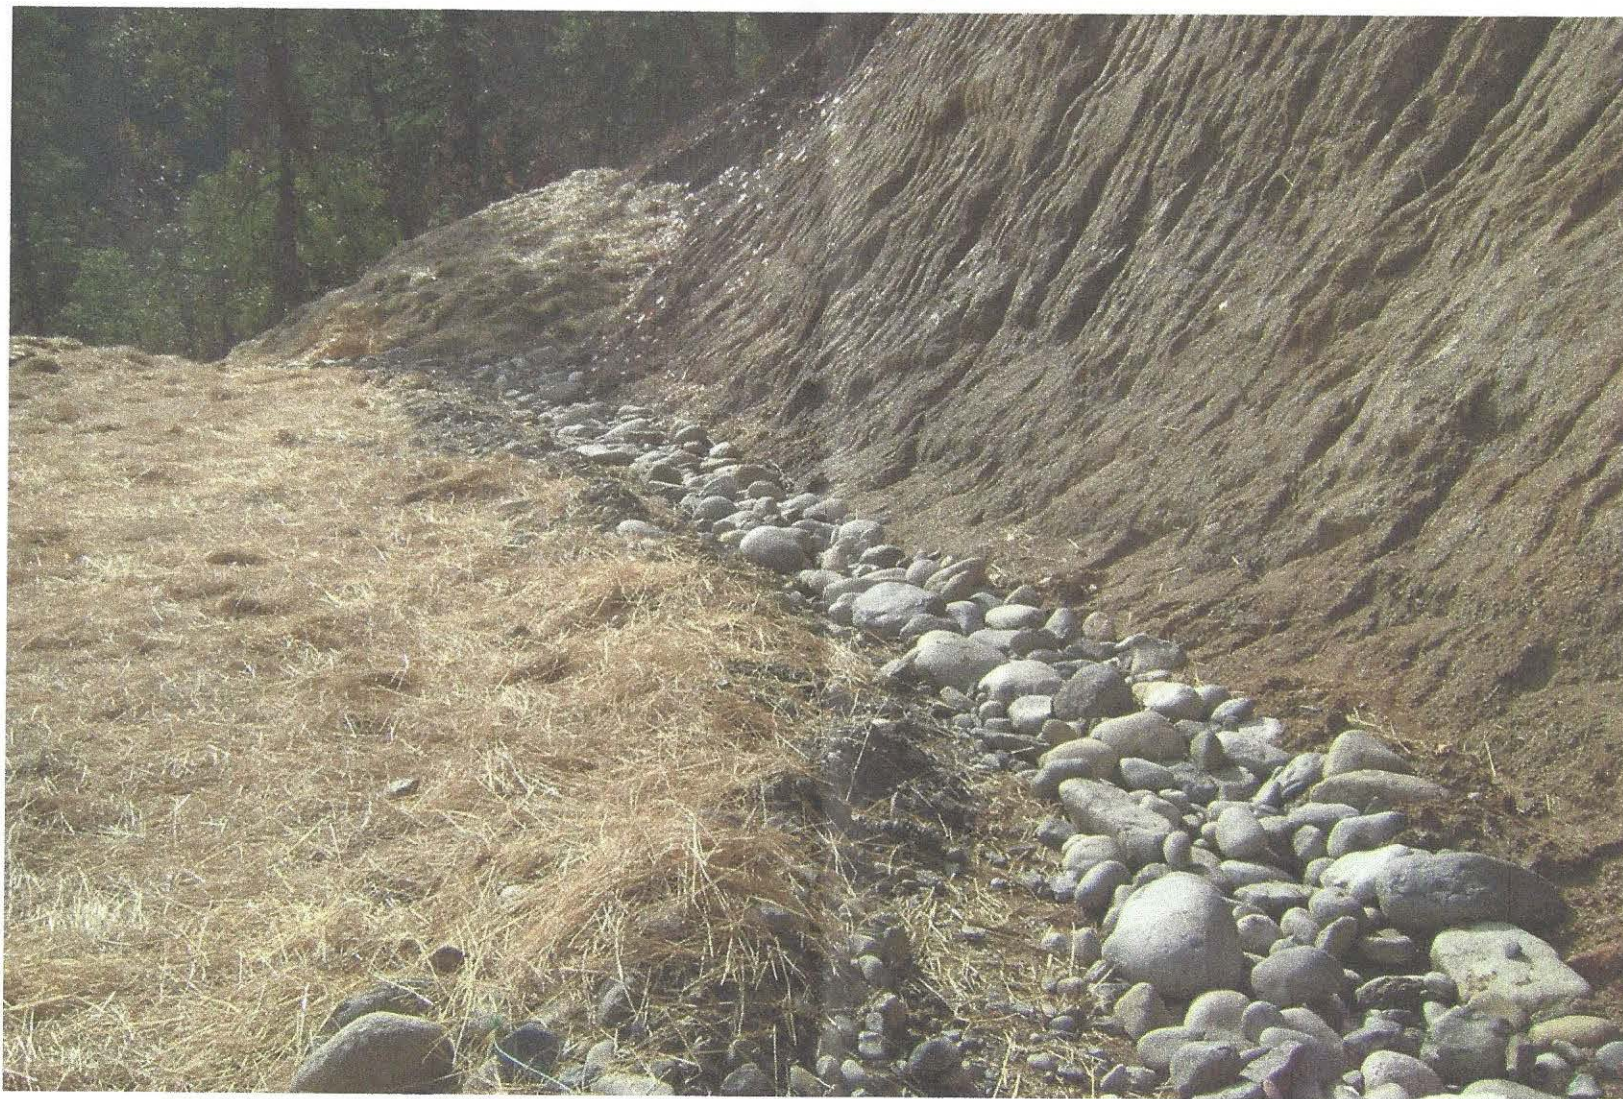
DSC01928- Inside ditch used to divert flow around P1 and P2.

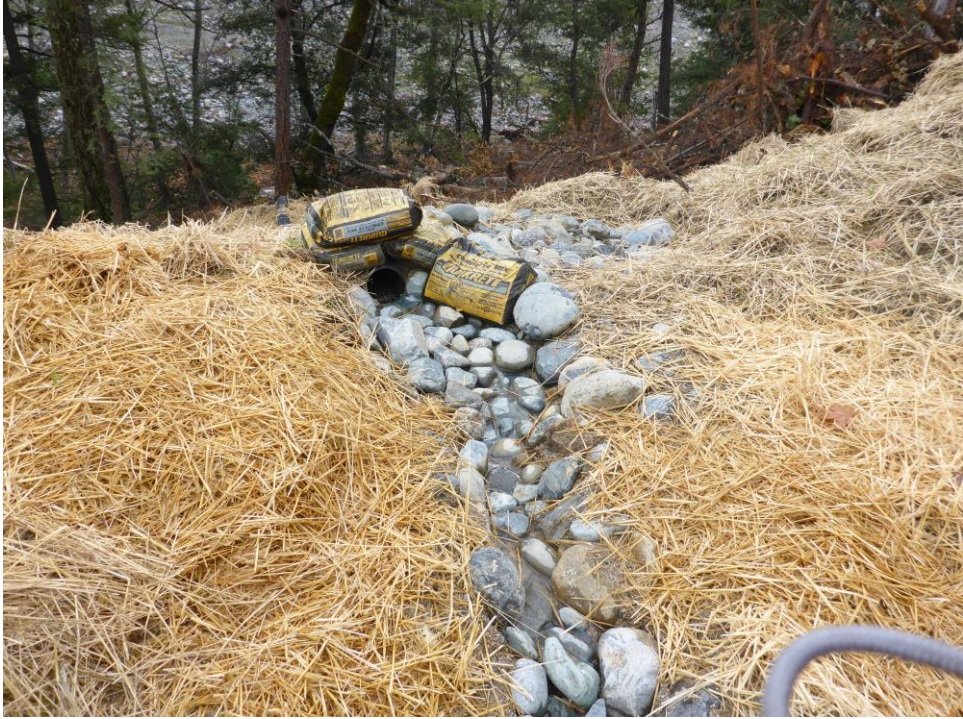
Figure 2: Crossing P2 Inlet

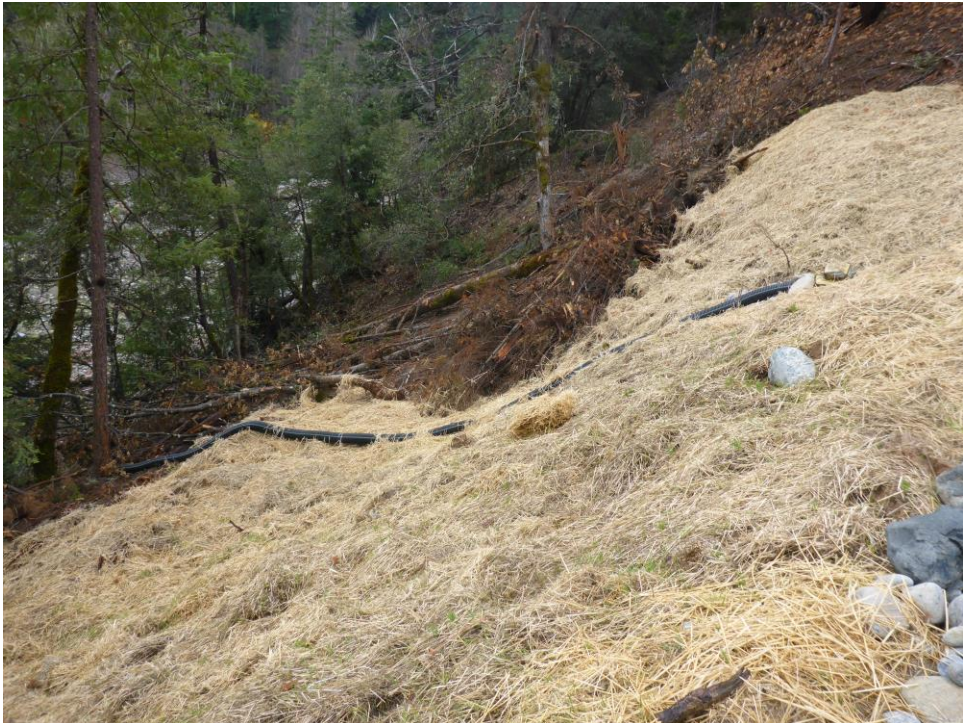
Figure 3: Crossing P2 side view

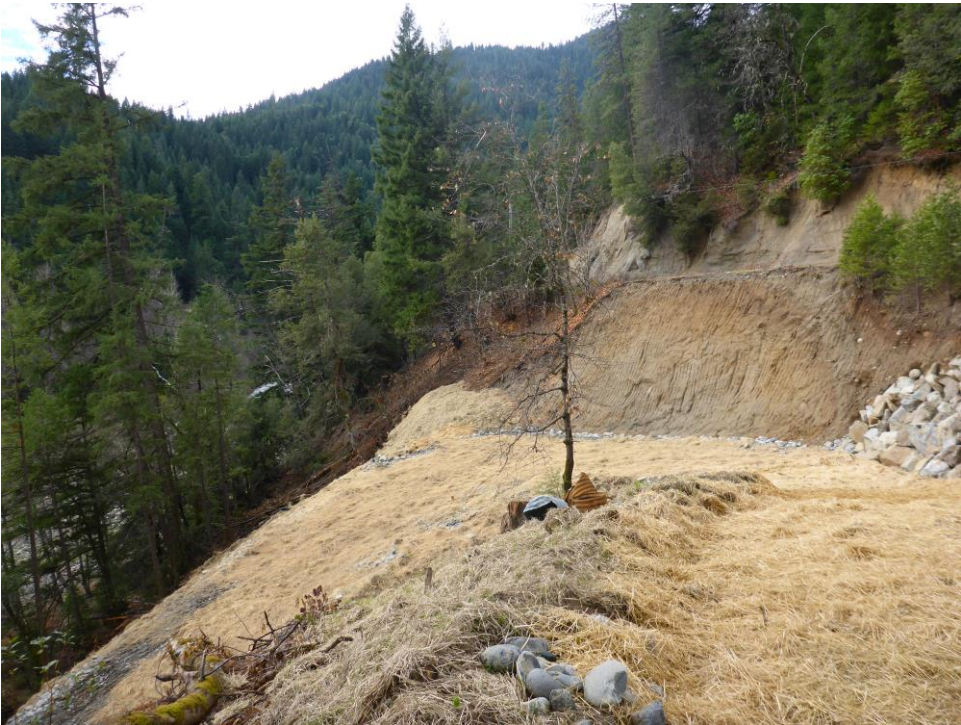
Figure 4: Road Approaches to and from P1 and P2

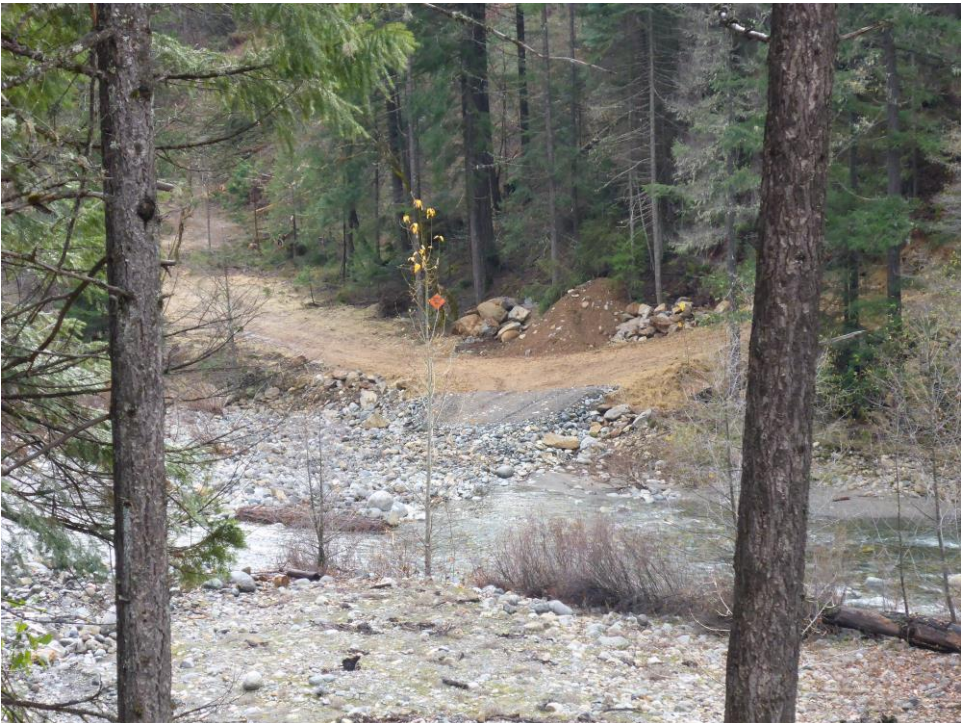
The CDFW inspector identified an uncovered fill stockpile staged directly above the southern approach to the seasonal bridge over Stuart Fork (see Figure 5 in Attachment C). Placement of the fill within the Class I WLPZ constitutes a threatened discharge of sediment to waters of the state and was documented in the CDFW report as a violation of Fish and Game Code section 5650(a)(1)(6).

Figure 5: Loose fill placed at T1

The seasonal bridge was removed between the November 14, 2016, CAL FIRE inspection and the November 18, 2016, CDFW inspection. The Discharger covered the fill stockpile with straw mulch prior to the PHI on November 29, 2016, but the fill stockpile was left in place. This fill stockpile left in the WLPZ constitutes the FGC violation documented in the CDFW inspection report. Leaving the stockpile of fill material adjacent to Stuart Fork is also a threatened discharge of earthen material to waters of the state.

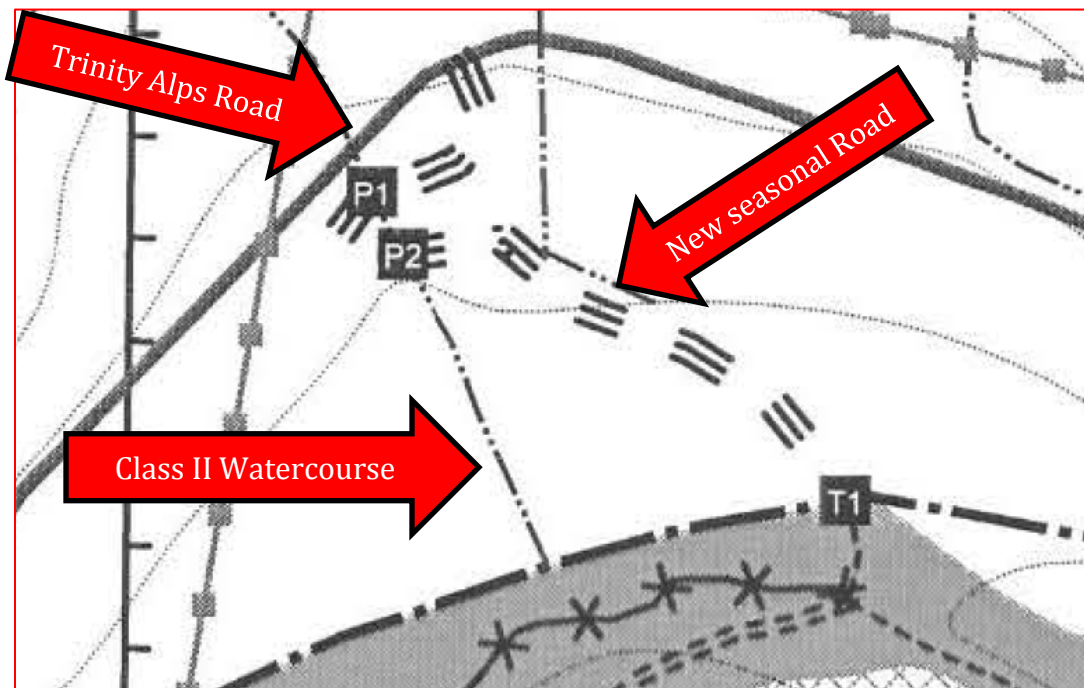
The approved THP includes construction of approximately 800 feet of new seasonal road to access THP Unit 3527 (Figure 1) including a switchback located over a Class II watercourse. Two new culverted watercourse crossings, P1 and P2, were proposed to be installed and connected to the existing 18-inch diameter corrugated metal pipe (CMP) that conveys flow from the Class II watercourse under Trinity Alps Road. Trinity Alps Road is a Trinity County road and is located immediately upstream of the new seasonal road construction. The outlet of P2 was proposed to convey stream flow onto the floodplain of Stuart Fork.

Figure 1: Excerpt from page 55 of Section II of the approved THP

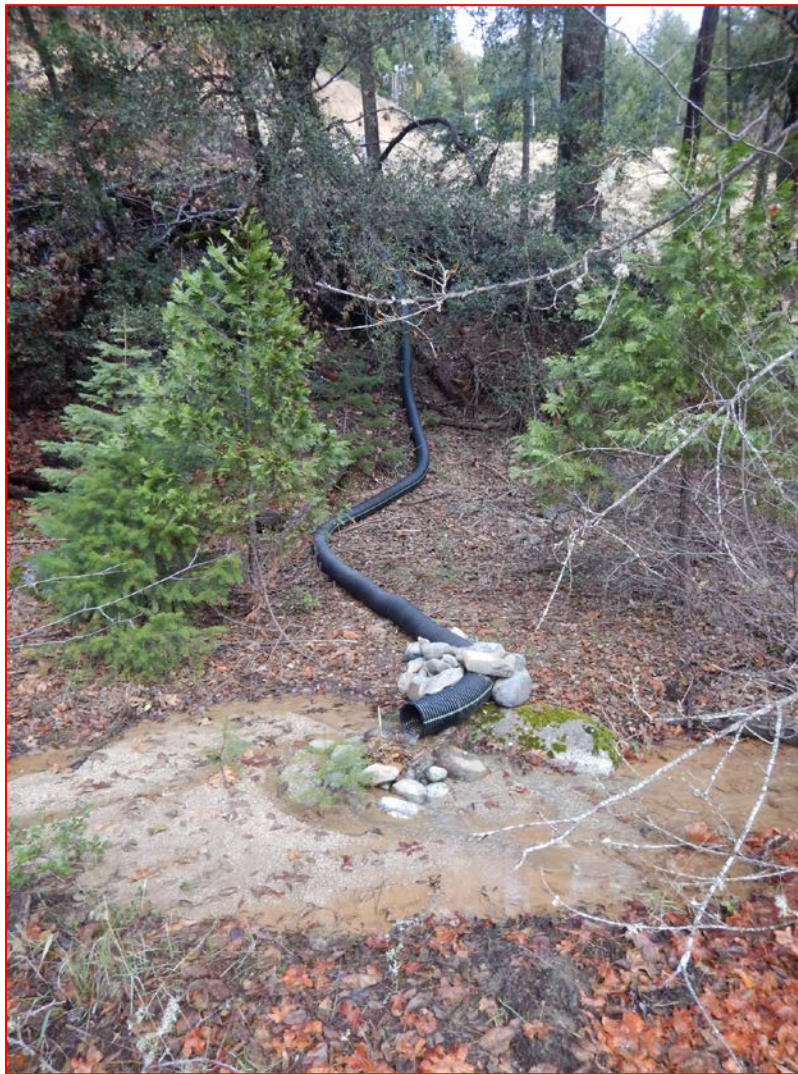
A six-inch diameter plastic culvert had been installed and conveyed flow in the Class II watercourse referenced in AM3 to a discharge point on the floodplain of Stuart Fork (Figure 2). We observed deposition of fine earthen material on the edge of the floodplain of Stuart Fork below the outfall.

Figure 2: Six-inch plastic culvert discharging to the edge of the floodplain of Stuart Fork

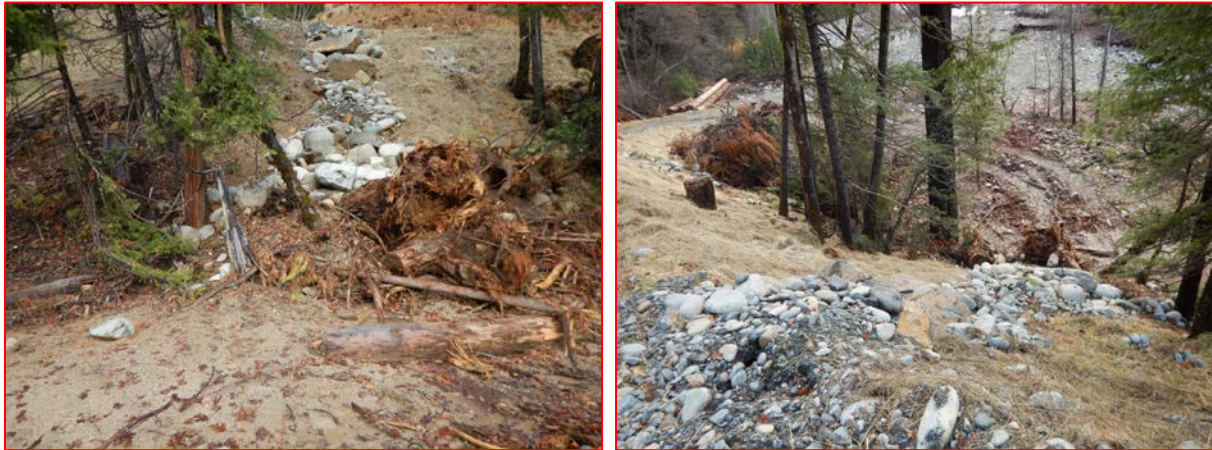
Continuing around the base of the fill slope, we observed a recent fill failure on the lower portion of the new seasonal road construction onto the floodplain of Stuart Fork. We observed that the fill failure had deposited fine earthen material onto the floodplain of Stuart Fork, and the fill had been stabilized with river rock sourced from the adjacent floodplain (Figure 3).

Figure 3: Failure in fill slope of new seasonal road construction, from below (left) and above (right)

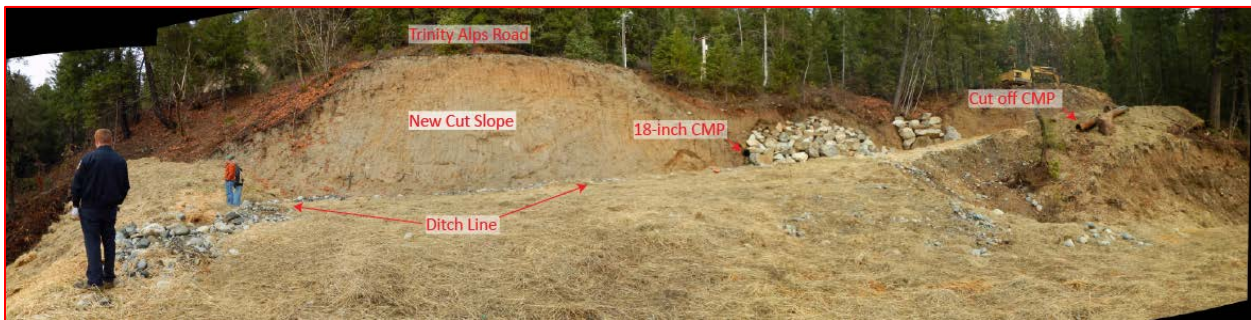
The PHI inspection team assessed the Class II watercourse and switchback on the new seasonal road construction where P1 and P2 were proposed to be installed (Figure 4). Exposed fill on the new seasonal road construction was stabilized with straw mulch, but the road was not rocked as proposed in the THP.

Figure 4: Annotated panorama of the seasonal road switchback

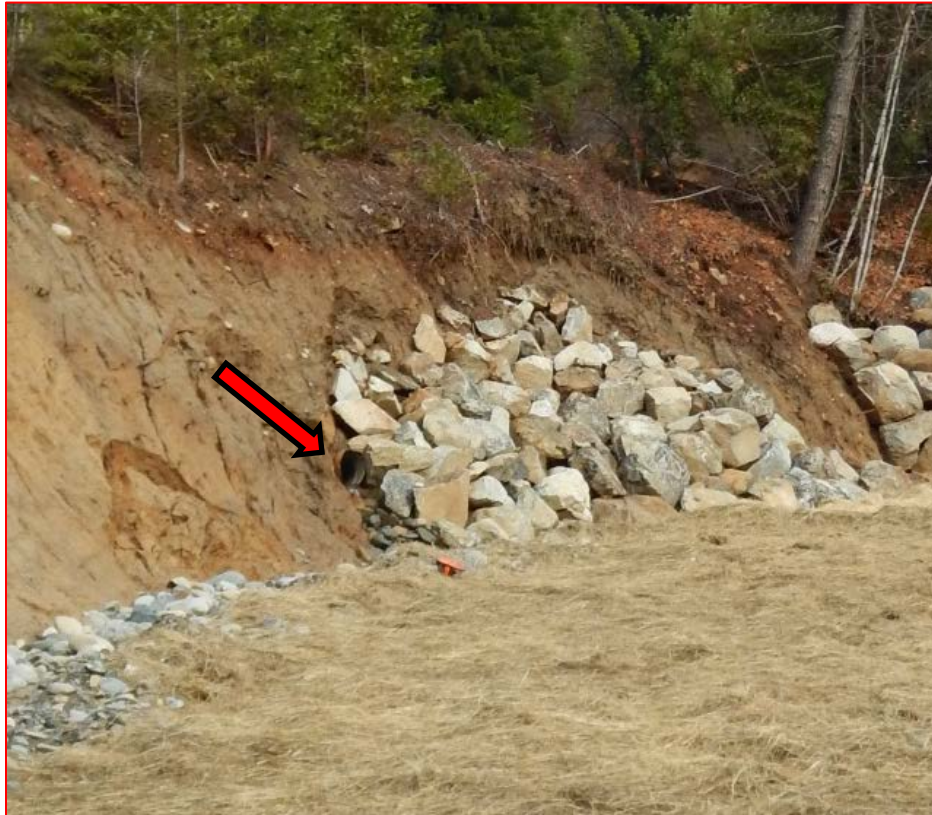
Figure 5: 18-inch CMP outlet of the Class II watercourse crossing on Trinity Alps Road

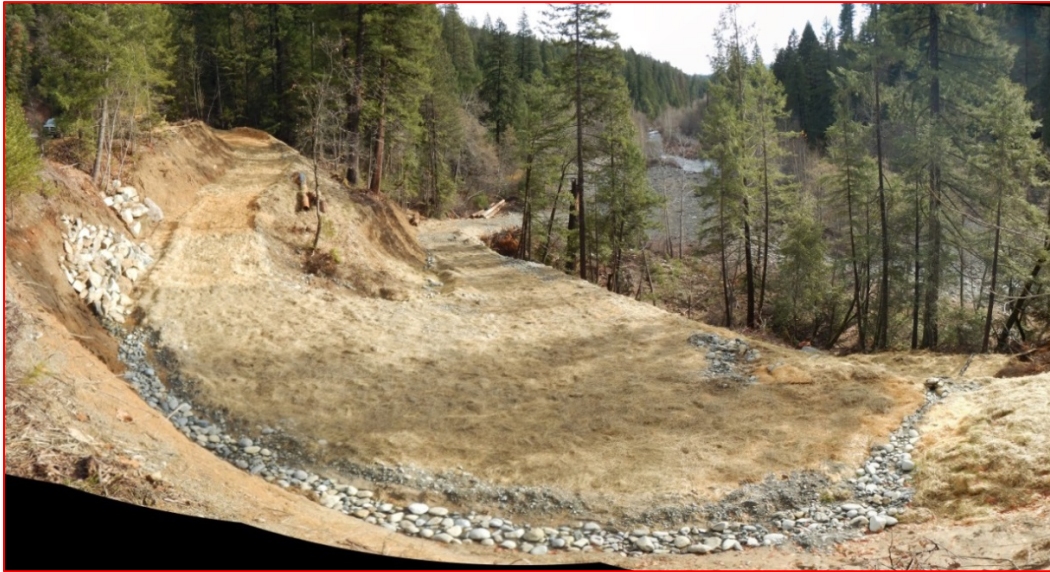
During the PHI, Mr. Walz described the original condition of the Class II watercourse associated with AM3 as a gully formed by an eight-foot portion of shotgunned 18-inch CMP that extended over the fill slope of Trinity Alps Road. We observed that the Class II

watercourse now flows from the outlet of the remaining portion of the CMP down an inboard ditch that extends along the base of the DG cut slope (Figure 6).

Figure 6: Panorama of the new seasonal road switchback and ditch, taken from top of the DG cut slope on the shoulder of Trinity Alps Road

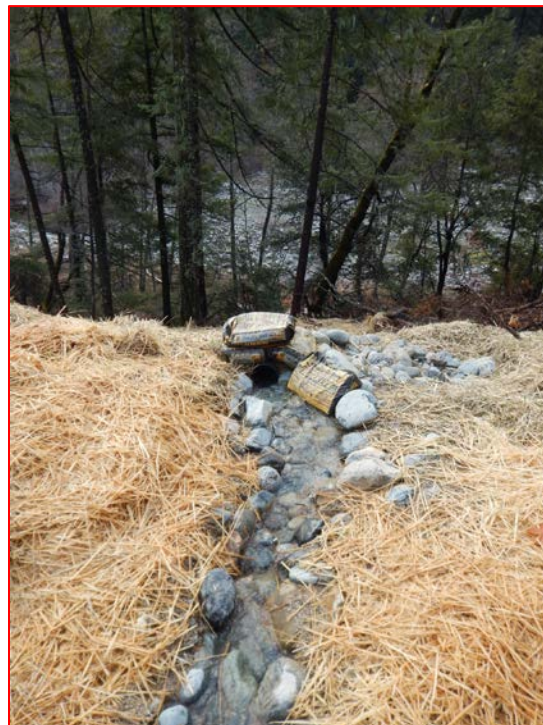
The inboard ditch discharges into a small inlet structure formed by river rock and concrete bags placed around the inlet of the six-inch diameter flexible plastic (Figure 7). The flexible pipe extends down the fill slope and discharges to the floodplain of Stuart Fork.

Figure 7: Inlet of six-inch plastic pipe that extends to the floodplain of Stuart Fork

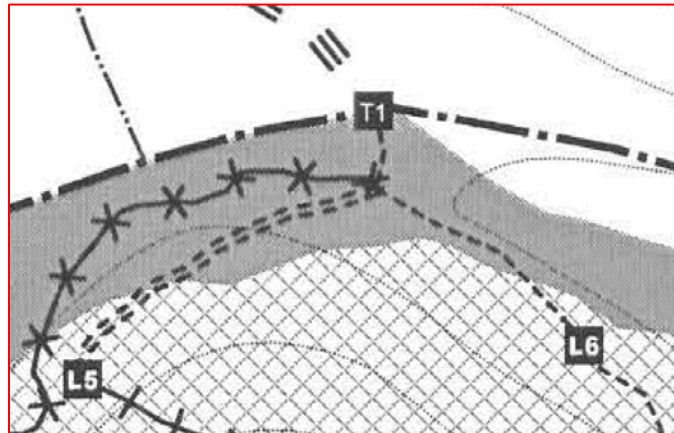
AM3 proposes change the approved running surface of the temporary roads within the Class I WLPZ of Stuart Fork (Figure 8) to straw mulch instead of rock, as originally proposed in the THP. We observed that temporary road construction and reconstruction proposed in AM3 had already occurred, and according to Mr. Walz, the majority of log hauling on these temporary roads had also already occurred. Only a few loads of logs remain on the landings, and the landowner proposes to haul those logs next year.

Figure 8: Excerpt from Page 55 of the approved THP.

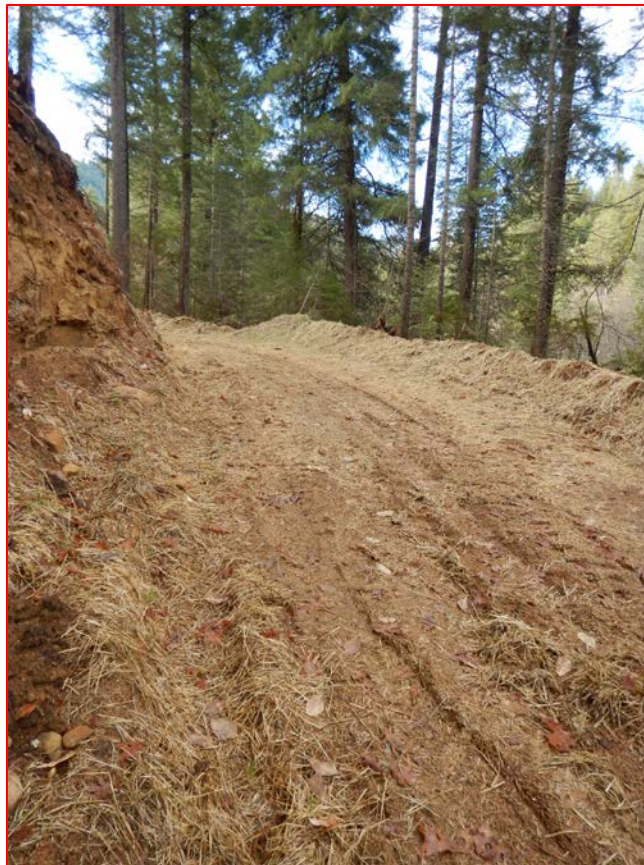
All exposed fill on the temporary road construction and reconstruction was stabilized with straw mulch within the Class I WLPZ. We observed that the temporary road reconstruction that extends south east from T1 to landing L6 is relatively flat. However, the new temporary road segment that extends southwest from T1 to landing L5 is relatively steep, with an outboard berm breached at only two points with hand-dug water bars providing road drainage (Figure 9).

Figure 9: Portion of the new temporary road construction between T1 and L5

The two- to three- foot high outboard berm on the new temporary road construction makes the current condition of the road a through cut. We observed transport of earthen material through the straw mulch placed on the new temporary road construction and coverage of the native surface appeared to be less than 90 percent (Figure 9). Although Mr. Walz stated that the majority of log hauling on the temporary road had already occurred, he also stated that the new temporary road was still under construction and the final road design would remove the outboard berm on the steep portion of the temporary road.

The PHI inspection team agreed that placement of straw mulch on the portion of temporary road reconstruction extending from T1 to L6 through the Class I WLPZ appeared appropriate. However, the segment of new temporary road construction between T1 and L5 shall be rocked once access to Unit 3527 at temporary crossing T1 is restored in the spring (**Recommendation 2**).

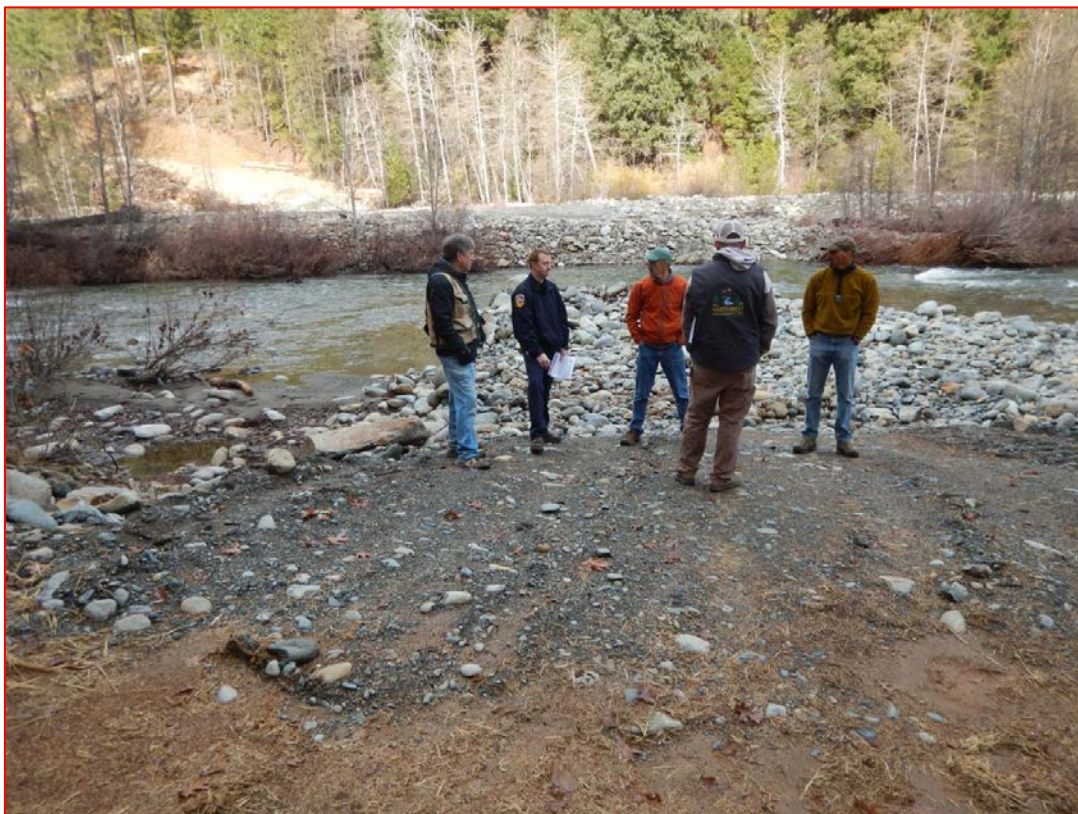
The PHI inspection team discussed the condition of the short rocked segment of the southern approach to temporary bridge crossing T1 and a discharge of earthen material to Stuart Fork that occurred during the October rains. T1 was left in place during the increased stream flow that followed the first rain and Stuart Fork overtopped the bridge and eroded away an approximately ten-foot length of the cap of fine native material placed over the abutment's coarser substrate (Figure 10).

Figure 10: South approach to T1

Mr. Dresselhaus of CF estimated that one to two cubic yards of the fine native material may have been discharged to Stuart Fork from erosion of the bridge approach. By the date of the PHI for AM3 no discharge notification was provided to the RWB regarding this discharge, as required by the GWDR. The landowner shall provide a discharge notification to the RWB regarding the erosion of the southern abutment associated with temporary bridge T1 (**GWDR Recommendation 1**).

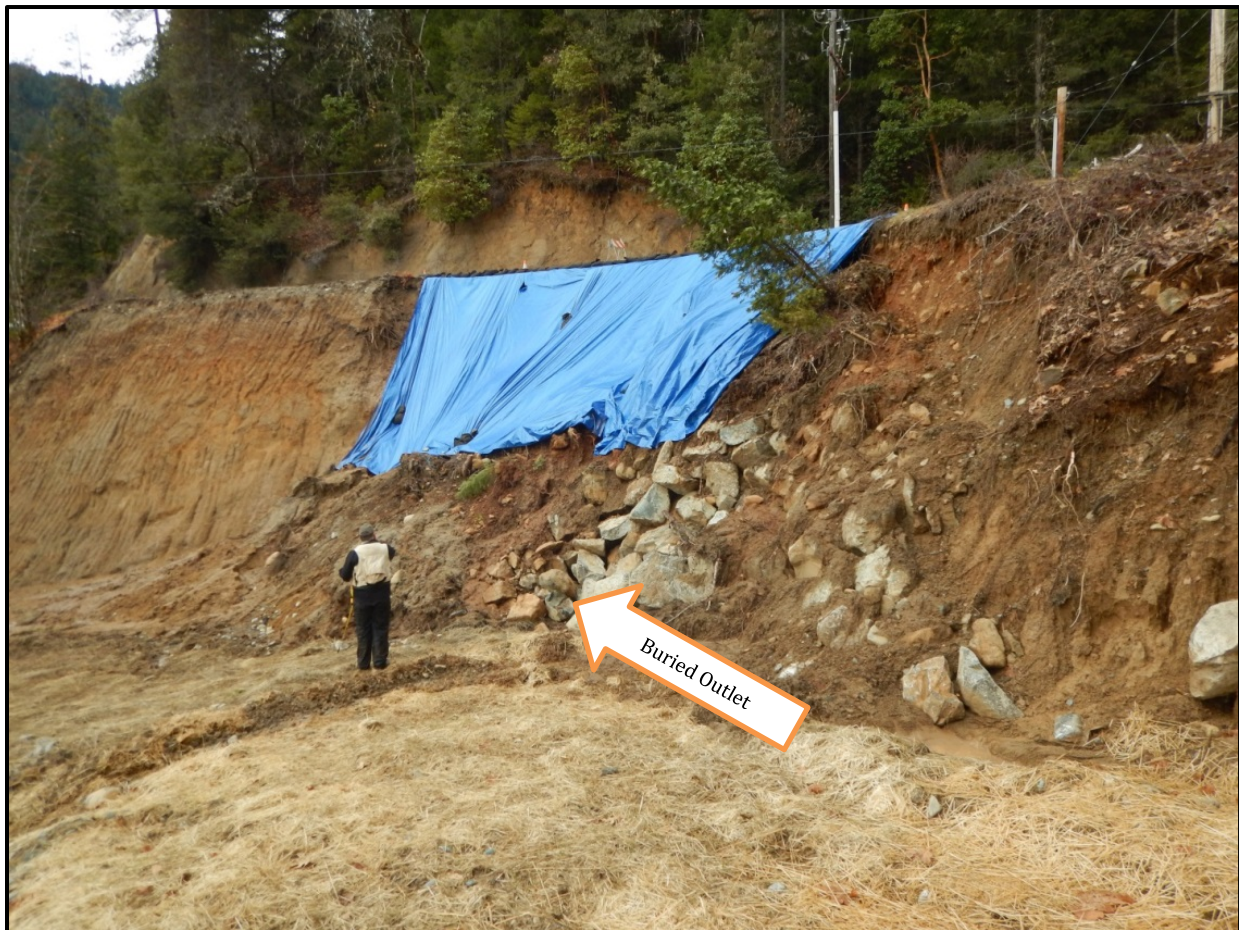
Next, we crossed Trinity Alps Road and began inspecting the AM3 area. We observed that the failed cutslope had buried the rock-lined channel and the outlet of the 18-inch diameter culvert under Trinity Alps Road (see Photo 1). The observed conditions were consistent with the December 1, 2016 discharge notification. We also observed tension fractures in the asphalt of Trinity Alps Road. Trinity County staff had placed traffic cones along the road to divert traffic away from the road shoulder adjacent to the failing cutslope. Mr. Taylor stated that SPI staff had installed the blue tarp over the failing cutslope.

Photo 1: The failing cutslope
(Graham Brown, December 20, 2016)

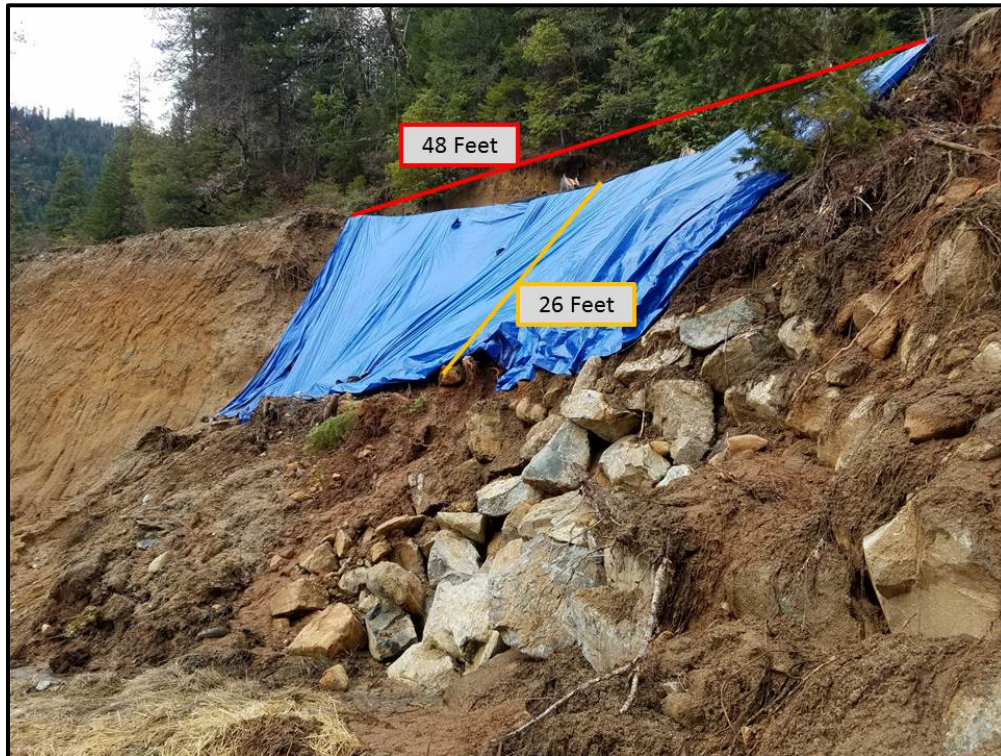
We measured the void in the failed cutslope to be approximately 48-feet long and 26-feet high (see Photo 2). We estimated an average depth of the failure to be 5-feet and calculated the volume of the wedge-shaped void to be 113-cubic yards. Based on our visual assessment, we estimated that half the earthen material from the failed cutslope,

approximately 56-cubic yards, had already been discharged to Stuart Fork with an additional 56-cubic yards still on the switchback at risk of discharge.

**Photo 2: Annotated figure illustrating dimensions of the failed cutslope
(Graham Brown, December 20, 2016)**

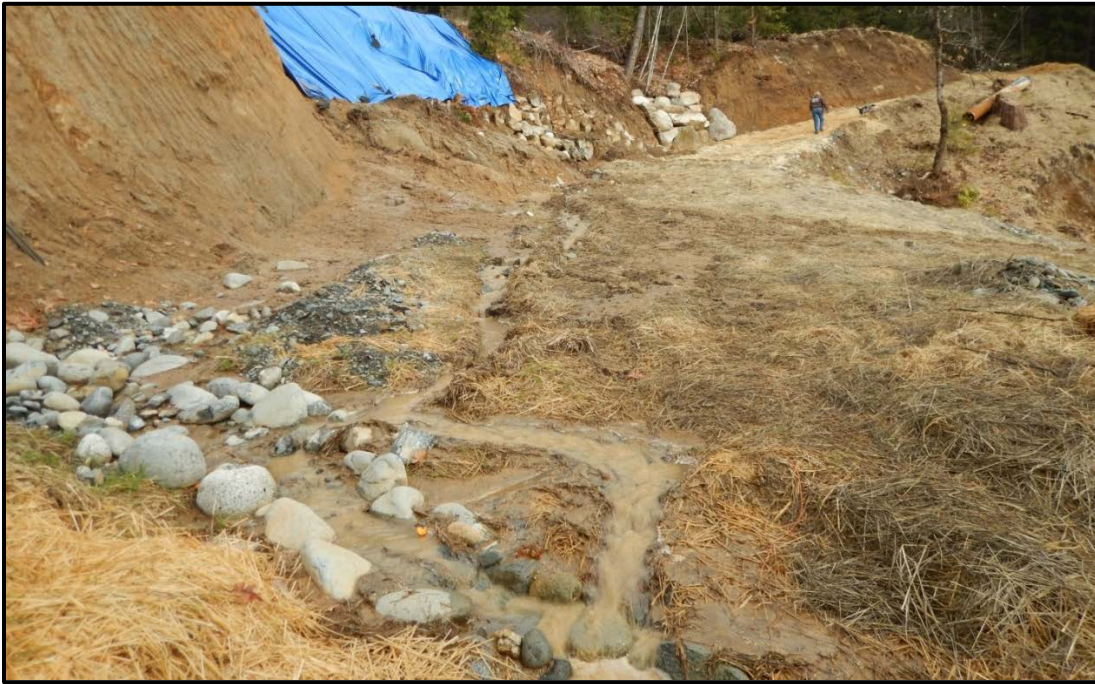
We observed that flow from the buried culvert outlet and seepage from the cutslope was diverted into a hand dug drainage channel constructed by SPI personnel (see Photo 3). The hand dug channel was installed on or adjacent to the unauthorized rock lined channel which was mostly buried under earthen materials originating from the failing cutslope. We measured the hand dug drainage channel to be 103-feet long, 1-foot wide, and 4-inches deep.

**Photo 3: Hand dug drainage channel across the switchback
(Graham Brown, December 20, 2016)**

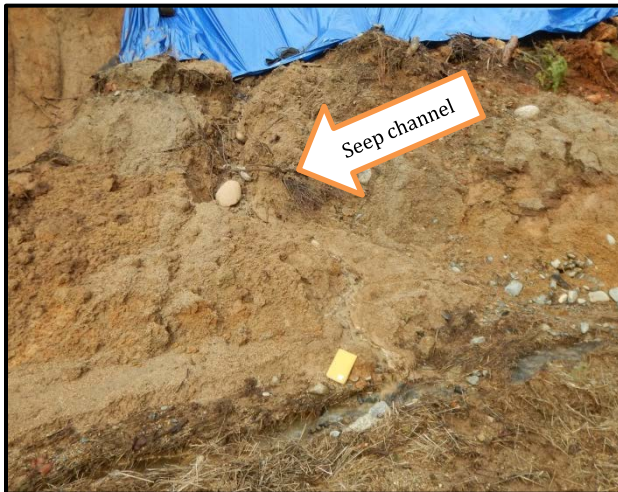
We also observed a seep flowing out from under the tarp placed over the failed cutslope (see Photo 4). The seep had cut a channel through the earthen material deposited at the toe of the failed cutslope (see Photo 5).

**Photo 4: Seep on west side of cutslope failure
(Graham Brown, December 20, 2016)**

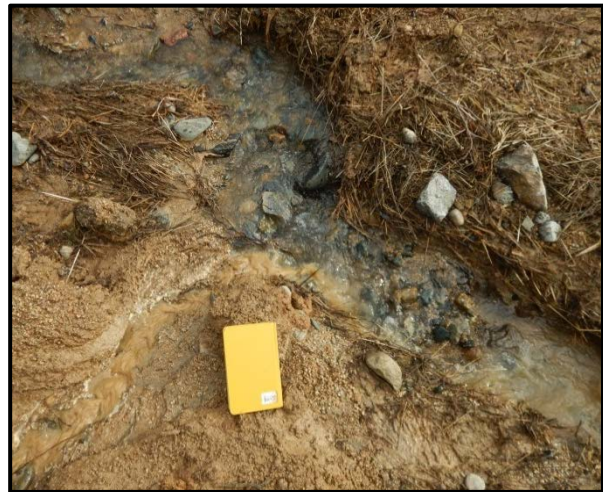
**Photo 5: Seep channel flowing into hand dug channel
(Graham Brown, December 20, 2016)**

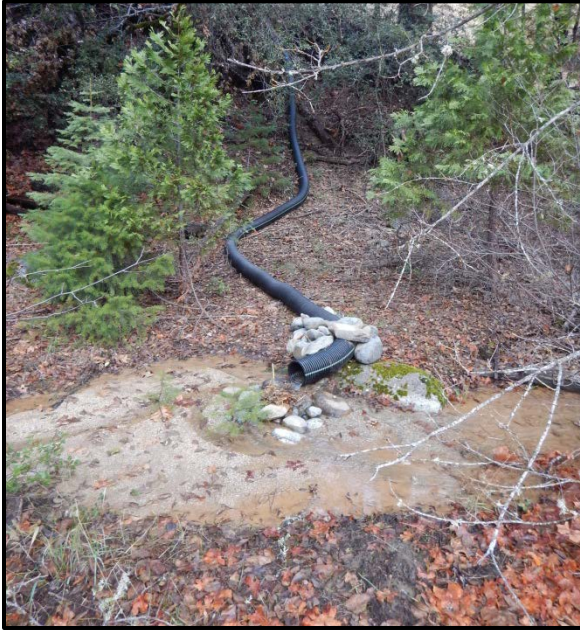
Combined flow from the culvert outlet of the Class II watercourse and the seep was conveyed in the hand dug drainage channel across the apex of the switchback to the inlet of the unauthorized six-inch diameter flexible plastic pipe. We measured the unauthorized pipe from the inlet end to the outlet end on the floodplain of Stuart Fork to be 100-feet long. During the PHI for AM3, Regional Water Board staff documented the discharge of sediment to a discrete area at the outlet of the unauthorized pipe (see Photo 6). We

**Photo 6: Plastic flexible pipe discharging onto Class I floodplain of Stuart Fork
(Forest Fortescue, November 29, 2016)**

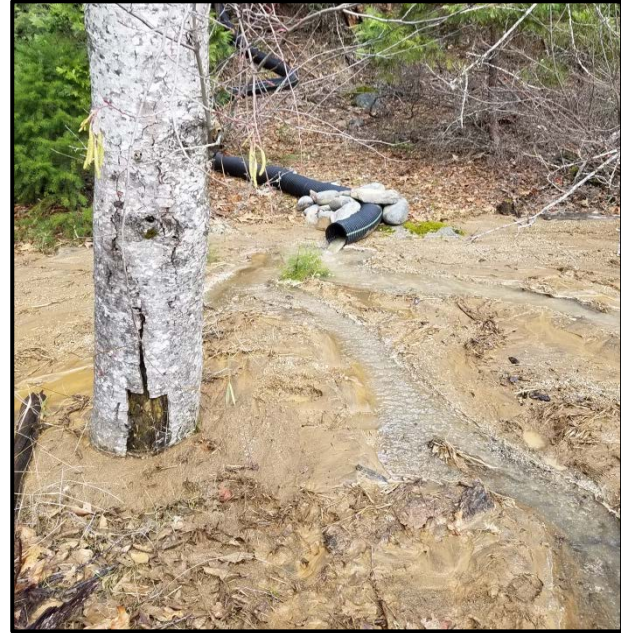
measured a 22-foot long sediment plume that fanned out from the pipe outlet to a high flow channel (secondary channel) on the floodplain of Stuart Fork (see Photo 7).

**Photo 7: Plastic flexible pipe discharging onto Class I floodplain of Stuart Fork
(Graham Brown, December 20, 2016)**

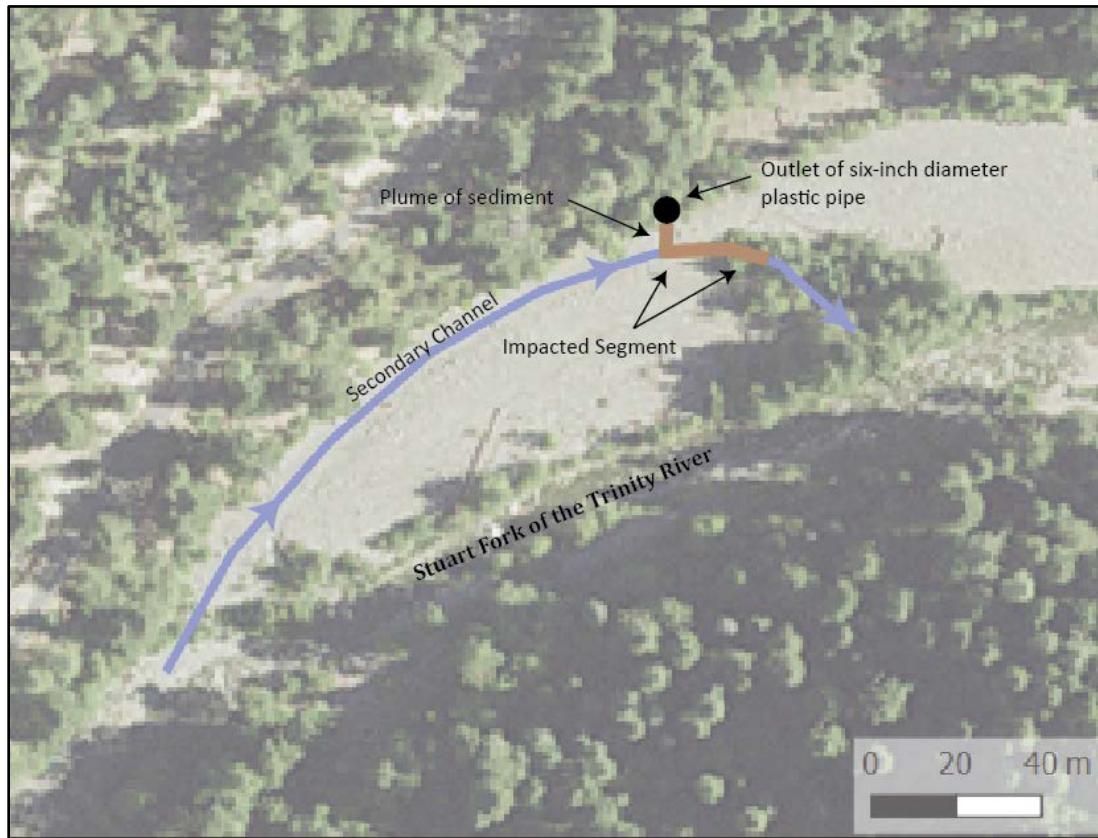
Tim and I then inspected impacts to the secondary channel and the floodplain of Stuart Fork. We observed that the secondary channel upstream of the plume contained only native material and was not impacted with material from the plastic flexible pipe. We measured a 110-foot long segment of continuous deposition in the channel downstream from the confluence of the plume and secondary channel. We measured the secondary channel beyond this point an additional 110-feet before meeting the primary channel. In this lower segment the channel banks become vegetated, the channel widens to 42 feet, and deposition becomes intermittent as the flow begins to slow and move subsurface (see Figure 1).

Figure 1: Map showing the spatial layout of the floodplain of Stuart Fork

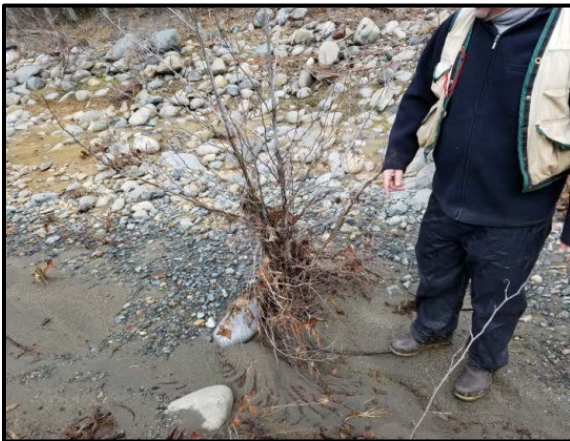
In the upper portion of the secondary channel we observed ripple marks in sediment deposited on the floodplain and above the water line (see Photo 8). In the lower portion of the secondary channel we observed thin intermittent deposits of fine sediment on the cobbles (see Photo 9). Based on our observations it appeared that recent high flows had delivered sediment from the secondary channel into the primary channel of Stuart Fork.

**Photo 8: Ripple marks on the bank of the secondary channel
(Graham Brown, December 20, 2016)**
