North Coast Regional Water Quality Control Board

Subject: **Notice of Violation** of the *Water Quality Control Plan for the North Coast Region* and Order No. R1-2004-0030, *General Waste Discharge Requirements for Discharges Related to Timber Harvest Activities on Non-Federal Lands in the North Coast Region*; and
13267 Investigative Order Pursuant to California Water Code section 13267, for Sierra Pacific Industries

File: THP 2-15-021 TRI "YESMON" (CW-814600)

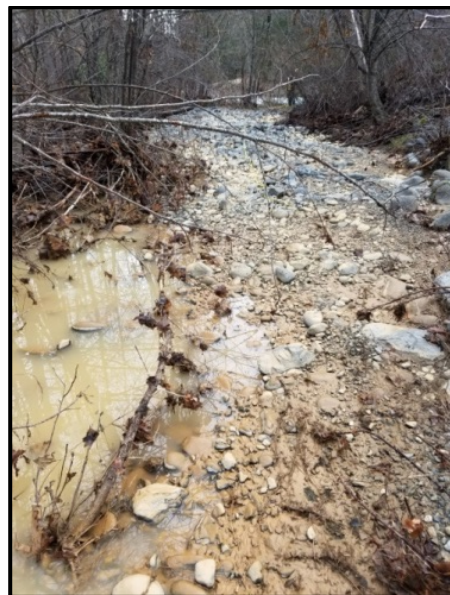
In the upper portion of the secondary channel we observed ripple marks in sediment deposited on the floodplain and above the water line (see Photo 8). In the lower portion of the secondary channel we observed thin intermittent deposits of fine sediment on the cobbles (see Photo 9). Based on our observations it appeared that recent high flows had delivered sediment from the secondary channel into the primary channel of Stuart Fork.

**Photo 9: Deposition of fines in the secondary channel
(Graham Brown, December 20, 2016)**

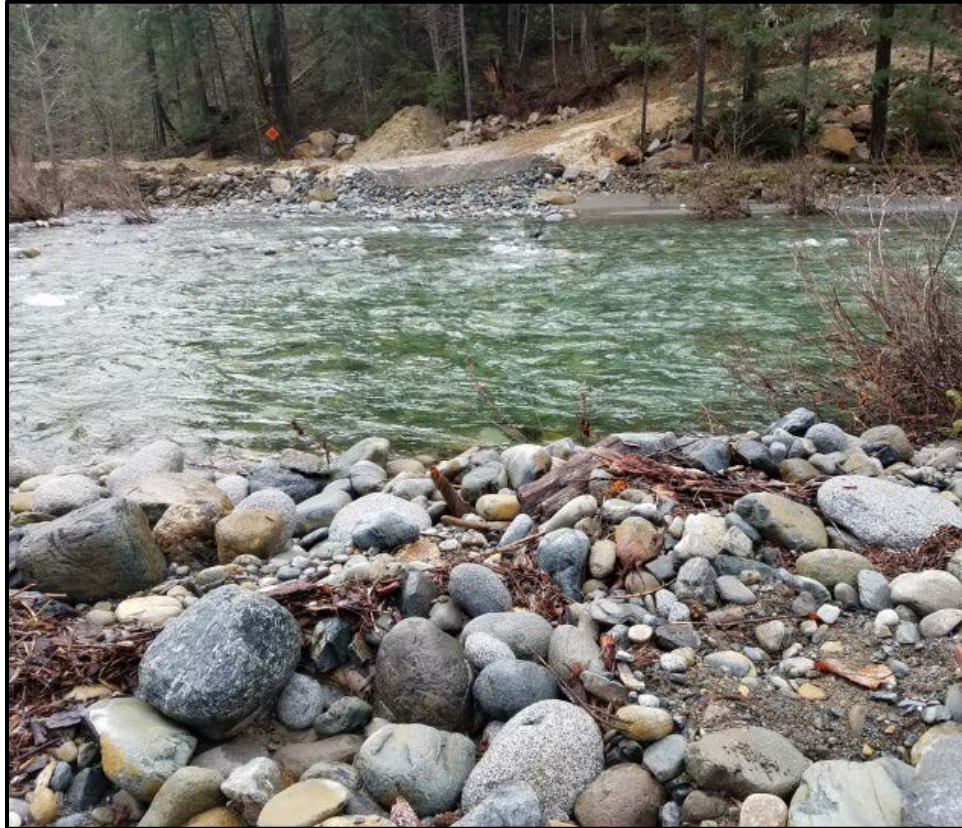
We then inspected the northern abutment to the temporary bridge crossing over Stuart Fork identified as T1 in the THP. SPI had removed the temporary bridge in October 2016. We also looked across Stuart Fork at the southern bridge approach. The southern approach was constructed with native floodplain material and extended from the south bank of Stuart Fork into the primary flow channel. Stuart Fork was overtopping the southern abutment (see Photo 10).

**Photo 10: View to the south across Stuart Fork
(Graham Brown, December 20, 2016)**

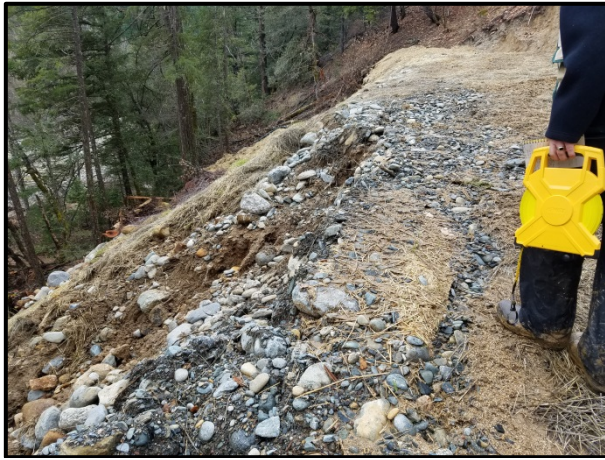
We walked north across the floodplain back towards the switchback and Trinity Alps Road. We observed a series of gullies and erosion on the fillslope below the southern extent of the seasonal road below the switchback (see Photo 11). The erosion had deposited road embankment fill materials into an elliptical-shaped depression on the floodplain at the base of the fillslope (see Photo 12). We measured the deposit to be 90-foot long and 16-foot wide with an estimated average depth of 6-inches. Based on our measurements and the elliptical shape the sediment deposit we estimated 20-cubic yards of eroded fill material had been deposited in the depression.

**Photo 11: Erosion of the fillslope
(Graham Brown, December 20, 2016)**

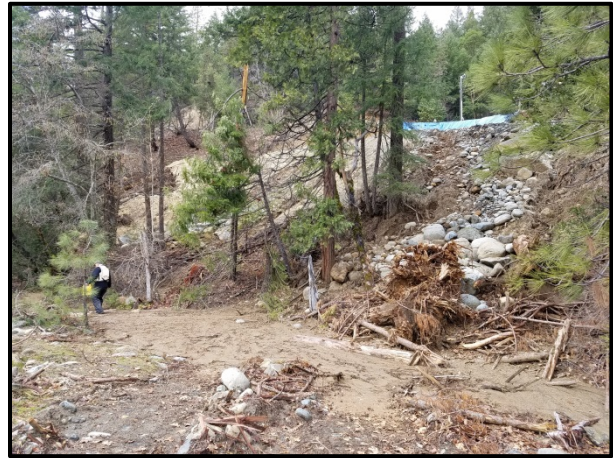
**Photo 12: Deposition on floodplain below the
switchback
(Graham Brown, December 20, 2016)**
