## **Attachment A**

### **Site Photos from Recent Site Inspection of the Willits Bypass Mitigation Lands**

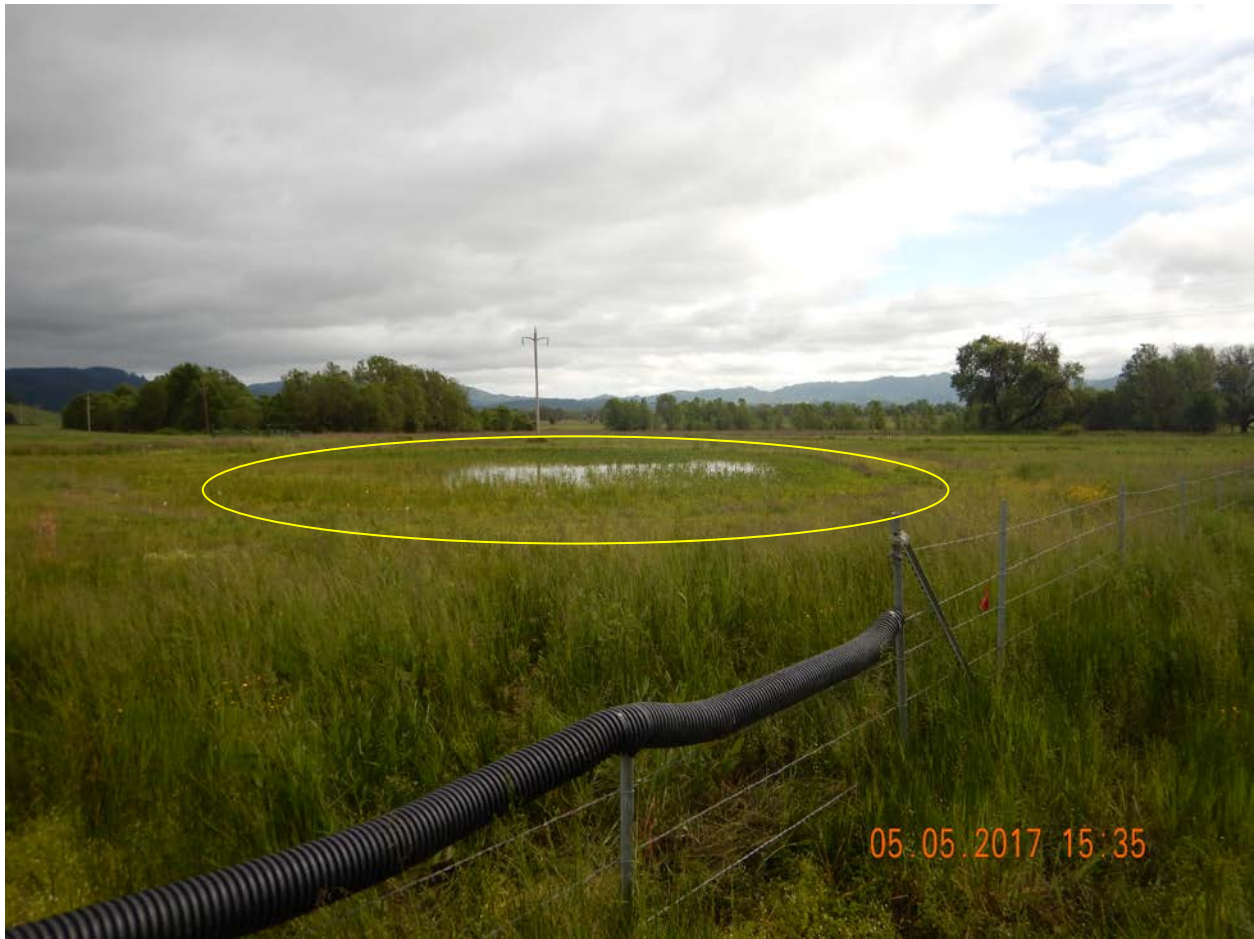
Photo taken on 5/5 – Standing just northeast of the Watson 037-221-30 parcel facing southwest. Ponding seen within bermed area, highlighted in yellow.

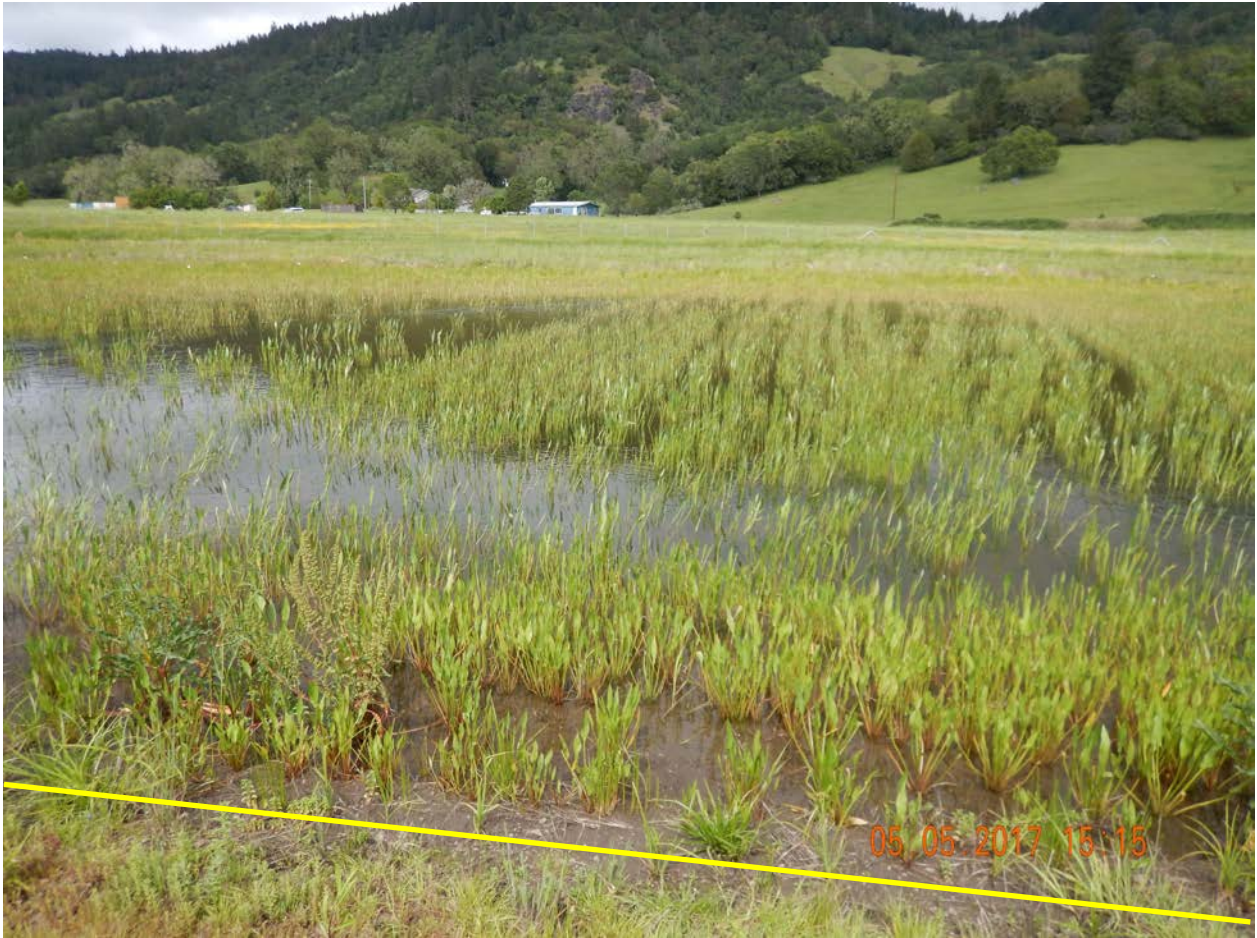
Photo taken on 5/5 - Standing on berm facing northeast. Lower edge of the berm highlighted in yellow.

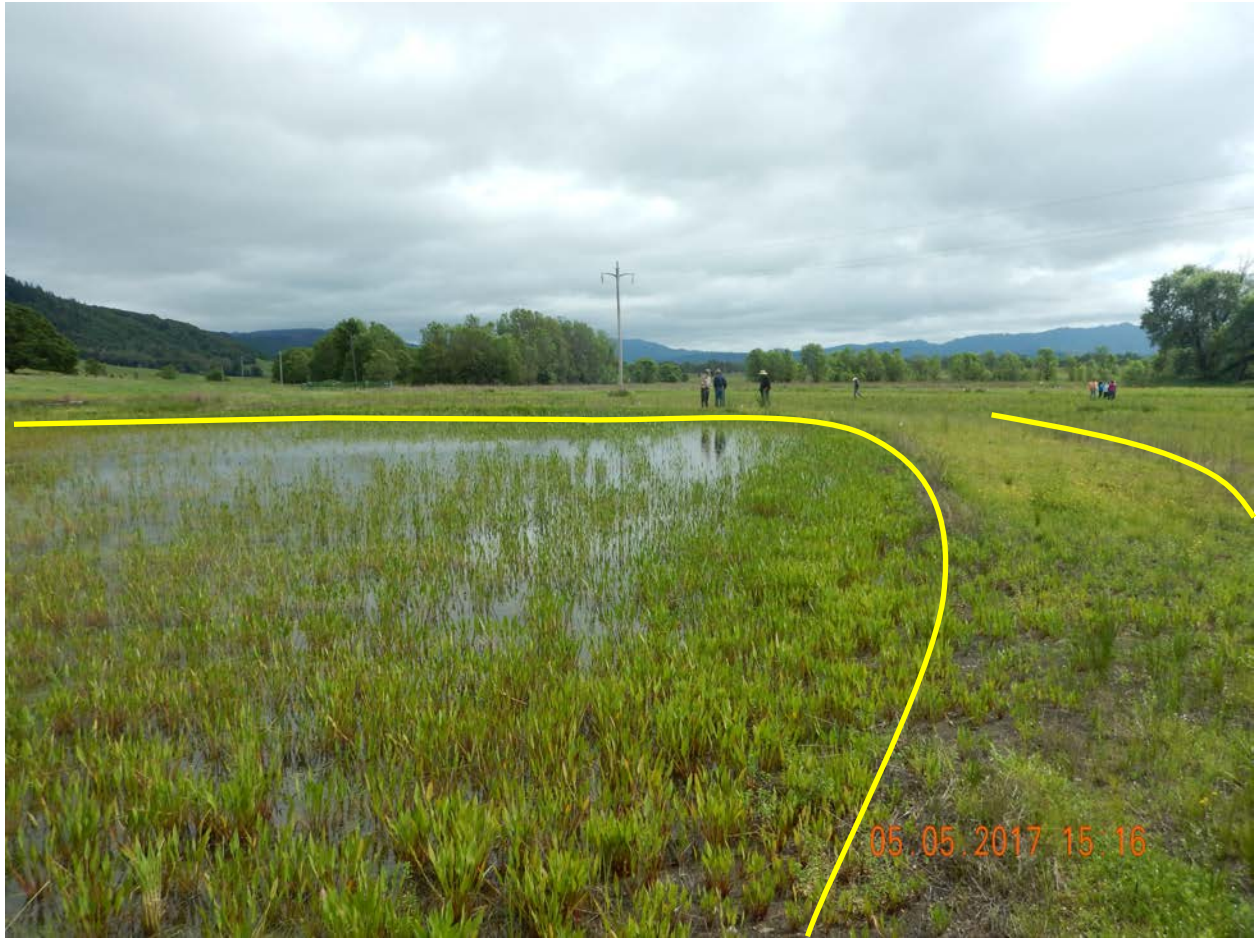
Photo taken on 5/5 - Standing on berm facing south. Ponding seen within berm limits, highlighted in yellow.

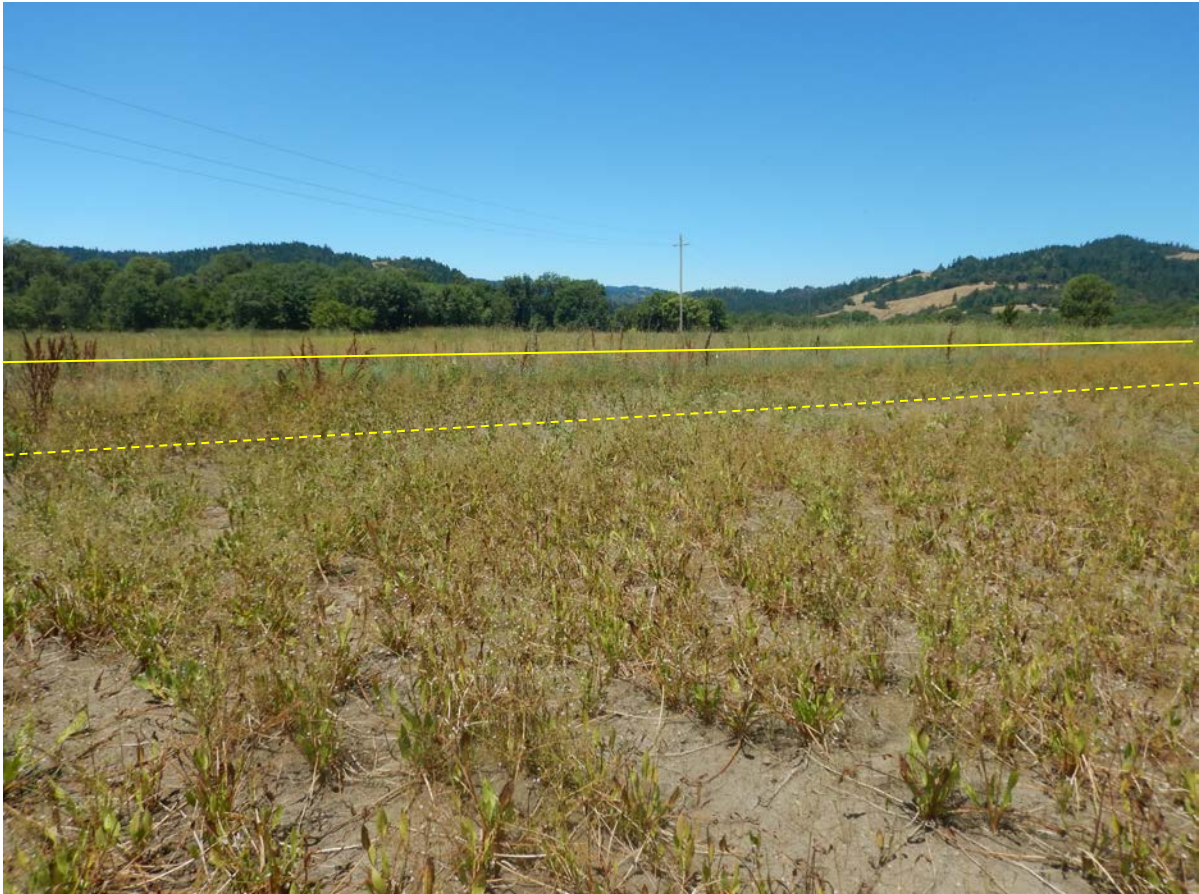
Photo taken on 6/29 - Standing in previously inundated pond facing west. Lower limit of berm highlighted in a dotted yellow line, top of berm highlighted with a solid yellow line.

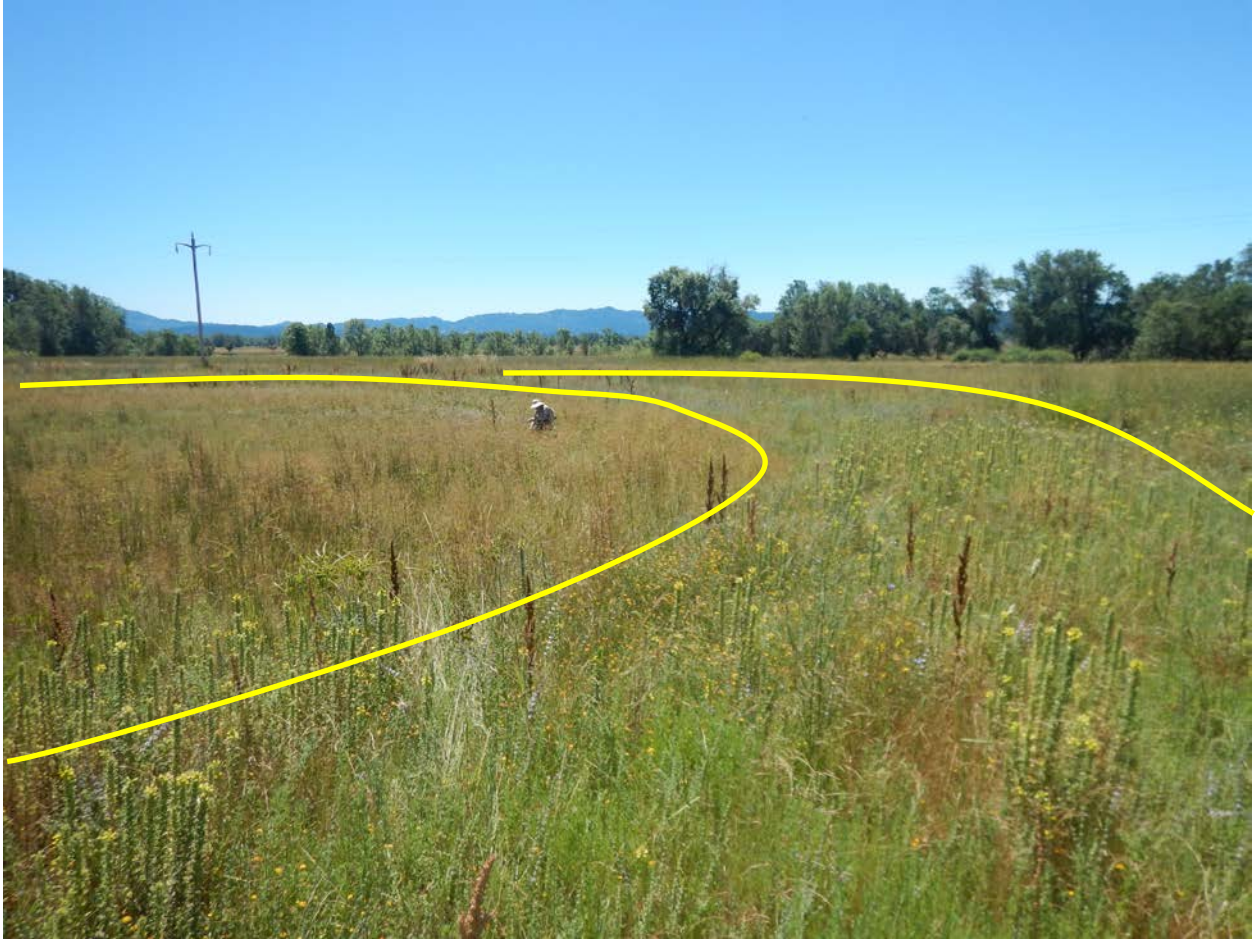
Photo taken on 6/29 - Standing on berm facing south/southwest. Berm highlighted in yellow. Ponding not present in this photo.

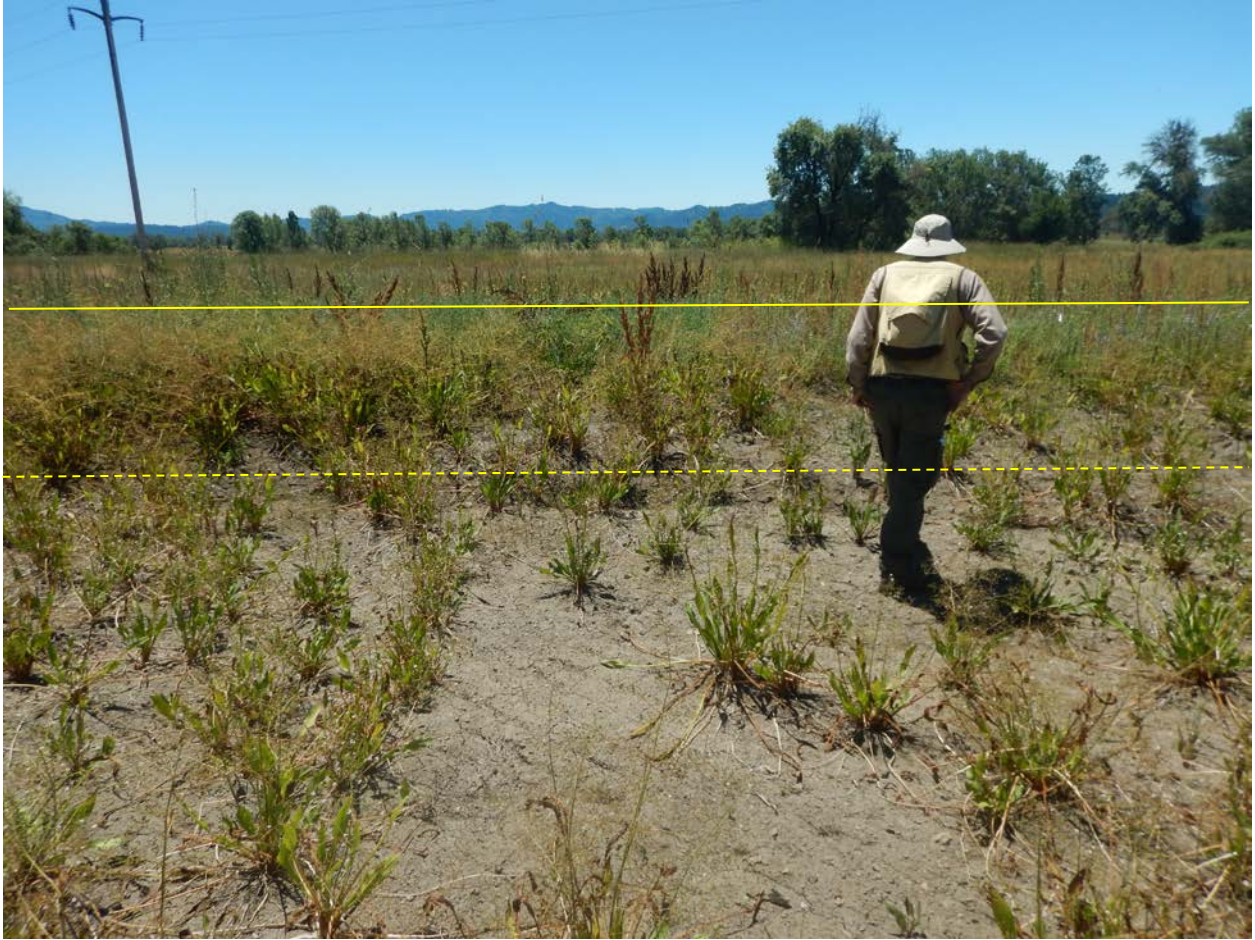
Photo taken on 6/29 - Standing in previously inundated pond facing southwest. Lower limit of berm highlighted in a dotted line, top of berm highlighted with a solid line.
