**Subject: Notice of Violation, Directive to Obtain Regulatory Coverage for Cannabis Cultivation, and Transmittal of Inspection Report for August 8, 2019, Inspection of Humboldt County Assessor's Parcel No. 216-391-023**

### **Inspection Report for August 08, 2019, Warrant Inspection Humboldt County Assessor's Parcel Number 216-391-023**

File: Cannabis Program Inspections, Humboldt County, August 2019 HCSO/CAMP  
Inspections, Christopher Michael Waters, CIWQS Place ID.860388

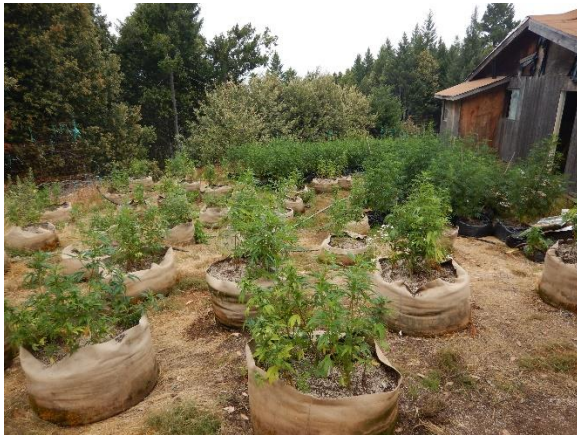
OG1 is on a ridgetop, with an approximately 4,000-square foot earthen pad/clearing with cannabis cultivation in mesh bags and potting soil (photos 1-2). In this area I observed a fertilizer mixing tank, fertilizer bags, and soil amendments, uncovered and/or uncontained. I observed no nearby watercourses; as such the overall potential for pollutant delivery to receiving waters from OG1 appeared to be low.

Photo 1: OG1, next to ST1, uncontained soil amendments in foreground

1. Collect and dispose of or contain all refuse and cultivation-related wastes in a location and manner so as to minimize potential for these wastes to enter or be transported into receiving waters
2. Store and contain all chemicals, including petroleum, fertilizer and/or pesticides in locations and in a manner in which they cannot enter or be transported into surface waters and such that nutrients or other pollutants cannot be leached into groundwater. Provide secondary containment for all petroleum products.

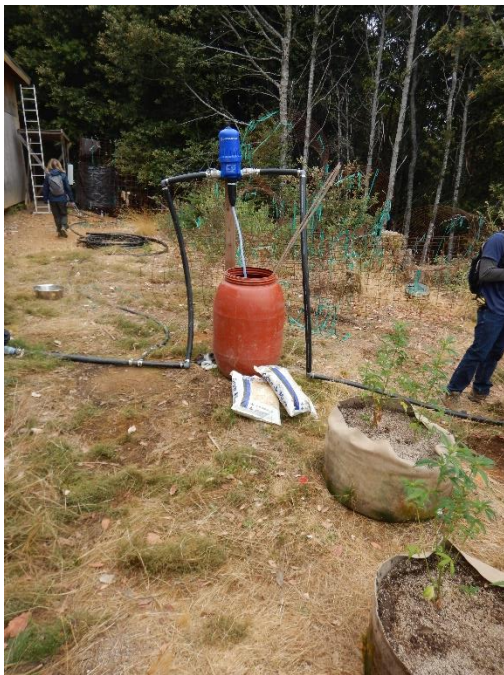
Photo 2: Fertilizer mixing tank with fertilizer bags near OG1

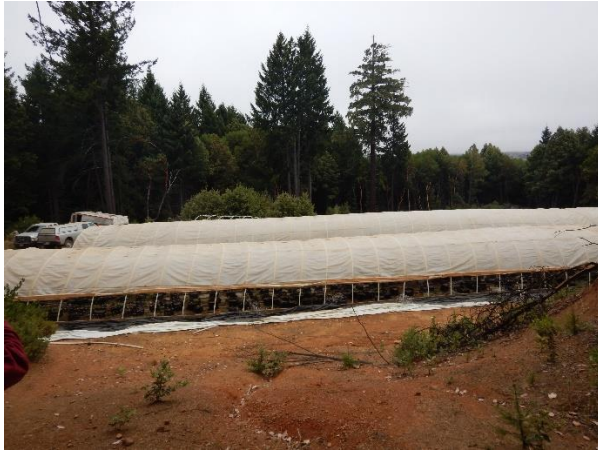
GH1-4 (Photos 3-5), is downhill and to the east of OG1, and consists of an approximately 13,700-square foot earthen pad/clearing with cannabis cultivation in four greenhouses. In this area I observed refuse, fertilizer mixing tanks, petroleum products, and soil amendments, uncovered, uncontained, and/or not properly disposed of. I observed no nearby watercourses; as such the overall potential for pollutant delivery to receiving waters from OG1 appeared to be low.

Photo 3: GH1-4

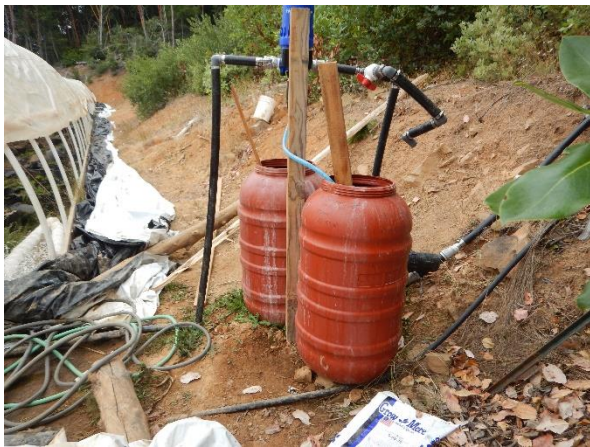
Photo 4: Fertilizer mixing tanks with no containment, leaking onto ground

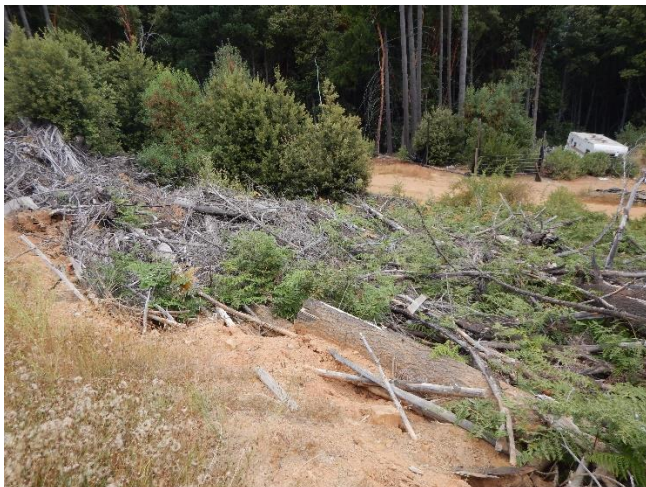
Photo 5: Slash associated with clearing of GH1-4

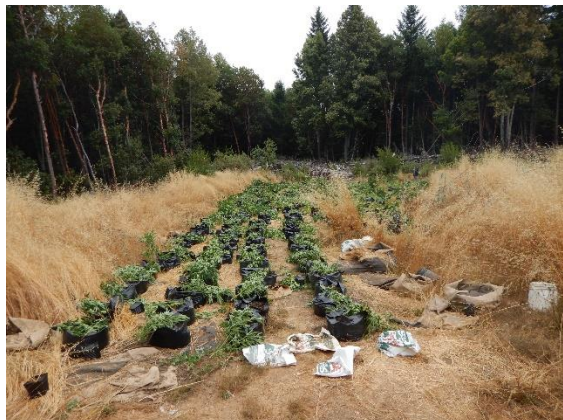
OG2 (Photo 6) is located just downhill from GH1-4 and consists of an approximately 4,000-square foot clearing with cannabis cultivation in plastic bags with soil amendments. In this area, I observed soil amendments uncovered and/or uncontained. I observed no nearby watercourses; as such the overall potential for pollutant delivery to receiving waters from OG1 appeared to be low.

Photo 6: OG2, soil bags, trash in the foreground

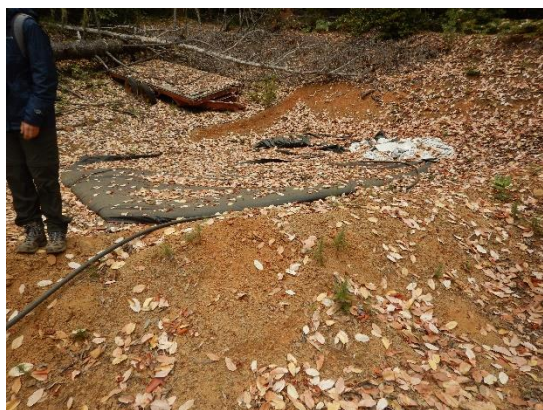
Uphill from OG1, I observed a well structure and water storage bladder, labeled W1 and B1 on Figure 1 (Photos 7 and 8). At these locations I observed that the water storage bladder lacked secondary containment, and there were multiple generators near W1 without secondary containment.

Photo 7: Bladder, B1, no secondary containment

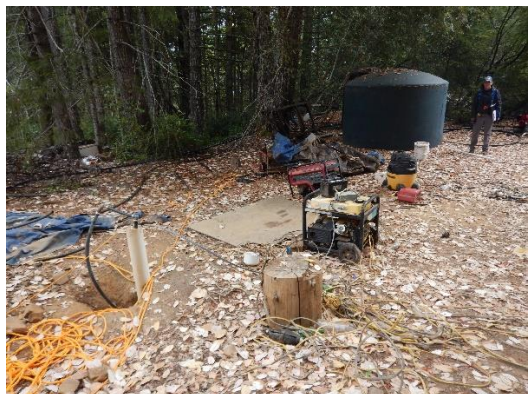
Photo 8: Well, W1, generators adjacent with no containment and refuse strewn about
