Subject: Notice of Violation, Directive to Obtain Regulatory Coverage for Cannabis Cultivation, and Transmittal of Inspection Report for August 6, 2019, Inspection of Humboldt County Assessor's Parcel No. 208-241-008

Inspection Report for August 6, 2019, Warrant Inspection Humboldt County Assessor's Parcel Number 208-241-008

File: Cannabis Program Inspections, Humboldt County, August 2019 HCSO/CAMP
Inspections, Diana Amelina, CIWQS Place ID.860369

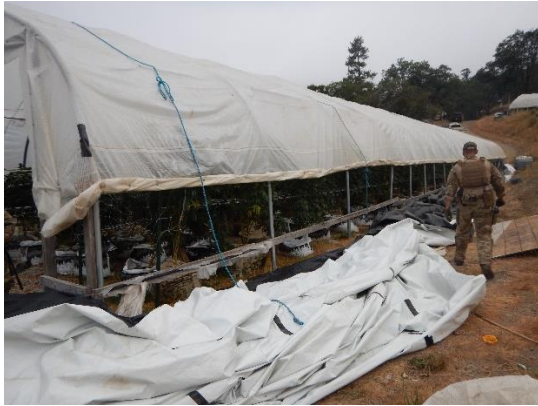
Photo 1: Greenhouse 1

GH1, the first area we inspected, is located uphill from a swale feature, with an approximately 4,000-square foot earthen pad/clearing with cannabis cultivation in one greenhouse. In this area I observed containers of fertilizers, trash in bags, and cannabis cultivation-related soil spoils piles (Photos 1-3), uncovered, uncontained, and/or not properly disposed of. The swale feature represents the beginning of potential surface water flow, however, I observed no bed or bank of a channel, and the overall potential for pollutant delivery to receiving waters appeared to be low.

4. Collect and dispose of or contain all refuse and cultivation-related wastes in a location and manner so as to minimize potential for these wastes to enter or be transported into receiving waters.
5. Store and contain all chemicals, including petroleum, fertilizer and/or pesticides properly to prevent spillage and discharge to receiving waters. Provide secondary containment for all petroleum products.
6. If the property owner and/or tenant(s) choose to continue to cultivate cannabis, enroll for coverage under and take steps to comply with the requirements of the CANGO (Order WQ 2017-0023-DWQ, General Waste Discharge Requirements and Waiver of Waste Discharge Requirements for Discharges of Waste Associated with Cannabis Cultivation Activities). More information about the CANGO can be found at this hyperlink:

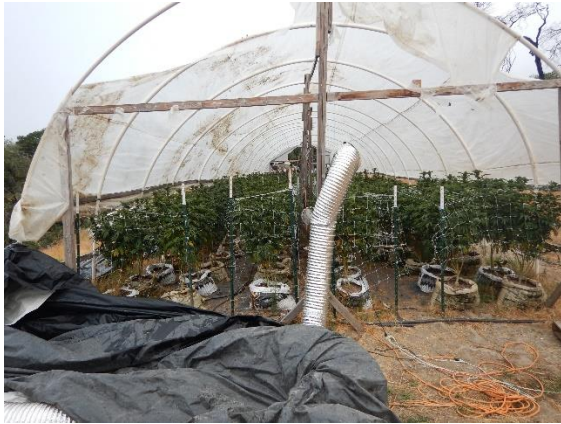
Photo 4: Greenhouse 2

GH2 (Photo 4) is uphill from GH1, alongside the main access road, with an approximately 2,900-square foot earthen pad/clearing with cannabis cultivation in one greenhouse. In this area I observed containers of fertilizers, trash in bags, and cannabis cultivation-related soil spoils piles (Photo 5-6), uncovered, uncontained, and/or not properly disposed of. However, there are no nearby watercourses, and likely the potential for pollutant delivery to receiving waters is low.

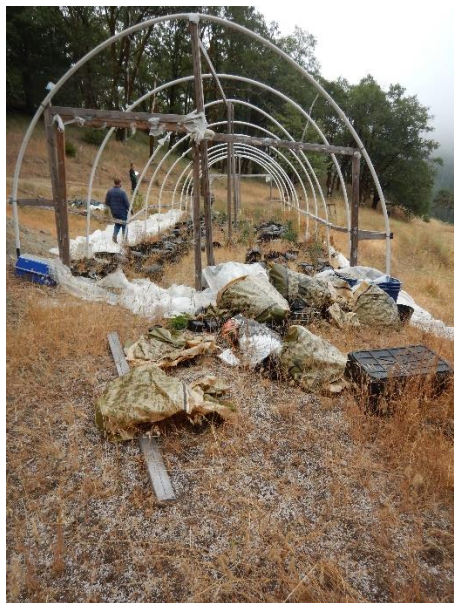
Photo 7: Greenhouse 3, cultivation related soils and waste present

GH3 (Photo 7), is located north of GH2, along the main access road, with an approximately 900-square foot earthen pad/clearing with evidence of previous cannabis cultivation activities. In this area I observed cannabis cultivation-related soil spoils piles (Photo 7), uncovered, uncontained, and/or not properly disposed of. GH3 is approximately 50 feet from a class II watercourse; the intervening buffer is vegetated, and the potential for pollutant delivery to receiving waters from this site is low.

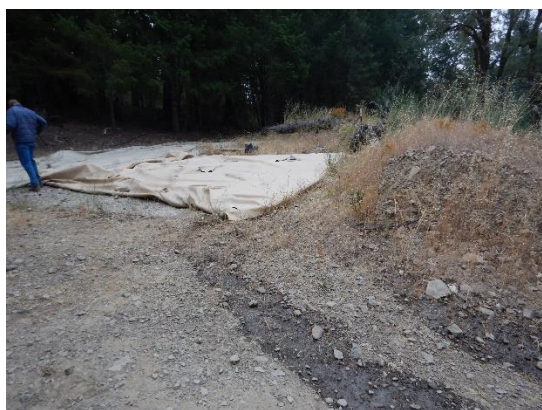
Photo 8: Bladder, B1, leaking its contents onto the road

Just south of C1, I observed a 10,000-gallon army grade bladder (Photo 8), used for holding water. I observed no secondary containment around the bladder, which was leaking its contents onto the access road leading back down towards GH3. Water from the nearby class II watercourse is diverted into B1 via a 1-inch plastic pipe. CDFW has more information regarding the diversion point.

5. Water storage and use: As noted above, I observed a I water storage bladder that was not properly sited, did not include proper secondary containment, and was leaking its contents onto the road system, contributing to erosion of the road.

2. Work with CDFW and the State Water Resources Control Board's Division of Water Rights (DIV) to determine and secure any applicable permits or licensing required for surface water diversion, storage, and use on the site. If the existing surface water diversions do not meet applicable CDFW or DIV requirements, remove diversion infrastructure from surface waters and include provisions for restoring any instream or riparian disturbance associated with this features or removal thereof.

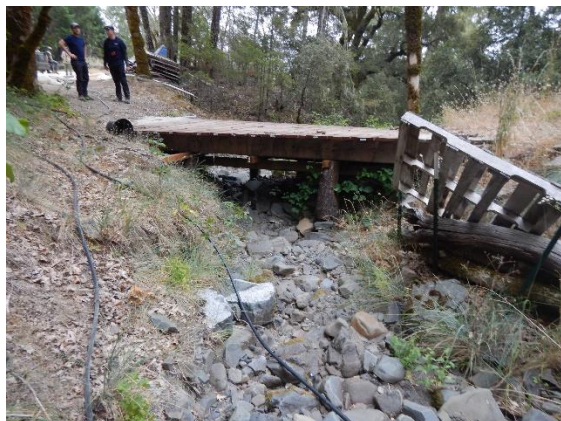
Photo 9: Bridge crossing, C1

Heading northeast on the road, I observed a watercourse crossing, C1 (Photo 9), where a bridge structure had been built above the ordinary high-water mark of the stream. The bridge is supported with wooden pylon beams within the channel, and the bridge itself consists of pressure-treated wood. Immediately north of the bridge, the road steepens uphill significantly and I observed evidence of erosion along the road that delivers to the class II watercourse just upstream of the bridge crossing (photo 10).

2. Stream crossing maintenance and improvement: As noted above, I observed one watercourse crossing that was improperly sized, constructed, and/or maintained, and represented a threat to water quality.

1. Retain a licensed professional to inventory, assess, and develop a workplan and schedule to implement measures to ensure that all developed features, roads, watercourse crossings, and cultivation areas throughout the Property are corrected, restored, and/or maintained in conditions that prevent or minimize erosion, sediment transport/delivery, and adverse impacts to water quality and beneficial uses. Include measures to ensure that unstable features caused or affected by onsite development and operations are removed or otherwise protected so as to minimize the potential for these features to cause adverse impacts to water quality and beneficial uses. Dispose of all development and restoration-related earthen spoils in a manner to prevent/minimize transport and delivery to receiving waters.

3. Prior to conducting any instream work associated with recommendation 1, above, submit to the Regional Water Board an application for Clean Water Act section 401 water quality certification, and secure approval from the Regional Water Board.

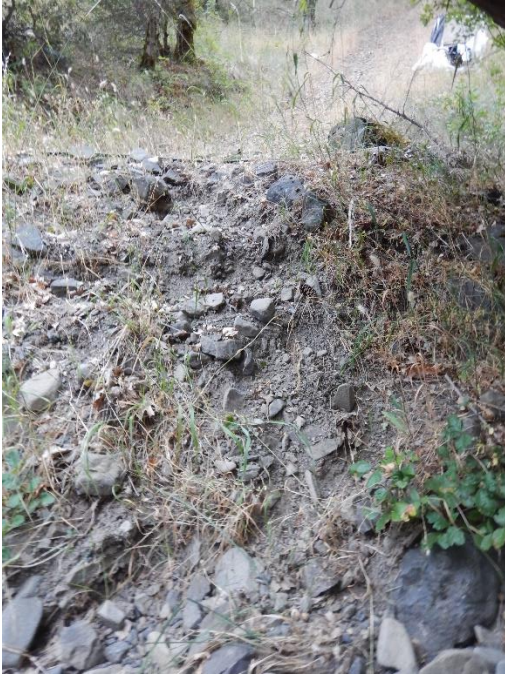
Photo 10: Sediment delivery from road above C1 to class II stream below

C1	Road drainage near bridge	Drainage from steep road segment causing/resulting in sediment discharge.	Discharge of waste to waters of the State.	10

1. Site maintenance, erosion control and drainage features: I observed a steep section of road that appeared to concentrate water along its surface and deliver sediment to a class II stream below.

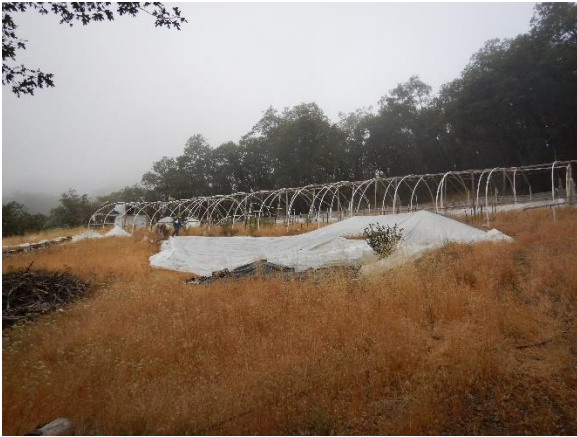
Photo 11: GH4-6

GH4-6 (Photo 11), is uphill from C1, at the end of the main access road, with an approximately 11,200-square foot clearing with cannabis cultivation in three greenhouses. In this area I observed refuse and cannabis cultivation-related soil spoils piles (Photo 12-13), uncovered, uncontained, and/or not properly disposed of. GH4-6 is approximately 60 feet from a class III watercourse, with a somewhat vegetated buffer between the activities and the watercourse. As a result, the potential for pollutant delivery to receiving waters from this site is low to moderate.
