**Subject: Notice of Violation, Directive to Obtain Regulatory Coverage for Cannabis Cultivation, and Transmittal of Inspection Report for August 7, 2019, Inspection of Humboldt County Assessor's Parcel No. 216-201-002**

### **Inspection Report for August 07, 2019, Warrant Inspection Humboldt County Assessor's Parcel Number 216-201-002**

File: Cannabis Program Inspections, Humboldt County, August 2019 HCSO/CAMP Inspections, Emil Terzisky, CIWQS Place ID.860374

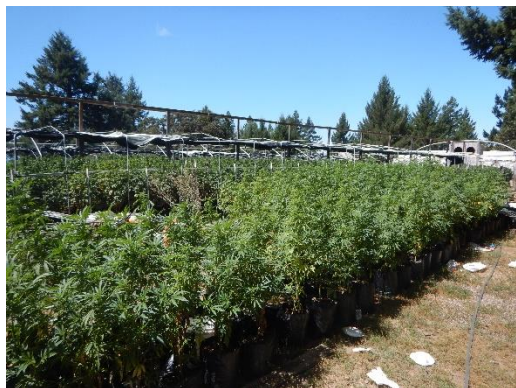
GH1-4 is located on a relatively flat clearing on a hill with an approximately 20,300-square foot earthen pad/clearing with cannabis cultivation in four greenhouses (photo 1). In this area I observed a soil amendments and refuse (Photos 2-3), uncovered and/or uncontained. Uphill from GH1-4, I observed a fertilizer mixing tank, labeled MT1 on Figure 1 without secondary containment (photo 4). Adjacent to the mixing tank, I observed multiple fertilizer containers that were uncovered and/or uncontained. Immediately uphill from MT1, I observed three water storage tanks of varying size used to store water for cannabis cultivation (photo 5). The water storage tanks did not appear to contain appropriate overflow prevention valves. Both GH1-4 and MT1 are located a fair distance from any surface waters. As such, the overall potential for pollutant delivery to receiving waters from GH1-4 or MT1 appeared to be low.

Photo 1: Cannabis cultivation associated with GH1-4

1. Retain a licensed professional to inventory, assess, and develop a workplan and schedule to implement measures to ensure that all developed features, roads, watercourse crossings, and cultivation areas throughout the Property are corrected, restored, and/or maintained in conditions that prevent or minimize erosion, sediment transport/delivery, and adverse impacts to water quality and beneficial uses. Include measures to ensure that unstable features caused or affected by onsite development and operations are removed or otherwise protected so as to minimize the potential for these features to cause adverse impacts to water quality and beneficial uses. Dispose of all development and restoration-related earthen spoils in a manner to prevent/minimize transport and delivery to receiving waters.

7. In the event that the property owner and/or tenant(s) propose in the future to develop or use the Property in a manner or method that will or may result in a discharge of waste to waters of the state in the future, staff recommend that the owner(s)/tenant(s) be aware of and comply with relevant regulatory requirements for water quality protection. For example, Water Code section 13260 requires that a person discharging waste, or proposing to discharge waste, within any region that could affect the quality of the waters of the state, other than into a community sewer system shall file with the appropriate regional board a report of the discharge. Further, Water Code section 13264 states, in part: "No person shall initiate any new discharge of waste or make any material changes in any discharge...prior to the filing of the report required by Section 13260." In addition, projects involving the disturbance of an acre or more of land are subject to regulation under the State Water Board's Construction General Stormwater permit, and projects involving dredge or fill in waters of the United States are subject to regulation under Clean Water Act section 401. You may find further information about Water Board permits that may apply to proposed site development or land use activities at this hyperlink:

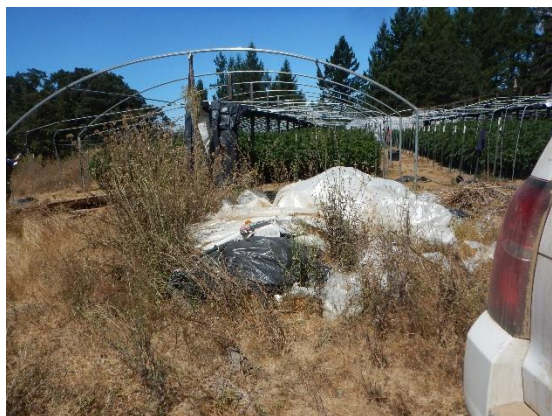
11. Refuse and human waste: I observed one location where refuse was improperly stored and/or disposed of.

Photo 2: Refuse pile near GH1-4, cultivation in the background

4. Collect and dispose of or contain all refuse and cultivation-related wastes in a location and manner so as to minimize potential for these wastes to enter or be transported into receiving waters
5. Store and contain all chemicals, including petroleum, fertilizer and/or pesticides properly to prevent spillage and discharge to receiving waters. Provide secondary containment for all petroleum products.
6. If the property owner and/or tenant(s) choose to continue to cultivate cannabis, enroll for coverage under and take steps to comply with the requirements of the CANGO (Order WQ 2017-0023-DWQ, General Waste Discharge Requirements and Waiver of Waste Discharge Requirements for Discharges of Waste Associated with Cannabis Cultivation Activities). More information about the CANGO can be found at this hyperlink:

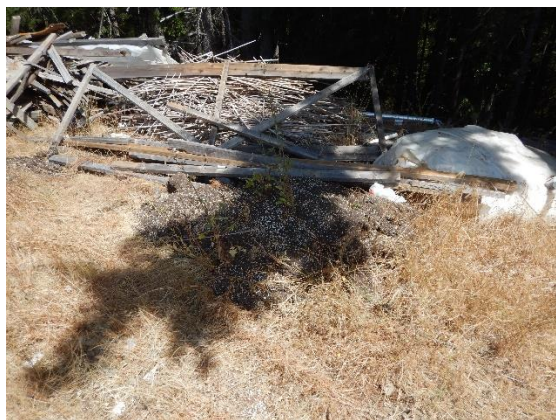
10. Cultivation-related wastes: I observed multiple locations where cultivation-related wastes were uncovered and/or uncontained. However, as noted above, these materials were in a location where potential for delivery to receiving waters appeared relatively low.

Photo 3: Soil amendments, refuse, improperly stored near GH1-4

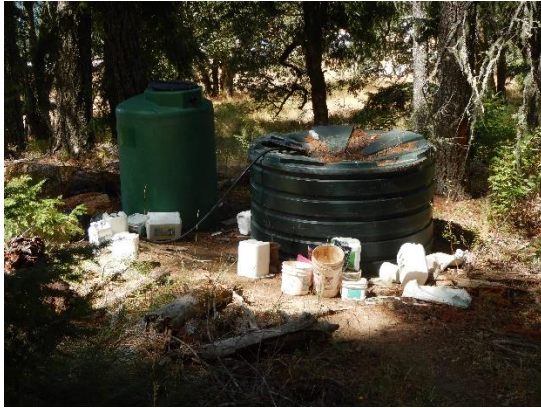
6. Irrigation runoff: I observed no water quality concerns relating to irrigation runoff on the subject parcel.
7. Fertilizers and soil amendments: As noted above, I observed one location where fertilizers and soil amendments were uncovered and/or uncontained. However, as noted above, these materials were in a location where potential for delivery to receiving waters appeared relatively low.

Photo 4: Mixing tanks and fertilizer containers not properly sited or stored, MT1

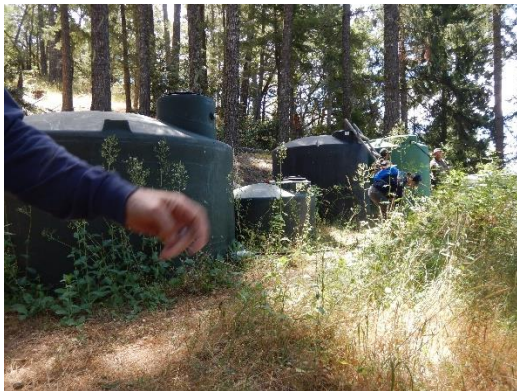
4. Spoils management: I observed no water quality concerns relating to spoils management on the subject parcel.
5. Water storage and use: As noted above, I observed water storage tanks lacking proper outflow prevention mechanisms.

Photo 5: Water Storage tanks on a hillside, adjacent to MT1

2. Work with CDFW and the State Water Resources Control Board's Division of Water Rights (DIV) to determine and secure any applicable permits or licensing required for surface water diversion, storage, and use on the site. If the existing surface water diversions do not meet applicable CDFW or DIV requirements, remove diversion infrastructure from surface waters and ensure that restoration plans developed pursuant to Recommendation 1, above, include provisions for restoring any instream or riparian disturbance associated with this features or removal thereof.

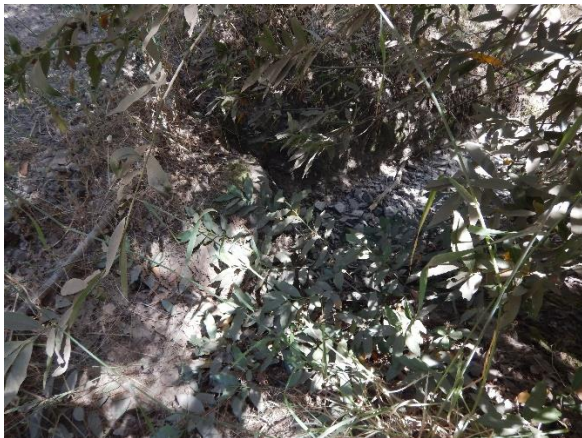
Throughout the Property, I observed an extensive network of roads. In the southeast portion of the Property (farthest uphill and closest to the cultivation area, GH1-4), along the main access road, I observed a culverted watercourse crossing, C1 (photos 6-7). The culvert is a 24" concrete pipe that has a degraded and broken outlet. Additionally, the culvert appears undersized and is slightly perched.

Photo 6: C1 inlet

3. Prior to conducting any instream work associated with recommendations 1 and 2, above, submit to the Regional Water Board an application for Clean Water Act section 401 water quality certification, and secure approval from the Regional Water Board.

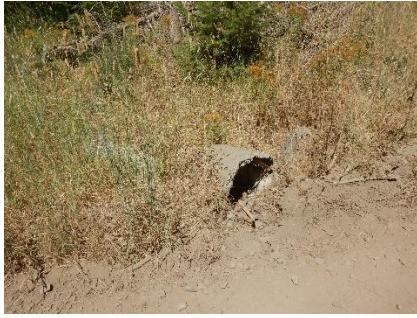
Photo 7: C1 outlet

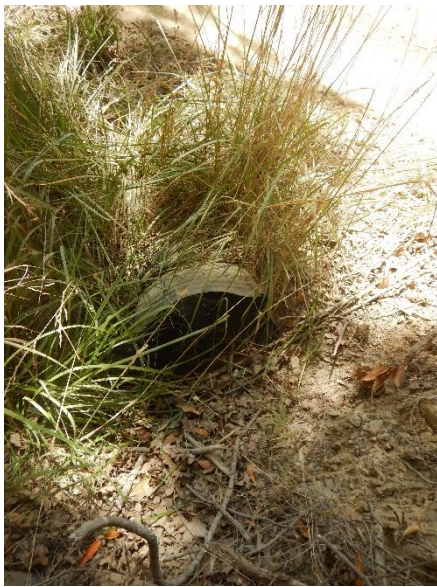
Heading northwest on the road, I observed a second culverted watercourse crossing, C2 (Photos 8-9). The culvert at C2 consists of an 18" corrugated plastic pipe (CPP) that appears undersized, misaligned, and inadequately armored.

Photo 8: C2 inlet

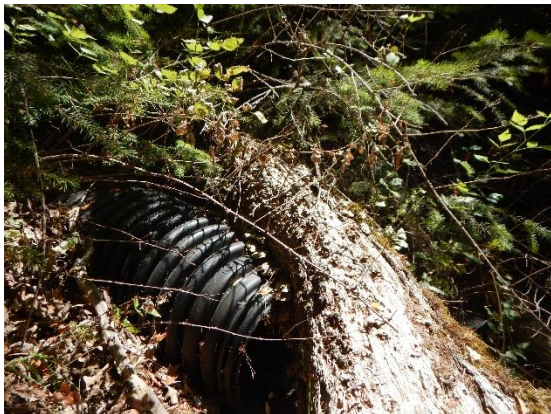
Photo 9: C2 outlet

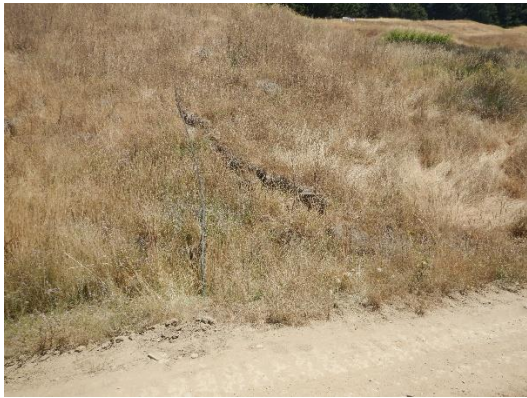
In between C1 and C2, along the main access road, I observed a ditch relief culvert, DRC1, not labeled on Figure 1. DRC1 consists of an 18" CPP with a partially buried inlet (Photos 10-11). DRC1 drains an approximately 100-foot segment of road, and adjacent slumping hillside, and discharges onto a more severely slumping hillside on the downstream side. While not directly onstream, vegetation below the outlet of DRC1 indicates the presence of a shallow groundwater table, and I observed a class III watercourse channel 150 feet below the outlet where drainage from DRC1 would discharge. This point presents a significant concern to water quality as concentrated discharge from DRC1 could lead to further instability on the slumping hillside, potentially causing mass wasting and large amounts of sediment delivery to the watercourse below.

1. Site maintenance, erosion control and drainage features: As noted above, I observed slumping hillslopes above and below a segment of road with a ditch relief culvert that discharges onto the slumping hillslope below.

Photo 10: Hillside above DRC1, plastic polypipe leads into and through the crossing.

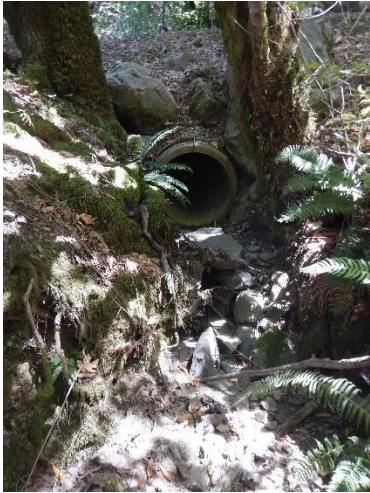
Downhill from C2, along the same channel and on a lower switchback segment of the main access road, I observed a third stream crossing, C3. C3 consists of an 36" concrete pipe that has signs scouring evident at its outlet and is misaligned (photos 12-13).

Photo 13: C3 Outlet

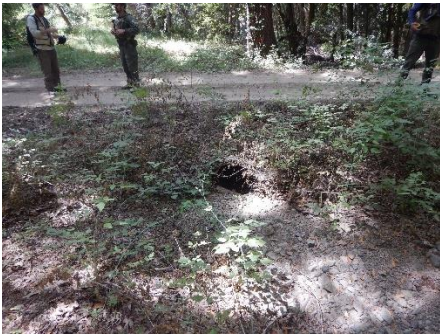
Farther south on the lower switchback of the main access road, I observed a fourth watercourse crossing, labeled C4 on Figure 1. C4 consists of a 24" concrete pipe that has signs of sediment aggradation at its inlet, demonstrating that it is likely undersized (photos 14-15).

Photo 14: C4 inlet

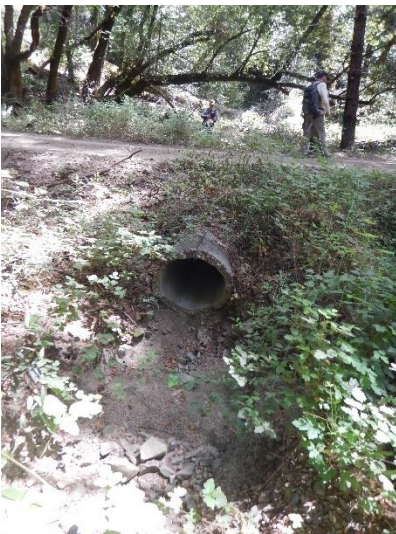
Photo 15: C4 outlet
