**Subject: Notice of Violation, Directive to Obtain Regulatory Coverage for Cannabis Cultivation, and Transmittal of Inspection Report for July 15, 2019, Inspection of Mendocino County Assessor's Parcel Nos. 032-225-05 and -20**

### **Inspection Report for July 15, 2019, Warrant Inspection Mendocino County Assessor's Parcel Number 032-225-05 and -20**

File: Cannabis Program Inspections, Mendocino County, July 2019 MCSO  
Inspections, Grapevine Consulting LLC, CIWQS Place ID. 859887 and 859888

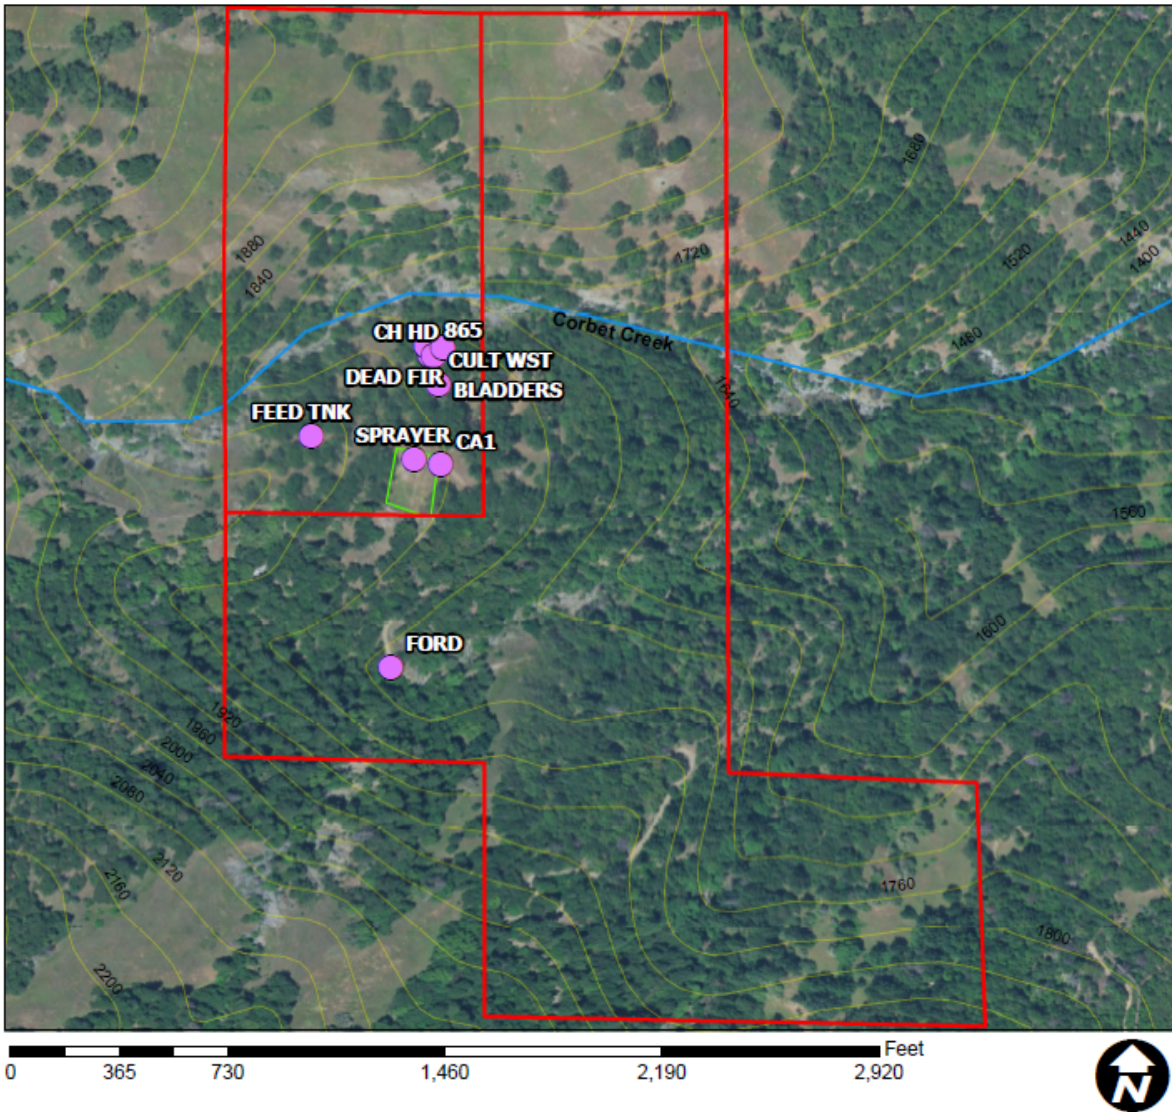
Figure 1 – Map of parcels, aerial imagery, and inspection map points.

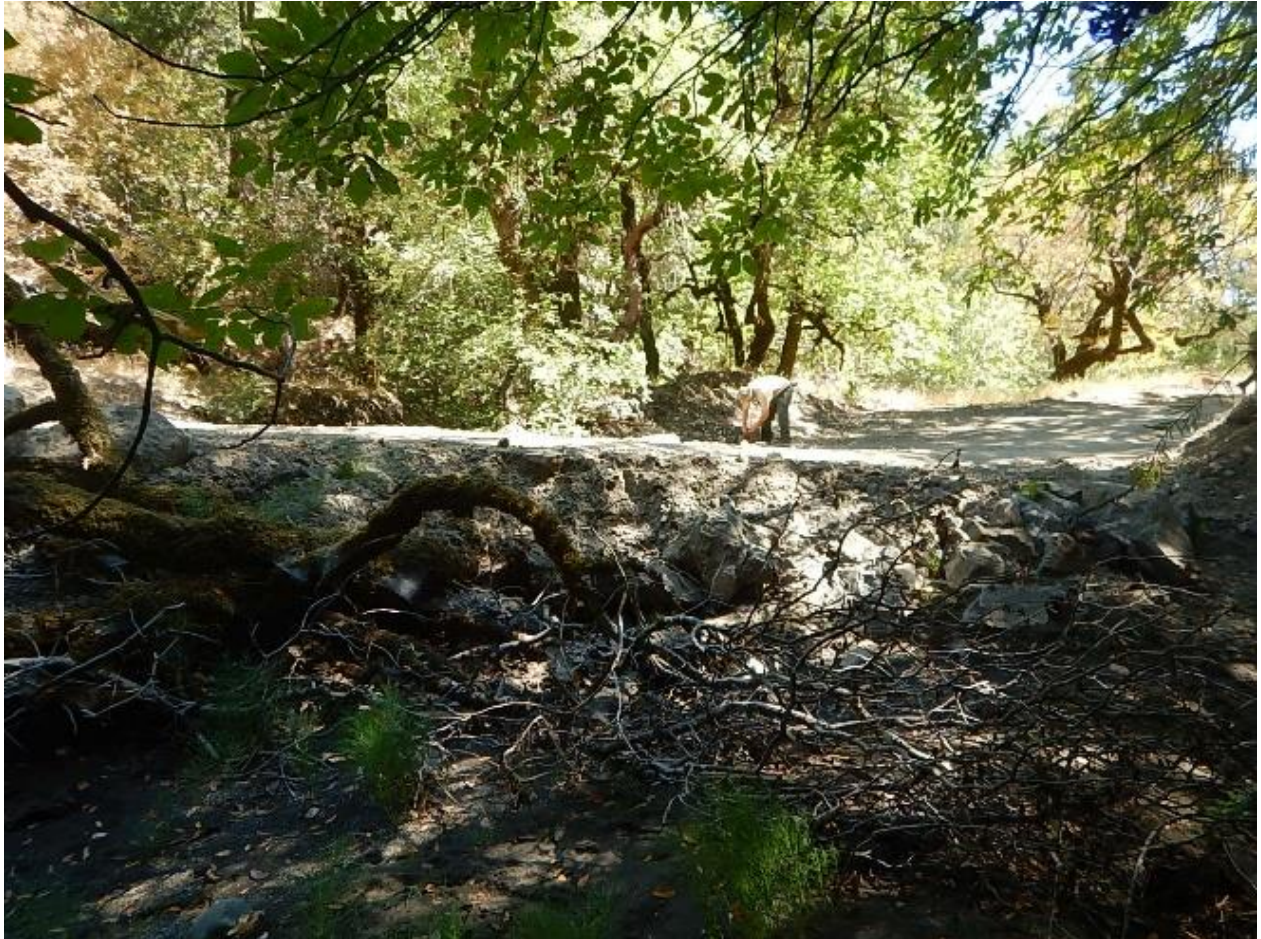
We accessed the Property from the south. Approaching CA1, the access road crosses a Class II watercourse (FORD). Fill material at this crossing was chunky and unweathered, apparently recently installed. Assuming a trapezoidal-shaped prism, I estimated fill dimensions of approximately 50' long, 20' wide at the base, 12' wide at the top, 4.75' average depth. Based upon these measurements, I estimate 140 yd<sup>3</sup> of earthen fill had been placed on/over the watercourse channel at this crossing.

Within the fill prism, I observed an undersized, misaligned, 24" corrugated plastic pipe (CPP) culvert with a crushed inlet and water lines through. I observed sediment deposition extending up the watercourse channel approximately 50' upstream of the crossing. I measured the bankfull channel width at 23' upstream and 12' downstream.

The crossing is not allowing free flow of water and sediment. Downstream of the crossing, I observed dry and coarse material; upstream, the channel is moist, with finer material. Approximately 75' upstream of the crossing, CDFW staff located and identified several adult foothill yellow-legged frogs in pools, upstream of the influence of the crossing. At the culvert inlet, I observed a 15" diameter at breast height tree that had been cut and left in channel; this could potentially block the undersized culvert. I observed large boulders that had apparently been placed to hold fill back from channel.

*Figure 2. Crossing FORD, looking downstream at crossing fill. The crossing consists of rip rap in the channel, an undersized culvert near the right bank (facing downstream, on the far right of the photo), and loose fill placed over the watercourse as the road surface. The left road approach is hydrologically connected and in its current condition, will deliver sediment to the watercourse. This crossing has a high probability of plugging, failure, and sediment discharge in winter flows.*

2. Retain a qualified professional to develop a workplan and schedule to remove the rock, earthen fill, and culvert associated with Class II watercourse crossing FORD and restore the channel to its natural state. Dispose of all development and restoration-related earthen spoils in a manner to prevent/minimize transport and delivery to receiving waters.

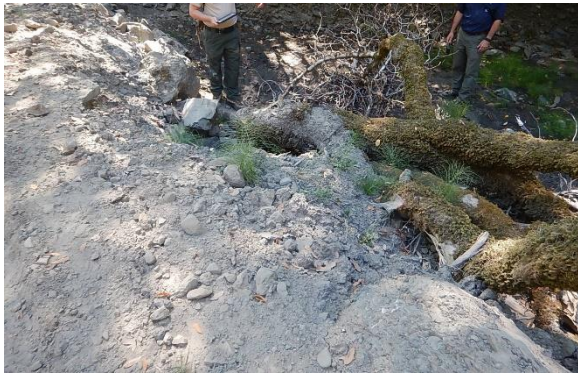
*Figure 3. Rock and loose fill in the crossing, looking from the road surface. Cut tree is felled into watercourse upstream of the culvert.*

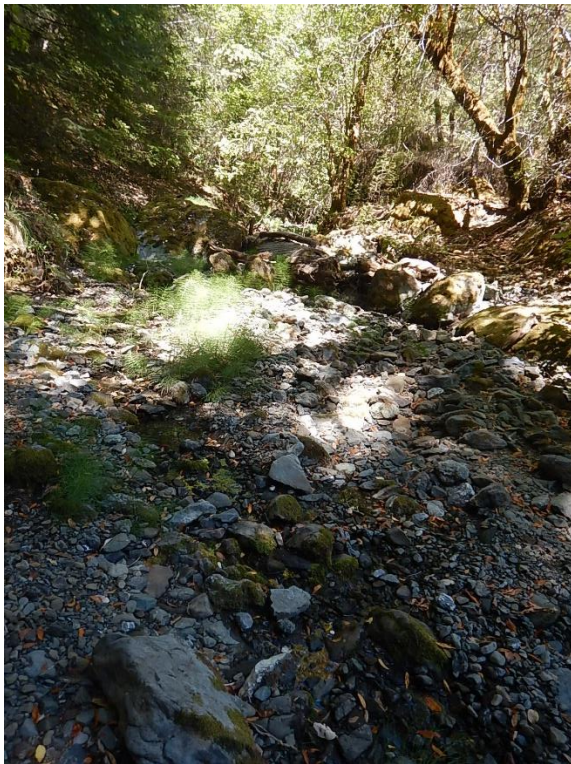
*Figure 4. Watercourse looking upstream of crossing.*

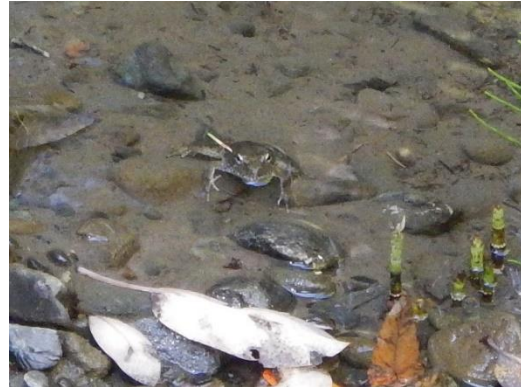
*Figure 5. Foothill yellow legged frog in watercourse, upstream of crossing, FORD.*

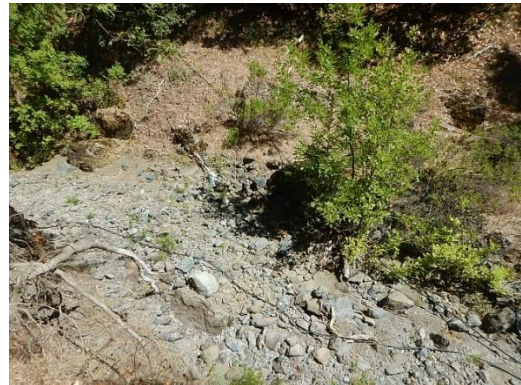
*Figure 6. Watercourse downstream of crossing, FORD.*

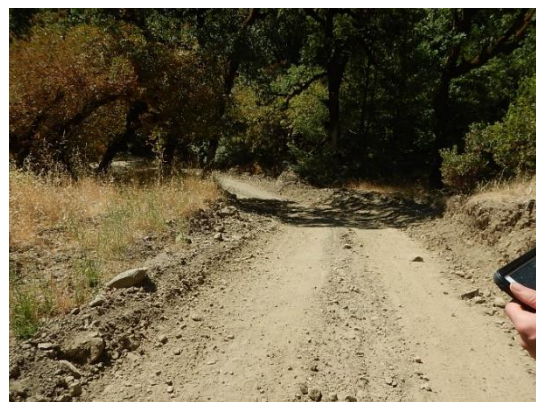
I observed that the road approaches to the crossing were hydrologically connected; road runoff will concentrate and discharge fine sediment into the watercourse at the crossing, with winter rains.

1. Site maintenance, erosion control and drainage features: As mentioned above, I observed hydrologically-connected road segments and threatened discharge of sediment to a Class II watercourse (Rd to FORD).

*Figure 7. Left bank road approach to crossing FORD is hydrologically connected to the watercourse; the road is steep, and the condition creates the threat of sediment delivery to the Class II watercourse.*

1. Retain a licensed professional to inventory, assess, and develop a workplan and schedule to implement measures to ensure that all developed features, roads, watercourse crossings, and cultivation areas throughout the Property are corrected, restored, and/or maintained in conditions that prevent or minimize erosion, sediment transport/delivery, and adverse impacts to water quality and beneficial uses. Include measures to ensure that unstable features caused or affected by onsite development and operations are removed or otherwise protected so as to minimize the potential for these features to cause adverse impacts to water quality and beneficial uses. Dispose of all development and restoration-related earthen spoils in a manner to prevent/minimize transport and delivery to receiving waters.

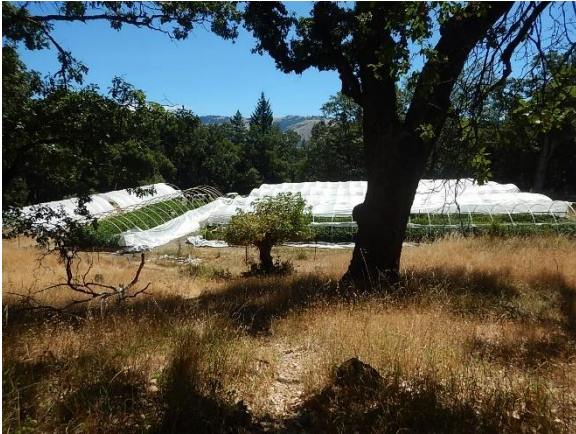
The cultivation area (CA1) was cleared and graded, and I observed approximately 16,000 square feet of cannabis cultivation in greenhouses. In the cultivation area, I observed a sprayer with clear tubing line, in which I could see pinkish-brown liquid.

*Figure 8. The cultivation area, CA1 is constructed on a graded flat in a grassy area of an oak woodland.*

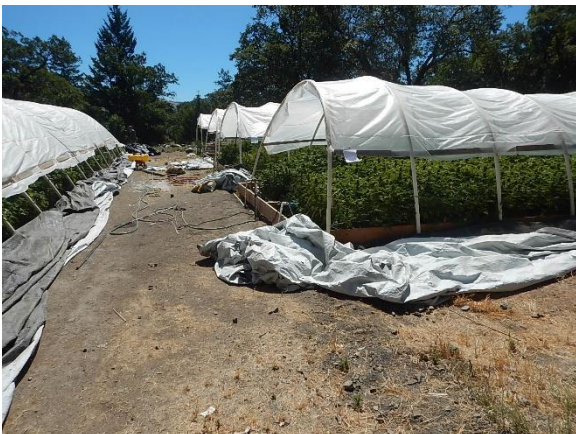
*Figure 9. Greenhouses constructed of plastic were used with light deprivation tarps.*

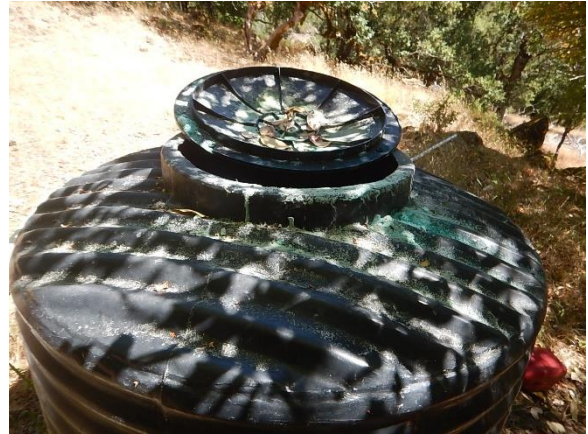
West of CA1, I observed fertilizers open to environment and two varieties of blue crystal GrowMore fertilizer (0-50-30 and 20-20-20) located at the feed tank.

7. Fertilizers and soil amendments: As noted above, I observed fertilizers and soil amendments, uncovered and/or uncontained, with residual on the feed tank. As noted above, there was one location where there was potential for delivery to the head of a Class III watercourse (CH HD).

*Figure 10. Residual fertilizer crystals on feed tank.*

7. Collect and dispose of or contain all refuse and cultivation-related wastes in a location and manner so as to minimize potential for these wastes to enter or be transported into receiving waters.
8. Store and contain all chemicals, including petroleum, fertilizer and/or pesticides properly to prevent spillage and discharge to receiving waters. Provide secondary containment for all petroleum products.

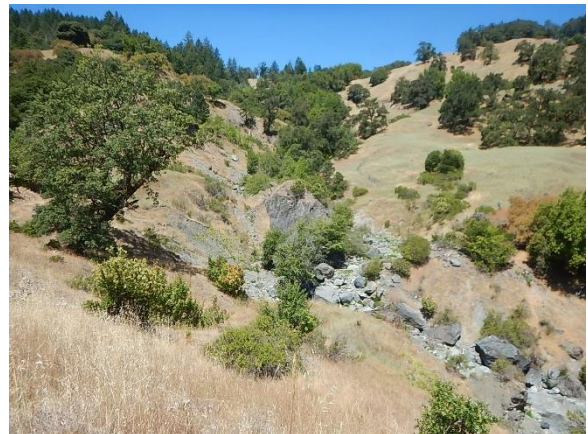
DIV and CDFW staff reported that they located a diversion pipe but no pump in the northern Class II watercourse.

*Figure 11. Class II watercourse where agency partners identified a point of surface water diversion.*

3. Work with CDFW and the State Water Resources Control Board's Division of Water Rights (DIV) to determine and secure any applicable permits or licensing required for surface water diversion, storage, and use on the site. If the existing surface water diversions do not meet applicable CDFW or DIV requirements, remove diversion infrastructure from surface waters and ensure that restoration plans developed pursuant to Recommendation 1, above, include provisions for restoring any instream or riparian disturbance associated with these features or removal thereof.
4. Prior to conducting any instream work associated with recommendation 2, above, submit to the Regional Water Board an application for Clean Water Act section 401 water quality certification, and secure approval from the Regional Water Board. The 401 Application may be found at the following hyperlink:

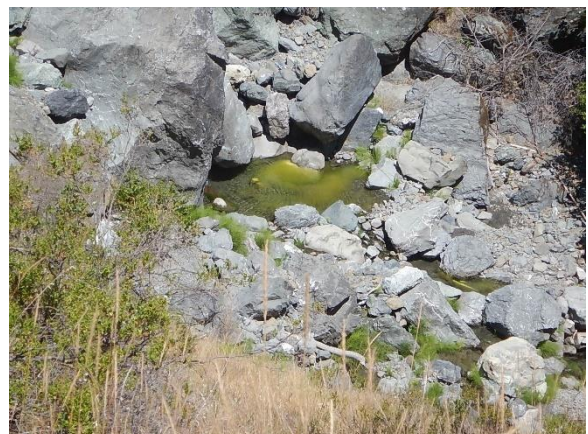
*Figure 12. Isolated pool with algae in Class II,*

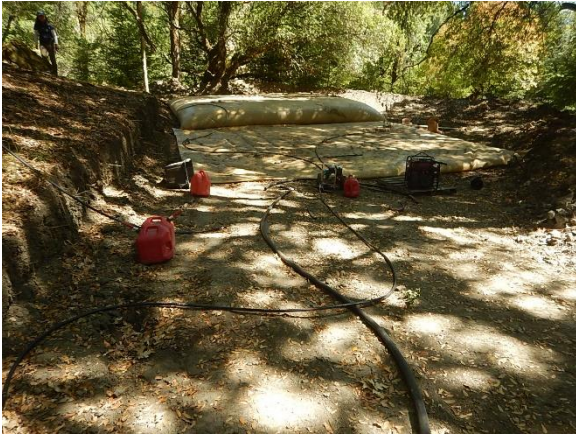
North of CA1, I observed two water bladders in a recently graded area (BLADDERS). The graded pad was approximately 4,000 square feet in size, and I observed earthen spoils piled at the far end of the pad, forming a berm. The fill was piled on what appears to be a stable, small topographic bench, with the exception of the northeast corner, which leads to a swale and Class III watercourse (CH HD). Pollutants that enter the swale could be transported to the Class III channel and down to a larger nearby Class II watercourse. There were bags of urea (46-0-0) located at top of swale.

*Figure 13. Cut made for the pad constructed for bladders.*

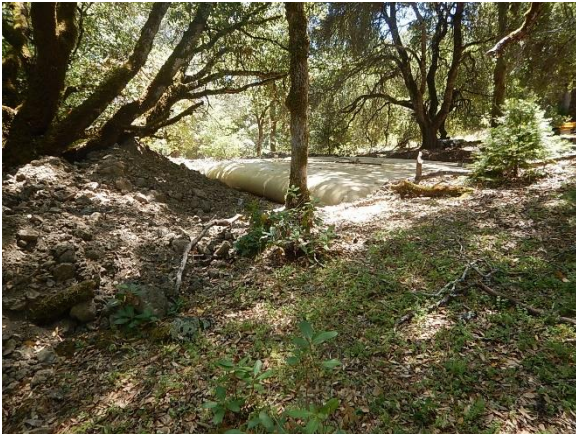
3. Stream and wetland buffers: I observed no water quality concerns relating to riparian and wetland protection and management on the subject parcel.
4. Spoils management: Apart from the earthen spoils adjacent to the bladder pad, at a location where a portion may enter or be transported down the swale toward the Class II watercourse, I observed no water quality concerns relating to spoils management on the subject parcel.

*Figure 14. Pushed fill associated with the construction of the bladder pad.*

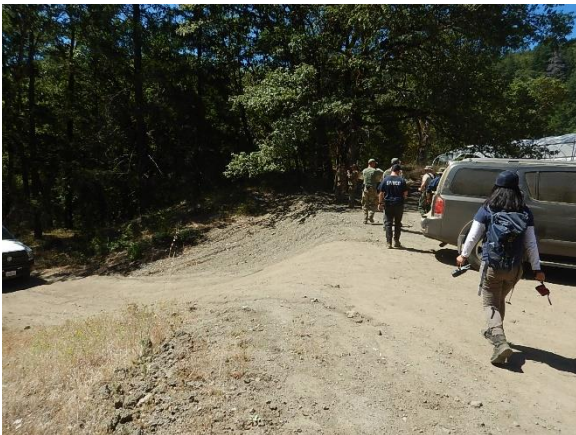
*Figure 15. The access road is steep up to the cultivation area, CA1.*
