Subject: Notice of Violation, Directive to Obtain Regulatory Coverage for Cannabis Cultivation, and Transmittal of Inspection Report for July 15, 2019, Inspection of Mendocino County Assessor's Parcel No. 032-230-32

Inspection Report for July 15, 2019 Warrant Inspection Mendocino County Assessor's Parcel Number 032-230-32

File: Cannabis Program Inspections, Mendocino County, July 2019 MCSO
Inspections, David Phillips and Triple K Family Trust, CIWQS Place ID. 859868

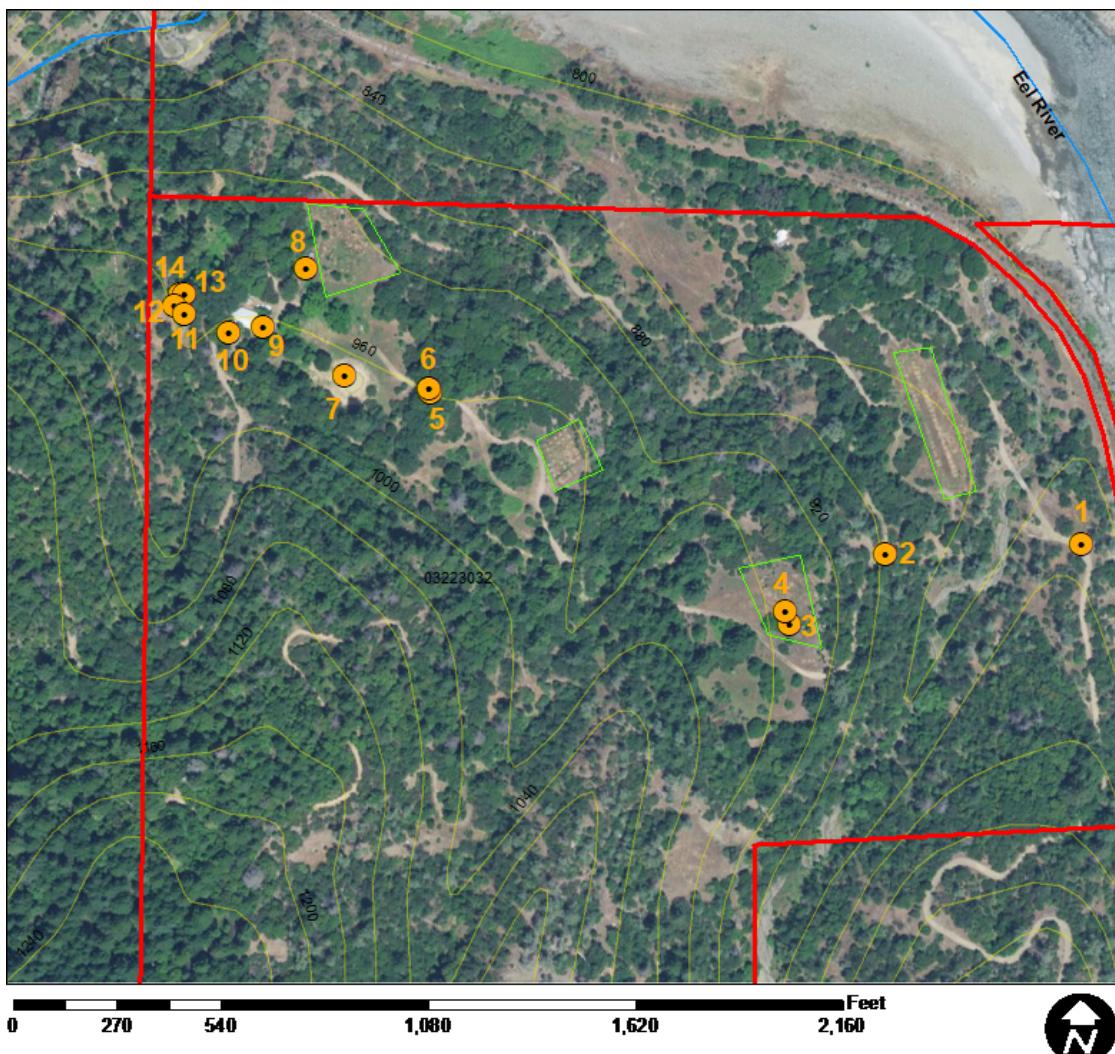
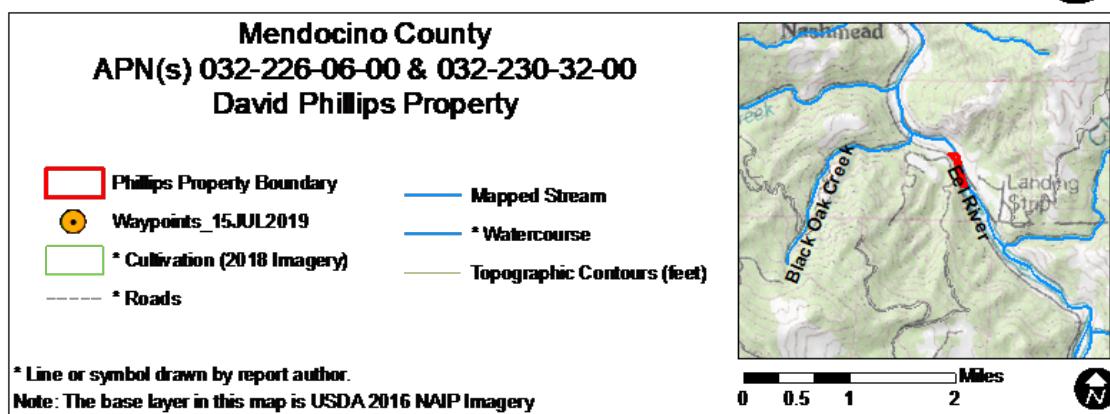
Inspection Map

On July 15, 2019, I inspected the subject property. The inspection map, above, shows the inspection points identified and discussed below.

Development on the property includes several clearings and a road network. I observed four clearings with cannabis cultivation (outlined on the inspection map and identified for purposes of this report as cultivation areas #1 through #4, from east to west across the parcel). Disturbance associated with each cannabis cultivation area was more than 2,000 square feet.

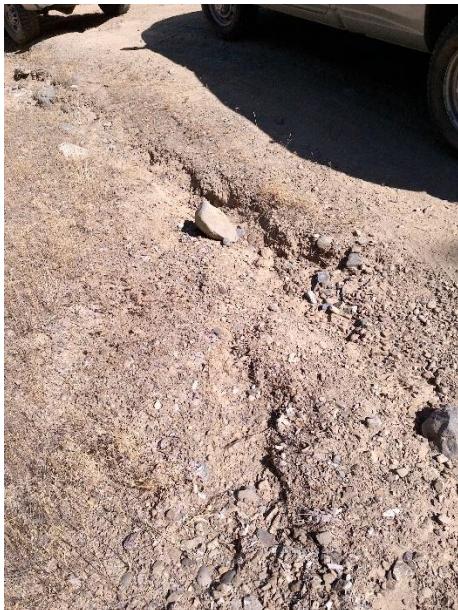
At inspection points 1 and 2, along the access road, I observed rilling. I observed no water quality concerns at cultivation area #1. At cultivation area #2, I observed an uncovered/uncontained pile of used potting soil (photo 11); delivery potential from this location appeared to be low. I observed no water quality concerns at cultivation area #3. At inspection points 5 and 6 along the access road between cultivation areas #3 and #4, I observed a dry ford crossing on a Class III watercourse with evidence of sediment discharge from the road into the watercourse (photo 3). At inspection point 7, south of cultivation area #4, I observed an off-stream water catchment pond and a large water storage tank (photos 4 and 5). A nearby surface water diversion (photo 14) appeared to be the main water source for the Property, feeding water to a rubber spillway that drained into the pond.

1. Site maintenance, erosion control and drainage features: As noted above, I observe two locations along the access road where erosion from the road surface and/or watercourse crossing fill prisms was resulting in sediment discharges to receiving waters.

Photo 1 – Rill erosion on access road to property.

1. Retain a licensed professional to inventory, assess, and develop a workplan and schedule to implement measures to ensure that all developed features, roads, watercourse crossings, and cultivation areas throughout the Property are corrected, restored, and/or maintained in conditions that prevent or minimize erosion, sediment transport/delivery, and adverse impacts to water quality and beneficial uses. Include measures to ensure that unstable features caused or affected by onsite development and operations are removed or otherwise protected so as to minimize the potential for these features to cause adverse

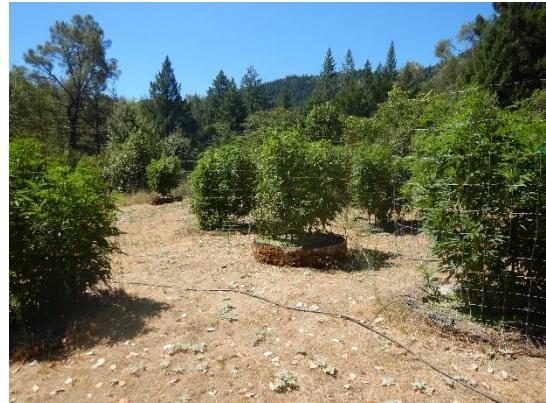
Photo 2 – View of active cannabis cultivation area #2.

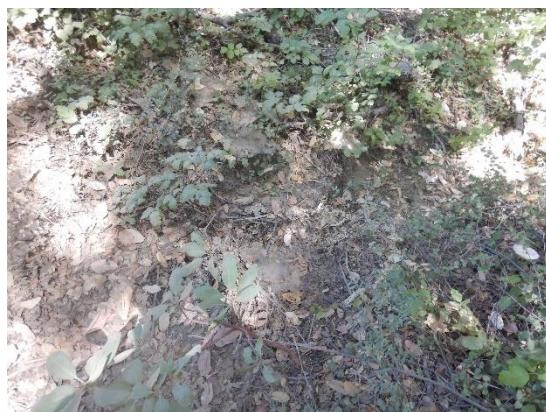
2. Stream crossing maintenance and improvement: As noted above, I observed two stream crossing areas which produced sediment discharge into two watercourses on the parcel.

Photo 3 – View of sediment discharged into watercourse.

2. Retain a qualified professional to develop a workplan and schedule to remove the sediment and road fill associated with Map Points: 5, 6, 11 - 14 and restore affected watercourse channels to their natural state. Dispose of all development and restoration-related earthen spoils in a manner to prevent/minimize transport and delivery to receiving waters.

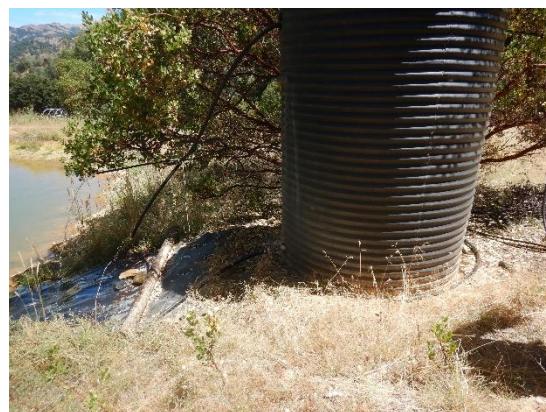
5. Water storage and use: As mentioned above, I observed a point of diversion that appeared to be the main water source for this parcel. This diversion also fed a water catchment pond, discharging onto a rubber spillway into the pond. In addition, I observed a large water storage tank at the catchment pond.

Photo 4 – Water storage tank and view of water catchment pond.

3. Work with CDFW and the State Water Resources Control Board's Division of Water Rights (DIV) to determine and secure any applicable permits or licensing required for surface water diversion, storage, and use on the site. If the existing surface water diversion does not meet applicable CDFW or DIV requirements, remove diversion infrastructure from surface waters and ensure that restoration plans developed pursuant to Recommendation #1, above, include provisions for restoring any instream or riparian disturbance associated with these features or removal thereof.

9. In the case that the landowner intends to keep or replace the impoundment observed at location P1, ensure that the assessment described under recommendation 1., above, includes review by an appropriately qualified, licensed professional, certifying that the impoundment meets, or specifying necessary work to ensure that the impoundment will meet the following standards:

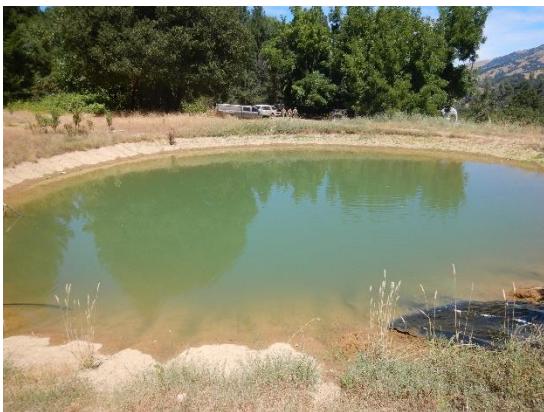
7	Catchment pond	Off stream catchment pond with water sourced from an unpermitted POD.	N/A	5

Photo 5 – Water catchment pond.

- a. Interior and exterior embankment slopes are no steeper than a 2:1 ratio
 - b. 90% compaction of earthen slopes
 - c. The pond must have a liner. If a geosynthetic membrane liner is deemed unacceptable for biological resources, then a proper dry bentonite application may be proposed, including specifications and oversight on bentonite amount, application, mix with soil, hydration, and compaction.

- d. The impoundment must have no discernible cracks in any portion of the berm.
 - e. The impoundment must be designed, constructed, and maintained to ensure a 2-foot elevational freeboard above the outlet structure.

- f. The outlet structure must have a minimum capacity adequate to accommodate the expected 100-year peak inflow plus debris.
 - g. A stability analysis must demonstrate that the factor of safety for the critical slope is at least 1.5 under dynamic conditions and include a description of the method used to calculate the factor of safety and a description of the assumptions used in the stability analysis.

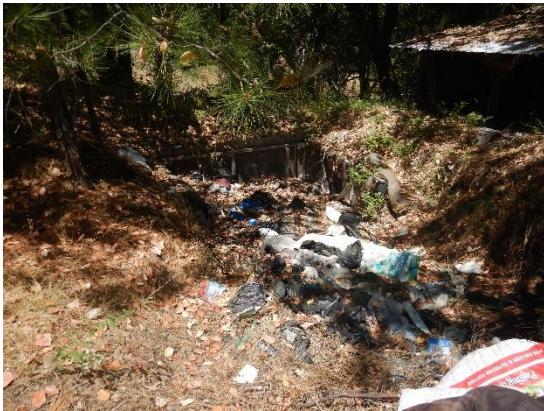
10. Cultivation-related wastes: I observed cultivation waste throughout the parcel, including netting, irrigation line, and fertilizer bottles.

11. Refuse and human waste: As noted above, I observed a trash pit behind the farm shed. I did not identify water quality issues associated with storage or disposal of human waste.

Photo 7 – View of garbage pit with fertilizer
bottles, and other cultivation waste.

7. Collect and dispose of or contain all refuse and cultivation-related wastes in a location and manner so as to minimize potential for these wastes to enter or be transported into receiving waters.

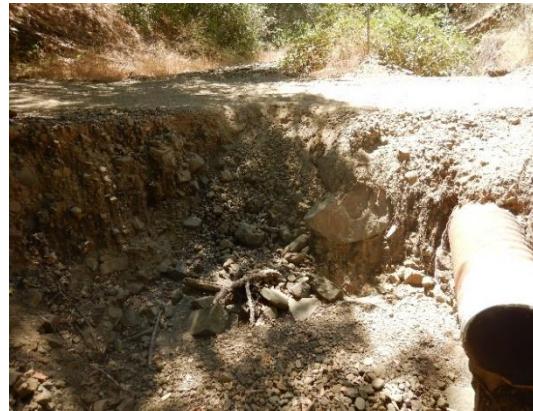
On the access road northwest of the pond, I observed two culverted watercourse crossings (inspection points 12 and 14) that appeared to be undersized, incorrectly installed and/or maintained, and causing or resulting in sediment discharges to receiving waters. At these crossings, I also observed evidence of significant sediment discharges from the road and from the fill prisms surrounding the culverts (photos 8 and 9).

Photo 8 – Watercourse crossing
and discharging sediment into the
watercourse.

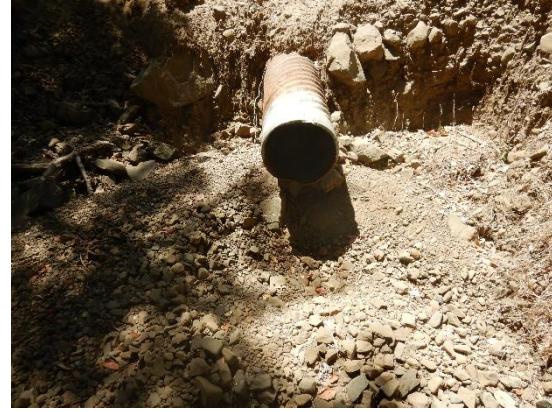
Photo 9 – Undersized shotgun culvert
with road fill discharged into the
watercourse.

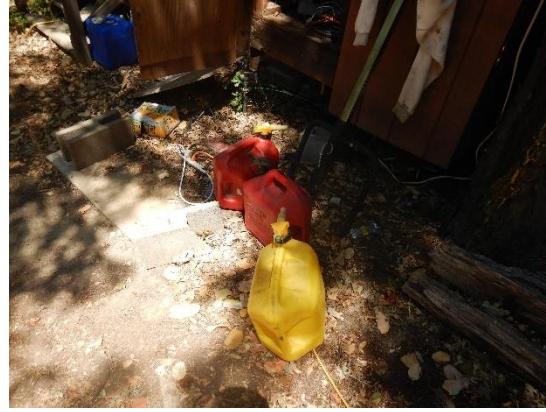
9. Petroleum products and other chemicals: I observed gasoline and motor oil canisters throughout the parcel, many sitting on the bare ground.

Photo 10 – Petroleum products stored
on the bare ground.

8. Store and contain all chemicals, including petroleum, fertilizer and/or pesticides properly to prevent spillage and discharge to receiving waters. Provide secondary containment for all petroleum products.

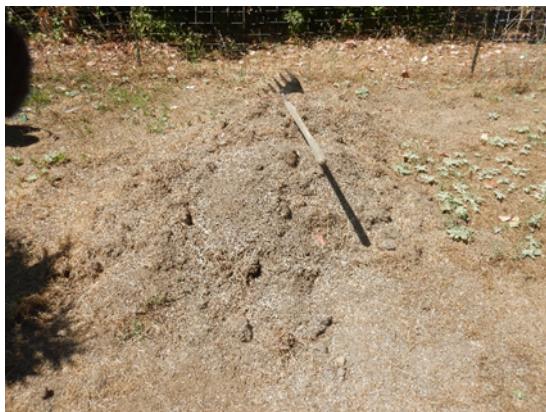
4. Spoils management: As mentioned above, I observed several soil piles throughout the parcel which were not covered/contained.

Photo 11 – Soil and growth media spoils piles.

impacts to water quality and beneficial uses. Dispose of all development and restoration-related earthen spoils in a manner to prevent/minimize transport and delivery to receiving waters.

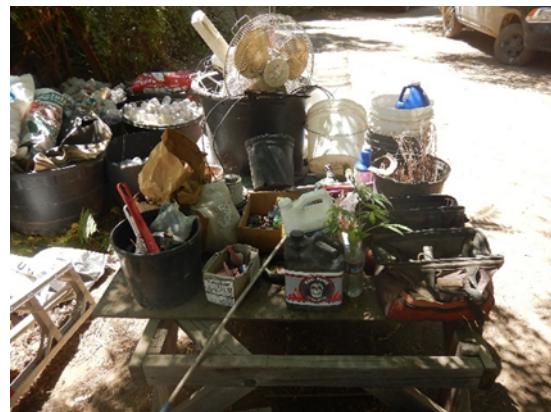
7. Fertilizers and soil amendments: I did not observe a designated fertilizers and soil amendments storage area. I observed fertilizers, soil amendments, and empty fertilizer bottles on the ground.

8. Pesticides: I observed pesticides on the ground, without cover/containment, but I observed no direct water quality concerns associated with these materials.

Photo 12 – Petroleum products, chemicals, and trash at the cultivation site.

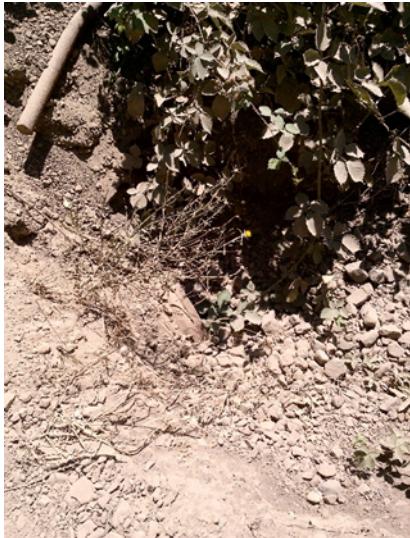
14	Watercourse Crossing	Buried inlet of an undersized, unpermitted, and misaligned 12-inch culvert	Discharges of waste into waters of the State	13

Photo 13 – Buried culvert inlet.

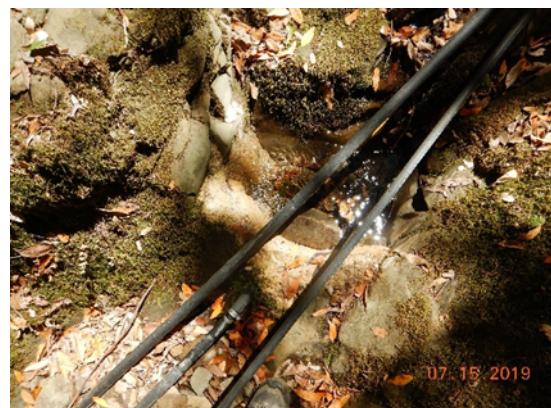
Photo 14 – Point of diversion from a watercourse providing water for cultivation on the parcel.
