Subject: Notice of Violation, Directive to Obtain Regulatory Coverage for Cannabis Cultivation, and Transmittal of Inspection Report for August 6, 2019, Inspection of Humboldt County Assessor's Parcel No. 208-221-009

Inspection Report for August 6, 2019, Warrant Inspection Humboldt County Assessor's Parcel Number 208-221-009-000

File: Cannabis Program Inspections, Humboldt County, August 2019 HCSO
Inspections, Courtney Fleming, CIWQS Place ID. 825152

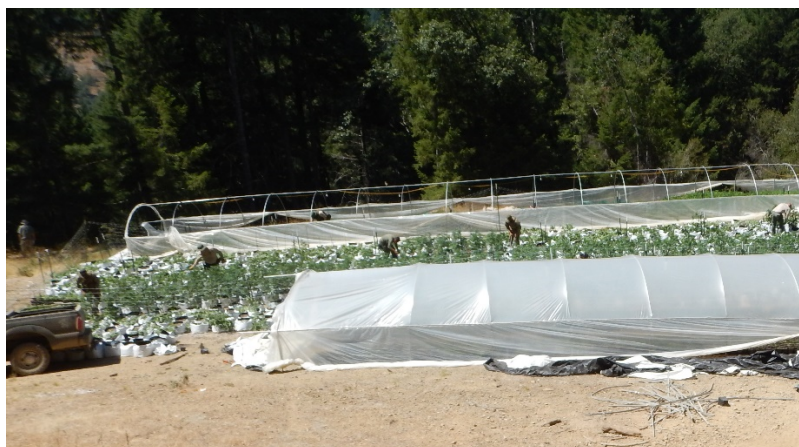
GH1-3 (photo 1), the first cultivation area we inspected, is located about 500 feet north from the southern property line, accessed via the southeastern access road. This area has a flat topography covering an approximate area of 10,700 square feet, with three hoop houses. In this area, I observed uncontained trash, plastic containers, soil amendment spoils, plastic fencing nets, and other irrigation-related products and wastes (photos 2,3).

Photo 1: Greenhouse at inspection point GH1-3

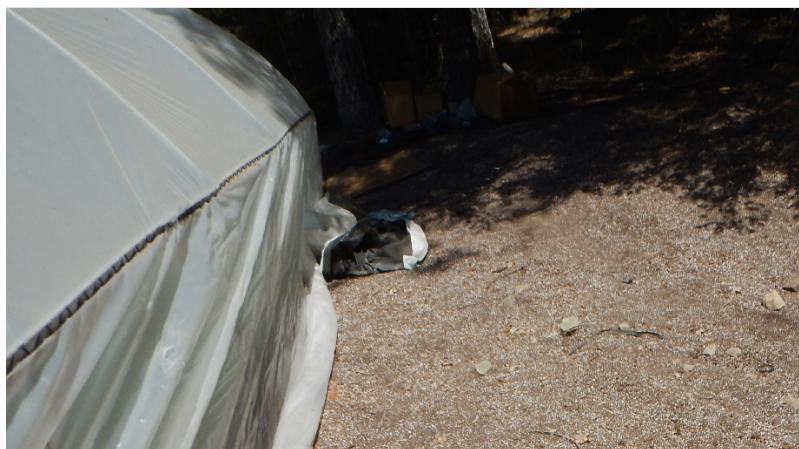
7. Fertilizers and soil amendments: As mentioned above, I observed uncovered and/or uncontained soil amendment spoils and plastic containers near cultivation areas OG1, OG2, and GH1-3.

Photo 2: Soil amendment spoils at inspection point GH1-3

1. Retain a licensed professional to inventory, assess, and develop a workplan and schedule to implement measures to ensure that all developed features, roads, watercourse crossings, and cultivation areas throughout the Property are corrected, restored, and/or maintained in conditions that prevent or minimize erosion, sediment transport/delivery, and adverse impacts to water quality and beneficial uses. Include measures to ensure that unstable features caused or affected by onsite development and operations are removed or otherwise protected to minimize the potential for these features to cause adverse impacts to water quality and beneficial uses. Dispose of all development and restoration-related earthen spoils in a manner to prevent/minimize transport and delivery to receiving waters.

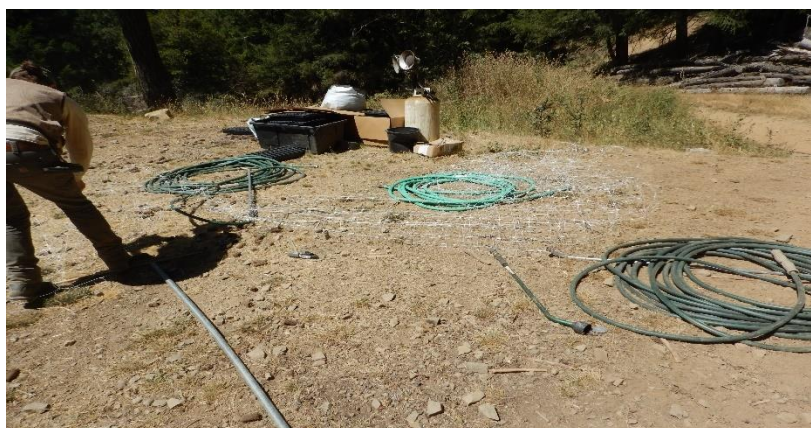
10. Cultivation-related wastes: I observed cultivation-related wastes, uncovered and/or uncontained, on OG1, OG2, and GH1-3.
11. Refuse and human waste: I observed cultivation-related refuse and human waste, uncovered and/or uncontained, on OG1, OG2, and GH1-3.

Photo 3: Irrigation plastic pipes and uncontained plastic container and fence netting at inspection point GH1-3

5. Discontinue use of and dismantle any outhouse/pit toilet features and work with Mendocino County to ensure that all domestic and human wastes are collected and disposed of consistent with applicable County requirements.
6. Collect and dispose of or contain all refuse and cultivation-related wastes in a location and manner so as to minimize potential for these wastes to enter or be

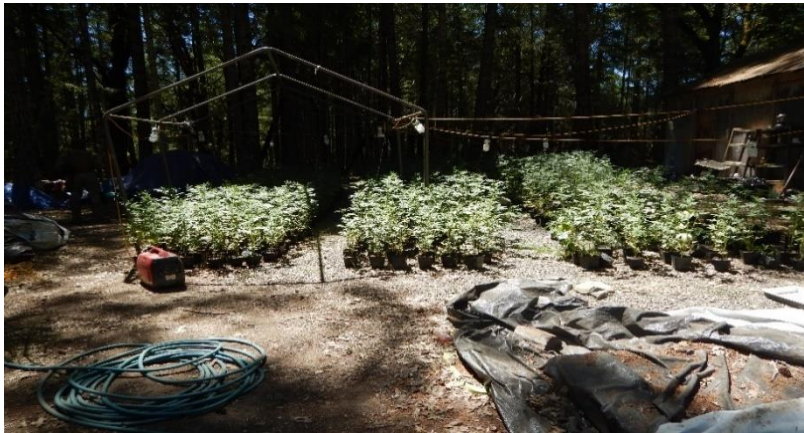
OG1 (photo 4) is located approximately 200 feet southwest of GH1-3(photo 4) with an area of approximately 350 square feet. Approximately 100 feet north of OG1 I observed GH4-5 (Photo 6), two greenhouses with an area of approximately 525 square feet. OG1 appeared to be mostly used for a nursery. I also observed plastic irrigation pipes, a battery, toilets, plastic containers, a generator, and human waste in the vicinity of the cultivation area (photos 5,7,13).

Photo 4: Open grows at inspection point OG1

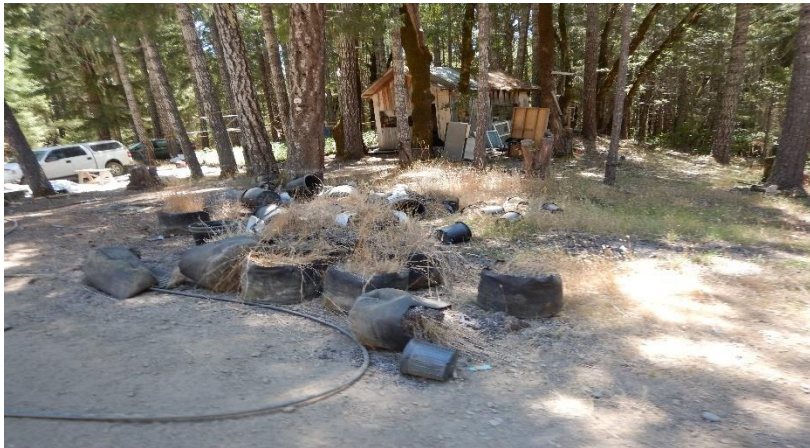
Photo 5: uncontained waste at inspection point OG1

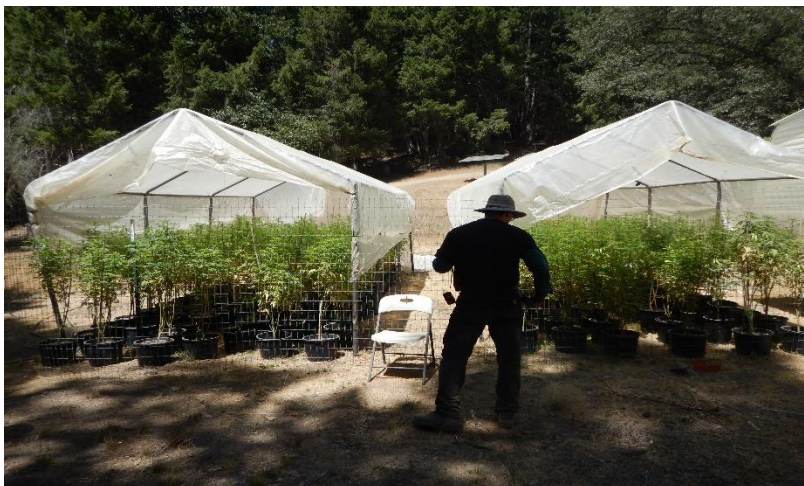
Photo 6: Greenhouses at inspection point GH4-5

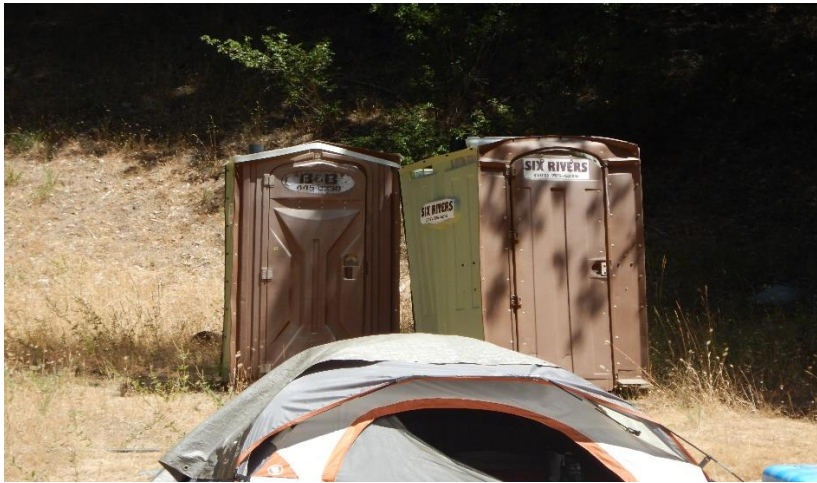
Photo 7: Outhouse toilet at inspection point OG1

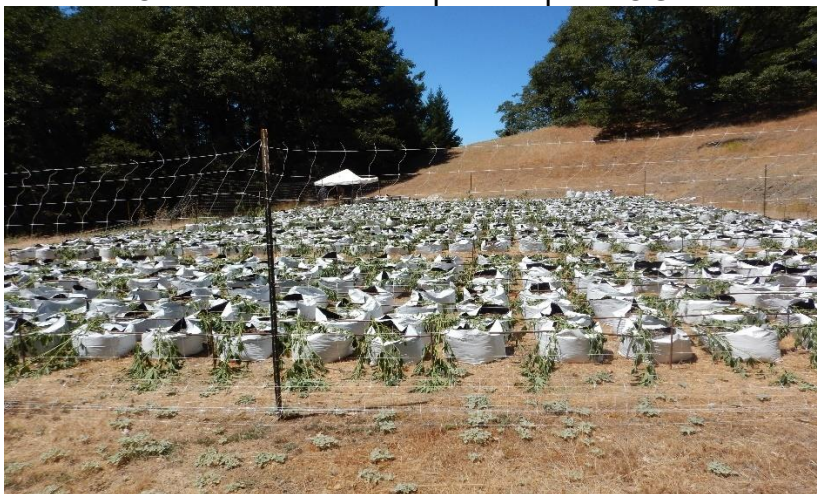
I observed another outdoor cultivation area OG2 (photo 8) on the northwestern part of the property, with an area of approximately 4,200 square feet. In the vicinity of this cultivation area I observed plastic net fencing, soil amendment spoils, and irrigation-related features, including storage tanks and plastic pipes (photo 17).

OG2	Cannabis cultivation area	Outdoor cultivation area with active cannabis cultivation	Cannabis cultivation without report of waste discharge and/or enrollment in Water Boards cannabis program	Photo 8

Photo 8: Open grow at inspection point OG2

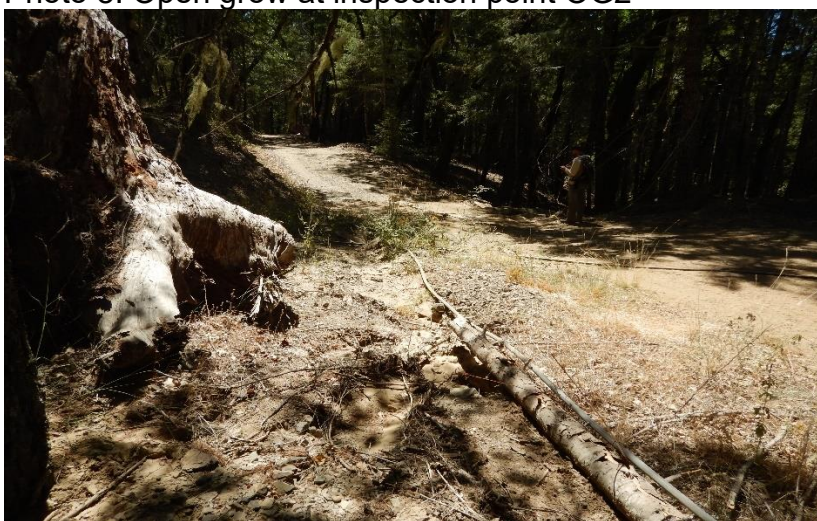
In addition to the cannabis cultivation areas, I observed stream crossings C1, C2, C3, C4, C5. Crossing C1 (photo 9) is about 500 feet from the southeastern access road to the property. The road is built through a Class III watercourse at this location, with no constructed feature to provide stable conveyance for stream flows. I observed evidence of sediment delivery into the watercourse at this crossing. C2 (Photo 10) is a Class III stream crossing on the western access road, approximately 200 feet to the west of GH1-3, with no visible water conveyance structure. I observed evidence of sediment discharge into the watercourse. C3 is approximately 100 ft southwest of C2 (photo 11), another stream crossing without any stream conveyance structure, delivering sediment to the class III watercourse. On the eastern part of the property access road, I observed two Class III crossings, C4 (Photo 15) and C5 (photo 16), within 100 feet of each other. I observed evidence of sediment delivery at both crossings, and there was no indication of a stable stream conveyance feature at either crossing.

<i>Map point</i>	<i>Feature</i>	<i>Brief Description</i>	<i>Water Quality Concern</i>	<i>Associated Photo(s)</i>
C1	Stream crossing	Road built through Class III water course; evidence of sediment delivery.	<p>Construction- related earthen material placed in or where it can enter surface water.</p> <p>Dredge/fill in waters of the State.</p> <p>Discharge and threatened discharge of waste to receiving waters.</p>	Photo 9
C2	Stream crossing	Road built through Class III water course; evidence of sediment delivery.	<p>Construction-related earthen material placed in or where it can enter surface water.</p> <p>Dredge/fill in waters of the State.</p> <p>Discharge and threatened discharge of waste to receiving waters.</p>	Photo 10
C3	Stream crossing	Road built through Class III water course; evidence of sediment delivery.	<p>Construction-related earthen material placed in or where it can enter surface water.</p> <p>Dredge/fill in waters of the State.</p> <p>Discharge and threatened discharge of waste to receiving waters.</p>	Photo 11

Photo 9: Stream crossing at inspection point C1

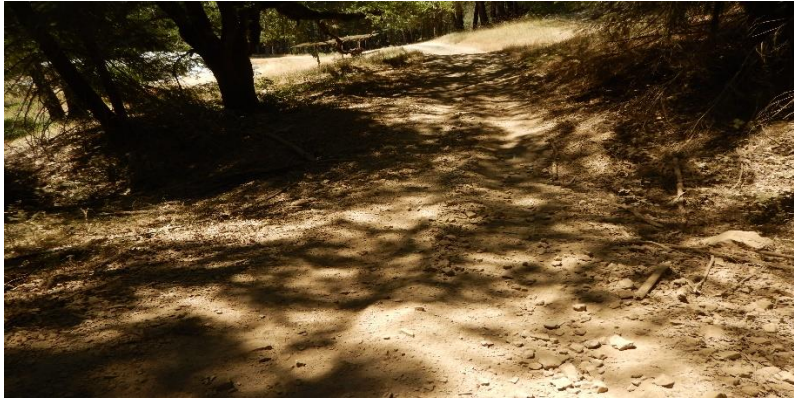
1. Site maintenance, erosion control and drainage features: I observed a poorly designed access road with a potential of delivering sediment to the waters of the state.
2. Stream crossing maintenance and improvement: I observed 5 stream crossings (C1, C2, C3, C4, C5) on the access road to the property; as discussed above, all were constructed without any structure or design to protect water quality. All five crossings are causing or resulting in active discharge of sediment to class III watercourses.

Photo 10: Stream crossing at inspection point C2

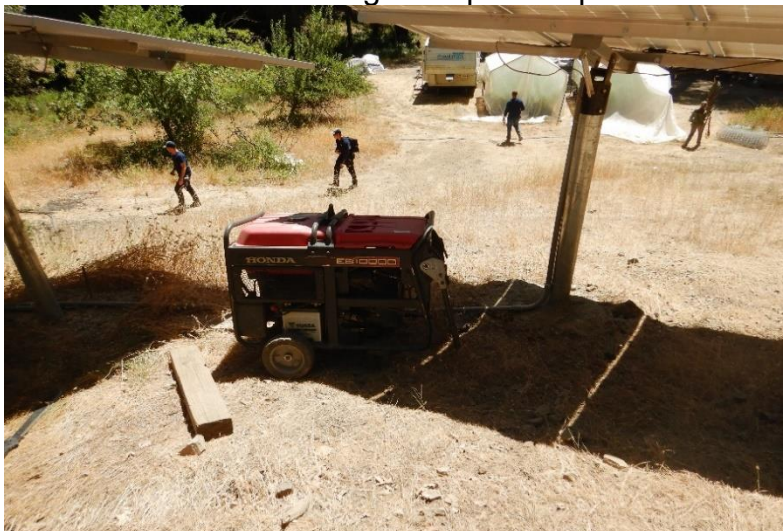
Photo 12: Uncovered or uncontained generator at inspection point GH4-5

7. Store and contain all chemicals, including petroleum, fertilizer and/or pesticides properly to prevent spillage and discharge to receiving waters. Provide secondary containment for all petroleum products.

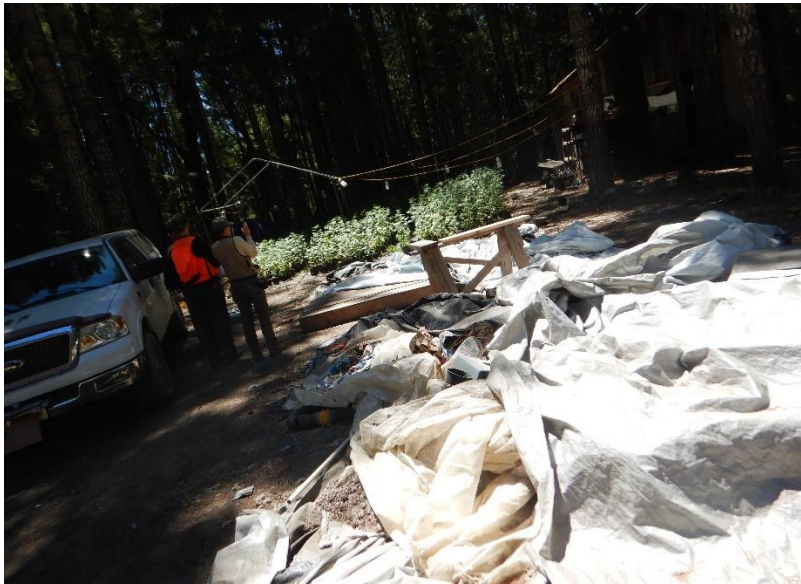
Photo 13: uncontained human waste at inspection point OG1

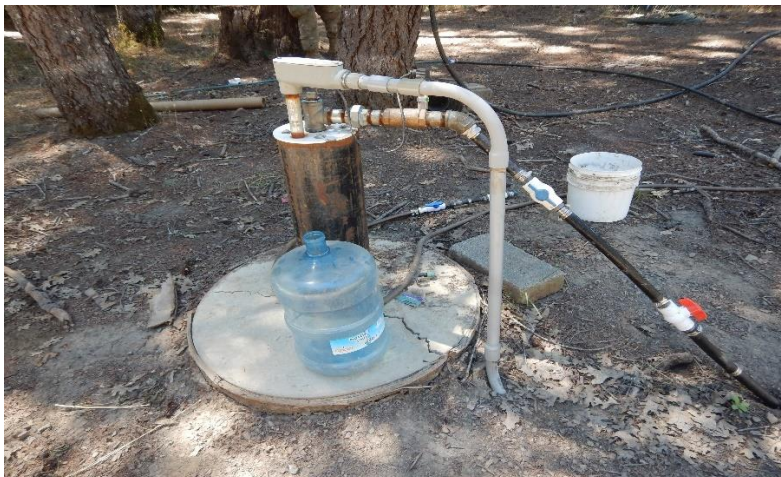
<i>Map point</i>	<i>Feature</i>	<i>Brief Description</i>	<i>Water Quality Concern</i>	<i>Associated Photo(s)</i>
C4	Stream crossing	Road built through Class III water course; evidence of sediment delivery.	Construction-related earthen material placed in or where it can enter surface water. Dredge/fill in waters of the State. Discharge and threatened discharge of waste to receiving waters.	Photo 15
C5	Stream crossing	Road built through Class III water course; evidence of sediment delivery.	Construction-related earthen material placed in or where it can enter surface water. Dredge/fill in waters of the State. Discharge and threatened discharge of waste to receiving waters.	Photo 16
W1	Well	Ungauged ground water well	NA	Photo 14

Photo 14: Groundwater well at inspection point W1

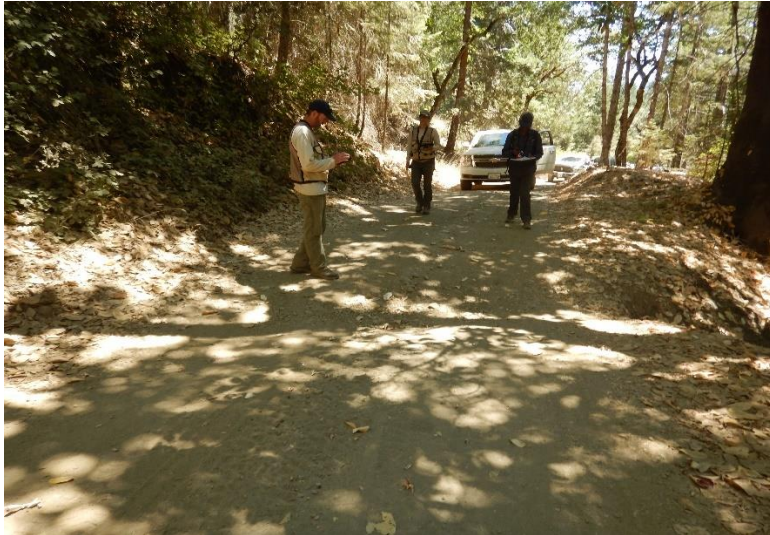
Photo 16: stream crossing at inspection point C5

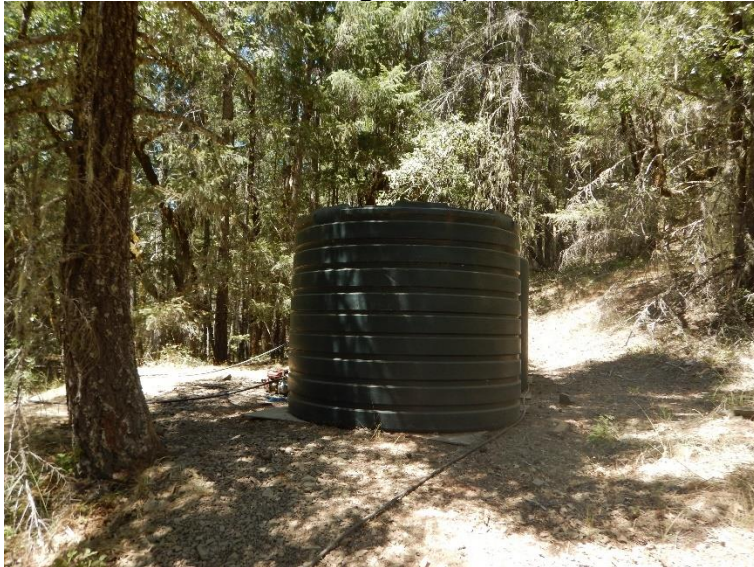
Photo 17: water storage tank near to inspection point C4
