North Coast Regional Water Quality Control Board

Subject: Notice of Violation, Directive to Obtain Regulatory Coverage for Cannabis Cultivation, and Transmittal of Inspection Report for July 16, 2019, Inspection of Mendocino County Assessor's Parcel No. 033-040-34

Inspection Report for July 16, 2019, Warrant Inspection Mendocino County Assessor's Parcel Number 033-040-34

**Mendocino County
 APN 033-040-34-00
 Patricia Byarlay Property**

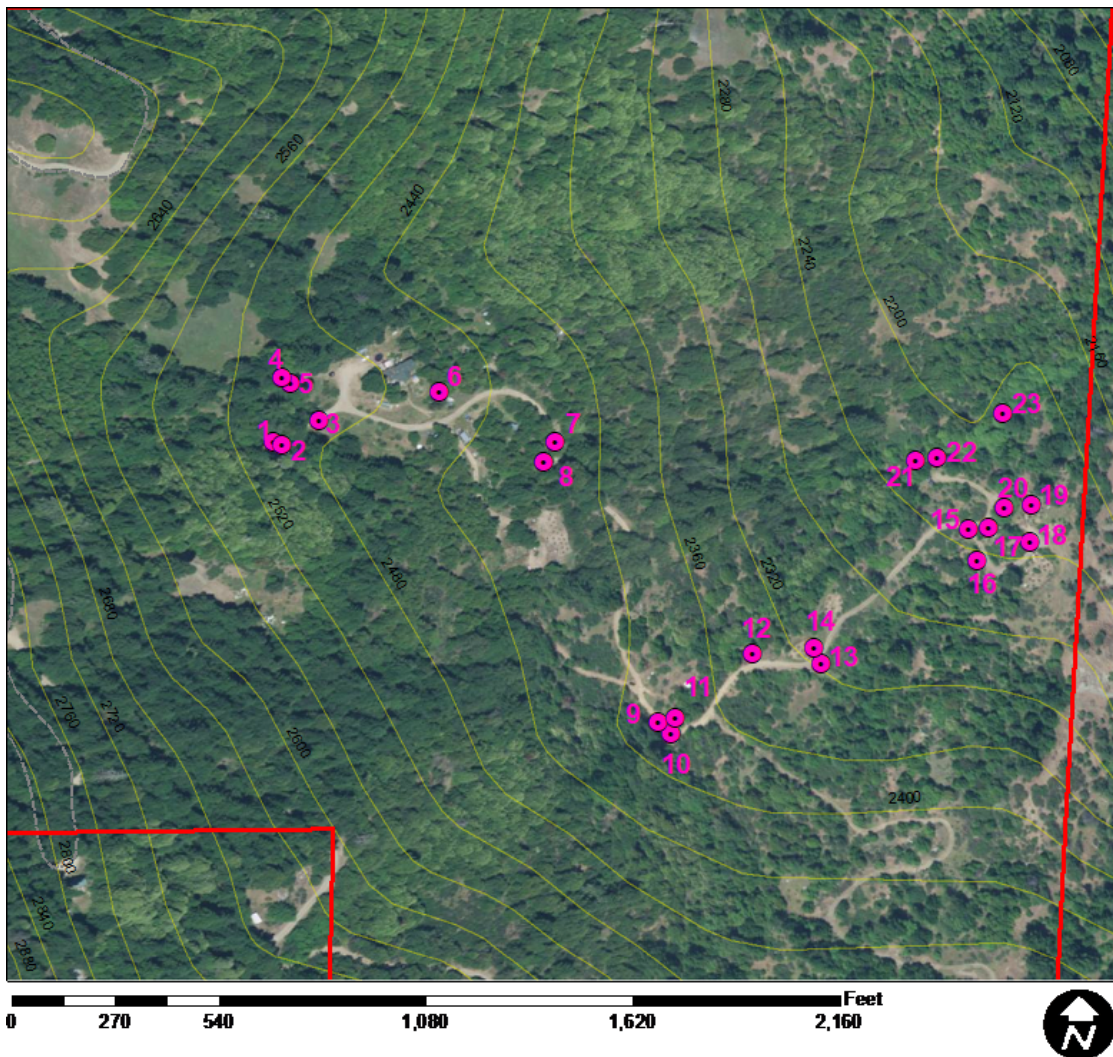
Inspection Map

On July 16, 2019, I inspected the Byarlay property (Property). The inspection map above shows the inspection points identified and discussed below.

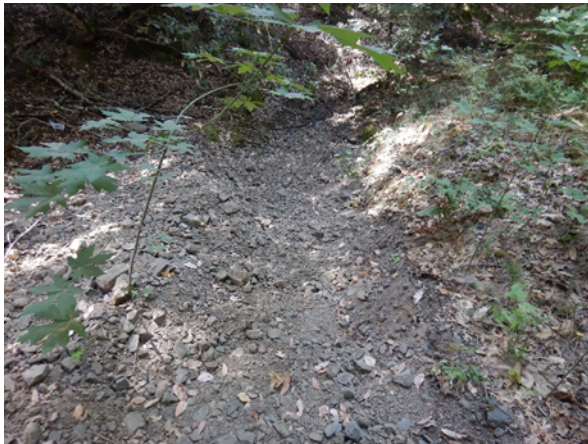
Photo – 1 Rock and dirt in watercourse channel.

3. Retain a qualified professional to develop a workplan and schedule to remove the sediment/fill, culverts, and the point of diversion from their respective watercourses. The table below identifies locations where staff observed sediment/fill in and where it could enter surface waters; ensure that the workplan includes specifications and a schedule to address these features. The site assessment associated with Recommendation 1., above, may identify additional such features on the Property, and the workplan should include these as well. In addition, apply for the appropriate permits and submit engineered plans for all instream work. Dispose of all development and restoration-related earthen spoils in a manner to prevent/minimize transport and delivery to receiving waters.

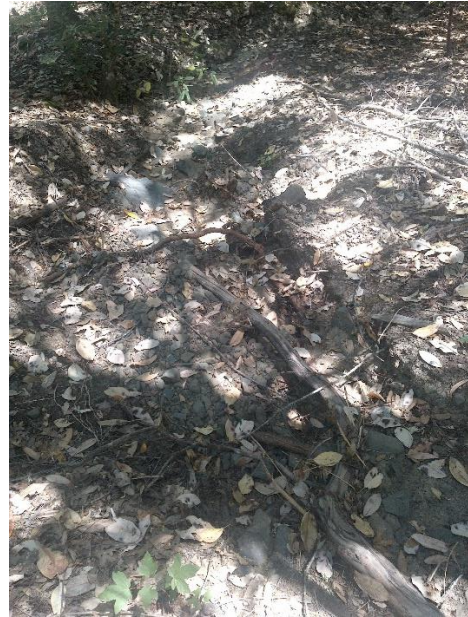
Photo – 2 Sediment and road fill in a watercourse.

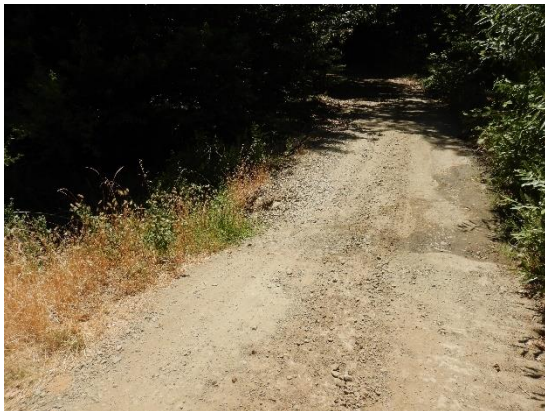
Photo – 3 Road rills.

1. Retain a licensed professional to inventory, assess, and develop a workplan and schedule to implement measures to ensure that all developed features, roads, watercourse crossings, and cultivation areas throughout the Property are corrected, restored, and/or maintained in conditions that prevent or minimize erosion, sediment transport/delivery, and adverse impacts to water quality and beneficial uses. Include measures to ensure that unstable features caused or affected by onsite development and operations are removed or otherwise protected so as to minimize the potential for these features to cause adverse impacts to water quality and beneficial uses. Dispose of all development and restoration-related earthen spoils in a manner to prevent/minimize transport and delivery to receiving waters.

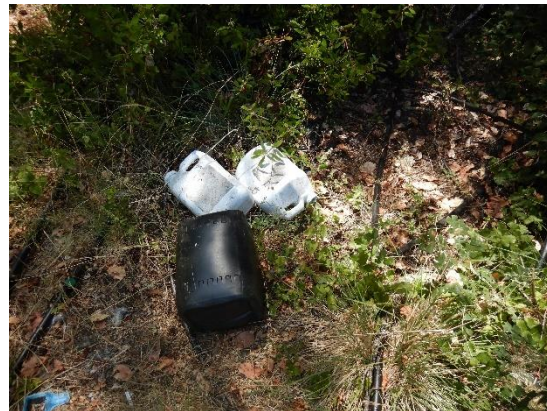
Photo – 4 Chemical bottles on the ground.

9.Store and contain all chemicals, including petroleum, fertilizer and/or pesticides properly to prevent spillage and discharge to receiving waters. Provide secondary containment for all petroleum products.

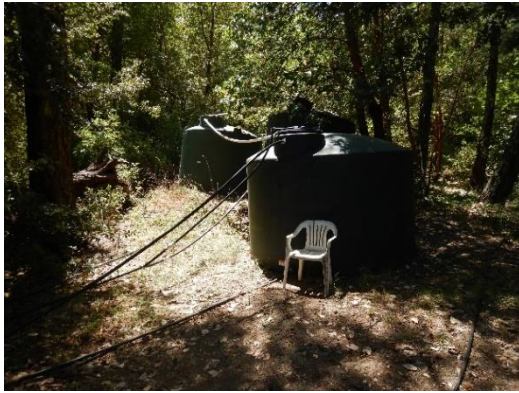
Photo – 5 Water storage tanks.

4. Work with CDFW and the State Water Resources Control Board's Division of Water Rights (DIV) to determine and secure any applicable permits or licensing required for surface water diversion, storage, and use on the site. If the existing surface water diversions do not meet applicable CDFW or DIV requirements, remove diversion infrastructure from surface waters and ensure that restoration plans developed pursuant to Recommendation 1, above, include provisions for restoring any instream or riparian disturbance associated with this features or removal thereof.

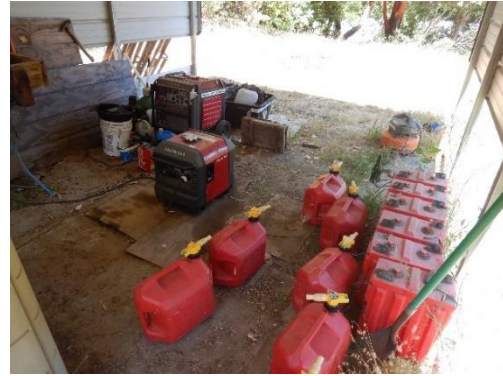
Photo – 6 Generator and gas tanks.

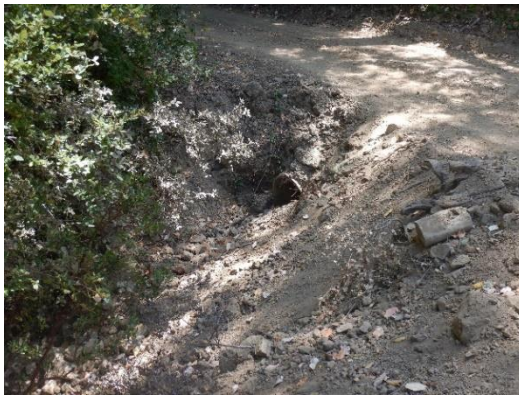
Photo – 7 Road built through a watercourse. A mostly buried culvert is visible in the loose fill and unstabilized fill slope.

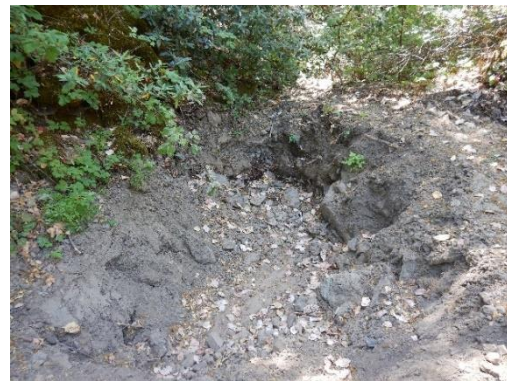
Photo – 8 Disturbed streambank and riparian area upstream of culvert.

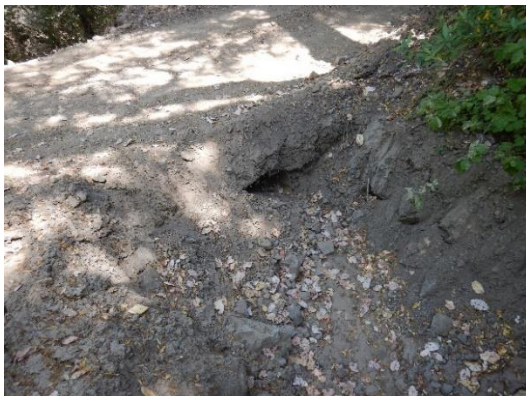
Photo – 9 Downstream view of culvert inlet filled with road fill and sediment. The streambank is disturbed along with riparian area. The banks show signs of heavy machinery work. The inlet of the culvert is cracked.

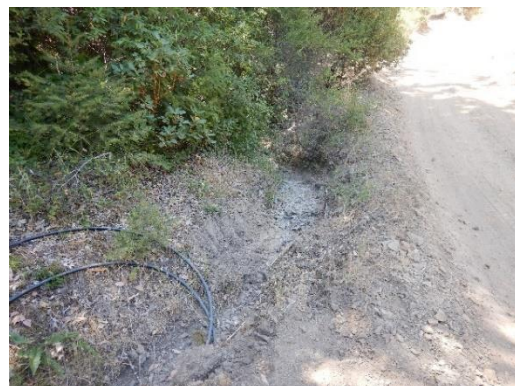
Photo – 10 Watercourse channel with road fill pushed into it. In addition, the watercourse channel shows signs of streambank disturbance from heavy machinery.

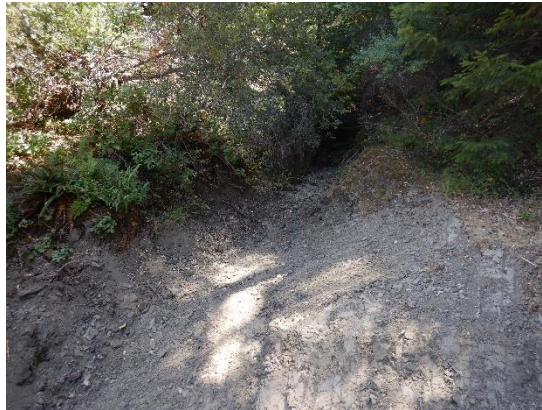
Photo – 11 Disturbed riparian area and sediment deposits in a watercourse channel.

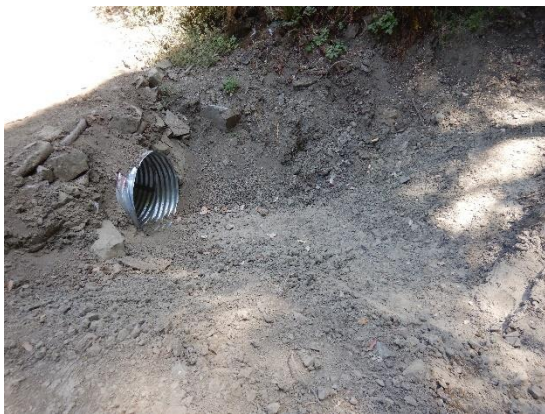
Photo – 12 Disturbed riparian area, 2-foot culvert, and bare, unstable soil in and around the stream channel.

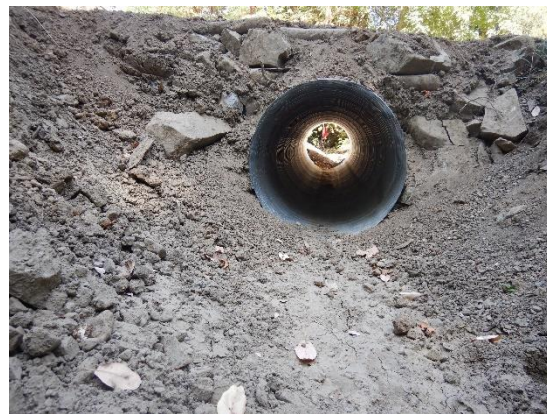
Photo – 13 Inlet view of culvert.

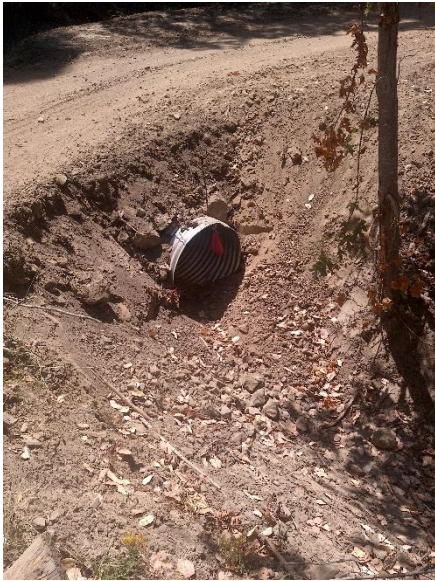
Photo – 14 Culvert outlet with discharged sediment and loose road fill into watercourse.

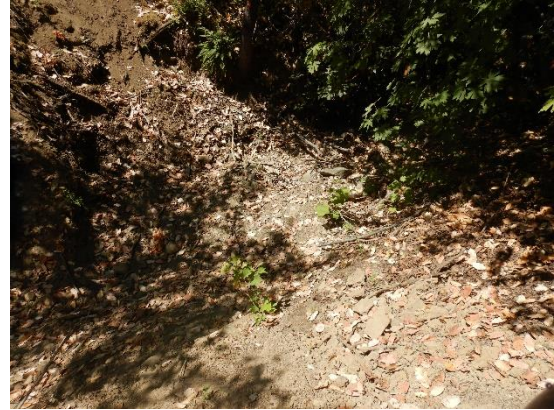
Photo – 15 Road fill extending into watercourse channel downstream of culvert outlet.

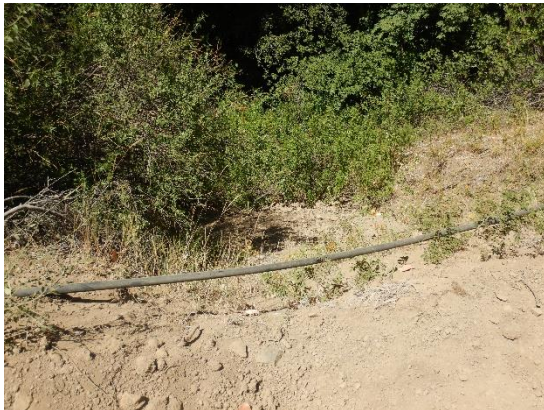
Photo – 16 Road fill pushed into watercourse.

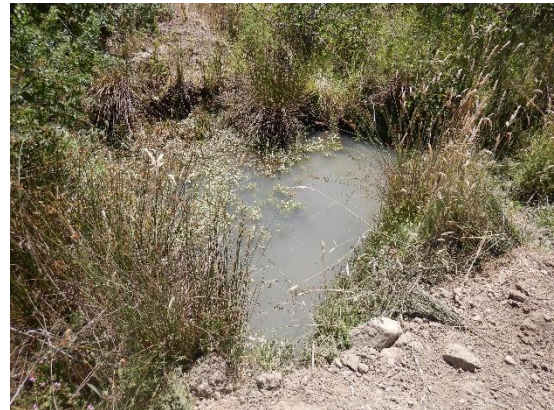
Continuing farther east along the access road, at inspection point 13, I observed that the roadway encroached on/partially buried what appeared to be a wetland seep (photo 17). Less than 40 feet from the seep, I observed a fenced flat area with patch tall grass and several cannabis plants in grow bags/rings (inspection point 14). Farther east along the road, at inspection points 15, 16, and 17, I observed further evidence of unpermitted instream work, where the road had been built through a watercourse, with associated stream and riparian disturbance, loose fill, and sediment discharges. I observed an undersized, misaligned culvert comprised of both PVC and HDPE. I estimate approximately 600 linear feet of riparian area, streambank, and stream channel was disturbed due to unpermitted instream work at inspection points 10, 11, 15, 16, and 17.

Photo – 17 Saturated wetland seep-like area, partially buried by the road.

2. Engage an appropriately licensed, qualified professional to conduct a U.S. Army Corps verified forensic wetland delineation of the entire Property. Engage an appropriately qualified professional with relevant experience in wetland restoration to prepare and submit a wetland restoration plan which includes but is not limited to, a project description, goal of restoration, implementation plan and schedule, plan for monitoring and site maintenance following restoration, and contingency measures addressing the diversity index of wetland/ non-wetland native plant species occurring on the Property. The plan should include proposed mitigation to address the temporal and permanent losses of wetland value and function. The plan should include specifications for debris removal and disposal.

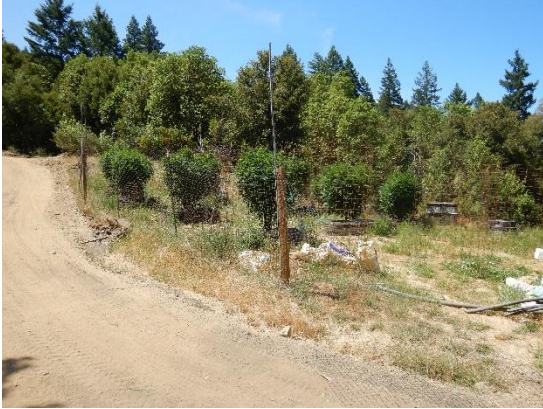
Photo – 18 Cannabis cultivation area.

6.If the property owner and/or tenant(s) choose to continue to cultivate cannabis, enroll for coverage under and take steps to comply with the requirements of the CANGO (Order WQ 2017-0023-DWQ, General Waste Discharge Requirements and Waiver of Waste Discharge Requirements for Discharges of Waste Associated with Cannabis Cultivation Activities). More information about the CANGO can be found at this hyperlink:

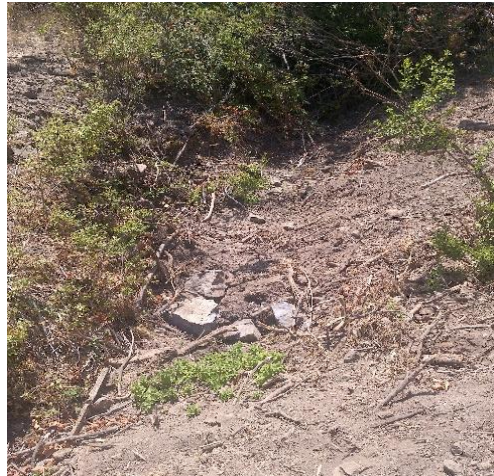
Photo – 19 Watercourse with riparian and streambank disturbance, and deposited debris and sediment.

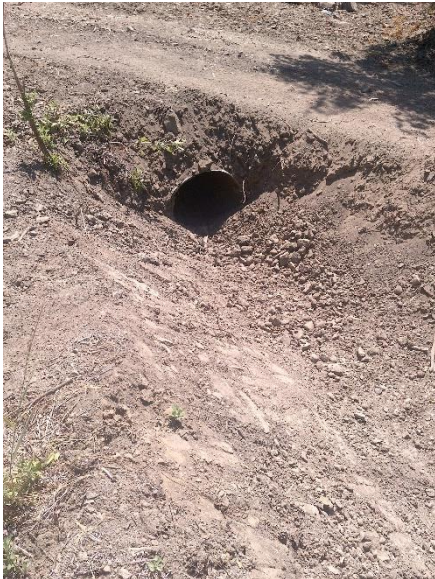
Photo – 20 Outlet of 3-foot culvert at inspection point 17.

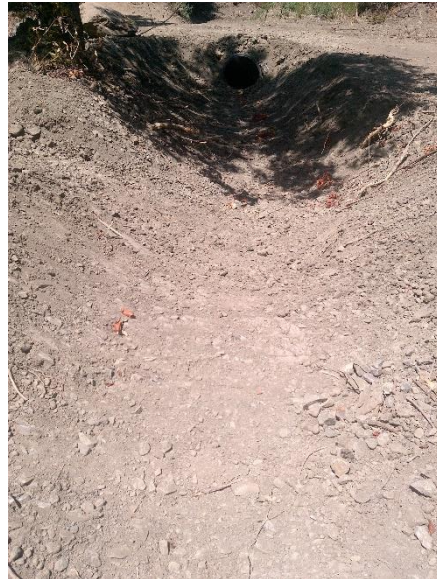
Photo – 21 Inlet of 3-foot culvert at inspection point 17.

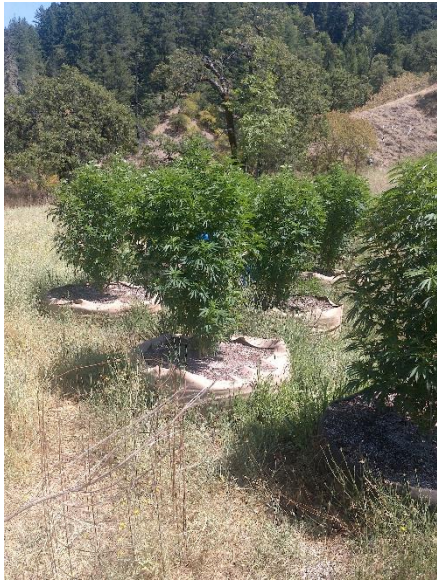
Just east of the stream crossing at inspection points 15-17, near the eastern edge of the Property, I observed a second cannabis cultivation area, inspection point 18, with several cannabis plants in grow bags. A portion of this cultivation area was within 70 feet of the watercourse affected by the crossing at inspection points 15-17.

Photo – 22 Cannabis cultivation

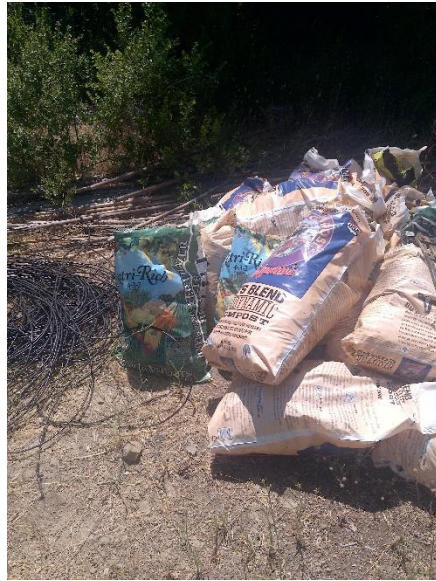
Within the cultivation area, I observed soil amendments, uncovered and uncontained, approximately 70 feet from a watercourse.

Photo – 23 Soil amendments near watercourse.

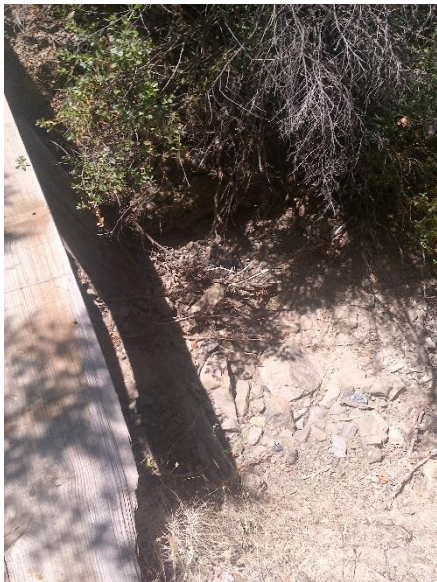
Photo – 24 Watercourse channel.

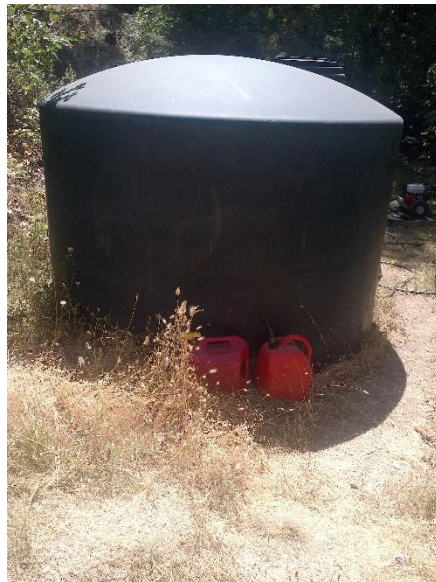
Photo – 25 Water storage tanks and gas tanks.

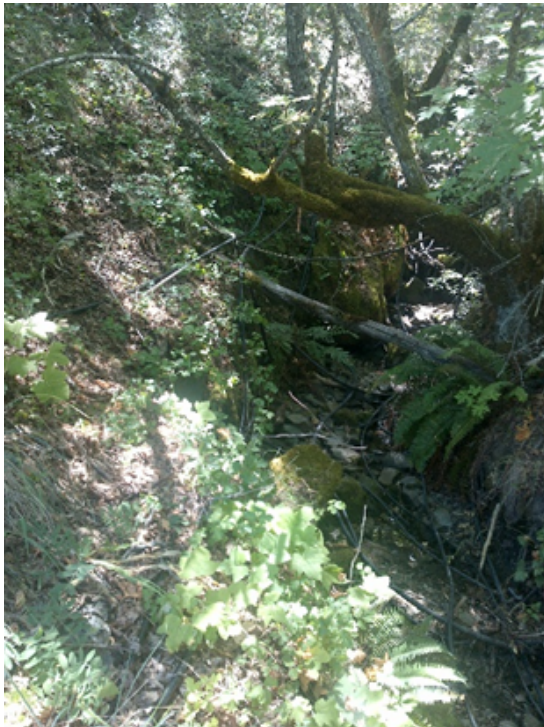
Photo – 26 Old irrigation lines in watercourse

8.Collect and dispose of or contain all refuse and cultivation-related wastes in a location and manner so as to minimize potential for these wastes to enter or be transported into receiving waters.

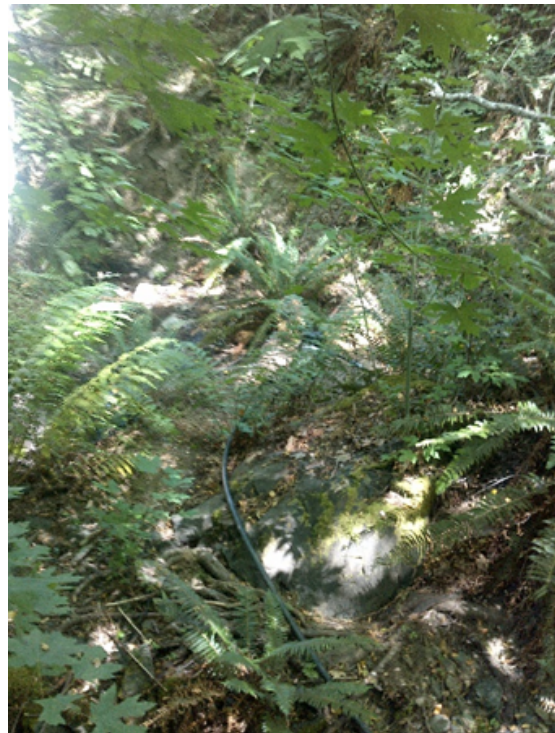
Continuing on the access road beyond the cultivation area, I observed cultivation-related waste, including old polyethylene irrigation lines and used chemical/fertilizer containers, at inspection points 21 and 22. In addition, I observed an unpermitted point of diversion (POD) in a watercourse at inspection point 23.

Photo – 27 Point of diversion.
