## North Coast Regional Water Quality Control Board

**Subject: Notice of Violation, Directive to Obtain Regulatory Coverage for Cannabis Cultivation, and Transmittal of Inspection Report for July 16, 2019, Inspection of Mendocino County Assessor's Parcel No. 056-510-08**

### **Inspection Report for July 16, 2019, Warrant Inspection Mendocino County Assessor's Parcel Number 056-510-08**

File: Cannabis Program Inspections, Mendocino County, July 2019 MCSO  
Inspections, David Randall Jones, CIWQS Place ID. 859920

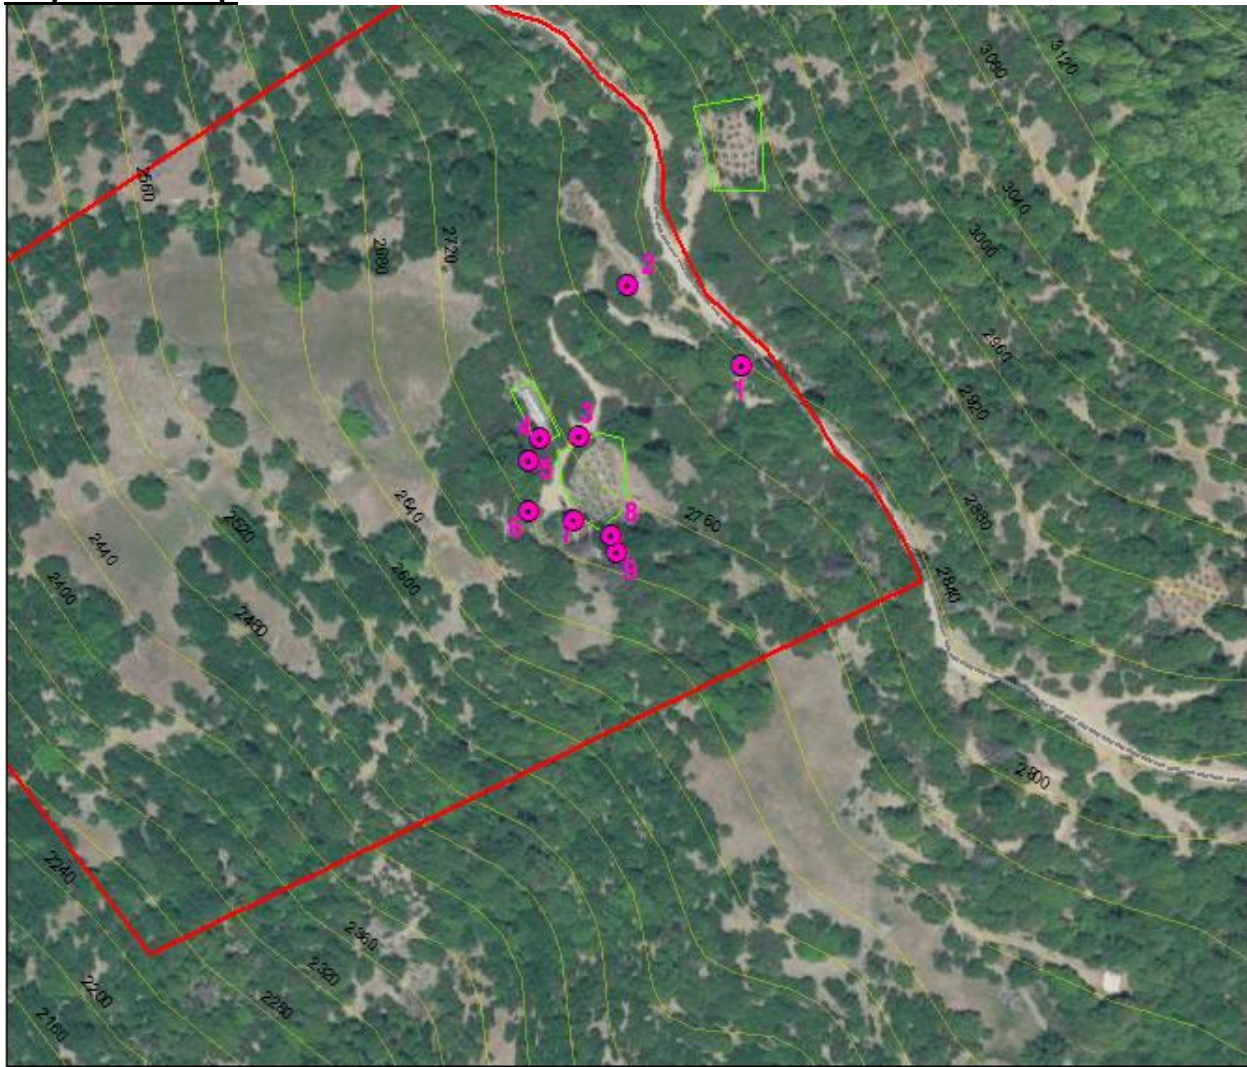
### Inspection Map

**Mendocino County  
APN 056-510-08-00  
David Jones Property**

On July 16, 2019, I inspected the subject property. The inspection map, above, shows the inspection points identified and discussed below.

Development on the property includes a clearing near the property entrance with a well and photovoltaic solar area (inspection point 2), a larger clearing with two cannabis cultivation areas and associated structures and features (inspection points 3-8), and a connecting driveway.

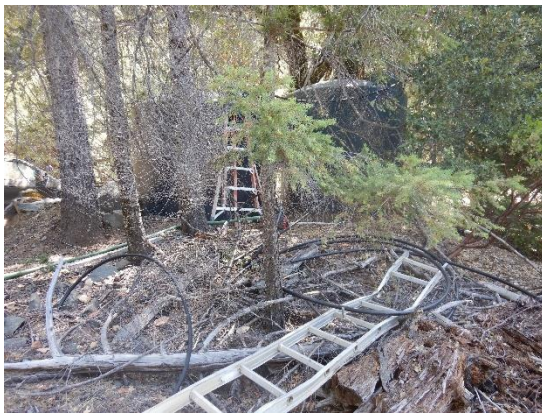
Photo – 1 Water storage tanks.

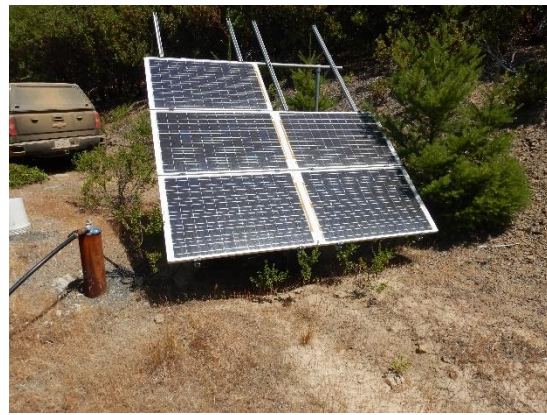
Photo – 2 Well head with solar pump.

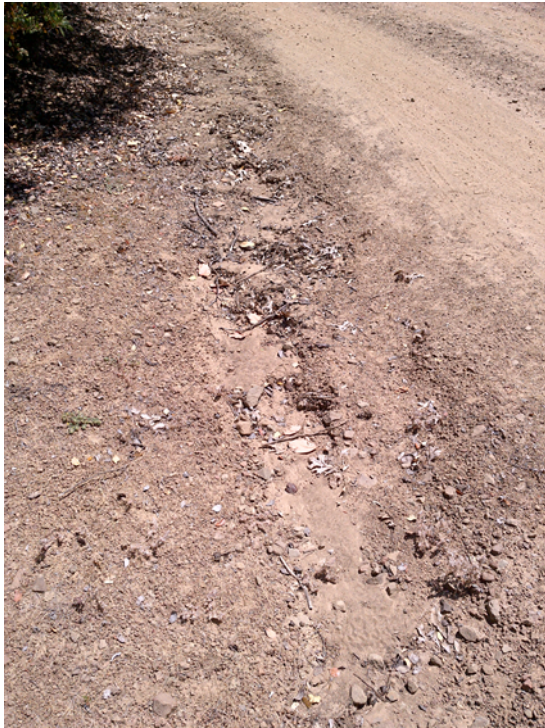
Near the driveway as we accessed the property, I observed water storage tanks (inspection point 1). I did not observe any water quality concerns associated with this area. I observed a groundwater well and photovoltaic array on the clearing at inspection point 2. I did not observe any water quality concerns in this area. South of the property entrance following the access road, I observed rill erosion on the outboard side of the access road at inspection point 3.

1. Site maintenance, erosion control and drainage features: As mentioned above, I observed rilling on the outboard edge of the access road, posing a threat of sediment discharges to receiving waters.

Photo – 3 Outboard road erosion.

1. Retain a licensed professional to inventory, assess, and develop a workplan and schedule to implement measures to ensure that all developed features, roads, and cultivation areas throughout the Property are corrected, restored, and/or maintained in

conditions that prevent or minimize erosion, sediment transport/delivery, and adverse impacts to water quality and beneficial uses. Include measures to ensure that unstable features caused or affected by onsite development and operations are removed or otherwise protected so as to minimize the potential for these features to cause adverse impacts to water quality and beneficial uses. Dispose of all development and restoration-related earthen spoils in a manner to prevent/minimize transport and delivery to receiving waters.

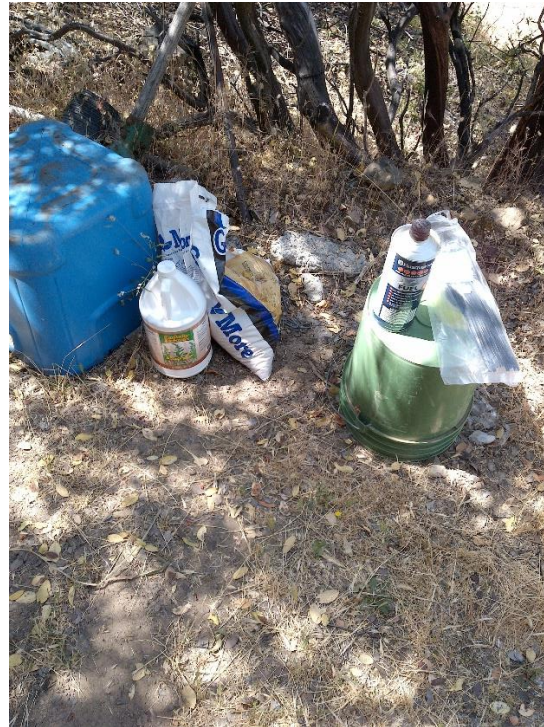
Directly south of inspection point 3, I observed an outdoor cannabis cultivation area, approximately 3,400 square feet in area (Photo 7). To the west of this cultivation area, I observed fertilizer and petroleum products on the ground at inspection point 4. Farther south along the access road, I observed a clearing with a structure used for drying cannabis. At this structure, I observed a pesticide bottle and pesticide applicator (photo 12). South of the drying structure, between inspection points 5 and 6, I observed a clearing with 3 greenhouses with cannabis cultivation. At inspection point 6 on the south side of the greenhouses, I observed piles of cultivation waste.

6. Irrigation runoff: I did not observe evidence of irrigation runoff during the inspection.
7. Fertilizers and soil amendments: I observed fertilizers that were uncovered and/or uncontained, but they were at a location with a low potential for spills or leaks to enter or be transported into receiving waters.

Photo – 4 Fertilizers and other chemicals stored on the ground.

6. Store and contain all chemicals, including petroleum, fertilizer and/or pesticides properly to prevent spillage and discharge to receiving waters. Provide secondary containment for all petroleum products.

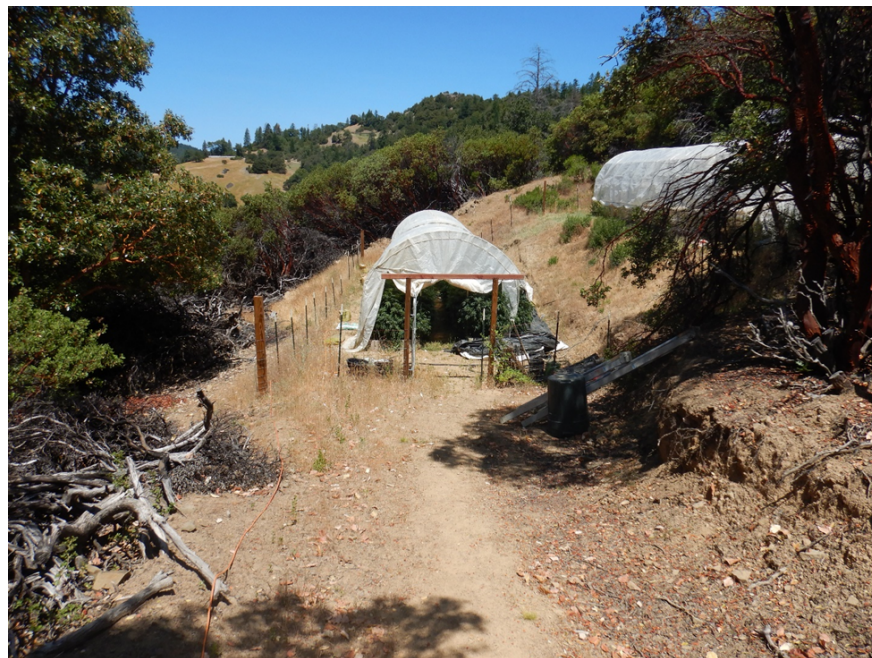
Photo – 5 Cannabis cultivation area at inspection points 5/6.

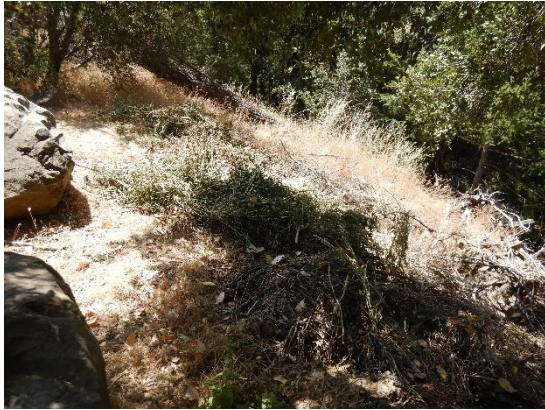
4. Spoils management: As mentioned above, I observed cultivation spoil piles, but they were at a location with a low potential to enter or be transported into receiving waters.

9. Petroleum products and other chemicals: As mentioned above, I observed generators and fuel containers sitting on bare dirt near the residence
10. Cultivation-related wastes: Apart from the spoils pile I observed at inspection point 6, I observed no other cultivation-related wastes.

Photo – 6 Cannabis cultivation waste.

5. Collect and dispose of or contain all refuse and cultivation-related wastes in a location and manner so as to minimize potential for these wastes to enter or be transported into receiving waters.

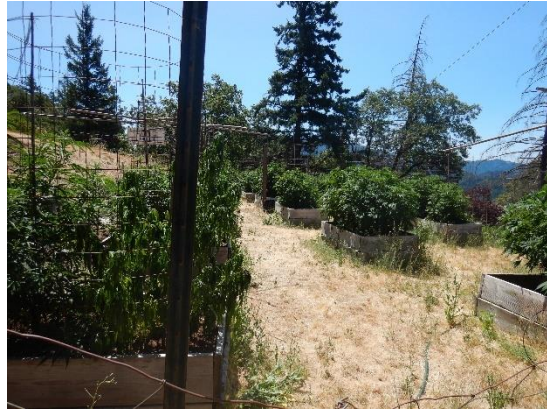
Photo – 7 Cannabis cultivation area near inspection point 3.

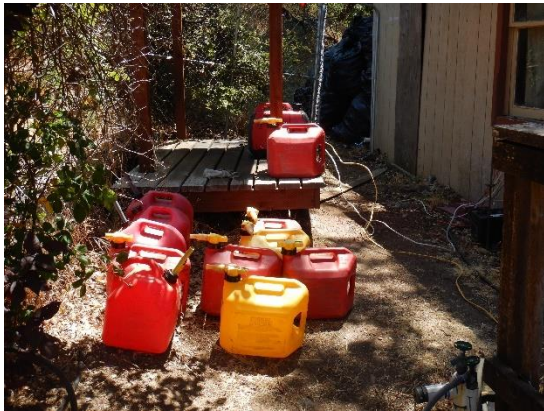
Photo – 8 Gas containers and generator.

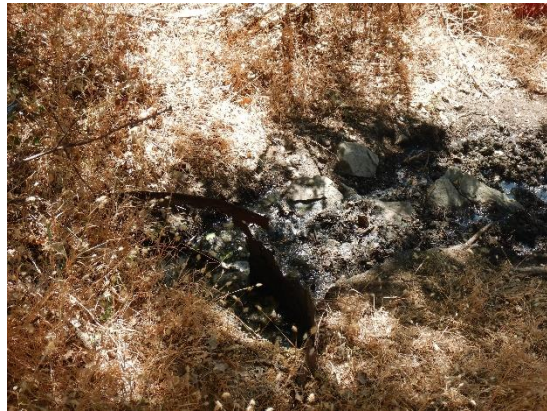
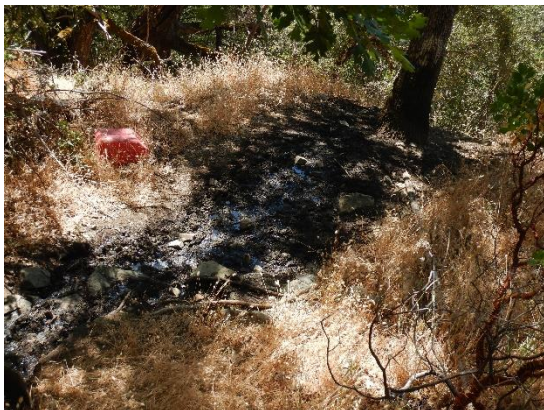
South of the cultivation areas, at inspection points 7, 8, and 9, I observed a house with gas generators and fuel containers stored in front, and refuse piles (inspection point 8) and a sewage outfall (inspection point 9) in back. In the vicinity of the sewage outfall, I observed raw sewage accumulated on the ground (Photos 9 and 10).

9	Domestic waste	Raw sewage outfall from house discharging onto the ground.	Threatened discharge of waste to waters of the State. Sewage disposal practices not consistent with applicable County Health Department standards.	9 & 10

11. Refuse and human waste: As noted above, I observed garbage bags piled behind the residence. In addition, as noted above, I observed an open sewage outfall with raw sewage ponded on the ground. While neither feature was located in the immediate vicinity of surface water, both pose a potential threat to water quality and public health.

Photo – 9 Sewage outfall.

Photo – 10 Sewage outfall flowing downhill.

4.Discontinue sewage discharges to the ground. Collect and properly dispose of all discharged sewage. Work with Mendocino County to identify and implement appropriate temporary sewage containment/disposal features as needed. Engage a licensed professional with relevant experience to identify/design an onsite waste treatment/disposal system consistent with applicable County requirements. Ensure that all domestic and human wastes are collected and disposed of consistent with applicable County requirements over both the short and long term.

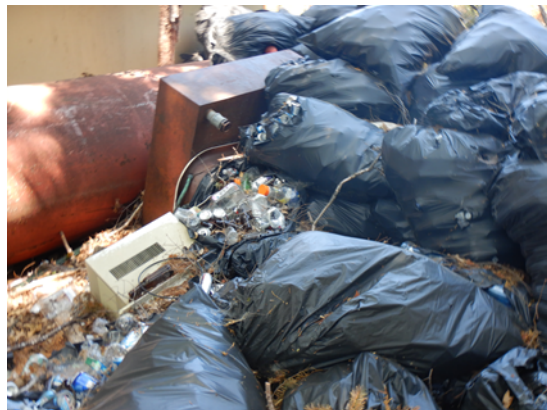
Photo – 11 Trash located behind the house.

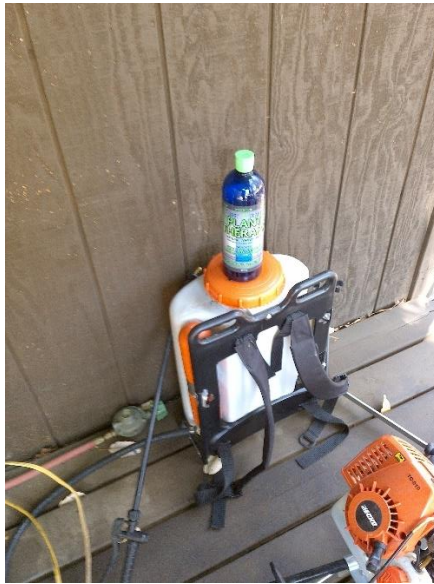
8. Pesticides: As noted above, I observed pesticide containers that were uncovered and/or uncontained, but they were at a location with a low potential for spills or leaks to enter or be transported into receiving waters.

Photo 12 – Pesticide and pesticide applicator.
