**Subject: Notice of Violation, Directive to Obtain Regulatory Coverage for Cannabis Cultivation, and Transmittal of Inspection Report for June 5, 2019, Inspection of Lake County Assessor's Parcel No. 002-012-230-000**

**June 05, 2019, Warrant Inspection  
Lake County Assessor's Parcel Number 002-012-230-000**

File: Cannabis Inspections, Lake County, 2019, 190605 Mendoza 002-012-230-000,  
CIWQS Place ID No. 858831

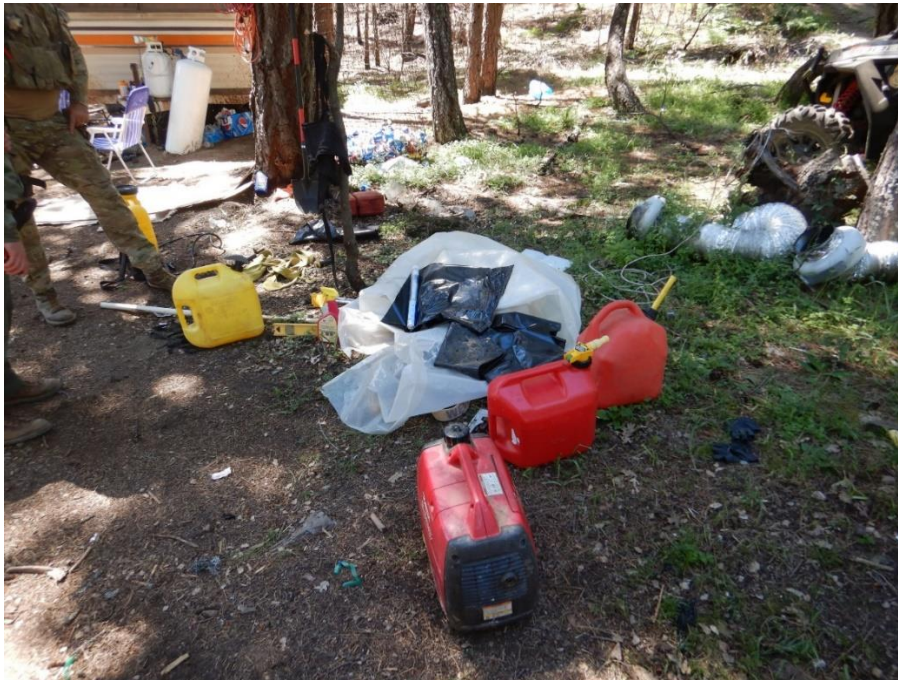
9. Petroleum products and other chemicals: I observed fuel cans uncontained and on bare ground.

photo 1 – Fuel stored uncontained and on bare ground in the vicinity of WQ 1.

9. Work with Lake County to ensure that all domestic and human wastes are collected and disposed of consistent with applicable County requirements.
10. Collect and dispose of or contain all refuse and cultivation-related wastes in a location and manner so as to minimize potential for these wastes to enter or be transported into receiving waters.
11. Immediately remove and properly dispose of all illegal pesticides.
12. Store and contain all chemicals, including petroleum, fertilizer and/or pesticides properly to prevent spillage and discharge to receiving waters. Provide secondary containment for all petroleum products.

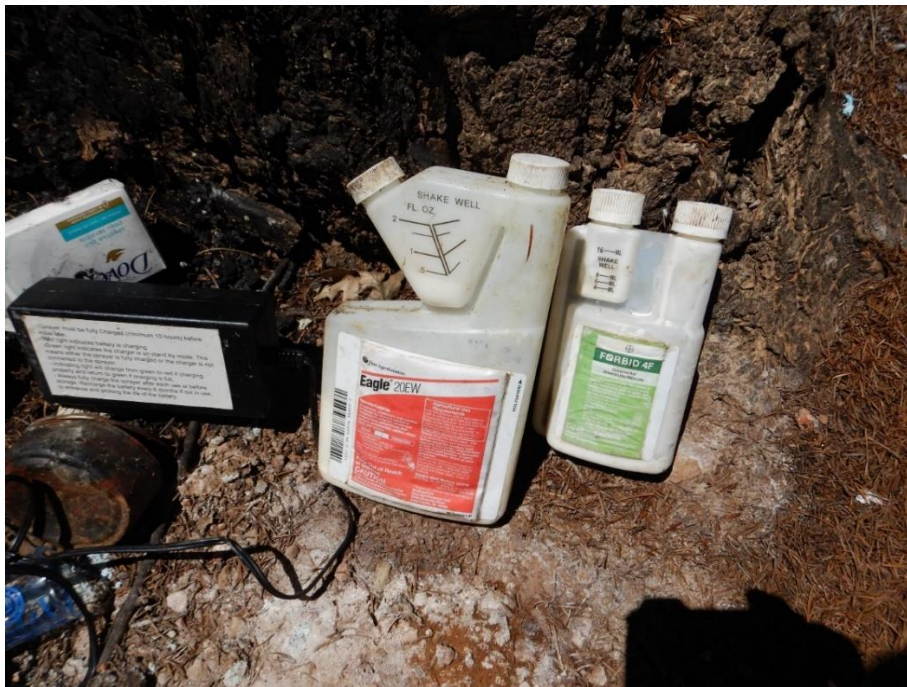
8. Pesticides: I observed pesticides, sitting on bare ground, without cover or containment, including Eagle 20 EW and Forbid 4f. These products are not permitted for cannabis cultivation and threaten beneficial uses of receiving waters.

photo 2 – Pesticides, that are not permitted for cannabis cultivation, stored uncontained and on bare ground in the vicinity of WQ 1.

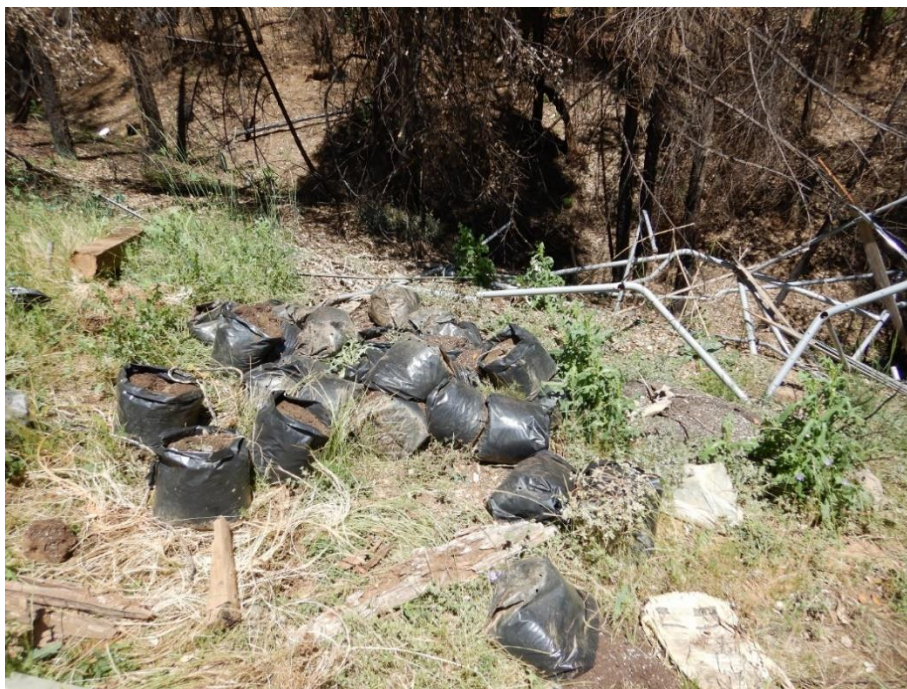
4. Spoils management:  
I observed waste cannabis plants and imported potting soils at locations where they are likely to discharge to receiving waters at WQ 2.

10. Cultivation-related wastes: I observed waste cannabis plants and imported potting soils on a slope above a watercourse at WQ 2.

photo 3 – Looking north at waste cannabis plants and imported potting soils placed where it is likely to discharge to the watercourse north of the greenhouse between WQ1 and WQ 2.

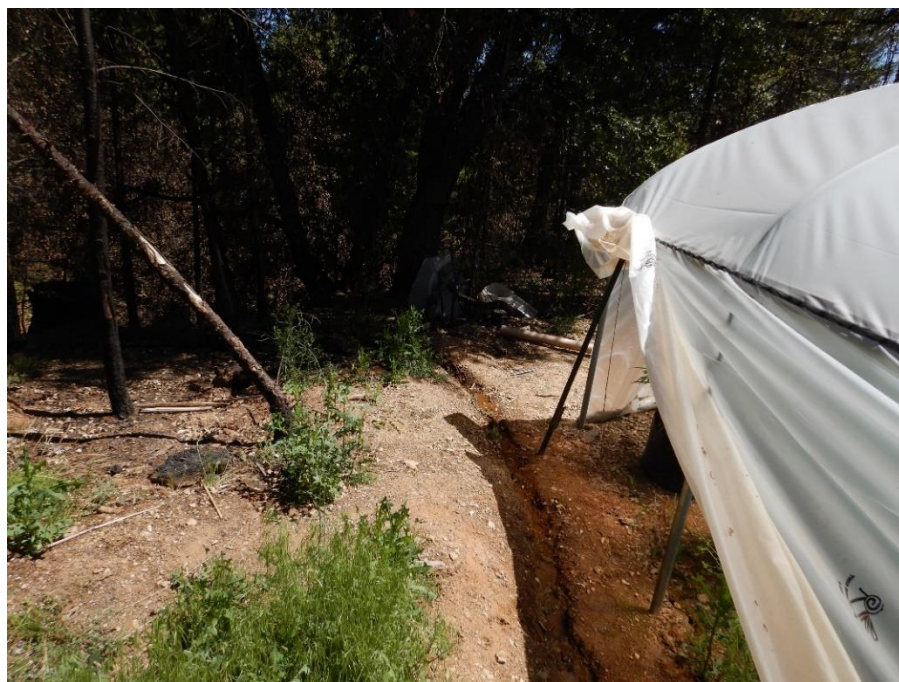
6. Irrigation runoff: I observed a man-made trench connecting the cultivation area to the watercourse in the vicinity of WQ 2, creating a preferential pathway for drainage of any excess irrigation water, and entrained pollutants into surface waters.

photo 4 – Irrigation runoff from cannabis shown in photo 6, in the vicinity of WQ 2, discharging where it is likely to reach receiving waters.

1. Retain a licensed professional to inventory, assess, and develop a workplan and schedule to implement measures to ensure that all developed features, roads, watercourse crossings, and cultivation areas throughout the Property are corrected, restored, and/or maintained in conditions that prevent or minimize erosion, sediment transport/delivery, and adverse impacts to water quality and beneficial uses. Include measures to ensure that unstable features caused or affected by onsite development and operations are removed or otherwise protected so as to minimize the potential for these features to cause adverse impacts to water quality and beneficial uses. Dispose of all development and restoration-related earthen spoils in a manner to prevent/minimize transport and delivery to receiving waters.

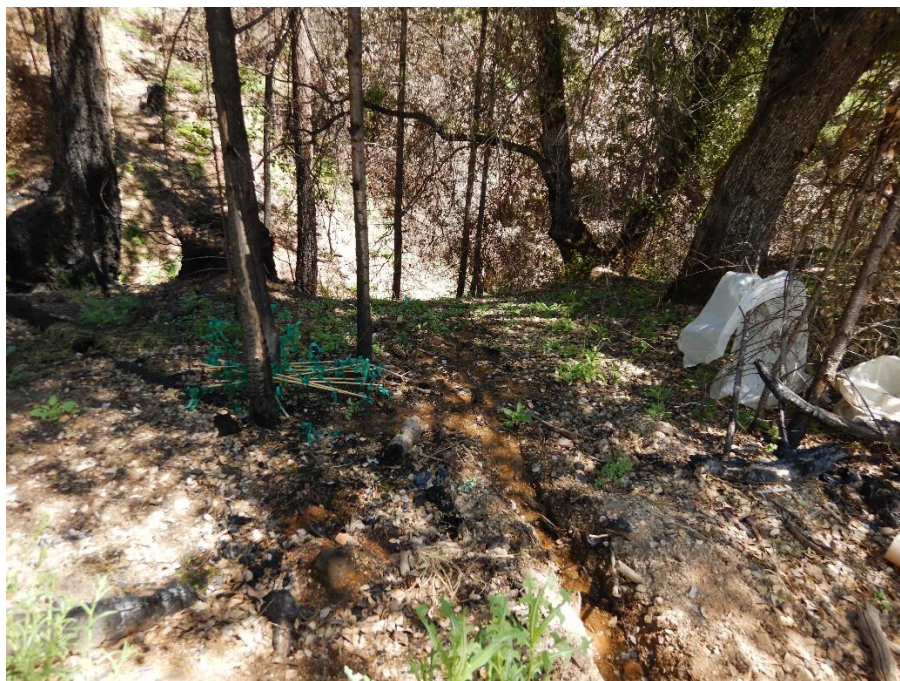
3. Riparian and wetland protection and management: The watercourse thalweg at WQ 2 is 35 feet from the edge of the greenhouse to the south. Furthermore, I observed a handmade trench that extended from the greenhouse directly to a watercourse, providing a conduit to transport pollutants to receiving waters.

photo 5 – Continuation of trench shown in photo 4, in the vicinity of WQ 2. Valley in background of image contains a watercourse.

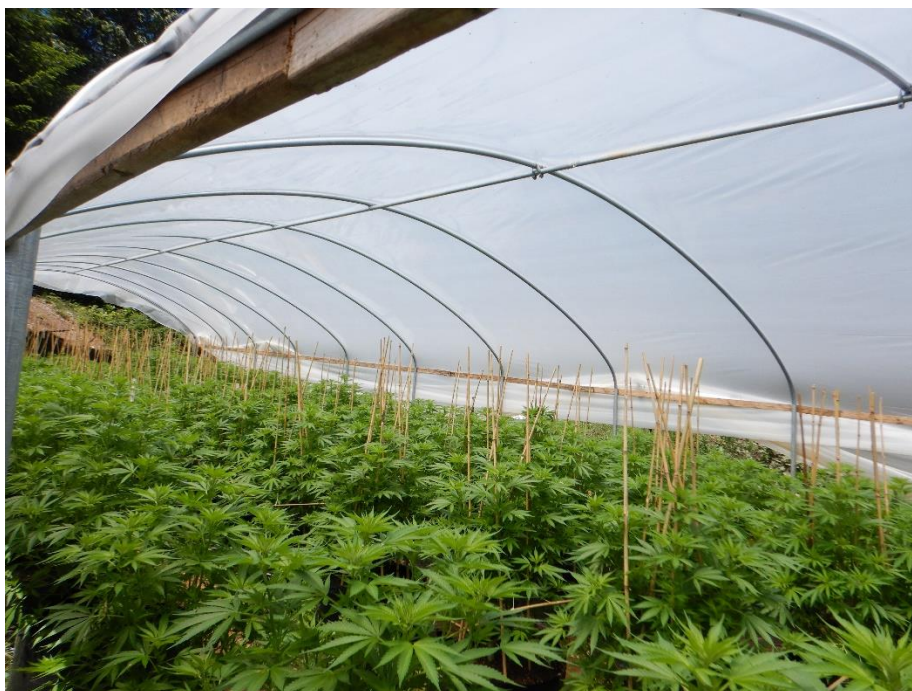
photo 6 – Cannabis plants inside hoop house shown in photo 4, in the vicinity of WQ 2. Watercourse thalweg is 35 feet from edge of greenhouse.

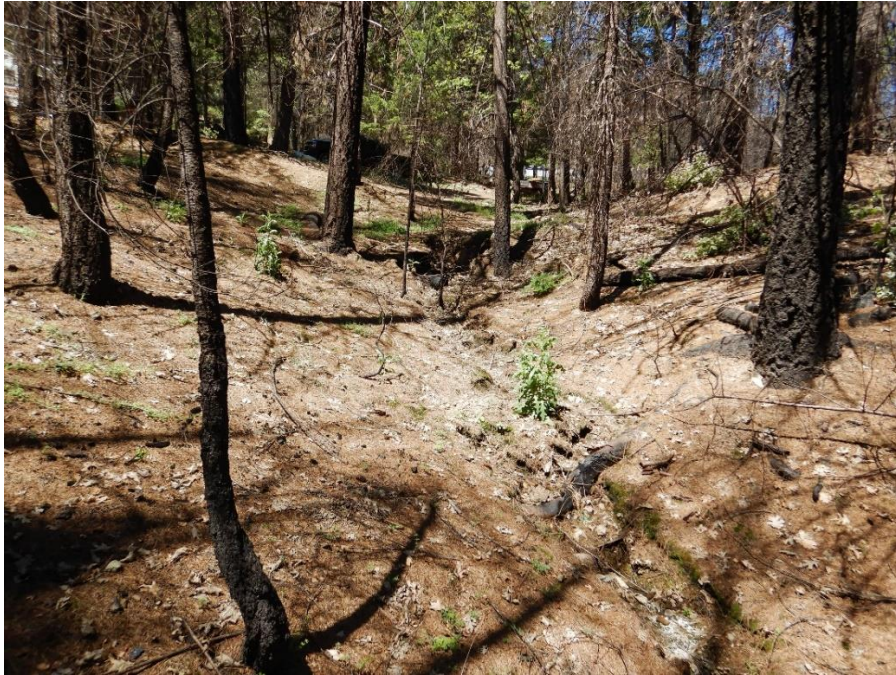
2. Stream crossing maintenance and improvement: I observed earthen fill from roads and trails crossing watercourses in the vicinity of WQ 1 and WQ 3, at locations where it could enter or be transported into receiving waters.

photo 7 – Looking upstream, and to the west, at watercourse. Road crossed watercourse over fill, 3,5 feet wide and 22 feet long. The watercourse has incised up into the fill.

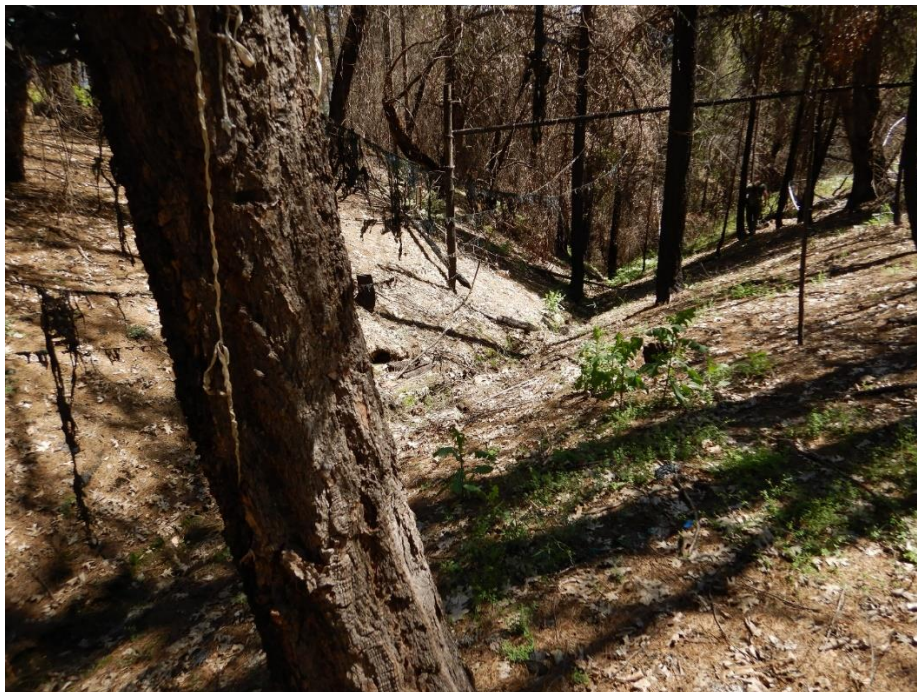
photo 8 – Looking downstream, and to the east, at watercourse.

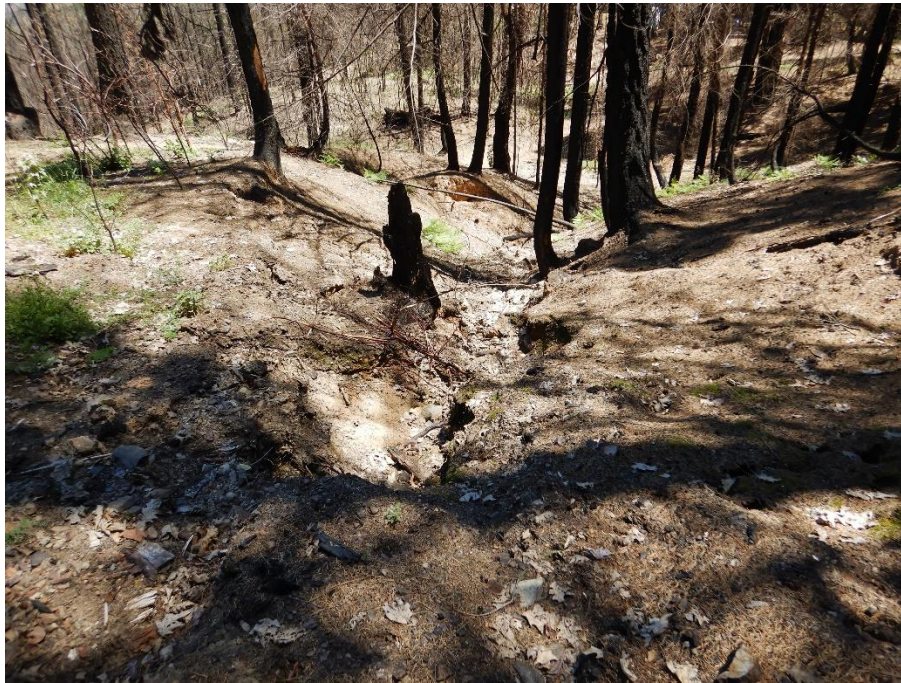
photo 9 – Watercourse east of WQ 3.

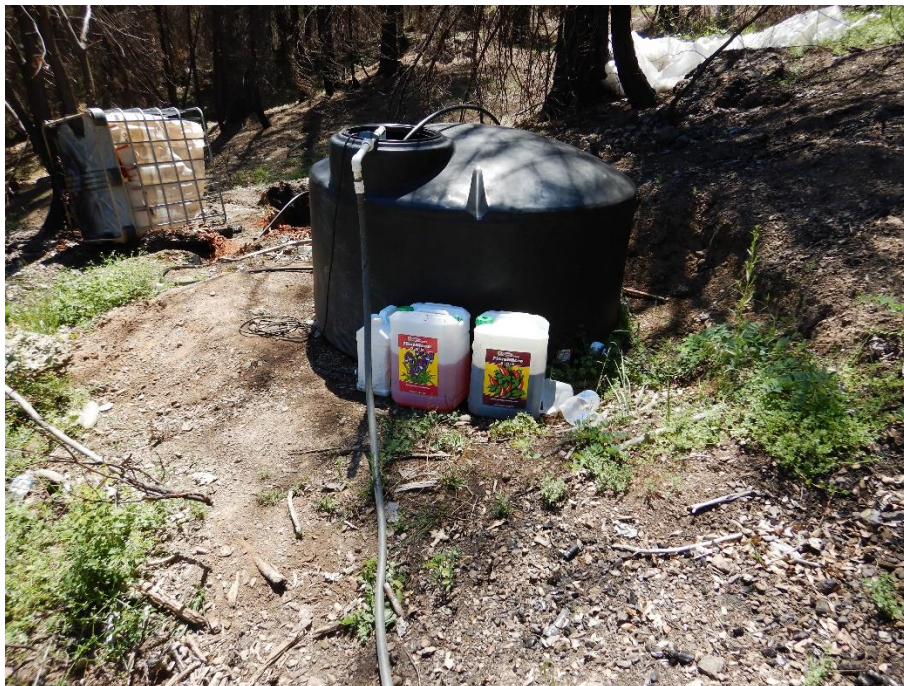
7. Fertilizers and soil amendments: I observed fertilizer containers sitting uncontained on bare ground next to a mixing tank with no lid at WQ 3.

photo 10 – Nutrient mixing located at WQ 3.

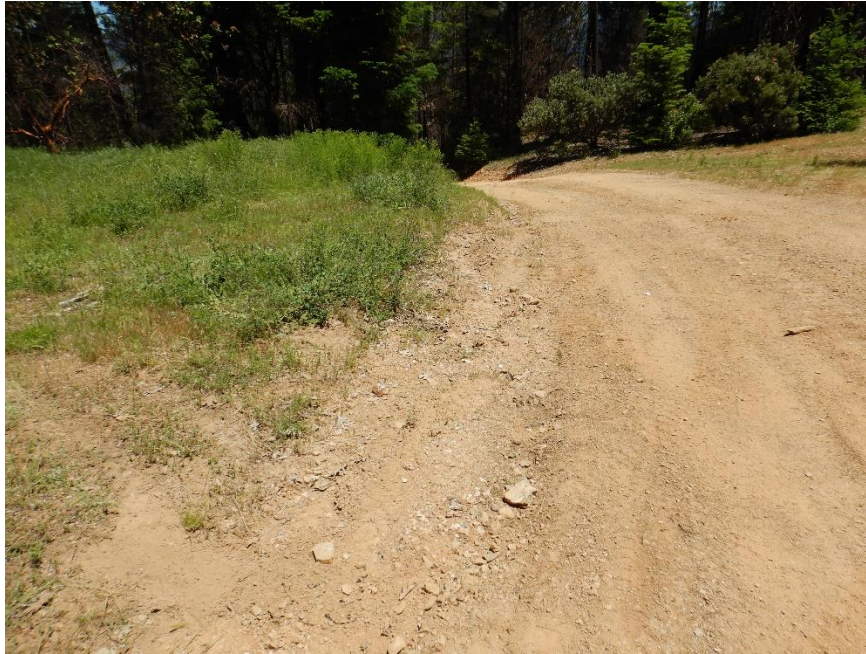
WQ 4	Rilling on roads	Erosional rill visible on road surface.	Threatened discharge of waste to receiving waters.	photo 11

1. Site maintenance, erosion control and drainage features: The roads between WQ 3 and WQ 6 are steep, susceptible to erosion by stormwater, and hydrologically connected to nearby watercourses. The road at WQ 4 is susceptible to erosion by stormwater.

photo 11 – Rilling on road-surface; evidence the road is susceptible to erosion by stormwater.

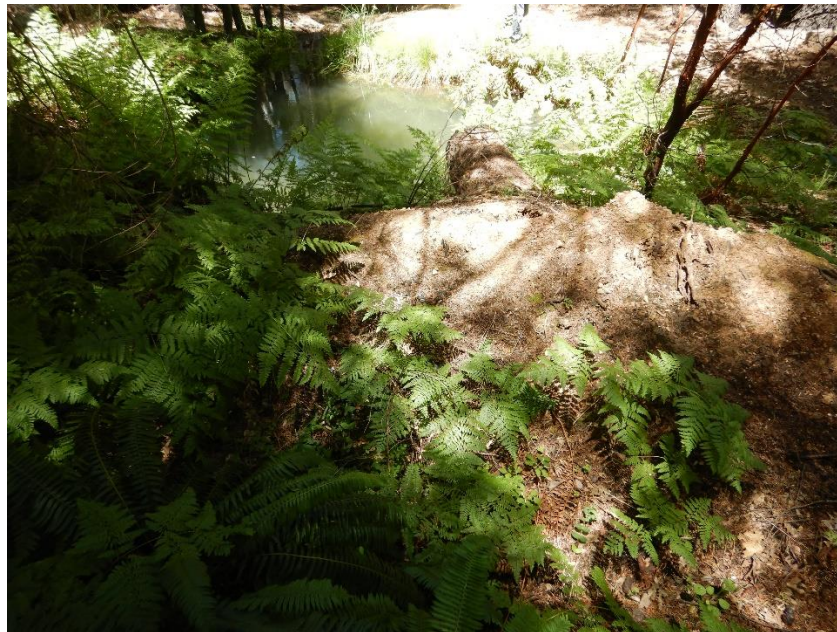
5. Water storage and use: I observed reservoirs in watercourses at WQ 5 and WQ 6. I observed a reservoir in a suspected wetland feature at WQ 7.

photo 12 – Reservoir excavated in watercourse at road crossing at WQ 5. The reservoir is approximately 8 feet deep. Impounding fill is approximately 8 feet high, 30 feet wide and 40 feet long.

4. Retain a qualified professional to develop a workplan and schedule to remove the reservoirs at WQ 5 and WQ 6 and restore the channels to their natural state. Dispose of all development and restoration-related earthen spoils in a manner to prevent/minimize transport and delivery to receiving waters.

6. Prior to conducting any work in surface waters associated with recommendations 3, 4, and 5, above, submit to the Regional Water Board an application for Clean Water Act section 401 water quality certification, and secure approval from the Regional Water Board.

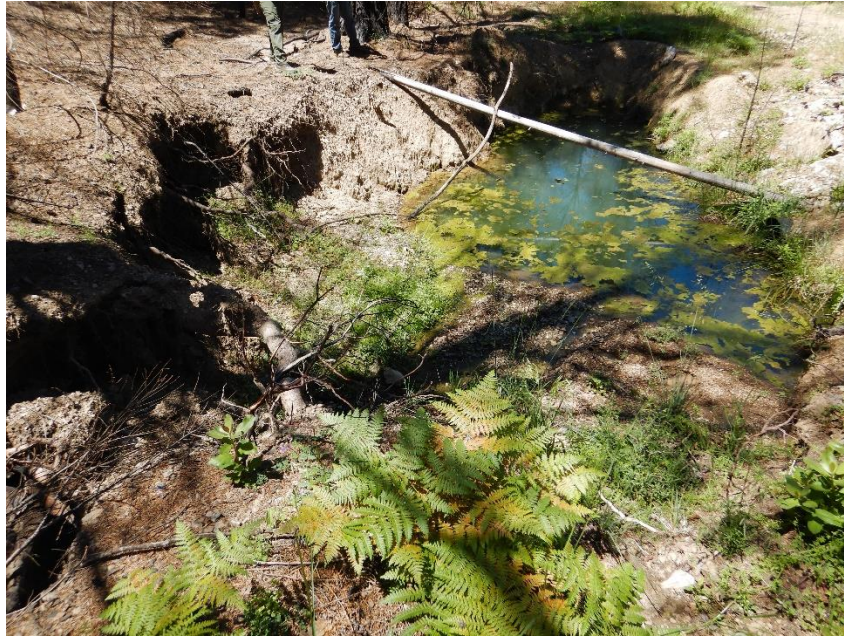
photo 13 – Excavated stream impoundment at WQ 6, with a wetted surface area 26 feet long, 35 feet wide and an approximate depth of 4 feet.

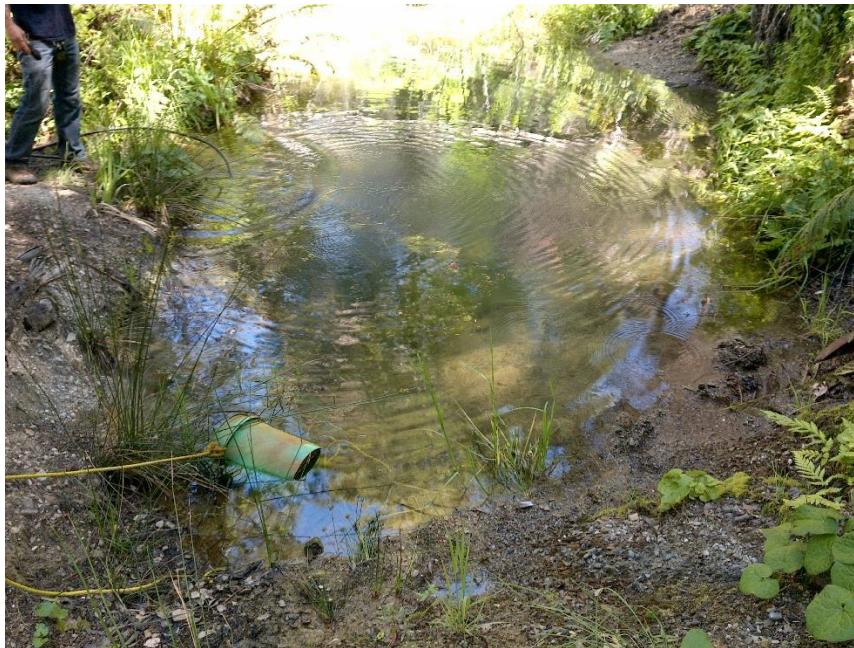
photo 14 – Reservoir dredged in suspected wetland/watercourse feature at WQ 7.

2. Engage an appropriately licensed, qualified professional to conduct a forensic wetland delineation, per U.S. Army Corps protocols, at WQ 7.
3. Engage an appropriately qualified professional with relevant experience in wetland restoration to prepare and submit a wetland restoration plan which includes but is not limited to, a project description, goal of restoration, implementation plan and schedule, plan for monitoring and site maintenance following restoration, and contingency measures addressing the diversity index of wetland/ non-wetland native plant species occurring at WQ 7. The plan should include proposed mitigation to address the temporal and permanent losses of

wetland value and function. The plan should include specifications for debris removal and disposal.
