Subject: Notice of Violation, Directive to Obtain Regulatory Coverage for Cannabis Cultivation, and Transmittal of Inspection Report for July 17, 2019, Inspection of Mendocino County Assessor's Parcel No. 036-230-53

Inspection Report for July 17, 2019, Warrant Inspection Mendocino County Assessor's Parcel Number 036-230-53

File: Cannabis Program Inspections, Mendocino County, July 2019 MCSO Inspections, Jose Manuel Espino-Cardoza and Elvira D. Najera-Revolorio, CIWQS Place ID.859930

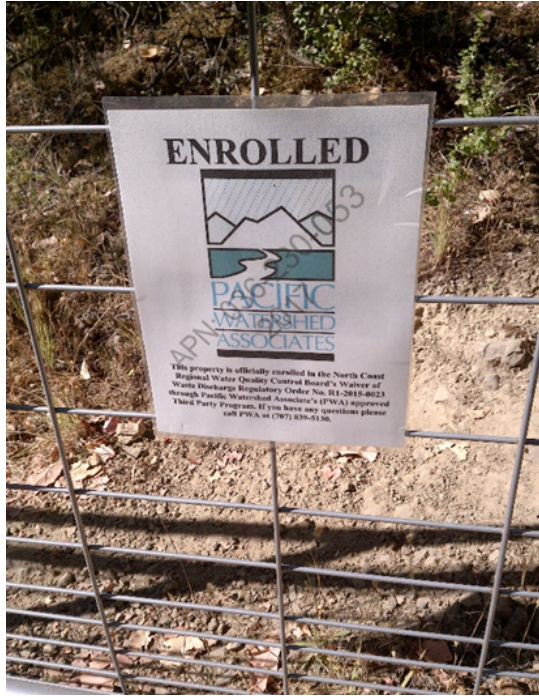
On the access road just south of cultivation area #1, I observed a gate with a third-party consultant sign, indicating enrollment in the Regional cannabis order, No. R1-2015-0023. Just north of the gate, I observed rill erosion in the middle of the access road (inspection point 2).

Photo 1 - Property entry gate with sign indicating enrollment under Regional cannabis order

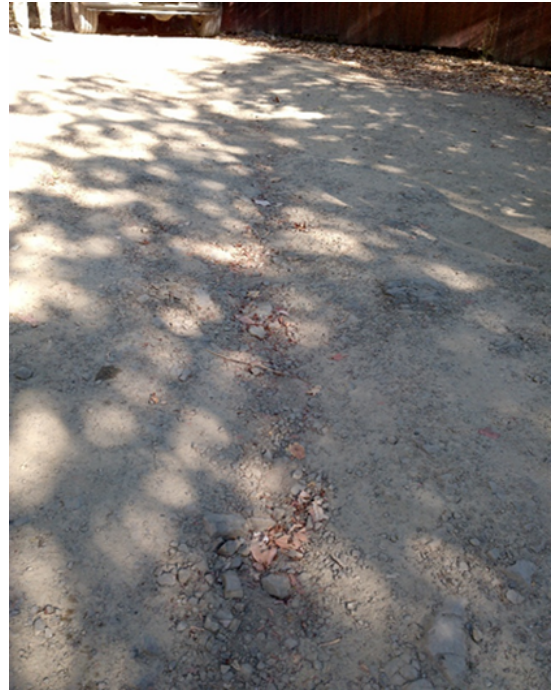
1. Site maintenance, erosion control and drainage features: As noted above, I observed rill erosion on the access road south of cultivation area #1, at a location where eroded material may enter or be transported into receiving waters.

Photo 2 – Rilling on road behind entry gate.

1. Retain a licensed professional to inventory, assess, and develop a workplan and schedule to implement measures to ensure that all developed features, roads, and cultivation areas throughout the Property are corrected, restored, and/or maintained in conditions that prevent or minimize erosion, sediment transport/delivery, and adverse impacts to water quality and beneficial uses. Include measures to ensure that unstable features caused or affected by onsite development and operations are removed or otherwise protected so as to minimize the potential for these features to cause adverse impacts to water quality and beneficial uses. Dispose of all development and restoration-related earthen spoils in a manner to prevent/minimize transport and delivery to receiving waters.

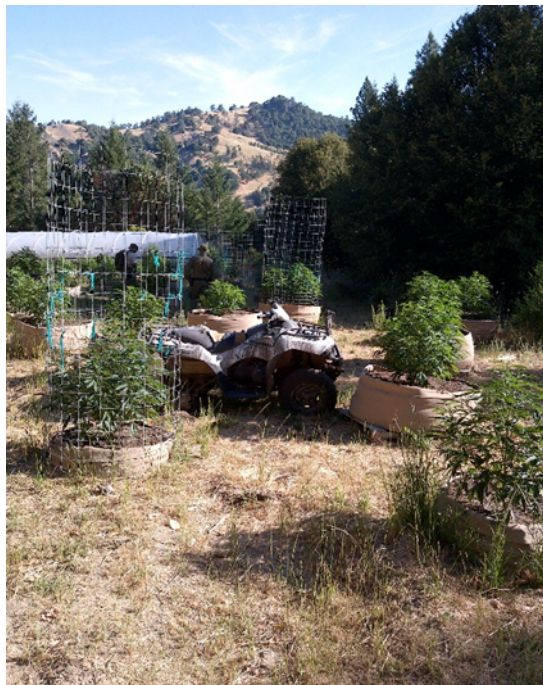
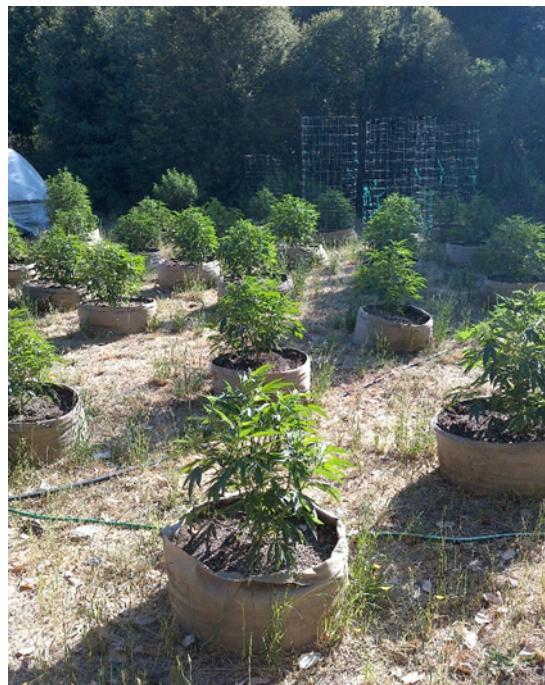
Proceeding to cannabis cultivation area # 1, I observed a large clearing with two large greenhouses and outdoor cultivation with cannabis plants in grow bags/rings. I observed several housekeeping issues within this area that posed a threat to water quality and were not consistent with the standard conditions of the statewide cannabis order. Specifically, I observed a large diesel generator and fuel canisters, uncovered and uncontained (inspection point 4); petroleum, chemical, and fertilizer bottles sitting on the bare ground (inspection point 6); and a large pile of amended soil, uncovered and uncontained (inspection point 10).

Photo 3 – Cannabis cultivation area #1

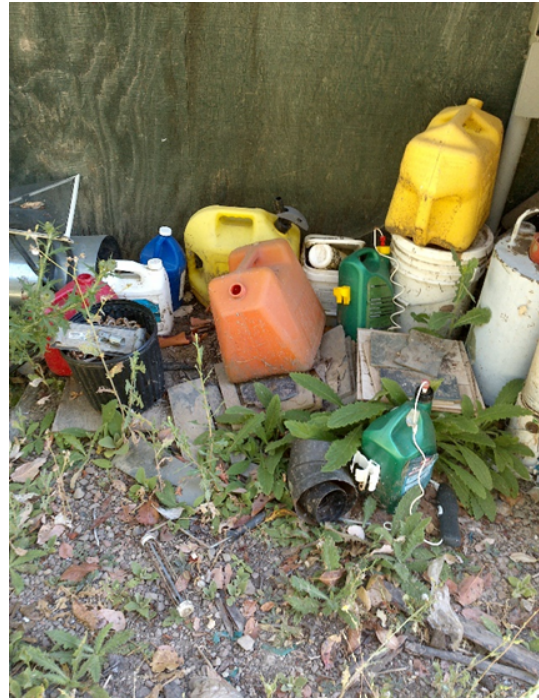
9. Petroleum products and other chemicals: As mentioned above, I observed petroleum products and generators, as well as various other chemical containers on the ground at several locations, including an area less than 10 feet from a Class III watercourse, fertilizers, and pesticides containers stored on the bare ground.

Photo 5 – Diesel generator and gasoline tanks.

6. Store and contain all chemicals, including petroleum, fertilizer and/or pesticides properly to prevent spillage and discharge to receiving waters. Provide secondary containment for all petroleum products.

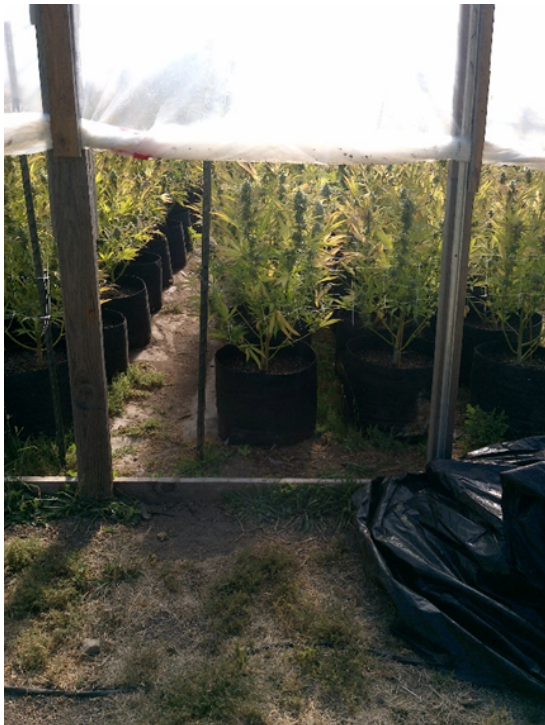
8. Pesticides: As mentioned above, I observed a pesticide banned for use in California, but it did not appear to pose a direct water quality concern. In addition, as mentioned above, I observed pesticide containers on the ground at cultivation area #1

Photo 6 – Petroleum, chemical, and pesticide bottles.

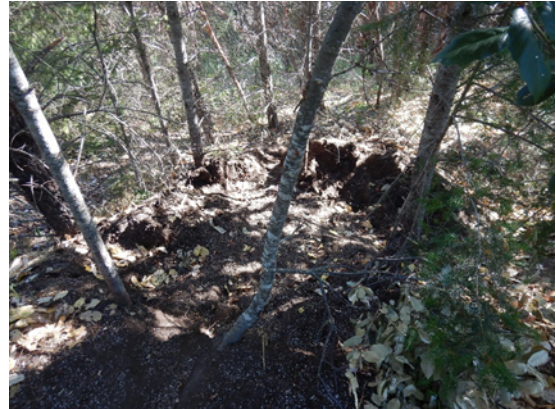
3. Stream and wetland buffers: I observed no water quality issues associated with wetland and riparian protection and management.
4. Spoils management: As mentioned above, I observed a large pile of potting soil spoils near cultivation area #1 at a location where the material may enter or be transported into receiving waters.

Photo 10 – Spoils pile of soil amendments.

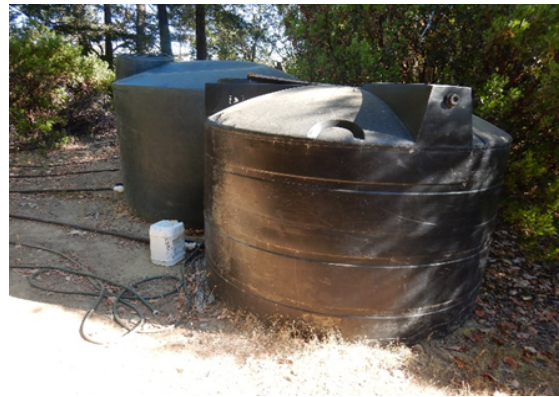
6. Irrigation runoff: I did not observe evidence of irrigation runoff during the inspection.
7. Fertilizers and soil amendments: As mentioned above, I observed fertilizer bottles and spent soil amendments sitting on the bare ground.

Photo 12 – Large water storage tanks with fertilizer bottles on the ground.

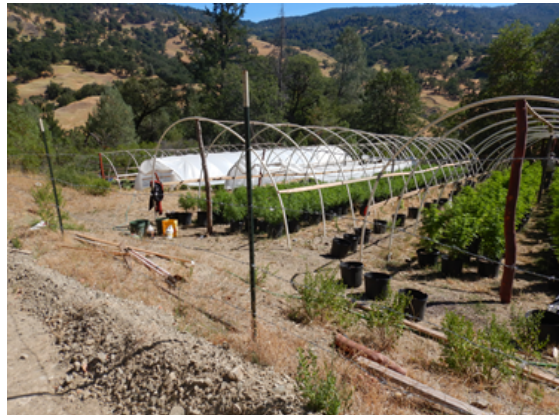
The remaining three cannabis cultivation areas # 2, 3, and 4, at inspection points 14, 16, and 19, were smaller than cannabis cultivation area #1, and with the exception of unknown chemical containers sitting on the ground at cultivation area #2, I did not observe any specific features of water quality concern in or associated with these areas.

Photo 14 – Cannabis cultivation area #2; plastic chemical containers are

visible on the ground at the end of the
hoop house frame toward the left side
of the photo.

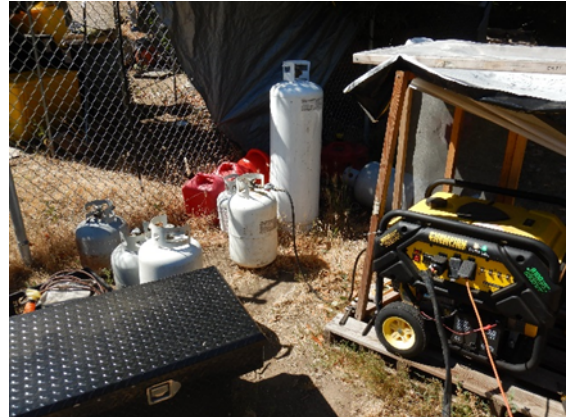
Photo 20 - Generator and gas tanks.

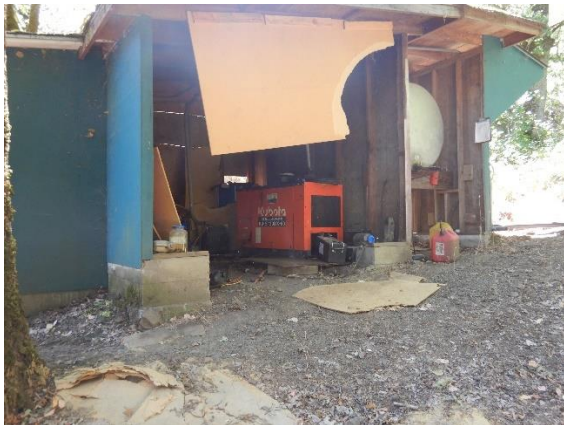
West of cannabis cultivation area #4, at inspection point 23, I observed a large diesel generator with a large fuel storage tank, approximately 10 feet from a class III watercourse (inspection point 22).

Photo 21 – Large diesel generator and large fuel storage tank.

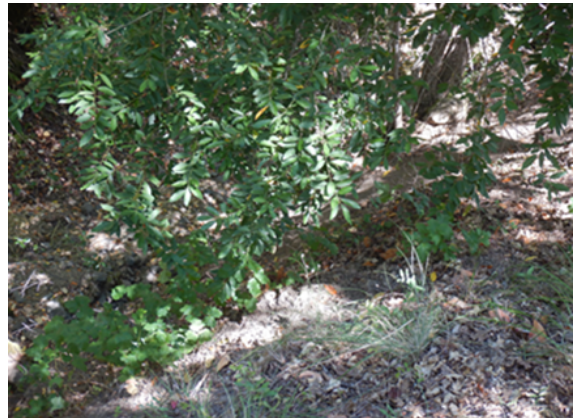
Photo 22 – Watercourse.

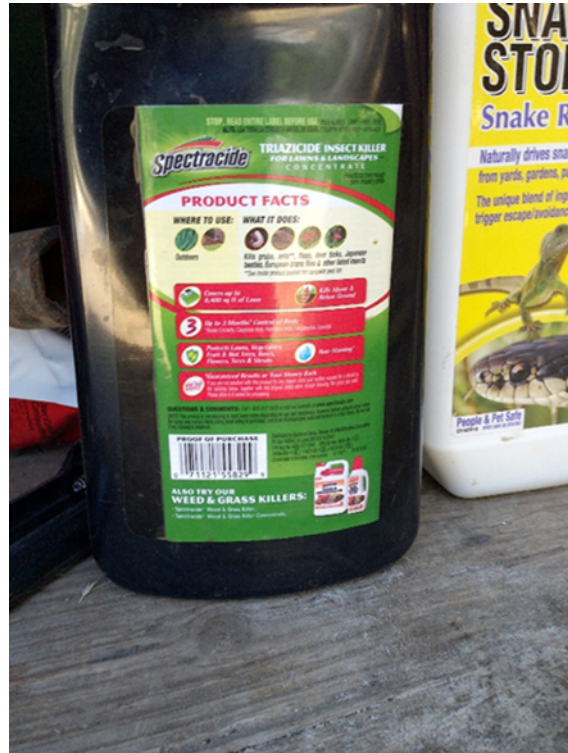
In a shed just west of cannabis cultivation area #4, at inspection point 24, I observed a container labeled as containing a pesticide, which is prohibited for use in cannabis cultivation.

Photo 24 – Pesticides.

5. Immediately remove and properly dispose of all illegal pesticides.
