Subject: Notice of Violation, Directive to Obtain Regulatory Coverage for Cannabis Cultivation, and Transmittal of Inspection Report for July 16, 2019, Inspection of Mendocino County Assessor's Parcel No. 056-490-27

Inspection Report for July 16, 2019, Warrant Inspection Mendocino County Assessor's Parcel Number 056-490-27

File: Cannabis Program Inspections, Mendocino County, July 2019 MCSO
Inspections, Black Mountain Spring LLC, CIWQS Place ID. 859924

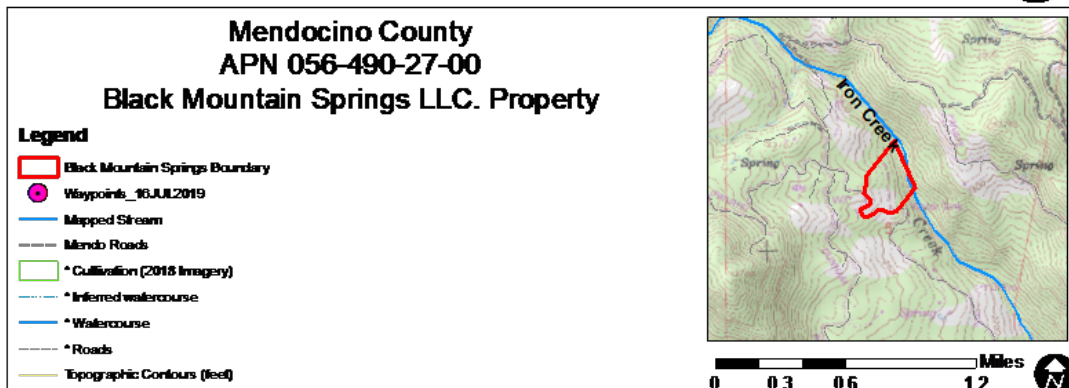
Inspection Map

On July 16, 2019, I inspected the Black Mountain Springs LLC property. The inspection map above, shows the inspection points identified and discussed below.

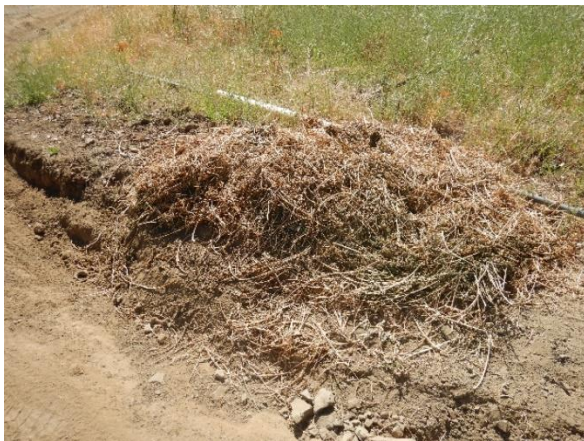
At cannabis cultivation area #2, I observed a hoop house full of cannabis plants. I observed a Class III watercourse approximately 40 feet north of the hoop house. Near the southeast corner of the hoop house, at inspection point 1, I observed cultivation waste piled on the outboard edge of the main access road. The waste at this location did not appear to pose a significant threat to receiving waters. At the north end of the hoop house, I observed pesticides sitting on the bare ground (inspection point 2).

Photo – 1 Cultivation waste (inspection Point 1).

6. Collect and dispose of or contain all refuse and cultivation-related wastes in a location and manner so as to minimize potential for these wastes to enter or be transported into receiving waters.

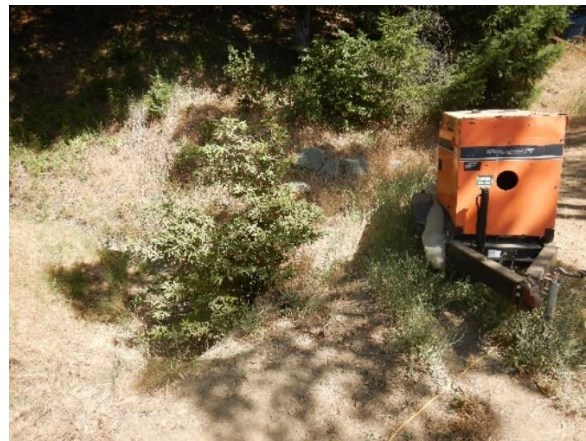
Just north of cannabis cultivation area #2, the access road crosses the Class III watercourse with a culverted crossing (inspection points 3/4/5). I observed a diesel generator and a large gas tank at this location (photos 2 and 5). The culvert appeared to be undersized, and I observed sediment and debris accumulated at the culvert inlet and outlet (photos 6 and 7). East of this crossing, a branch of the access road crosses the same Class III watercourse (inspection points 12/13). At this crossing, I observed an undersized culvert with sediment and debris deposits at the inlet, and trash and debris in the watercourse channel downstream of the culvert outlet.

8. Pesticides: As noted above, I observed pesticides uncovered/uncontained and posed a direct water quality concern.
9. Petroleum products and other chemicals: As noted above, I observed a diesel generator and a large gas tank adjacent to the Class III watercourse at the crossing at points 3/4.

Photo – 2 Diesel generator on a class III watercourse (inspection points 3 & 4).

2. Retain a qualified professional to develop a workplan and schedule to remove sediment and debris associated with inspection points 3, 5, 12, and 13, and restore the channel to its natural state. Dispose of all development and restoration-related earthen spoils in a manner to prevent/minimize transport and delivery to receiving waters. Remove diesel generator from watercourse crossing at inspection point 4.

7. Store and contain all chemicals, including petroleum, fertilizer and/or pesticides properly to prevent spillage and discharge to receiving waters. Provide secondary containment for all petroleum products.

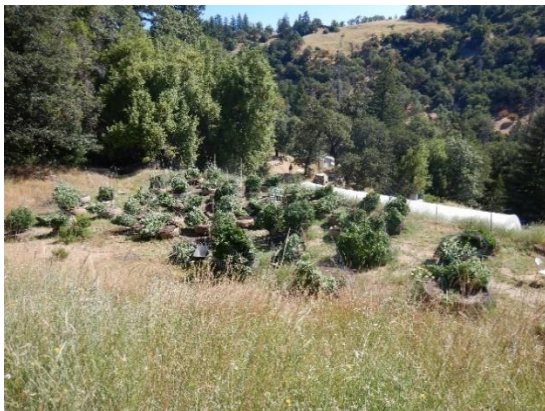
Cannabis cultivation area #1 consisted of a flat grassed upland plateau area with cannabis plants in grow bags. I did not observe any water quality concerns in this area.

Photo – 3 Cannabis cultivation area #1.

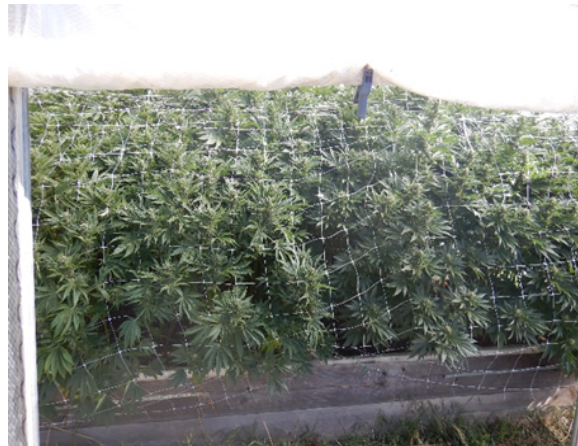
Photo – 4 Cannabis cultivation area #2.

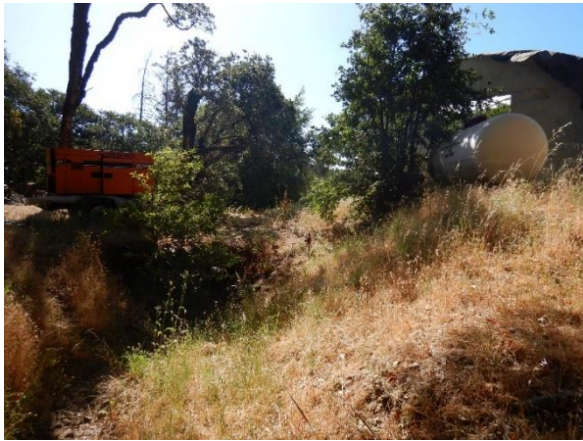
Photo 5 – Diesel generator above the culvert inlet at inspection point Cannabis cultivation area #2 and fuel tank are visible in this image and are less than 50 feet from the Class III watercourse at this location. (Inspection points 3, 4, and 5)

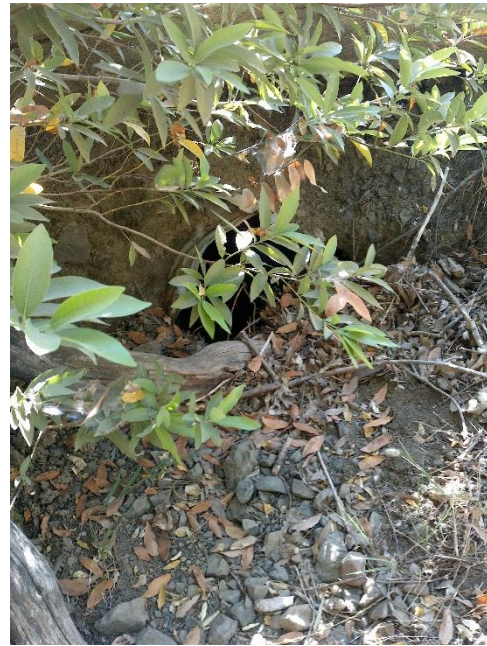
Photo – 6 Undersized culvert inlet filled with sediment and debris in watercourse. (Inspection points 3,4,5)

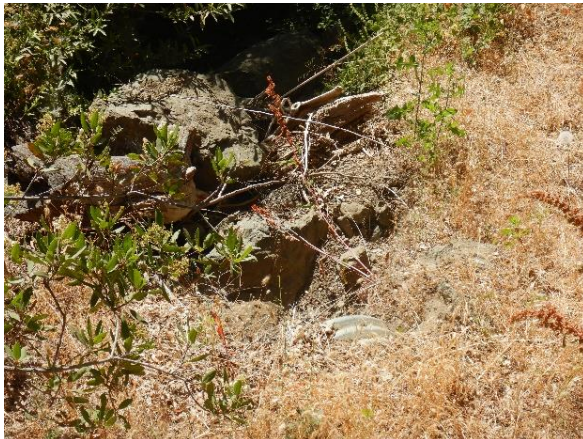
Photo – 7 Outlet of undersized culvert at inspection points 3, 4, and 5.

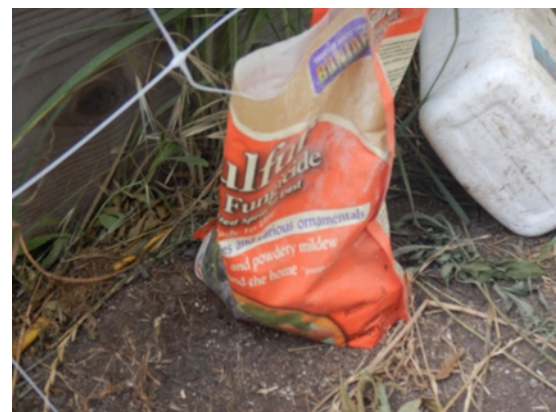
Photo – 8 Pesticide, fertilizer, and sediment, debris, and trash are visible in the netting.

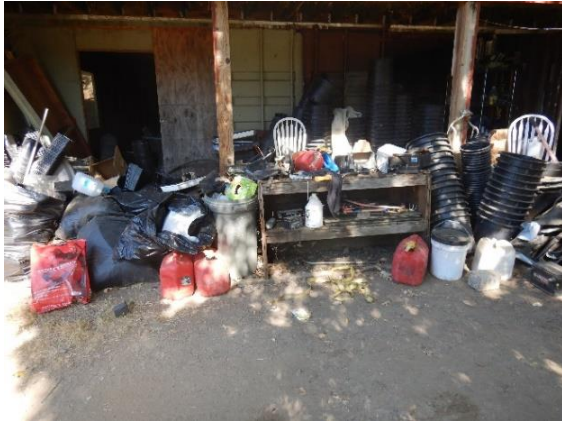
Near the house in the center of the property, at inspection point 6, I observed pesticides, fertilizers, chemicals and other cultivation materials sitting on the bare ground at location where spills/leaks could enter or be transported into receiving waters.

Photo – 9 Storage area with petroleum products, chemicals, cultivation materials.

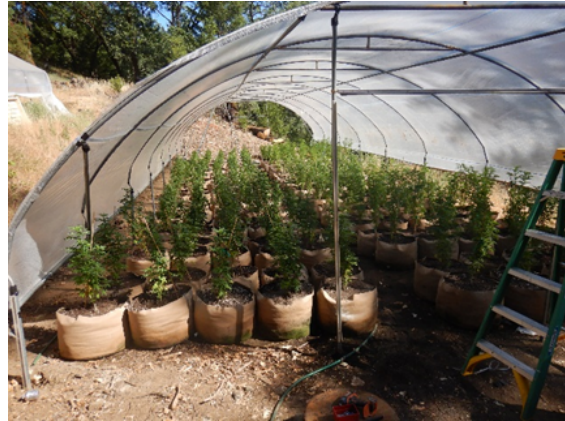
Photo 10 – Cannabis cultivation area #3.

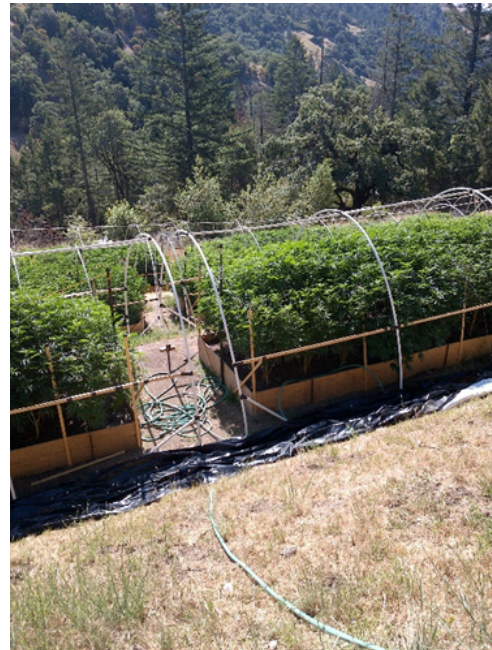
Photo – 12 Cannabis cultivation area #4.

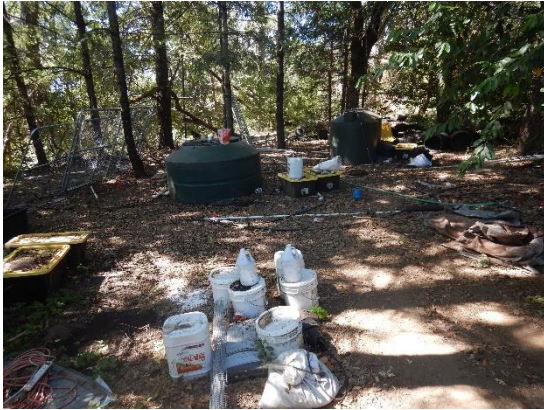
South of cannabis cultivation area #4, I observed two water storage tank areas (inspection point 9 and 10/11). I observed numerous chemical and fertilizer bottles sitting and lying on the ground around the water storage tanks at inspection point 9 stored on the ground (photo 13). The southern edge of flat where inspection point 9 was located was approximately 70 feet from the Class III watercourse moving through the parcel from west to east.

Photo – 13 Secondary tank area with fertilizers and other chemicals on the ground.

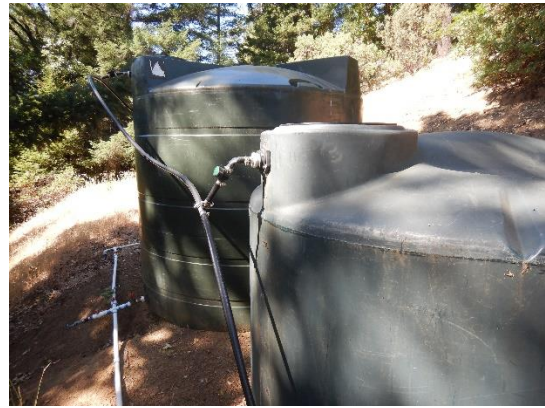
On the hillslopes below the water storage tank area at inspection points 10/11, I observed surface erosion apparently resulting from water overflows/discharges from the water tanks (photos 14 and 15), however I did not observe any water quality concerns.

Photo – 14 Primary water tank storage area.

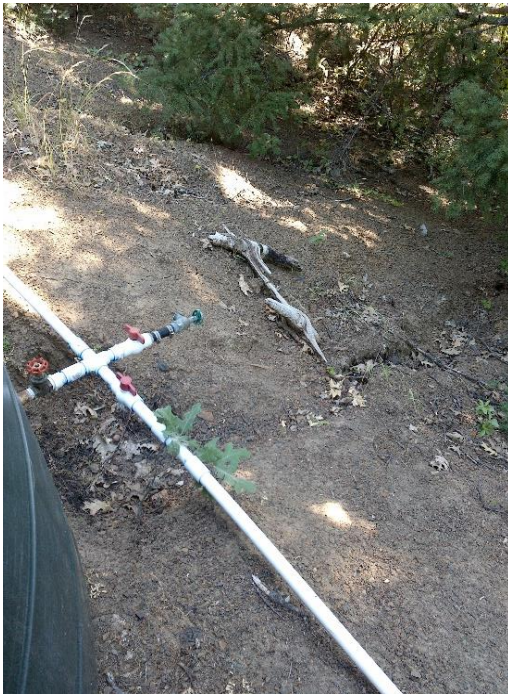
5. Water storage and use: I observed a groundwater well, as well as the two above-mentioned water storage tank areas (points 9 and 10/11). I observed rill erosion at the base of the storage tank area at 10/11, resulting from overflows/discharges from the water tanks.

Photo – 15 Rill erosion caused by discharge from water storage tanks.

1. Retain a licensed professional to inventory, assess, and develop a workplan and schedule to implement measures to ensure that all developed features, roads, watercourse crossings, and cultivation areas throughout the Property are corrected, restored, and/or maintained in conditions that prevent or minimize erosion, sediment transport/delivery, and adverse impacts to water quality and beneficial uses. Include measures to ensure that unstable features caused or affected by onsite development and operations are removed or otherwise protected so as to minimize the potential for these features to cause adverse impacts to water quality and beneficial uses. Dispose of all development and restoration-related earthen spoils in a manner to prevent/minimize transport and delivery to receiving waters.

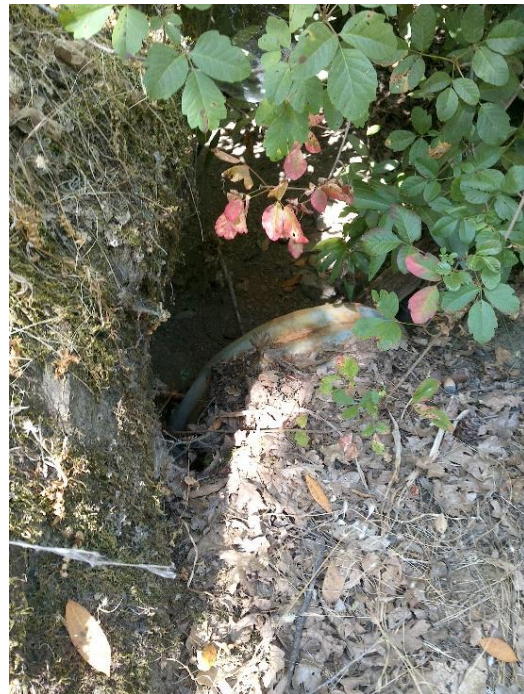
6	Pesticides, fertilizers, and chemicals	Pesticide, fertilizers, chemicals and other cultivation materials sitting on bare ground, uncovered/ uncontained.	Threatened discharge of waste to waters of the state.	9
7	Access Road	Rill erosion within the road prism.	Threatened discharge of waste to waters of the state.	11
9, 10, and 11	Water storage areas	Two water storage tank areas. Chemical containers on the ground around the tanks at point 9. Erosional rills on the slope below the tanks at point 10/11.	Threatened discharge of waste to waters of the state.	13 - 15
12 and 13	Watercourse Crossing	Undersized culvert with sediment accumulation in the inlet. Trash and debris in watercourse downstream of culvert outlet.	Discharge threatened discharge of waste to waters of the state.	16 - 18

Photo – 16 An undersized culvert with sediment discharge.

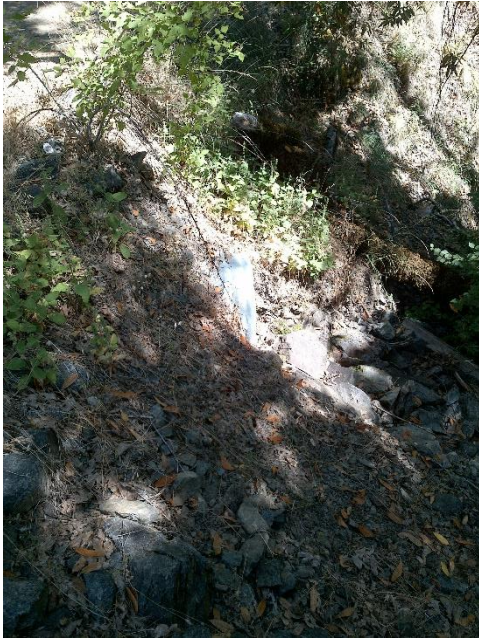
Photo – 17 Culvert outlet.

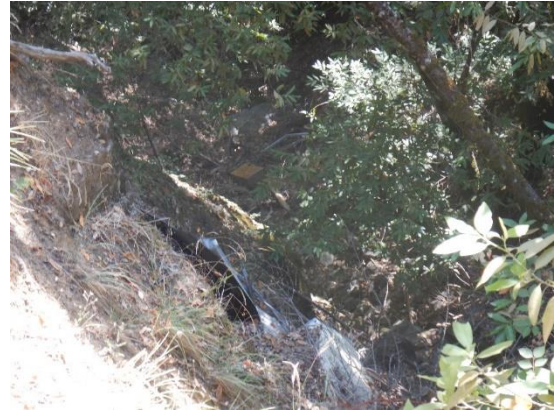
11. Refuse and human waste: I observed refuse on the ground at various locations throughout the property. Refuse was observed in a class III watercourse at inspection point 13. I did not observe or review human waste containment/disposal features on the property.

Photo – 18 View of stream channel with
trash and debris.
