Subject: Notice of Violation, Directive to Obtain Regulatory Coverage for Cannabis Cultivation, and Transmittal of Inspection Report for July 17, 2019, Inspection of Mendocino County Assessor's Parcel No. 036-230-48

Inspection Report for July 17, 2019, Warrant Inspection Mendocino County Assessor's Parcel Number 036-230-48

File: Cannabis Program Inspections, Mendocino County, July 2019 MCSO
Inspections, Cherie Sexton, CIWQS Place ID.859929

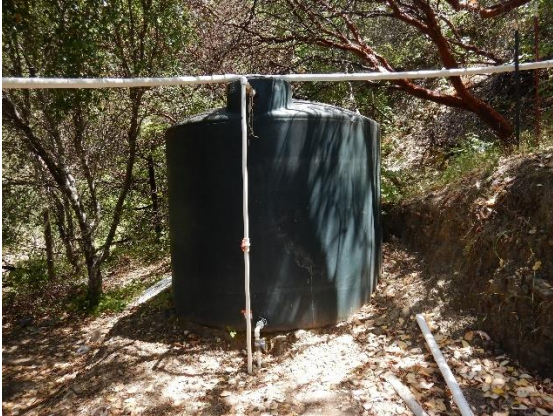
5. Water storage and use: As noted above, I observed two large water storage containers near the entrance of the Property. These tanks also had intake pipes for water delivery. In addition, I observed a groundwater well near the water tanks. I also observed three smaller 300-gallon tanks with an unidentified chemical in them.

Photo 1 – Water tank storage.

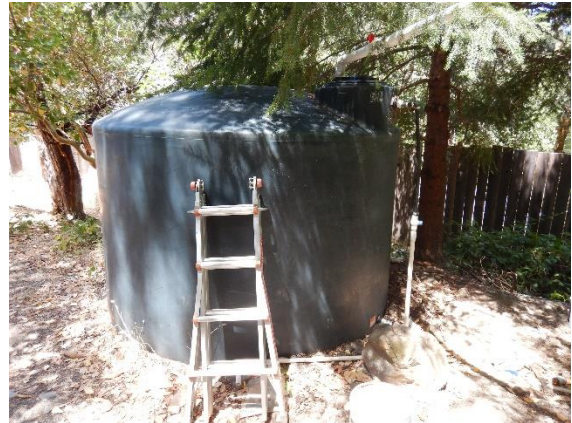
Photo 2 – Water storage tank.

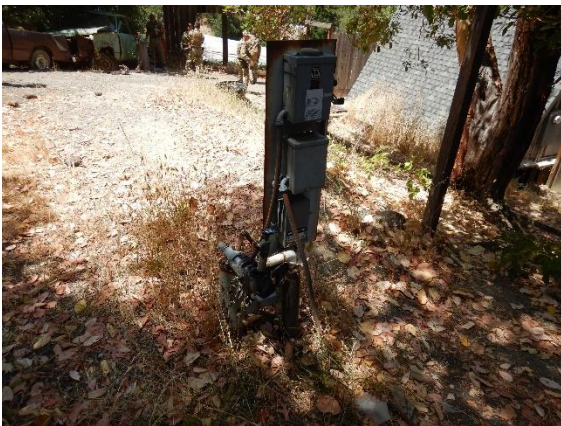
Photo 3 - Ground water well and pump.

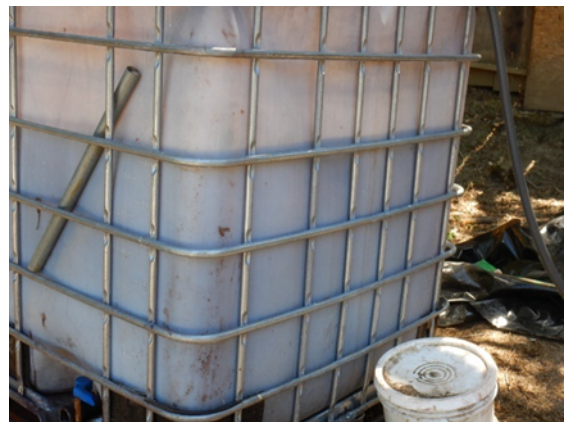
Photo 4 – Water storage with chemical

3. Discontinue use of and dismantle any outhouse/pit toilet features and work with Mendocino County to ensure that all domestic and human wastes are collected and disposed of consistent with applicable County requirements.
4. Collect and dispose of or contain all refuse and cultivation-related wastes in a location and manner so as to minimize potential for these wastes to enter or be transported into receiving waters.
5. Store and contain all chemicals, including petroleum, fertilizer and/or pesticides properly to prevent spillage and discharge to receiving waters. Provide secondary containment for all petroleum products.

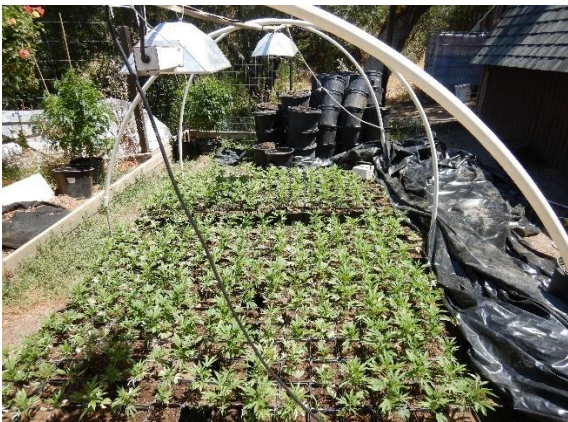
Photo 5 – Cannabis cultivation area insp.
pt. 4.

1.If the property owner and/or tenant(s) choose to continue to cultivate cannabis, enroll for coverage under and take steps to comply with the requirements of the CANGO (Order WQ 2017-0023-DWQ, General Waste Discharge Requirements and Waiver of Waste Discharge Requirements for Discharges of Waste Associated with Cannabis Cultivation Activities). More information about the CANGO can be found at this hyperlink:

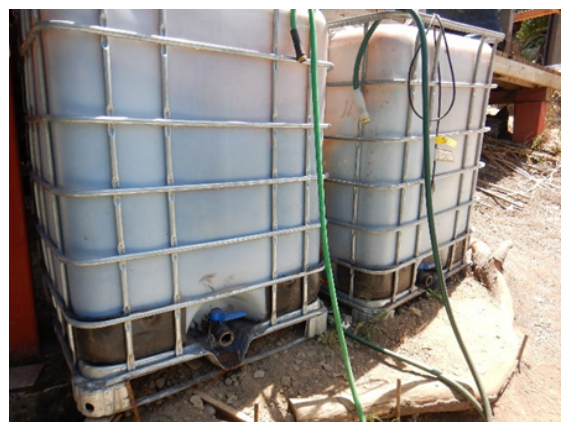
Photo 6 – Water container with
chemicals in it.

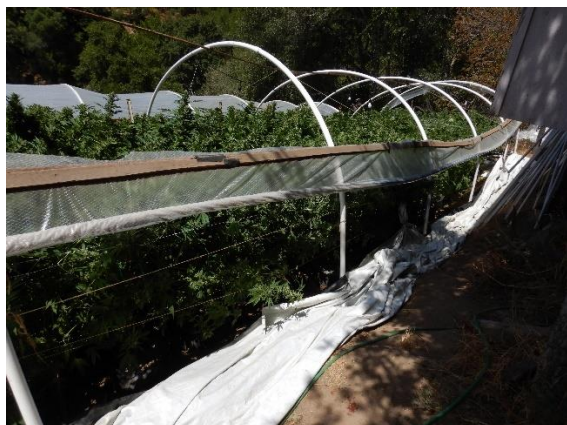
Photo 7 –Cannabis cultivation area insp.
pt. 5.

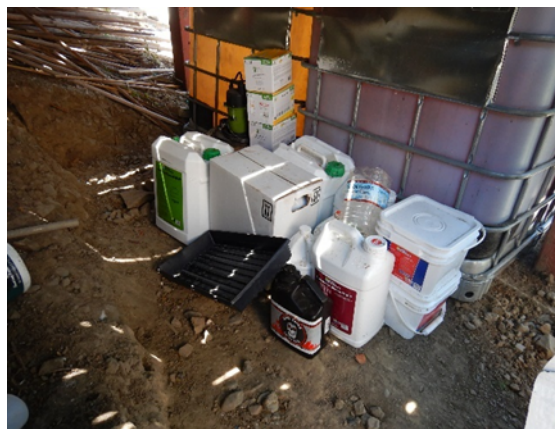
7. Fertilizers and soil amendments: As noted above, I observed fertilizers lying on the ground, uncovered and uncontained.
8. Pesticides: As noted above, I observed pesticides lying on the ground, uncovered and uncontained.

9. Petroleum products and other chemicals: I observed containers of petroleum and other chemicals on the ground.
10. Cultivation-related wastes: Apart from the spoils mentioned above, I observed no other water quality issues associated with storage/disposal of cultivation-related wastes.

Photo 8 – Chemicals, fertilizers,
pesticides

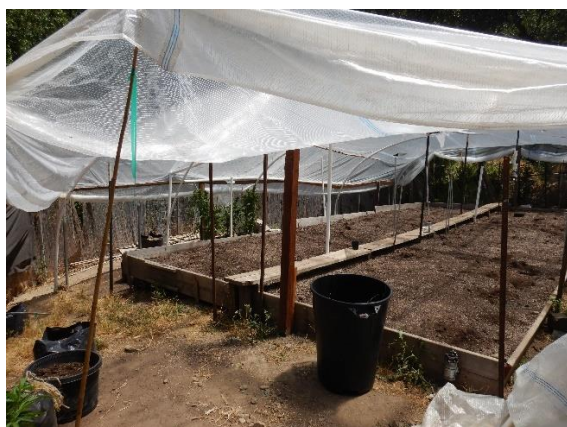
Photo 9 – Cannabis cultivation area insp.
pt. 8.

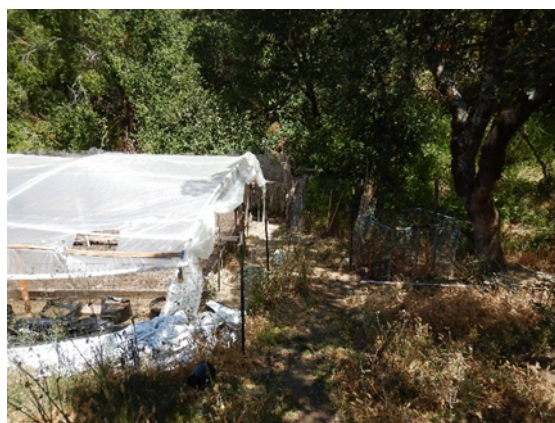
At inspection points, 1 and 2, I observed two large water tanks and a groundwater well. One of the water tanks had an intake pipe for water delivery service. At inspection points 4, 5, 8, 9, and 14 I observed cannabis cultivation areas. Cannabis cultivation at inspection points 9 and 14 is less than 200 feet from a class III watercourse. At inspection points 3 and 6, I observed 300-gallon water tanks filled with an unidentified chemical substance (photos 3 and 6). I observed fertilizers, pesticides, and chemicals on the bare ground at inspection point 7. I observed three areas where old harvested cultivation waste with soil medium had been dumped near surface waters (inspection points 10, 11, and 12). At inspection point 13, I observed an outhouse less than 75 feet from a class III watercourse.

6. Irrigation runoff: As noted above, two of the cultivation areas are close to surface waters, at locations where irrigation runoff would pose a threat to water quality.

Photo 10 – Cannabis cultivation area
insp. pt. 9.

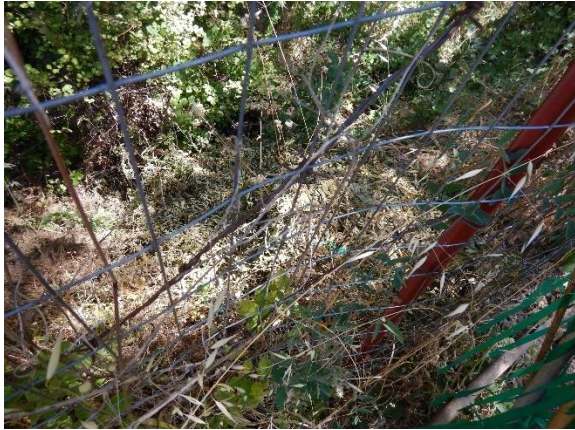
1. Site maintenance, erosion control and drainage features: I observed no water quality issues associated with site maintenance, erosion control, or drainage features.
2. Stream crossing maintenance and improvement: I observed no stream crossings during the inspection.
3. Stream and wetland buffers: I observed two cannabis cultivation areas located less than 200 feet from a class III watercourse.
4. Spoils management: As noted above, I observed cultivation-related potting soil spoils and plant waste at locations where material could enter or be transported into a class III watercourse. These spoils were approximately 25 feet away from the watercourse.

Photo 11 – Cannabis cultivation waste near a watercourse.

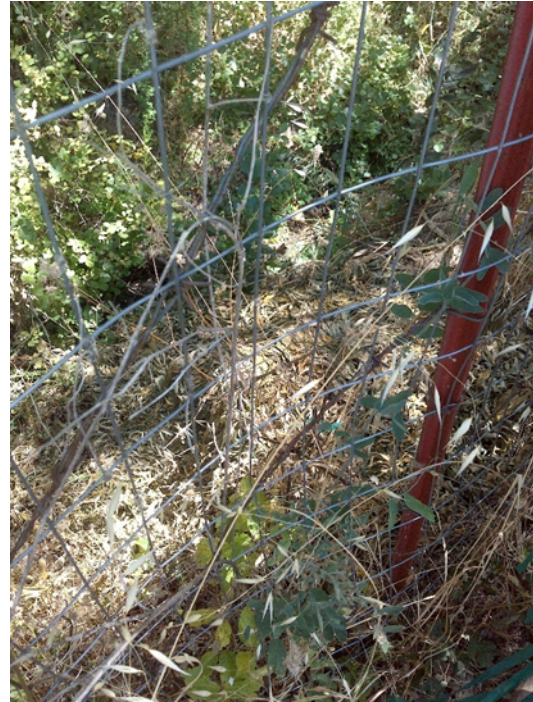
Photo 12 – Cannabis cultivation waste near a watercourse.

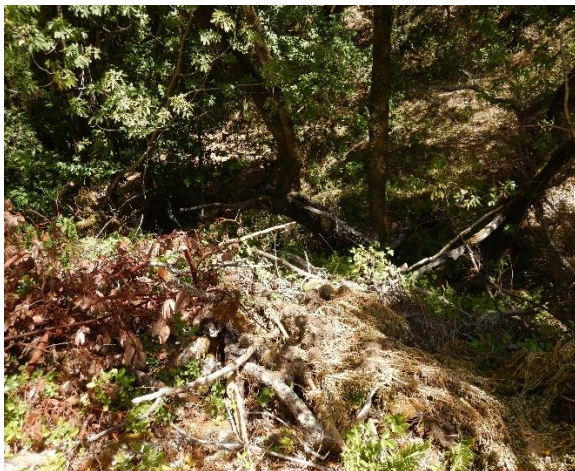
Photo 13 – Cannabis cultivation waste near a watercourse.

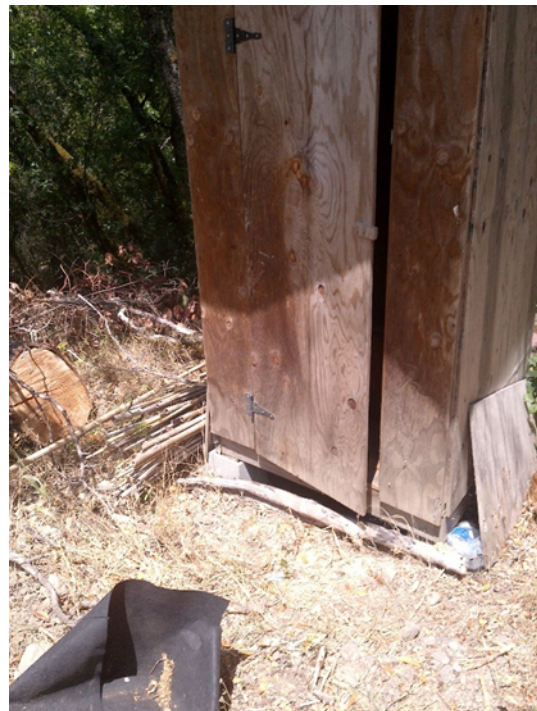
11. Refuse and human waste: As noted above, I observed an outhouse approximately 75 feet from a watercourse.

Photo 14 – Outhouse near a watercourse.

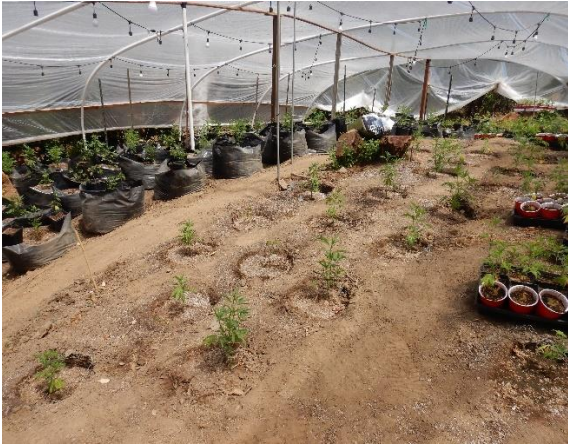
Photo 15 – Cannabis cultivation area insp.
pt. 14.
