North Coast Regional Water Quality Control Board

Subject: Notice of Violation, Directive to Obtain Regulatory Coverage for Cannabis Cultivation, and Transmittal of Inspection Report for September 3, 2019, Inspection of Humboldt County Assessor's Parcel Nos. 107-112-001 and -002

Inspection Report for September 03, 2019, Warrant Inspection Humboldt County Assessor's Parcel Numbers 107-112-001 and -002

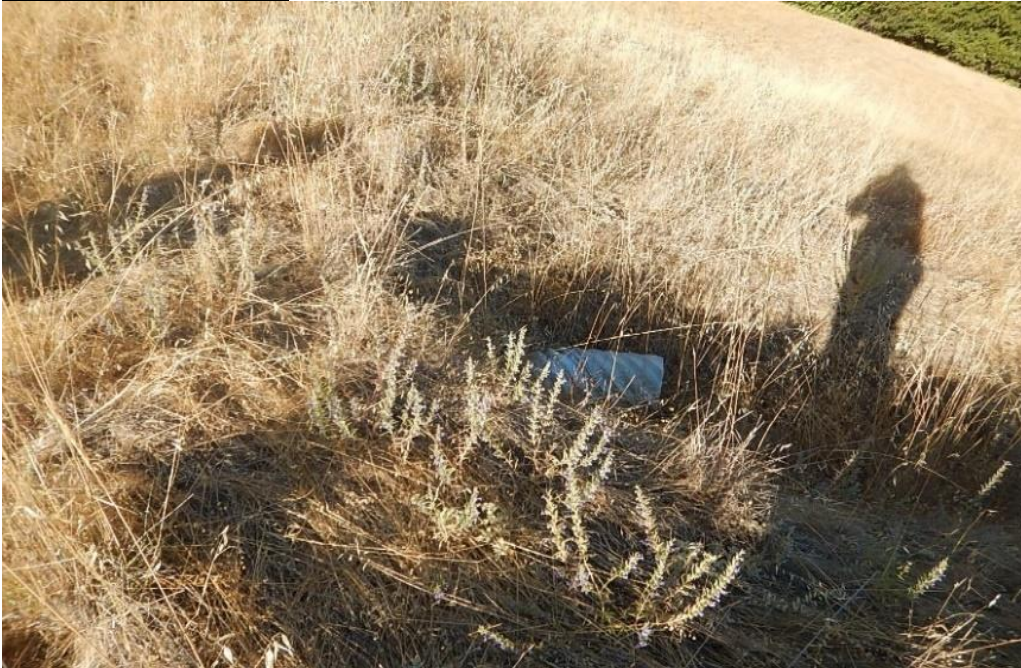
CMP, just south of OG1, (photo 1) is a culverted stream crossing, not properly constructed to provide stable conveyance for stream flows. It is longer than the road prism on the outlet side causing erosion to the streambed of a class III watercourse, threatening sediment delivery.

<i>Map point</i>	<i>Feature</i>	<i>Brief Description</i>	<i>Water Quality Concern</i>	<i>Associated Photo(s)</i>
CMP	Culverted stream crossing	Road built through Class III water course; evidence of sediment delivery.	Discharge and threatened discharge of waste to waters of the state	Photo 1

2. Stream crossing maintenance and improvement: I observed a stream crossing (CMP) on the access road to the property; as discussed above. CMP is poorly constructed culverted crossings, causing or resulting in active discharge of sediment to class III water course.

Photo 1 Culverted stream crossing at inspection point CMP

1. Retain a licensed professional to inventory, assess, and develop a workplan and schedule to implement measures to ensure that all developed features, roads, watercourse crossings, and cultivation areas throughout the Property are corrected, restored, and/or maintained in conditions that prevent or minimize erosion, sediment transport/delivery, and adverse impacts to water quality and beneficial uses. Include measures to ensure that unstable features caused or affected by onsite development and operations are removed or otherwise protected so as to minimize the potential for these features to cause adverse impacts to water quality and beneficial uses. Dispose of all development and restoration-related earthen spoils in a manner to prevent/minimize transport and delivery to receiving waters.

2. Prior to conducting any instream work associated with recommendation 1, above, submit to the Regional Water Board an application for Clean Water Act section 401 water quality certification, and secure approval from the Regional Water Board.

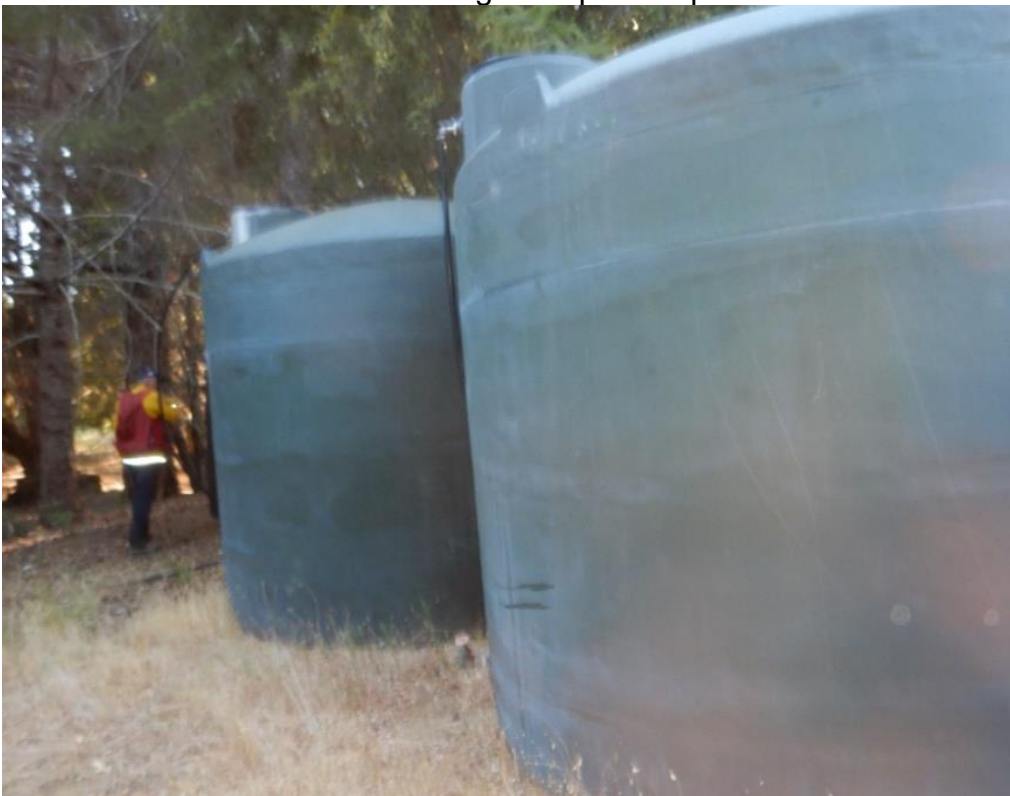
WST1 and WST2 (Photo 2 and Photo 6) are water storage tanks located on the northwestern and northeastern parts of the property respectively. The tanks at WST1 are positioned on a steep slope and pose a threat to water quality in times of storm events.

<i>Map point</i>	<i>Feature</i>	<i>Brief Description</i>	<i>Water Quality Concern</i>	<i>Associated Photo(s)</i>
WST1	Water storage tanks	Water storage tanks placed on a steep slope	Threatened discharge	Photo 2
GH1, GH2 and OG1	Cannabis cultivation areas	2 greenhouses and one open cultivation area with active cannabis cultivation	Cannabis cultivation without report of waste discharge and/or enrollment in Water Boards cannabis program.	Photos 3,4 and 8

5. Water storage and use: As noted above, the water storage tanks at WST1 are on a steep, unstable location which may fail and deliver sediment to waters of the state.

Photo 2 water storage tanks at inspection point WST1

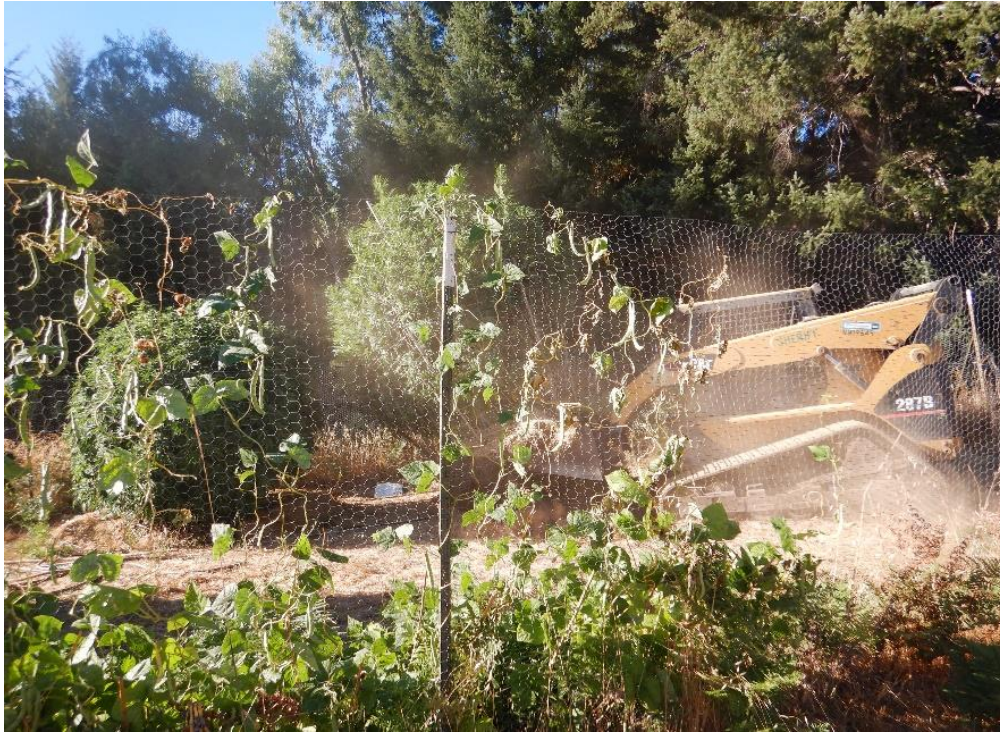
OG1 (photo 3), the first cannabis cultivation area we inspected, was located about 500 feet east of the northwestern property line. This area has a flat topography covering an approximate area of 5,000 square feet. GH1 (Photo 4) is a greenhouse located at the southwestern part of the property, with a total area of approximately 2,500 square feet.

Photo 3, Open grow at inspection point OG1

3. If the property owner and/or tenant(s) choose to continue to cultivate cannabis, enroll for coverage under and take steps to comply with the requirements of the CANGO (Order WQ 2019-0001-DWQ, General Waste Discharge Requirements and Waiver of Waste Discharge Requirements for Discharges of Waste Associated with Cannabis Cultivation Activities). More information about the CANGO can be found at this hyperlink:

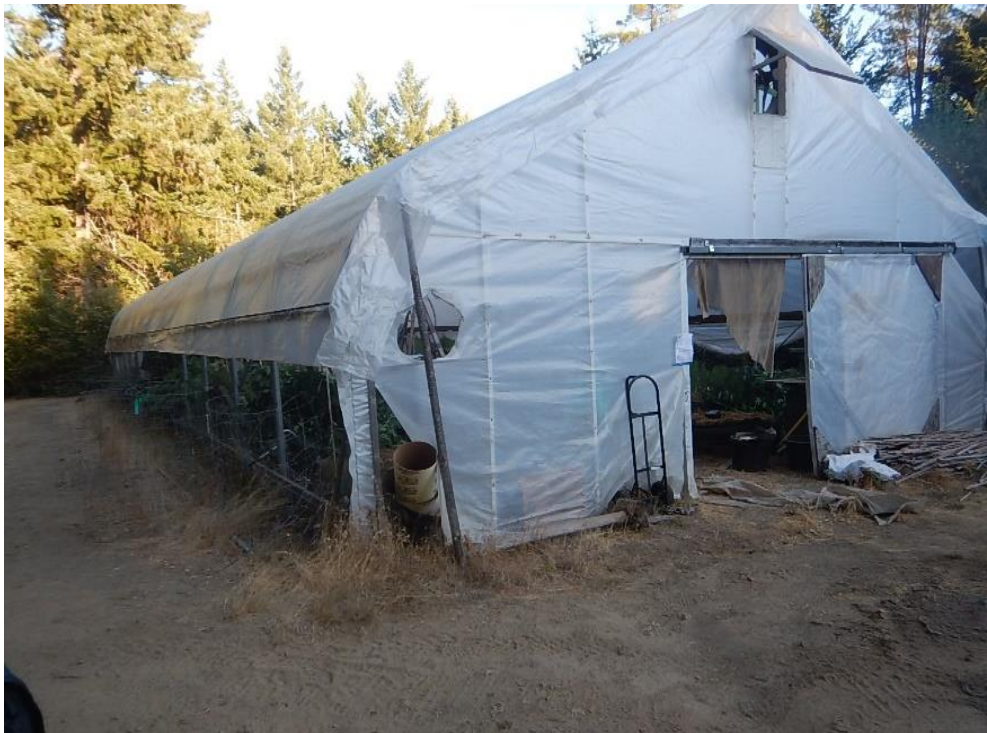
Photo 4, Green house at inspection point GH1

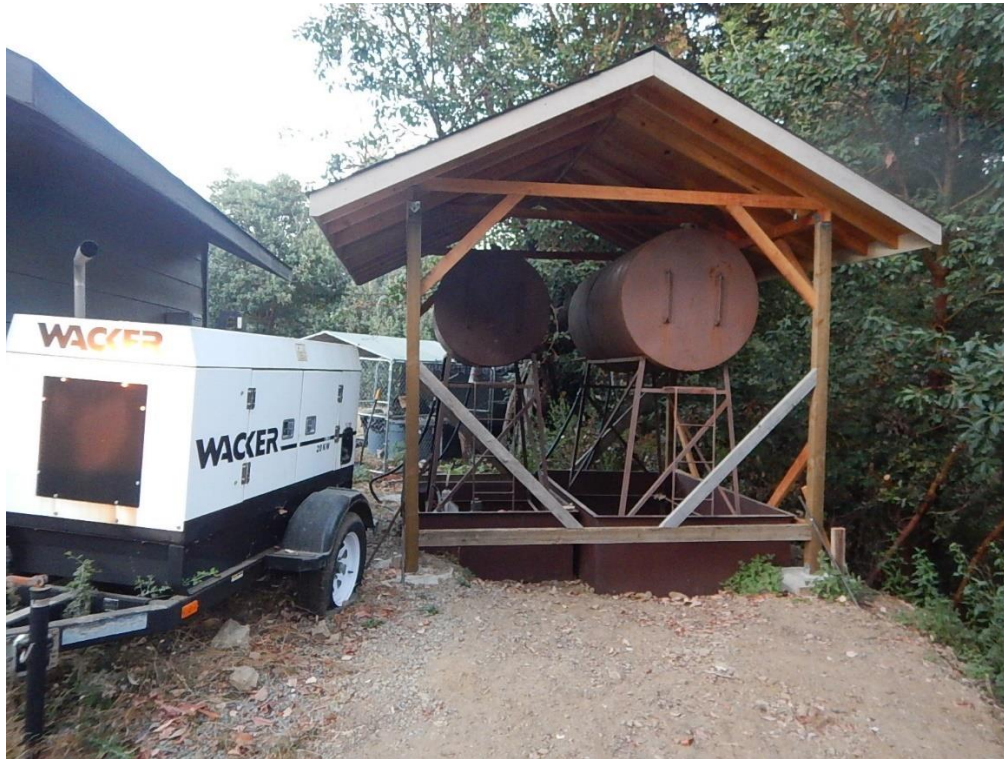
Fuel (Photo 5), located near the northeastern corner of the property, is a structure providing a roof and secondary containment for petroleum storage, with a generator in a trailer parked alongside. Just south of the fuel and water storage at Fuel and WST2, I observed a cultivation area with food agriculture greenhouses, including GH2 (Photo 8), a greenhouse with cannabis cultivation area of approximately 300 square feet. In this area, I observed a fertilizer storage area (Fert) that appeared to provide adequate cover and containment (Photo 7).

Photo 5, Petroleum and generator at inspection point Fuel

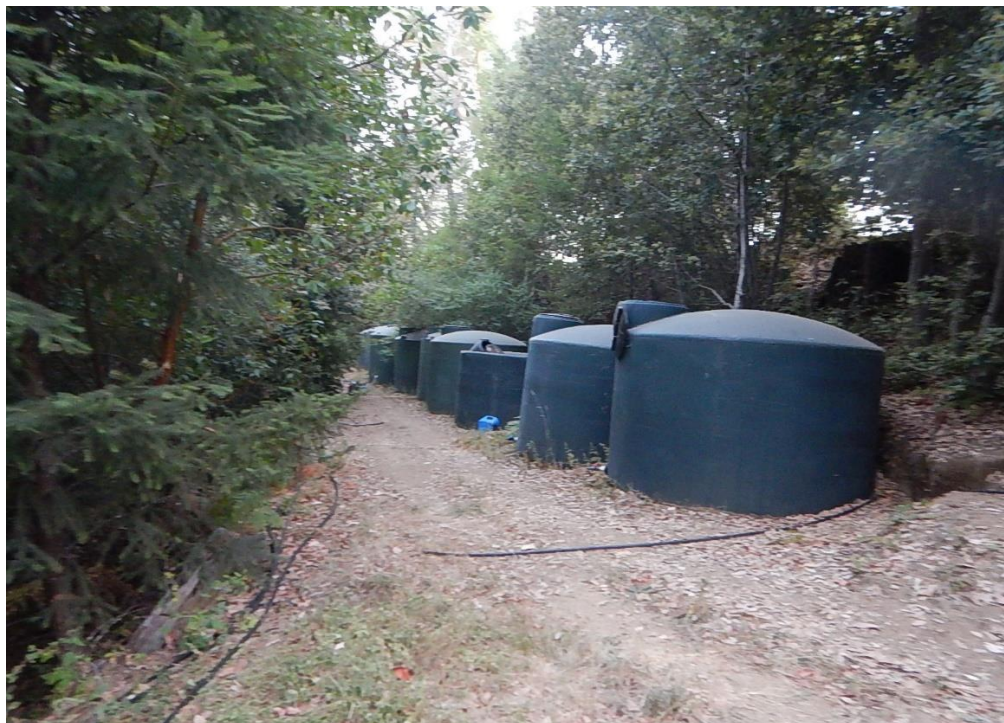
Photo 6, Water storages at inspection point WST2

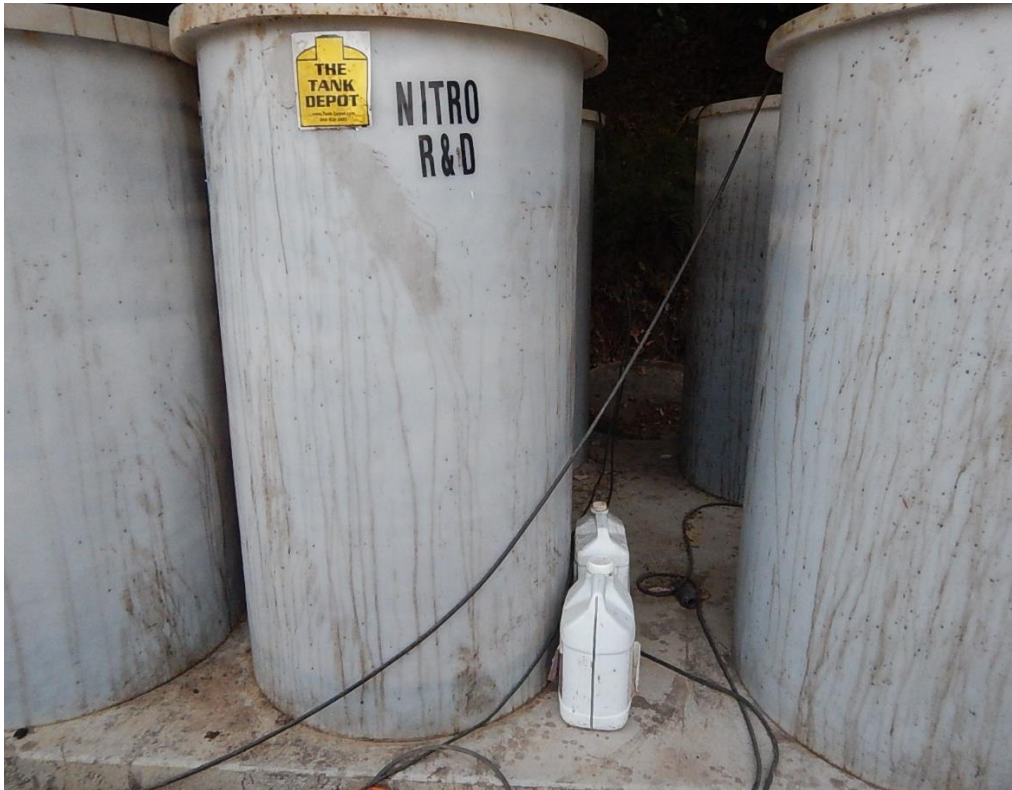
Photo 7, Fertilizers at inspection point Fert

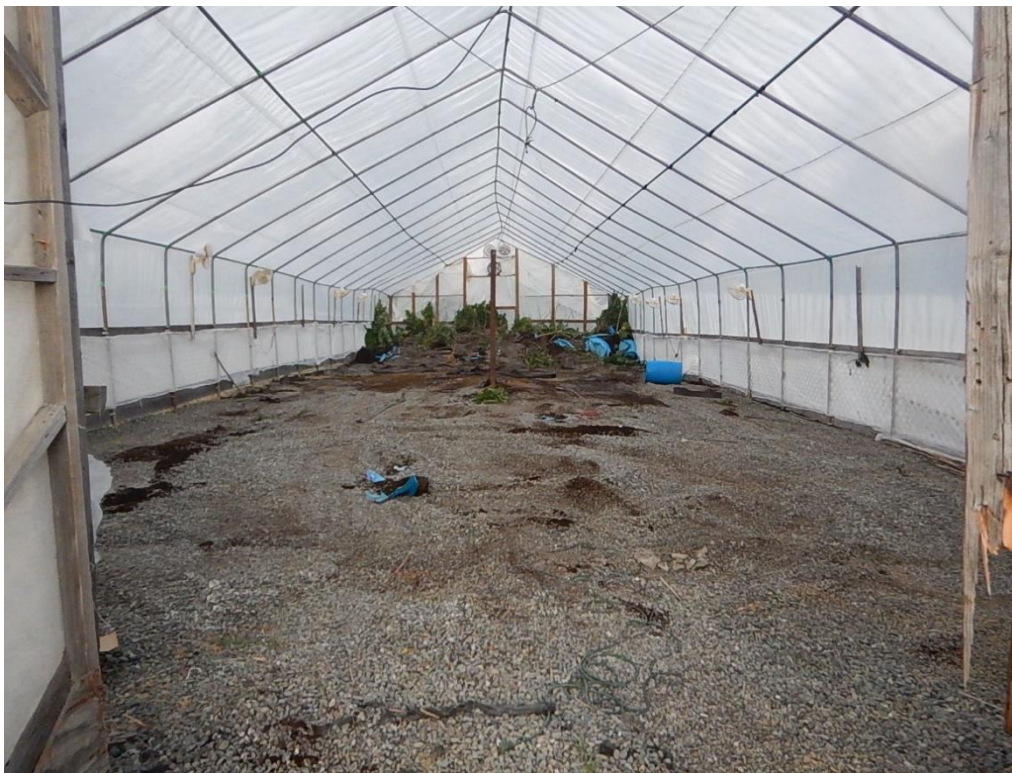
Photo 8, Green house at inspection point GH2
