North Coast Regional Water Quality Control Board

Subject: Notice of Violation, Directive to Obtain Regulatory Coverage for Cannabis Cultivation, and Transmittal of Inspection Report for September 5, 2019, Inspection of Humboldt County Assessor's Parcel Nos. 529-281-006-000 and 529-285-005-000

**Inspection Report for September 5, 2019, Warrant Inspection
Humboldt County Assessor's Parcel Numbers 529-281-006-000
and 529-285-005-000.**

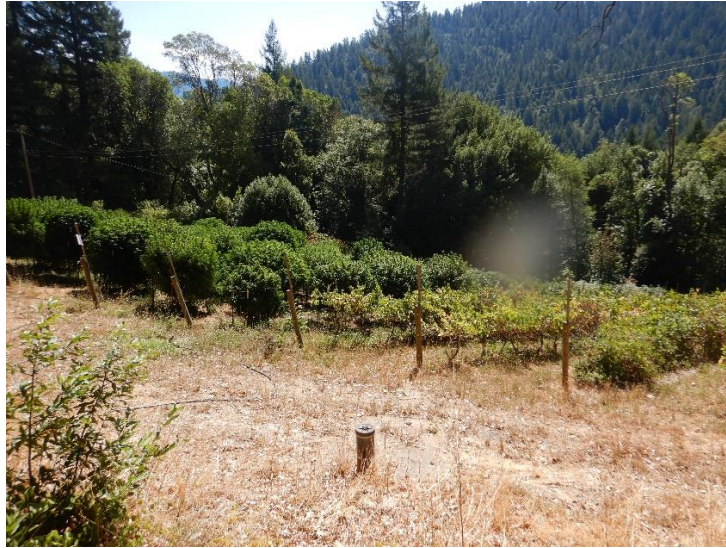
<i>Map point</i>	<i>Feature</i>	<i>Brief Description</i>	<i>Water Quality Concern</i>	<i>Associated Photo(s)</i>
WQ 1	Cannabis cultivation area	Approximately 12,000 square feet of outdoor cannabis cultivation adjacent to a vineyard of similar size	Cannabis cultivation/discharge of waste without a report of waste discharge and/or coverage under State Water Board regulatory order	Photo 1
WQ 2	Culverted watercourse	Culvert is rusted, 18" to 24" in diameter, perched and upstream from a 5 foot wide channel.	Threatened discharge of waste to receiving waters.	Photo 2
WQ 3	Pit toilet	Pit toilet is approximately 50 feet from watercourse.	Threatened discharge of waste to receiving waters.	Photo 3

Photo 1—Approximately 12,000 square feet of cannabis growing outdoors in the vicinity of WQ 1. Plants in the left of the image are cannabis.

3. If the property owner and/or tenant(s) choose to continue to cultivate cannabis, enroll for coverage under and take steps to comply with the requirements of the Statewide General Order (Order WQ 2019-0001-DWQ, General Waste Discharge Requirements and Waiver of Waste Discharge Requirements for Discharges of Waste Associated with Cannabis Cultivation Activities). More information about the Statewide General Order can be found at this hyperlink:

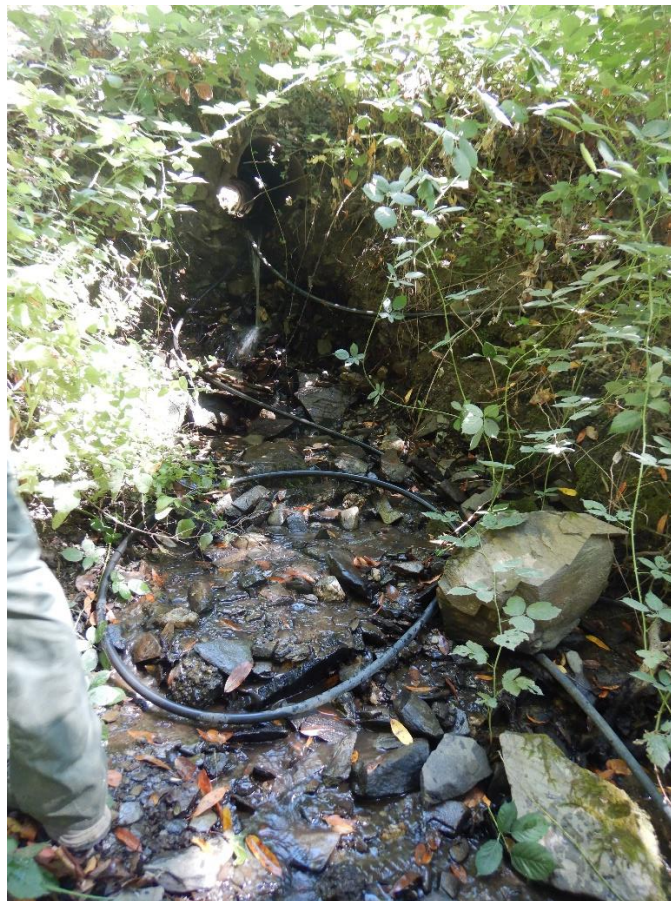
The culvert located at WQ 2 is undersized, perched and rusted to the point that water is flowing below the culvert (Photo 2).

Photo 2—Approximate 5-foot wide watercourse with 18 to 24-inch diameter culvert that has rusted through the bottom below the road upstream.

1. Retain a qualified professional to develop a workplan and schedule to decommission or replace the watercourse crossing at WQ 2. Dispose of all development and restoration-related earthen spoils in a manner to prevent/minimize transport and delivery to receiving waters.
2. Prior to conducting any instream work associated with recommendation 1, above, submit to the Regional Water Board an application for Clean Water Act section 401 water quality certification, and secure approval from the Regional Water Board.

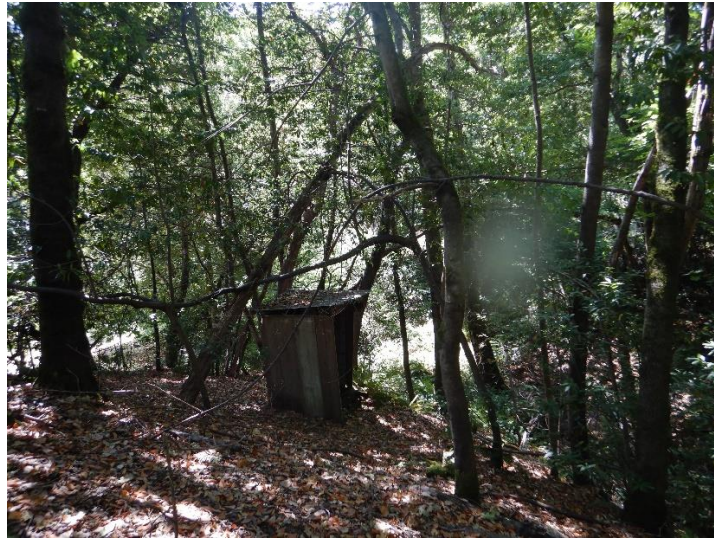
11. Refuse and human waste: Staff did not observe water quality concerns associated with storage or disposal of refuse. As noted above, the pit toilet at WQ 3 is approximately 50 feet from a watercourse (Photo 3).

Photo 3—Outhouse. Note watercourse is in background of image.

5. Discontinue use of and dismantle any outhouse features and work with Humboldt County to ensure that all domestic and human wastes are collected and disposed of consistent with applicable County requirements.
