**Subject: Notice of Violation, Directive to Obtain Regulatory Coverage for Cannabis Cultivation, and Transmittal of Inspection Report for September 4, 2019, Inspection of Humboldt County Assessor's Parcel Nos. 315-173-004 and 315-174-003**

### **Inspection Report for September 04, 2019, Warrant Inspection Humboldt County Assessor's Parcel Numbers 315-173-004 and 315-174-003**

File: Cannabis Program Inspections, Humboldt County, September 2019 HCSO  
CAMP Inspections, Jalal Ahmad Tahir, CIWQS Place ID 828457

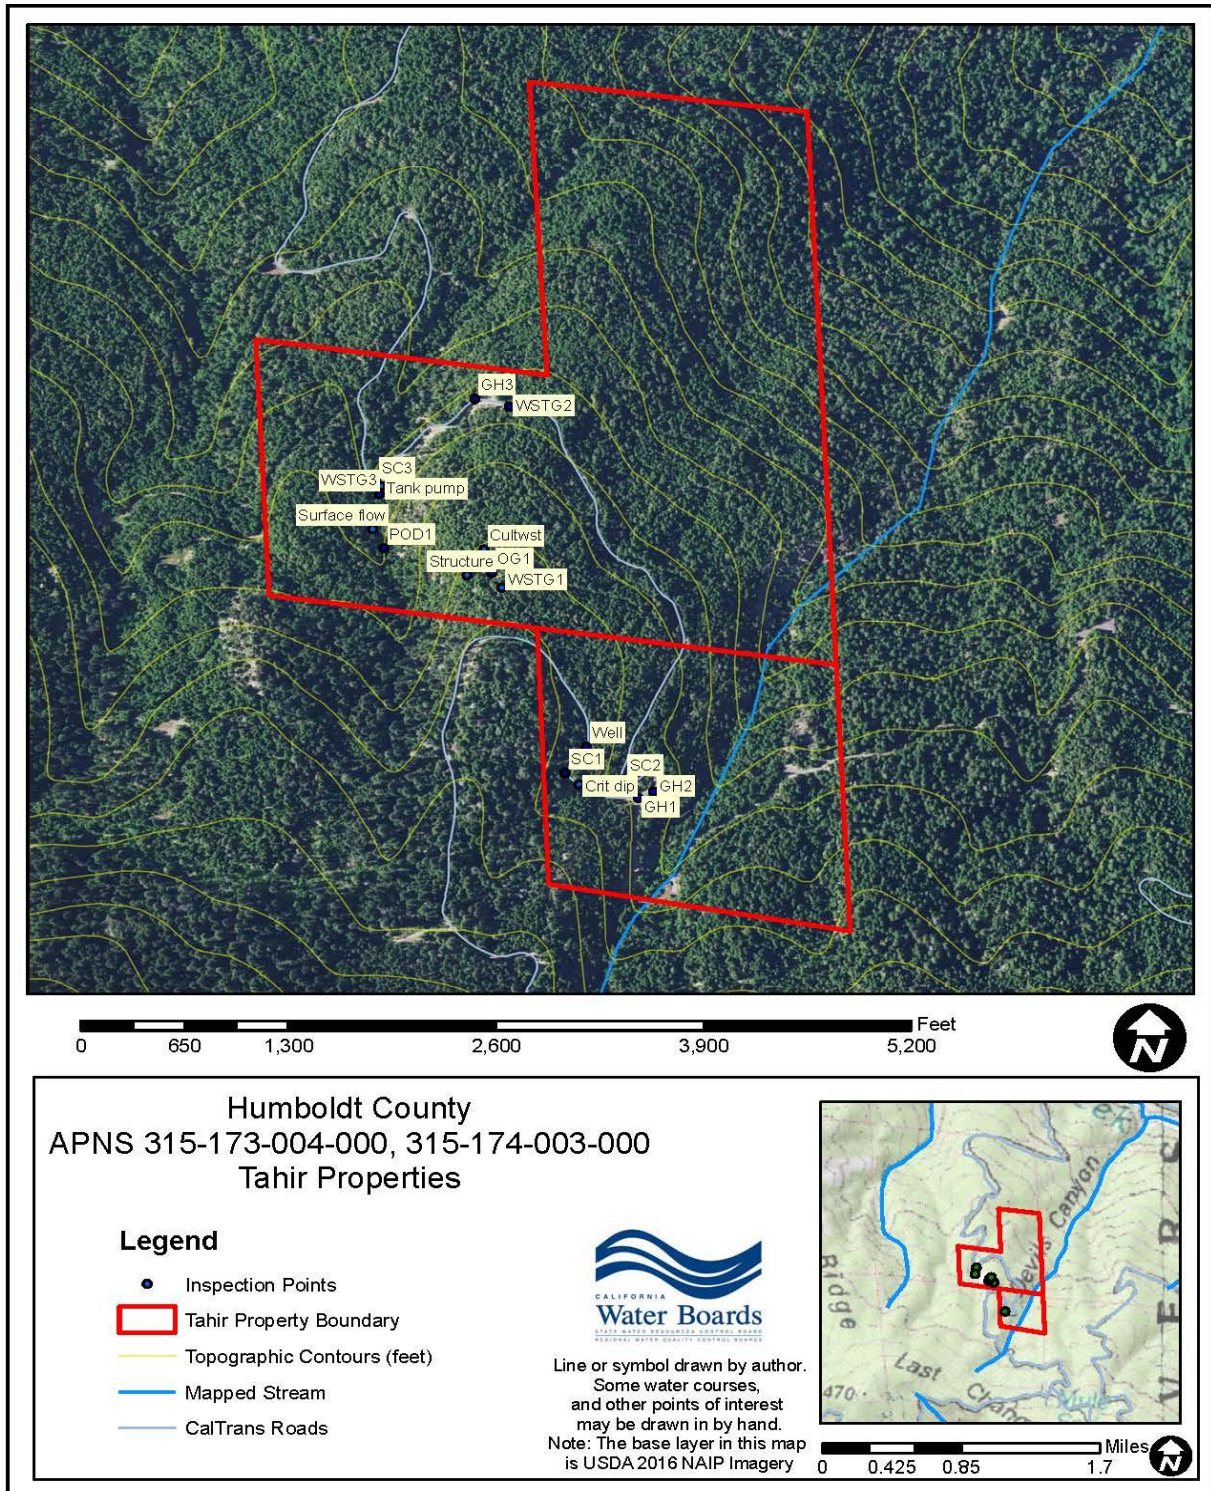
Figure 1 inspection map with inspection points

On September 4, 2019, I inspected the subject property. Figure 1, above, shows the inspection points discussed below, including GH1, GH2, GH3, OG1, SC1, SC2, SC3, Well, Crit Dip, WSTG1, WSTG2, WST3, Cultwst, POD1, Surface flow and Tank pump. In addition to those features marked on the inspection map, we observed, and photo-documented green houses, human waste, stream crossings, water storages, cultivation waste and other issues of water quality concern.

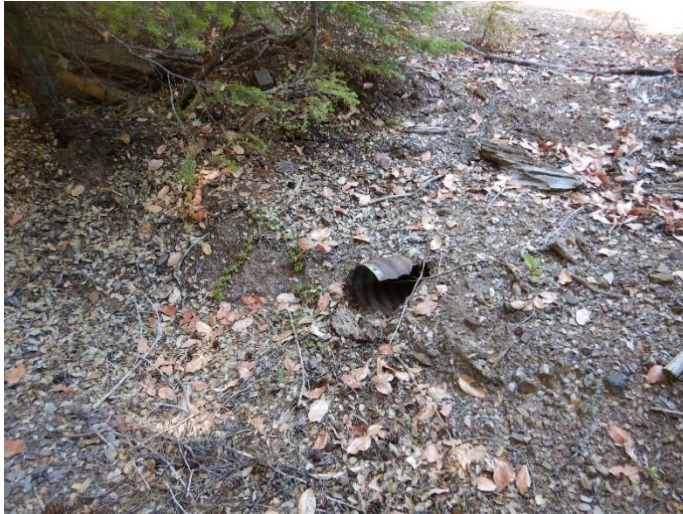
In addition to the cannabis cultivation areas, I observed stream crossings SC1, SC2, SC3. Crossing SC1 (photo 1) is about 1600 feet from the southern property line. The road is built through a Class III watercourse at this location, with an undersized, plugged, and rusted corrugated metal pipe culvert. I observed evidence of sediment delivery into the watercourse at this crossing. SC2 (Photo 2) is a Class III stream crossing on the southern access road, approximately 400 feet to the east of SC1, with no constructed feature to provide stable conveyance for stream flows. I observed evidence of erosion and sediment discharge into the watercourse. SC3 is approximately 2,500 feet Northwest of SC2 (photo 15), blown out stream crossing, delivered about 1,500 cubic yards of sediment to the class II watercourse.

2. Stream crossing maintenance and improvement: I observed 3 stream crossings (SC1, SC2, and SC3) on the access road to the property; as discussed above, all were constructed either improperly or without any structure or design to protect water quality. All three crossings are causing or resulting in active discharge of sediment to class II and III watercourses. (Photos 1,2 and 15)

Photo 1 stream crossing 1 at inspection point SC1

1. Retain a licensed professional to inventory, assess, and develop a workplan and schedule to implement measures to ensure that all developed features, roads, watercourse crossings, and cultivation areas throughout the Property are corrected, restored, and/or maintained in conditions that prevent or minimize erosion, sediment transport/delivery, and adverse impacts to water quality and beneficial uses. Include measures to ensure that unstable features caused or affected by onsite development and operations are removed or otherwise protected so as to minimize the potential for these features to cause adverse impacts to water quality and beneficial uses. Dispose of all development and restoration-related earthen spoils in a manner to prevent/minimize transport and delivery to receiving waters.

3. Prior to conducting any instream work associated with recommendation 1, above, submit to the Regional Water Board an application for Clean Water Act section 401 water quality certification, and secure approval from the Regional Water Board.

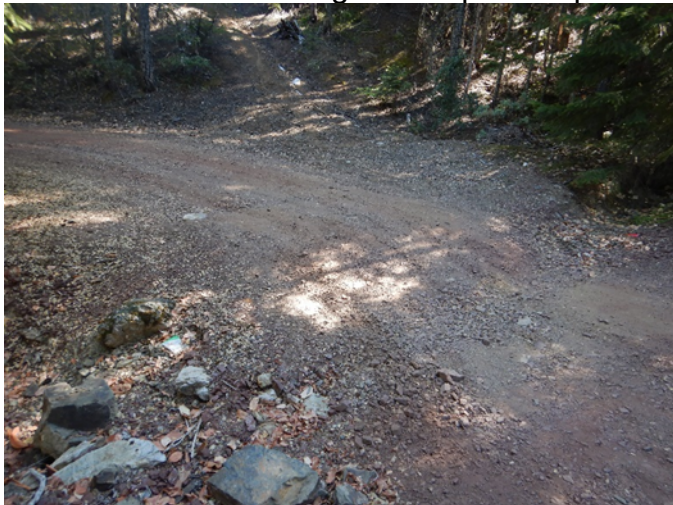
SC2	Stream crossing	Road built through Class III watercourse; evidence of sediment delivery.	Construction- related earthen material placed in or where it can enter surface water. Dredge/fill in waters of the State. Discharge and threatened discharge of waste to receiving waters.	Photo 2

Photo 2 stream crossing 2 at inspection point SC2

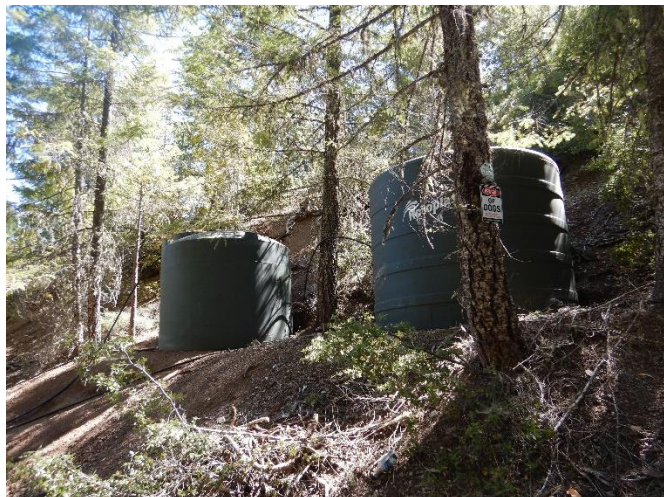
5. Water storage and use: I observed storage tanks on a very steep unstable location which may fail and deliver sediments to waters of the state. (Photo 3)

Photo 3 water storage tanks at inspection point WSTG1

2. Work with CDFW and the State Water Resources Control Board's Division of Water Rights (DIV) to determine and secure any applicable permits or licensing required for surface water diversion, storage, and use on the site. If the existing surface water diversions do not meet applicable CDFW or DIV requirements, remove diversion infrastructure from surface waters and ensure that restoration plans developed pursuant to Recommendation 1, above, include provisions for restoring any instream or riparian disturbance associated with this features or removal thereof.

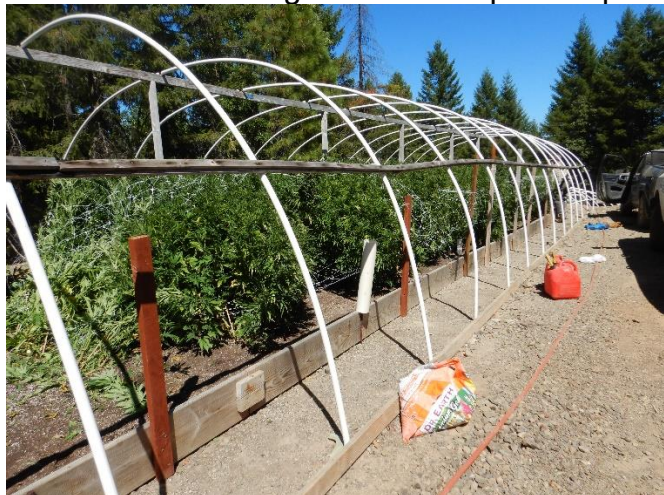
GH1 and GH2 (photos 4 and 5 respectively), the first cultivation area we inspected, is located about 700 feet north from the southern property line, accessed via the southeastern access road. This area has a flat topography covering an approximate area of 3,000 square feet, with three hoop houses. In this area, I observed uncontained trash, plastic containers, and wastes (photos 6). OG1 (photo 9), located approximately 2,000 feet northwest of GH2, is an old cultivation area with no active cannabis cultivation activities. Approximately 1,200 feet north of OG1, I observed GH3 (Photo 10), an active cultivation area of 600 square feet. I also observed a toilet, water tanks, water pumps, and cultivation waste in the vicinity of the cultivation areas (photos 5,7,13).

Photo 4 Cannabis cultivation area at inspection point GH1

4. If the property owner and/or tenant(s) choose to continue to cultivate cannabis, transfer enrollment for coverage under and take steps to comply with the requirements of the CANGO (Order WQ 2019-0001-DWQ, General Waste Discharge Requirements and Waiver of Waste Discharge Requirements for Discharges of Waste Associated with Cannabis Cultivation Activities). More information about the CANGO can be found at this hyperlink:

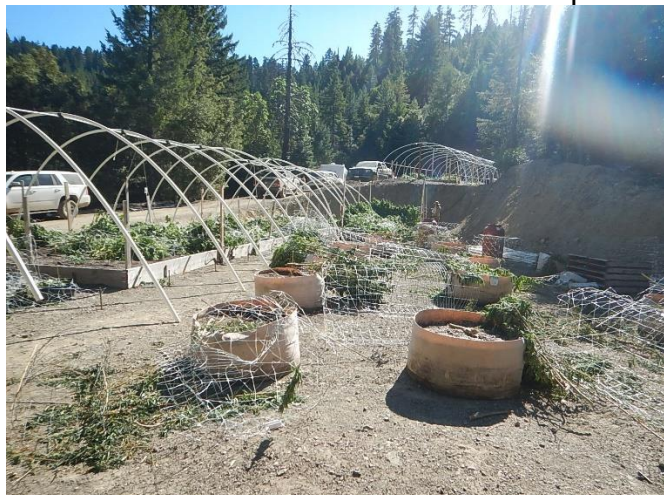
Photo 5 Cannabis cultivation area at inspection point GH2

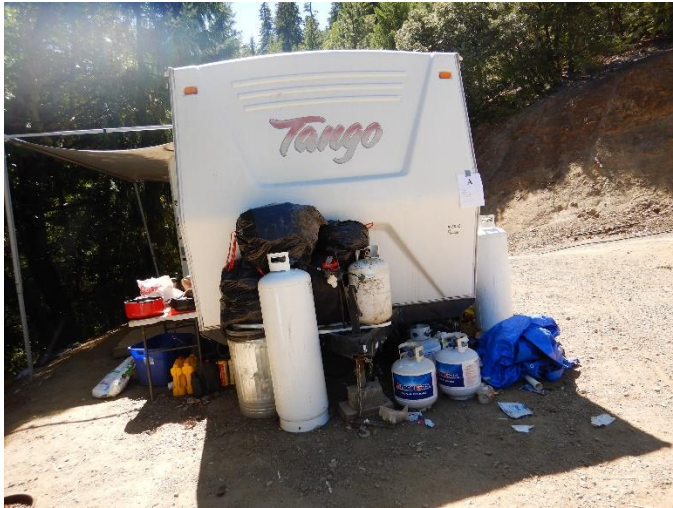
3. Stream and wetland buffers: I observed water storage tanks on a steep slope near a class II watercourse. (Photo 12,13 and 16)
4. Spoils management: I observed uncontained/ uncovered. (Photo 6, and 18)

Photo 6 Uncontained propane containers near GH1

6. Discontinue use of and dismantle any outhouse/pit toilet features and work with Humboldt County to ensure that all domestic and human wastes are collected and disposed of consistent with applicable County requirements.
7. Collect and dispose of or contain all refuse and cultivation-related wastes in a location and manner so as to minimize potential for these wastes to enter or be transported into receiving waters.
8. Store and contain all chemicals, including petroleum, fertilizer and/or pesticides properly to prevent spillage and discharge to receiving waters. Provide secondary containment for all petroleum products.

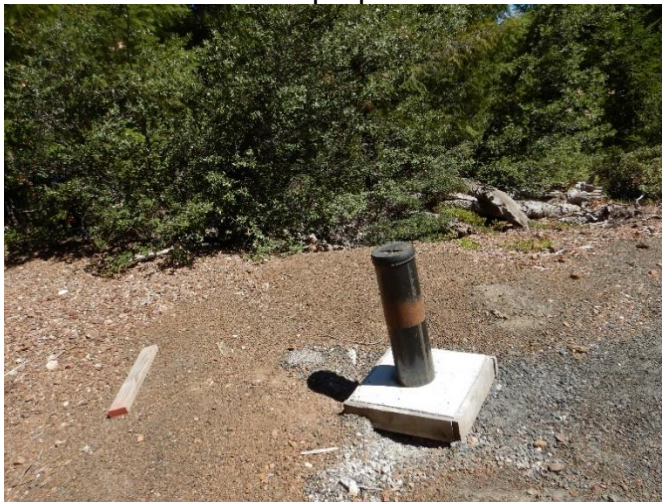
Photo 7, well head at inspection point Well

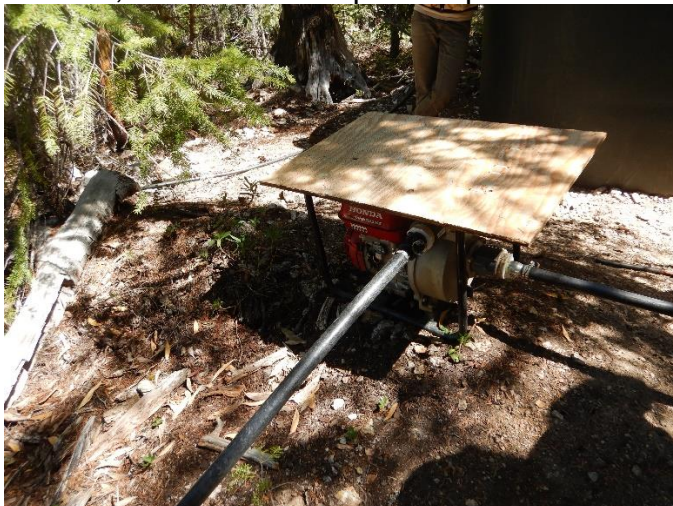
Photo 8 uncontained pump at inspection point Tank pump

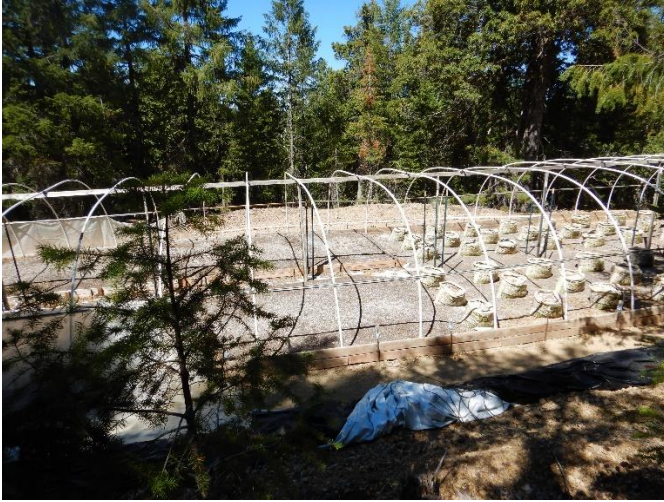
Photo 9 unused former cultivation site at inspection point OG1

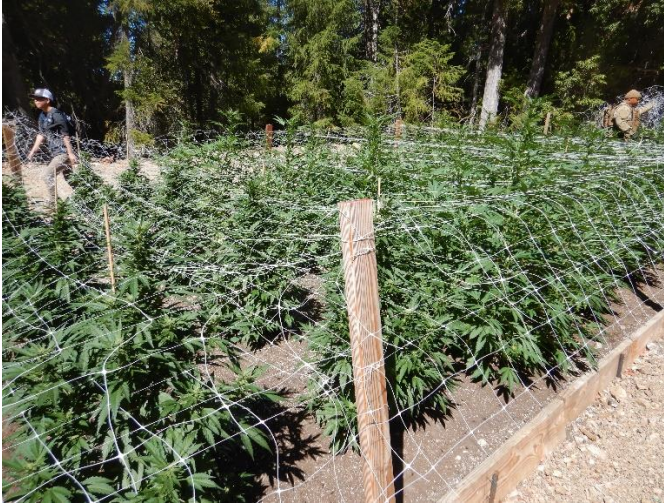
Photo 10 cannabis cultivation at inspection point GH3

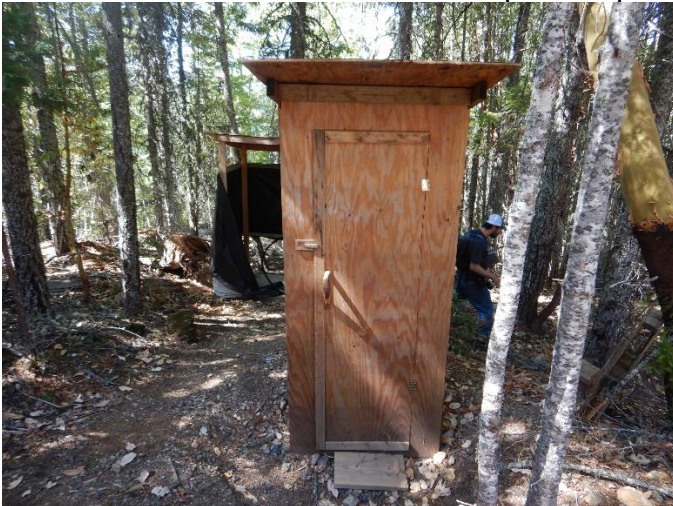
10. Cultivation-related wastes I observed uncovered and/or uncontained cultivation-related wastes at inspection points Cultwst and OG1. Photo 14)
11. Refuse and human waste: I observed an outhouse toilet. (photo 11)

Photo 11 outhouse toilet near inspection point GH3

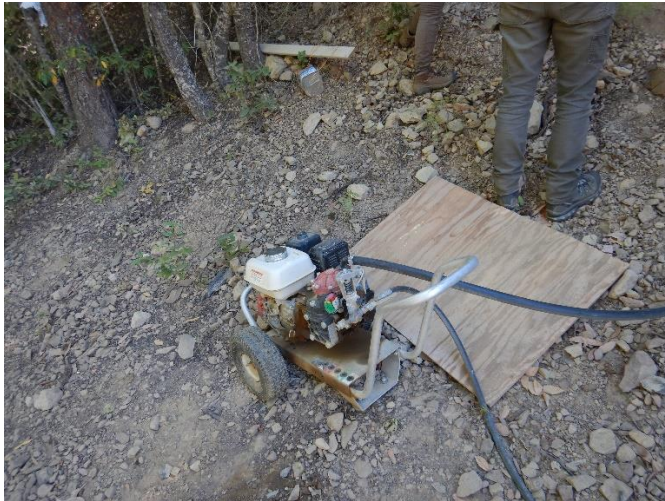
Photo 12, Uncontained pump near inspection point WSTG2

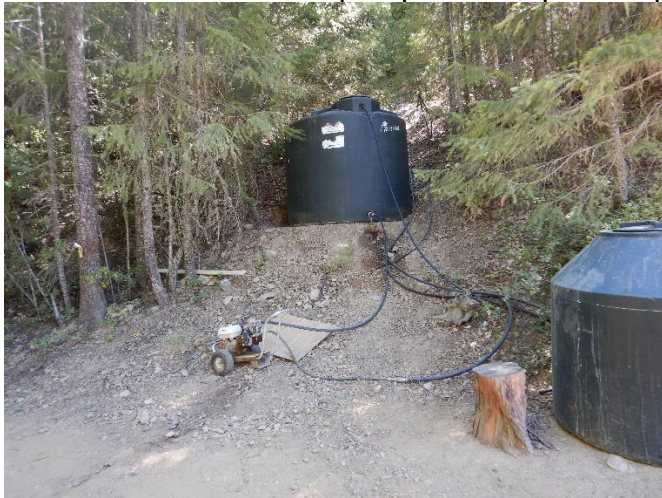
Photo 13, Water storage tanks and irrigation pump at inspection point WST2

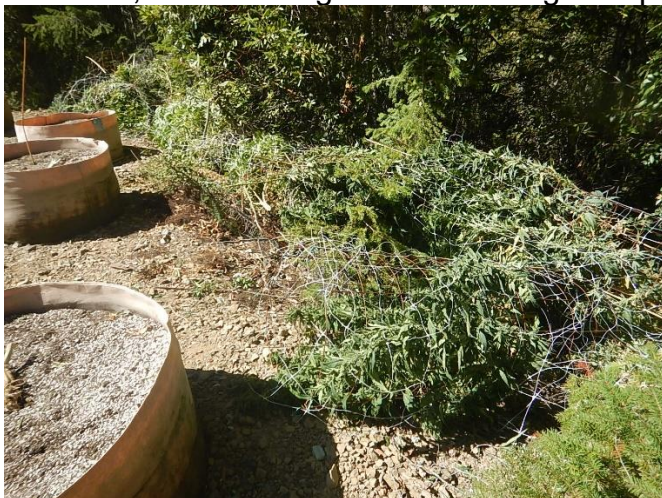
Photo 14, Cultivation waste at inspection point Cultwst

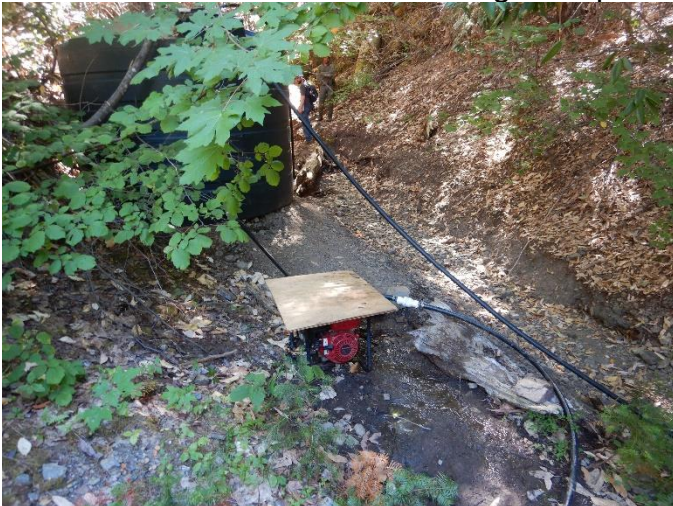
Photo 16 water storage tank and a pump at inspection point Surface flow

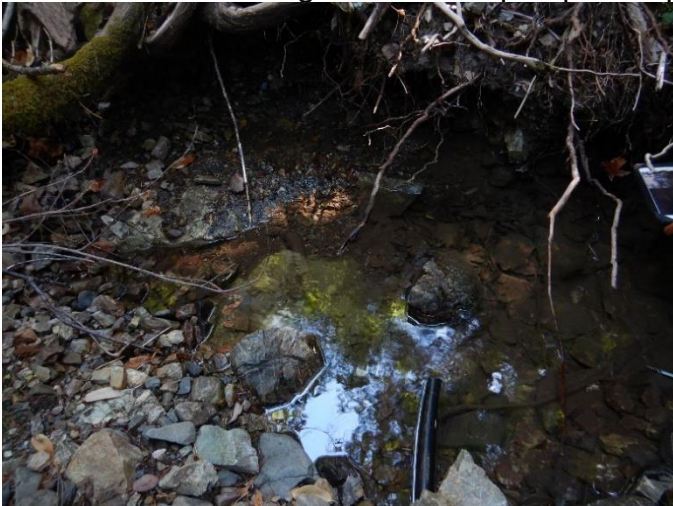
POD1	Point of diversion	Unpermitted point of diversion	Construction- related earthen material placed in or where it can enter surface water. Dredge/fill in waters of the State. Discharge and threatened discharge of waste to receiving waters.	Photo 17

Photo 17, Point of Diversion at inspection point POD1

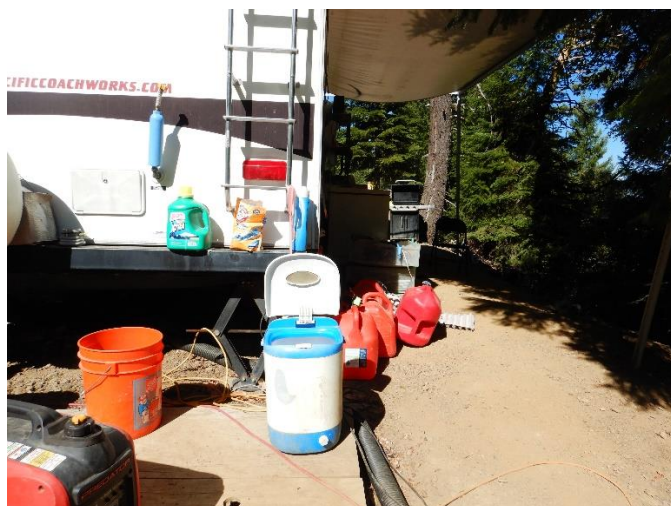
8. Pesticides: I observed no evidence of water quality concerns associated with storage and use of pesticides.
9. Petroleum products and other chemicals: I observed uncontained petroleum containers. (Photo 18)

Photo 18, uncontained plastic petroleum containers near inspection point GH1

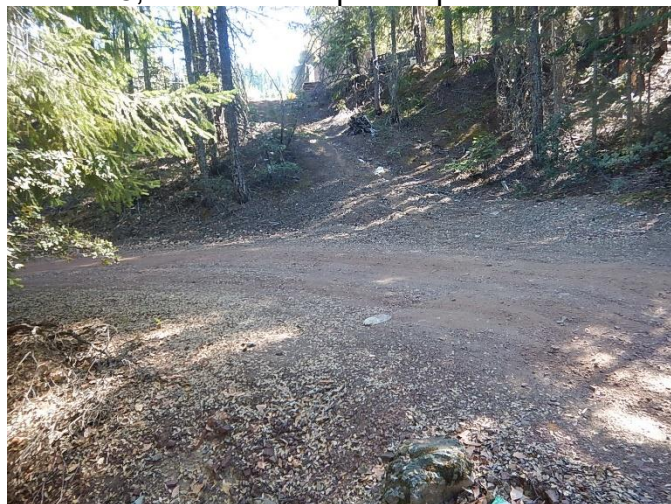
Photo 19, Threatened sediment delivery from the road near SC2
