Subject: Notice of Violation, Directive to Obtain Regulatory Coverage for Cannabis Cultivation, and Transmittal of Inspection Report for September 5, 2019, Inspection of Humboldt County Assessor's Parcel No. 530-151-001-000

Inspection Report for September 5, 2019, Warrant Inspection Humboldt County Assessor's Parcel Number 530-151-001-000

File: Cannabis Program Inspections, Humboldt County, September 2019 HCSC
CAMP Inspections, "Chris Wilson" property, owned by Michael Hinojosa, CIWQS
Place ID 842969

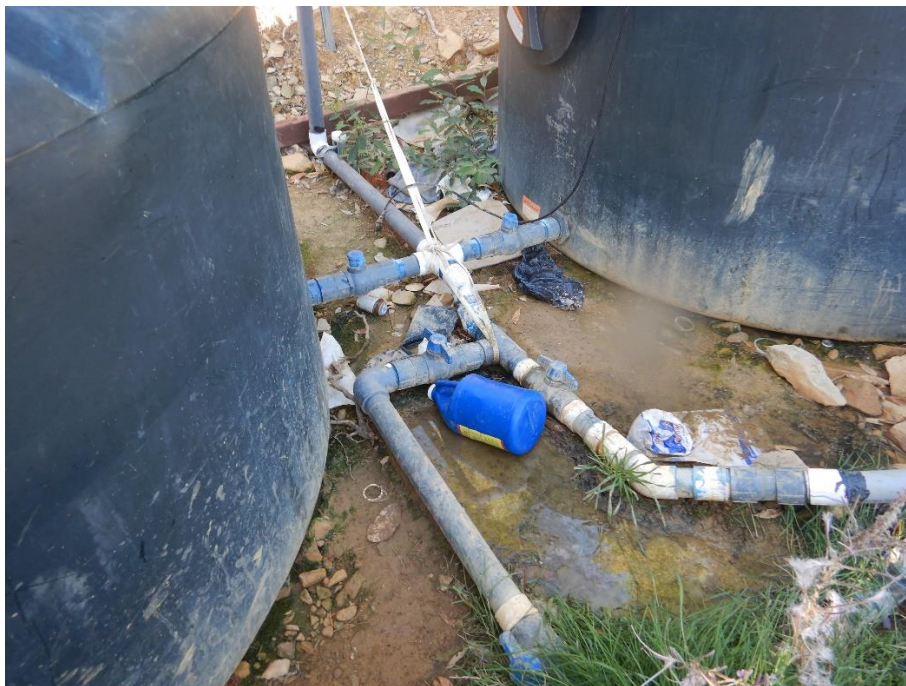
I accessed the property along a dirt road from the southeast, parked at the west end of an approximate 3 acre cleared flat area and walked east then south to water tanks at WQ 1, (Photo 1). Water was leaking from the tanks and flowing northeast. I observed fertilizers sitting uncovered, on bare ground in this area and a 1-gallon bottle resting label-down in the water. I noted a green hue in the water which I interpreted to be from algae, suggesting that the nutrients were being mixed in the tanks. I walked past the greenhouses with active cannabis cultivation (WQ 2) (Photo 2) to the northeast of the cleared area at WQ 3 and observed that the edge of the pad was composed of mixed earth and woody debris which was perched above a forested hillslope (Photo 3).

<i>Map point</i>	<i>Feature</i>	<i>Brief Description</i>	<i>Water Quality Concern</i>	<i>Associated Photo(s)</i>
WQ 1	Water tanks	Water from tanks flows over improperly stored chemicals and towards cultivation area.	Threatened discharge of waste to receiving waters.	Photo 1

5. Water storage and use: Water tanks at WQ 1 were leaking and transporting fertilizers across the property.

7. Fertilizers and soil amendments: Fertilizers were stored uncontained outdoors near WQ 1.

Photo 1—Tanks located at WQ 1

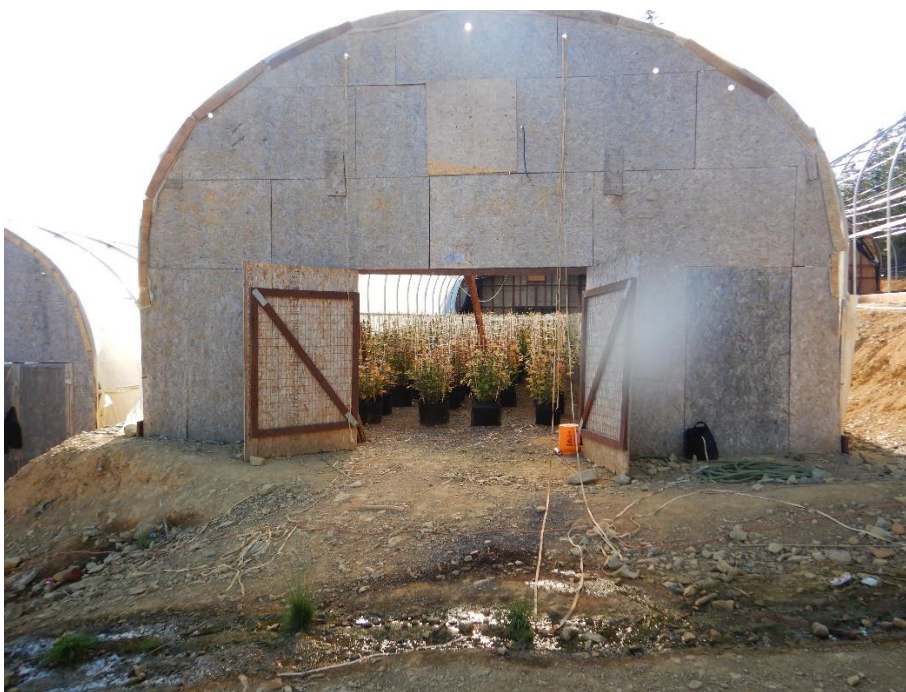
Photo 2—Water from tanks at WQ 1 flowing in front of greenhouse at WQ 2.

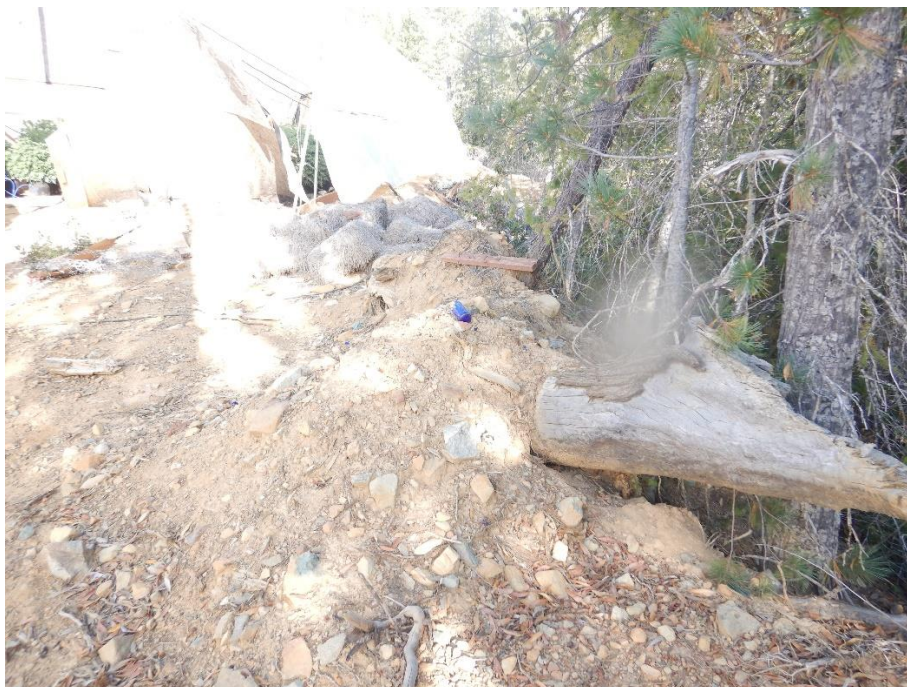
Fill on cultivation pads (WQ 3) and on roads (WQ 6) include woody debris in the matrix and display evidences of eroding.

Photo 3—Edge of cut and fill pad in the vicinity of WQ 3.

1. Retain a licensed professional to inventory, assess, and develop a workplan and schedule to implement measures to ensure that all developed features, roads, watercourse crossings, and cultivation areas throughout the Property are corrected, restored, and/or maintained in conditions that prevent or minimize erosion, sediment transport/delivery, and adverse impacts to water quality and beneficial uses. Include measures to ensure that unstable features caused or affected by onsite development and operations are removed or otherwise protected so as to minimize the potential for these features to cause adverse impacts to water quality and beneficial uses. Dispose of all development and restoration-related earthen spoils in a manner to prevent/minimize transport and delivery to receiving waters.

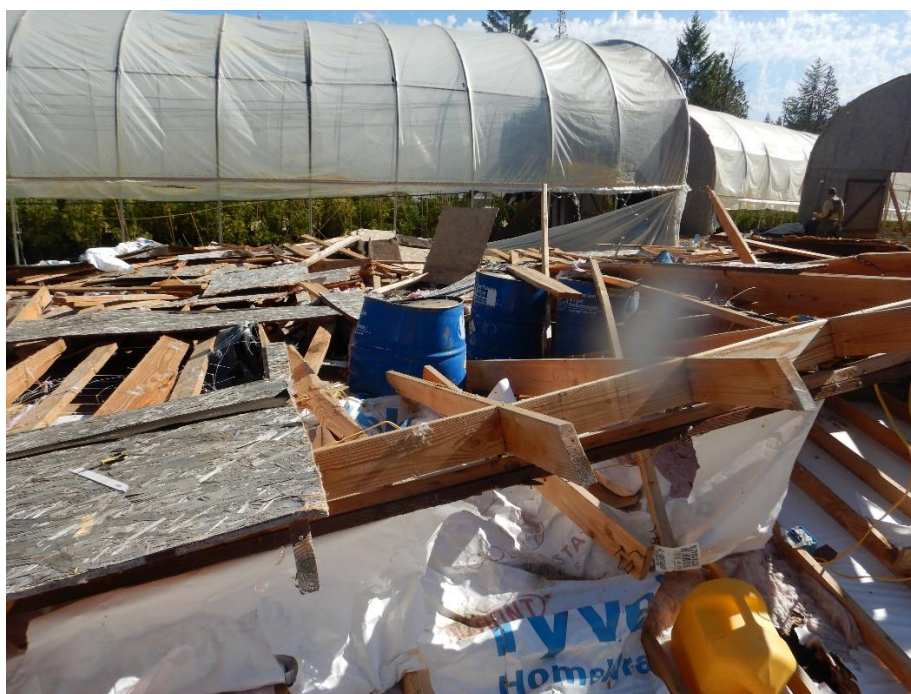
I walked back south and observed a large pile of greenhouse material with 55-gallon drums with unknown contents (WQ 4) (Photo 4). To the south, at WQ 5, I observed water at the entrance of a greenhouse which I interpreted to be from excess irrigation (Photo 5). The water appeared to have flowed through fuel containers and imported potting soils.

9. Petroleum products and other chemicals: Unknown waste in 55-gallon drums at WQ 4 and in the landfill at WQ 7 may contain chemicals.

10. Cultivation-related wastes: The large pile of waste at WQ 4 included greenhouse materials and other unknown materials.

Photo 4—Pile of waste in the vicinity of WQ 4, includes 55-gallon drums with unknown contents.

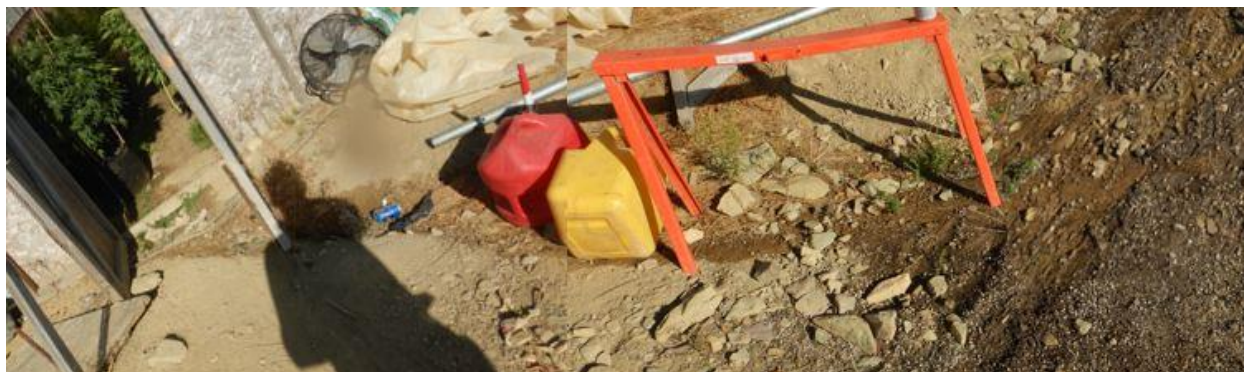
6. Irrigation runoff: Excess irrigation at WQ 5 appears to have flowed past fuel containers and out of the cultivation area.

Photo 5— Water passing through fuel containers and spent potting soils at WQ 5.

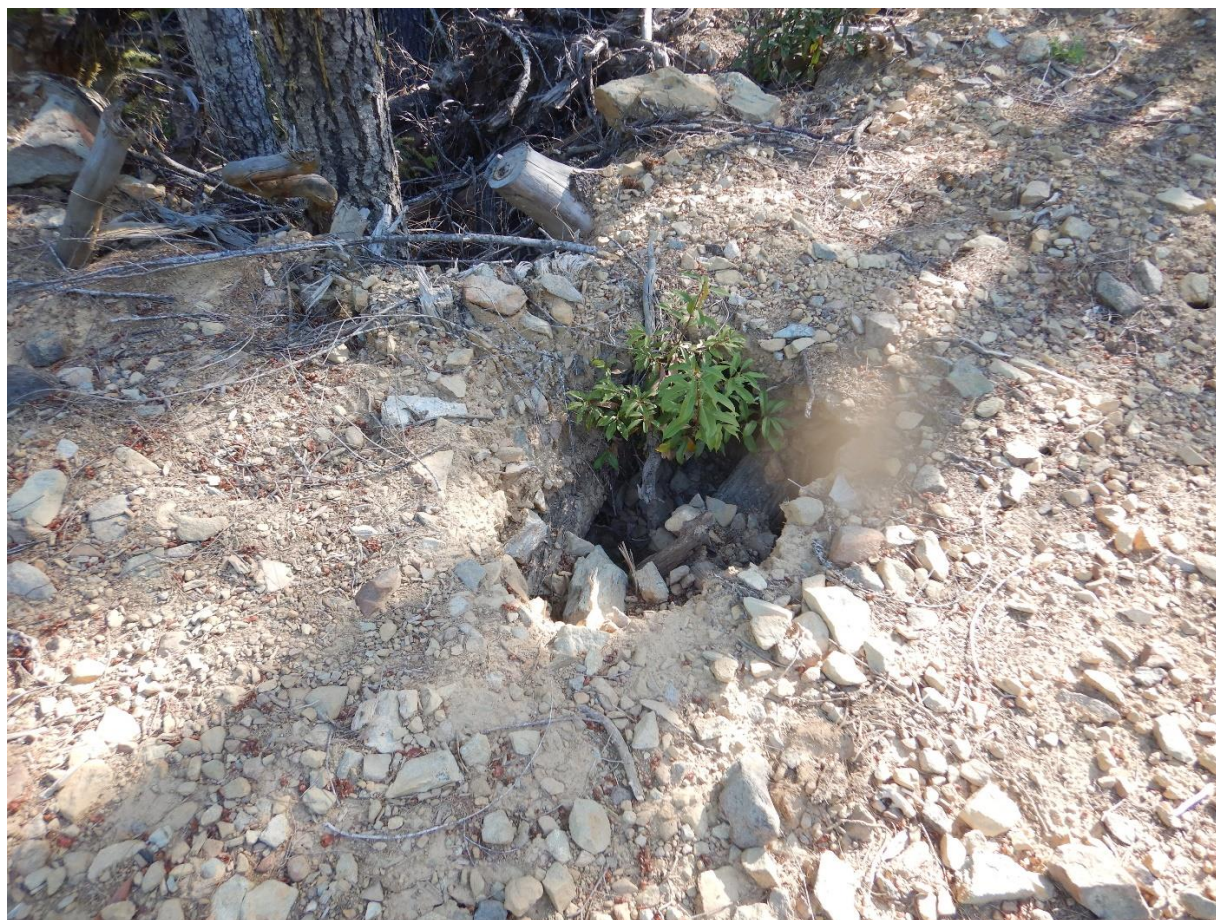
I walked west to WQ 6. Here the road appeared to have been widened with woody debris and trash pushed into the valley to the north (Photo 6). I observed that the northern edge of the road was composed of a loose matrix of earth and woody debris. I walked downhill and observed that immediately downstream from the toe of earthen fill and woody debris there was the form of a channel buried below duff with a width of 3 feet and a depth of 6 inches. I continued walking downstream and observed waste deposited in the channel as far as WQ 7 (Photo 7 through Photo 10).

<i>Map point</i>	<i>Feature</i>	<i>Brief Description</i>	<i>Water Quality Concern</i>	<i>Associated Photo(s)</i>
WQ 2	Cannabis cultivation area	One of nine approximate 6,000 square foot greenhouses. Cannabis visible from outside of structure.	Cannabis cultivation/discharge of waste without a report of waste discharge and/or coverage under State Water Board regulatory order	Photo 2
WQ 3	Edge of graded flat	Edge of graded pad is composed of loose fill mixed with woody debris.	Threatened discharge of waste to receiving waters.	Photo 3
WQ 4	Pile of waste	Includes 50-gallon drums and fuel cans with unknown contents.	Threatened discharge of waste to receiving waters.	Photo 4
WQ 5	Cultivation area	Excess irrigation water flows over improperly stored fuel containers and away from cultivation area.	Threatened discharge of waste to receiving waters.	Photo 5
WQ 6	Road-fill on top of watercourse.	Composed of loose fill mixed with woody debris. Suspected watercourse upstream and downstream.	Unauthorized dredge/fill in surface water.	Photo 6

4. Spoils management: The road fill at WQ 6 is within and/or threatens to discharge to Big Foot Creek and/or its tributaries.

Photo 6— Downstream edge of road fill in the vicinity of WQ 6. Note the hole in fill showing woody debris in the matrix of material.

3. Prior to conducting any instream work associated with recommendations 1 and 2, above, submit to the Regional Water Board an application for Clean Water Act section 401 water quality certification, and secure approval from the Regional Water

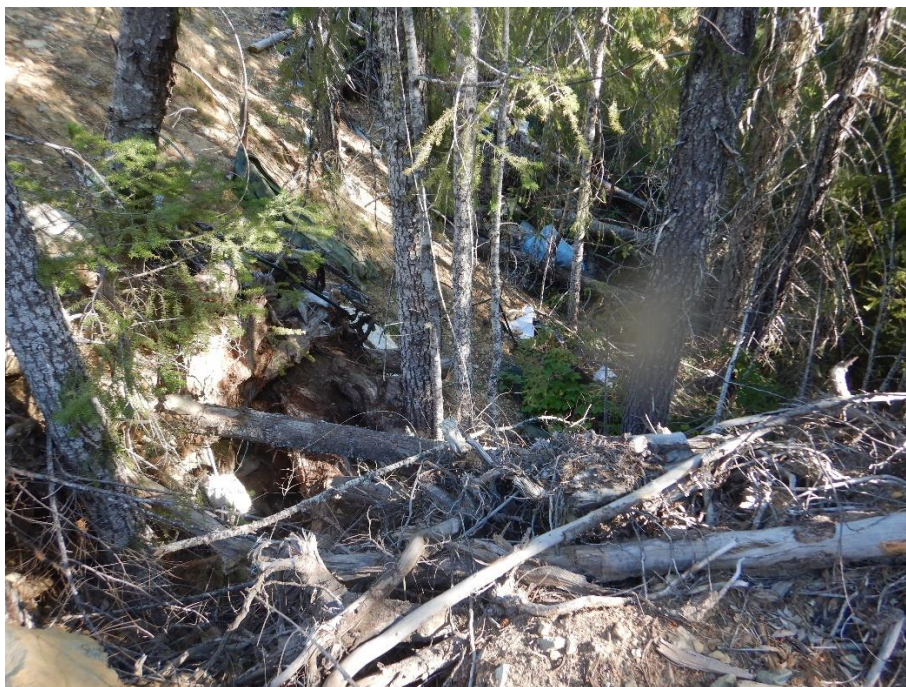
Photo 7— Looking Downstream from WQ6 at woody debris pushed into drainage.

2. Retain a qualified professional to develop a workplan and schedule to remove the waste between WQ 6 and WQ 7 and restore the channel to its natural state. Dispose of all development and restoration-related earthen spoils in a manner to prevent/minimize transport and delivery to receiving waters.

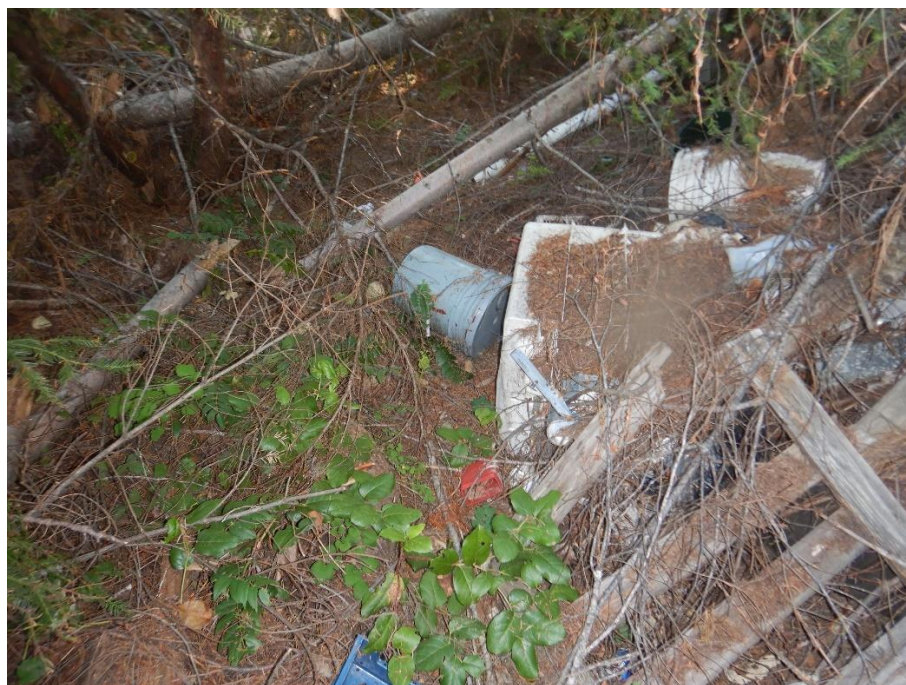
WQ 7	Landfill	Waste including household appliances discharged in watercourse	Unauthorized discharge of waste to receiving waters.	Photo 7 through Photo 10
WQ 8	Human feces	Several piles of human feces and soiled toilet paper within banks of an intermittent watercourse.	Unauthorized discharge of waste to receiving waters.	Photo 11

Photo 8— Waste appliances and sealed 5-gallon buckets between WQ 6 and WQ 7.

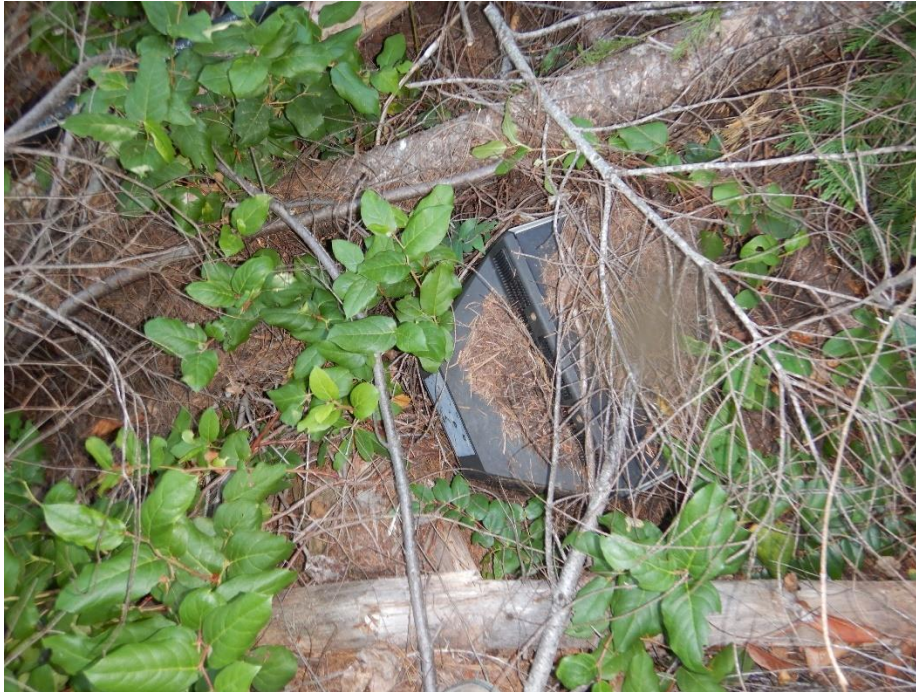
Photo 9— Waste television between WQ 6 and WQ 7.

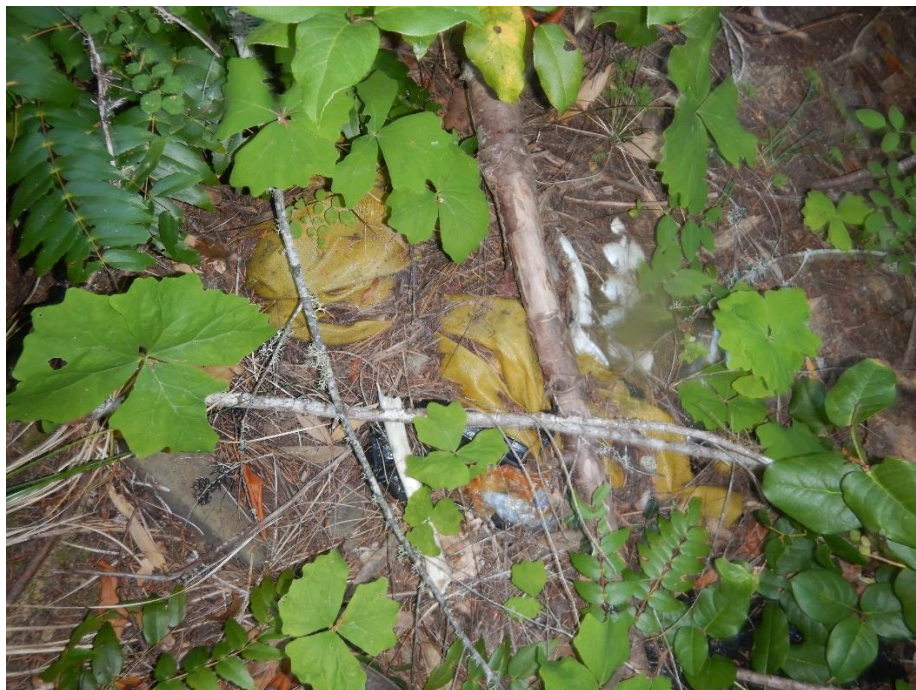
Photo 10— Trash bags with unknown contents between WQ 6 and WQ 7.

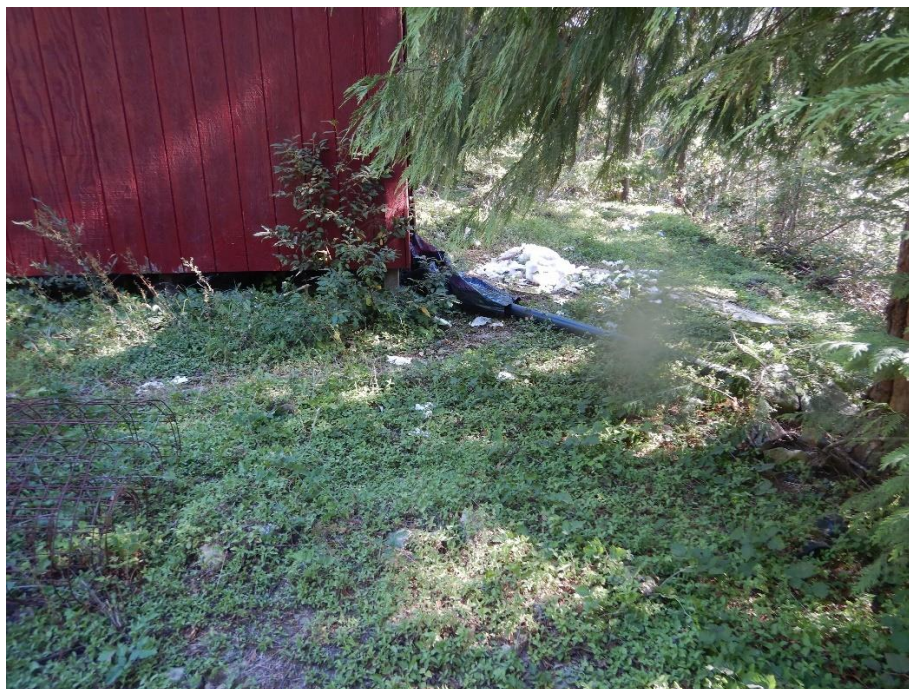
I then walked upstream from the road in the same watercourse to WQ 8 and observed intermittent locations where surface water had flowed. I also observed several deposits of human feces at locations where they could be easily transported via stormwater runoff into the watercourse channel (Photo 11). I returned to the road and walked to WQ 9, where I observed an outhouse that discharged to Big Foot Creek (Photo 12).

<i>Map point</i>	<i>Feature</i>	<i>Brief Description</i>	<i>Water Quality Concern</i>	<i>Associated Photo(s)</i>
WQ 9	Outhouse	Outhouse pipe discharges directly to a watercourse. There is an uncontained pile of soiled toilet paper behind the outhouse.	Unauthorized discharge of waste to receiving waters.	Photo 12

11. Refuse and human waste: As noted above, I observed a landfill between WQ 6 and WQ7 with waste placed where it is likely to be transported to Big Foot Creek. Human feces at WQ 8 are likely to contaminate local surface water, and the outhouse at WQ 9 discharges directly towards Big Foot Creek.

Photo 12— Outhouse discharging human waste where it is likely to enter receiving waters. Note the pile of soiled toilet paper at the back of the structure which is also likely to enter receiving waters.

6. Discontinue use of and dismantle any outhouse features and work with Humboldt County to ensure that all domestic and human wastes are collected and disposed of consistent with applicable County requirements.
7. Collect and dispose of or contain all refuse and cultivation-related wastes in a location and manner so as to minimize potential for these wastes to enter or be transported into receiving waters.
8. Store and contain all chemicals, including petroleum, fertilizer and/or pesticides properly to prevent spillage and discharge to receiving waters. Provide secondary containment for all petroleum products.
