North Coast Regional Water Quality Control Board

Subject: **Notice of Violation, Directive to Obtain Regulatory Coverage for Cannabis Cultivation, and Transmittal of Inspection Report for July 2, 2019, Inspection of Trinity County Assessor's Parcel No. 018-230-21-00**

File: Cannabis Inspections, Trinity County, 2019, 190702 Lost Coast Outreach LLC, CIWQS Place ID No. 854510

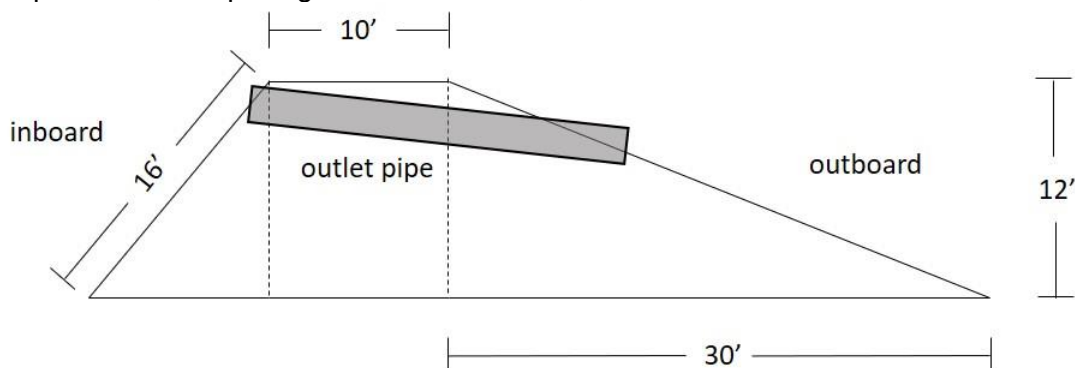
figure 1 – Cross-section of dam located at *WQ 9*.

We exited the southern edge of *Area A*, *WQ 7*, along a dirt road that was covered with a layer of fine, fluffy soil, up to 1.5 inches thick (*photo 12*), *WQ 8*. The road is shaped such that stormwater will run down the road surface and deliver to a pond to the south. We continued following this road south, arriving at a pond (*photos 13 - 17*), *WQ 9*. The pond is bound by the hillslope upstream and an earthen dam downstream. When full, the pond would have a wetted surface area approximating a 100' long by 60' wide ellipse, with an approximately 38,000 cubic foot capacity ($\pi \times 50' \times 30' = 4,700$ square feet x an average depth of 8'=38,000 cubic feet). Erosion on the inboard face of the dam has exposed poorly consolidated sediment of mixed sizes. The pond outflow is a plastic pipe with an inlet near the dam crest and outlet midway down the dam outboard face. Based on measurements I made using a rangefinder and a tape measure (see figure 1), I determined that the dam is 100 feet wide, with a cross-sectional area of 360 square feet, comprising a total volume of 36,000 cubic feet.

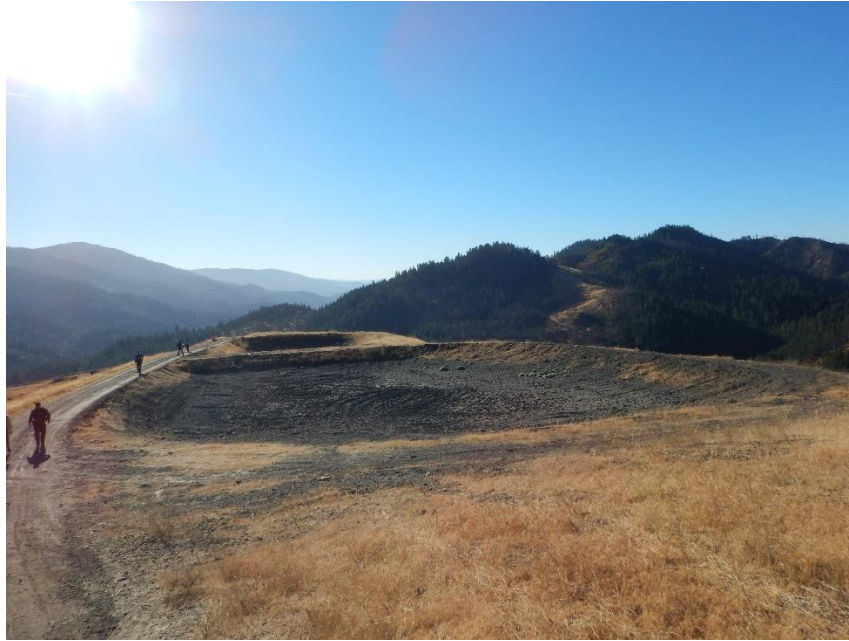
We accessed the property along a dirt road from the east and walked west, passing two empty ponds near the ridge-top (*photo 1*). The ponds, identified as *WQ 1*, had no apparent outlets; however, stormwater is unlikely to overtop and erode the pond berms, because there is no upslope catchment area or surface water connection. We continued walking northwest, past a group of 4 water tanks on the ridge-top (*photos 2 - 3*), identified as *WQ 2*, and noted rilling on the unvegetated hillslope below the tanks. We then headed west to another cluster of water tanks (*photos 4 - 5*), *WQ 3*, that were surrounded by uncovered and uncontained fuel, and fertilizers, and located where these pollutants have the potential to be transported 200 feet south to a tributary to Hale Creek.

photo 1 – Looking southeast at ponds located on top of a ridge a WQ 1.

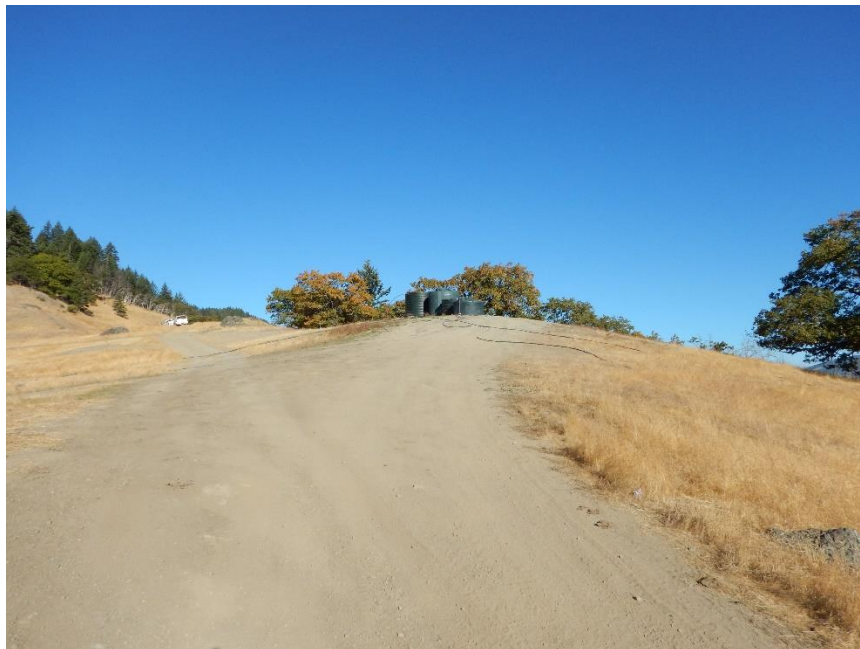
photo 2 – Looking northwest at Water tanks on top of a ridge at WQ 2.

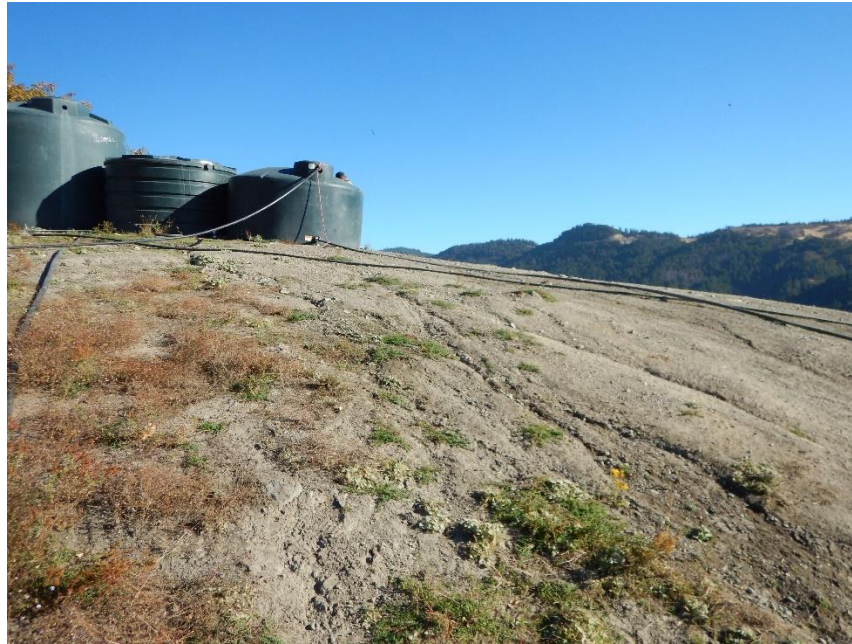
photo 3 – Water tanks on top of the ridge at WQ 2. Note rilling on portions of hillslope that have no vegetation.

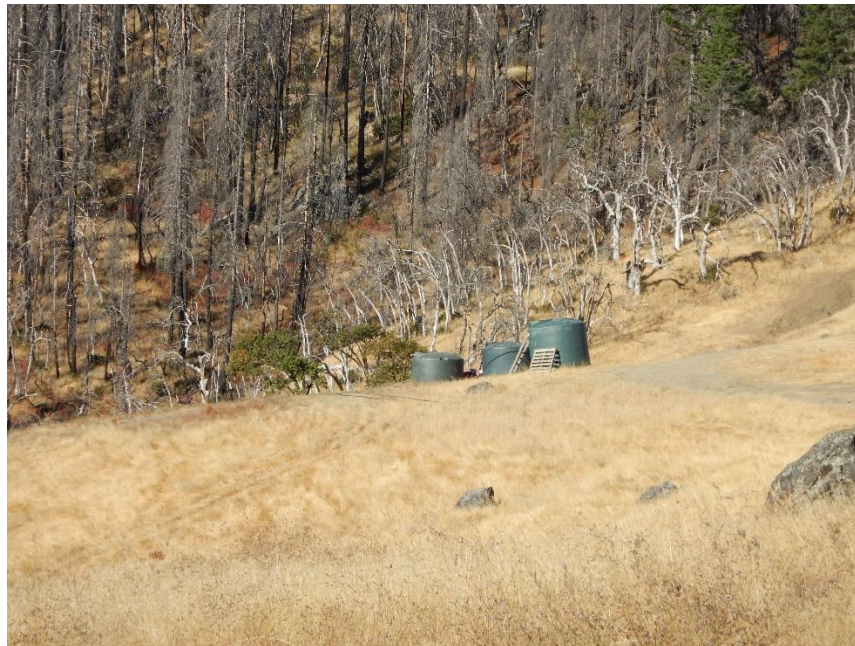
photo 4 – Cluster of water tanks at WQ 3. Note change in topography behind tanks signaling the presence of a drainage swale.

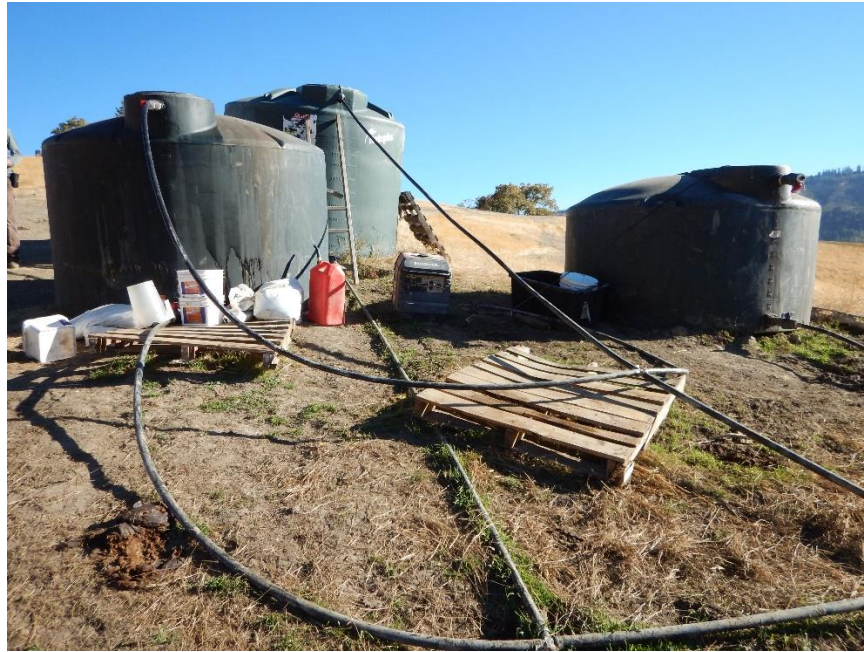
photo 5 – Cluster of water tanks at WQ 3 also pictured in photo 4. Note uncovered and uncontained fuel and fertilizers.

- 4) Store and contain potting soils, fertilizers, petroleum products and other chemicals properly to prevent spillage and discharge to receiving waters. As a reference for the goal of this recommendation, review standard conditions 7 and 9 of the regional cannabis order and relevant portions of the CANGO.

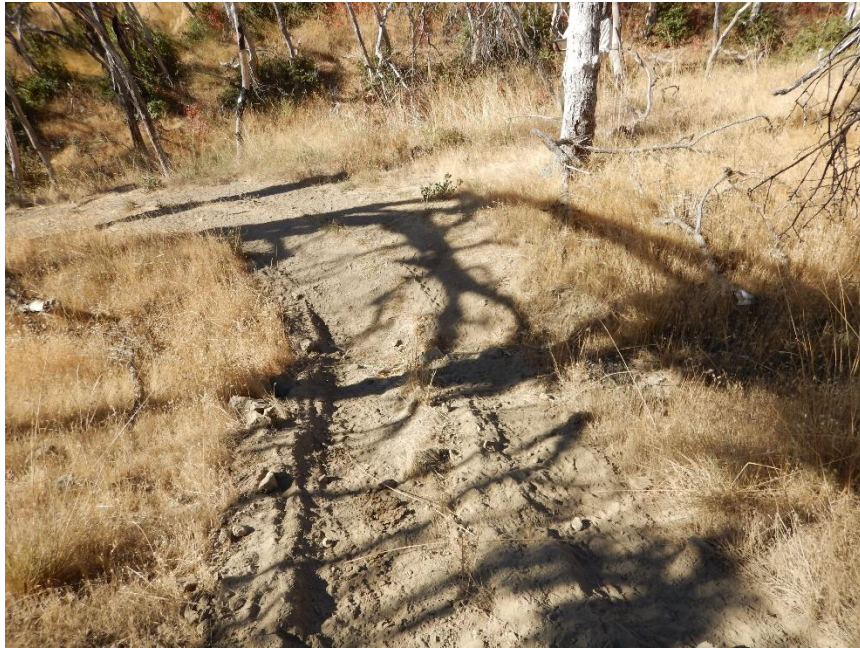
photo 7 – WQ 5, ATV trail crossing tributary to Hale Creek.

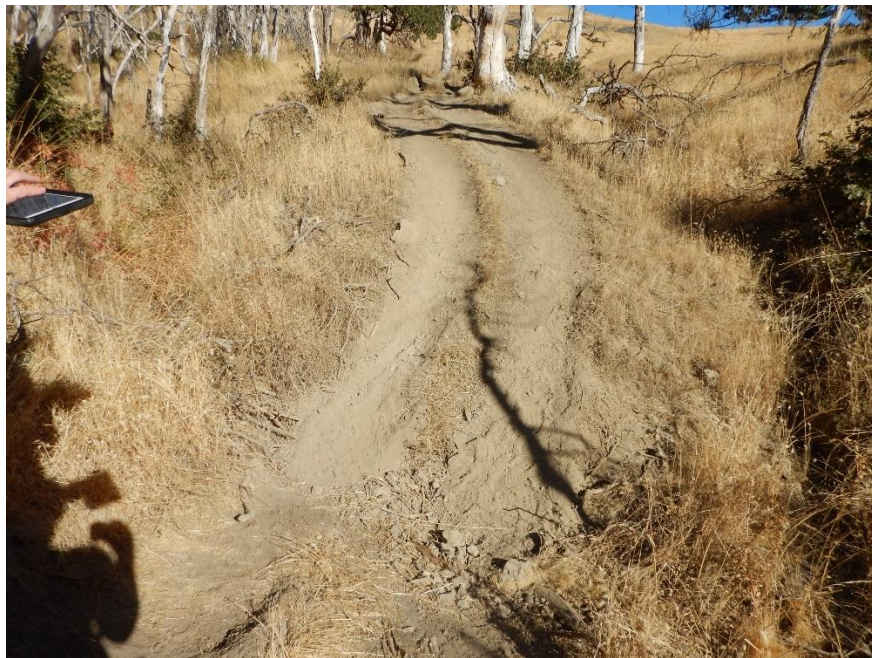
photo 8 – WQ 6, ATV trail crossing tributary to Hale Creek.

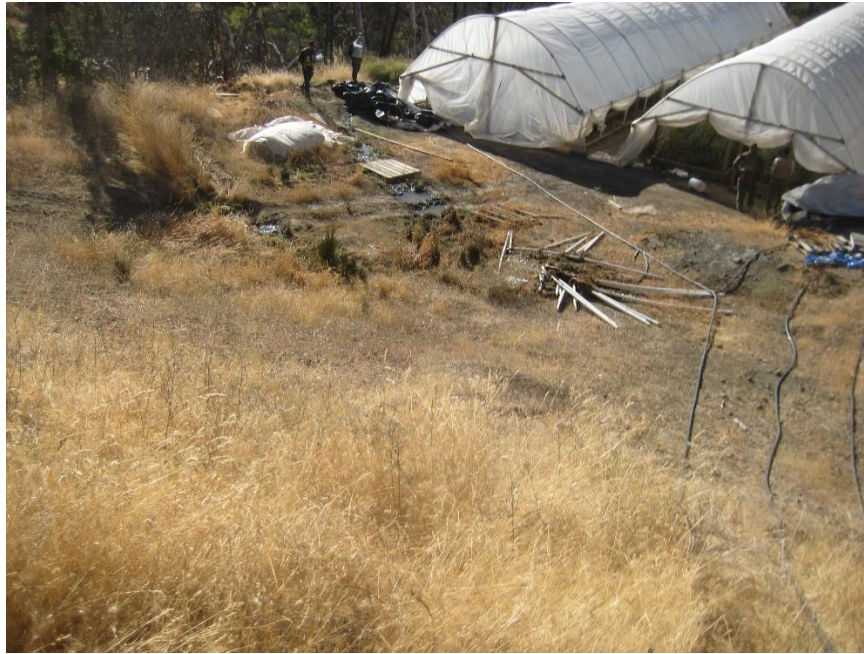
photo 9 – Looking south at the northern edge of the graded flat located at WQ 7. Note water is emanating from the ground. Location shown as Area A in aerial images.

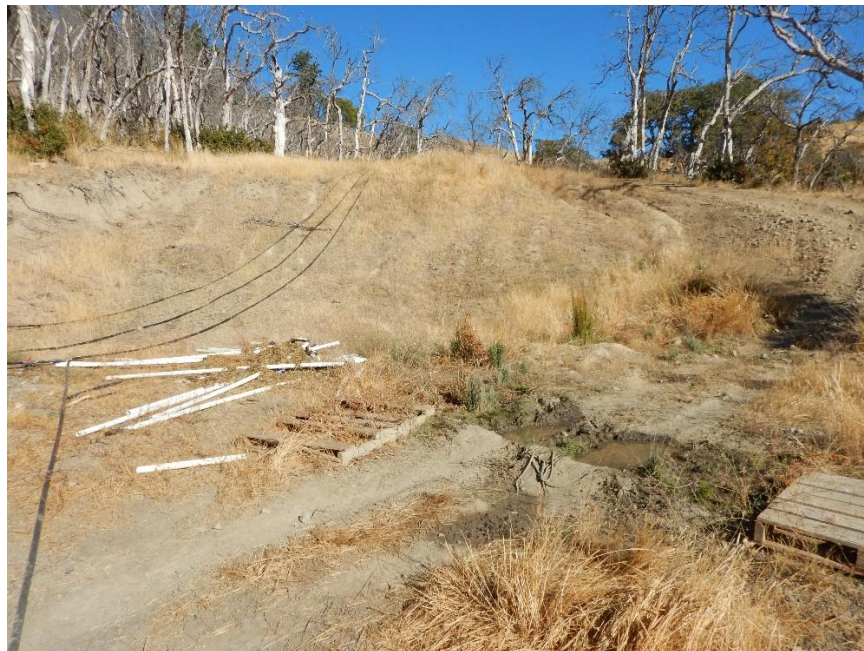
photo 10 – WQ 7, northern edge of the graded flat looking north. Note juncus growing where water is emanating from the ground. Depth of excavation into hillslope is apparent in back left of image

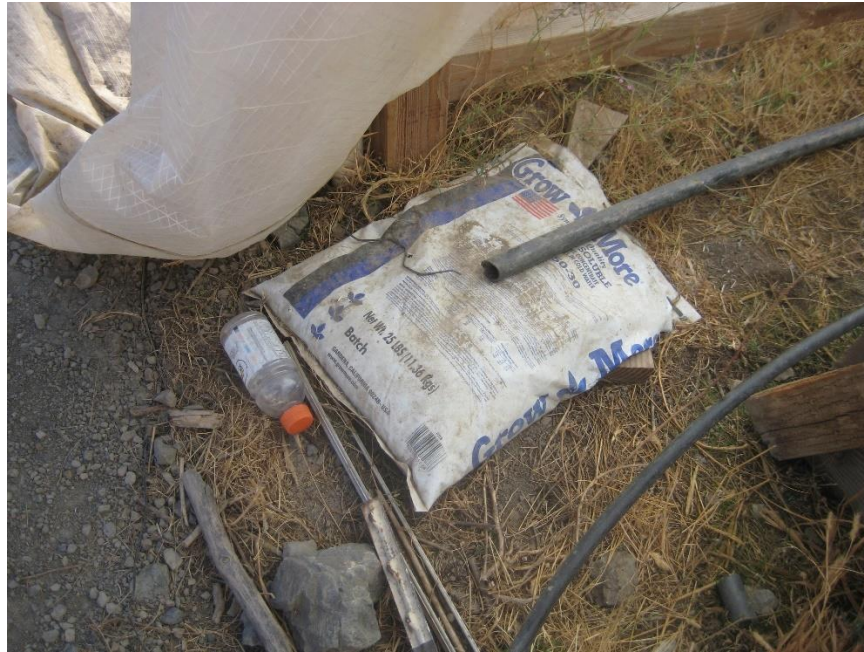
7. **Fertilizers and soil amendments:** In addition to the fertilizers located at *WQ 3* discussed above, staff observed a bag of high-concentration, water soluble fertilizer lying uncovered on bare ground at *WQ 7*.

photo 11 – WQ 7, area in front of greenhouse depicted in photo 9. Note bag of high-concentration, water soluble fertilizer is lying uncovered on bare ground.

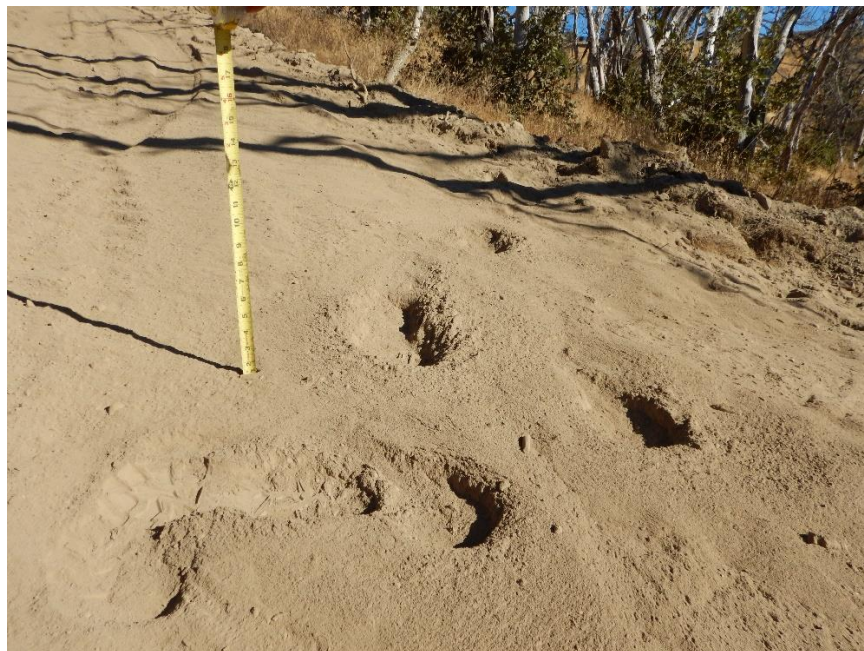
photo 12 – WQ 8, layer of fine, fluffy soil as thick as 1.5 inches on the road.

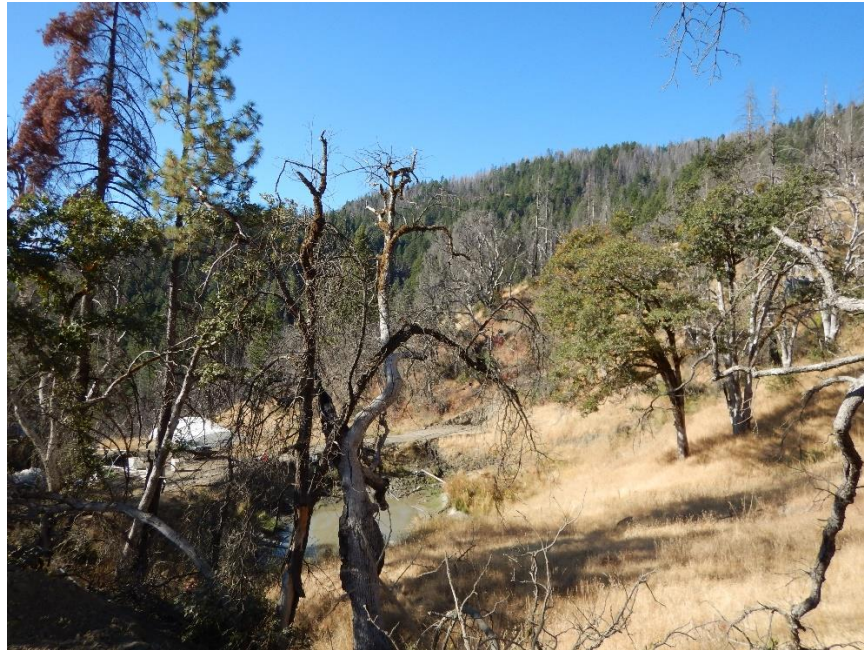
photo 13 – Looking southwest from the road towards the pond located at WQ 9.

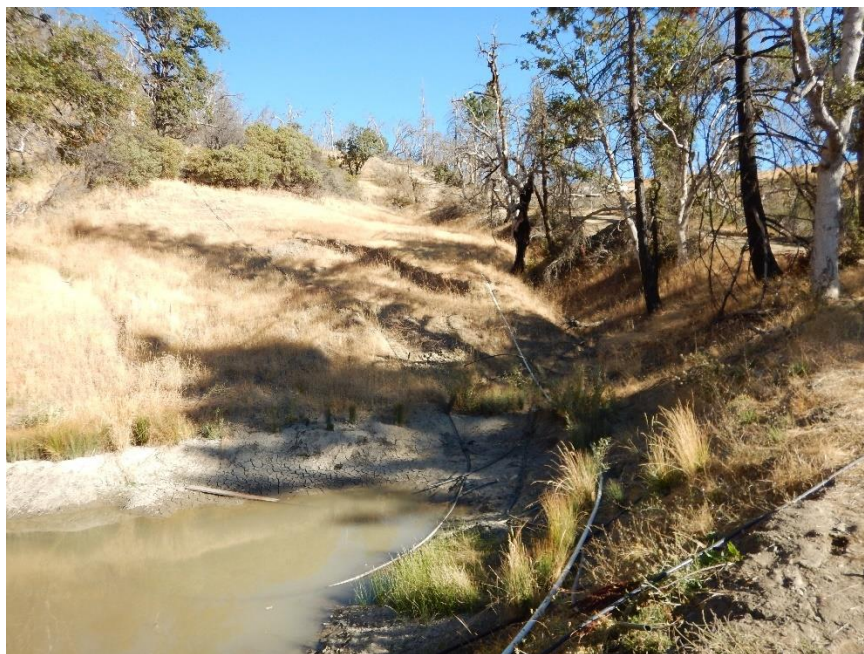
photo 14 – Looking northeast from pond dam located at WQ 9 with road in the background right of the picture.

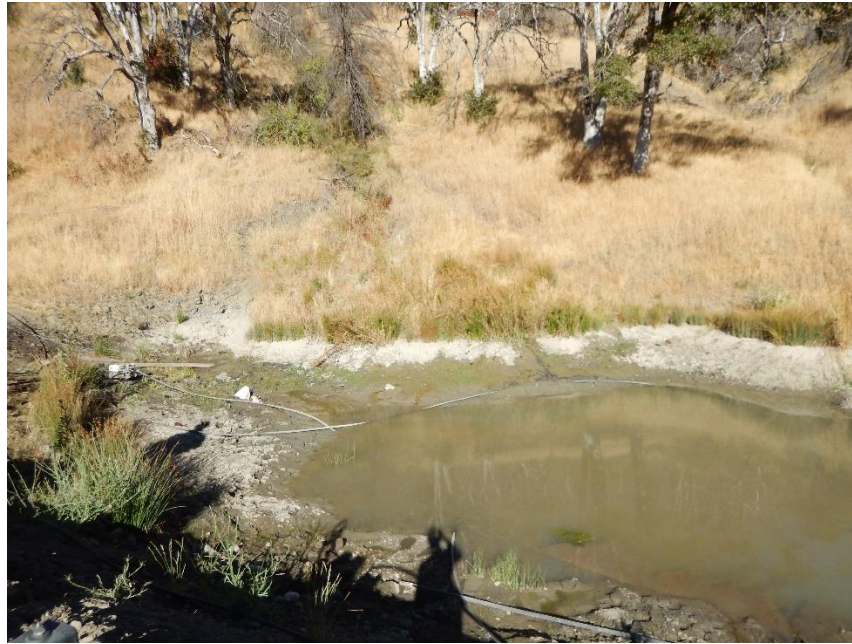
photo 15 – Looking northwest from pond dam located at WQ 9. Note ephemeral watercourse in top right of picture.

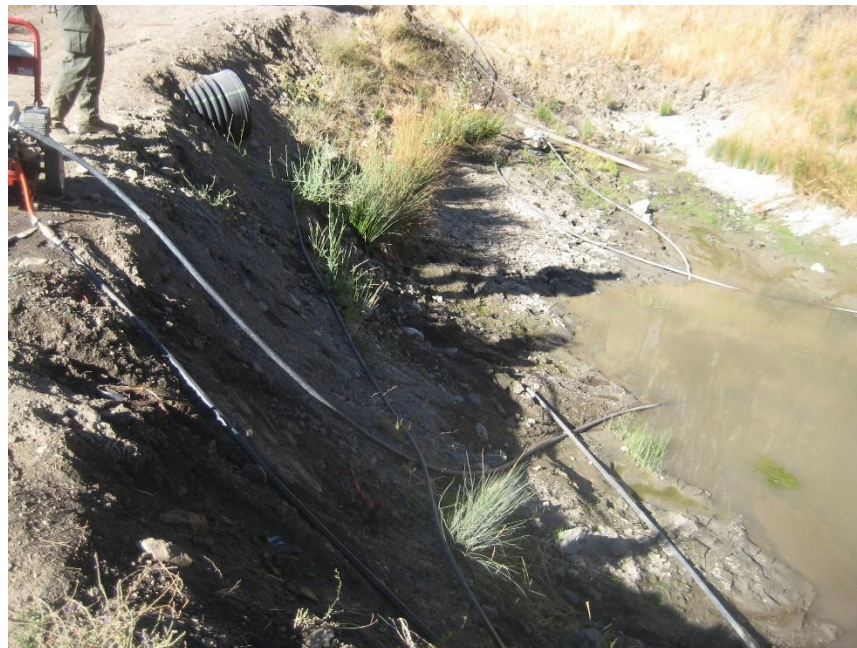
photo 16 – Looking west from pond dam located at WQ 9. Note inlet to pond overflow pipe.

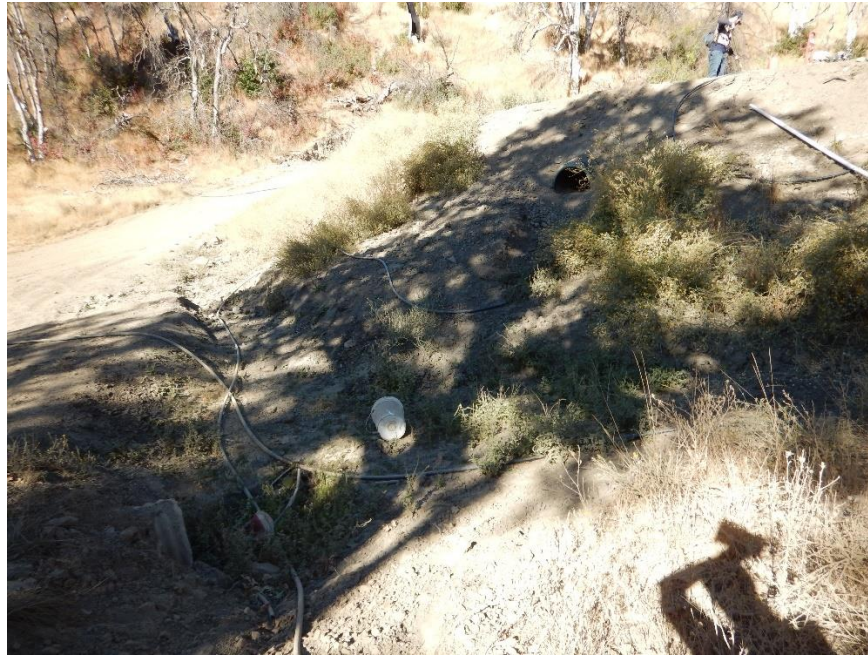
photo 17 – Looking north at pond dam outboard face located at *WQ 9*. Note pond outlet at upper right of image discharging onto dam face. Culvert pictured in *photo 18* is in the lower left of the image.

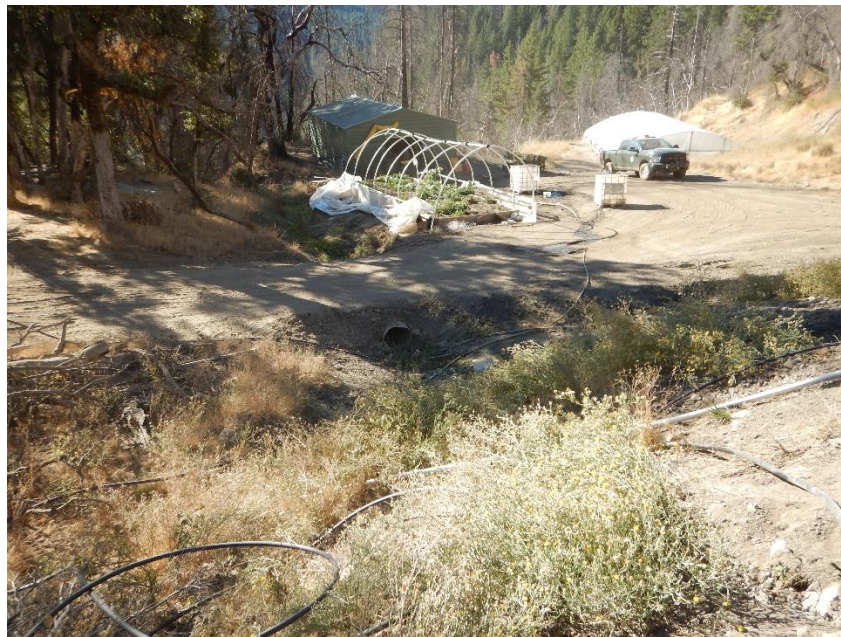
The watercourse immediately downstream from the pond passes under a road through a 24" diameter metal culvert that is more than half filled with sediment (*photo 18*). Downstream from the road crossing, I observed an earthen fill pad adjacent to the west bank of the channel, with a hoop house (*photos 18 and 19*). At the south end of the fill pad, I observed a roadway constructed in the watercourse (*photos 19 and 20*). Uphill, less than 50' from the watercourse, there is a toilet discharging to ground (*photo 21*).

photo 18 – Looking south from the pond at *WQ 9*, greenhouse on placed fill pictured in photo 19 is in center back of picture and greenhouse at *WQ 10* is in back right of picture.

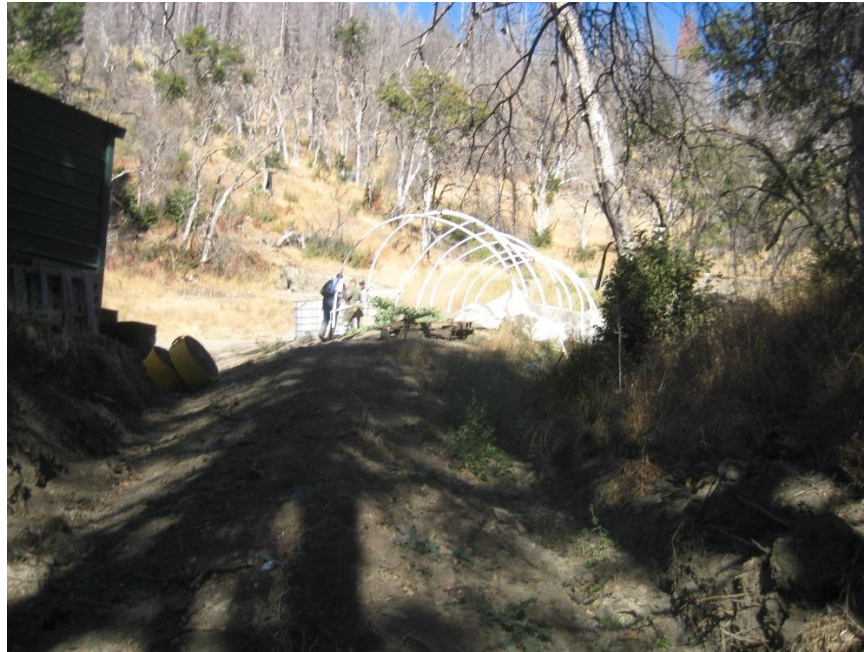
photo 19 – Looking north at the greenhouse on fill pictured in *photo 18*.

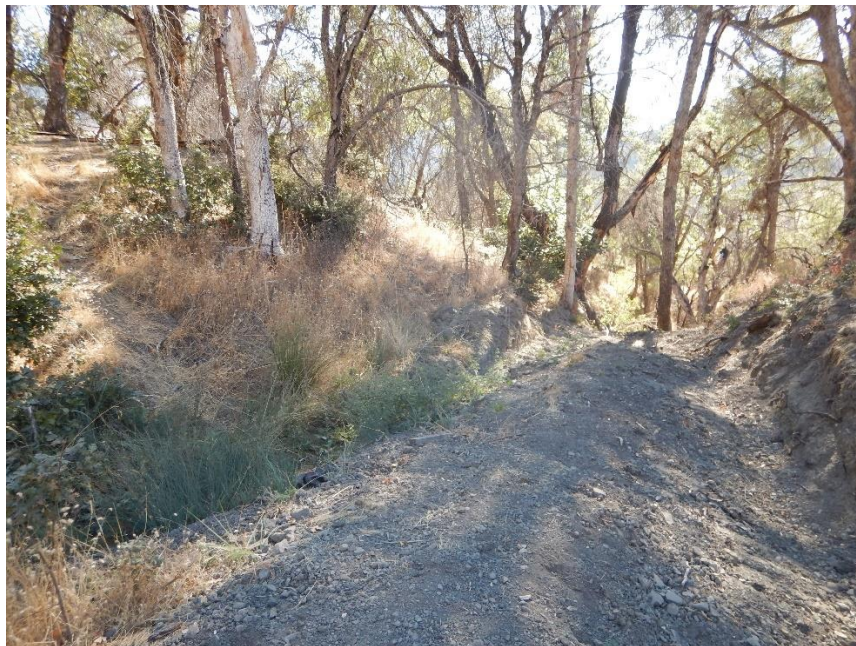
We then walked south to another earthen fill pad, at *WQ 10*, cut into the hillslope. We observed loose soil on the access road surface, that appeared to be susceptible to erosion (*photo 20*). Similar to what we had observed at *WQ 7* on *Area A*, we observed saturated ground and juncus growing in front of the greenhouse at *WQ 10* (*photo 23*). We continued walking south and followed a waterline to a tributary to Hale Creek and observed a dam in the watercourse at *WQ 11* to facilitate a water diversion (*photo 24*).

4. **Spoils management:** Staff observed earthen spoils from site development at locations where they may enter or be transported into receiving waters (*photo 20*).

photo 20 – Looking south from same photo location as *photo 19*, water flowing from the pond enters from the left, flows over the spoils in the foreground of the picture, and enters a watercourse in the back right of the picture.

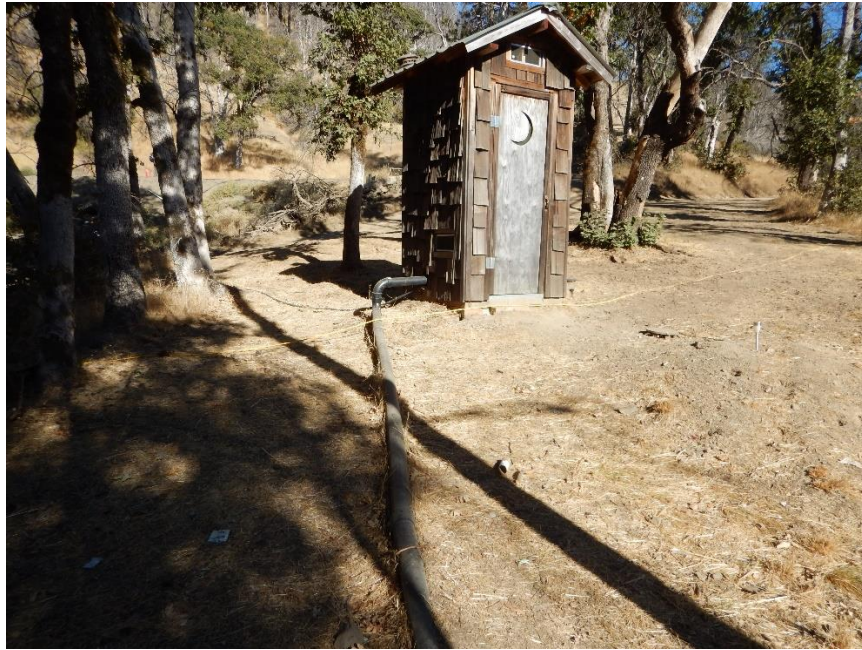
photo 21 – Toilet discharging to ground, located between two watercourses southeast of WQ 9.

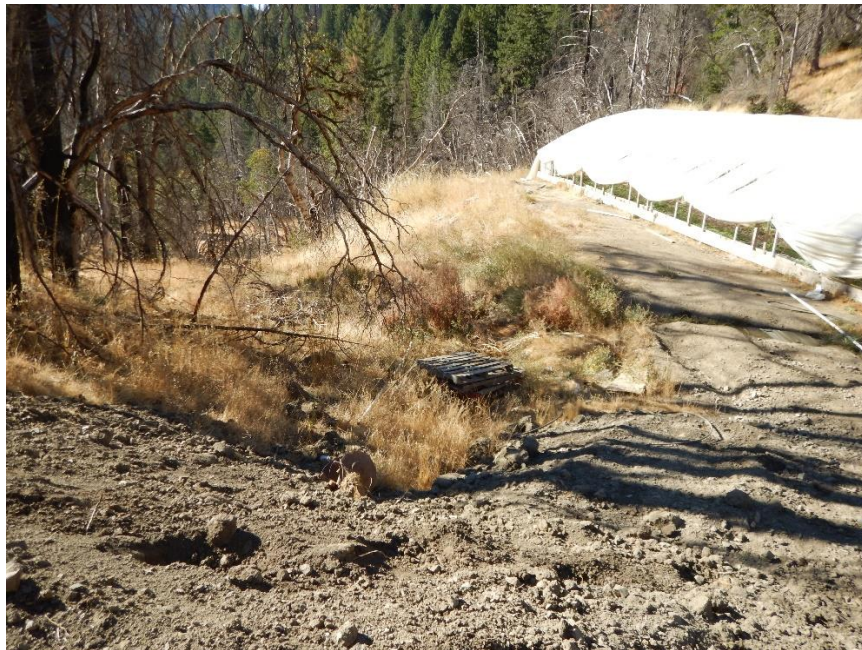
photo 22 – Looking southwest at the greenhouse occupying the flat on top of placed fill at WQ 10. Note loose earthen material on the road is susceptible to erosion.

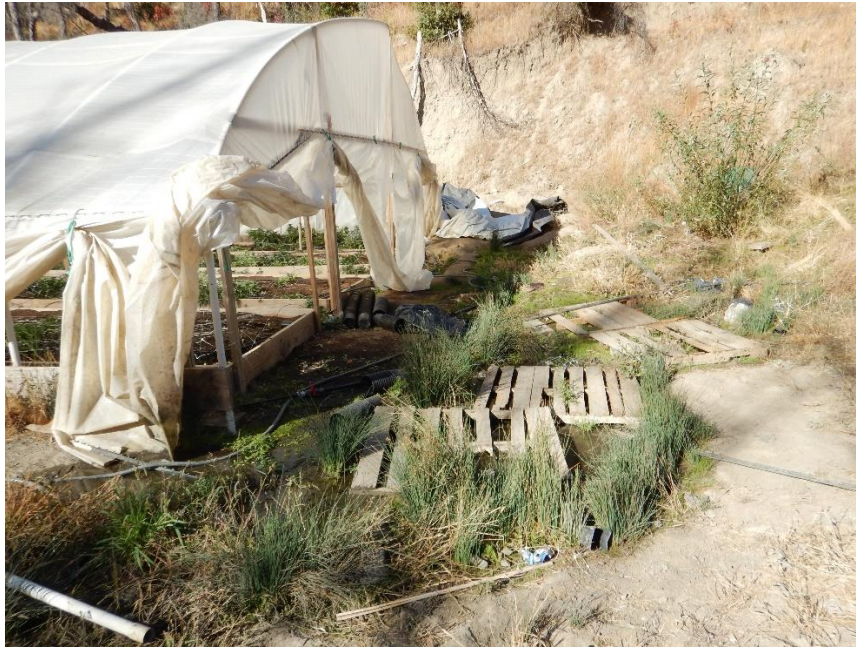
photo 23 – Looking west at the greenhouse at WQ 10. Note juncus and other grasses grow in the saturated ground at the front of the greenhouse.

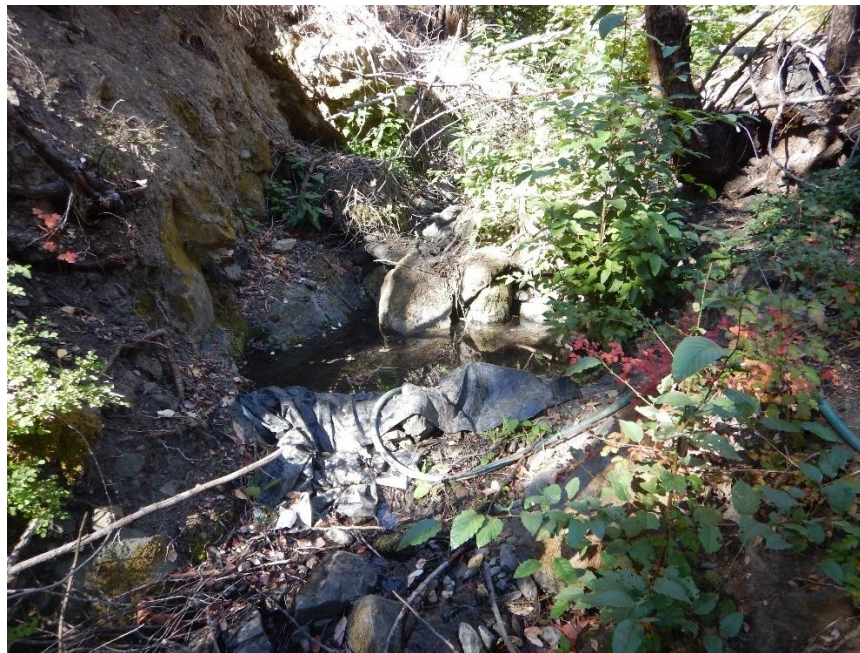
photo 24 – Tributary to Hale Creek is dammed at 40°22'13.19"N, 123°27'31.09"W, WQ 11, to facilitate a water diversion.

- 3) Comply with requirements/directives from CDFW and the Division of Water Rights with respect to appropriate permitting/licensing for water source(s), diversion(s), storage, and use, and ensure that water storage features are modified/maintained so as to minimize the potential for adverse impacts to water quality and beneficial uses. As a reference for the goal of this recommendation, review standard condition 5 of the Regional Water Board Order and relevant portions of the statewide cannabis order, or CANGO (see links to these orders below).

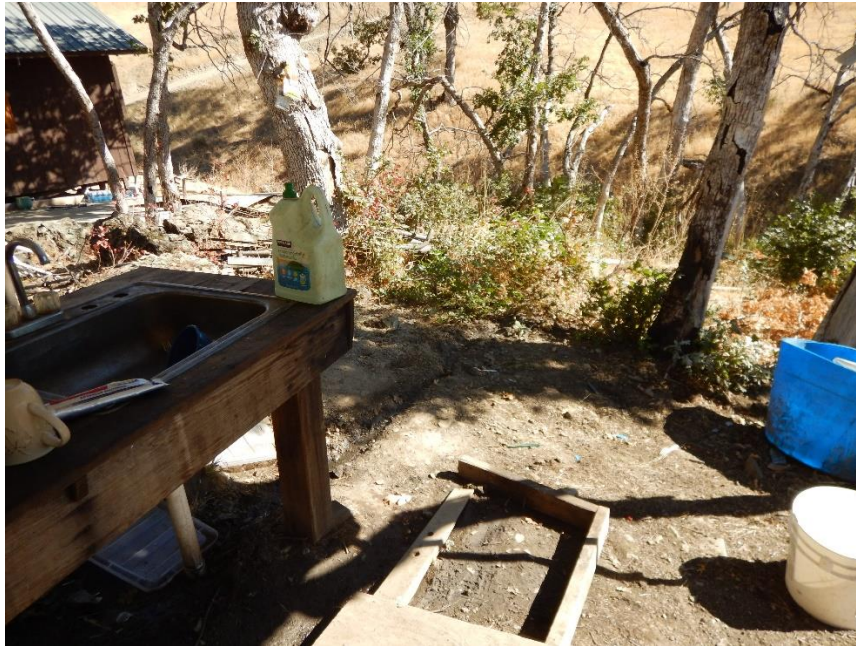
We then walked back north to a small group of structures at *WQ 12* which is bound by watercourses to the east and west. These structures included cooking and bathing areas that discharged directly to a tributary to Hale Creek (*photo 25*), and an area with five 55-gallon drums of chemicals (*photo 26*). The watercourse west of *WQ 12*, is blocked by a greenhouse (*photo 27*), downstream from which is a crushed 12" diameter culvert, that historically would have directed flows below the road that passes north of the structures. Approximately 130 feet east of the crushed culvert, we observed another culvert crossing that was undersized and perched (*photo 28*) *WQ 13*. We followed the road 200 feet east of *WQ 13* and observed a segment of road that crossed through the head of an ephemeral watercourse (*photo 29*).

photo 25 – Runoff from cooking and bathing area at WQ 12, flows directly into the watercourse located in the background of the picture.

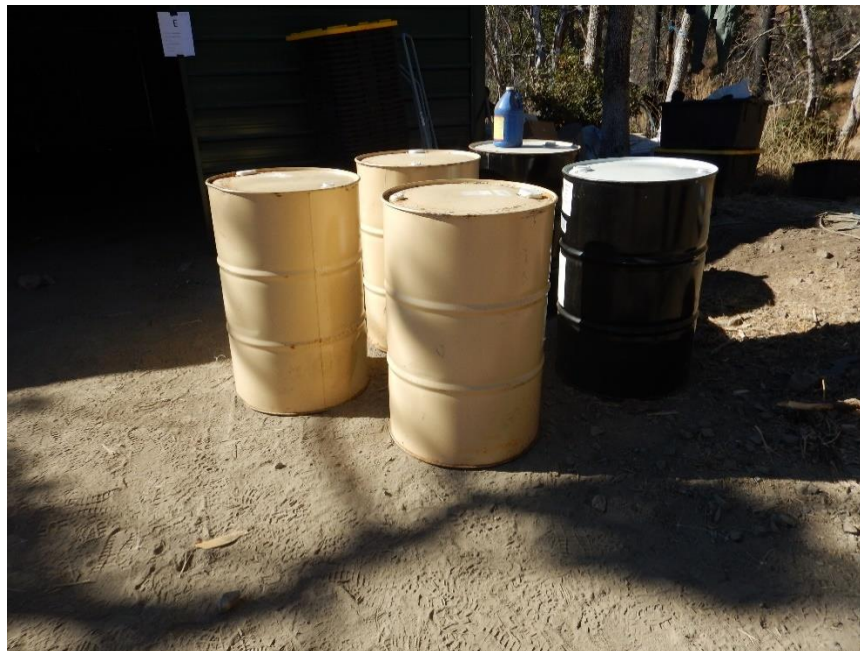
photo 26 – 55-gallon drums of Gaco Western ISO-52 ISO component A, and 183M Polyol Component B, sitting on bare ground at WQ 12.

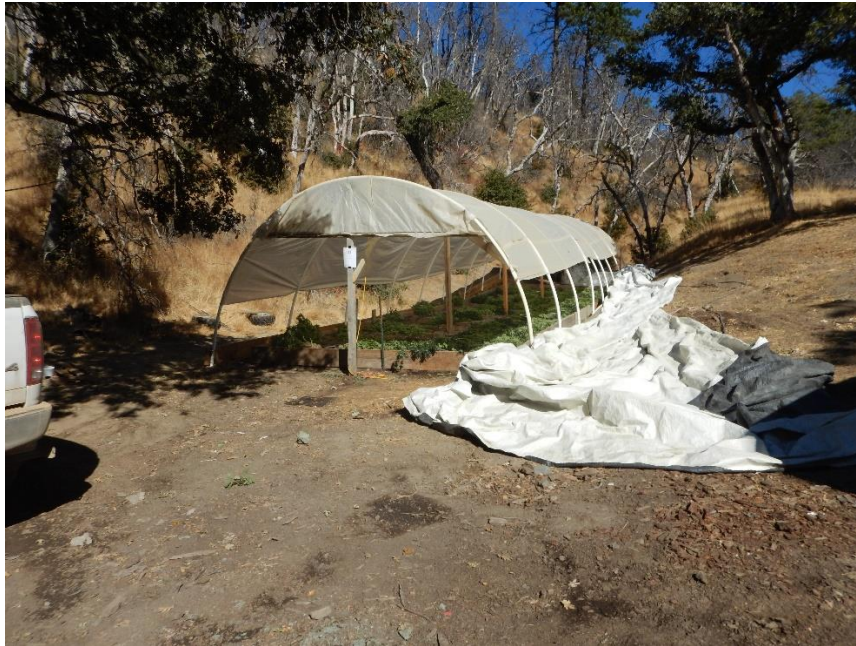
photo 27 – Greenhouse in ephemeral watercourse west of WQ 13.

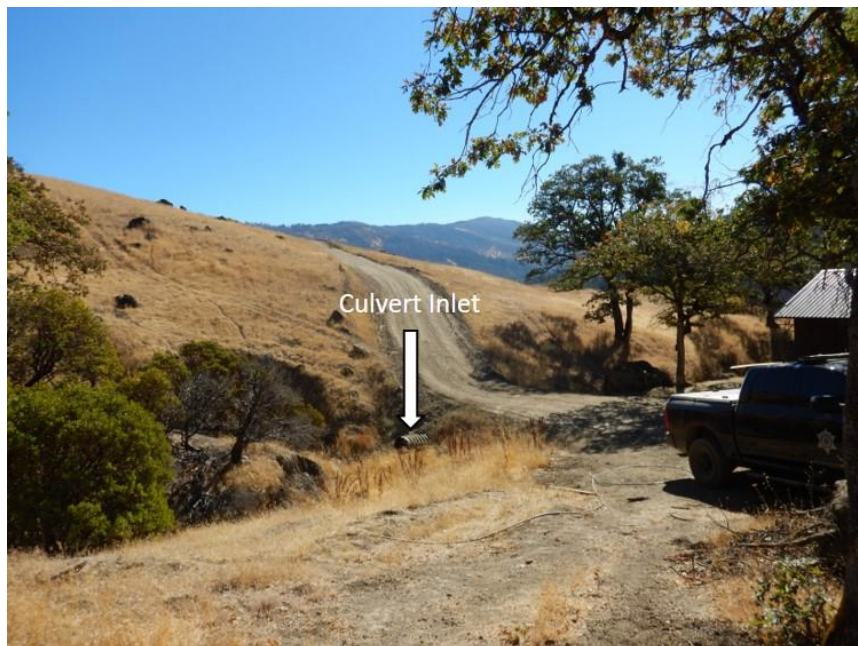
photo 28 – Picture taken looking east at WQ 13, shows a culvert with a substantially smaller diameter than the channel width.

- 2) Retain a licensed professional to inventory, assess, and develop a workplan and schedule to implement measures to ensure that all developed features, roads, and crossings throughout the parcels are corrected, restored, and/or maintained in conditions that prevent or minimize erosion, sediment transport/delivery, and adverse impacts to water quality and beneficial uses. The plan should comply with the State's Wetlands Conservation Policy of no net loss to wetlands. Include measures to ensure that unstable features caused or affected by onsite development and operations are removed or otherwise protected so as to minimize the potential for these features to cause adverse impacts to water quality and beneficial uses. Dispose of all development and restoration-related earthen spoils in a manner to prevent/minimize transport and delivery to receiving waters. As a reference for the goal of this recommendation, review standard conditions 1, 2, 3, and 4 of the regional cannabis order and applicable portions of the statewide cannabis general order, (CANGO) (see links to these orders below).

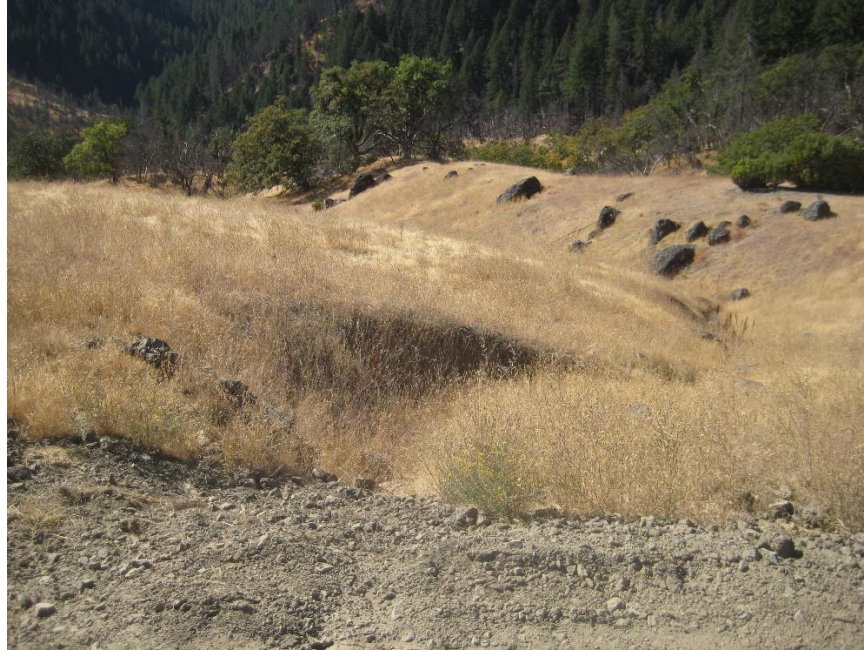
photo 29 – Road crossing watercourse head east of WQ 13.

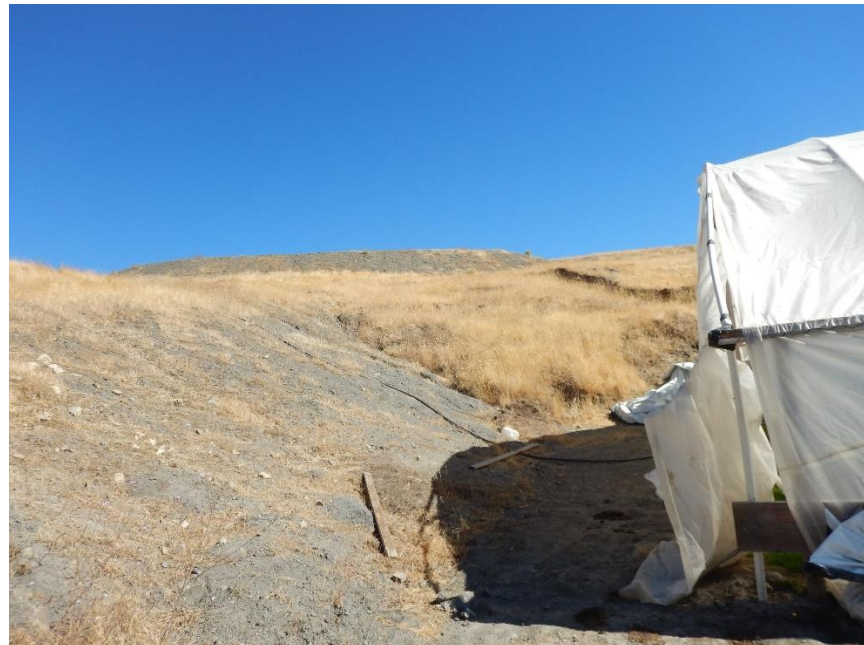
We eventually returned to the northern portion of the property and walked to the greenhouse at *WQ 14*. Immediately north of the greenhouse, where the flat was cut into the hillslope, we observed sparse vegetation and rilling (*photo 30*), and erosion on the fill (*photo 31*). We observed that the southwest portion of the fill pad abuts an ephemeral watercourse that is tributary to Hale Creek (*photo 32*).

photo 30 – Looking northeast where the flat area was cut into the hillslope for the greenhouse at WQ 14. Note rilling on the upslope cut-bank.

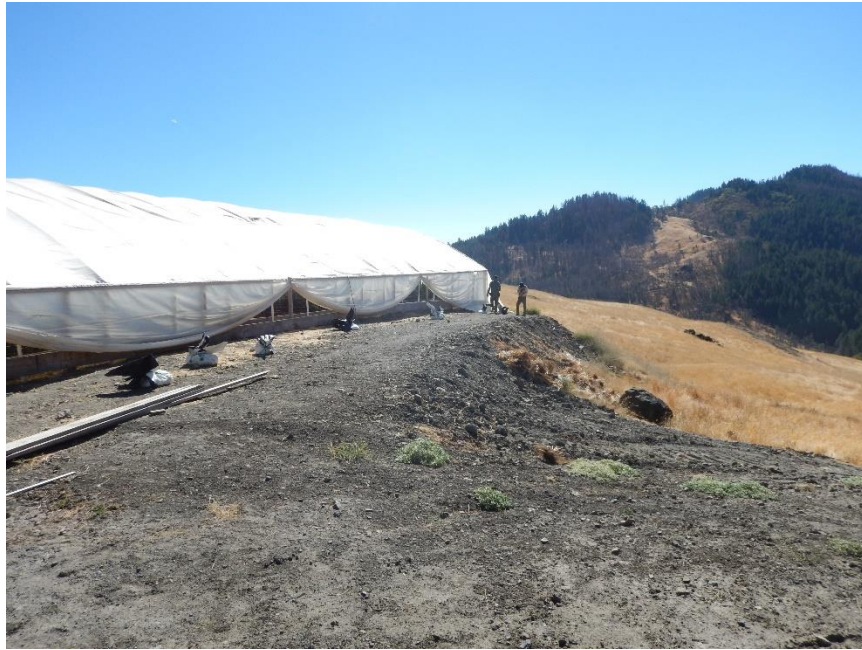
photo 31 – Looking southeast at the fill pad and greenhouse at WQ 14.

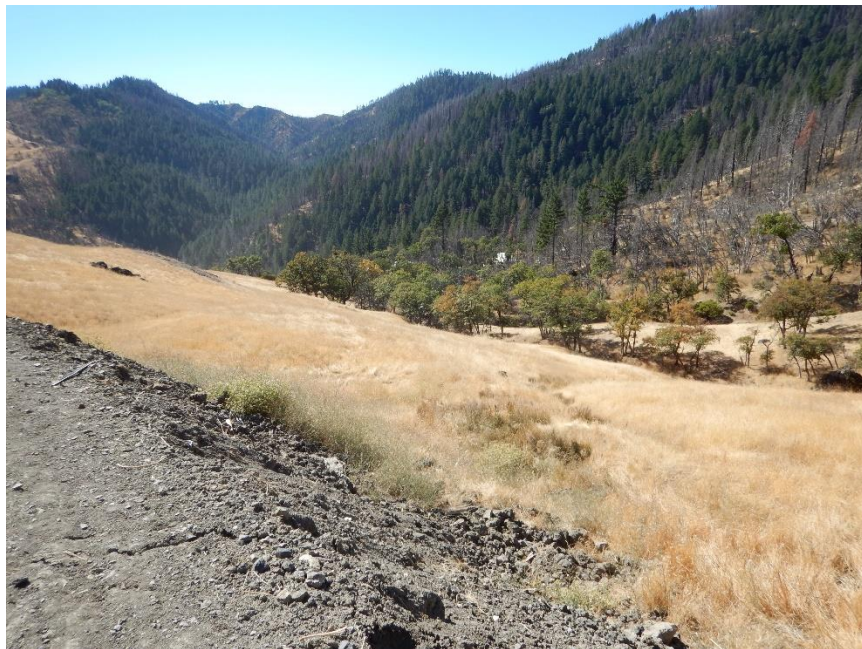
photo 32 – Looking southwest at the earthen fill pad at WQ 14. Note fill upslope from ephemeral watercourse that is tributary to Hale Creek.

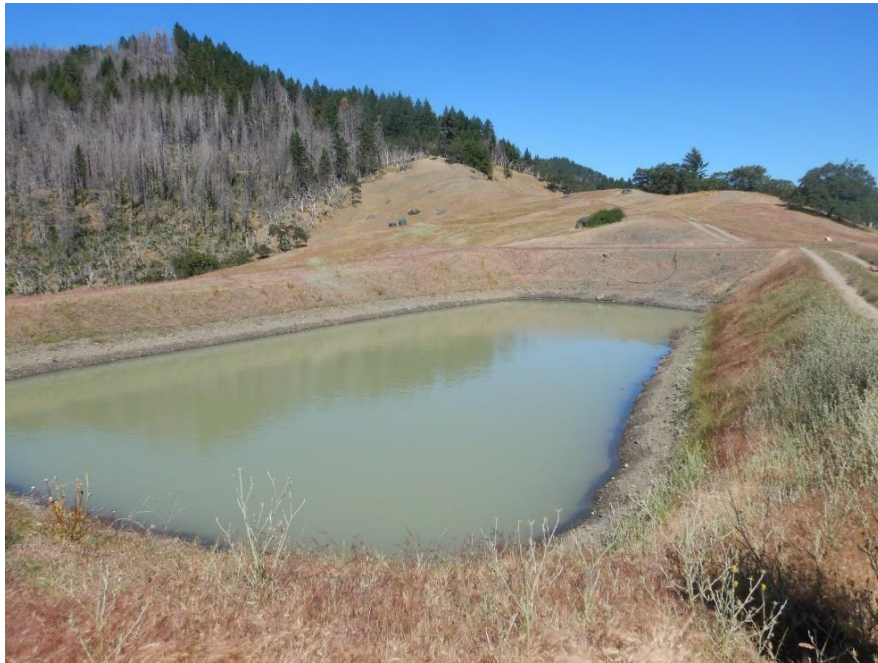
The above site map shows inspection points with features representing water quality concerns that are discussed below. We accessed the property along a dirt road from the east and walked west, passing two empty ponds near the ridge-top (photo 1). On a previous inspection, in September 2018, I had observed a group of 4 water tanks, northwest of the pond at WQ 2; these were no longer present. We headed west to WQ 3, where I had observed another cluster of tanks in September 2018. These tanks remained (photo 2), WQ 3, and as I had observed in September 2018, the area still had uncovered and uncontained fuel and fertilizer containers, at a location where these pollutants have the potential to be transported 200 feet south to a tributary to Hale Creek.

photo 1 —Looking northwest at ponds located on top of a ridge a WQ 1.

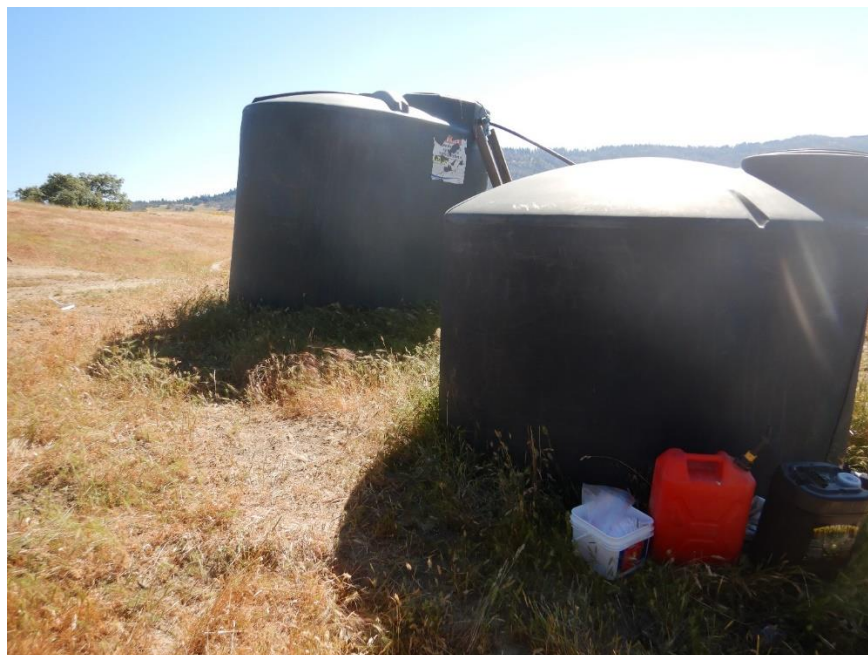
photo 2 —Looking east at nutrient mixing tanks at WQ 3.

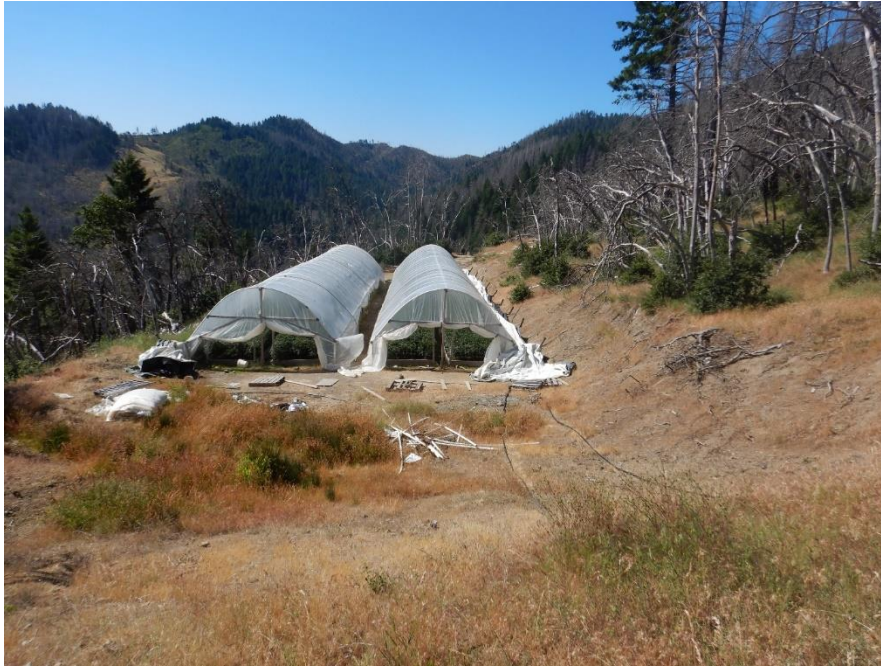
We continued south from WQ 3 to WQ 7, along the route of a former ATV trail that had been present in September 2018, now overgrown with vegetation. At WQ 7, we observed a 0.3-acre cleared earthen pad, approximately 50 feet west of a tributary to Hale Creek (photo 3). Conditions at WQ 7 were the same as I had observed during the September 2018 inspection; I observed water emanating from the ground near the northern edge of one greenhouse (photo 3) and I observed the plant species juncus growing in the saturated ground. In front of another greenhouse, I observed a bag of Grow More Brand fertilizer lying uncovered on bare ground (photo 4).

photo 3 —Looking south at graded flat cut into hillslope at WQ 7. Note concentrated vegetation between greenhouse and photographer where water is emanating from the subsurface.
