North Coast Regional Water Quality Control Board

Subject: **Notice of Violation, Directive to Obtain Regulatory Coverage for Cannabis Cultivation, and Transmittal of Inspection Report for July 2, 2019, Inspection of Trinity County Assessor's Parcel No. 018-230-21-00**

File: Cannabis Inspections, Trinity County, 2019, 190702 Lost Coast Outreach LLC, CIWQS Place ID No. 854510

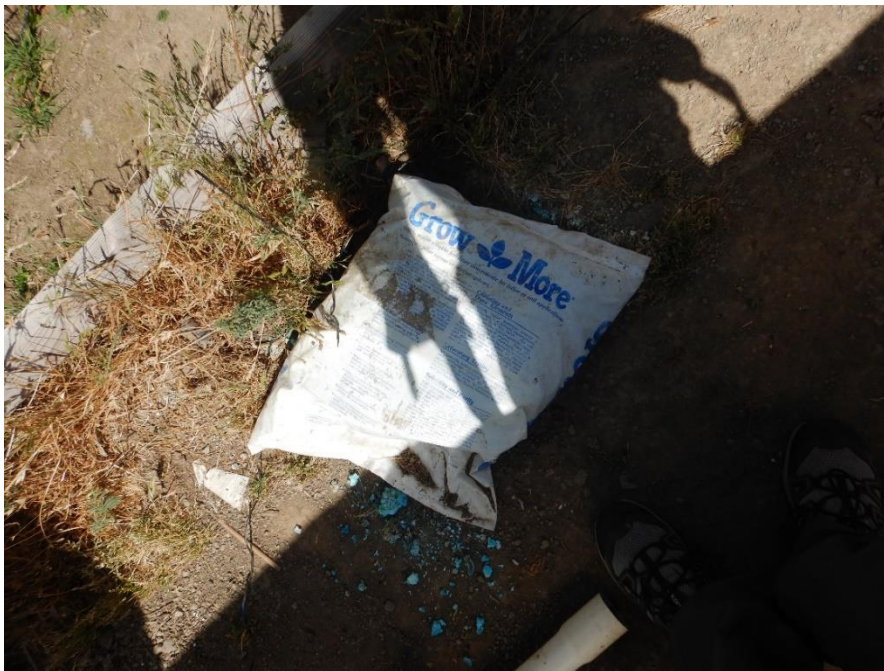
We continued south from WQ 3 to WQ 7, along the route of a former ATV trail that had been present in September 2018, now overgrown with vegetation. At WQ 7, we observed a 0.3-acre cleared earthen pad, approximately 50 feet west of a tributary to Hale Creek (photo 3). Conditions at WQ 7 were the same as I had observed during the September 2018 inspection; I observed water emanating from the ground near the northern edge of one greenhouse (photo 3) and I observed the plant species juncus growing in the saturated ground. In front of another greenhouse, I observed a bag of Grow More Brand fertilizer lying uncovered on bare ground (photo 4).

photo 4 —Bag of high-concentration, water-soluble, fertilizer discharging to ground between the two hoop-houses pictured in photo 3 at WQ 7.

- 4) Store and contain potting soils, fertilizers, petroleum products and other chemicals properly to prevent spillage and discharge to receiving waters. As a reference for the goal of this recommendation, review standard conditions 7 and 9 of the regional cannabis order and relevant portions of the CANGO.

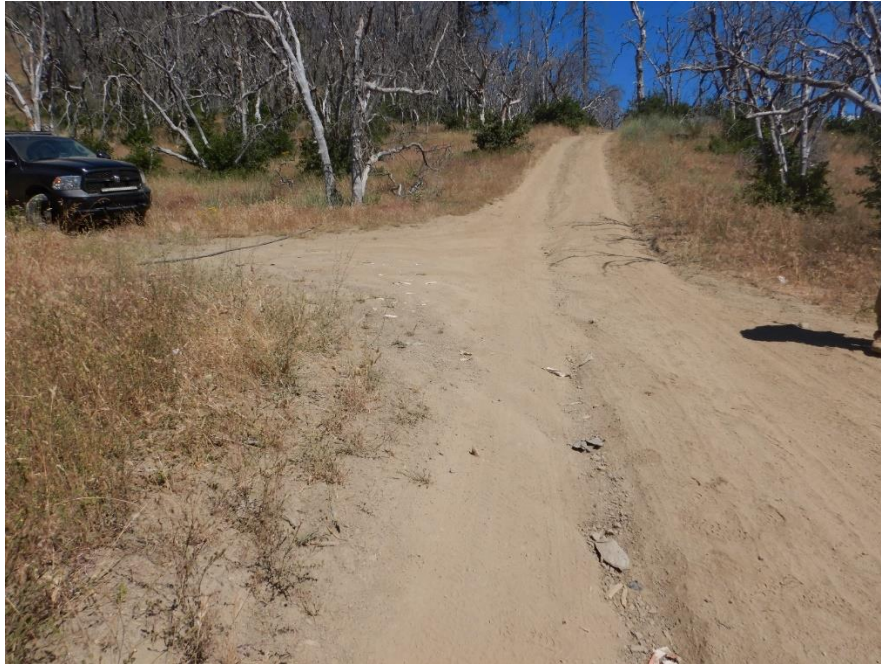
We continued south from WQ 7 along a dirt road that was in similar condition as I observed during the September 2018 inspection (photo 5). At inspection point WQ 8 along this dirt road, the road is shaped such that stormwater will run down the road surface and deliver to a pond to the south. We continued following this road south, arriving at the pond (photo 6 - photo 9), WQ 9. Conditions at the pond were similar to those I had observed in September 2018, but with more vegetation on the pond buttress and the addition of a tank on the southwest edge of the pond, for mixing fertilizers (photo 10).

photo 5 —Looking north up steep, unarmored road with ruts and loose, fine sediment.

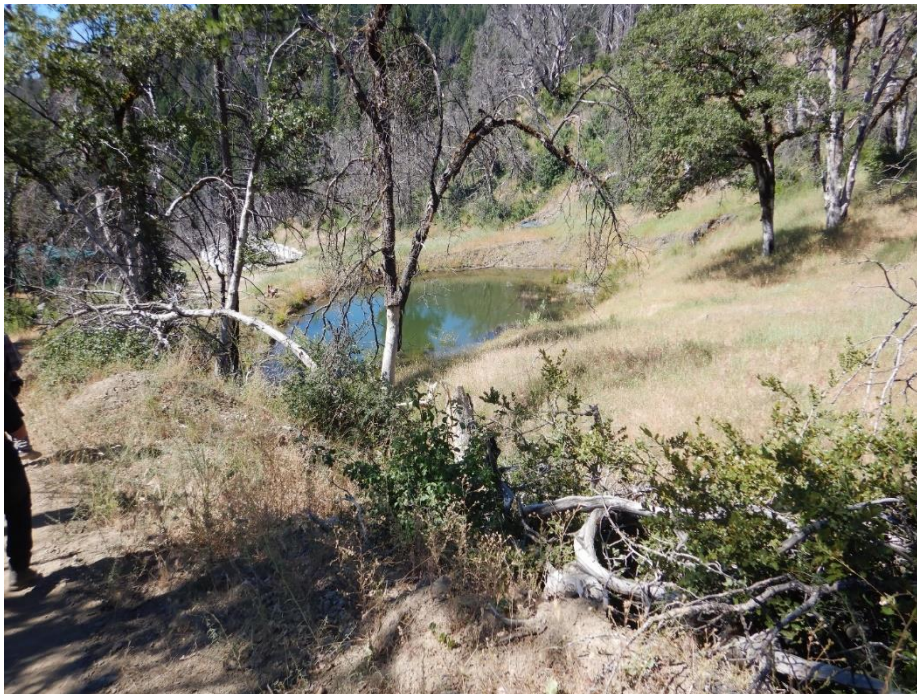
3. Riparian and wetland protection and management: A jurisdictional spring and associated wetland at WQ 9 appears to have been excavated and replaced with a pond. The cut and fill construction for greenhouses at WQ 7 and WQ 10 has enabled groundwater to reach the surface, creating wetland-like features.

photo 6 —Looking southwest at reservoir impounding watercourses at WQ 9.

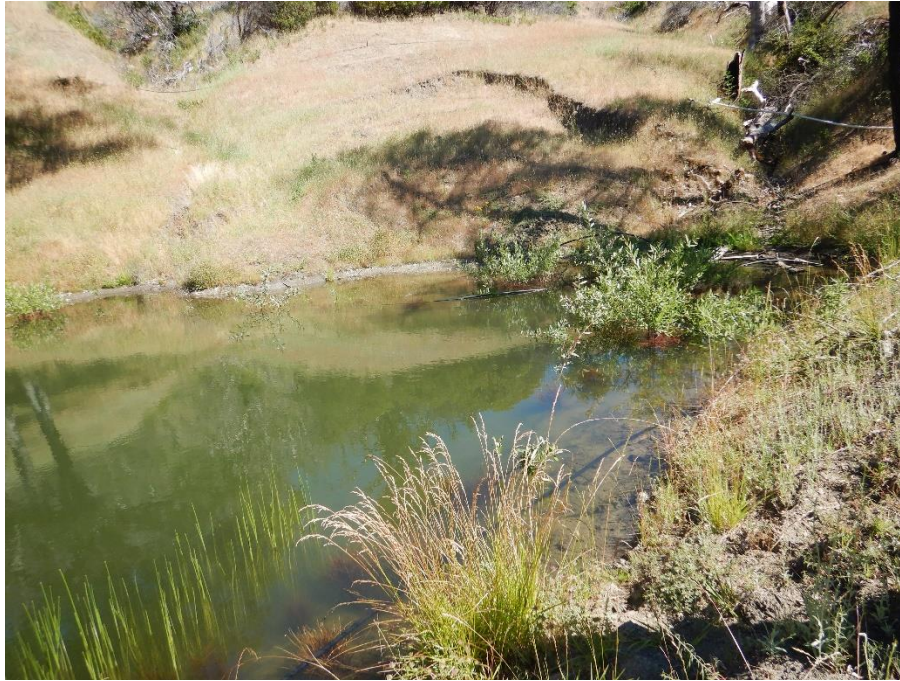
photo 7 —Looking north at reservoir impounding watercourses at WQ 9.

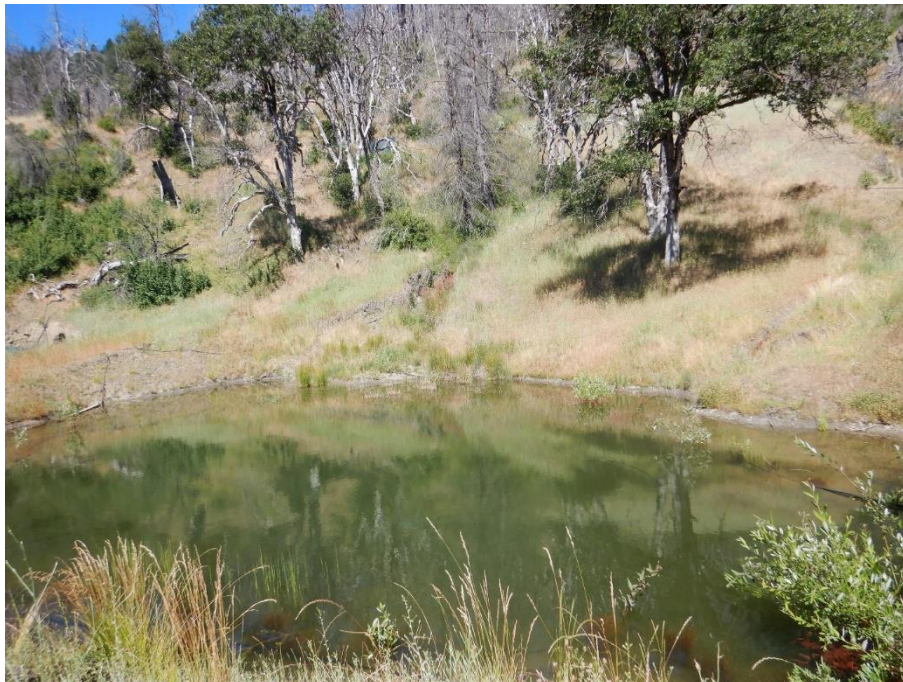
photo 8 —Looking west at reservoir impounding watercourses at WQ 9.

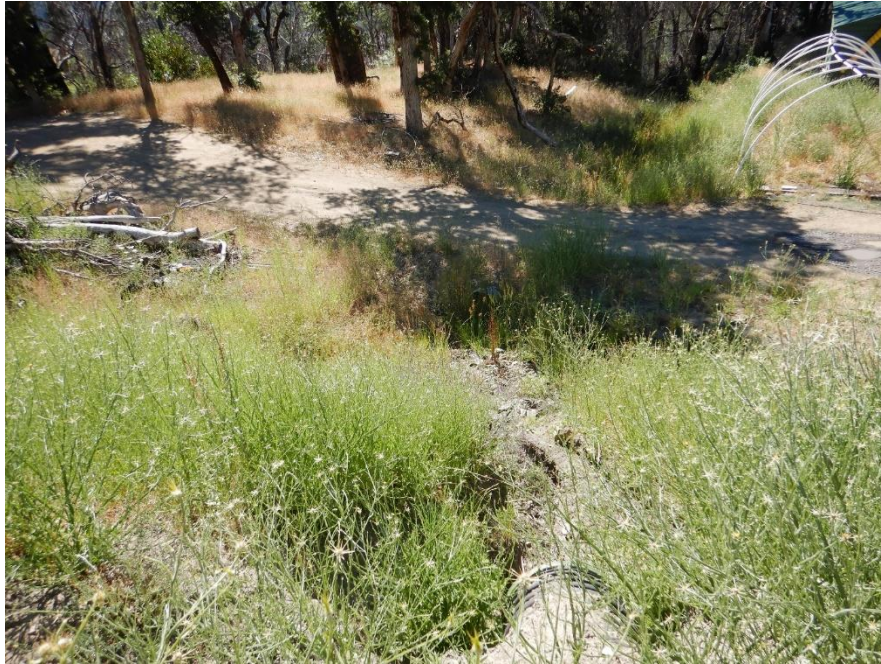
photo 9 —Looking south from top of the reservoirs impounding buttress in the vicinity of WQ 9.

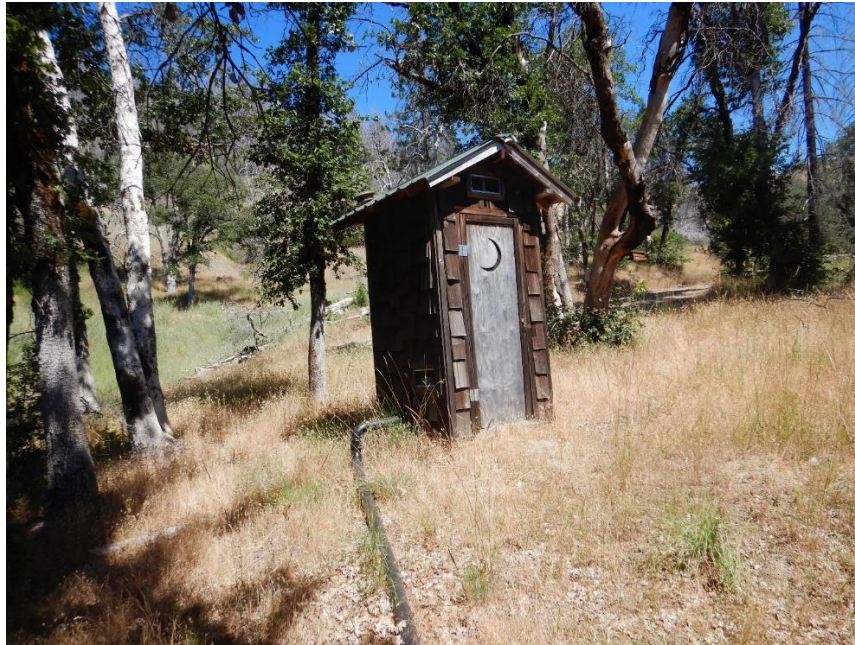
Immediately south of the pond at WQ 9, I observed a toilet discharging to the ground less than 50' from a watercourse (photo 11), in similar condition to what I had observed in September 2018.

photo 11 —Looking at the outhouse southeast of WQ 9.

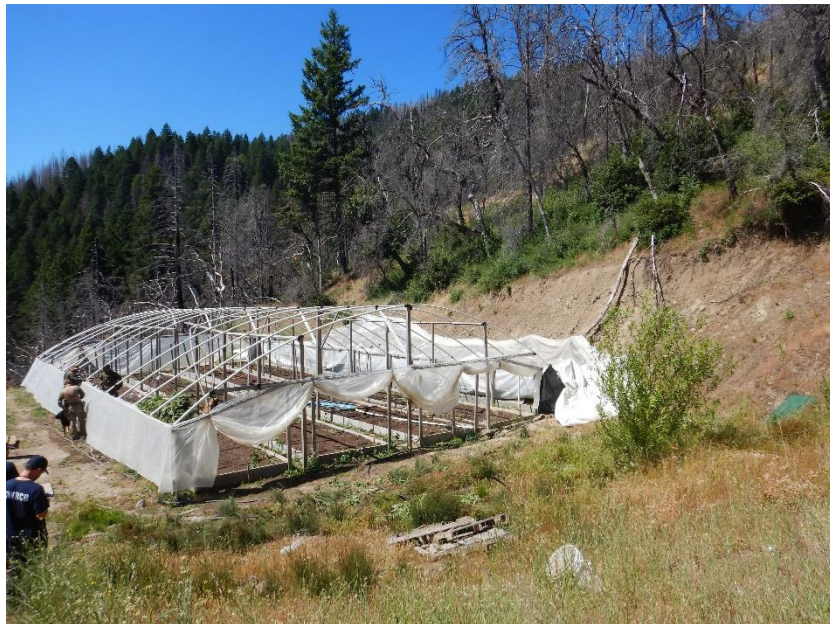
From WQ 9, we walked south to another earthen fill pad, at WQ 10, cut into the hillslope. Similar to the conditions at WQ 7, I observed saturated ground and juncus growing in front of the greenhouse at WQ 10 (photo 12). Inspection participant Ermias Berhe reported observing a point of diversion, including a small instream dam comprised of river cobbles, in the vicinity of WQ 15, southwest of WQ 10 (photo 13).

photo 12—Looking south at graded flat cut into hillslope at WQ 10. Note concentrated vegetation between greenhouse and photographer where water is emanating from the subsurface.

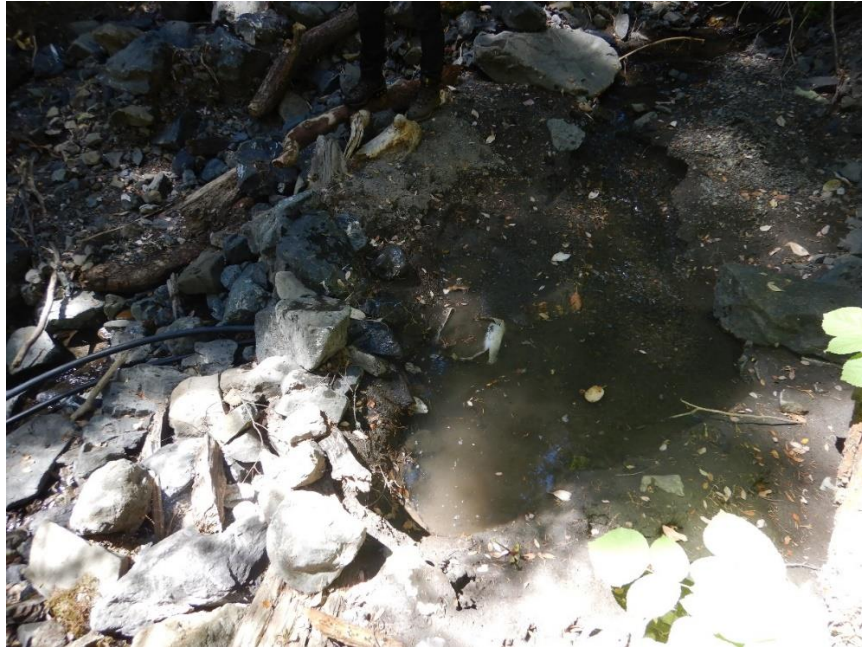
photo 13 —Watercourse dammed in the vicinity of WQ 15, to facilitate a water diversion.

- 3) Comply with requirements/directives from CDFW and the Division of Water Rights with respect to appropriate permitting/licensing for water source(s), diversion(s), storage, and use, and ensure that water storage features are modified/maintained so as to minimize the potential for adverse impacts to water quality and beneficial uses. As a reference for the goal of this recommendation, review standard condition 5 of the Regional Water Board Order and relevant portions of the statewide cannabis order, or CANGO (see links to these orders below).

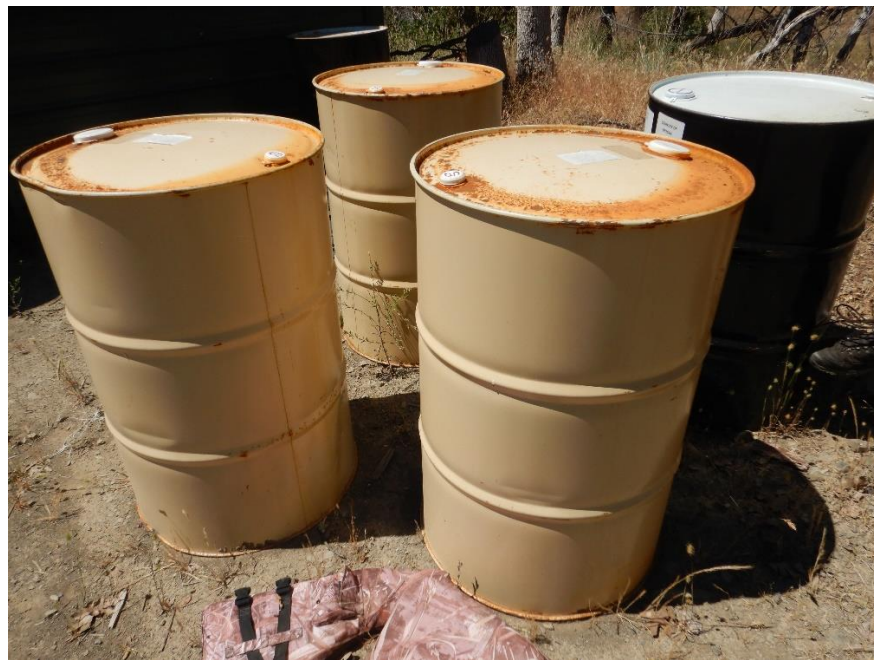
Northeast of WQ 9, at WQ 12, is a small group of structures bound by watercourses to the east and west; these were in a similar condition as I had observed during the September 2018 inspection, and I observed the same four 55-gallon drums of

chemicals I had observed in September 2018 (photo 14). On the road north of WQ 12, I observed that the undersized culvert at WQ 13 (photo 15) was in the same condition as it had been during the September 2018 inspection. We returned to the northern portion of the property and I observed that the greenhouses present at WQ 14 during the September 2018 inspection were no longer present, however the ground disturbance remained (photo 16).

photo 14 —55-gallon drums of Gaco Western ISO-52 ISO component A, and 183M Polyol Component B, sitting on bare ground at WQ 12.

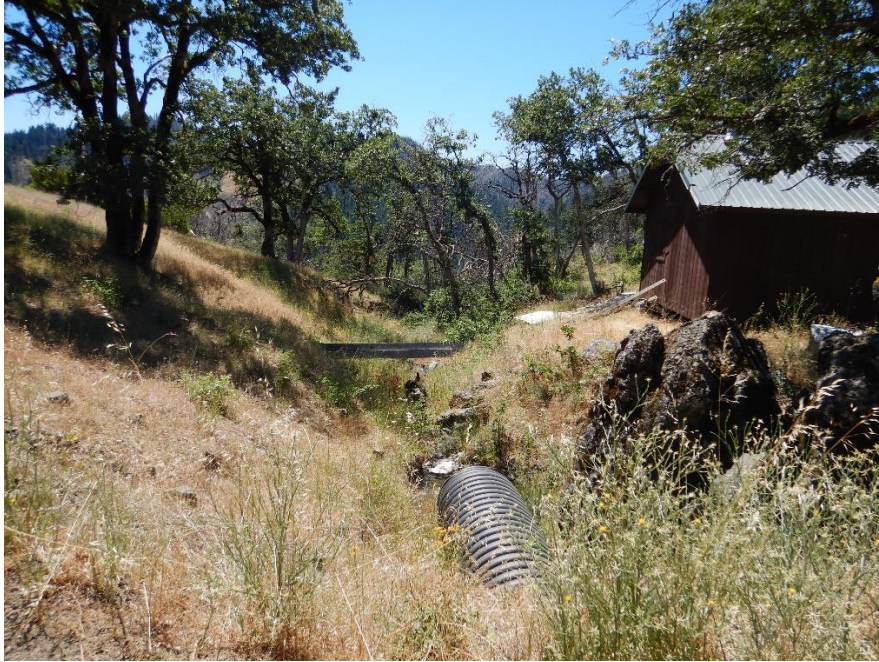
photo 15 —Picture taken looking south at undersized culvert outlet located at WQ 13.

- 2) Retain a licensed professional to inventory, assess, and develop a workplan and schedule to implement measures to ensure that all developed features, roads, and crossings throughout the parcels are corrected, restored, and/or maintained in conditions that prevent or minimize erosion, sediment transport/delivery, and adverse impacts to water quality and beneficial uses. The plan should comply with the State's Wetlands Conservation Policy of no net loss to wetlands. Include measures to ensure that unstable features caused or affected by onsite development and operations are removed or otherwise protected so as to minimize the potential for these features to cause adverse impacts to water quality and beneficial uses. Dispose of all development and restoration-related earthen spoils in a manner to prevent/minimize transport and delivery to receiving waters. As a reference for the goal of this recommendation, review standard conditions 1, 2, 3, and 4 of the regional cannabis order and applicable portions of the statewide cannabis general order, (CANGO) (see links to these orders below).

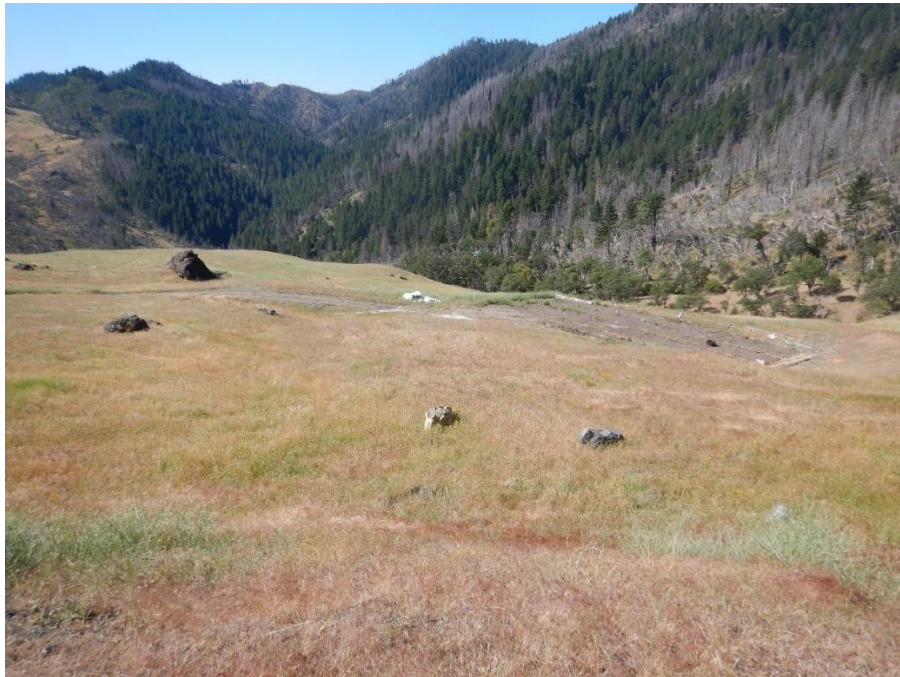
photo 16 —Looking southwest at the earthen fill pad at WQ 14. Note that bare earth is susceptible to erosion and transport to receiving water from stormwater.
