North Coast Regional Water Quality Control Board

Subject: **Notice of Violation, Directive to Obtain Regulatory Coverage for Cannabis Cultivation, and Transmittal of Inspection Report for September 25, 2018 and July 2, 2019 Inspections of Trinity County Assessor's Parcel No. 018-230-20-00**

Subject: **Inspection Report for September 25, 2018, Warrant Inspection of Trinity County Assessor Parcel Number (APN) 018-230-20-00**

APN: 018-230-20-00

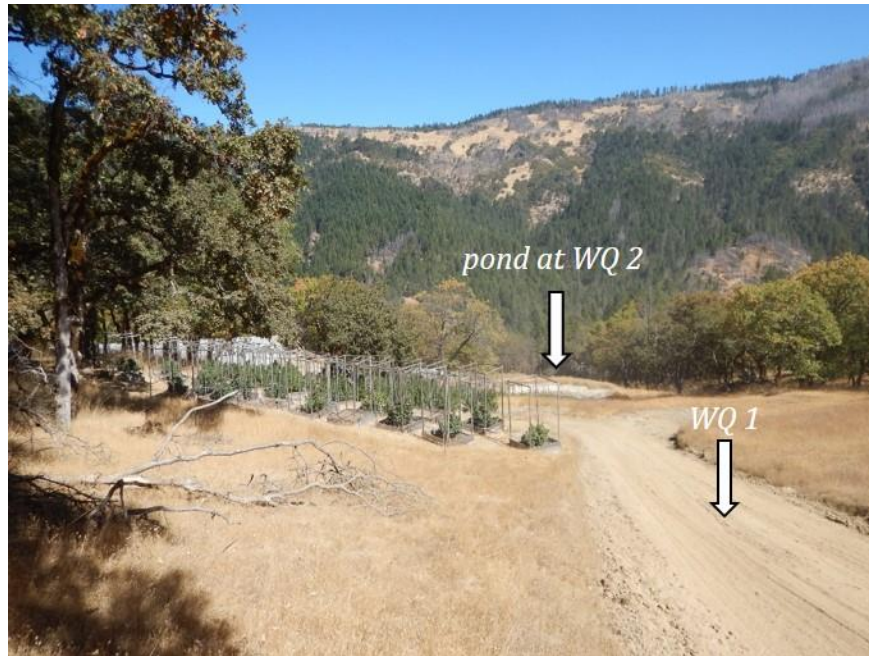
Photo Taken by: S. Utley 25 September 2018

We accessed the property along a dirt road from the south and walked northeast. The road, in the vicinity of *WQ 1*, was steep and the road surface did not have sufficient rock to prevent stormwater-related erosion (*photos 1 - 2*). We followed the road past an outdoor cannabis cultivation area, then left the road to investigate a lined pond (hereafter referred to as the Pond), located at *WQ 2*. At the Pond site, I observed an ephemeral watercourse draining into the Pond (*photos 3 - 4*). The hillslope was locally steeper upstream from the Pond, which I suspect resulted from earthwork during construction of the Pond, and this over-steepened cut-face appears to be eroding and discharging sediment into the Pond (*photos 3 - 5*). The Pond outflow discharges to a watercourse (hereafter referred to as the Watercourse), (*photos 6 - 8*), which flows towards the Mad River, however staff did not explore the northeastern portion of the property and were unable to determine the extent of the Watercourse.

photo 1 – Looking northeast towards the Mad River. Note steep road with a surface of fine sediment in lower right of image WQ 1.

- 1) Retain a licensed professional to inventory, assess, and develop a workplan and schedule to implement measures to ensure that all developed features, roads, and crossings throughout the parcels are corrected, restored, and/or maintained in conditions that prevent or minimize erosion, sediment transport/delivery, and adverse impacts to water quality and beneficial uses. Include measures to ensure that unstable features caused or affected by onsite development and

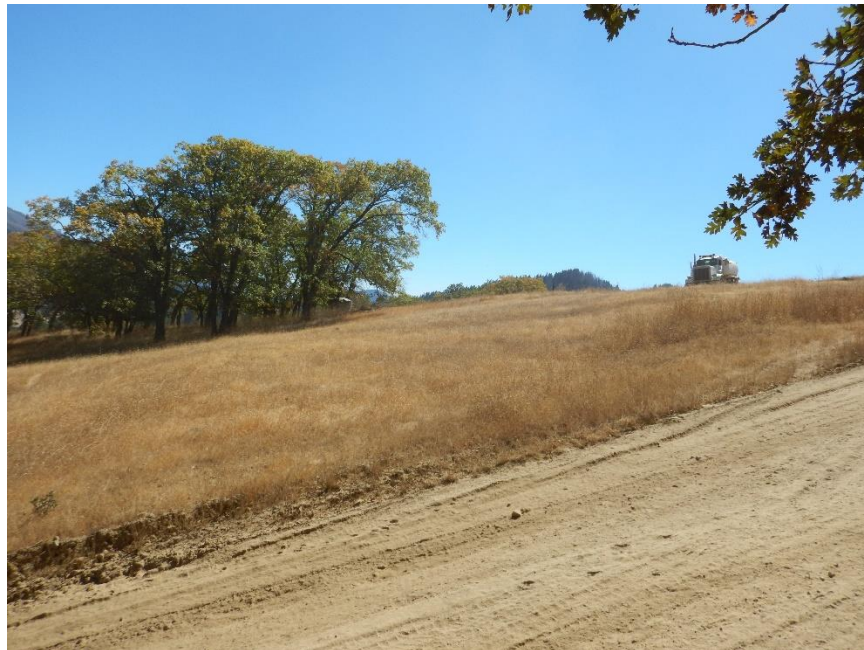
Photo Taken by: S. Utley 25 September 2018

photo 2 – Looking south from same location as photo 1. Note steep road with a surface of fine sediment.

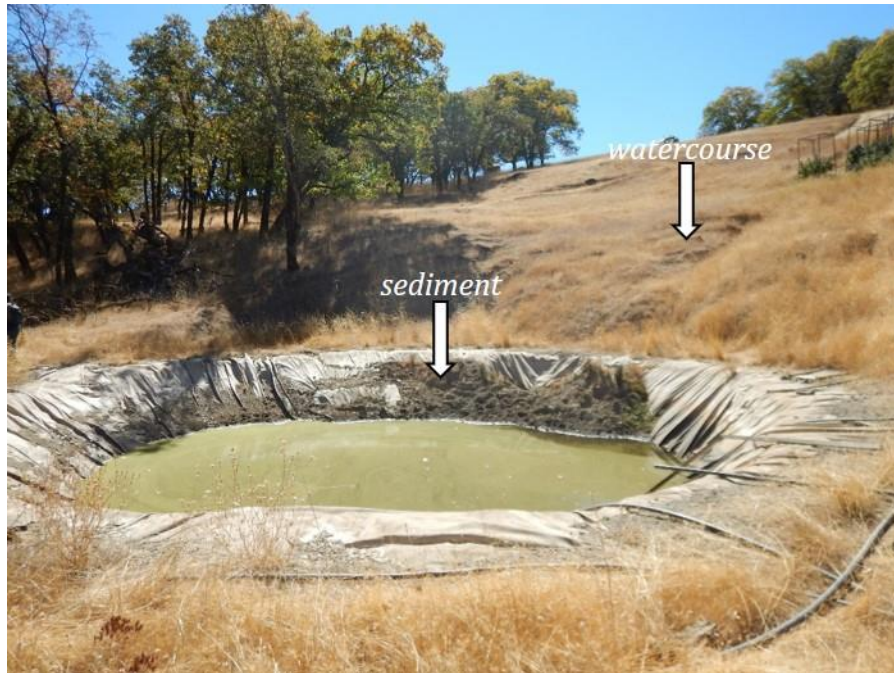
Photo Taken by: S. Utley 25 September 2018

photo 3 – Looking southwest at pond located at WQ 2. Note sediment covering pond liner on upslope side. Also note outline of ephemeral watercourse draining to pond.

- 2) Comply with requirements/directives from CDFW and the Division of Water Rights with respect to appropriate permitting/licensing for water source(s), diversion(s), storage, and use, and ensure that water storage features are modified/maintained so as to minimize the potential for adverse impacts to water quality and beneficial uses. As a reference for the goal of this recommendation, review standard condition 5 of the Regional Water Board Order and relevant portions of the statewide cannabis order, or CANGO (see links to these orders below).

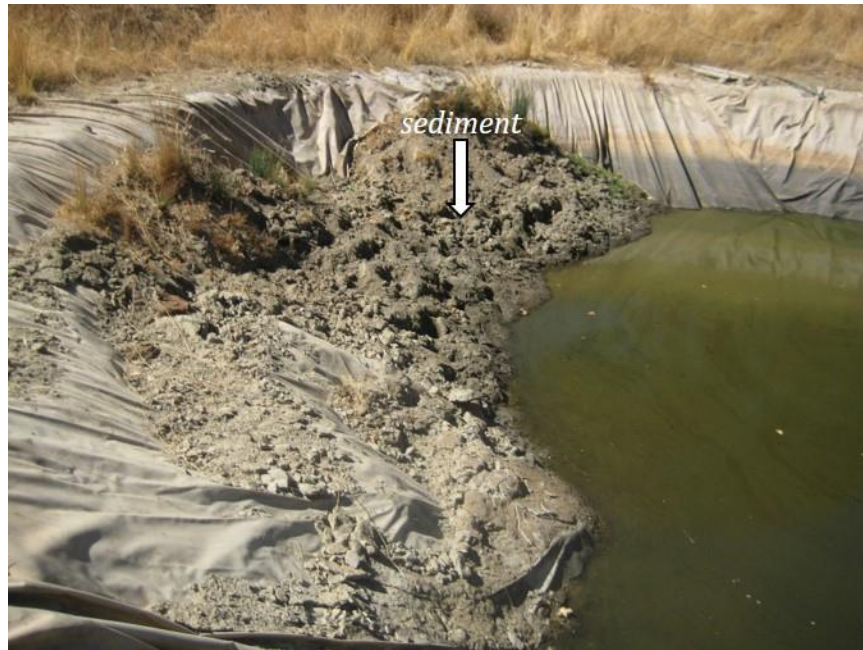
Photo Taken by: B. Fuller 25 September 2018

photo 5 – Looking west at pond located at WQ 2. Note sediment covering pond liner on upslope side.

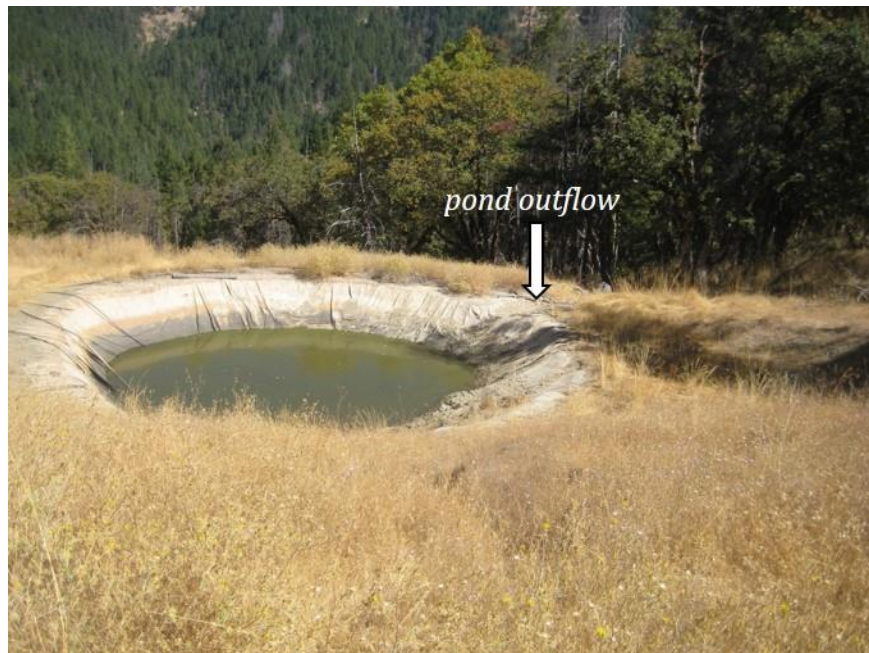
Photo Taken by: B. Fuller 25 September 2018

photo 6 – Looking northeast from south of pond located at WQ 2. Pond outflow is located on northeast side, back right of the image, and drains to ephemeral watercourse which follows the tree line in the back right of the image.

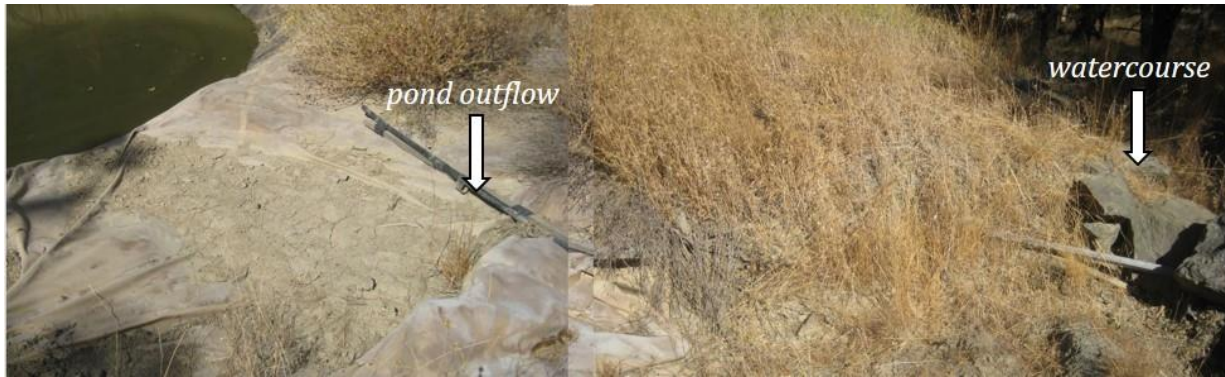
Photo Taken by: B. Fuller 25 September 2018

photo 7 – Looking at pond outflow. Note how pond outflow discharges to watercourse also pictured in photo 8.

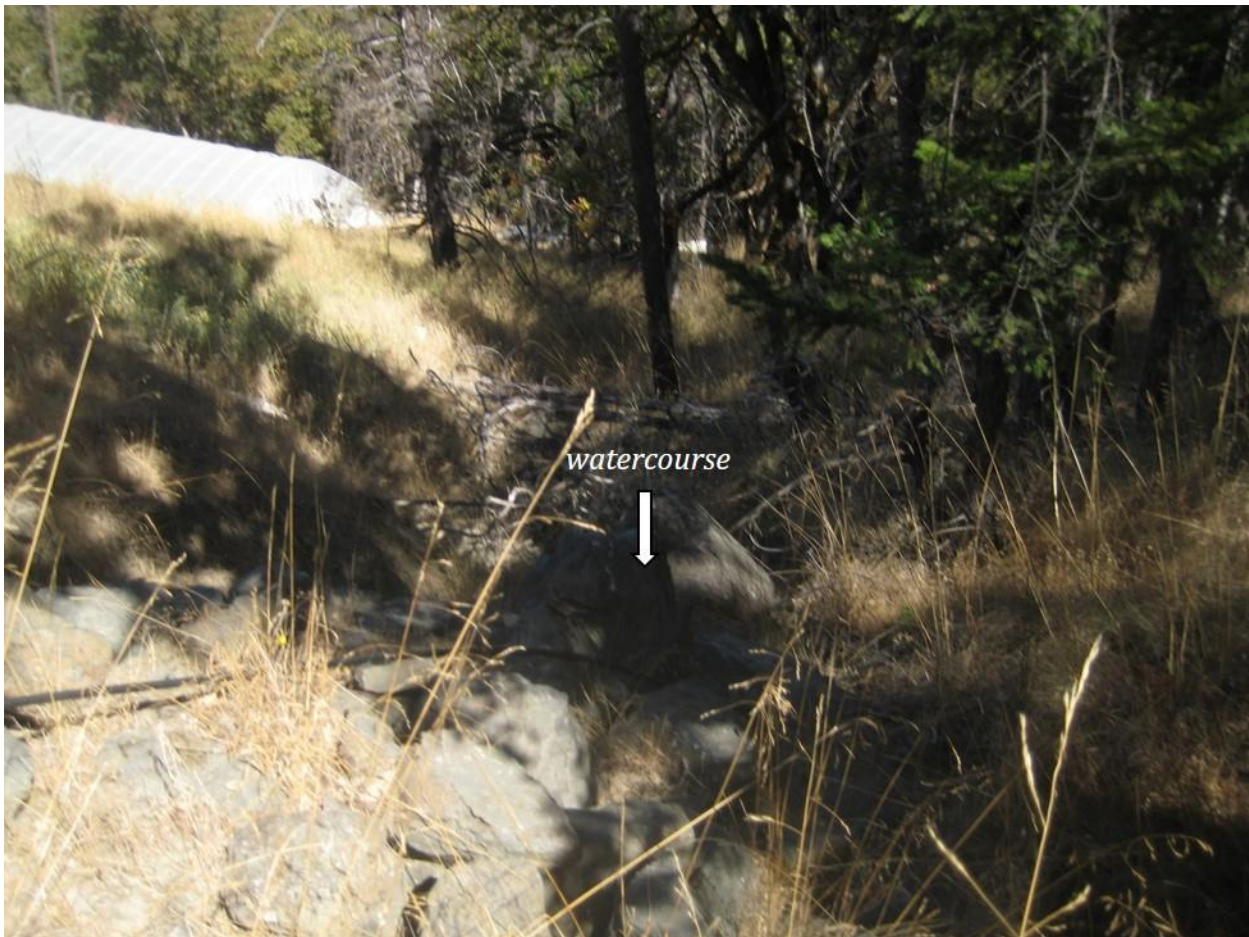
Photo Taken by: B. Fuller 25 September 2018

photo 8 – Looking east at ephemeral watercourse from where pond discharge enters watercourse.

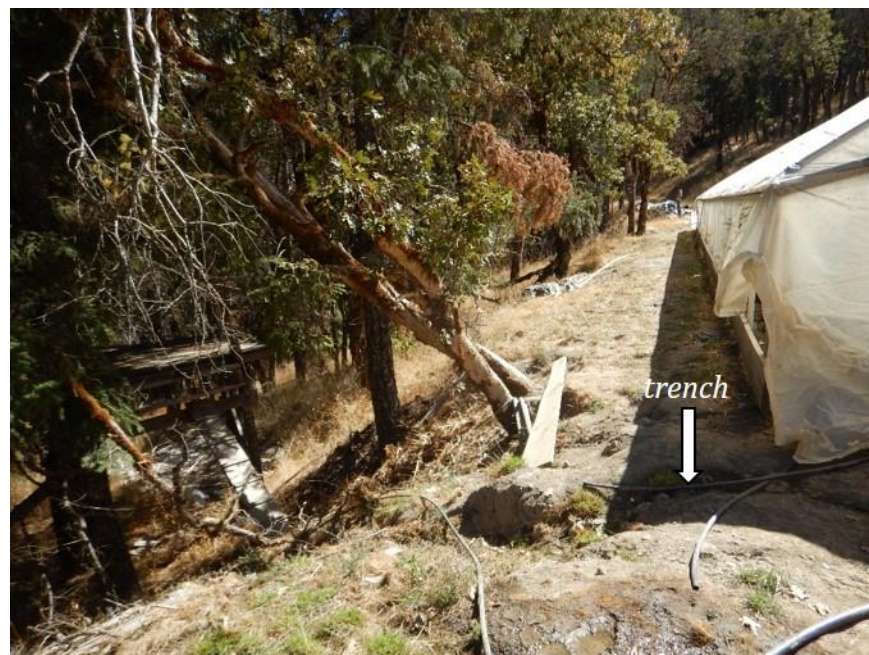
Photo Taken by: S. Utley 25 September 2018

photo 10 – Looking southeast from north side of greenhouse (*WQ 4*). Note trench in foreground of image drains greenhouse directing flow to the hillslope to the east.

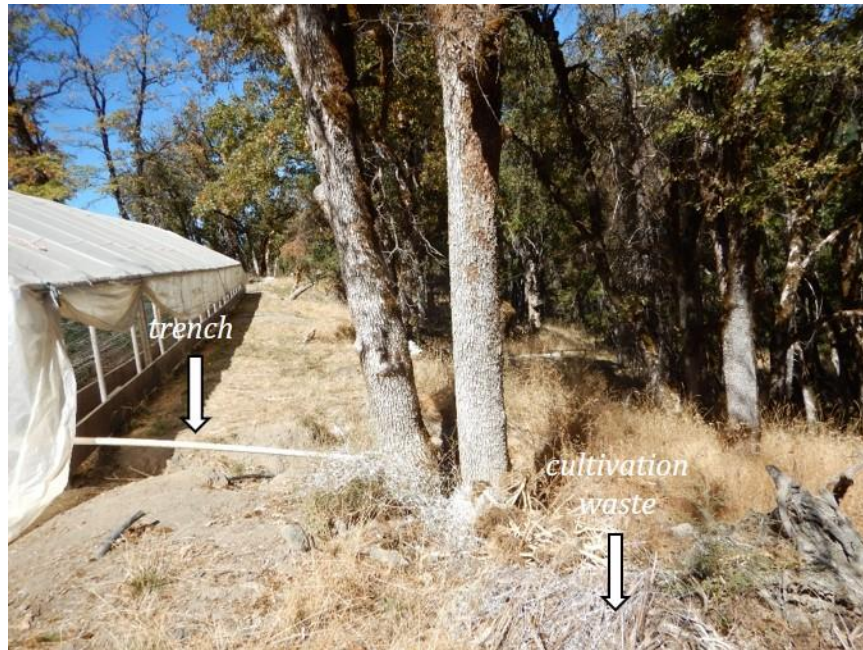
Photo Taken by: S. Utley 25 September 2018

As noted above, staff observed cultivation-related waste, including roots and plastic netting, is placed where stormwater can transport it to receiving waters at *WQ 5*, (*photos 11 - 12*).

photo 11 – Looking north west from WQ 5 to WQ 4. Note the trench draining the watercourse in the left of the image, cultivation waste is in the right foreground of the image and watercourse pictured in photo 12 is behind the photographer.

- 3) Remove and properly dispose of all trash, refuse, and cultivation-related waste. As a reference for the goal of this recommendation, review standard conditions 10 and 11 of the regional cannabis order and applicable portions of the statewide cannabis order, or CANGO (see links to these orders below).

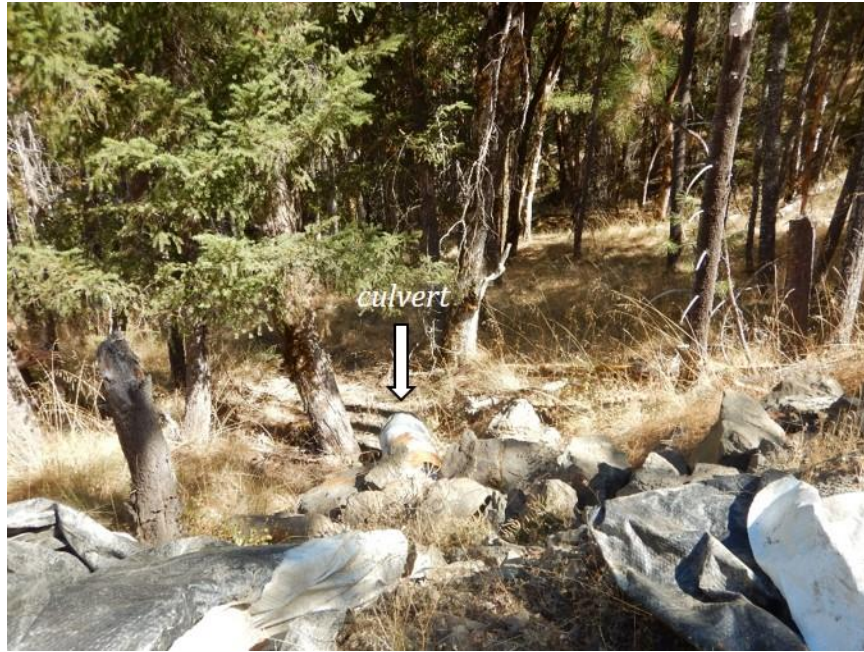
Photo Taken by: S. Utley 25 September 2018

photo 13 – Culvert 20 feet south of cultivation waste pictured in photo 12.

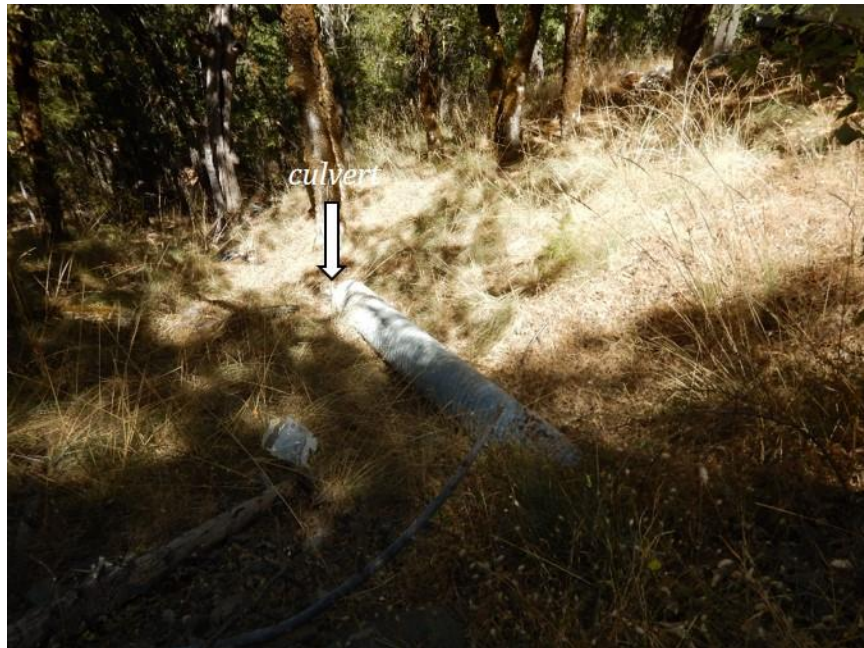
Photo Taken by: S. Utley 25 September 2018

We next followed the road southeast of *WQ 5*, and I observed an 18-inch diameter metal culvert on the hillslope northeast of *WQ 6* (*photo 14*). Above this culvert, staff observed a graded flat area, inspection point *WQ 6*, with uncontained refuse (*photos 15a and 15b*). We then returned to the greenhouse at *WQ 4* and walked west to a greenhouse at *WQ 7*. The road leading to this greenhouse from the northwest was steep, and the road surface did not have sufficient rock to prevent stormwater-related erosion (*photo 16*). We then walked southwest, up a hill (*photo 17*), and arrived at a pit-toilet located at *WQ 8*, (*photo 18*).

photo 14 – Metal culvert, with an 18inch diameter, on the hillslope northeast of WQ 6.

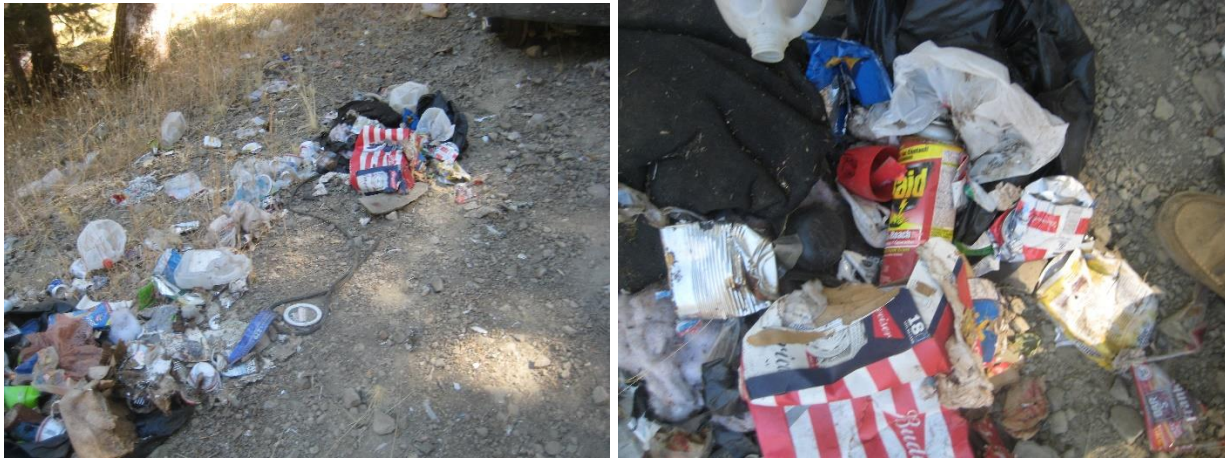
Photo Taken by: B. Fuller 25 September 2018

Staff observed Raid insecticide among the refuse at *WQ 6*.

photos 15a and 15b – Refuse uncontained at WQ 6.

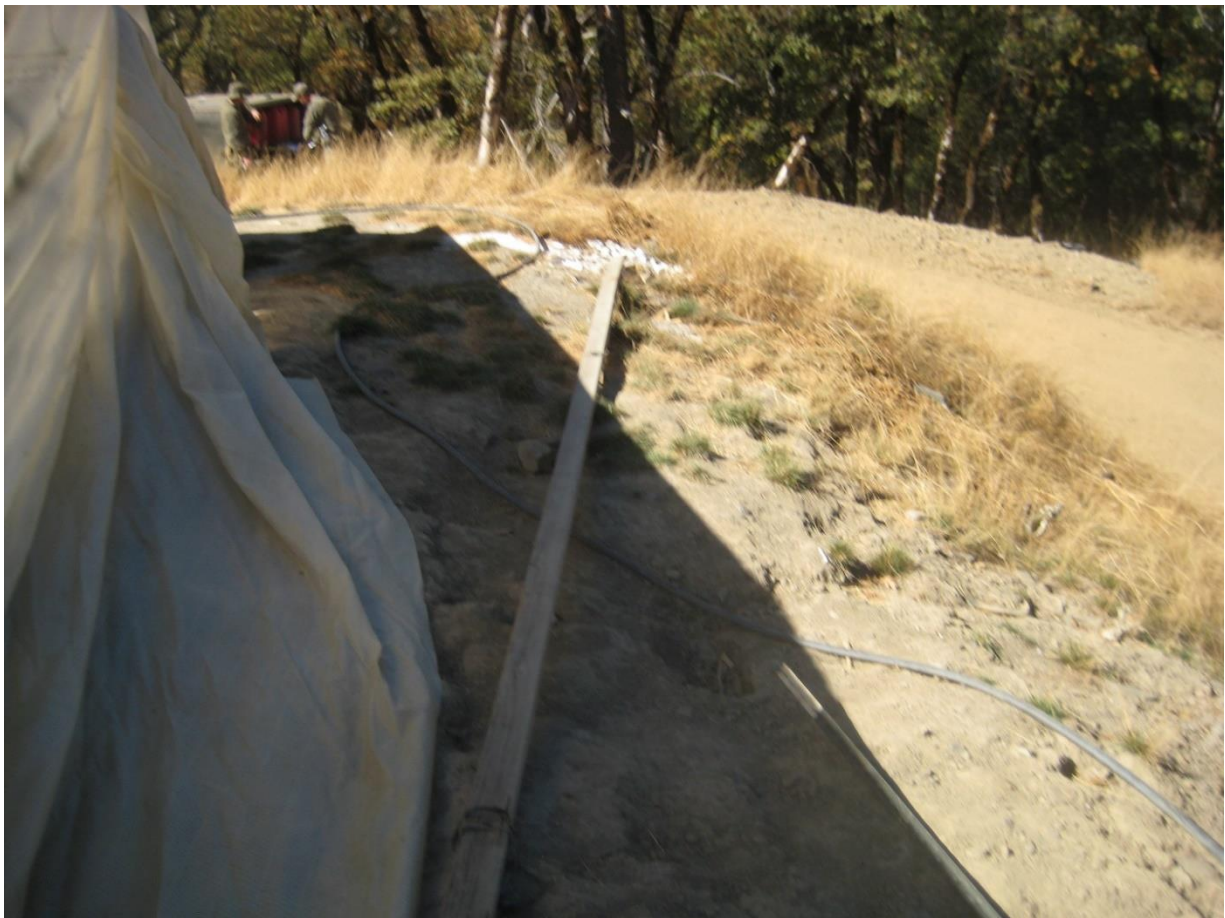
Photo Taken by: B. Fuller 25 September 2018

photo 16 – Northwestern corner of greenhouse at WQ 7. Note road in the background is susceptible to erosion from stormwater.

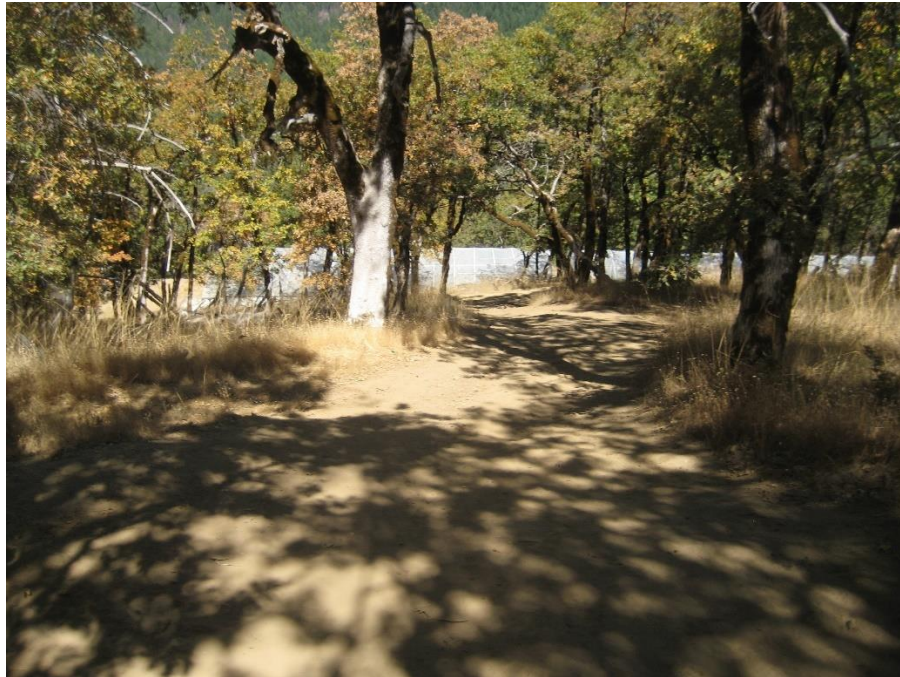
Photo Taken by: B. Fuller 25 September 2018

photo 17 – Looking northeast at greenhouse located at WQ7. Pit-toilet in photo 18 is behind the photographer.

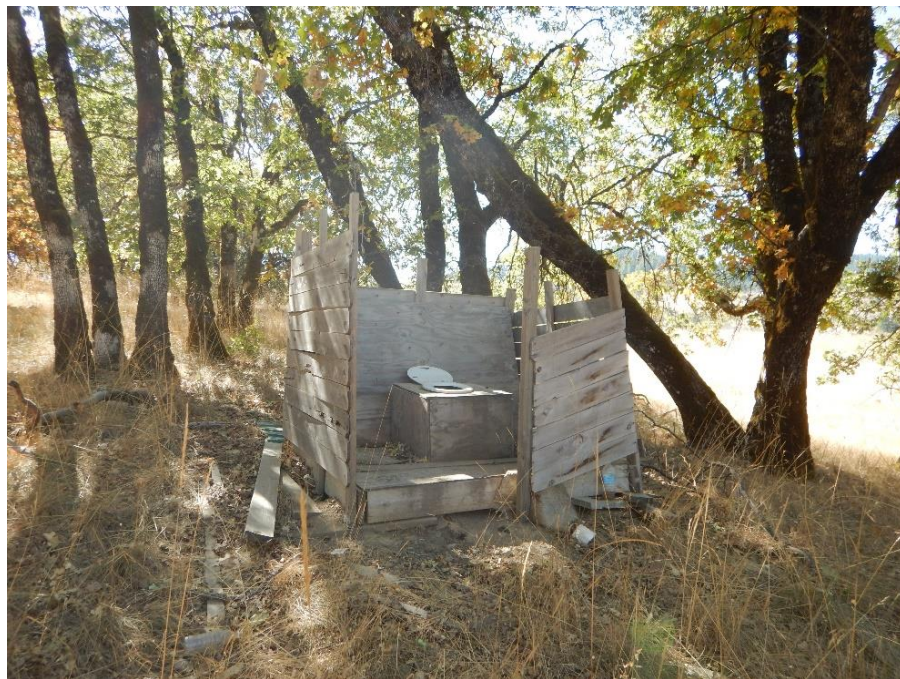
Photo Taken by: S. Utley 25 September 2018

photo 18 – Pit-toilet located at WQ 8.

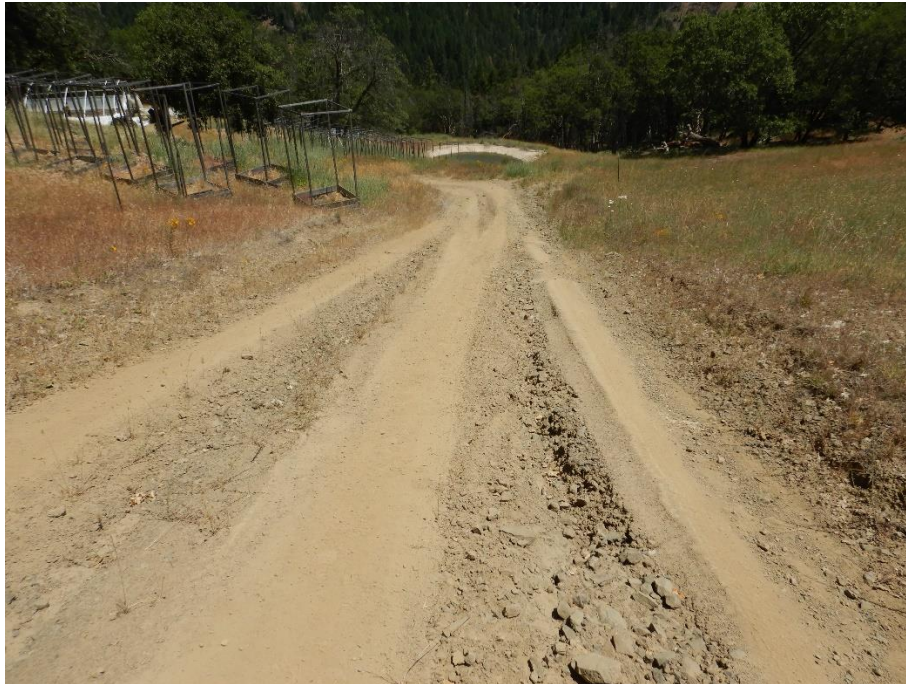
During the July 2, 2019 inspection, I observed that rutting in the road at WQ 1 had deepened since the September 2018 inspection (Photo 1). I inspected the hillslope upstream from the pond at WQ2, and I did not identify the channelized watercourse that I had suspected was there during the September 2018 inspection. I observed that the pond water had a thick layer of algae at the surface (Photo 2). The pond drains to a watercourse channel, in which I observed a number of uniform-sized boulders that appeared to have been placed at the pond outfall. I did not observe cannabis plants in the vicinity of WQ 1 or WQ 3 (Photo 5).

Photo 1—Looking northeast towards the Mad River from WQ 1. Note steep road with a surface of fine sediment and ruts.

- 1) Retain a licensed professional to inventory, assess, and develop a workplan and schedule to implement measures to ensure that all developed features, roads, and crossings throughout the parcels are corrected, restored, and/or maintained in conditions that prevent or minimize erosion, sediment transport/delivery, and adverse impacts to water quality and beneficial uses. Include measures to ensure that unstable features caused or affected by onsite development and operations are removed or otherwise protected so as to minimize the potential for these features to cause adverse impacts to water quality and beneficial uses. Dispose of all development and restoration-related earthen spoils in a manner to prevent/minimize transport and delivery to receiving waters. As a reference for the goal of this recommendation, review standard conditions 1, 2, 3, and 4 of the regional cannabis order and applicable portions of the statewide cannabis order, or CANGO (see links to these orders below).

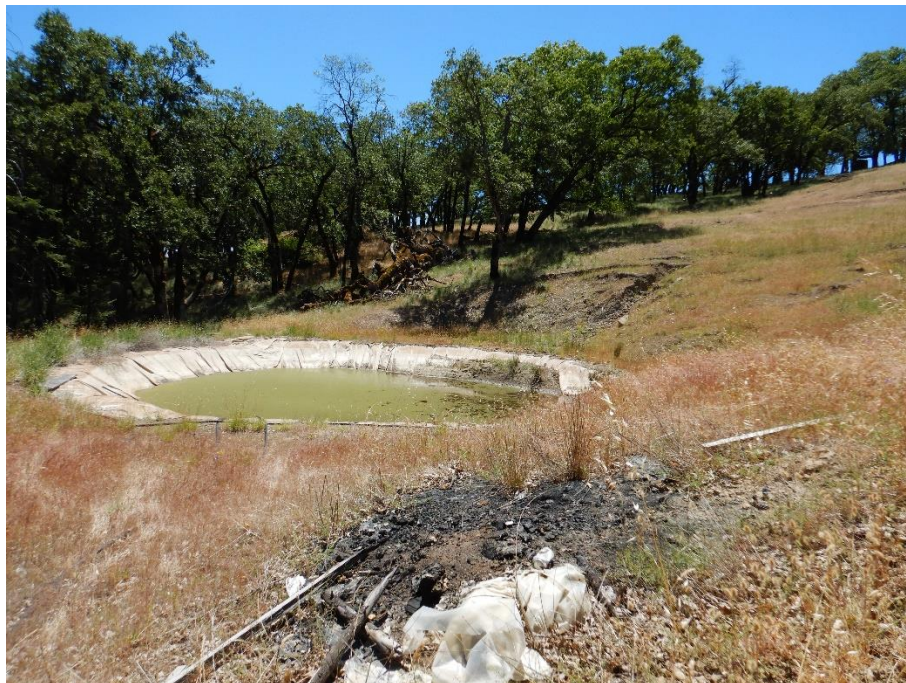
Photo 2—Looking at pond located at WQ 2. Note sediment covering pond liner on upslope side.

- 2) Comply with requirements/directives from CDFW and the Division of Water Rights with respect to appropriate permitting/licensing for water source(s), diversion(s), storage, and use, and ensure that water storage features are modified/maintained so as to minimize the potential for adverse impacts to water quality and beneficial uses. As a reference for the goal of this recommendation, review standard condition 5 of the Regional Water Board Order and relevant portions of the statewide cannabis order, or CANGO (see links to these orders below).

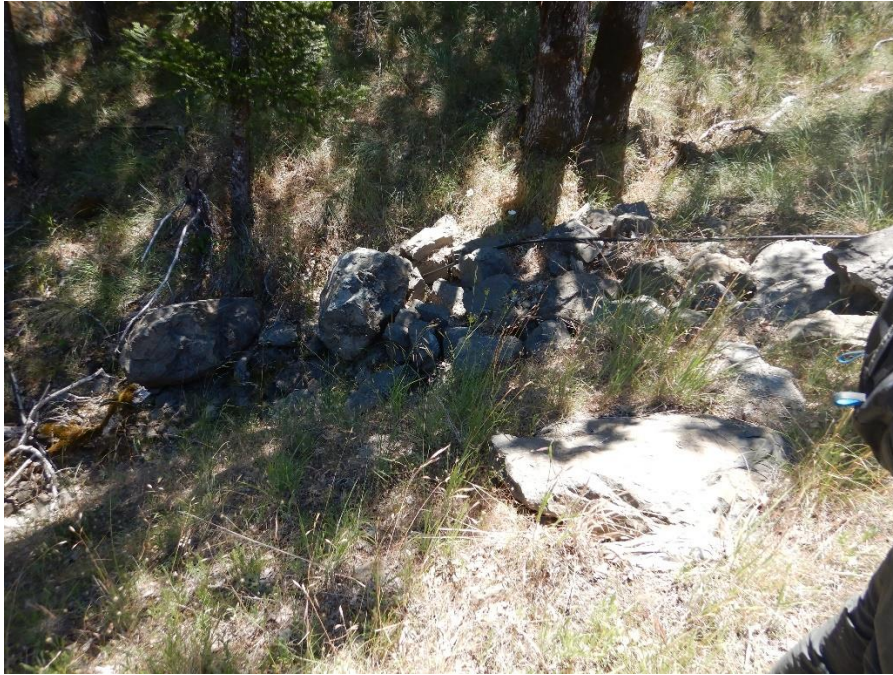
Photo 3—Pond outflow discharges to watercourse. Note a relatively uniform distribution of small boulders fill the small headwater channel.

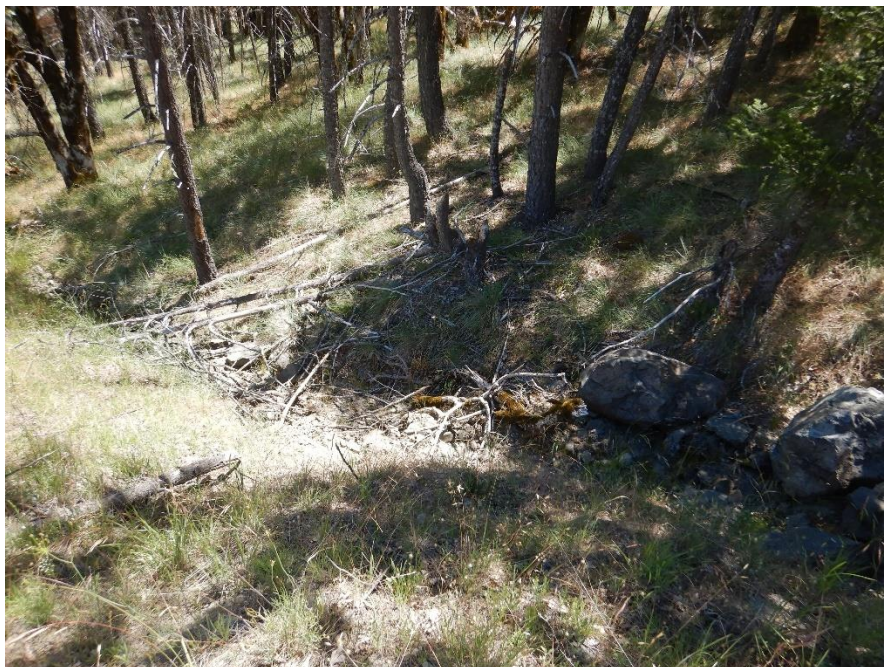
Photo 4—Watercourse downstream from the previous picture. Note transition from boulder filled segment to smaller sediment size downstream.

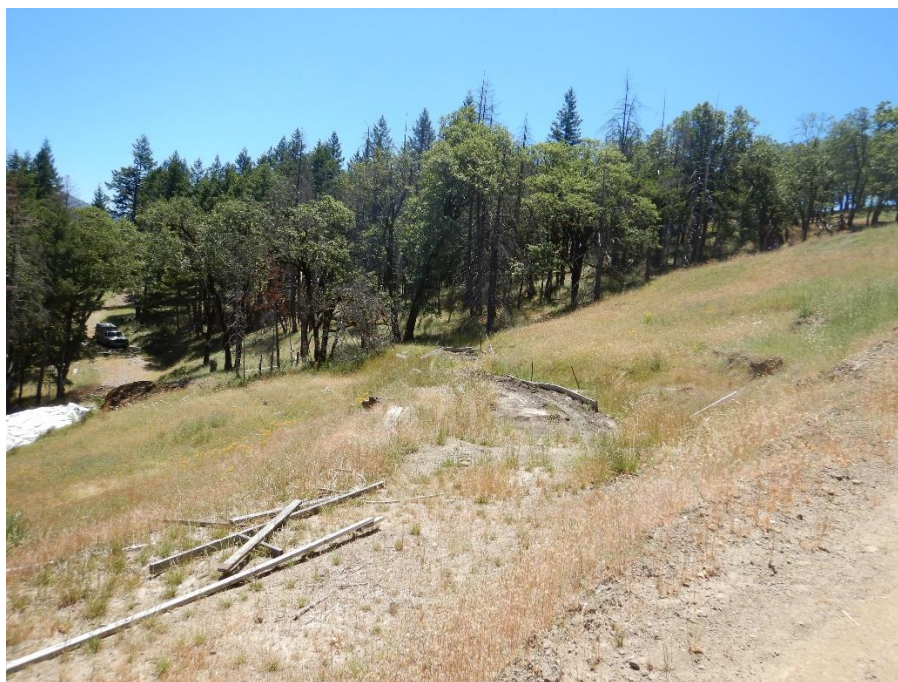
4. Spoils management: During the September 2018 inspection, I observed earthen spoils at WQ 3 where they may be transported via runoff down the road and northeast towards Mad River. The spoils appeared to have dispersed and were stabilized with vegetation during this inspection.

Photo 5—Historical cultivation area at WQ3. No cannabis growing at this location during this inspection. The roadwork spoils that I had observed the previous year have dispersed.

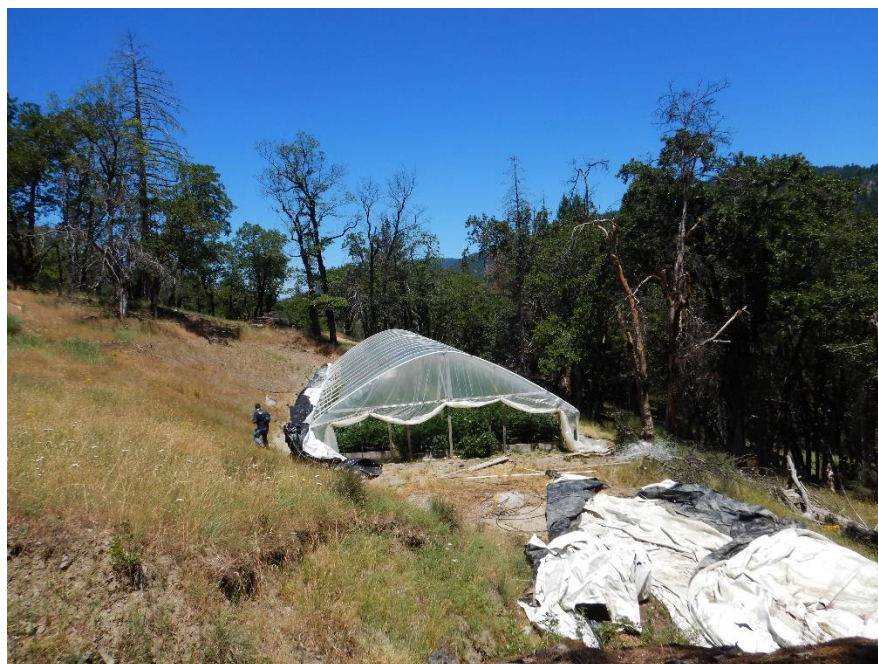
10. Cultivation-related wastes: I observed waste plastic netting uncontained at WQ 5.

Photo 6—Looking north at the greenhouse between WQ 4 and WQ 5. Note pile of plastic netting at the right corner of the greenhouse.

- 3) Remove and properly dispose of all trash, refuse, and cultivation-related waste. As a reference for the goal of this recommendation, review standard conditions 10 and 11 of the regional cannabis order and applicable portions of the statewide

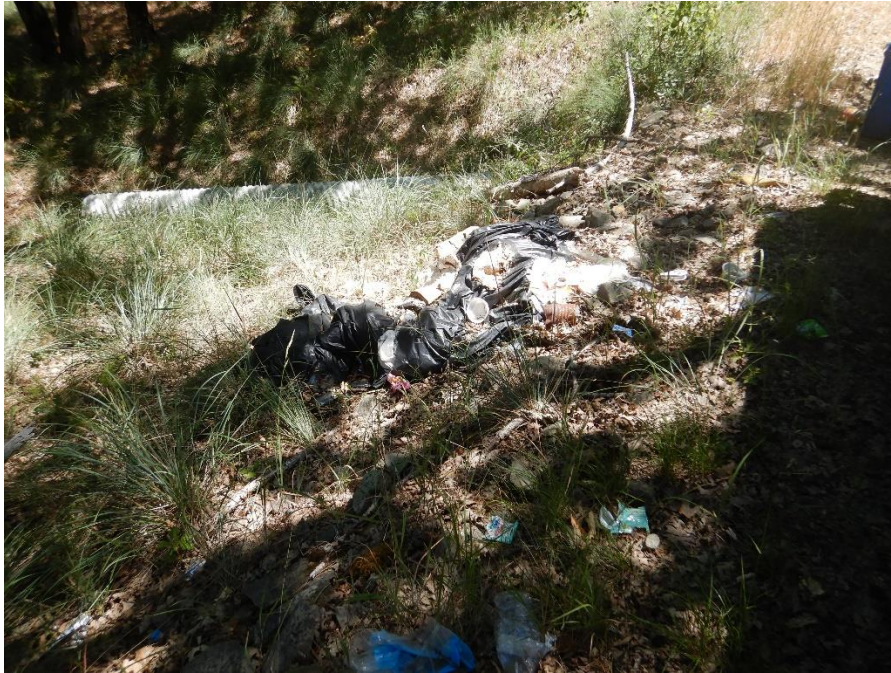
11. Refuse and human waste: During the September 2018 inspection, I observed uncontained refuse at WQ 6 and a pit-toilet located a WQ 8. I observed the same piles of refuse near WQ 6; however, I did not inspect location WQ 8.

Photo 7—Refuse above culvert outlet in the vicinity of WQ 6.

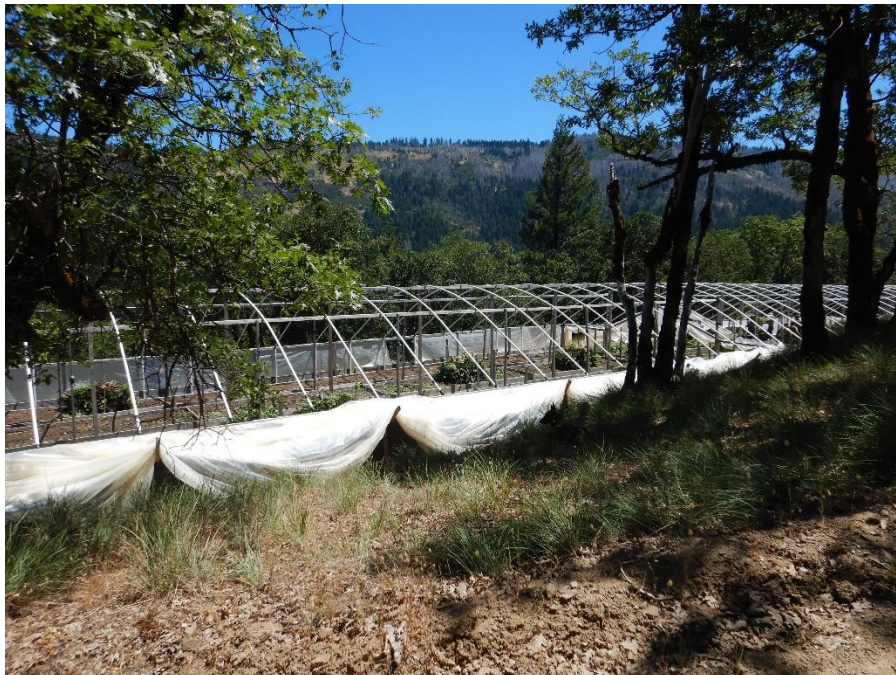
I observed cannabis growing in an approximately 3,000-square foot greenhouse at WQ 5 and I observed that cannabis had been growing in 7,000 square feet of greenhouses at WQ 7 (Photo 6 and Photo 8). I observed what appeared to be the same refuse that was present in the September 2018 inspection at WQ 6 (Photo 7). I did not re-inspect the pit-toilet located at WQ 8.

Photo 8—Greenhouse located at WQ 7. The cannabis plants have been cut and piled in bundles.
