## North Coast Regional Water Quality Control Board

**Subject: Notice of Violation of California Water Code (Water Code) sections 13260, 13264, and 13376 and Directive to Modify your Application for Coverage Under the State Water Resources Control Board Order WQ 2019-0000-DWQ General Waste Discharge Requirements for Discharges of Waste Associated with Cannabis Cultivation Activities (CANGO)**

**Inspection Report for August 23, 2019 Warrant Inspection of Humboldt County Assessor's Parcel Number 524-114-011-000 and Trinity County Assessor's Parcel Number 008-080-34-00**

File: Cannabis Program Inspections, Trinity County, August 2019 WET Inspections, CIWQS Place ID: 863056, 862742 and 832104

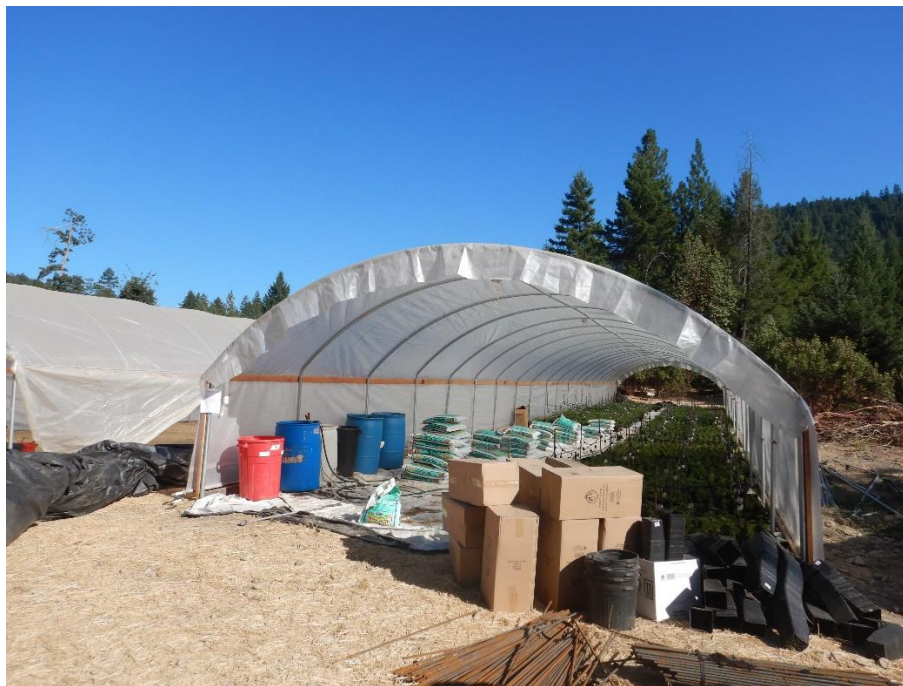
We accessed the property from the north along South Fork Road/Forest Route 5N03 and parked east of an approximate 32,000-square foot cultivation area at WQ 1 (Photo 1 and Photo 2). I observed many greenhouses with growing cannabis plants or under preparation for planting. I walked to an approximately 8,000-square foot cannabis cultivation area to WQ 2 (Photo 3), and I observed potting soil (Photo 4) and refuse (Photo 5) left uncontained on bare ground. I observed uncontained chemical containers at the fertilizer mixing area (Photo 6).

*Photo 1—Cannabis cultivation area in the vicinity of WQ 1.*

2. Modify enrollment under the Statewide General Order to reflect actual disturbed and cultivation areas. The Statewide General Order defines land disturbance as including all activities whatsoever associated with developing or modifying land for cannabis cultivation, related activities, or access. Land disturbance activities include, but are not limited to, construction of roads, buildings, water storage areas; excavation, grading, and site clearing. Disturbed land includes cultivation areas, storage areas where soil or soil amendments (e.g., potting soil, compost, or biosolids) are located. All access roads and water crossings that have not been designed, constructed, and maintained consistent with the Handbook for Forest, Ranch, and Rural Roads and Attachment A of the Statewide General Order, are considered disturbed areas, as well.

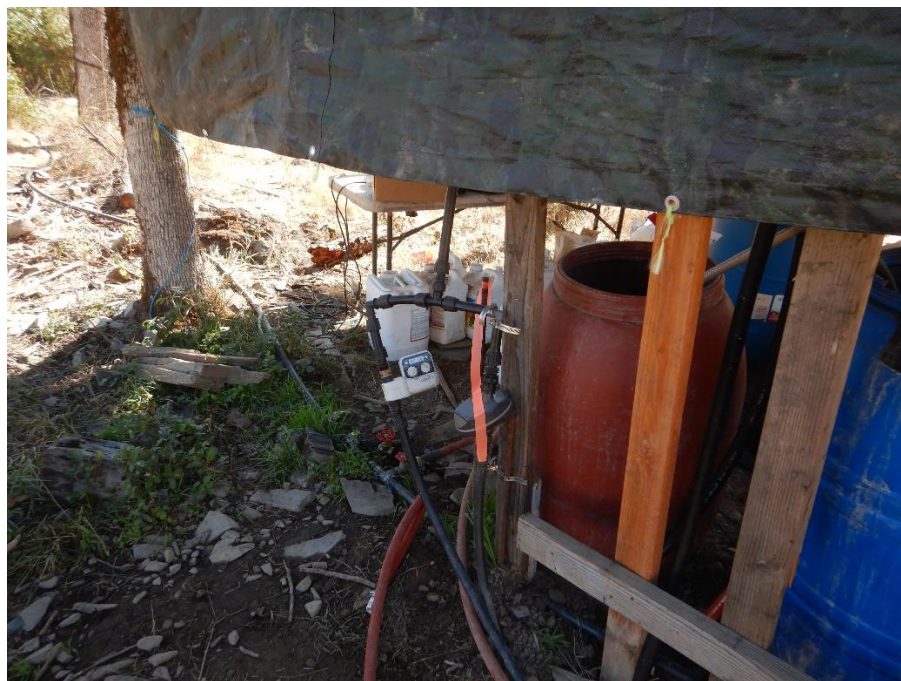
*Photo 2—Fertilizer mixing area in the vicinity of WQ 1.*

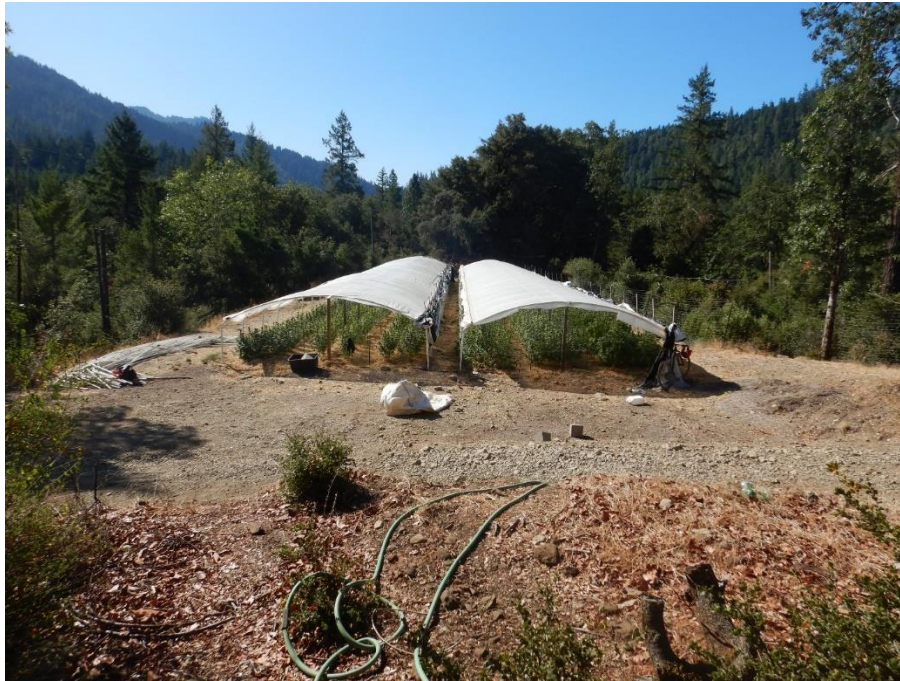
*Photo 3—Cannabis cultivation area in the vicinity of WQ 2.*

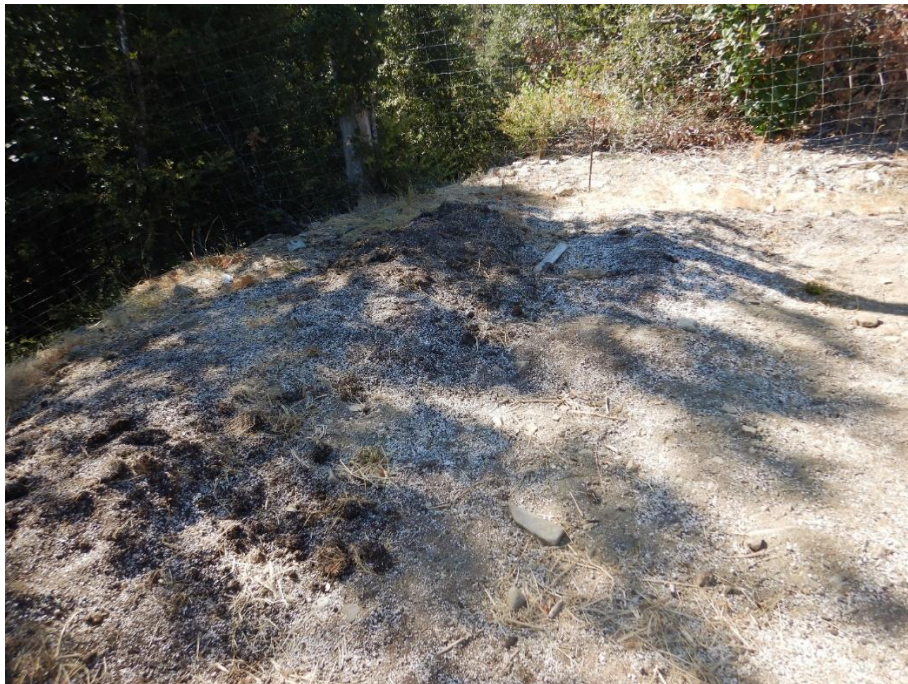
7. Fertilizers and soil amendments: Potting soils were left uncontained on bare ground at WQ 2. Chemicals were being mixed in a precarious setup at WQ 7 which might result in a spill.

*Photo 4—Potting soils uncontained at the edge of the cultivation area at WQ 2.*

4. Discontinue use of and dismantle any outhouse features and work with the appropriate County to ensure that all domestic and human wastes are collected and disposed of consistent with applicable County requirements.
5. Collect and dispose of or contain all refuse and cultivation-related wastes in a location and manner so as to minimize potential for these wastes to enter or be transported into receiving waters.
6. Store and contain all chemicals, including petroleum, fertilizer and/or pesticides properly to prevent spillage and discharge to receiving waters. Provide secondary containment for all petroleum products.

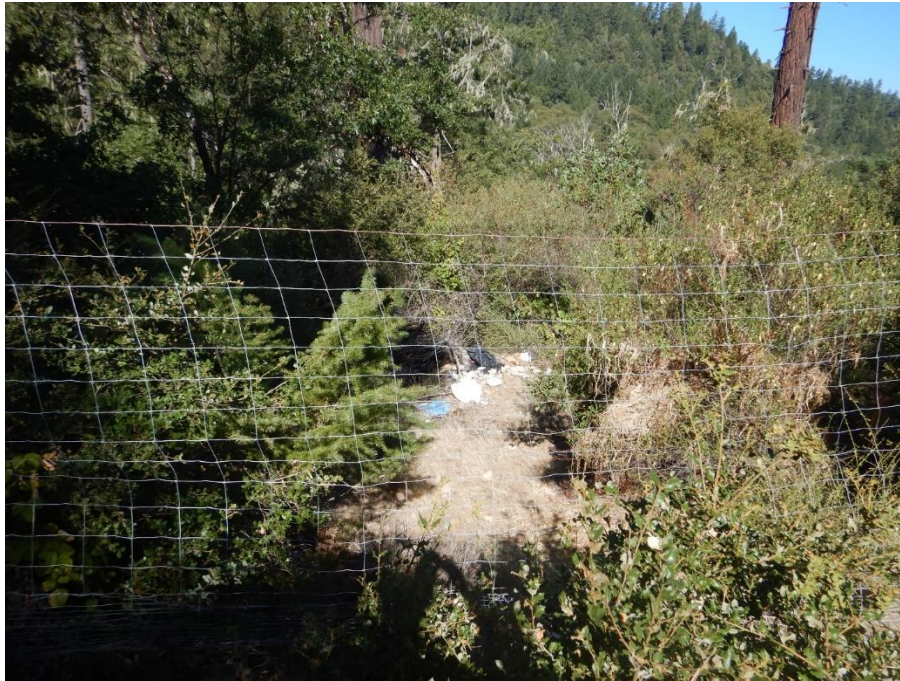
11. Refuse and human waste: I observed uncontained refuse at WQ 2, WQ 10, and WQ 11. I observed human waste being collected in a bucket at WQ 10, which may be a problem depending on how the bucket is disposed of.

Photo 5—Uncontained refuse in the vicinity of WQ 2.

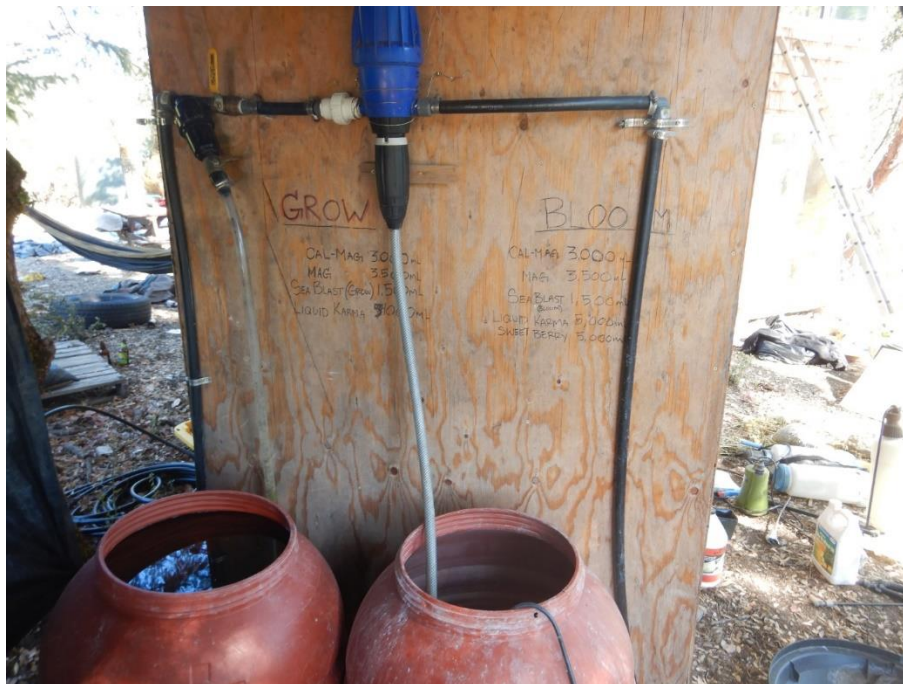
Photo 6— Fertilizer mixing area in the vicinity of WQ 2.

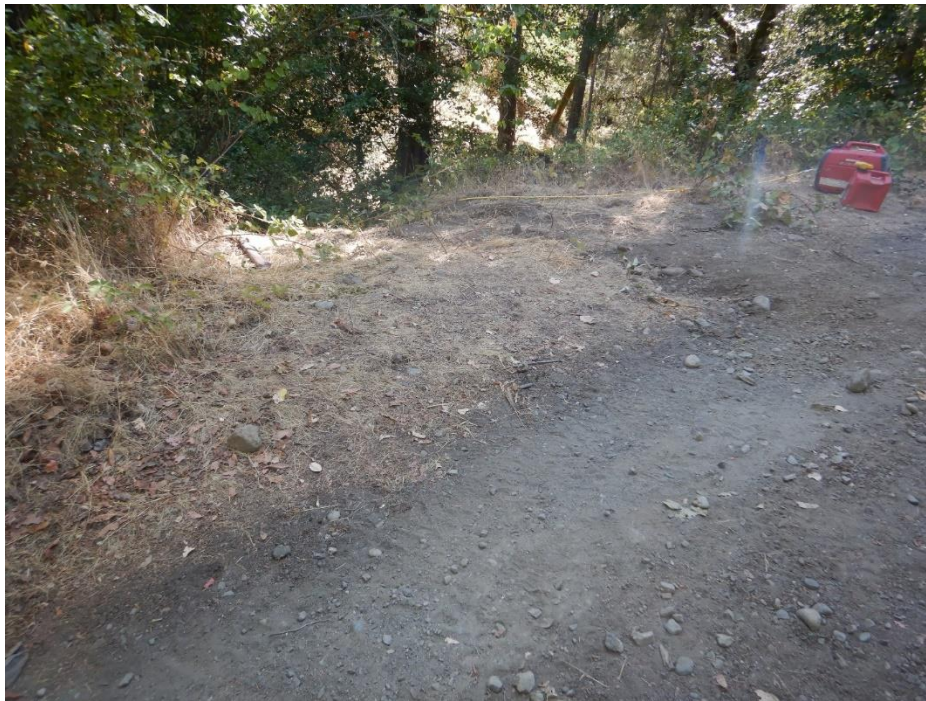
I walked back to the parking area and down a road heading southwest. At inspection point WQ 3, I observed the inlet of a culvert that appeared to be adequately sized at (Photo 7), but I did not investigate the culvert outlet. I continued down the road, which had a surface of fine sediment, and at inspection point WQ 4, I noticed fuel cans on the side of the road, and a footpath (Photo 8) that hydrologically connected the road to the watercourse below the footpath. The footpath led to a point where the watercourse was being diverted (Photo 9). I went back to the road and walked to the right bank of the South Fork Trinity River and walked to the location where the watercourse arrived at the floodplain of the river at WQ 5 (Photo 10).

*Photo 8—Trail leading to point of diversion at WQ 4. The footpath hydrologically connects the road to the watercourse.*

1. Retain a licensed professional to inventory, assess, and develop a workplan and schedule to implement measures to ensure that all developed features, roads, watercourse crossings, and cultivation areas throughout the Property are corrected, restored, and/or maintained in conditions that prevent or minimize erosion, sediment transport/delivery, and adverse impacts to water quality and beneficial uses. Include measures to ensure that unstable features caused or affected by onsite development and operations are removed or otherwise protected so as to minimize the potential for these features to cause adverse impacts to water quality and beneficial uses. Dispose of all development and restoration-related earthen spoils in a manner to prevent/minimize transport and delivery to receiving waters.

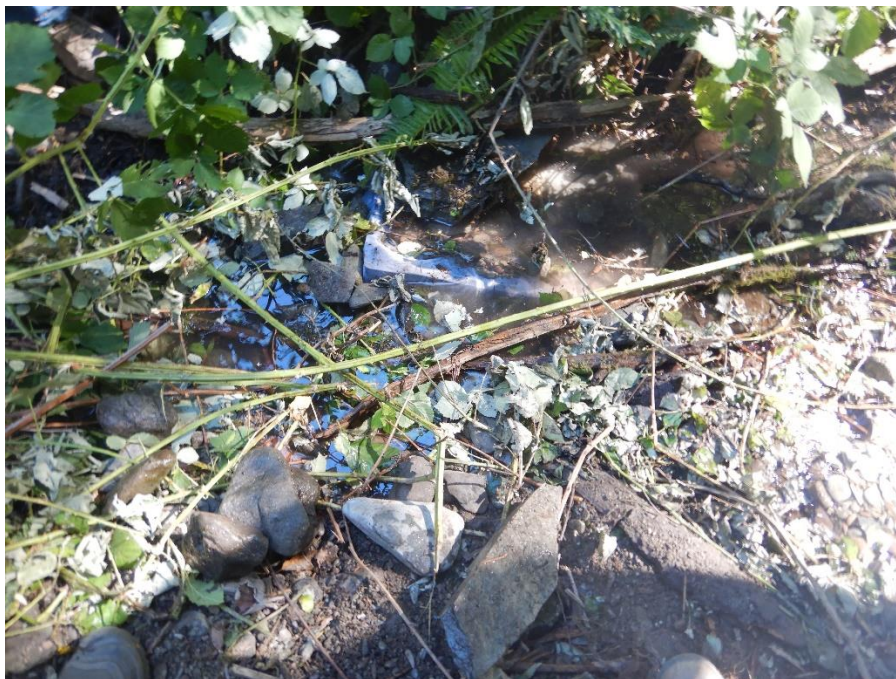
5. Water storage and use: I observed the point of diversion at WQ 4 and water storage tanks at WQ 8. Other than these observations, I did not review water storage and use.

*Photo 9—Lid to box can be seen in the middle of the image. The box was placed in an excavated hole in the stream bed to facilitate the diversion at WQ 4.*

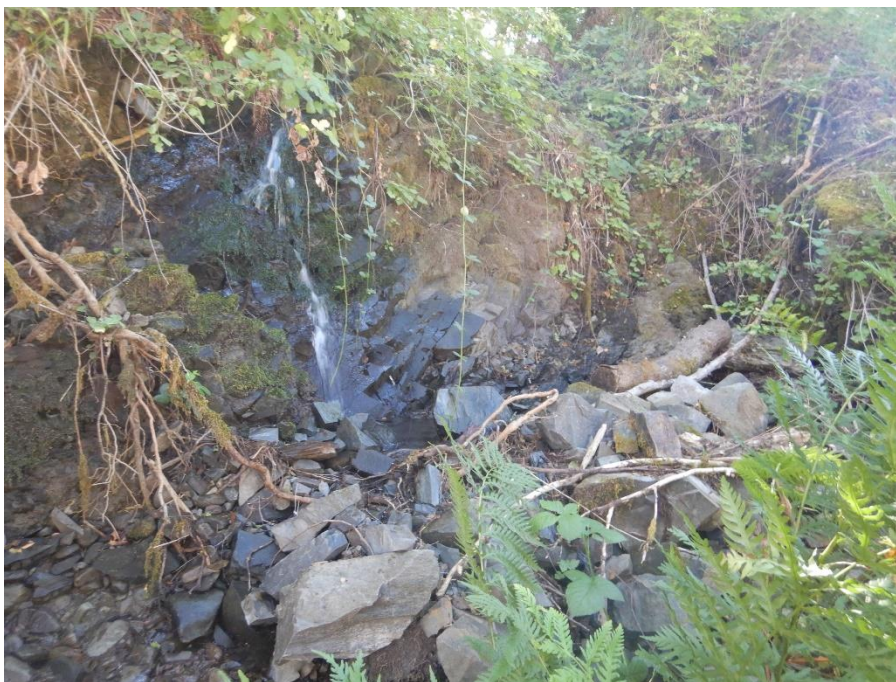
*Photo 10—Watercourse entering the flood plain at the right bank of the South Fork Trinity River at WQ 5.*

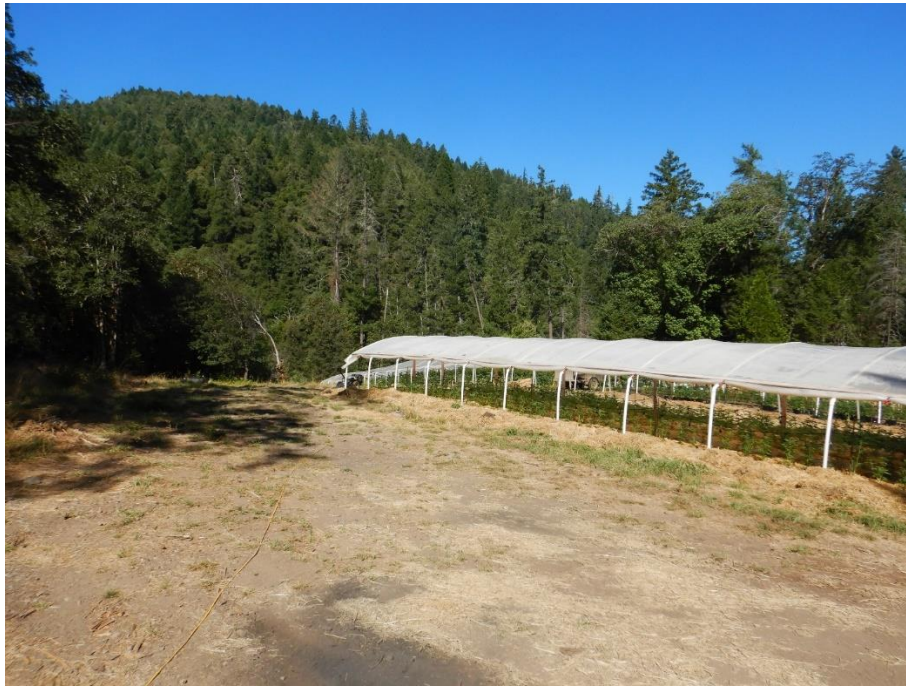
I returned to the road and observed an approximately 8,000-square foot cannabis cultivation area at WQ 7 (Photo 11). In this area, I observed trashcans that were being used to mix fertilizers. The trashcans were sitting on a board balanced on 5-gallon buckets, and appeared prone to spillage (Photo 12). I returned to the road and observed a swale passing across a duff-covered road south of WQ 6. The swale channelizes, then enters an 8" culvert passing below the main road (Photo 13).

*Photo 11—Looking west at cannabis cultivation area located at WQ 7.*

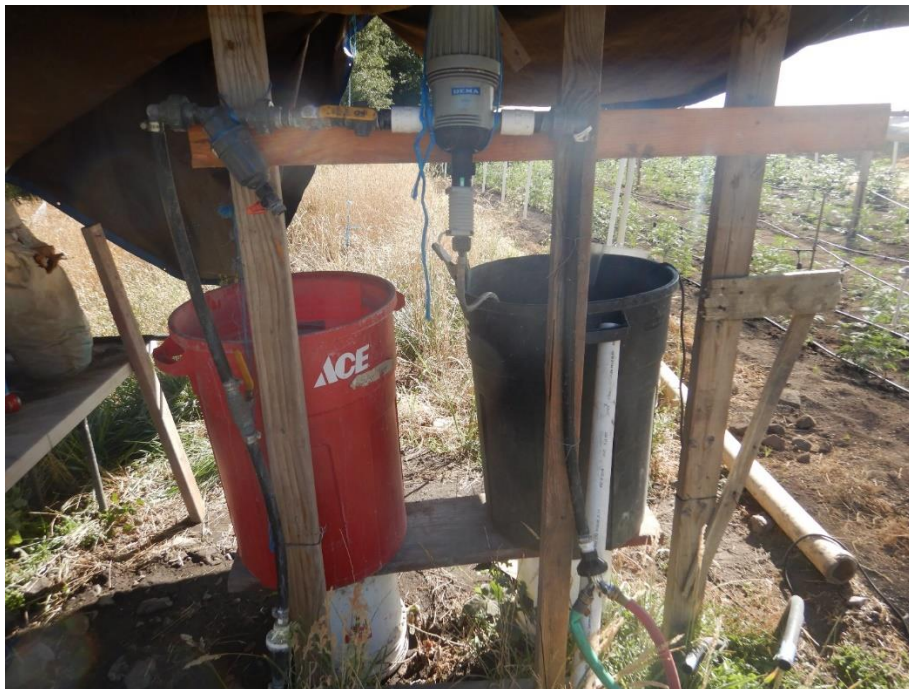
10. Cultivation-related wastes: I observed soil bags among uncontained refuse at WQ 11. Chemicals were being mixed above bare ground at WQ 7, in a manner that could result in a spill as discussed above.

*Photo 12—Fertilizer mixing tanks located at WQ 7.*

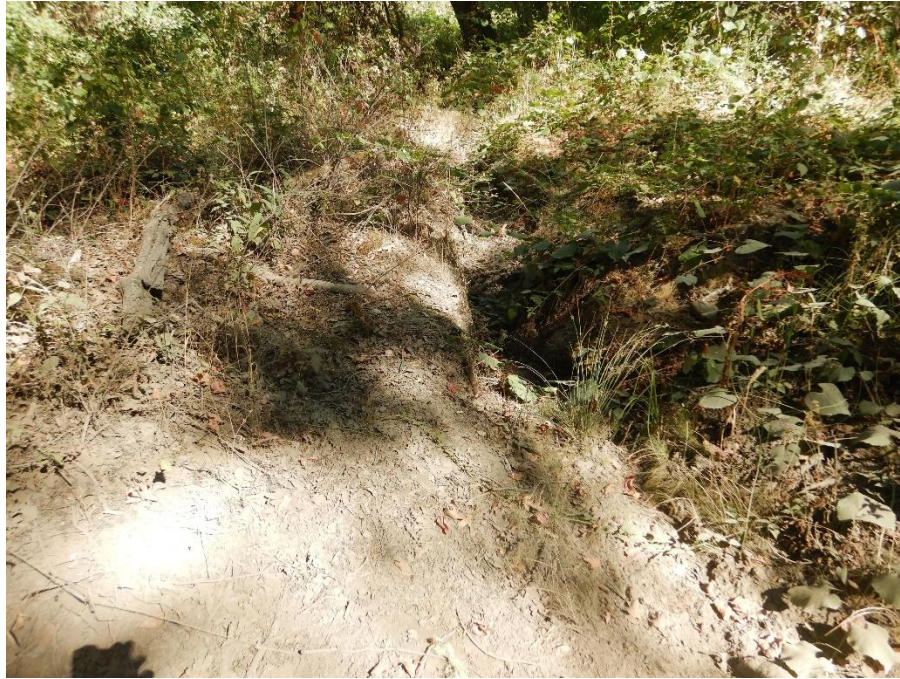
The culvert at WQ 3 may be adequately sized. I did not inspect the outlet and cannot say whether it is aligned appropriately. The watercourse at WQ 6 is shallow, so a larger culvert may not be appropriate. Armoring the road in this location may limit erosion of the road surface.

*Photo 13—Looking upstream in the vicinity of WQ 6. The picture shows an ephemeral watercourse before it passes over a less-used road and through an 8" culvert below the main road. The culvert bends the watercourse to cross the road over a shorter length before discharging along the side of the road.*

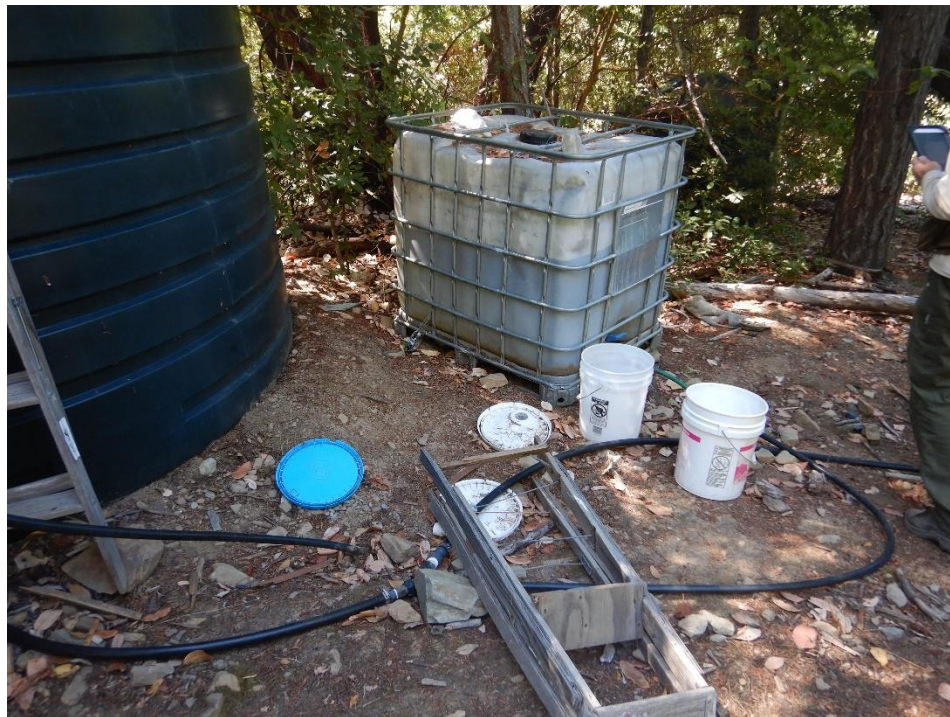
I walked back to WQ 1 and traveled east up a road to water tanks and a nutrient mixing area at inspection point WQ 8 (Photo 14). I walked back down the road and observed an approximately 26,000-square foot cannabis cultivation area at WQ 9 (Photo 15). I continued west to WQ 10, and observed a bucket of waste oil (Photo 16), uncontained refuse (Photo 17), and a human habitation area (Photo 18). To the south, I observed more uncontained refuse at WQ 11 (Photo 19) near to what appeared to be a dry riverbed (Photo 20). To the west of WQ 10, I observed an approximately 4,000-square foot cultivation area.

*Photo 14—Water tanks at and fertilizer mixing tanks at WQ 8.*

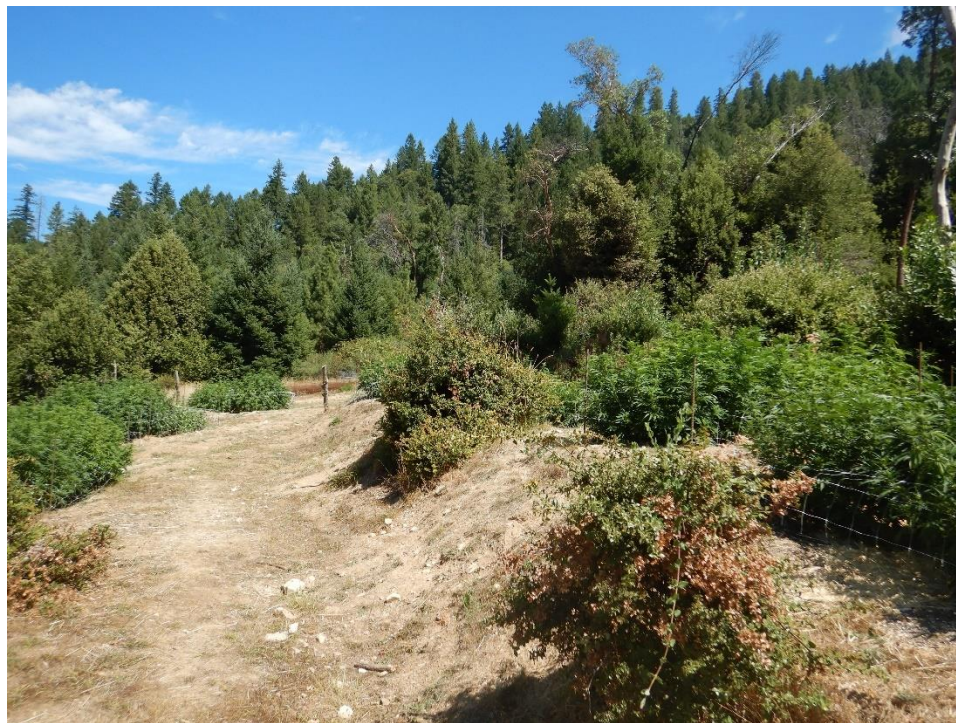
*Photo 15—Cultivation area at WQ 9*

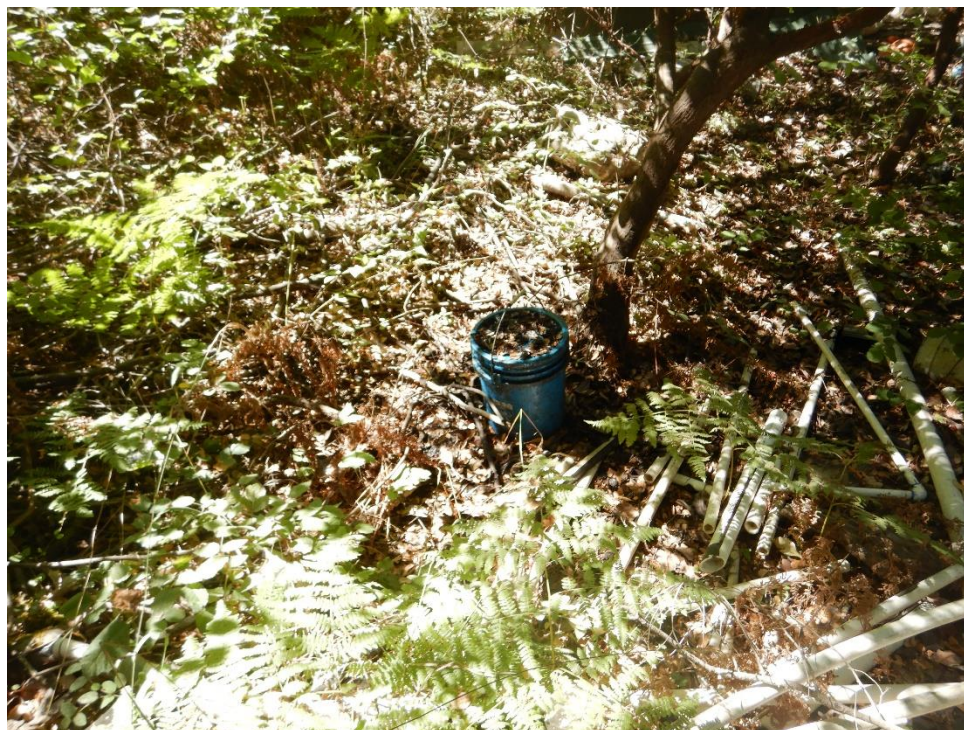
9. Petroleum products and other chemicals: Waste oil at WQ 10 had been sitting outdoors long enough to collect leaf litter on the lid.

*Photo 16—Waste motor oil at WQ 10. Note the lid is covered with leaf litter suggesting it has been there for a while.*

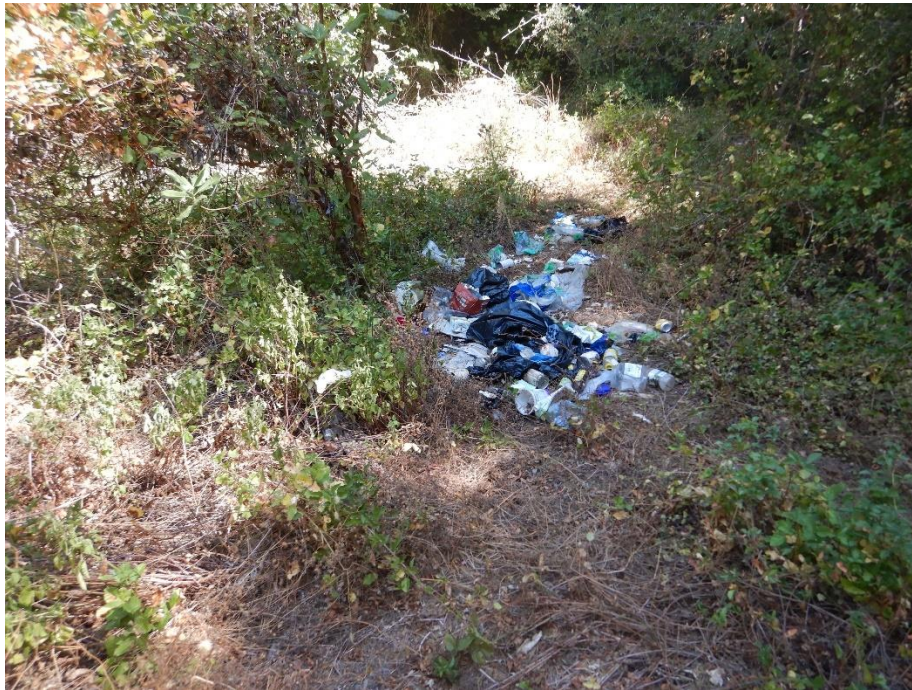
*Photo 17—Uncontained refuse at WQ 10*

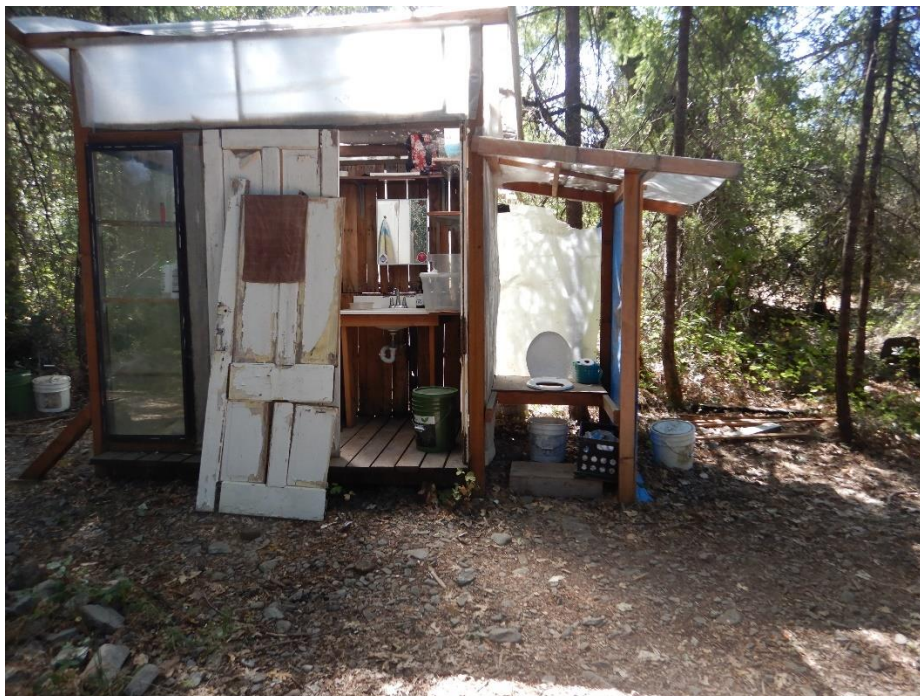
*Photo 18—Toilet and shower at WQ 10. Human waste is collected in a bucket.*

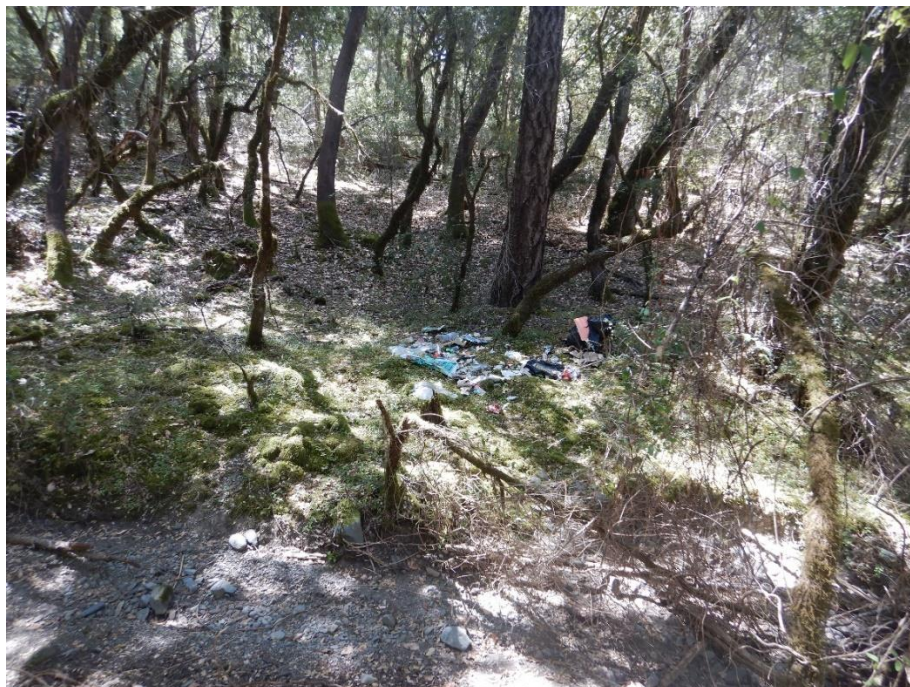
*Photo 19—Uncontained refuse, including soil bags, at WQ 11. Refuse is adjacent to a dry watercourse pictured in the foreground of the image and in below.*

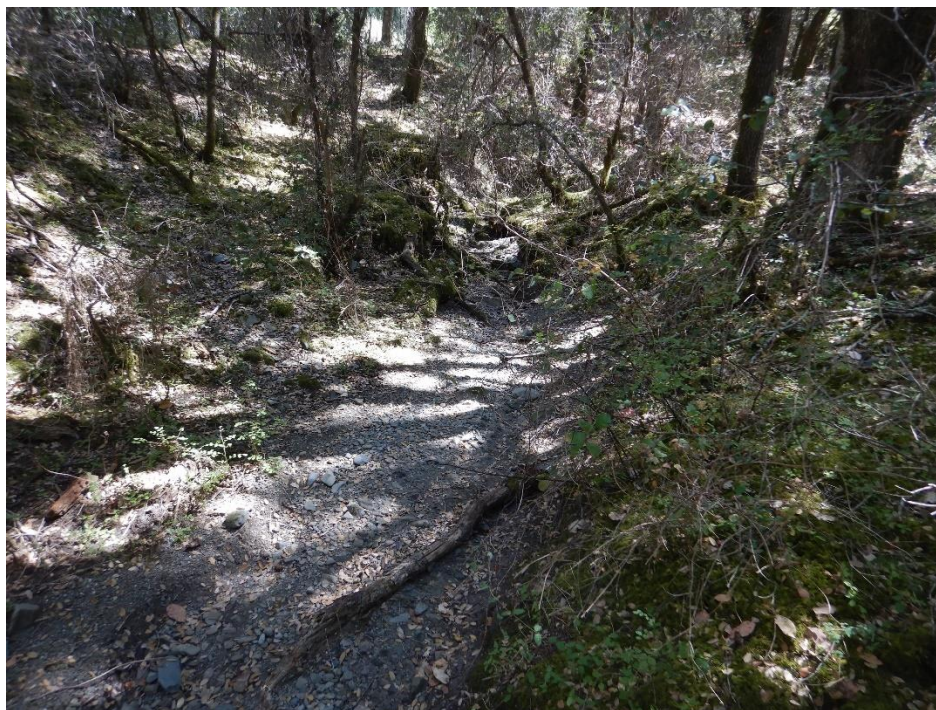
*Photo 20—Dry watercourse located in the vicinity of WQ 11.*

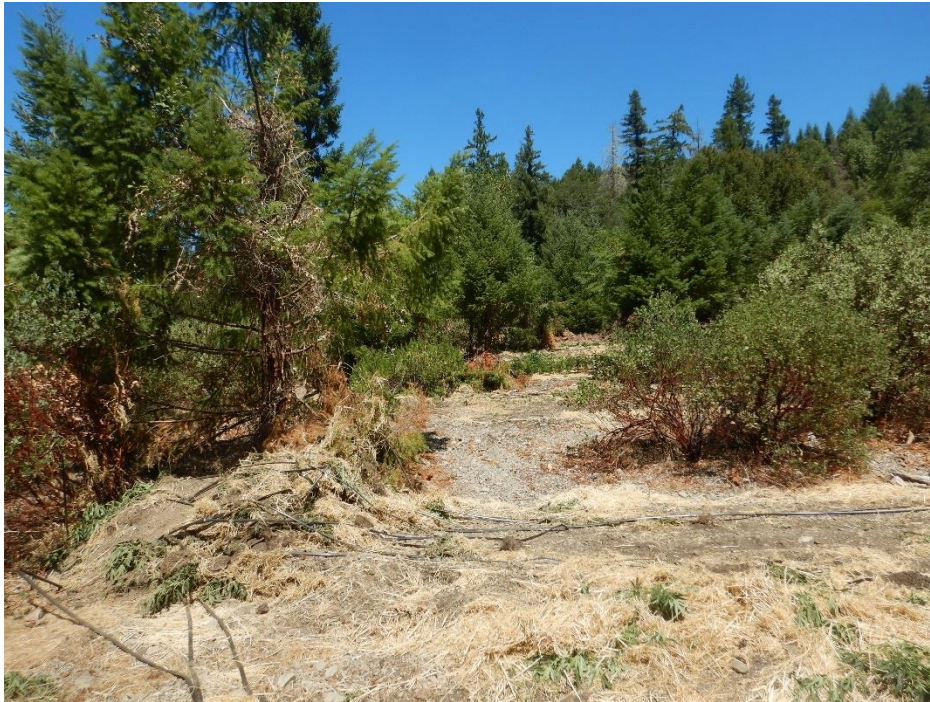
I continued to WQ 12 and observed a large area that appeared to be in the process of being cleared for some sort of development (Photo 21). I also observed a well at WQ 12 (Photo 22).

*Photo 21—Hummocky ground from recent earthwork suspected grading for cannabis cultivation in the vicinity of WQ 12.*

3. In the event that the property owner and/or tenant(s) propose in the future to develop or use the Property in a manner or method that will or may result in a discharge of waste to waters of the state in the future, staff recommend that the owner(s)/tenant(s) be aware of and comply with relevant regulatory requirements for water quality protection. For example, Water Code section 13260 requires that a person discharging waste, or proposing to discharge waste, within any region that could affect the quality of the waters of the state, other than into a community sewer system shall file with the appropriate regional board a report of the discharge. Further, Water Code section 13264 states, in part: "No person shall initiate any new discharge of waste or make any material changes in any discharge...prior to the filing of the report required by Section 13260." In addition, projects involving the

disturbance of an acre or more of land are subject to regulation under the State Water Board's Construction General Stormwater permit, and projects involving dredge or fill in waters of the United States are subject to regulation under Clean Water Act section 401.

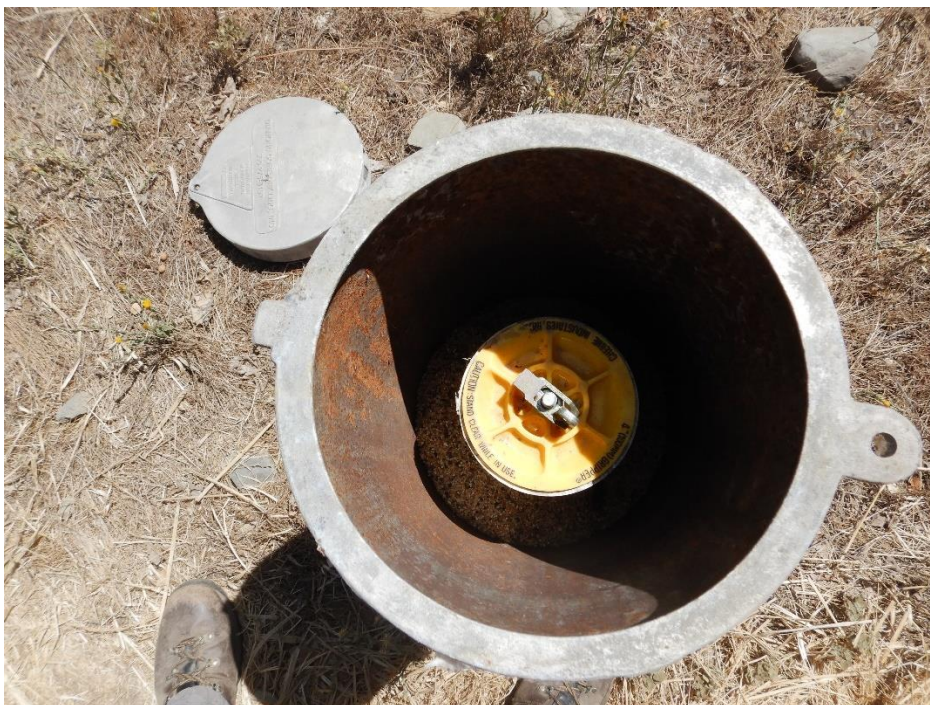
*Photo 22—Monitoring well located at WQ 12*
