North Coast Regional Water Quality Control Board

Subject: **Notice of Violation** and Transmittal of Inspection Report for June 26, 2019
Inspection of Humboldt County APNs 104-071-004-000, 104-071-005-000,
and 104-112-007-000

Inspection Report

Site: Freerange Holdings
CIWQS Place ID: 854339
Inspection Date: June 26, 2019

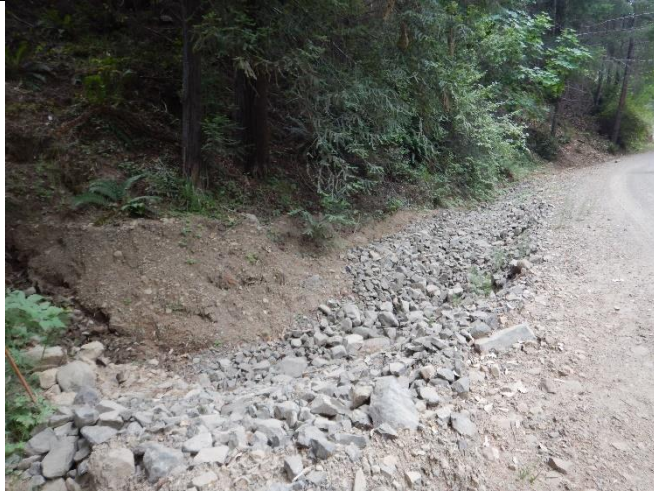
FR1: I observed a 30-inch diameter culvert receiving flow from a steep Class III watercourse and a rock-lined inboard ditch (photo 1). The culvert outlet was perched about 2 feet above the channel with a half-round downspout. The adjacent slope was bare, and fill from the road had been pushed above the culvert outlet and had entered the stream (photo 2, 3).

Photo 1 – FR1; inboard ditch and stream entering culvert

1. Submit an updated Site Management Plan that includes:
 - a. An evaluation of all stream crossings for capacity to convey the 100-year flood flow and associated debris. Provide a schedule to address all crossings needing upgrade

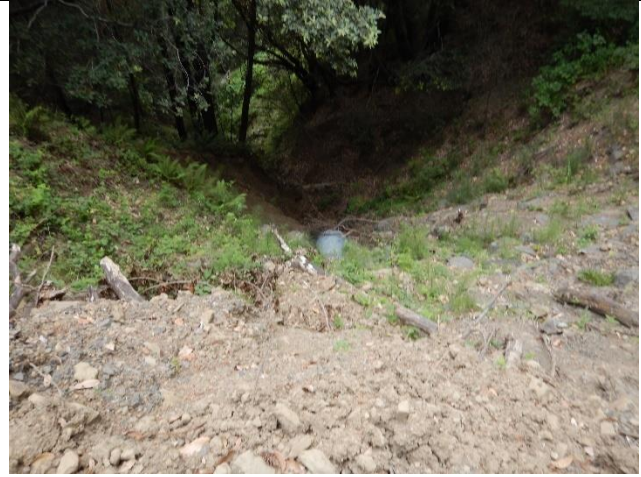
Photo 2 – FR1; looking down at culvert outlet standing on fill placed above the watercourse

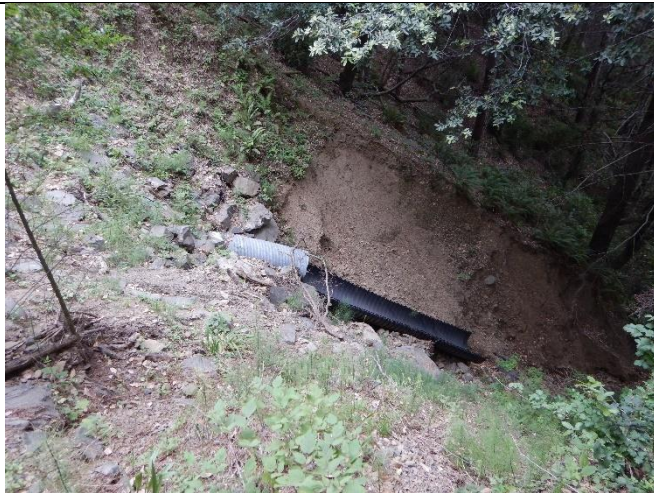
Photo 3 – FR1; side view of culvert outlet with sediment discharge visible in the foreground and the steep, bare, adjacent slope visible in the background

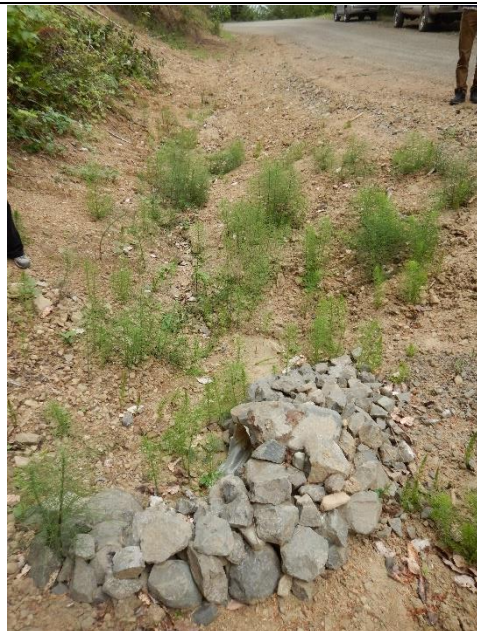
FR2: I observed an 18-inch diameter culvert receiving flow from a Class III watercourse and an inboard ditch (photo 4). The culvert outlet was perched about 2 feet above the channel. I observed sediment that had been placed on the road above the culvert and sediment that had been pushed or discharged over the hillside (photo 5).

Photo 4 – FR2; culvert inlet surrounded by rock and view of road ditch discharging to culvert

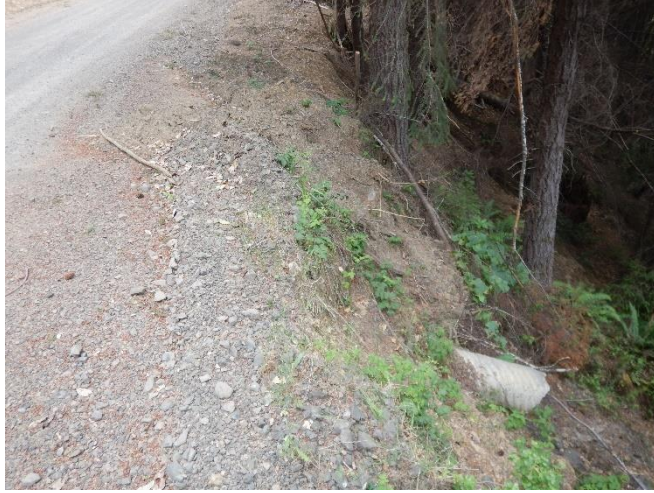
Photo 5 – FR2; perched outlet of culvert with sediment placed above the culvert from roadwork

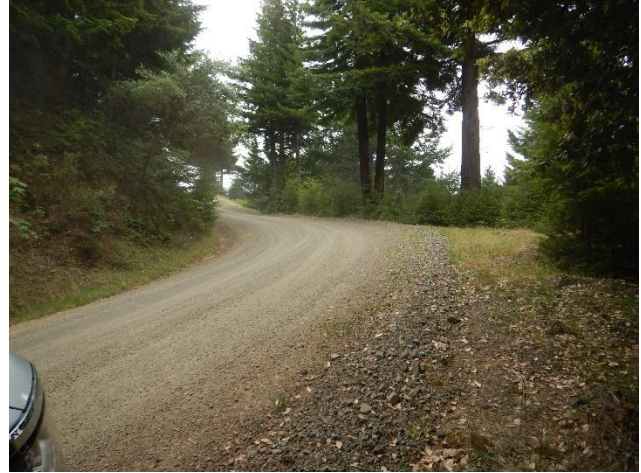
FR3: I observed a section of road draining to an inboard ditch. The inspection participants agreed on the need to add a ditch relief culvert and/or outslope the road in this area to push water off the road and onto a vegetated flat (photo 6).

Photo 6 – FR3; insloped portion of road with inboard ditch

- c. Installation of an appropriately sized and aligned crossing at FR8 or decommissioning of the road stretch
2. Improve road alignment, surfacing, and drainage to minimize erosion and sediment transport. Hydrologically disconnect road and road ditches from watercourses

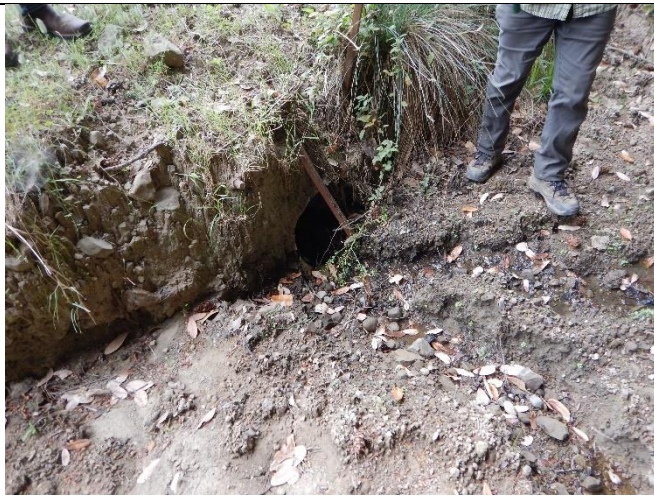
FR4: I observed an 18-inch diameter culvert receiving flow from a Class II watercourse/ spring and an inboard ditch (photo 7). I observed that the bed and banks of the stream channel were bare and eroding, apparently as a result of cattle activity in the stream (photo 8). I observed cow footprints in the stream and the property representatives confirmed cows congregate in the stream. The culvert outlet was perched about six inches above the channel, and the culvert was partially occluded with sediment.

Photo 7 – FR4; disturbed stream channel and inlet of culvert

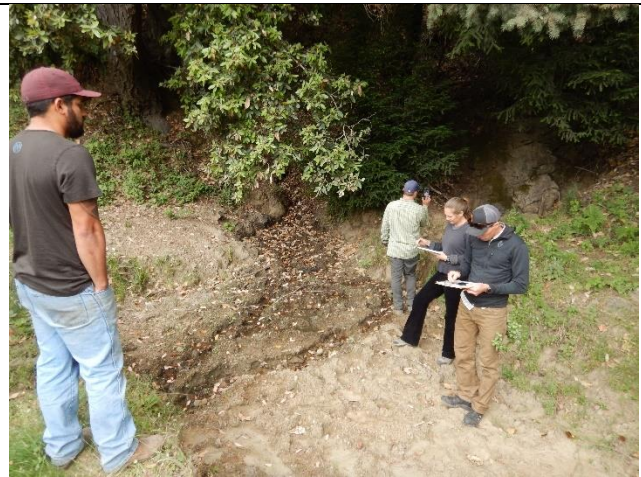
Photo 8 – FR4; disturbed stream channel

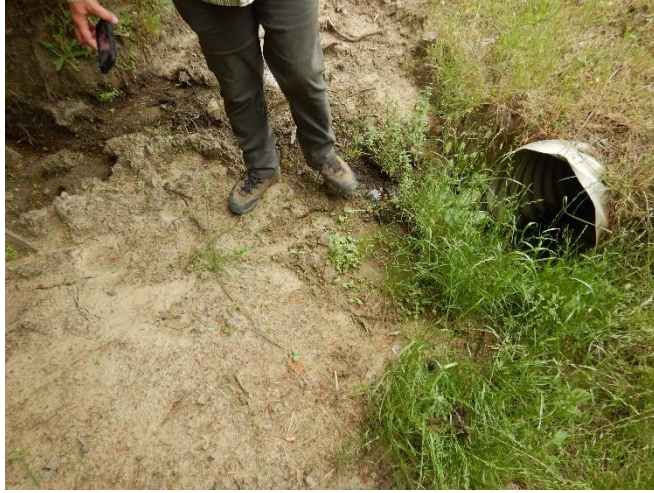
FR5: I observed an 18-inch diameter culvert receiving flow from a watercourse and an inboard ditch (photo 9). The culvert outlet had a downspout attachment but was still perched about 6 feet above the channel, and I observed a scour pool below the downspout (photo 10). I also observed fill that had been sidecast into the watercourse.

Photo 9 – FR5; inboard ditch and stream meet at culvert inlet

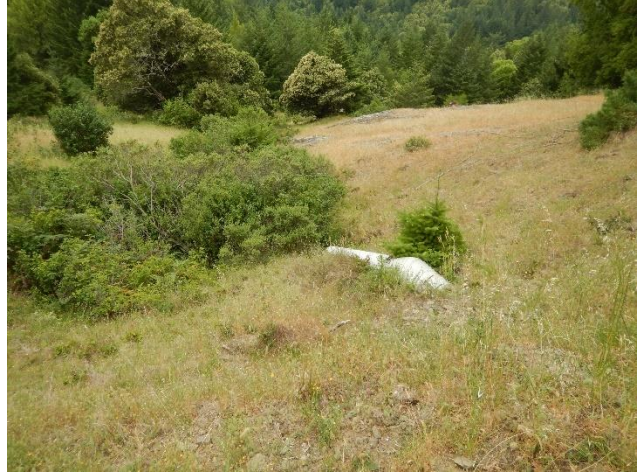
Photo 10 – FR5; looking downhill at culvert downspout

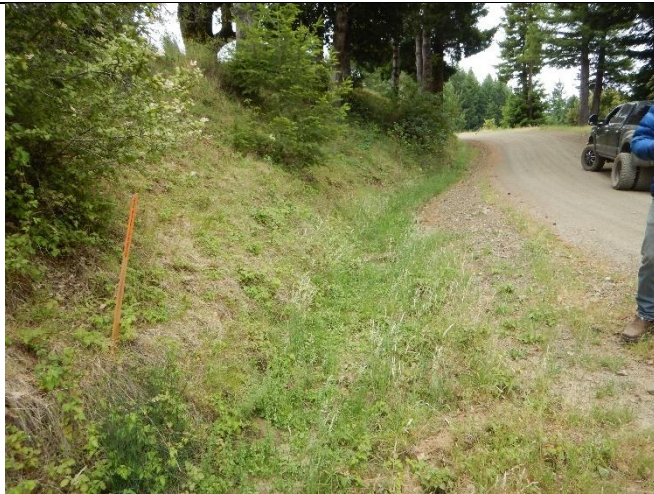
FR6: I observed a well-vegetated stretch of ditch and a functioning ditch relief culvert (photo 11).

Photo 11 – FR6; well vegetated ditch and ditch relief culvert

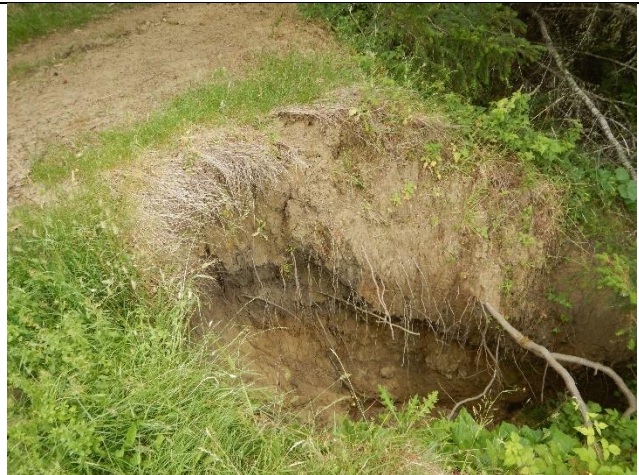
FR7: I observed a large chasm in a hillside where water originating from a spring/ seep traveled across a road and eroded down a hillside (photo 12).

Photo 12 – FR7; chasm in hillside adjacent to road

The SMP does not include an evaluation of stream crossings' capacity to convey the 100-year flood flow and associated debris. The SMP does not address erosional feature FR7 or spring FR8 on the access road to the proposed cultivation area. The SMP also does not address the disturbed stream sections FR22 and FR23.

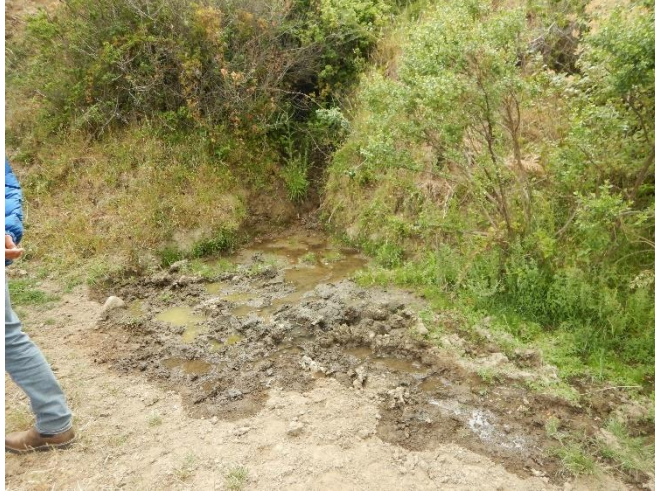
FR8: I observed a spring/ seep adjacent to a road. I observed a muddy path across the road starting at FR8 and discharging to the chasm at FR7 (photo 13). The inspection participants agreed on the need for a rock-lined ford or culvert to convey spring/ seep flow across the road without eroding the road surface and hillside.

Photo 13 – FR8; spring/ seep

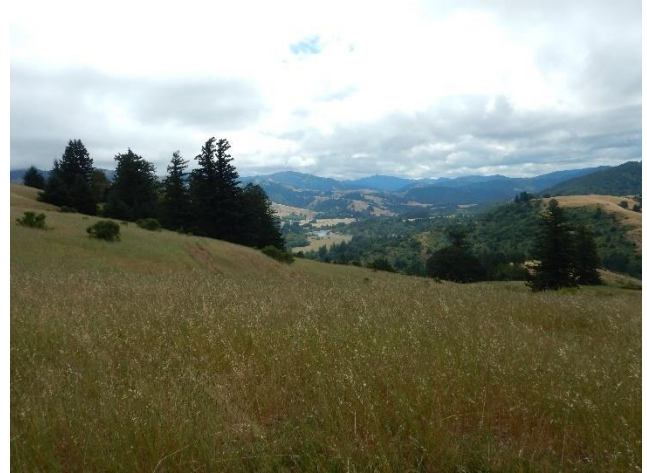
FR9: At this location, the property representatives advised the inspection group that they were proposing to develop a cannabis cultivation area. I observed prairie habitat (photo 14). The inspection participants discussed alternative cannabis cultivation locations that were already disturbed. Access to this location for cannabis cultivation would require conformance of the steep access road to the Handbook for Forest, Ranch and Rural Roads guidelines, stabilization of the chasm observed at FR7, and development of an appropriate crossing structure for surface water observed at FR8.

Photo 14 – FR9; potential cannabis cultivation area

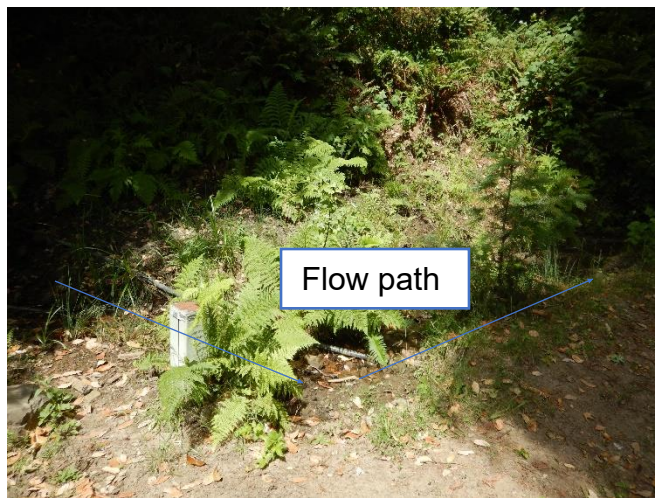
FR10: I observed pipes in a Class II watercourse, serving as a surface water diversion. At the road, the Class II watercourse crossing consisted of a partially crushed, undersized culvert with a buried inlet, causing the watercourse to divert down a ditch alongside the road (photo 15). The surface water diversion did not have a meter.

Photo 15 – FR10; watercourse with diversion pipe running through buried culvert and water diverted down ditch along road

4. Remove water diversion and storage infrastructure, including water lines and tanks, from the riparian setbacks to the extent possible
5. Install water meter(s) as appropriate to measure water diverted for cannabis cultivation

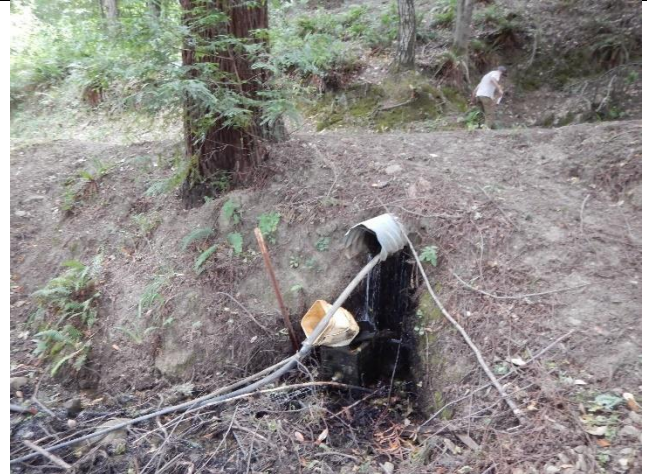
FR11: I observed a Class II watercourse with a culverted stream crossing. The culvert outlet was perched approximately 3 feet above the stream channel, and the stream channel was littered with water diversion infrastructure (photo 16). The bottom of the culvert had rusted out.

Photo 16 – FR11; culvert stream crossing with water diversion infrastructure in stream

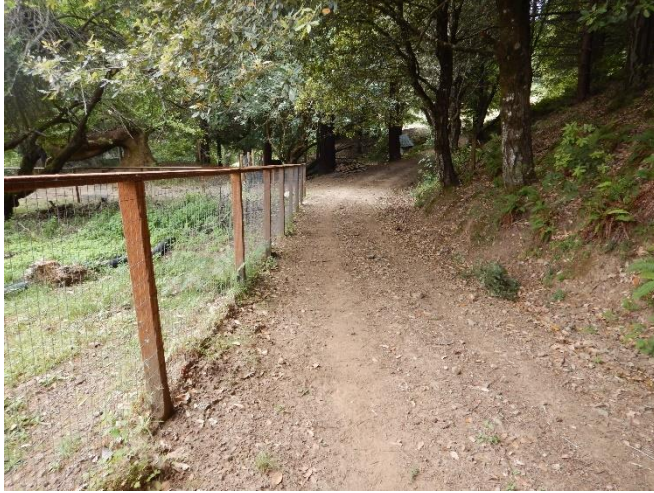
FR12: I observed a stretch of insloped road with an inboard ditch discharging to stream crossings FR10 and FR11 (photo 17). The inspection participants agreed on the need to outslope the road and/or add water bars to hydrologically disconnect the road from the watercourse.

Photo 17 – FR12; stretch of insloped road with inboard ditch discharging to stream crossings FR10 and FR11

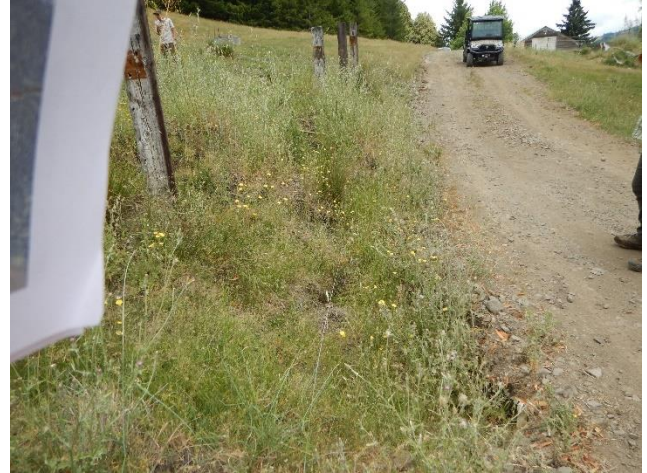
FR13: I observed a functioning ditch relief culvert (photo 18).

Photo 18 – FR13; ditch relief culvert

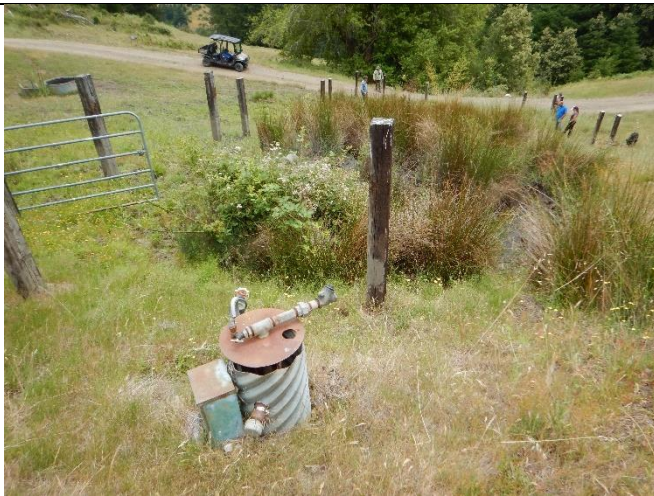
FR14: I observed a developed spring, not attached to piping, and a wetland feature downhill (photo 19). The wetland feature supported hydrophytic vegetation and had about 4 inches of standing water.

Photo 19 – FR14; developed spring and wetland feature on slope

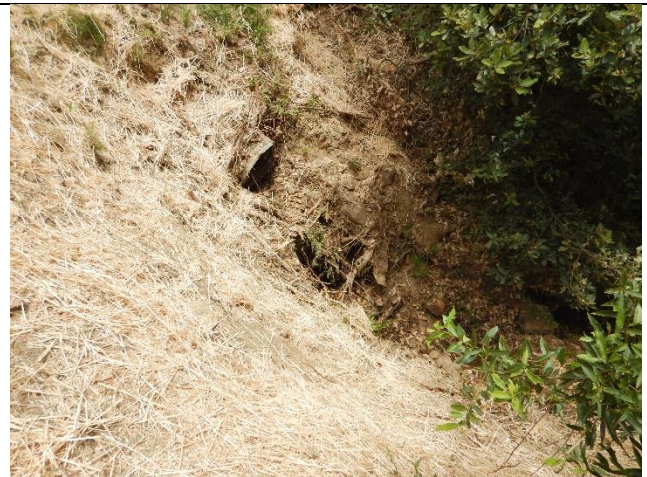
FR15: I observed a 30-inch diameter culvert with an outlet perched 8-10 feet above the channel (photo 20). I observed water flowing under the culvert. I observed straw covering the bare soil adjacent to the culvert outlet.

Photo 20 – FR15; culvert outlet perched above the watercourse channel

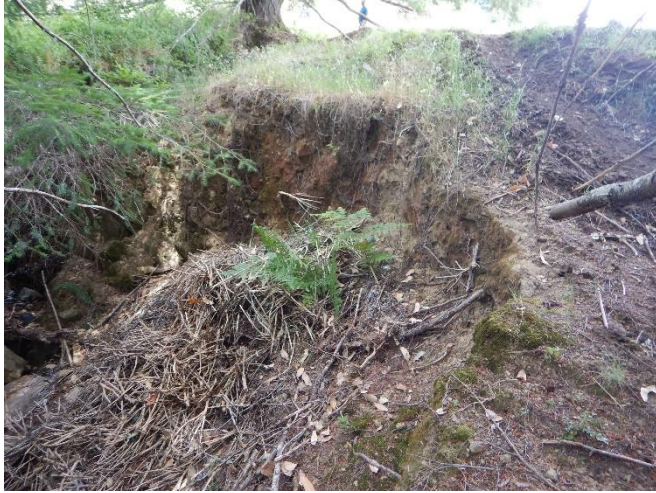
FR16: I observed a decommissioned cannabis cultivation area where infrastructure had been removed and straw placed on bare soil. I observed cultivation waste including potting soil, cannabis stems, and green plastic ties had been pushed over the side of the flat and into a Class III watercourse (photo 21). Property representatives began removing the waste during the inspection.

Photo 21 – FR16; view looking up from watercourse channel at cultivation waste pushed over edge of hillside

-
6. Remove potting soil, cannabis stems, and green plastics from the watercourse and place or dispose of in a location and manner so as to prevent discharge into receiving waters

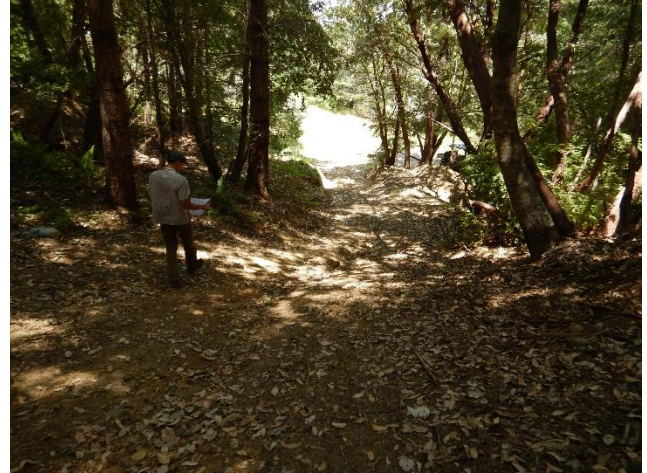
FR17: I observed a skid road with surface erosion (photo 22).

Photo 22 – FR17; skid road with rut down middle

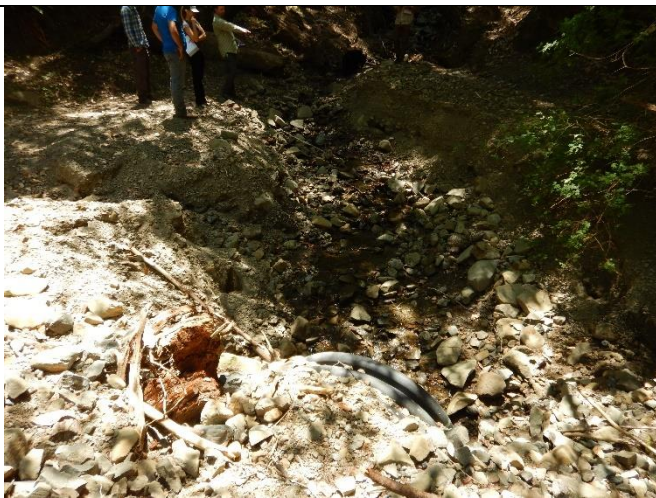
FR18: I observed a 4-foot diameter plastic culvert on a Class I or II watercourse with its outlet perched above the watercourse (photo 23-24). I observed yellow-legged frogs and a coastal giant salamander in the channel.

Photo 23 – FR18; aggraded inlet of culvert stream crossing

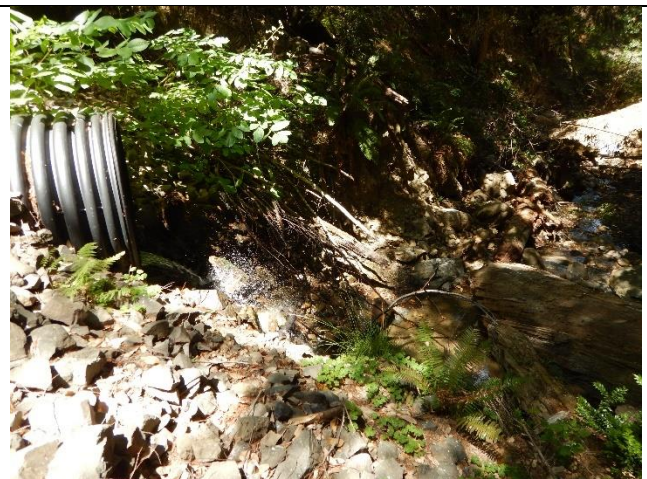
Photo 24 – FR18; perched outlet of culvert stream crossing

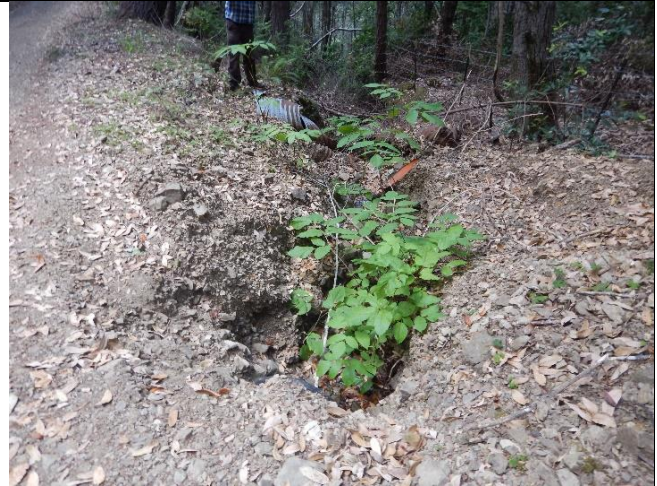
FR20: I observed an 18-inch diameter culvert stream crossing with its outlet perched about 1 foot above the stream channel. I observed evidence the stream overtopped the culvert. Road fill surrounding the culvert outlet had eroded away (photo 26).

Photo 26 – FR20; culvert stream crossing outlet

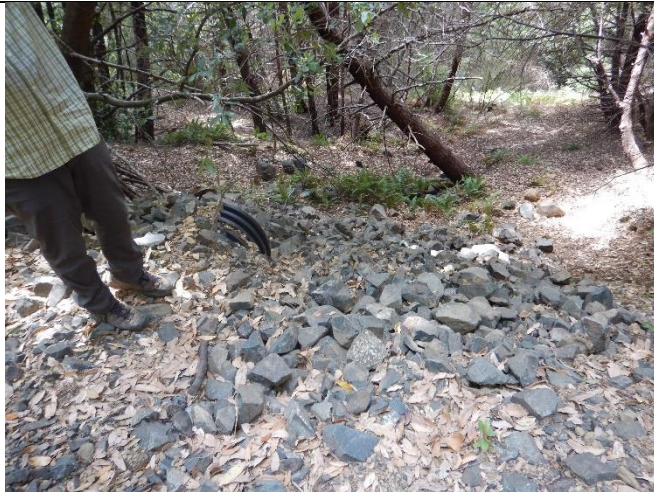
FR21: I observed a functioning 24-inch diameter ditch relief culvert with its outlet on a steep slope (photo 27). The culvert outlet was surrounded by rock.

Photo 27 – FR21; culvert stream crossing outlet with rock armoring

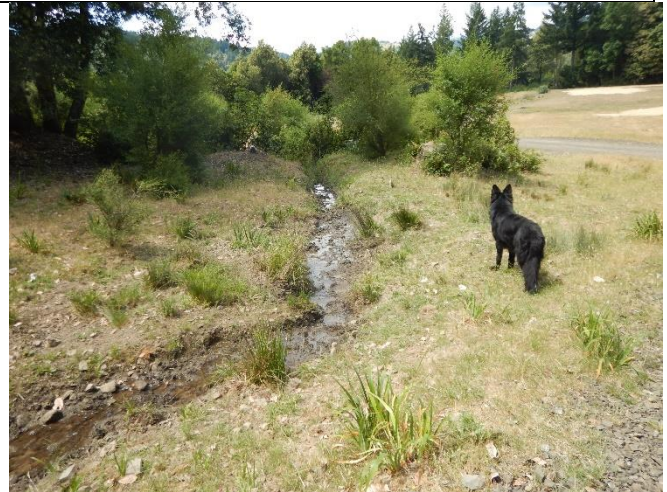
FR22: I observed a stream segment that appeared to have been recently disturbed adjacent to a decommissioned cultivation area (photo 28). I observed multiple frogs and tadpoles in the stream.

Photo 28 – FR22; stream segment adjacent to decommissioned cultivation area

- b. A delineation of the extent of FR22 and FR23. Provide plans to reconnect/ restore the watercourse to its historic stream channel. Do not cultivate cannabis or place cannabis-related infrastructure within the riparian setback to this watercourse

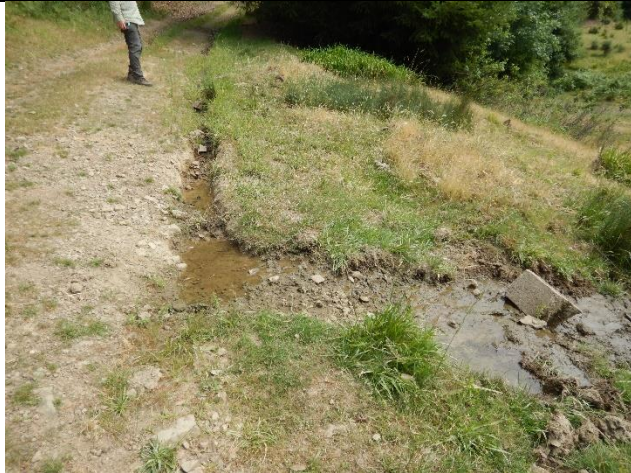
FR23: I observed a stream diverted down a lightly-used road (photo 29). I observed dry, historic channels perpendicular to the road. I observed pooled water that went subsurface adjacent to a decommissioned cultivation area.

Photo 29 – FR23; stream diverted down road adjacent to decommissioned cultivation area
