Subject: **Notice of Violation** of State Water Resources Control Board Order No. 2014-0057 DWQ General Permit for Storm Water Discharges Associated with Industrial Activities (Industrial General Permit) for the BoDean Co., Inc. Santa Rosa Hot Plant

File: BoDean Co., Inc. Santa Rosa Hot Plant, 1060 Maxwell Drive, Santa Rosa, Sonoma County, WDID No. 1 49I017446

Facility Stormwater Inspection Report

FACILITY INFORMATION		
Facility Name: BoDean Co Inc. Santa Rosa Hot Plant		
Facility WDID: 1 49I017446		
Facility Address: 1060 Maxwell Dr Santa Rosa CA 95401		
SIC Codes and Type of Industrial Activities: 2951 – Asphalt Paving Mixtures		
Legally Responsible Party: Charles Young		
Operator: Dean Soiland		
Facility Status: Level 2 for TSS		
Compliance Group: N/A		
History of Compliance: N/A		
INSPECTION INFORMATION		
Inspection Date: December 5, 2019	Start time: 13:00	End time: 15:00
Inspector Name: Farzad Kasmaei		
Weather: Dry weather following rain		
Type of Inspection: B Type compliance		
Purpose of Inspection: Complaint response		
Parties Present During Inspection: Masele Poueu (BoDean), Art Deicke (Consultant for BoDean), Ken Hutchins (City of Santa Rosa), Mark Maystrovich (City o

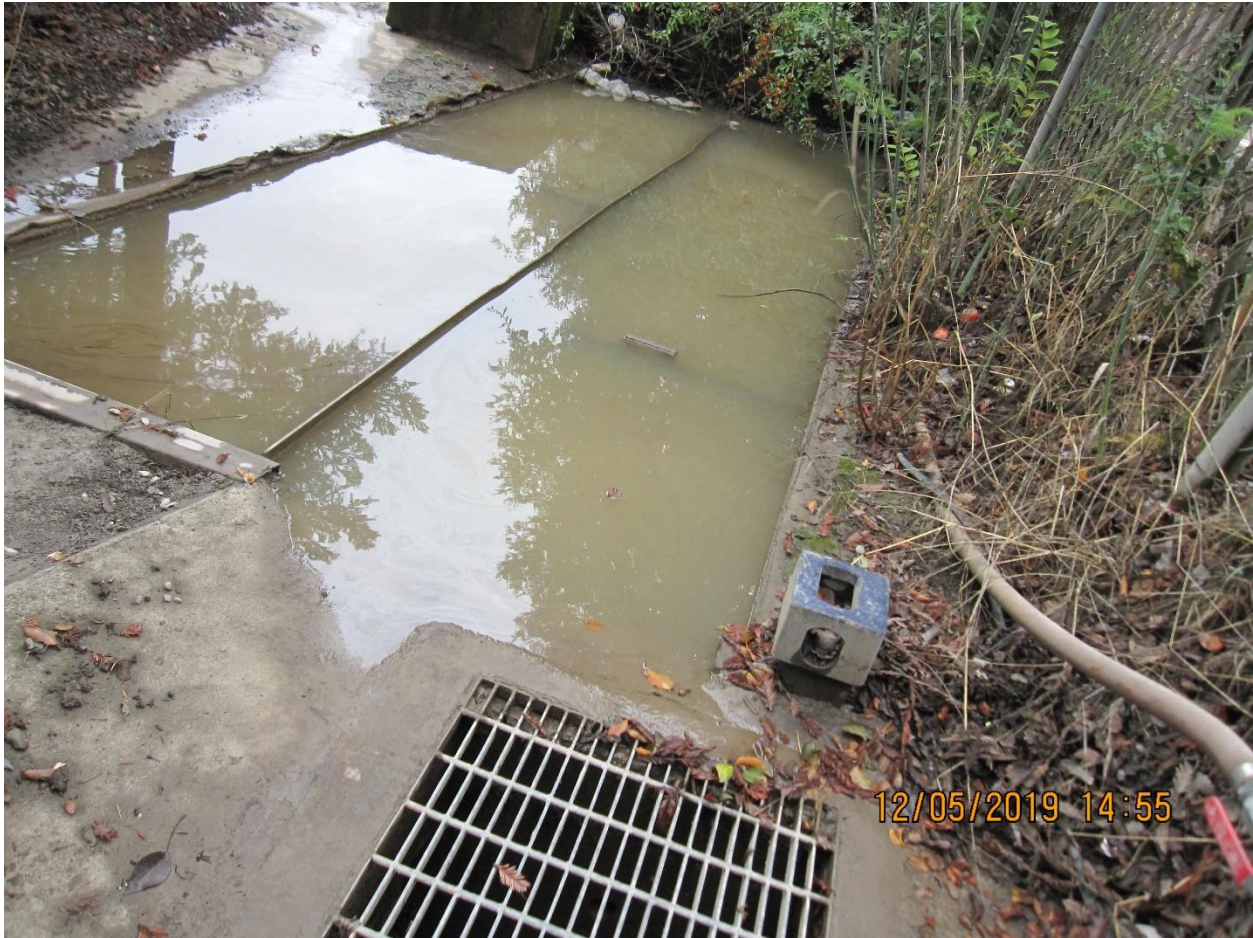
Picture 1- View of muddy settling tanks at the end of the bio swale. Significant sediment accumulation observed, and the inlet is not protected. Oil sheen observed in some areas.

Storm drain inlets are not adequately protected; inlet protection BMPs are not adequately installed and/or maintained in a manner to prevent the discharge of sediment. Advanced BMPs on the site, including bioswale(s) and settling pond(s), are not maintained.

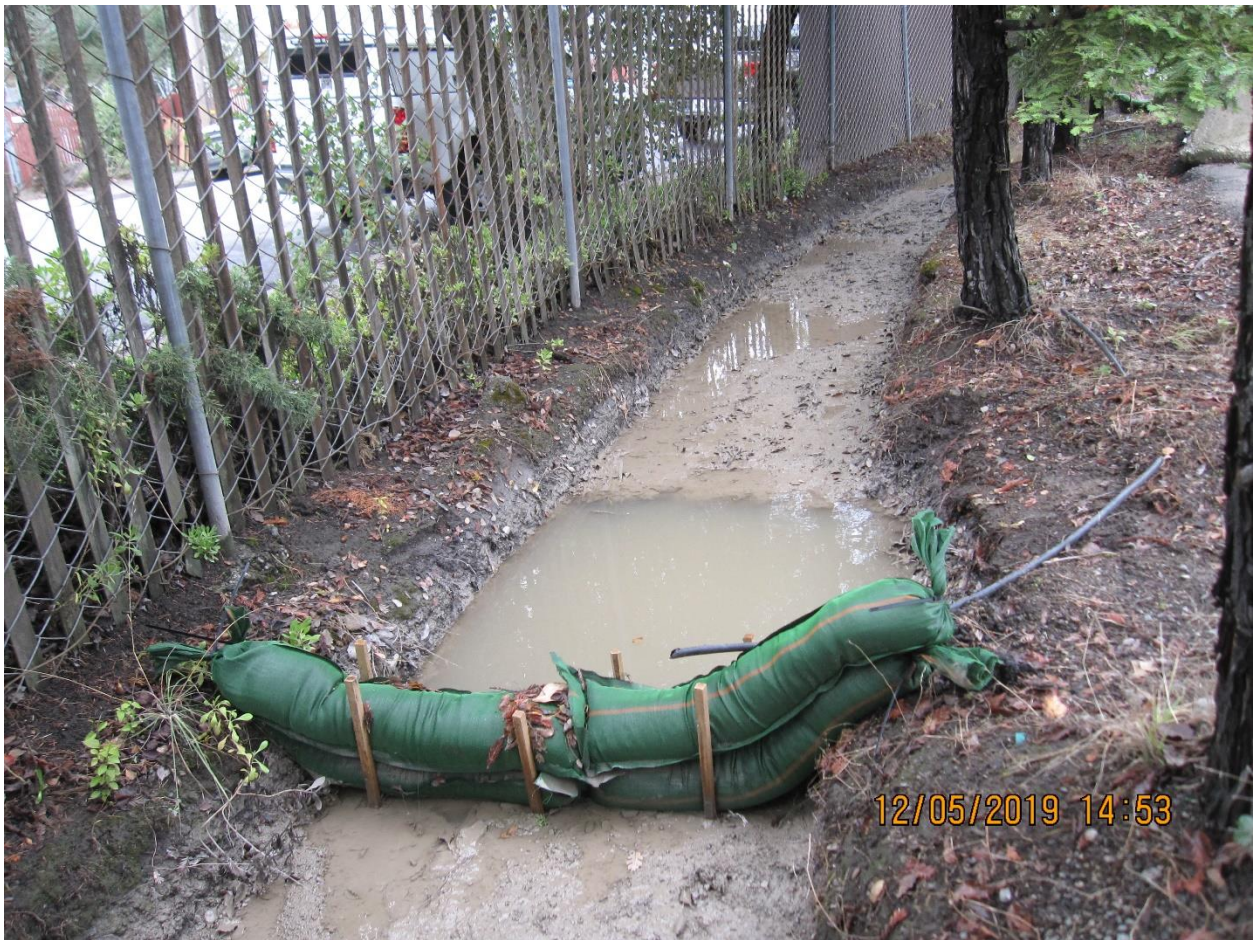
Picture 2 – View of bioswale along the southwest of the facility. Sediments trapped behind the check dams have not been removed. Significant sediment accumulation observed.

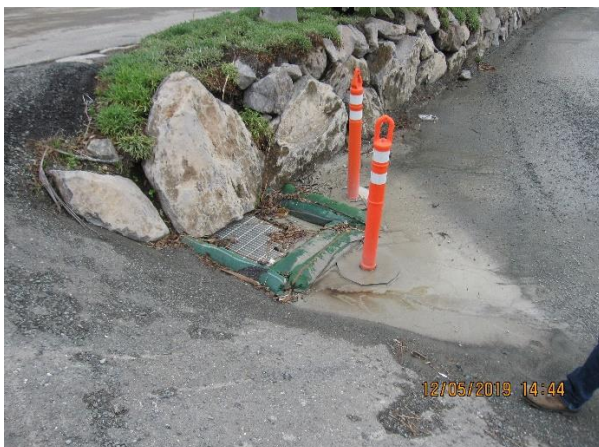
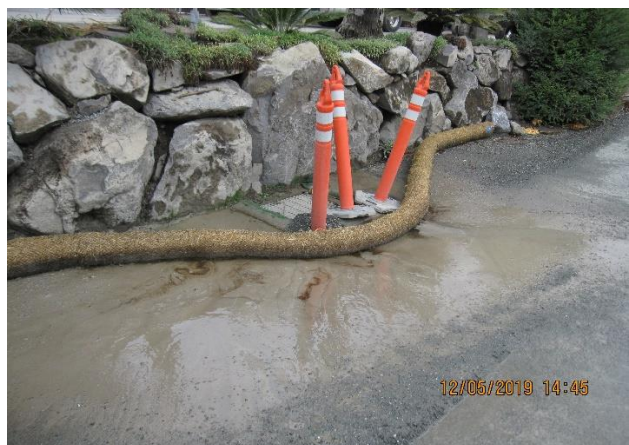
Pictures 3a, 3b – View of storm drain inlets with visible sediment accumulation and evidence of discharge of sediment into drainage system.

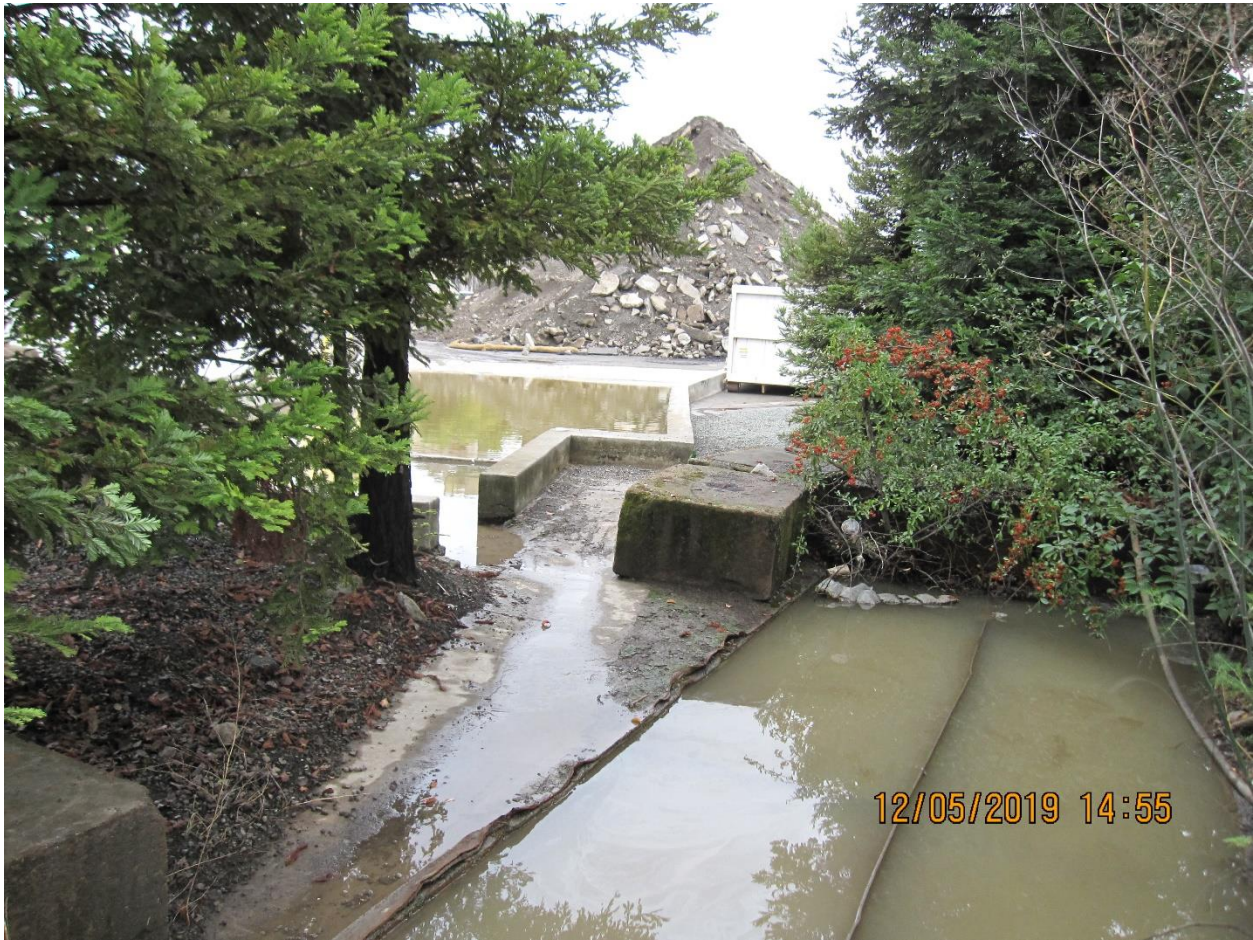
Picture 4 – View of the settling tanks and a settling pond adjacent to an asphalt recycling material stockpile – no measures in place to manage the stockpile or serve as source control. The permittee is required to ensure all minimum and advance BMPs for sediment and erosion control are implemented/ installed and maintained appropriately to eliminate or reduce the sediment that is discharged through the inlets.

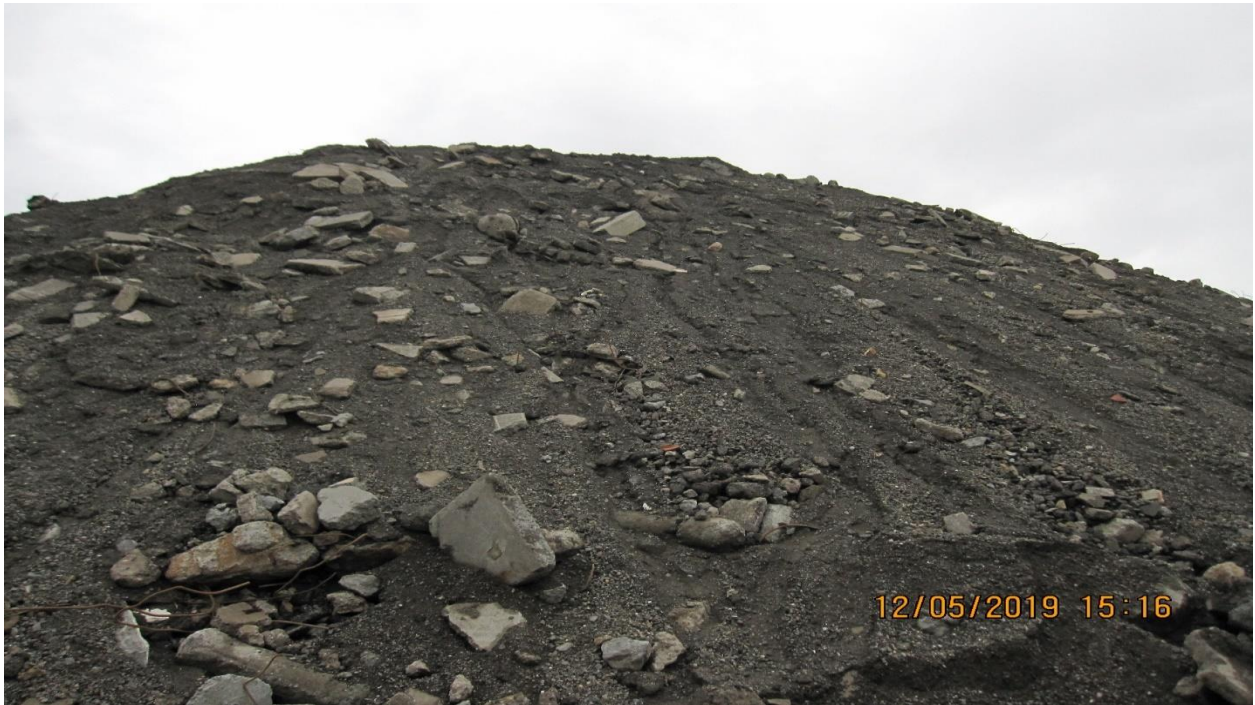
Picture 5 – View of a very large unprotected material stockpile located a few feet away from the existing muddy settling pond.

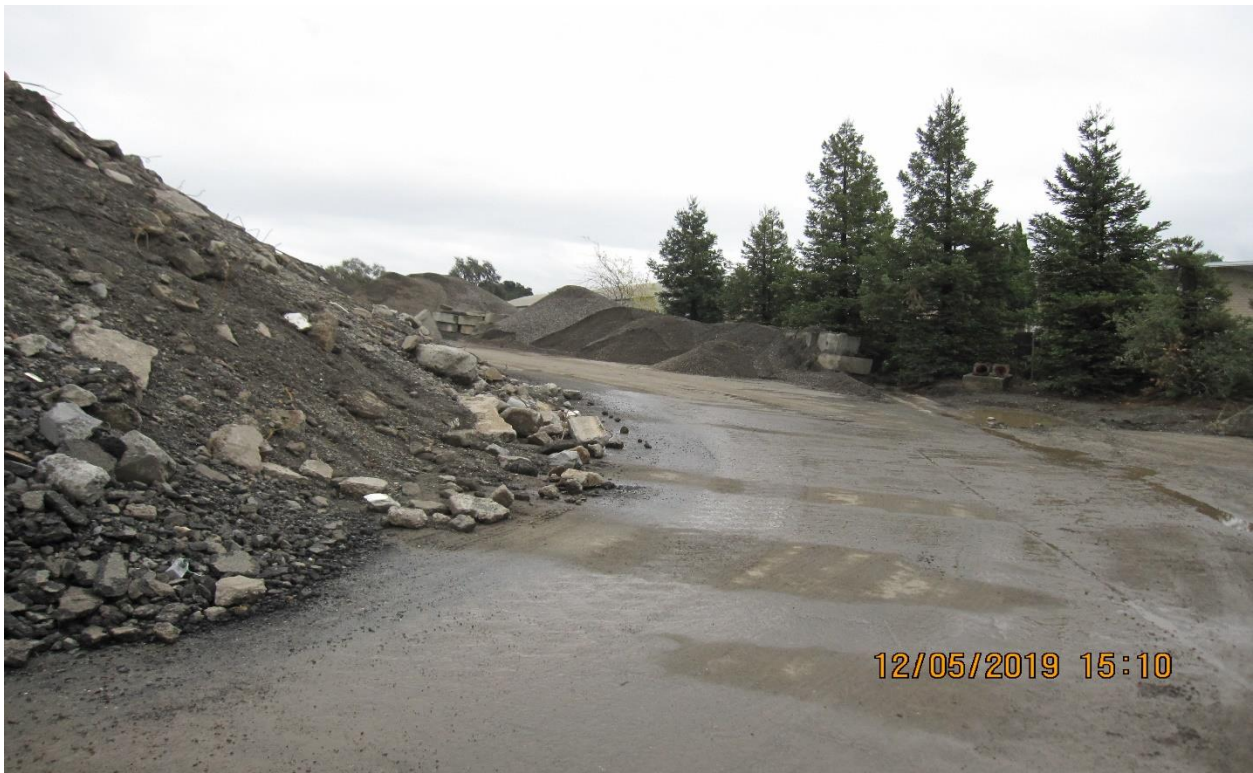
Picture 6 – View of unprotected asphalt recycling material and aggregate stockpiles located upstream of the settling tanks and ponds. No stockpile protection or perimeter control BMP installed.

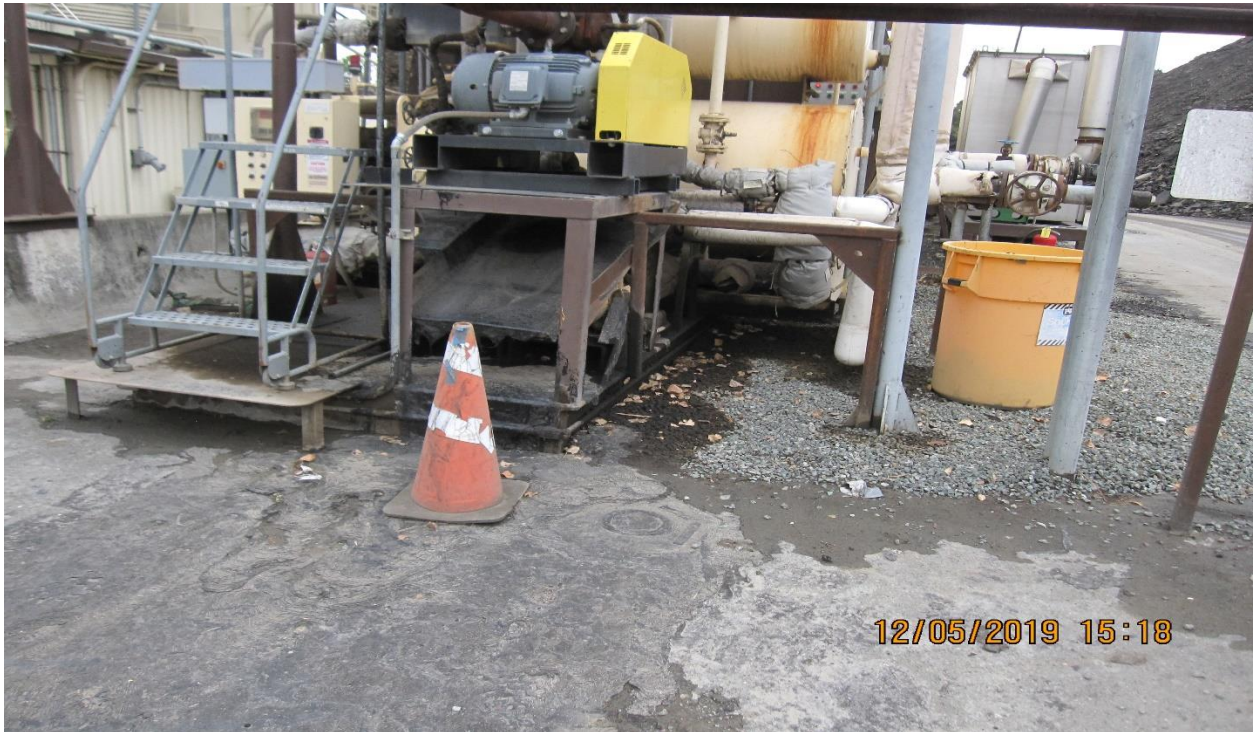
Picture 7 – View of industrial equipment in processing area. Oily material was observed in this area under the equipment. Spill prevention kits were not available on-site during the inspection. No containment controls BMPs were installed.

Conclusion: Staff observed poor housekeeping practices throughout the facility. Practices to minimize exposure, provide source control, and to manage stockpiles are not effectively implemented. The exit area is not adequately swept. Spill prevention procedures are not being implemented, and spill prevention kits are not present on-site.

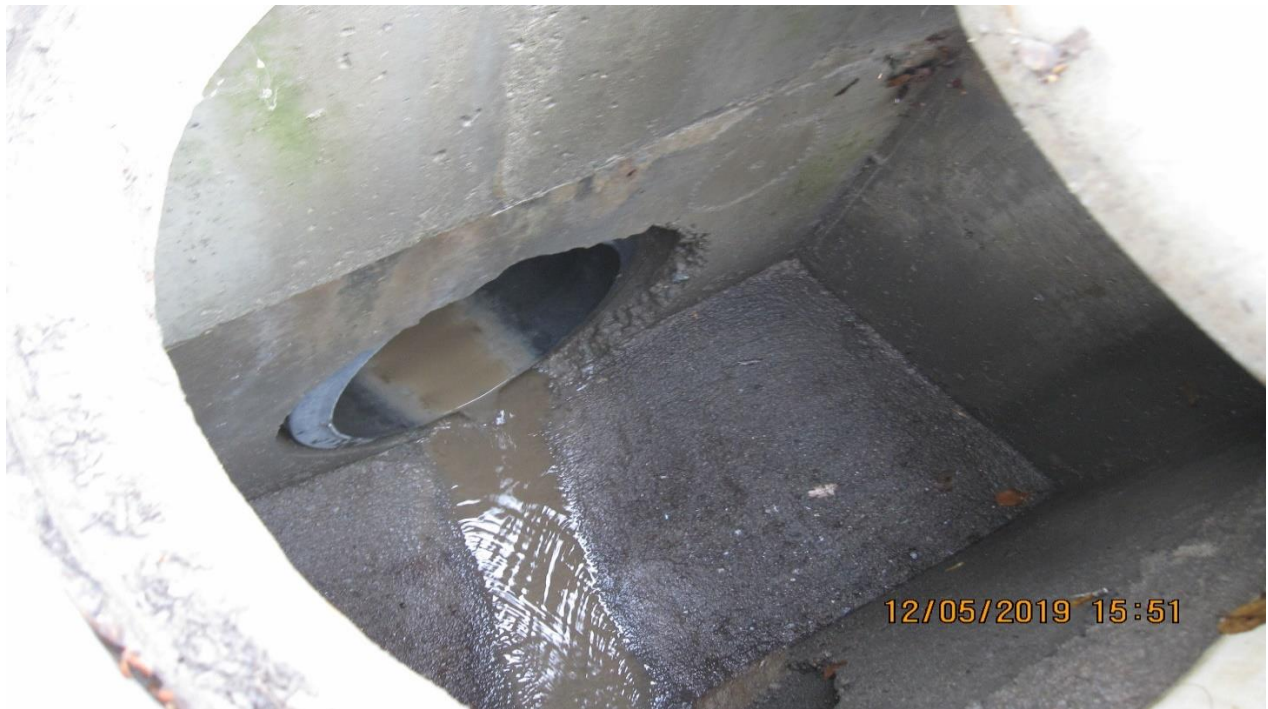
Picture 8 – View inside the public storm drain system of the discharge leaving the facility. This location the sampling point for the facility. The entire facility drains to this location and is the only source of the discharge. The discharged water is turbid. (Refer to the attached site map for location)

Muddy discharged water observed at the sampling point indicates that BMPs are inadequate. (refer to the picture No. 7).

Based on Regional Water Board staff's observation, site controls are inadequate. Portions of the site have no installed BMPs. Other BMPs are in need of maintenance or may be undersized. Additionally, as a result of past and ongoing discharge to the storm drain system and accumulation of sediment in the pipes and structures, the drainage system will also need to be cleaned.

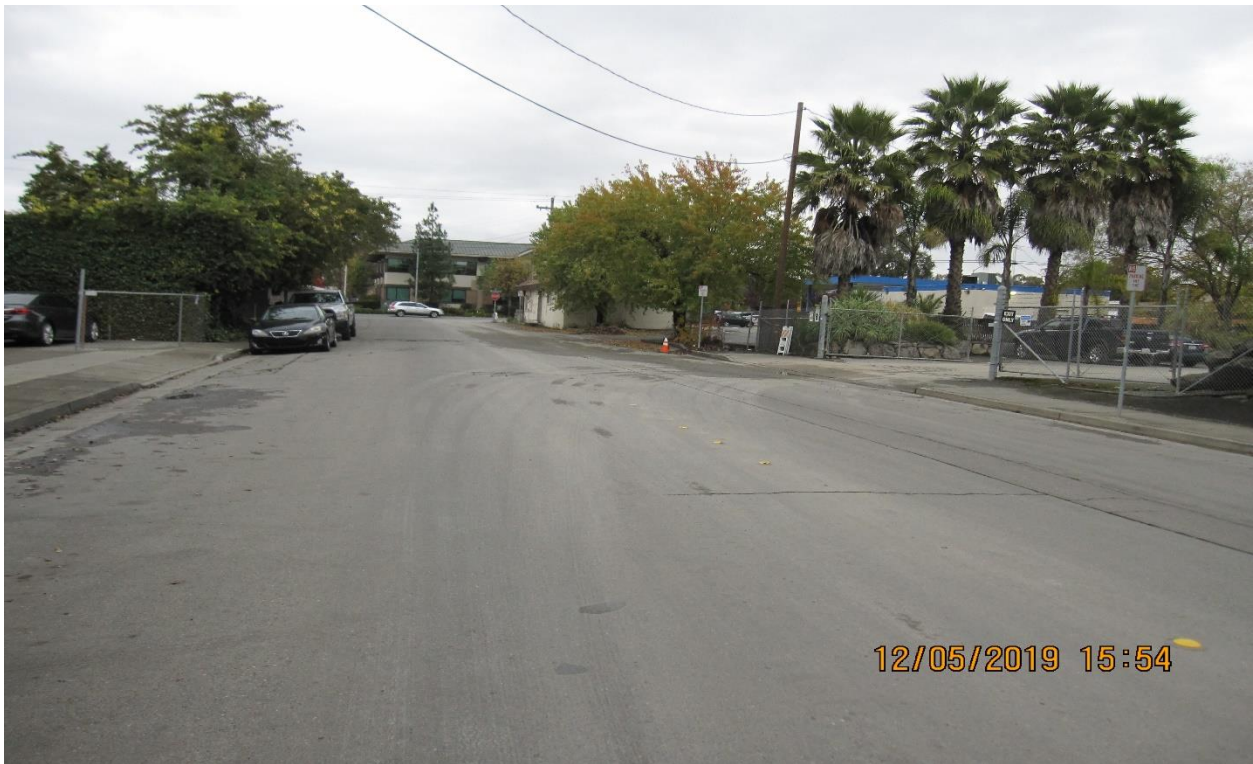
Picture 9 – Observed sediment track out from the facility to Maxwell Court which is a public street.

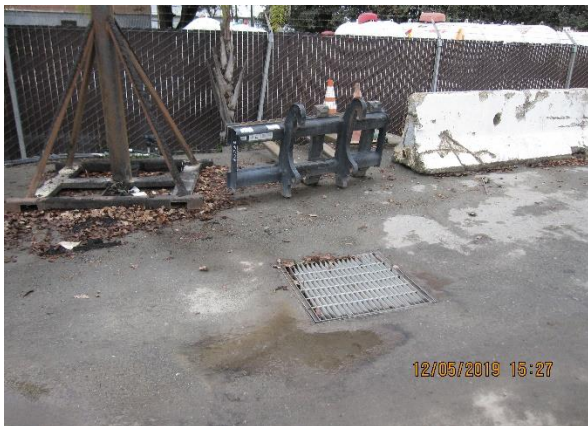
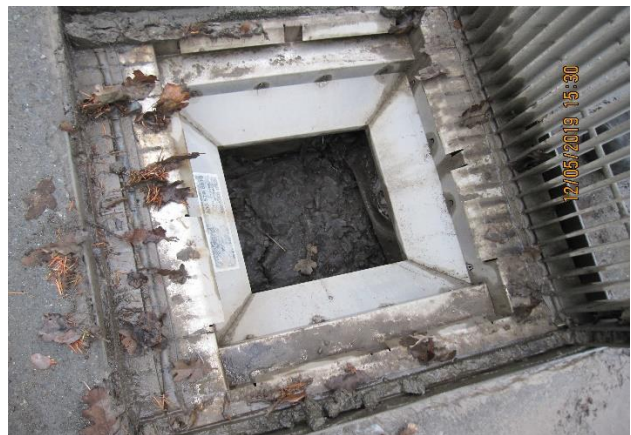
Pictures 10a, 10b – Views of unprotected drop inlet and the accumulated sediment discharged through the inlet.
