Subject: Notice of Violation and Transmittal of Inspection Report for January 9, 2020
Inspection of Humboldt County APNs 218-151-009 and 218-151-010

Palo Verde Reserve
CIWQS Place ID 828468
APNs 218-151-009 and 218-151-010
January 9, 2020 Inspection

Inspection Report for January 9, 2020 Compliance Inspection of Humboldt County Assessor's Parcel Numbers 218-151-009 and 218-151-010 (formerly 218-151-008)

File: Cannabis Program Inspections, Humboldt County, Palo Verde Reserve, CIWQS Place ID 828468

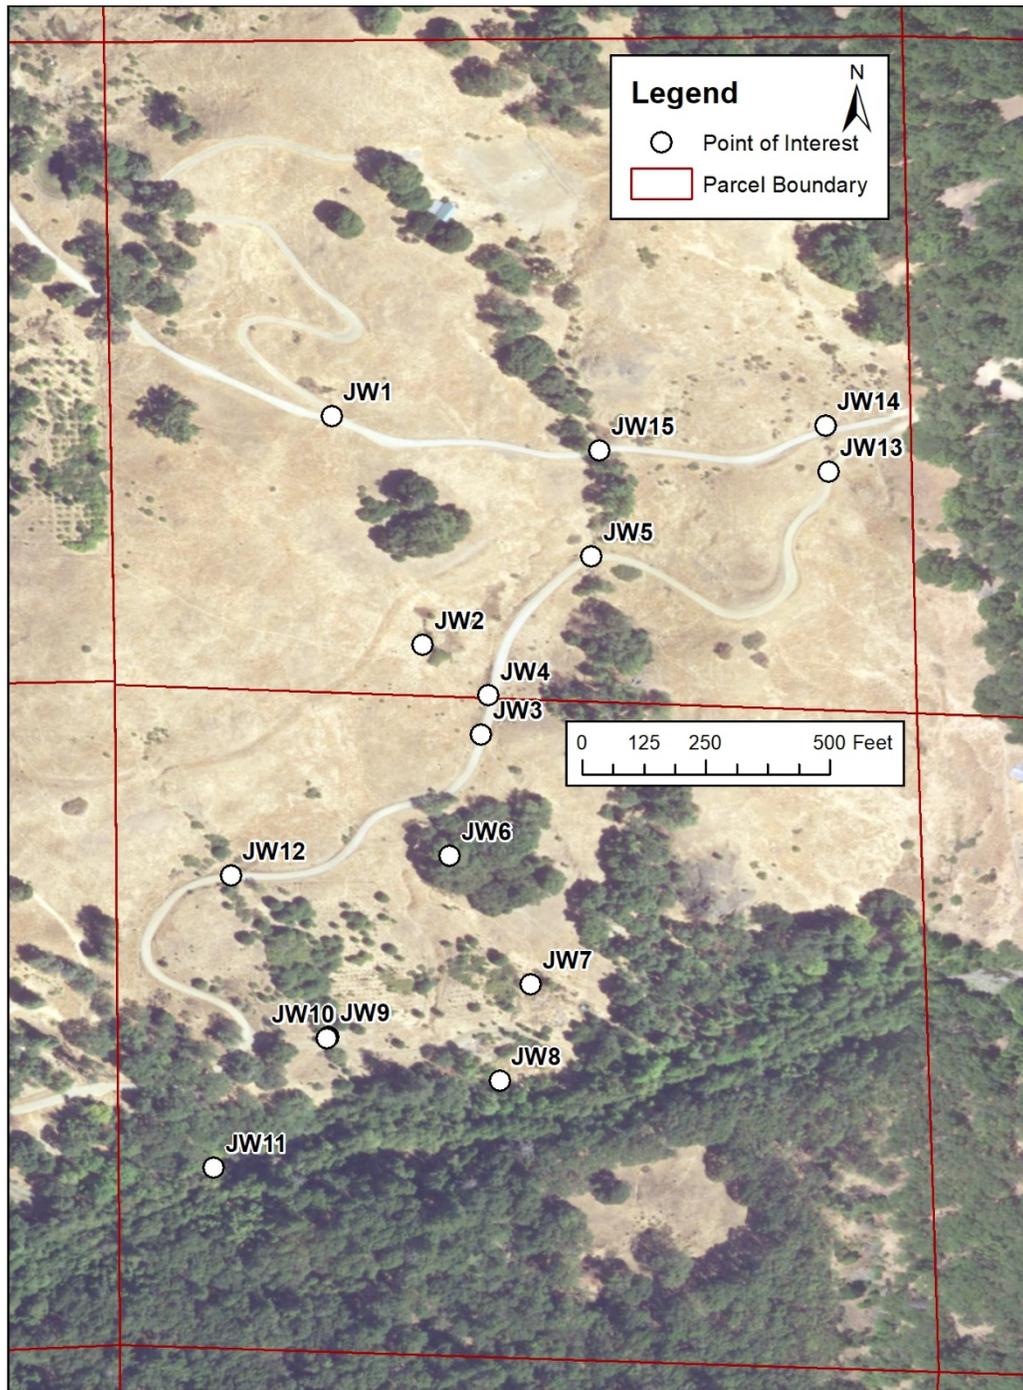
Figure 1: Map of John Wilhelm (JW) Property with inspection points of interest

On January 9, 2020, I inspected the subject property. Figure 1 is a site map showing inspection points discussed in Table 1. At JW3 I observed an inboard ditch with

standing water in it, and across the road, running perpendicular, a dry, historic channel. Downhill a couple hundred feet I observed at JW4 the discharge point of the inboard ditch, a cross drain with a clearly defined channel downstream. It appears the historic stream path may have been diverted down the ditch. I observed multiple failing and/or undersized culvert stream crossings. I also observed multiple road stretches with ditches hydrologically connected to watercourses, discharging road sediment to surface waters. I observed three stream crossings, JW9, JW10, and JW11 where decommissioning was proposed as a potential solution. If continued year-round vehicular access is need for JW9-11, these crossings should be upgraded to meet the standards of the Cannabis General Order.

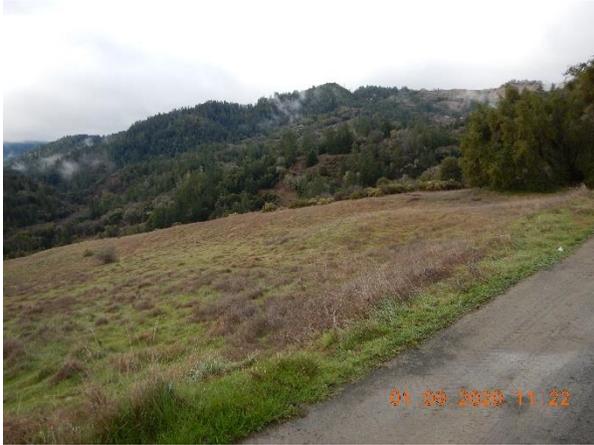
<p>Photo 1 – JW1; proposed cultivation area</p>	<p>Photo 2 – JW2; spring used for domestic water supply</p>

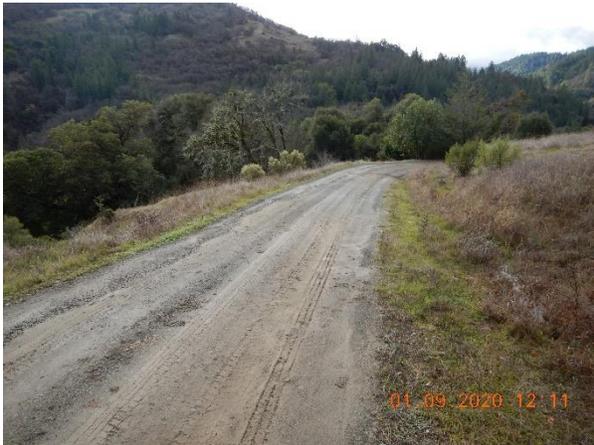
<p>Photo 3 – JW3; road section with inboard ditch</p>	<p>Photo 4 – JW3; historic dry channel</p>

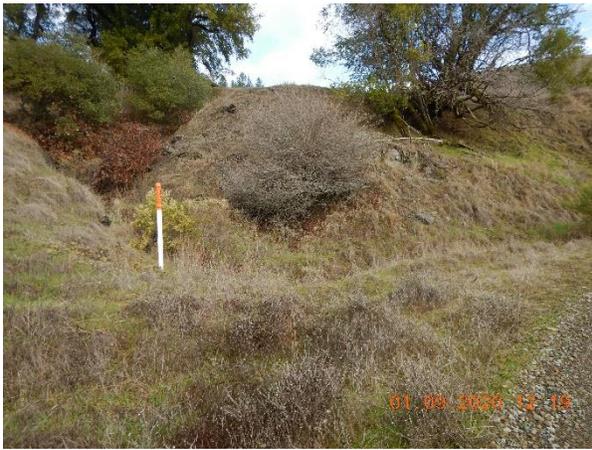
Photo 5 – JW4; inboard ditch culvert crossing

3. Add water bars, rolling dips, and/or cross drains as needed to disperse concentrated runoff. Manage roads to minimize surface erosion, hydrologic connectivity to surface waters, and sediment discharge. For additional guidance see Handbook for Forest, Ranch, & Rural Roads here:
<http://www.pacificwatershed.com/PWA-publications-library>

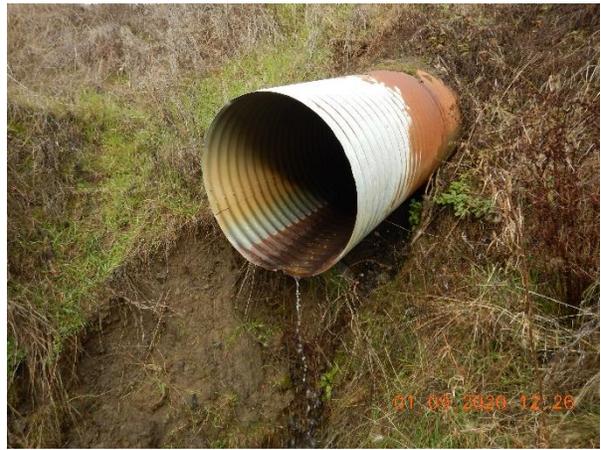
Photo 6 – JW5; outlet of stream and inboard ditch culvert crossing

1. Update Site Management Plan (SMP) to include:
 - a. Assessment of stream crossings for capacity to convey the 100-year flood flow and associated debris

- b. Schedule to upgrade or decommission stream crossings that do not meet the standards of the Cannabis General Order
2. Cease use of wet ford at map point JW11 until it is upgraded to meet the standards of the Cannabis General Order

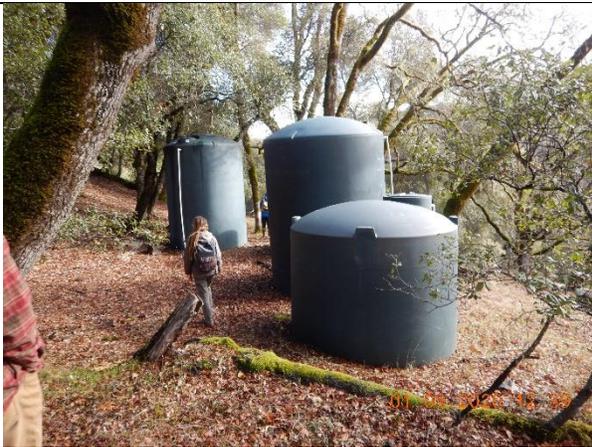
Photo 7 – JW6; four water storage tanks

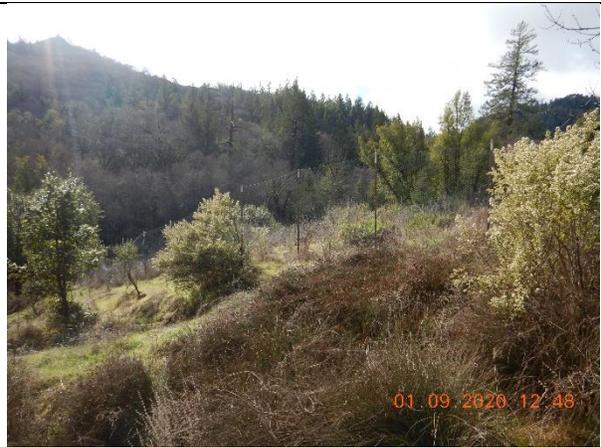
Photo 8 – JW7; decommissioned cultivation area adjacent watercourse

4. Remove cultivation related waste adjacent watercourses. Collect and dispose of or contain all refuse in a location and manner so as to minimize potential for these wastes to enter or be transported into receiving waters.

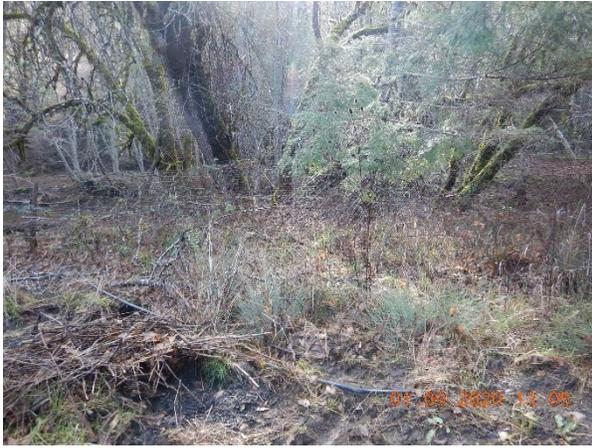
10. Cultivation-related wastes: I observed fencing and metal trellises left in place/abandoned where they may discharge to receiving waters.

Photo 9 – JW8; cultivation waste adjacent watercourse

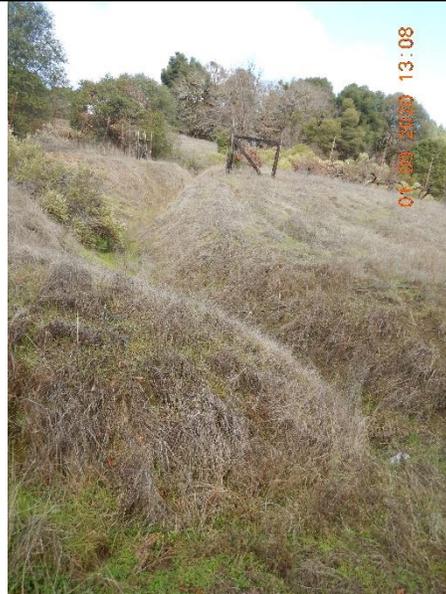
Photo 10 – JW9; culvert stream crossing adjacent vineyard

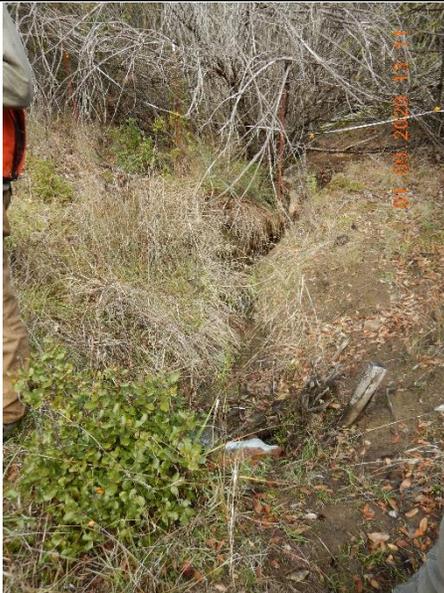
Photo 11 – JW10; culvert stream crossing adjacent vineyard

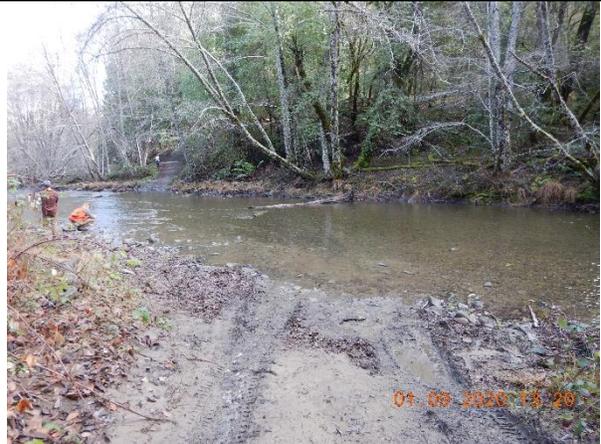
Photo 12 – JW11; unimproved Class I ford with tire marks on approaches and in the stream

Please note the recommendation in the inspection report to cease use of the wet ford at map point JW11 until it is upgraded to comply with all applicable regulatory requirements, including those of the Cannabis General Order, and is no longer threatening the discharge of waste to waters of the State.

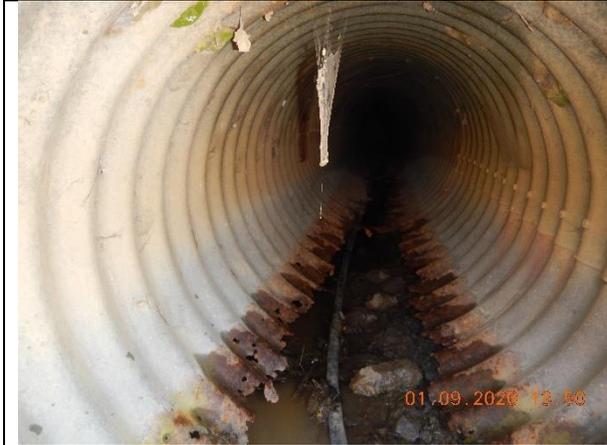
Photo 13 – JW12; rusted out culvert bottom

6. Prior to work in a stream, including culvert installation or replacement, submit design plans, construction schedule, and other relevant information to the Regional Water Board through the 401 Water Quality Certification. Work may not commence until authorization is received from the Regional Water Board. See 401 Water Quality Certification application here:
www.waterboards.ca.gov/northcoast/water_issues/programs/cannabis/pdf/190403/180731_031616_401_WQ2017-0023-Application.pdf

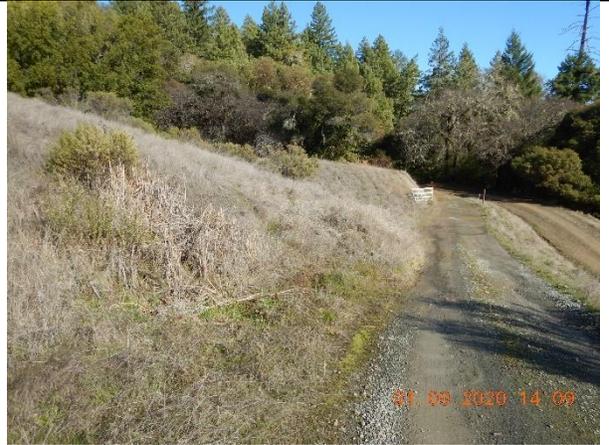
Photo 14 – JW14; spring feature on left uphill of road, some runoff visible on road

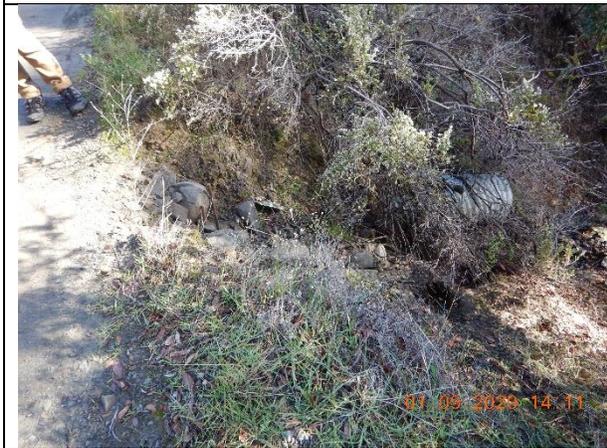
Photo 15 – JW15; culvert stream crossing

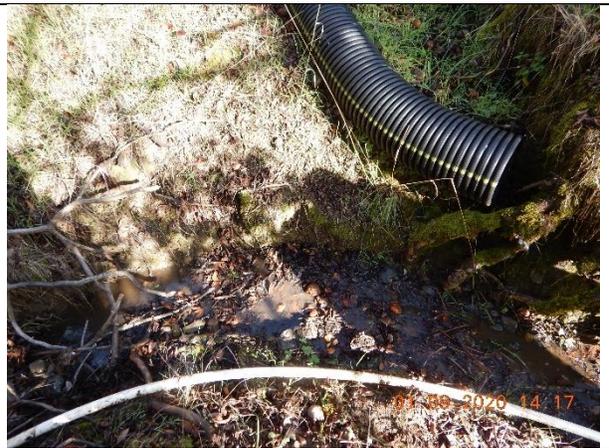
3. Riparian and wetland protection and management: I observed an inactive cultivation area, mostly decommissioned, in the riparian setbacks. I also observed a black plastic culvert piece and white pipe in a watercourse.

Photo 16 – JW15; waste in watercourse
