Complaint Inspection Report Renati Dairy

Report Date: August 19, 2020
Dairy Name: Renati Dairy
State Identification #'s: WDID 1B11124DSON, Place ID 768246
Dairy Address: 5950 Carroll Road, Petaluma, CA 94952
Complaint APN#: Assessor Parcel Number 027-170-015
Inspection Date: June 29, 2020, 10:00 AM
Purpose of Inspection: Respond to Anonymous Water Quality Complaint
Attendance: Cherie Blatt, North Coast Regional Water Quality Control Board (Regional Water Board), and Dan Renati, Co-owner, Renati Dairy

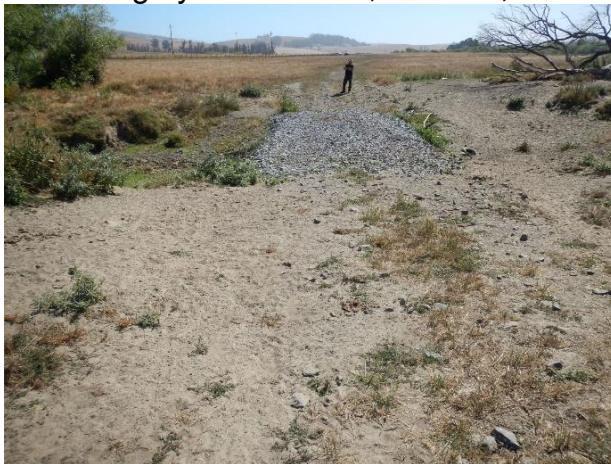
Watercourse crossing of Americano Creek – subject of complaint.

- A. Permanent Crossing: If a permanent crossing is to be left in place year-round, then a professional engineer or registered geologist must design the crossing utilizing options such as multiple culverts, arch culvert, clean rock fill, flat rail car with constructed approaches, or other bridge design. The engineering design must be submitted to the Regional Water Board for approval and is covered by the dairy's existing permit: General Waste Discharge Requirements for Dairies,

Temporary Crossing: If a temporary crossing at this location is preferred, then a proposal must be submitted to the Regional Water Board for review. Acceptable options include installation of the temporary crossing of similar design as the existing crossing (minimum 24-inch diameter culvert, clean angular rock fill) but annual installation and maintenance must protect the integrity of the creek. The temporary crossing must only be in place during the spring-summer-fall season when the creek is dry. Temporary crossings may be considered normal farming operations and may be exempt from federal and local regulations and permitting.

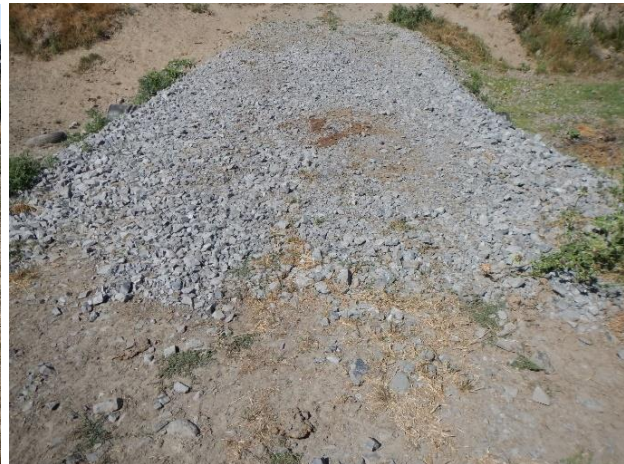
Mr. Renati said that farm equipment crosses the creek over 300 times per year for crop harvesting (grass/hay to make silage) and manure spreading. Also, the crossing is used about once per week for operators to check on livestock. He explained that the rock crossing was installed to make the crossing level for equipment and the rock protects the stream bank and bed from erosion during the multiple crossings.

Close-up of crossing. Note angular rock used.

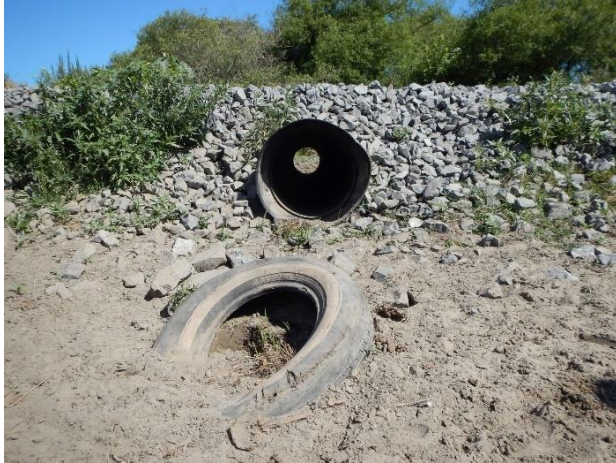
Regional Water Board staff observed that the subject crossing had an approximately 24-inch diameter black plastic culvert covered by angular rock up through the road crossing approaches. The creek bed was dry except for one pool as shown in the photo log at the end of this report. There was evidence of a small amount of scour erosion in the creek bed just below the culvert outlet.

Mr. Renati said that Americano Creek floods over the 24-inch culvert crossing area as well as the nearby Valley Ford Road during heavy rainstorms under saturated soil conditions, especially during high tide. He said that creek water level can rise to about 11 feet above the bottom of the culvert which is well over the crossing height. He said that the old tire located just above the culvert inlet (see photo log) was from a neighbor's tire (erosion control) discharge problem several years ago.

Culvert inlet. Probably 24-inch diameter. Tire is from neighbor's past discharge upstream.

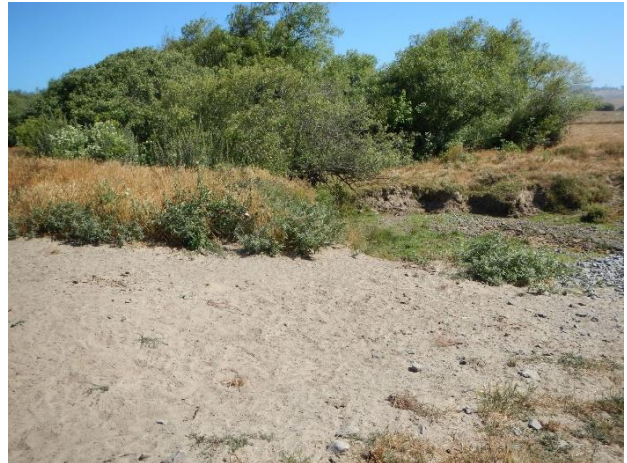
Bare dirt area near culvert crossing. Creek bed at right.

- C. The Riparian Management Plan must be submitted to the Regional Water Board prior to crossing reconstruction no later than **July 1, 2021** and must detail how riparian vegetation will be improved around the crossing area. Current conditions show approximately 600 linear feet of riparian area along Americano Creek that is devoid of adequate riparian vegetation. Measures such as limiting animal and machinery access to just the crossing area, replanting riparian vegetation, and protecting future plant growth for at least 35 feet from both creek banks, are necessary to protect the water quality of Americano Creek. Temporary fencing to preclude access to the creek area by cattle may be necessary during the dry season to project riparian vegetation. The Riparian Management Plan must ensure that animal water and feed troughs are located at least 35 feet away from Americano Creek banks to help maintain vegetation. Animals may cross the creek on the new crossing but must not have access to the creek.

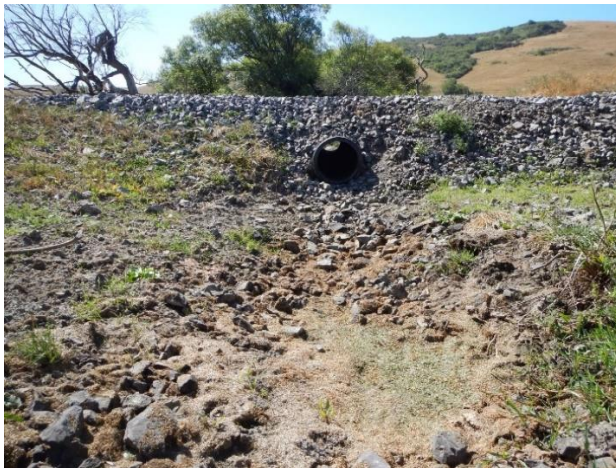
Culvert outlet area.

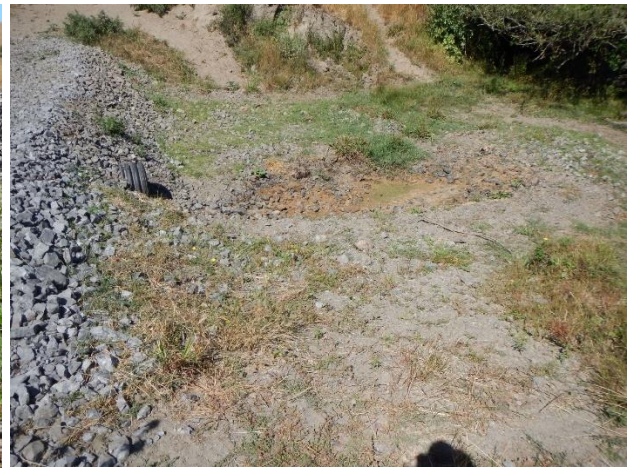
Although the culvert is installed to grade (on the creek bed) and clean angular rock appears to have stayed in place over the years, the current culvert is too small to pass large flows and could obstruct fish passage and limit some aquatic wildlife migration. Permanent fill in the creek such as the culvert and rock may require permits and design changes from various state and federal agencies. Please see Section IV. Recommendations below for options for this crossing area.

Culvert outlet center left. Some bed scour erosion below outlet.

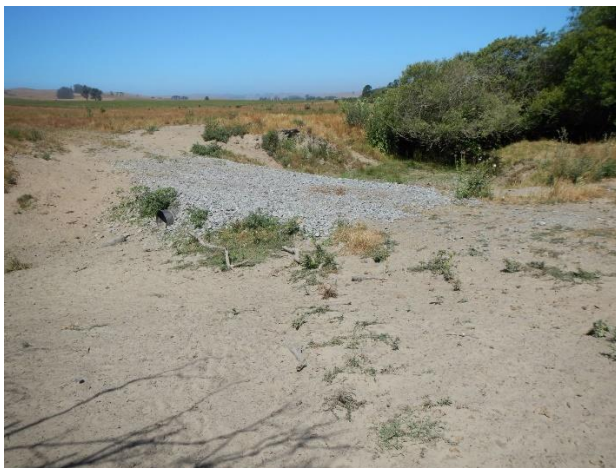
Note bare soil around crossing area.

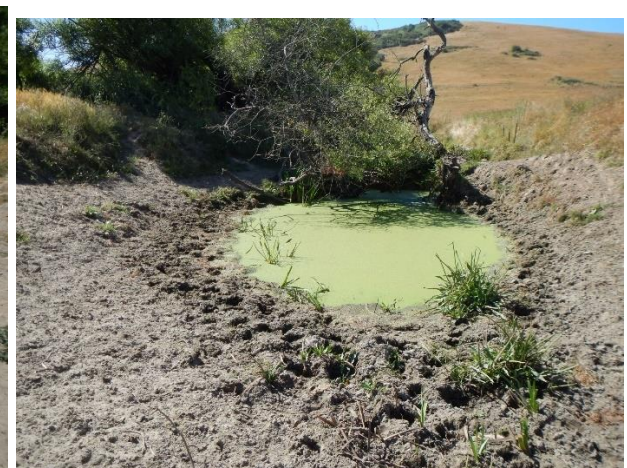
Creekbed was dry except for this pool near the crossing.

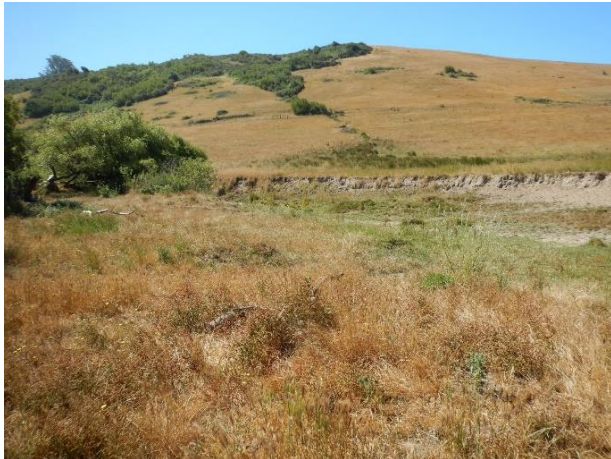
Americano Creek just upstream of the crossing, looking southeast.

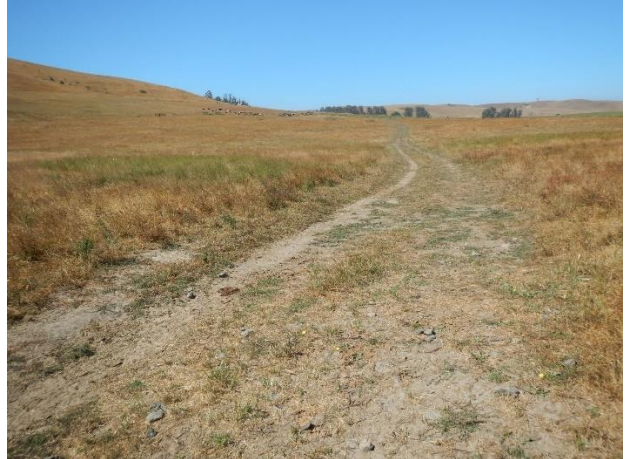
Dirt access road just south of creek crossing. About 25 heifers were grazing this field (background-left).

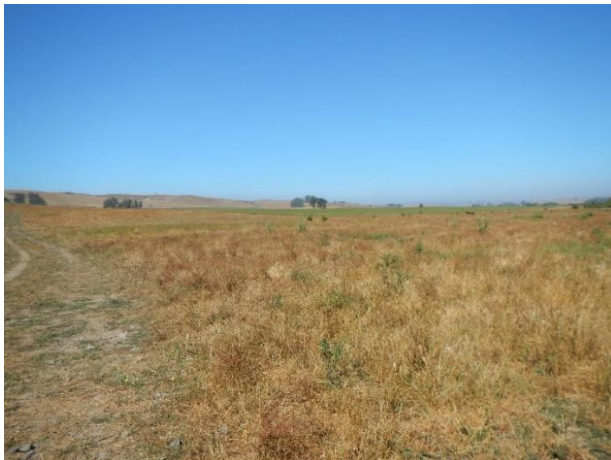
Renati's vegetated pasture. Looking southwest. Riparian vegetation along Americano Creek on right. Bare soil on approach to crossing area in foreground right.

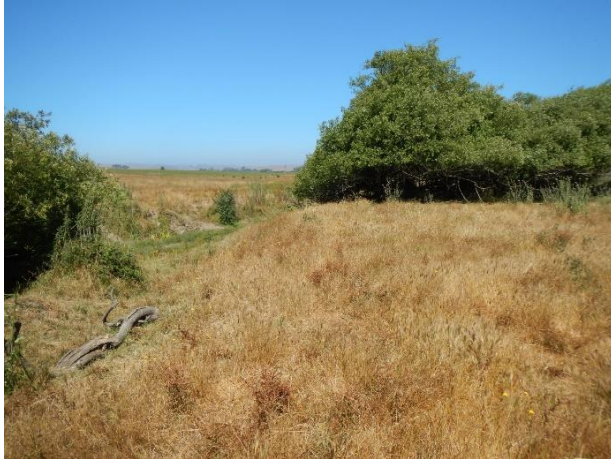
Americano Creek bed on left. Vegetated pasture in foreground. Riparian vegetation at right background. Looking west.

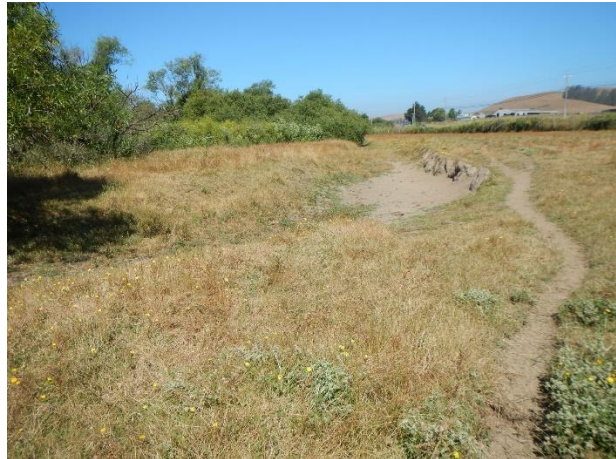
Americano Creek bed overflow channel at center surrounded by pasture. Cow trail on right. Riparian vegetation at left. Looking west.

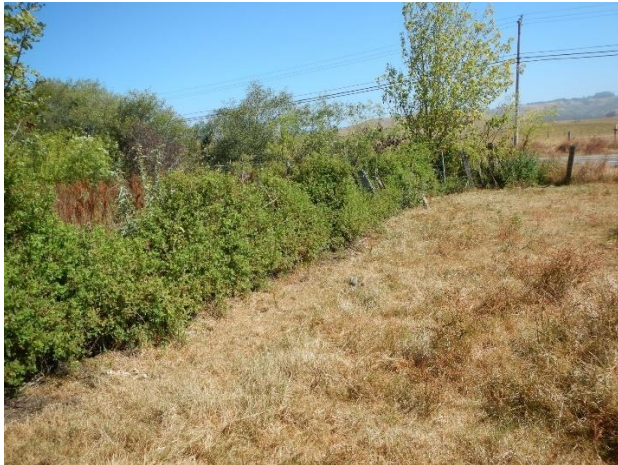
Neighbor's fenced-out, brushy field at left. Renati's pasture at right. Valley Ford Road at far right/background. Looking northwest.

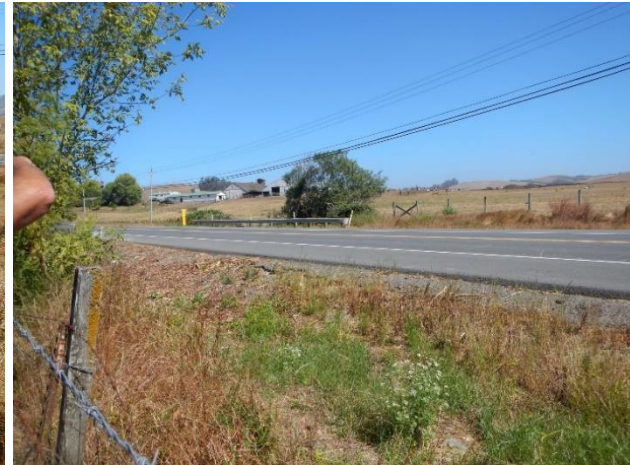
Valley Ford Road slightly higher in elevation than Renati's pasture (fenced at left). Looking west.

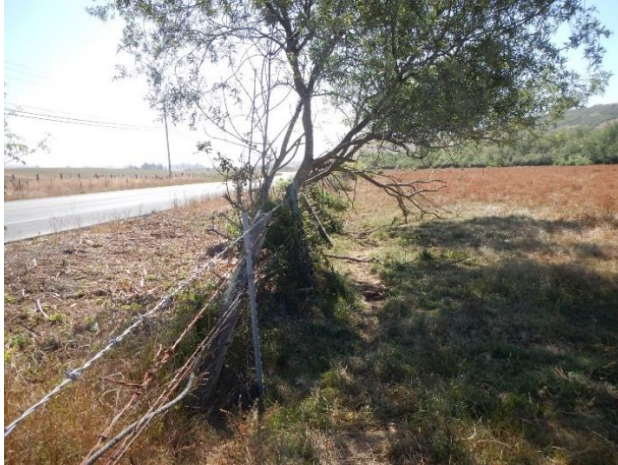
Valley Ford Road (left) slightly higher in elevation than Renati's pasture (right). Looking east.

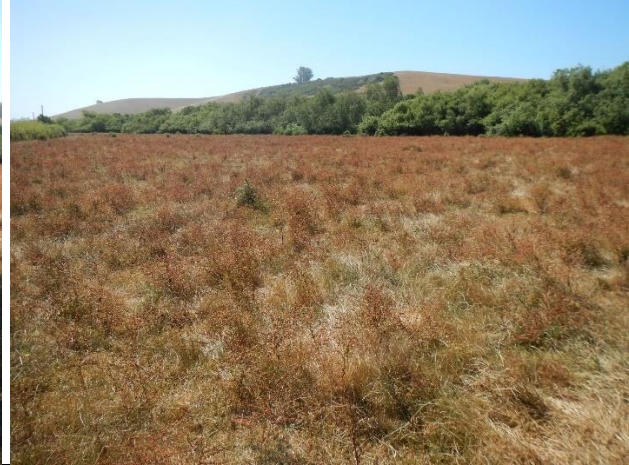
Renati's vegetated pasture (foreground). Americano Creek riparian vegetation (background). Looking east.

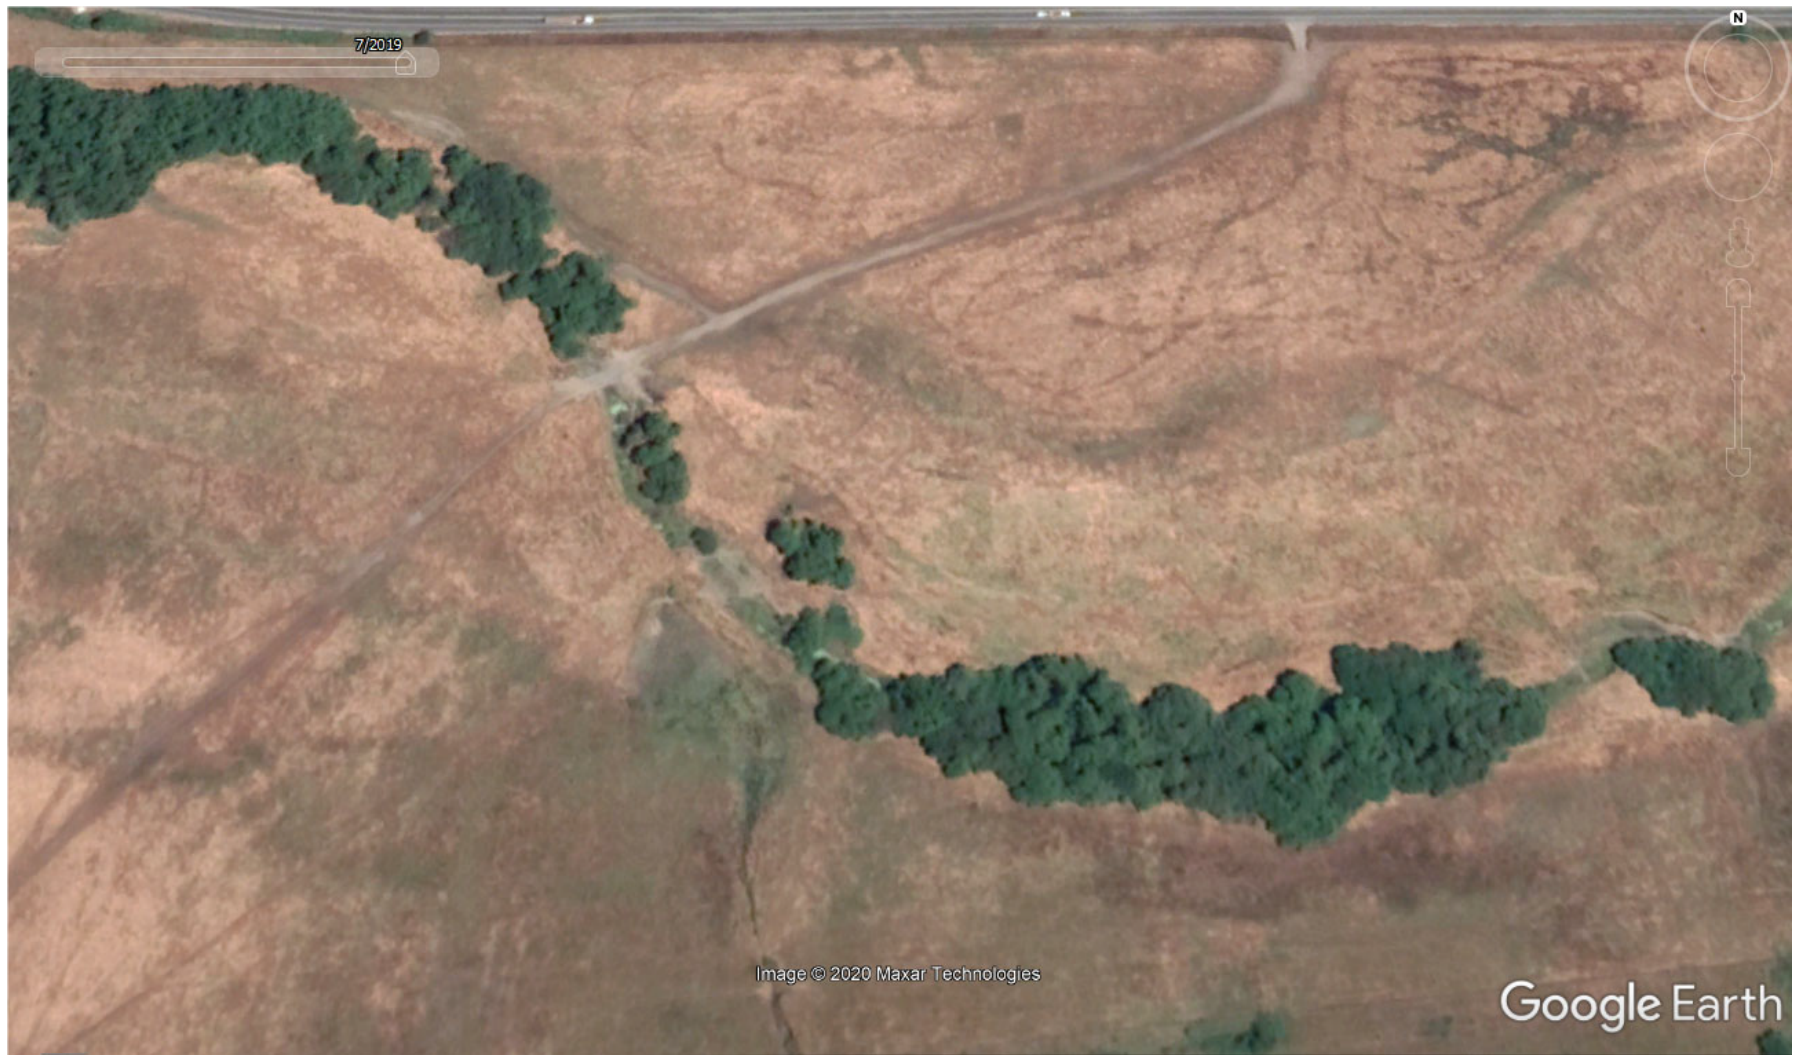
July 2019 Aerial Image

Google Earth aerial images show that the Caselli property at Americano Creek had several small narrow animal crossings around 2012 through 2017 but no obvious signs of crossings by farm machinery. However, aerial imagery from February 2018 to the present, show farm roads in the pastures including the current road crossing of Americano Creek (aerial imagery attached).
