Subject: **Notice of Violation, Directive to Obtain Regulatory Coverage for Cannabis Cultivation, and Transmittal of Inspection Report for July 20, 2020 Inspection of Humboldt County Assessor's Parcel No. 208-054-003-000**

July 20, 2020 Warrant Inspection
Humboldt County Assessor's Parcel Number (APN) 208-054-003-000

File: Cannabis Inspections, Humboldt County, 2020, APN 208-054-003-000,
Szagora LLC, CIWQS Place ID No. 830016

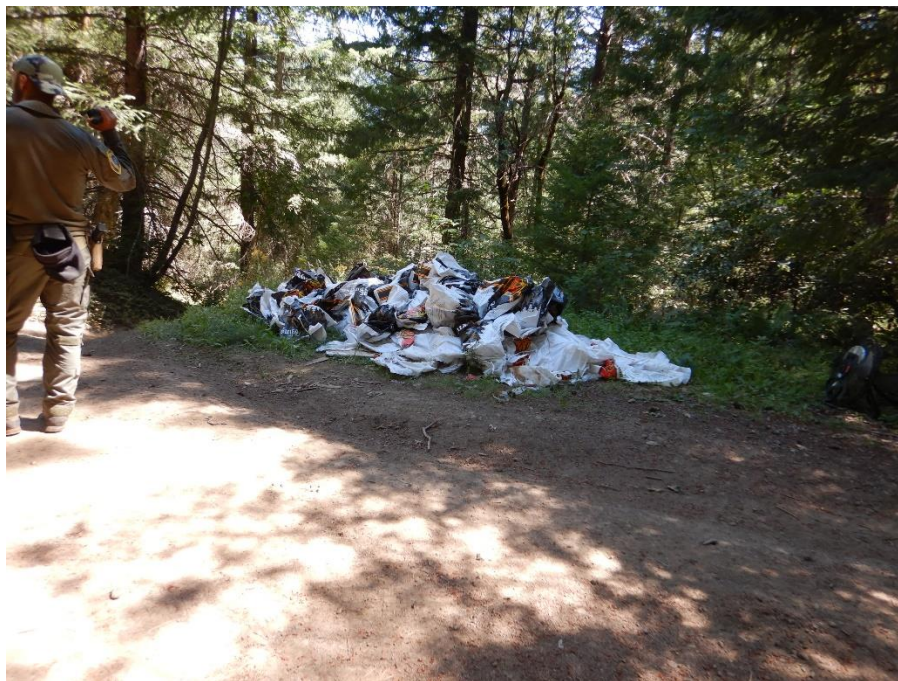
I observed waste potting soils bags, uncontained, in a pile at WQ 1 where they had the potential to be scattered by wind and blown to watercourses.

Photo 1—Pile of plastic waste, including empty soil bags, uncontained on side of road in the vicinity of WQ 1.

3. Collect and dispose of or contain all refuse and cultivation-related wastes in a location and manner so as to minimize potential for these wastes to enter or be transported into receiving waters.

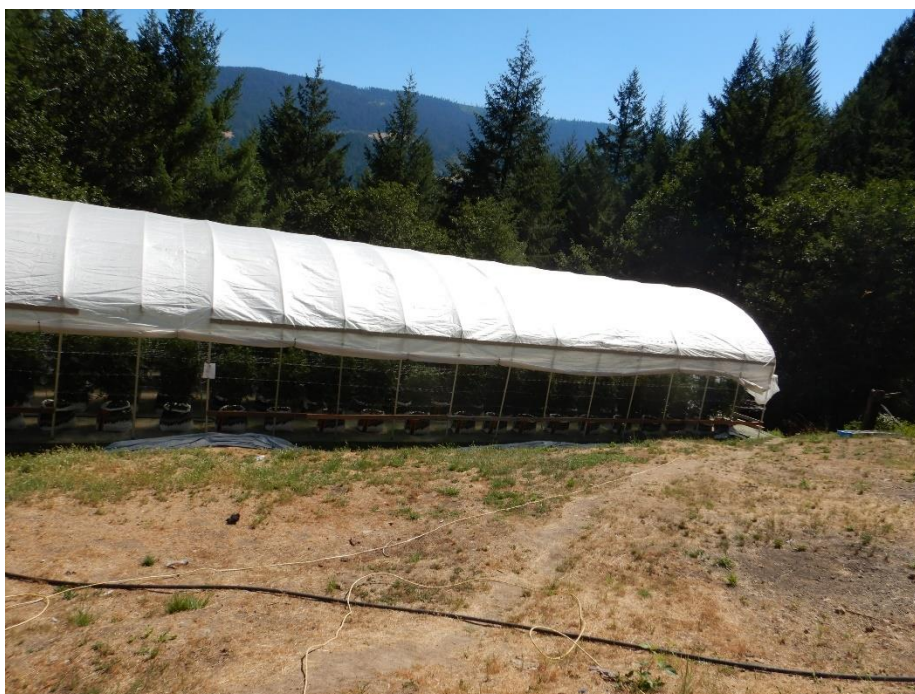
Photo 2— Approximately 3,500 square foot cannabis cultivation area at WQ 2.

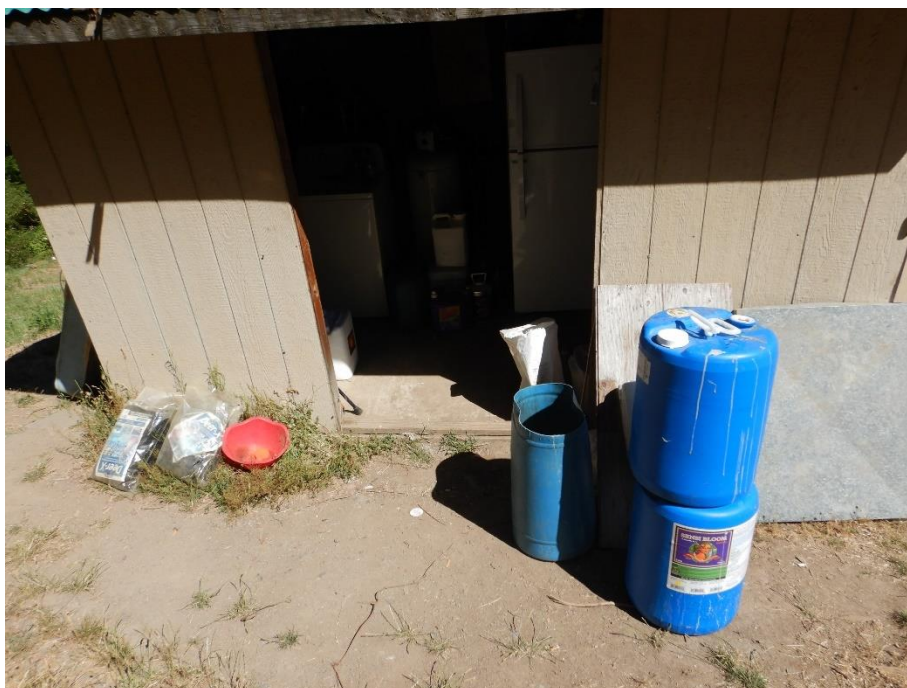
I observed liquid fertilizer containers outside at WQ 2 and staged for mixing near a pump on a piece of plywood at WQ 1. Fertilizer spills in this area would discharge to the ground, but are far from watercourses.

Photo 3—Fertilizer containers outdoors on bare ground next to a shed in the vicinity of WQ 2.

4. Store and contain all chemicals, including petroleum, fertilizer and/or pesticides properly to prevent spillage and discharge to receiving waters. Provide secondary containment for all petroleum products.

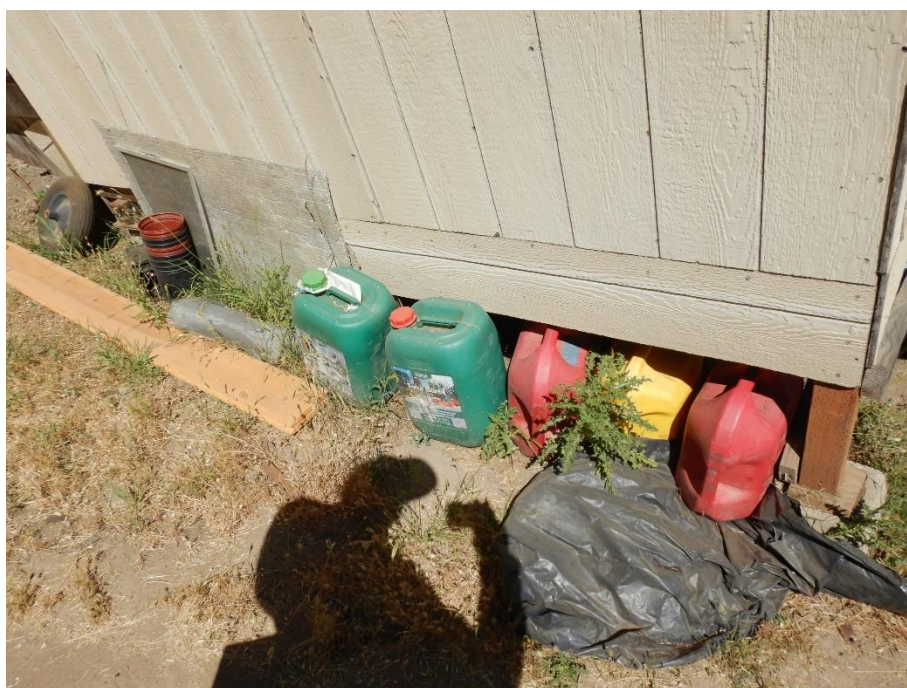
I observed fuel containers, uncontained, on bare ground at WQ 2, and partially resting on a sheet of plywood next to a 55-gallon drum at WQ 14. Petroleum spills in this area would discharge to ground, but are far from watercourses.

Photo 4—Fuel and fertilizer containers outdoors on bare ground next to a shed in the vicinity of WQ 2.

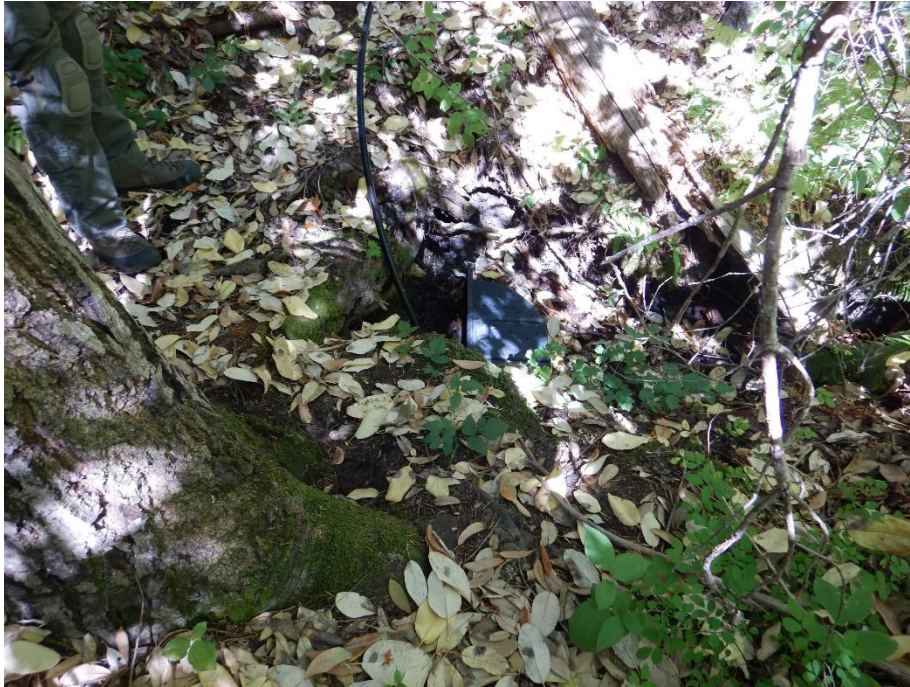
Photo 5— Plastic box in a three-foot-wide watercourse at WQ 3.

5. Comply with requirements/directives from CDFW and the Division of Water Rights with respect to appropriate permitting/licensing for water source(s), diversion(s), storage, and use, and ensure that water storage features are modified/maintained so as to minimize the potential for adverse impacts to water quality and beneficial uses.

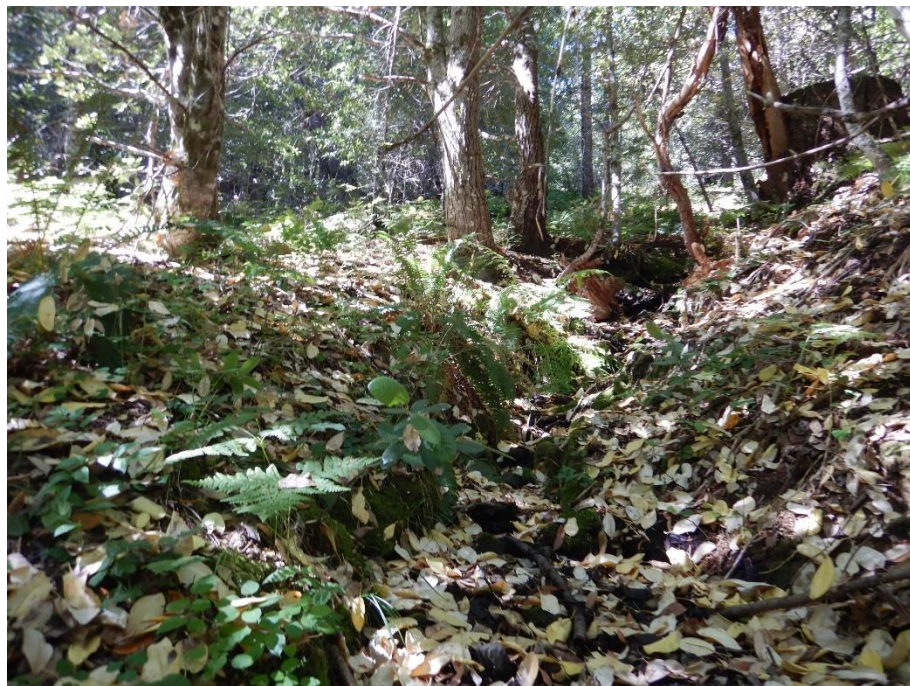
Photo 6—View of the watercourse upstream from the diversion, at WQ 3, pictured in the previous image.

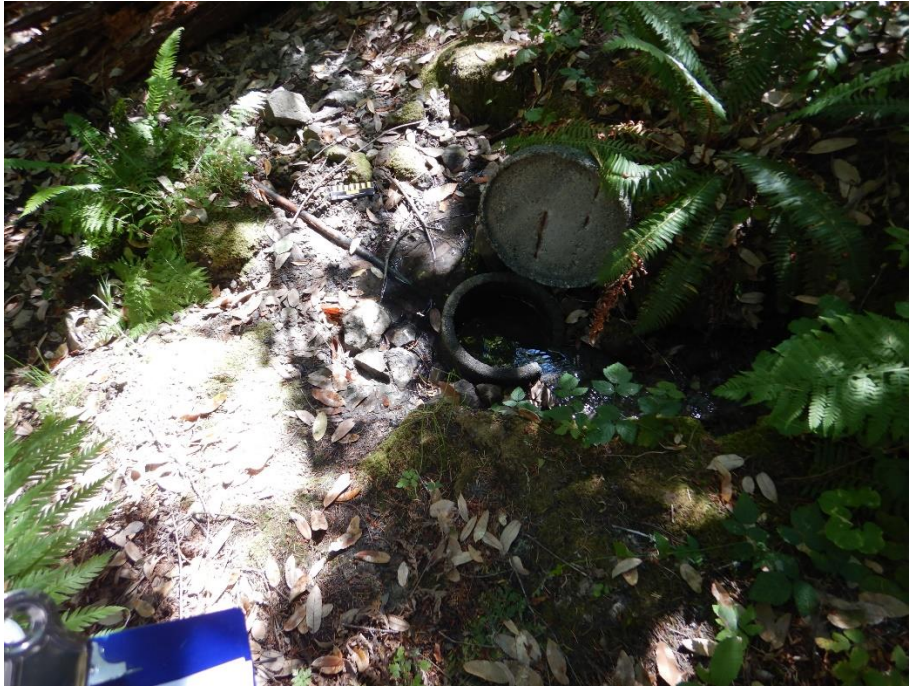
Photo 7—Watercourse diversion at WQ 4 with pipe leading to the diversion at WQ 3.

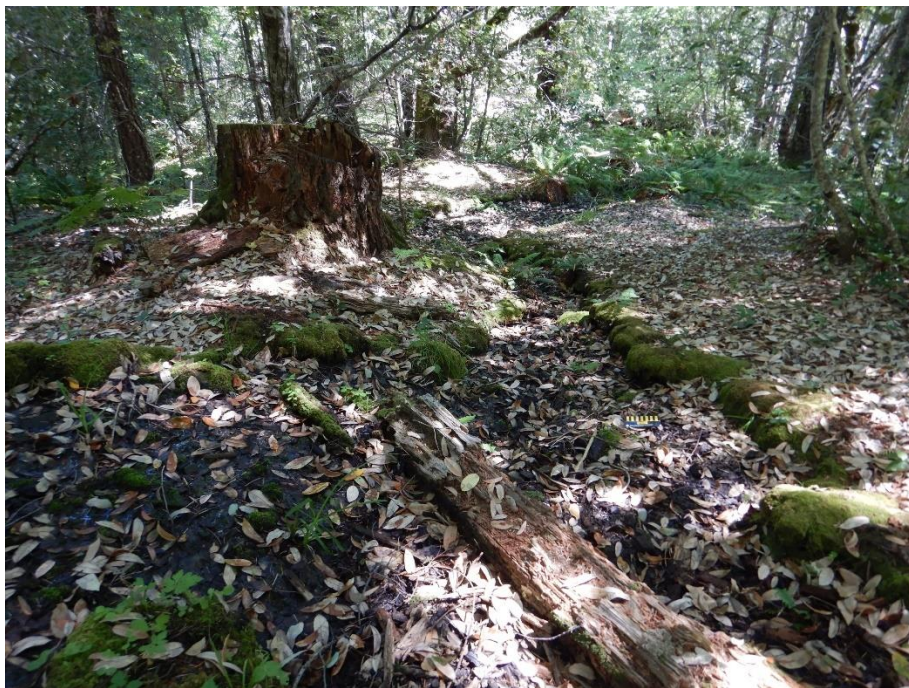
Photo 8— View of the watercourse downstream from the diversion, at WQ 4, pictured in the previous image.

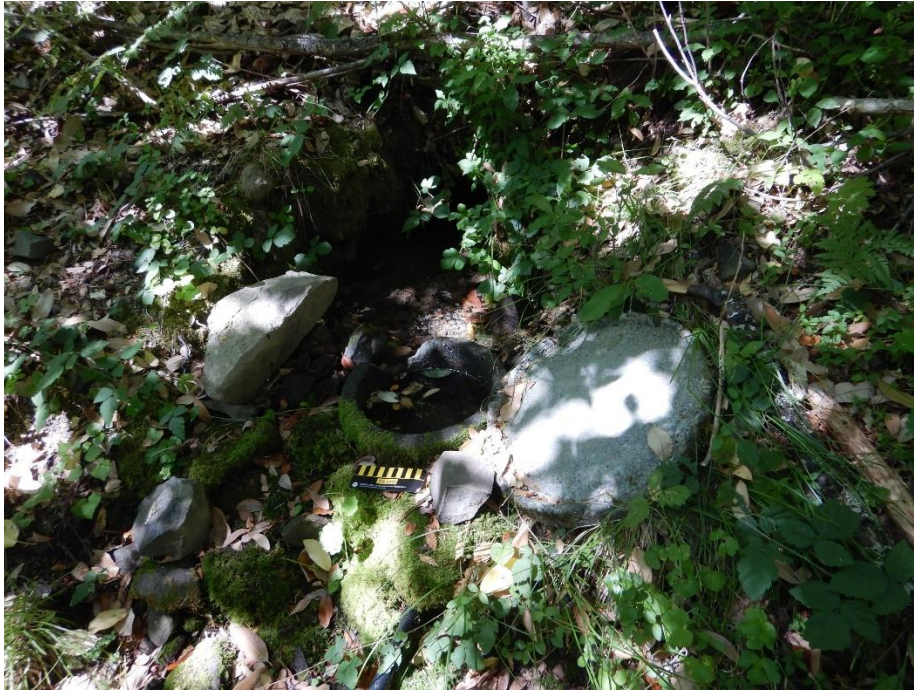
Photo 9— Watercourse diversion at WQ 5, on the same watercourse as the diversion at WQ 3 but farther upstream.

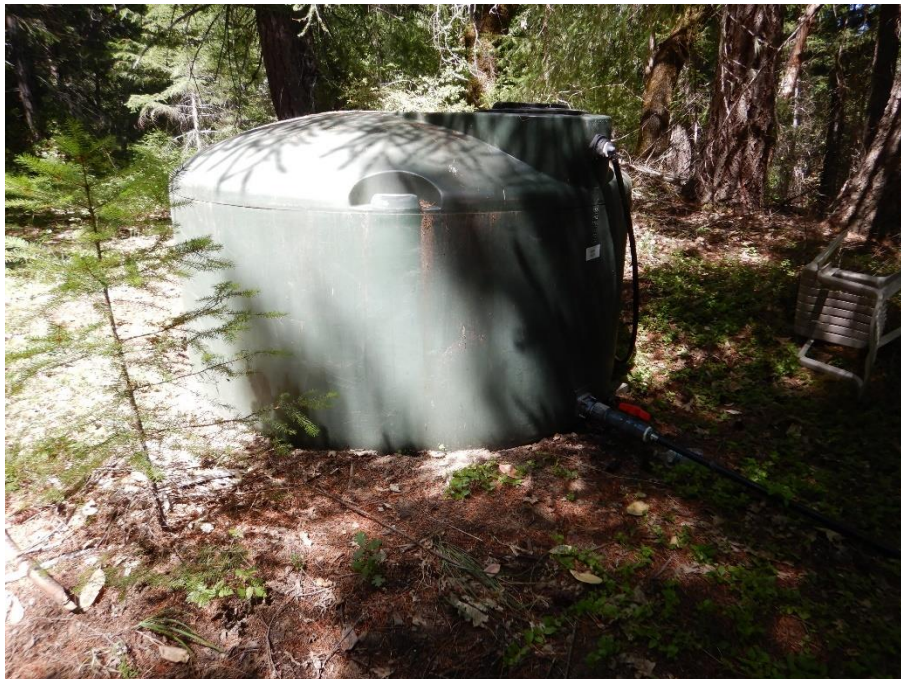
I observed a tank at WQ-6 storing water that had been diverted from surface water without authorization.

Photo 10—Water tank located at WQ 6. A plastic pipe originating from the diversion at WQ 5 leads to the top of the tank.

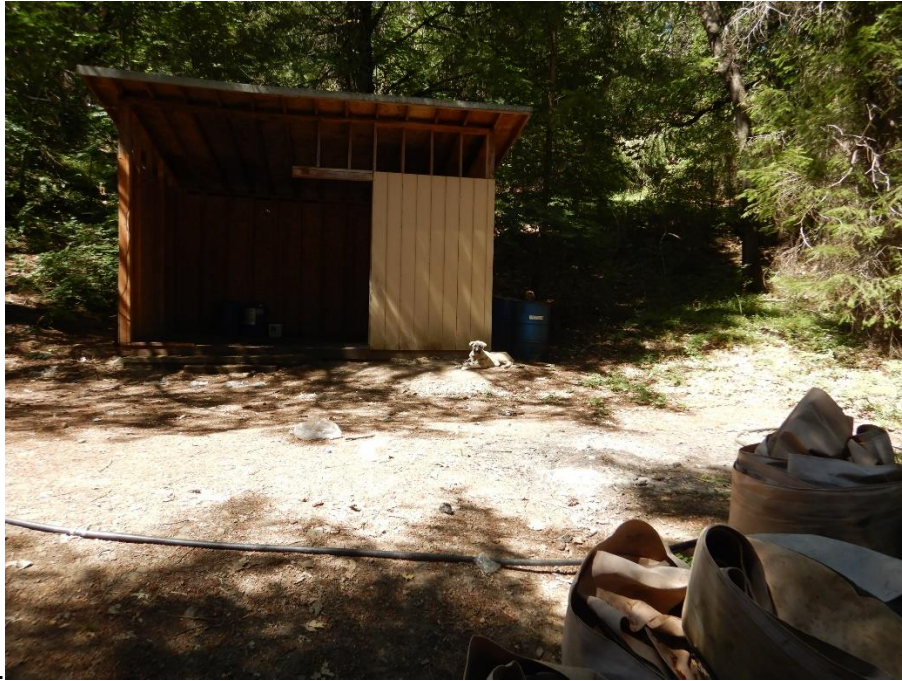
From WQ 6, I walked northeast and past a shed with a barking dog and a 55-gallon drum of unknown contents (Photo 11). Near to the shed, I observed liquid fertilizers, uncontained, outdoors, on a sheet of plywood (Photo 12). At a fork in the road I walked northeast from WQ 1 and I observed that the steep road lacked features, such as water bars or rolling dips, to direct stormwater off the road (Photo 13).

Photo 11—55-gallon drum with unknown contents next to a shed in the vicinity of WQ 1. A dog chained next to the drum prevented staff from inspecting.

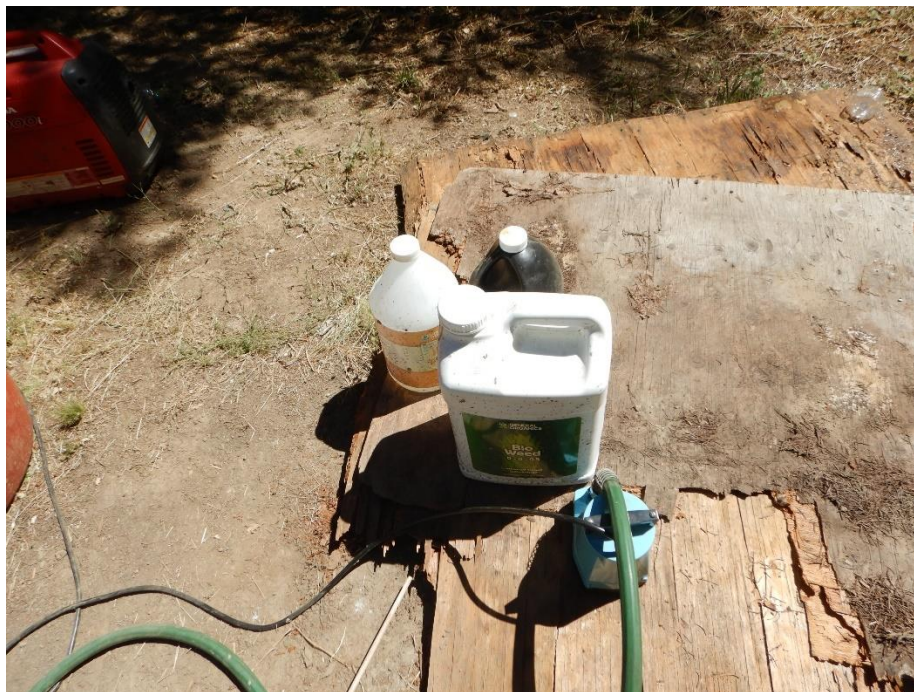
Photo 12— Liquid fertilizers and pump on a sheet of plywood in the vicinity of WQ 1.

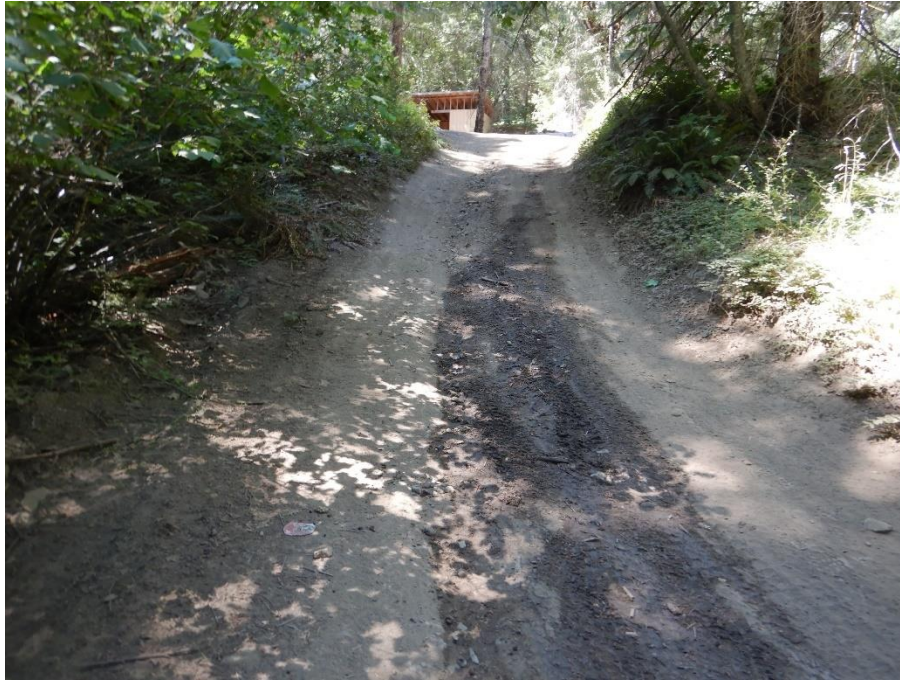
Photo 13—Looking south along a dirt road towards the shed pictured in Photo 11. The road is steep and lacks features, such as water bars or rolling dips, to direct stormwater off the road. The road's earthen surface is susceptible to erosion by stormwater.

1. Retain a licensed professional to inventory, assess, and develop a workplan and schedule to implement measures to ensure that all developed features, roads, watercourse crossings, and cultivation areas throughout the Property are corrected, restored, and/or maintained in conditions that prevent or minimize erosion, sediment transport/delivery, and adverse impacts to water quality and beneficial uses. Include measures to ensure that unstable features caused or affected by onsite development and operations are removed or otherwise protected so as to minimize the potential for these features to cause adverse impacts to water quality and beneficial uses. Dispose of all development and restoration-related earthen spoils in a manner to prevent/minimize transport and delivery to receiving waters.

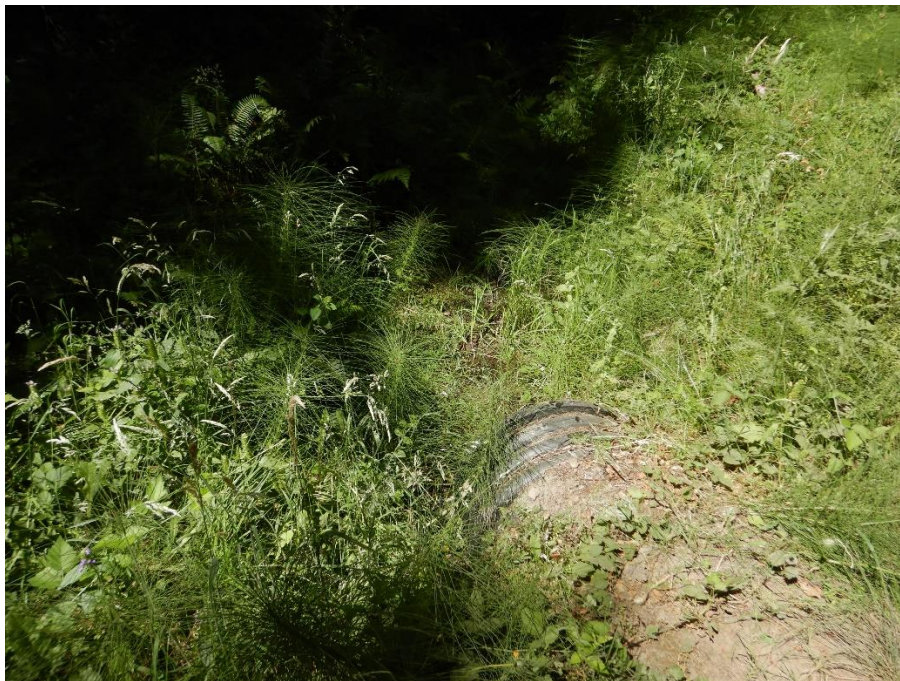
I followed the road north to a 24-inch diameter culvert (Photo 14) at the bottom of a steep, hydrologically-connected segment of road at WQ 7. I observed that the watercourse upstream was approximately 4 feet wide, and I ascertained that the culvert was likely too small to accommodate a 100-year stormflow. I continued down the road and observed another steep section of road hydrologically-connected to a watercourse at WQ 8 (Photo 15). I observed that the watercourse was culverted with a 24-inch diameter plastic pipe, partially buried in the road fill at WQ 8 (Photo 16 and Photo 17). I continued following the road to WQ 9 where I observed another watercourse culverted below the road (Photo 18 and Photo 19). I observed that the watercourse upstream was approximately four feet wide, the culvert was approximately 24 inches in diameter, and the culvert was buried shallowly in the road fill, and not aligned with the watercourse bed.

Culverts at WQ 7, WQ 8, WQ 9, WQ 10 and WQ 13 are not sized adequately to accommodate an anticipated 100-year storm event, are not aligned with the channel bed, and it is likely that if storm flows exceed culvert capacity, runoff will erode and transport earthen material making up the road prisms.

Photo 14— Looking upstream at a 24-inch diameter culvert at WQ 7. The watercourse upstream is approximately four feet wide.

2. Prior to conducting any instream work associated with recommendation 1, above, submit to the Regional Water Board an application for Clean Water Act section 401 water quality certification, and secure approval from the Regional Water Board.

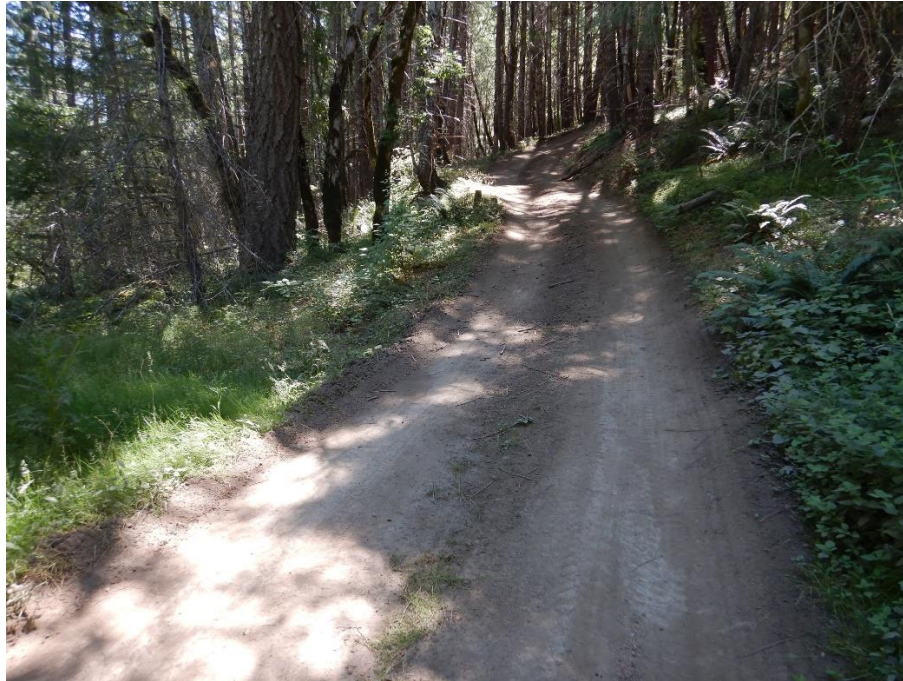
The road at WQ 1 is susceptible to erosion by stormwater. Between WQ 7 and WQ 10, as well as at WQ 13, the road is susceptible to erosion by stormwater and hydrologically-connected to receiving waters.

Photo 15— Looking east along a dirt road approaching the stream crossing at WQ 8 which is behind the photographer. The road is steep and lacks features, such as water bars or rolling dips, to direct stormwater off the road. The road's earthen surface is susceptible to erosion by stormwater.

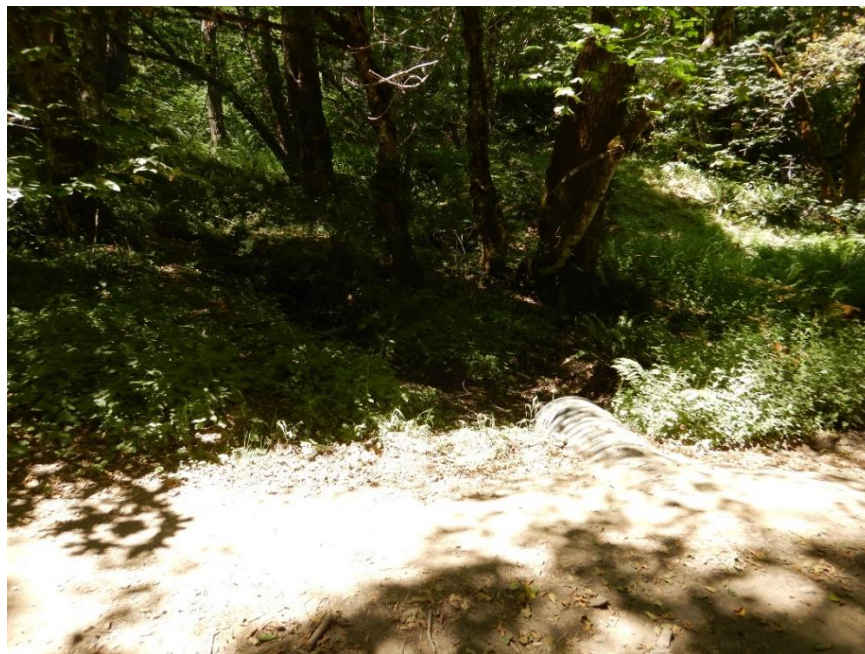
Photo 16— Looking upstream at a 24-inch diameter culvert at WQ 8. The watercourse upstream is approximately four feet wide. The culvert is only partially buried in the road fill prism.

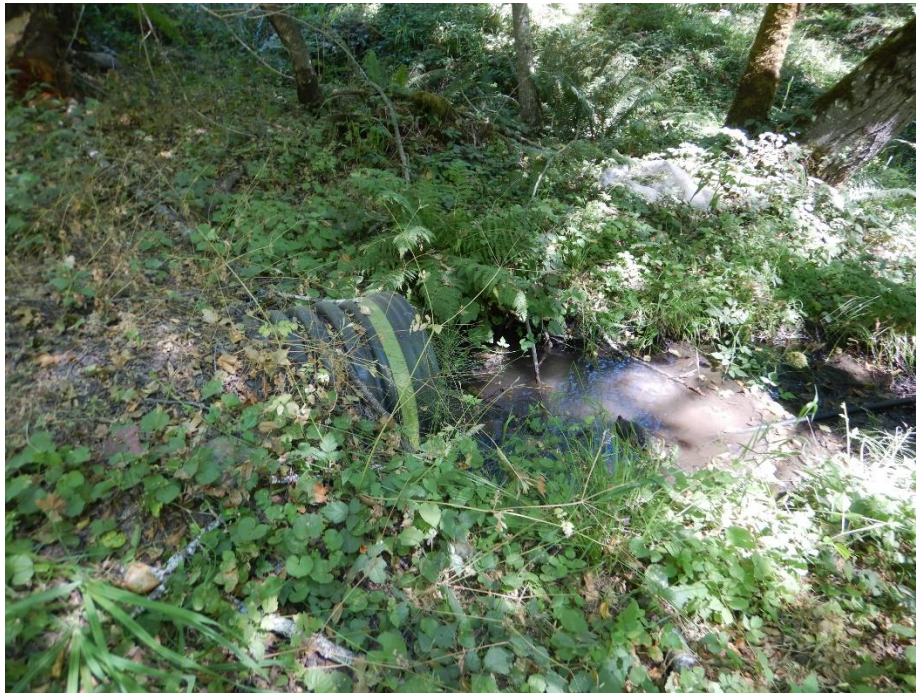
Photo 17— Looking at the outlet of the 24-inch diameter culvert at WQ 8.

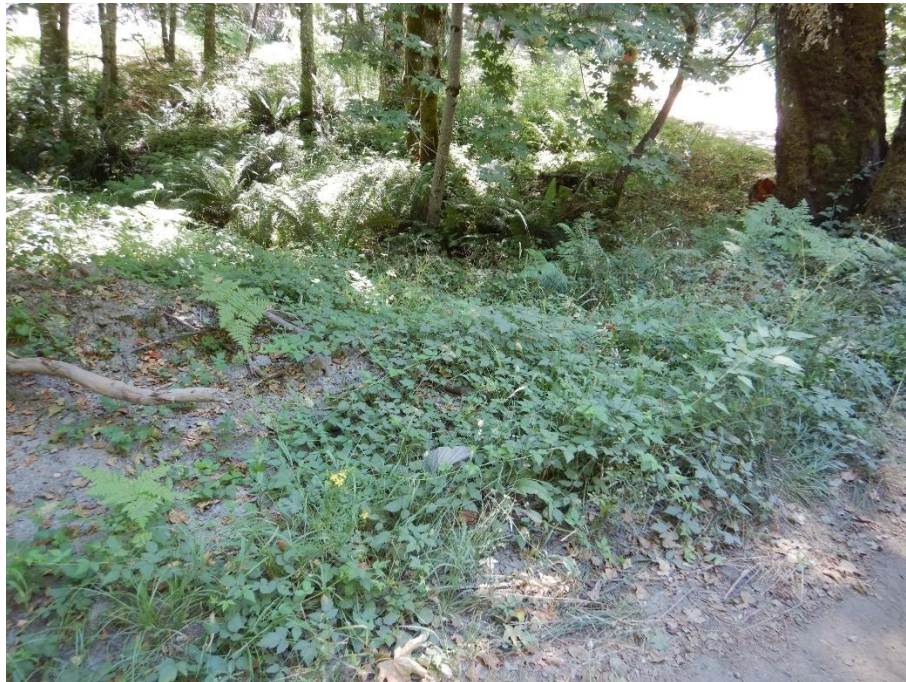
Photo 18—Looking upstream in the vicinity of the stream crossing at WQ 9.

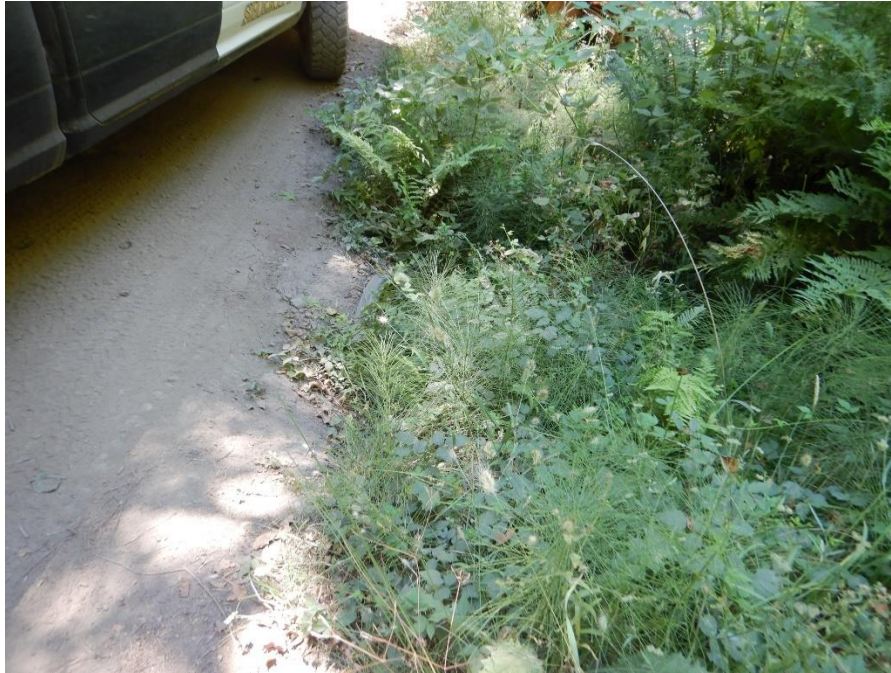
Photo 19—Looking at the outlet of the 24-inch culvert located at WQ 9.

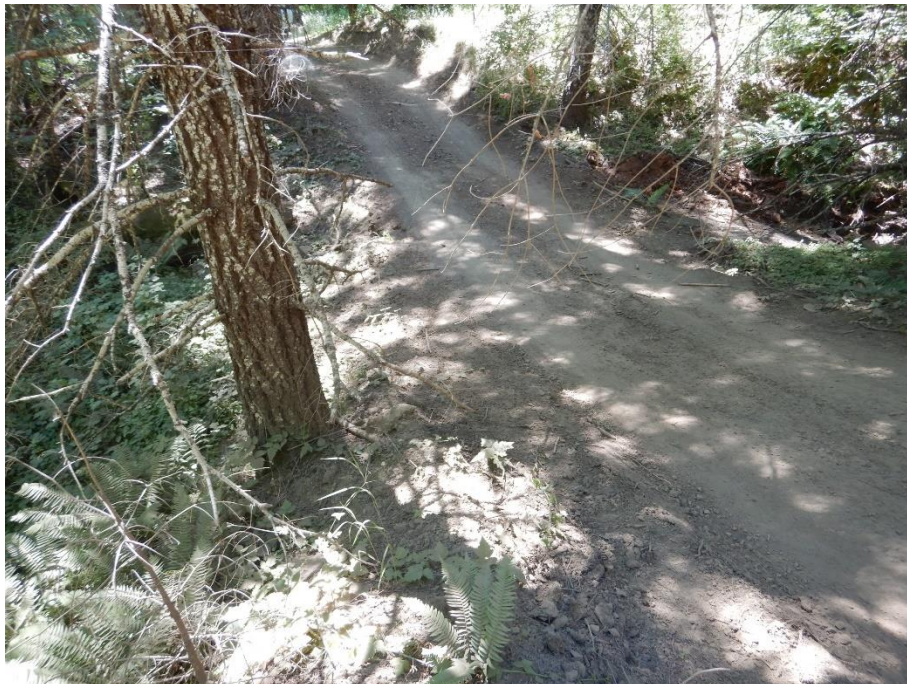
From WQ 9, I continued north along the road and observed another watercourse crossing at WQ 10. I observed that the road approaching the watercourse had an earthen surface that was susceptible to erosion and the road elevation was lowest above the culvert, so if the culvert failed to convey the full discharge of the watercourse, the stream overflow would pass over and scour the road fill prism (Photo 20). I observed that the culvert at WQ 10 was only partially buried in the road fill prism (Photo 21) and I observed the watercourse upstream from the road had aggraded with sediment which had been recently excavated (Photo 22).

Photo 20—Looking at the road crossing a watercourse at WQ 10. The road does not have any road aggregate to prevent erosion and the road shape does not provide a path for stream overflow outside from the road fill.

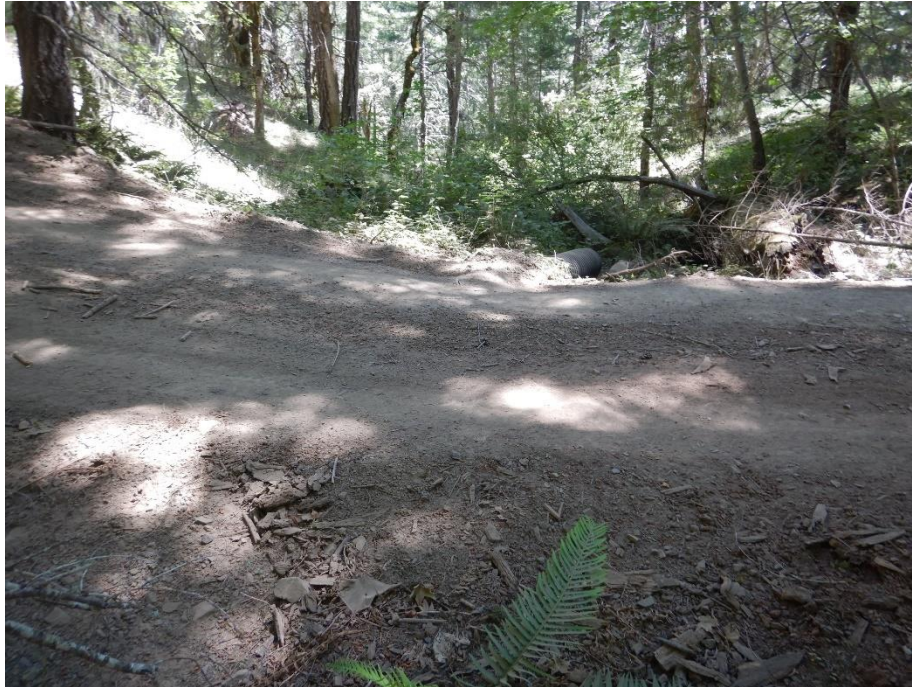
Photo 21—Looking downstream at WQ 10. The culvert is only partially buried in the road fill prism.

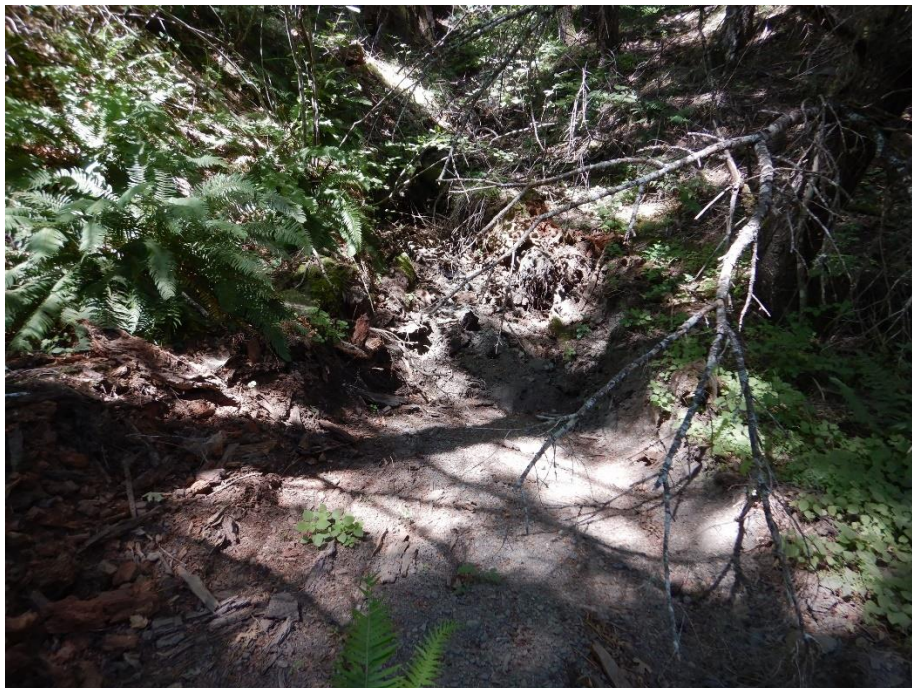
Photo 22—Looking upstream in the expected location of the culvert inlet at WQ 10. The area appeared to have been recently excavated. The culvert inlet is not visible.

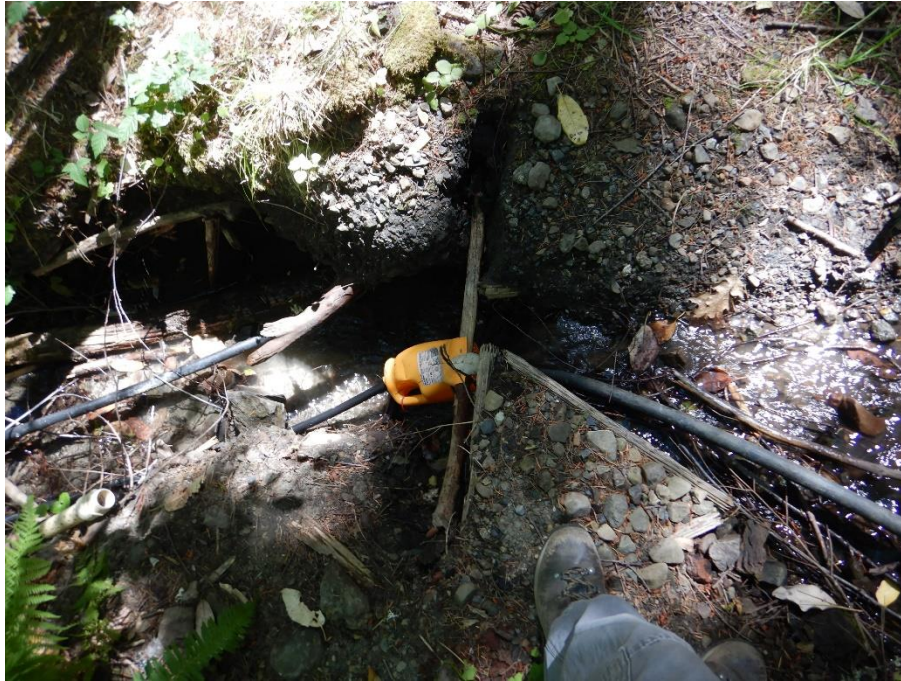
Photo 23—Stream diversion fabricated using a juice bottle at WQ 11.

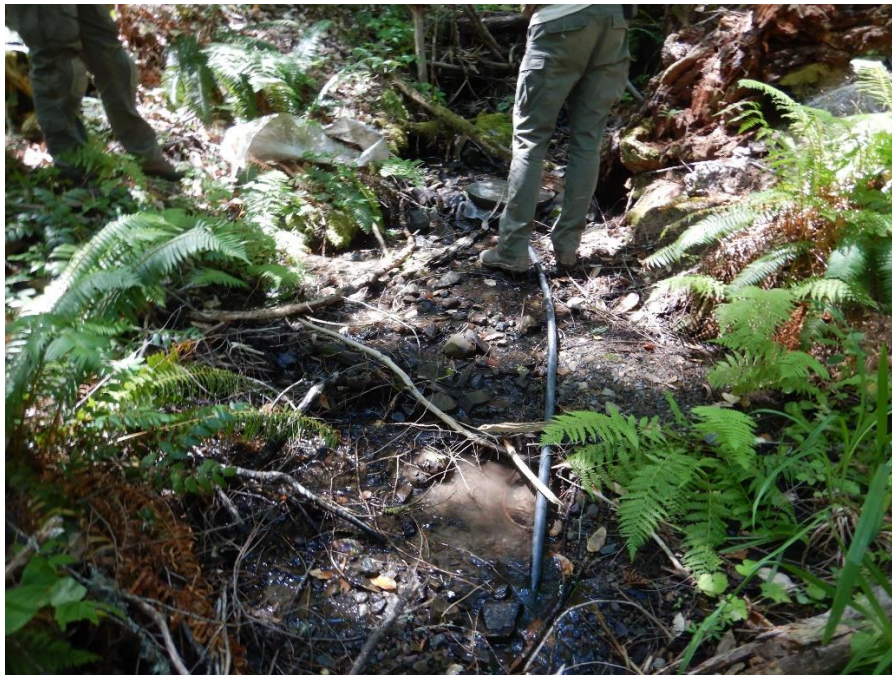
Photo 24—Additional stream diversion at WQ 11 located a short distance upstream from the diversion pictured in the previous photo.

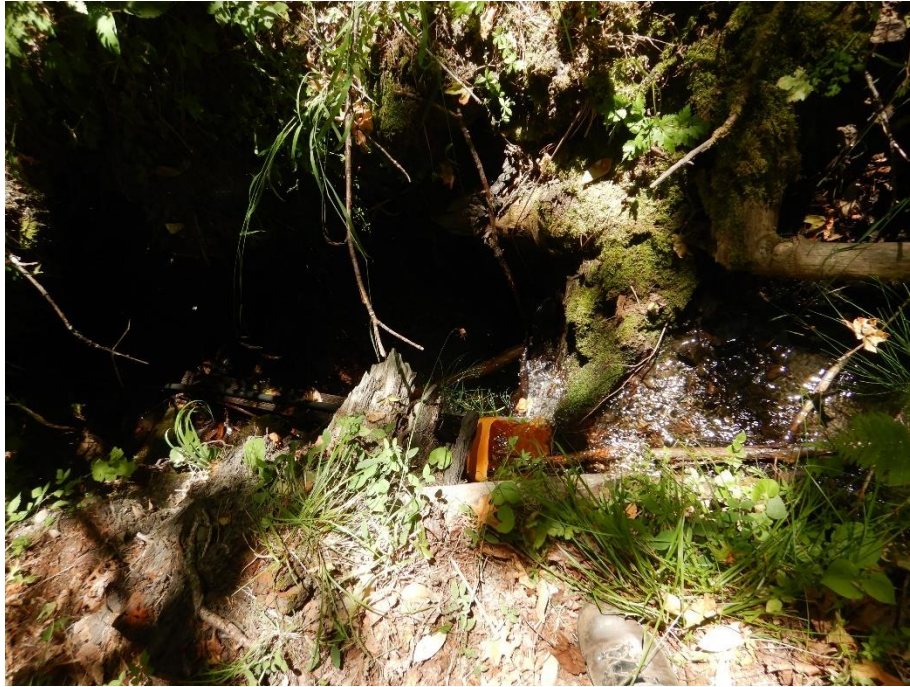
Photo 25— Stream diversion fabricated using a juice bottle at WQ 12.

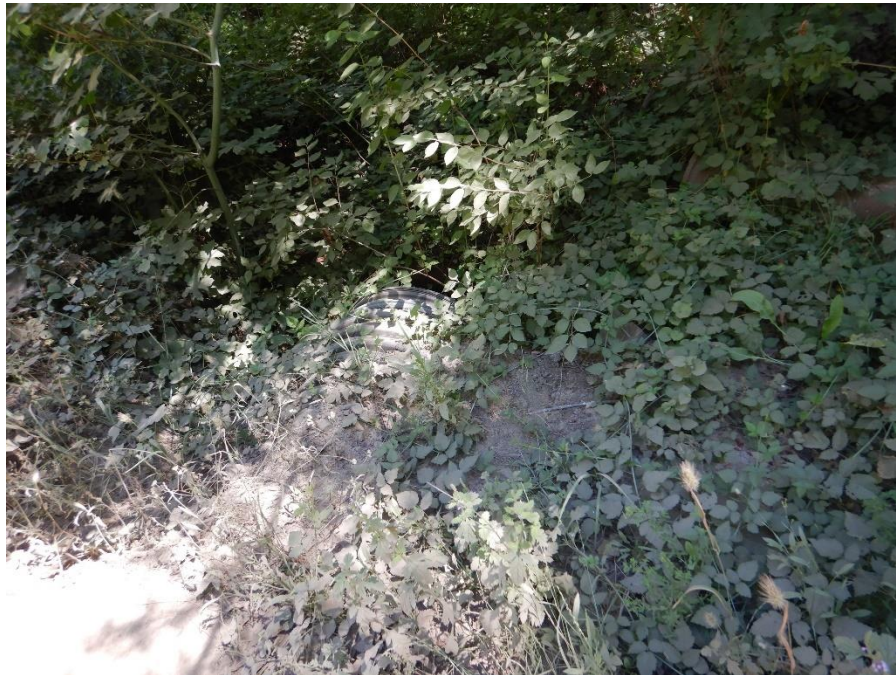
another watercourse, approximately 3 feet wide, culverted across the road through a 24 inch diameter, shallowly buried, plastic pipe (Photo 26).

Photo 26— Looking upstream at a 24-inch diameter culvert at WQ 13. The watercourse upstream is approximately three feet wide.

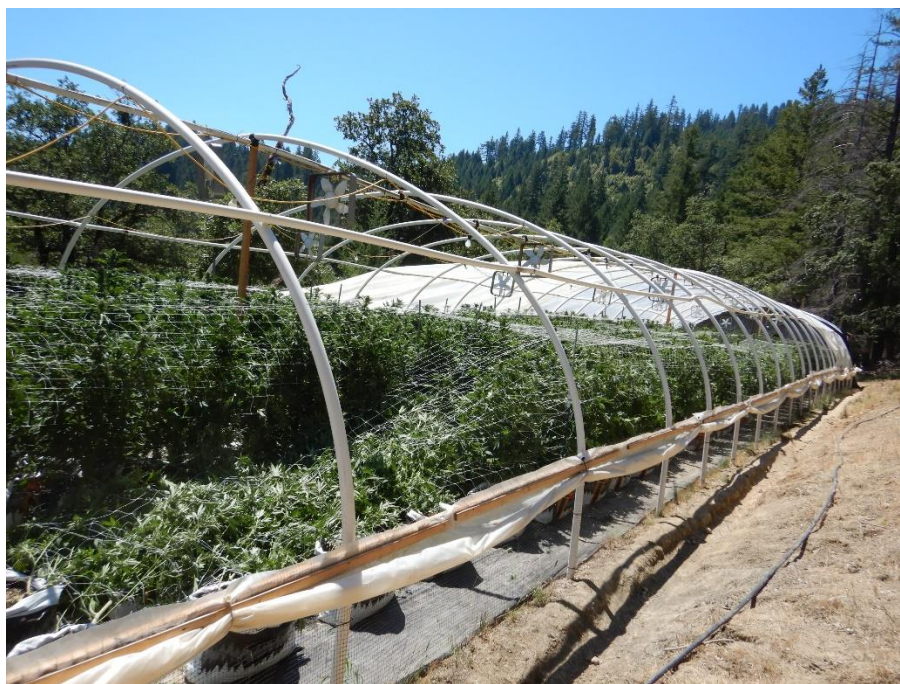
Photo 27— Approximately 6,000 square foot cannabis cultivation area at WQ 14.

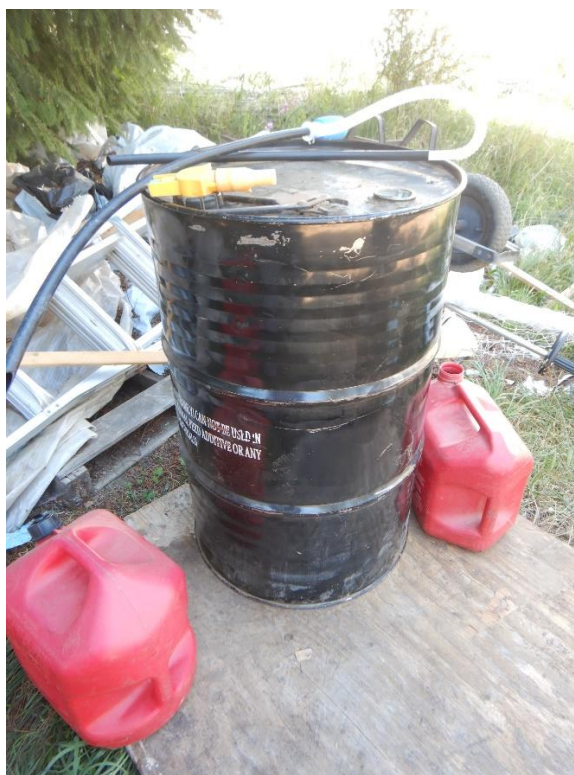
Photo 28—55-gallon drum with unknown contents and uncontained fuel canisters at WQ 14.

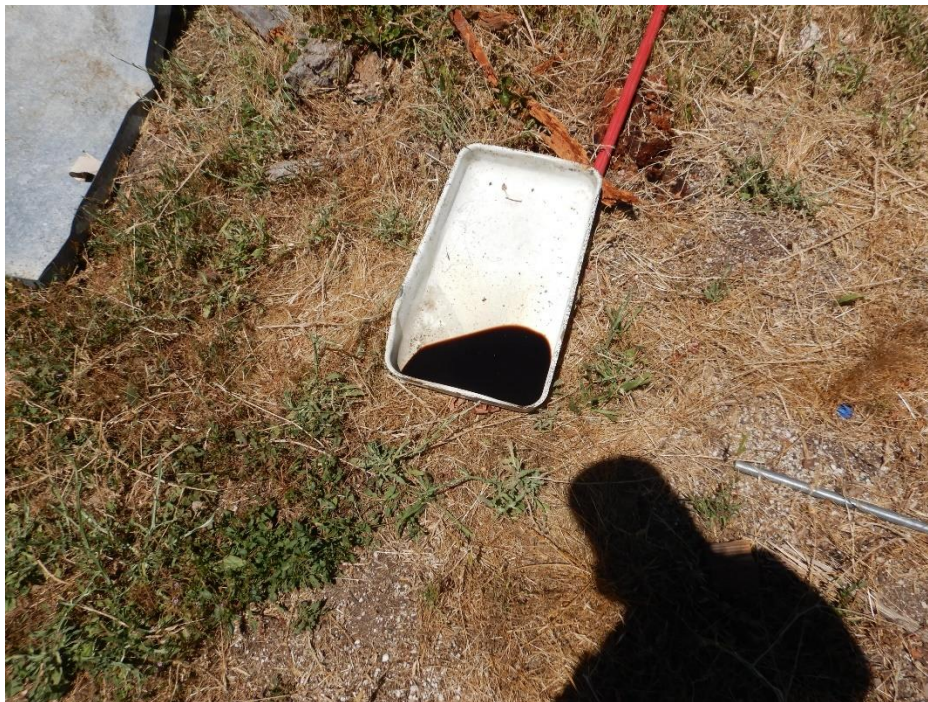
Photo 29—Dark, viscous liquid in a paint tray on bare ground at WQ 14
