North Coast Regional Water Quality Control Board

Subject: Notice of Violation, Directive to Obtain Regulatory Coverage for Cannabis Cultivation, and Transmittal of Inspection Report for June 27, 2019 and July 20, 2020 Inspections of Humboldt County Assessor's Parcel Nos. 210-191-035-000 and 210-191-036-000

**June 27, 2019 and July 20, 2020 Warrant Inspections
Humboldt County Assessor's Parcel Numbers (APNs) 210-191-035-000 and
210-191-036-000**

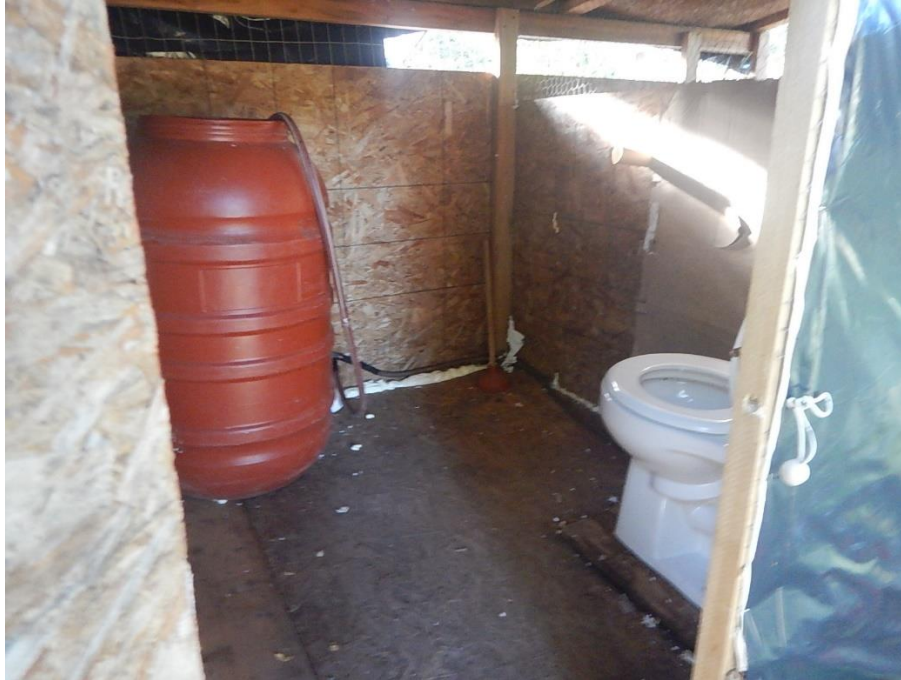
Staff observed uncontained refuse and human waste discharged to ground without a permitted septic system at WQ 1.

Photo 1—Taken June 27, 2019, flush toilet located at WQ 1.

1. Discontinue use of and dismantle any outhouse or pit-toilet features and work with Humboldt County to ensure that all domestic and human wastes are collected and disposed of consistent with applicable County requirements.

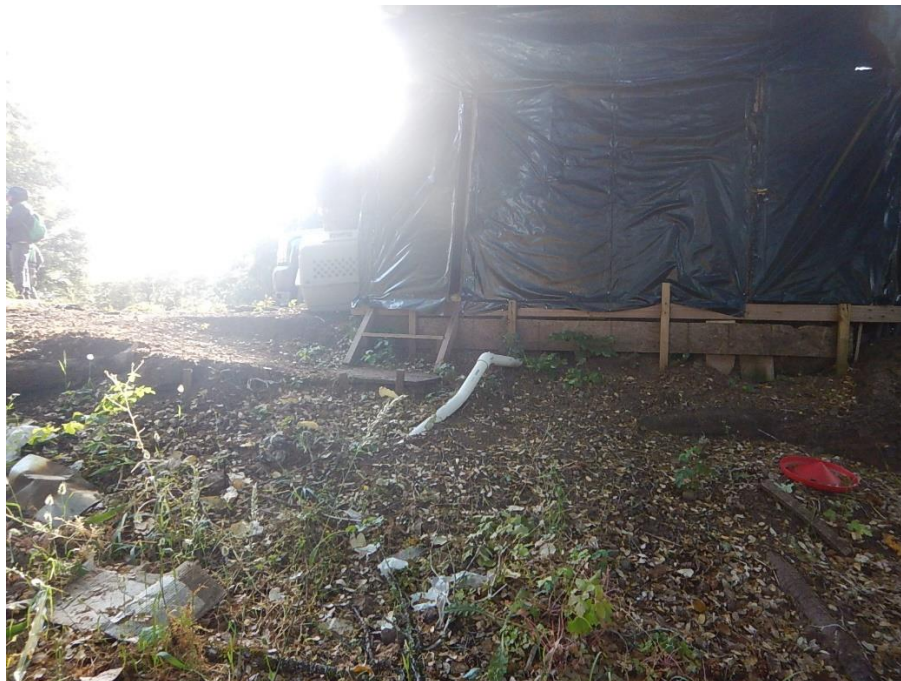
Photo 2—Taken June 27, 2019, plastic pipe leaving shed containing flush toilet and discharging to ground at WQ 1.

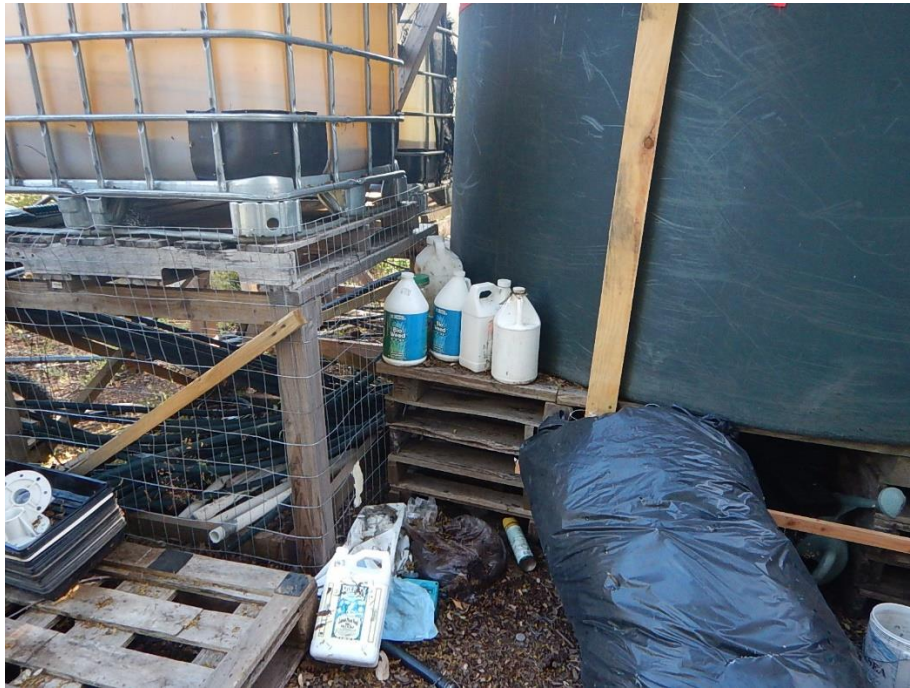
Staff observed fertilizers and soil amendments uncontained at WQ 2 and WQ 3.

Photo 3—Taken June 27, 2019, uncontained fertilizers and liquid soil amendments in the vicinity of WQ 2.

3. Store and contain all chemicals, including petroleum, and fertilizer properly to prevent spillage and discharge to receiving waters. Provide secondary containment for all petroleum products.

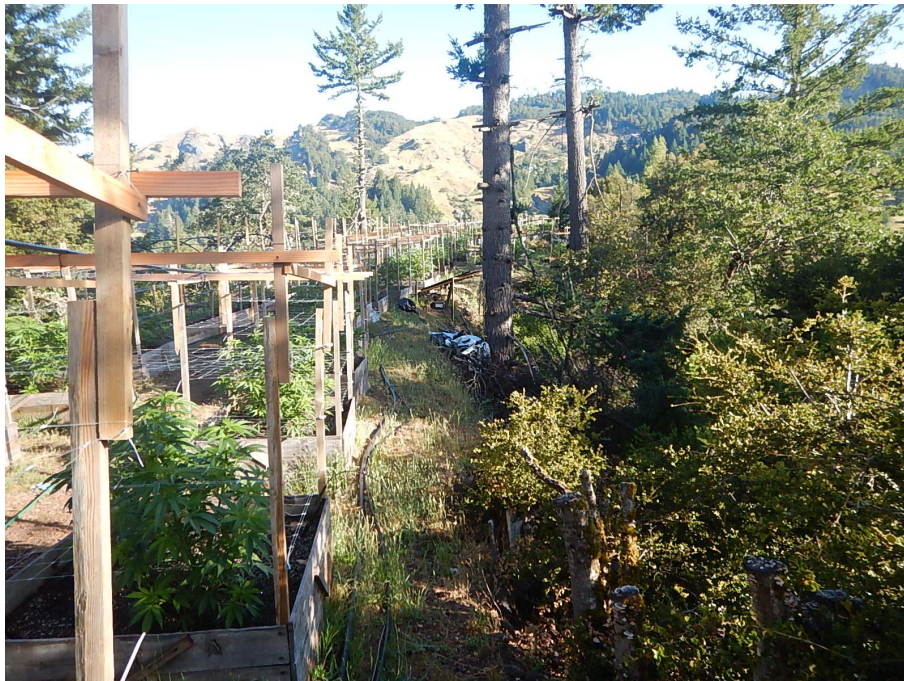
Photo 4—Taken June 27, 2019, cannabis plants growing outdoors in raised beds in the vicinity of WQ 2.

5. If the property owner and/or tenant(s) choose to continue to cultivate cannabis, enroll for coverage under and take steps to comply with the requirements of the Statewide General Order (Order WQ 2019-0001-DWQ, General Waste Discharge Requirements and Waiver of Waste Discharge Requirements for Discharges of Waste Associated with Cannabis Cultivation Activities). More information about the

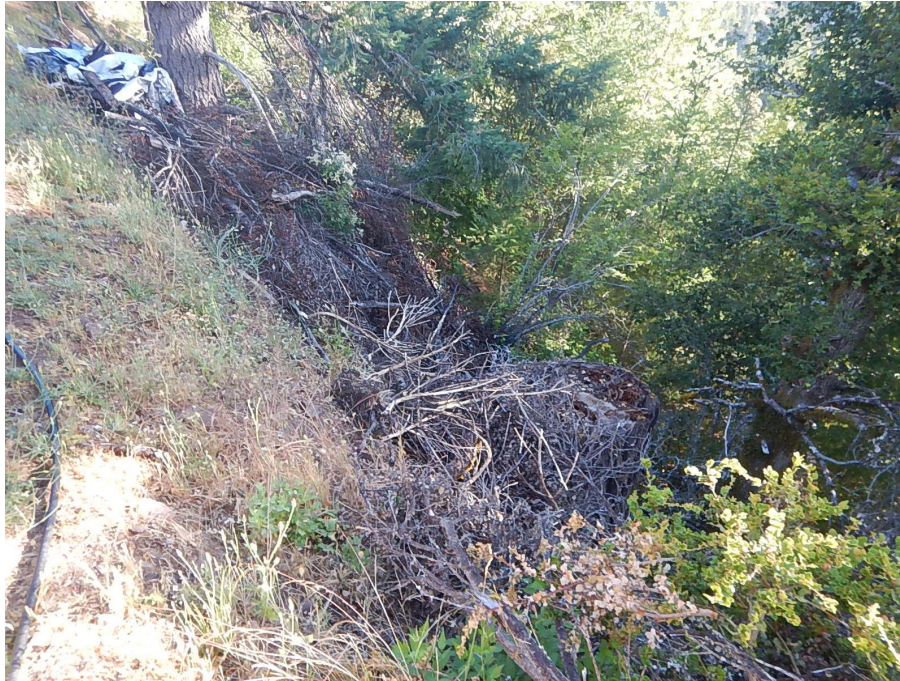
Staff observed cultivation waste at location(s) and in condition(s) that pose a threat to water quality at WQ 2 and WQ 3.

Photo 5—Taken June 27, 2019, plant stalks and other cannabis cultivation waste on the edge of cultivation area located in the vicinity of WQ 2.

2. Collect and dispose of or contain all refuse and cultivation-related wastes in a location and manner so as to minimize potential for these wastes to enter or be transported into receiving waters.

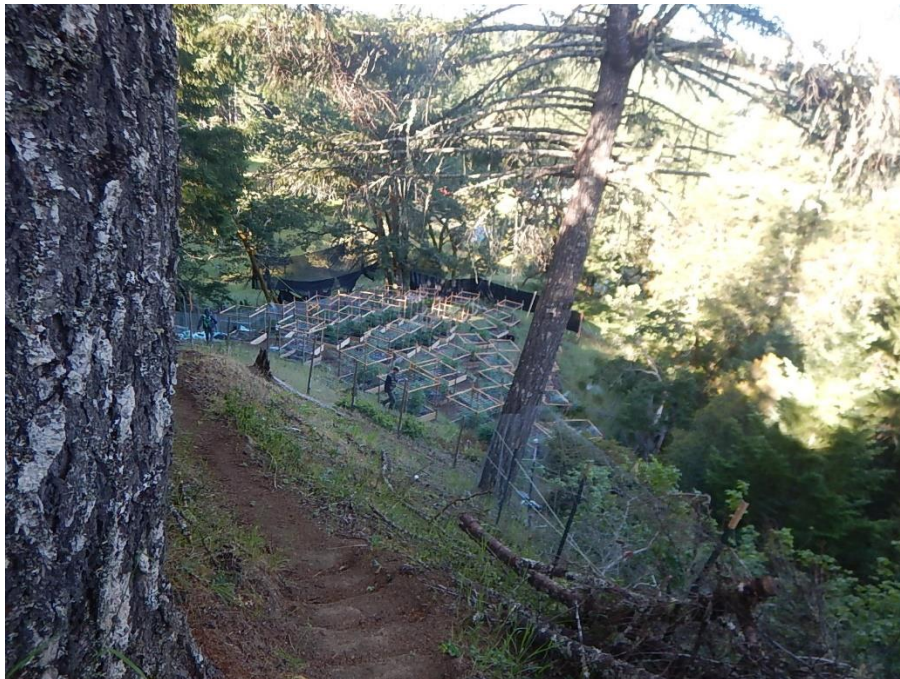
Photo 6—Taken June 27, 2019, Cannabis plants growing in raised beds in the vicinity of WQ 3.

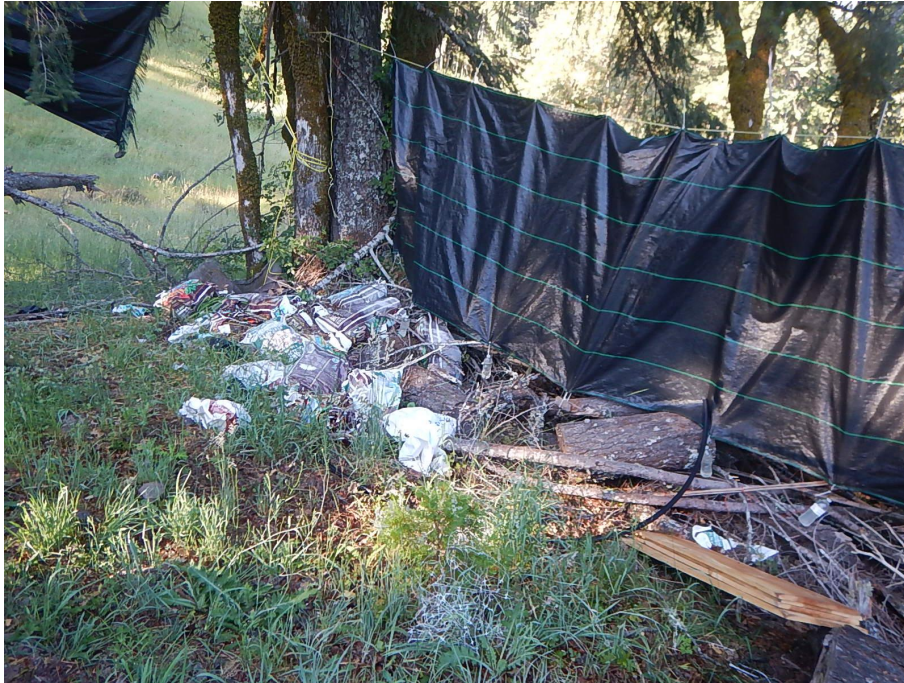
Photo 7—Taken June 27, 2019, uncontained cannabis cultivation waste including soil bags and plastic netting in the vicinity of WQ 3.

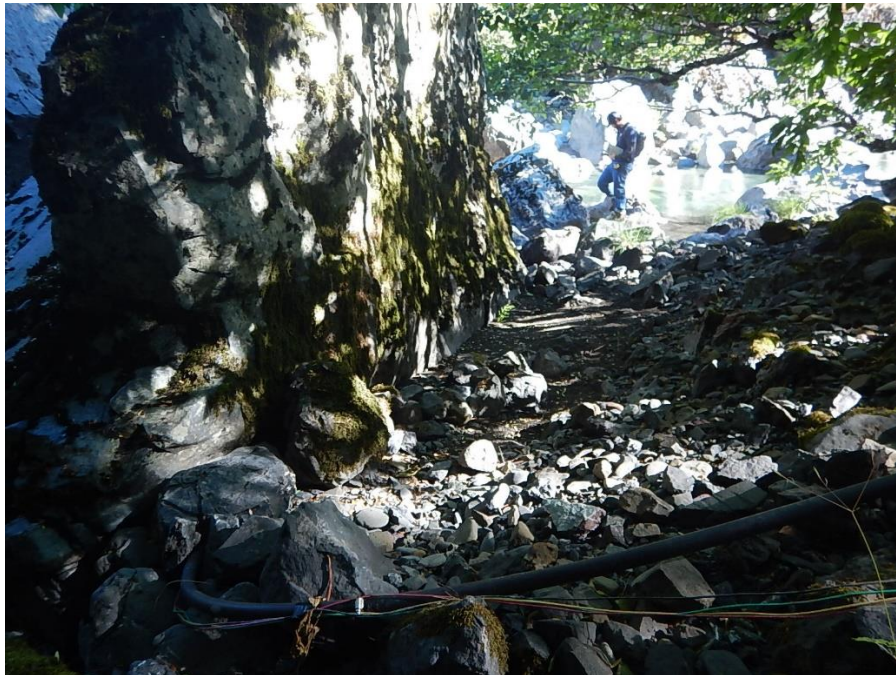
Water diverted from the Van Duzen river was being stored in an above ground pool at WQ 4.

Photo 8—Taken June 27, 2019, shows water line leading from the Van Duzen to water storage located at WQ 4 pictured in Photo 9 below.

4. Comply with requirements/directives from CDFW and the Division of Water Rights with respect to appropriate permitting/licensing for water source(s), diversion(s), storage, and use, and ensure that water storage features are modified/maintained so as to minimize the potential for adverse impacts to water quality and beneficial uses.

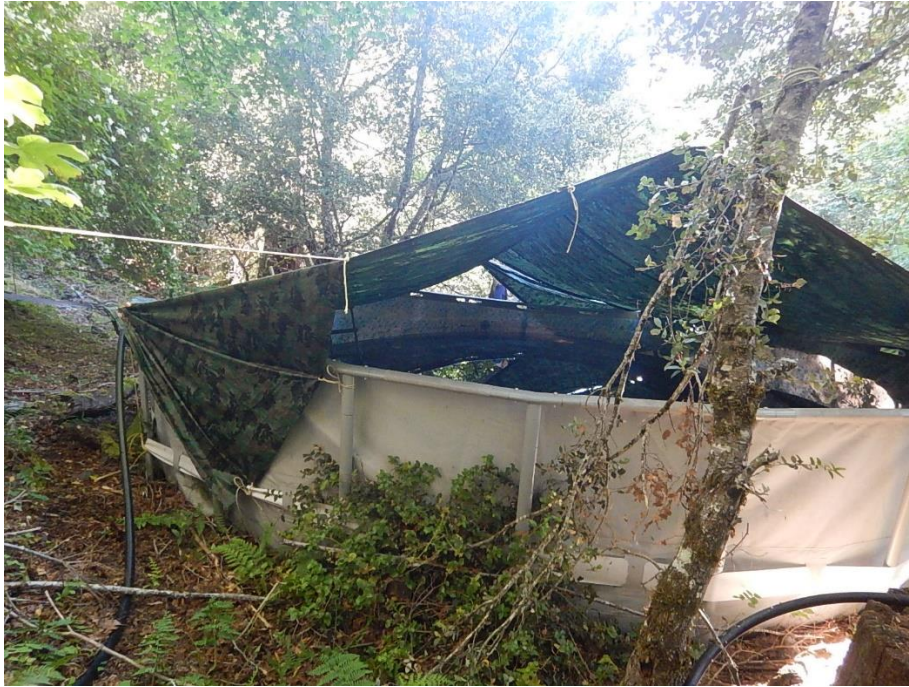
Photo 9—Taken June 27, 2019, water storage in above ground pool at WQ 4.

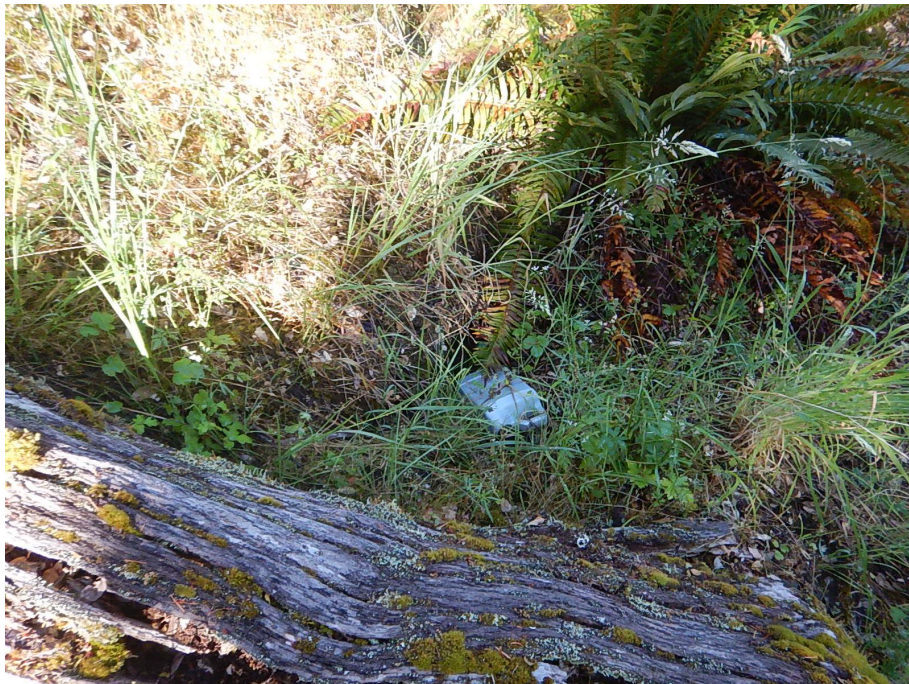
Photo 10—Taken June 27, 2019, waste motor oil container uncontained on bare ground in the vicinity of WQ 4.

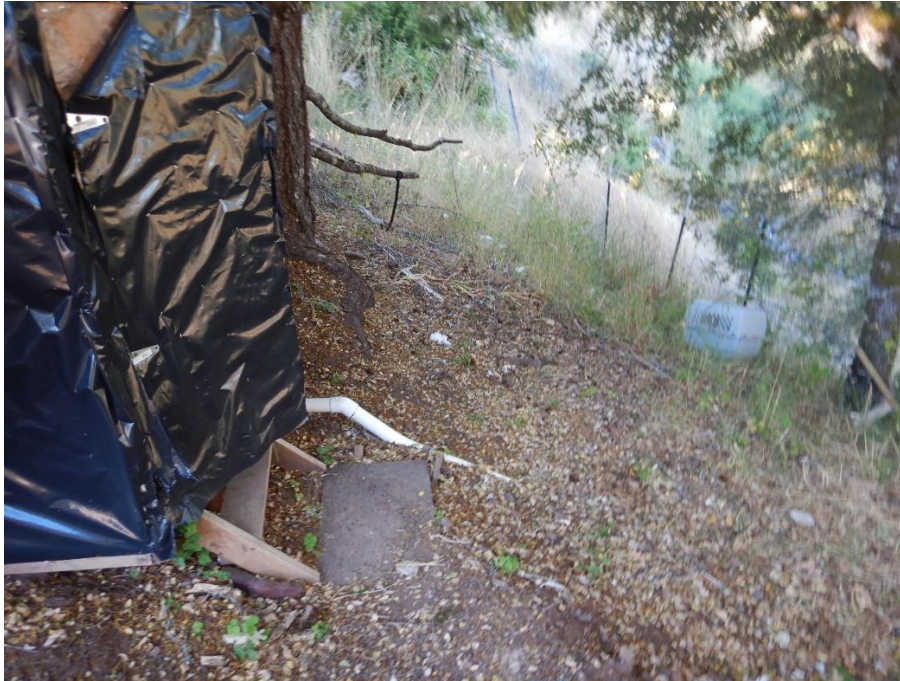
Photo 11—Taken July 20, 2020, plastic pipe leaving shed containing flush toilet and discharging to ground at WQ 1.

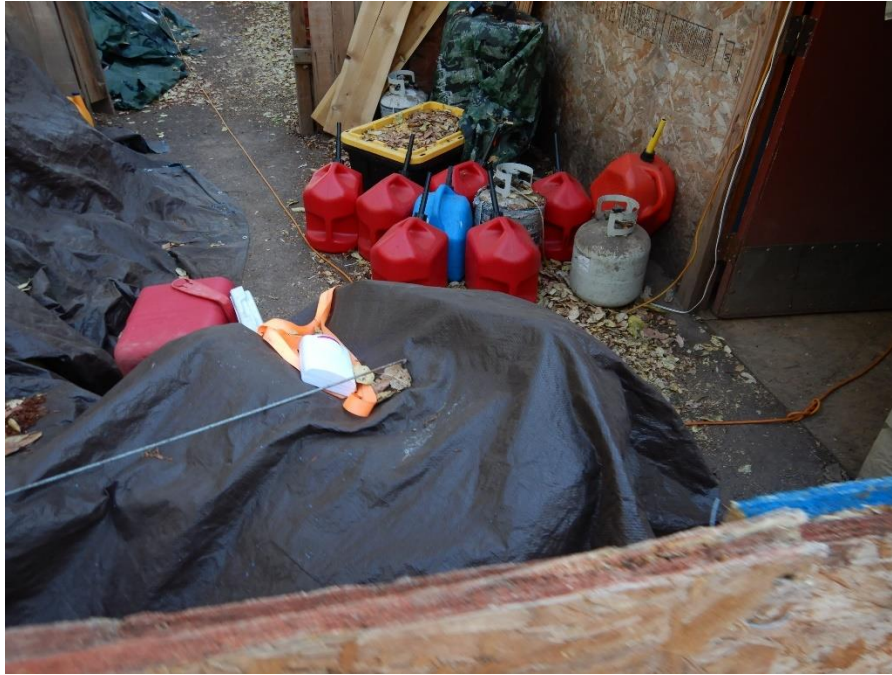
Staff observed fuel cans, uncontained, on the bare ground at WQ 1.

Photo 13—Taken July 20, 2020, uncontained fuel containers behind shed at WQ 1.

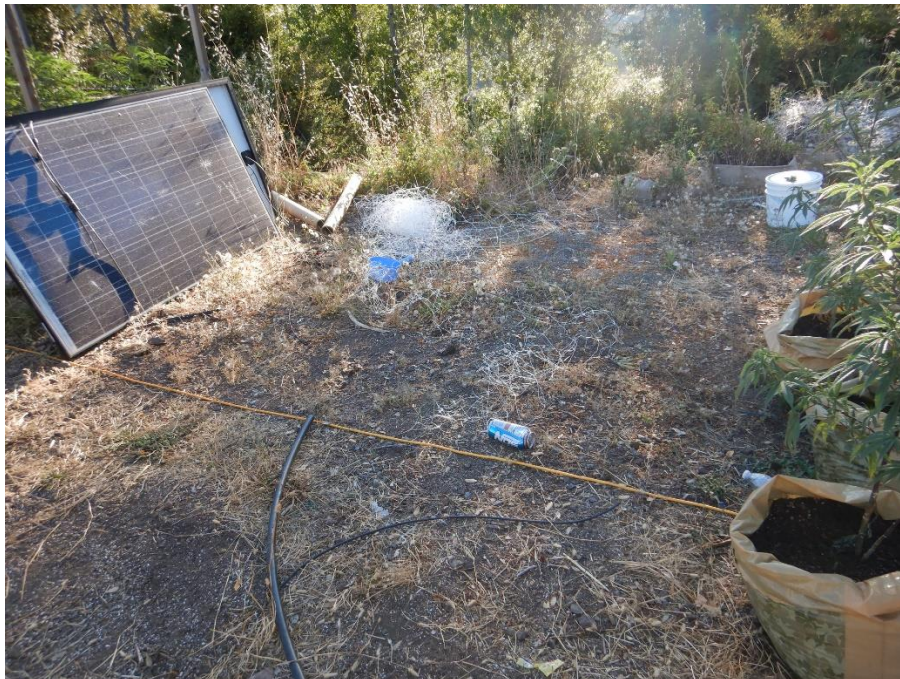
Photo 14—Taken July 20, 2020, uncontained cannabis cultivation waste including plastic netting in the vicinity of WQ 2.

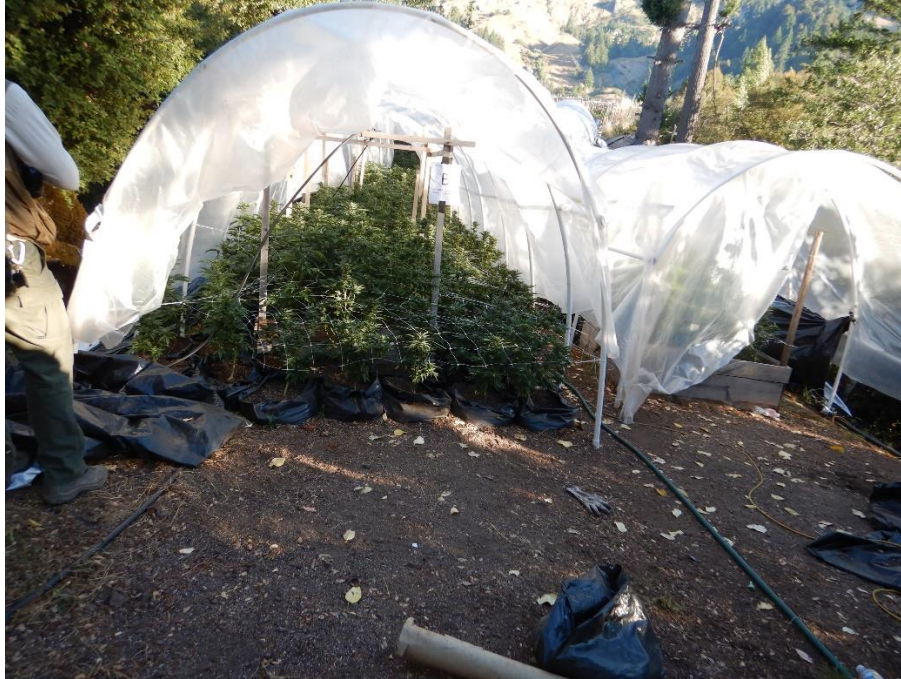
Photo 15—Taken July 20, 2020, cannabis cultivation in the vicinity of WQ 2.

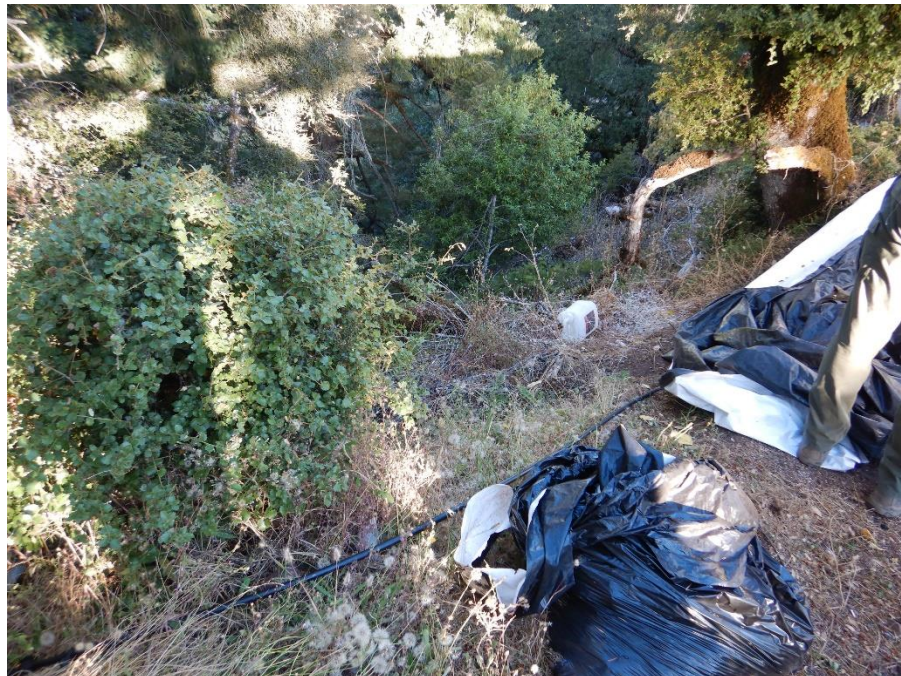
Photo 16—Taken July 20, 2020, uncontained cannabis cultivation waste including liquid nutrient container and plastic netting in the vicinity of WQ 2.

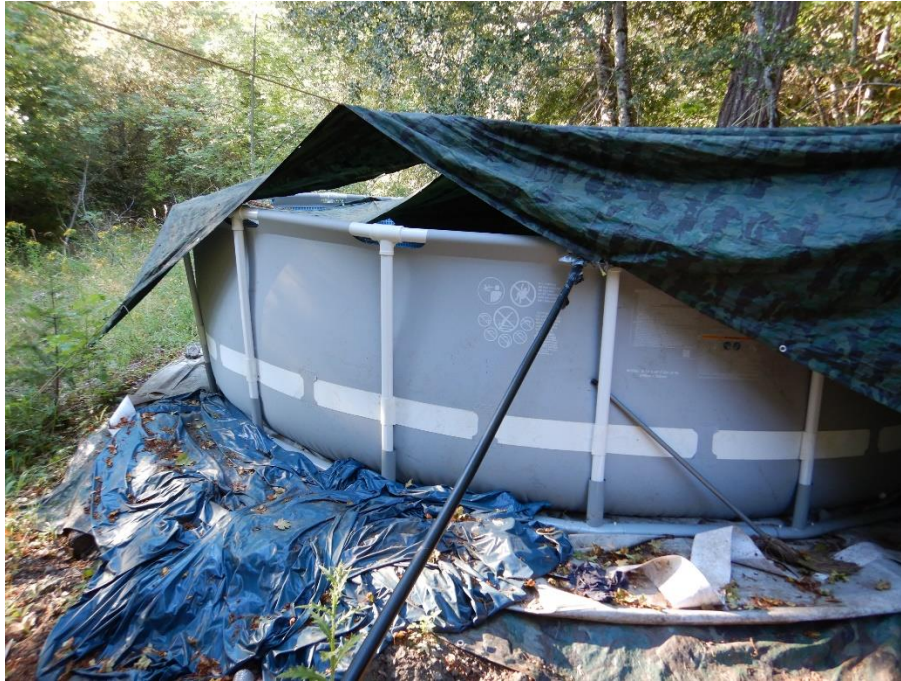
Photo 17—Taken July 20, 2020, water storage in above ground pool at WQ 4.

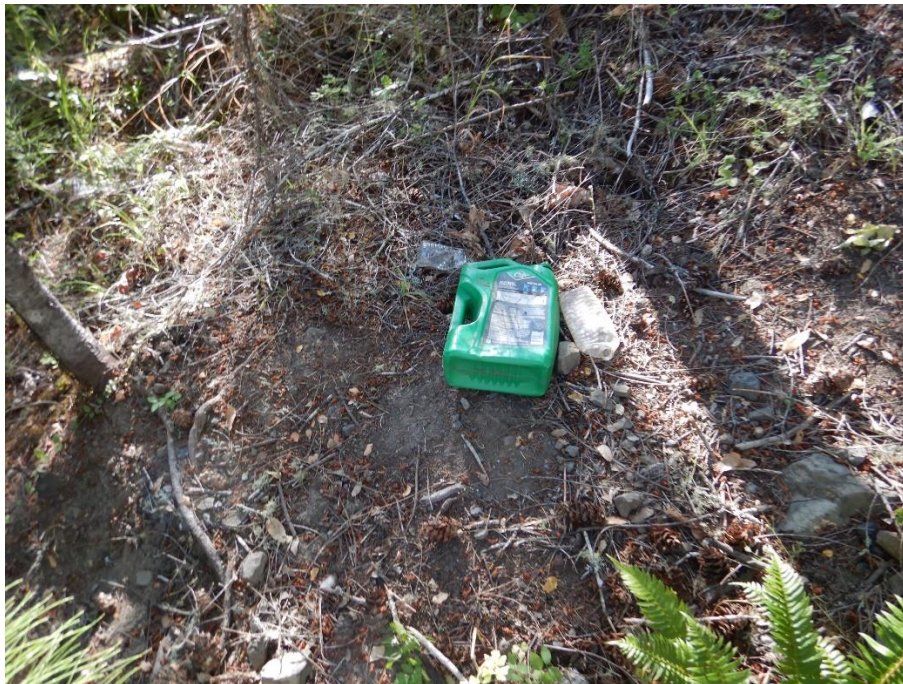
Photo 18—Taken July 20, 2020, waste motor oil container, uncontained, on bare ground in the vicinity of WQ 4.

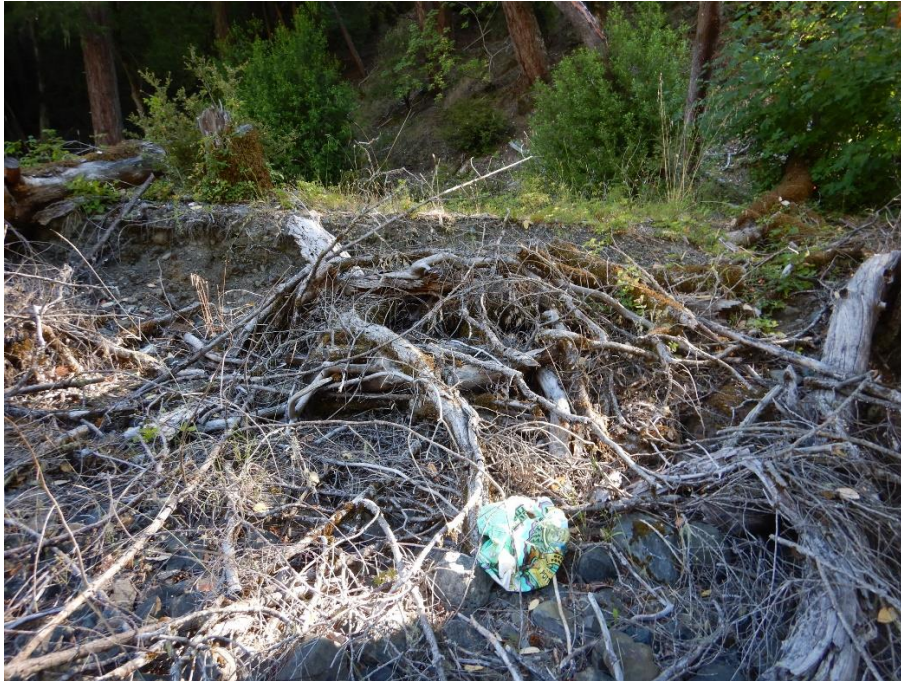
Waste from historical cannabis cultivation in the vicinity of WQ 5 threatens to discharge to the Van Duzen River during a large flow event.

Photo 19—Taken July 20, 2020, cannabis cultivation waste at WQ 5 within 100 feet of the Van Duzen river.

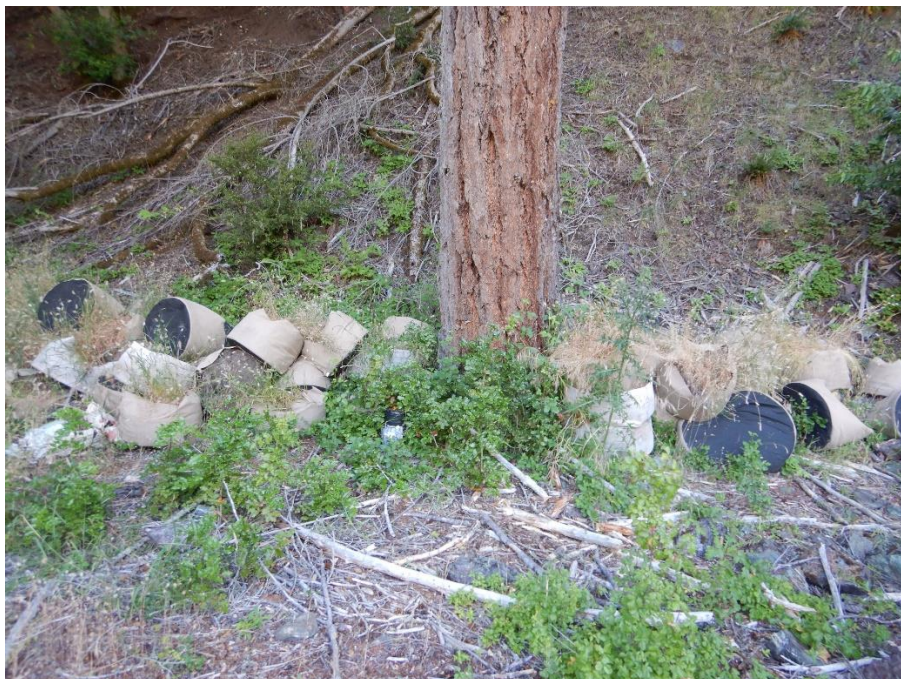
Other than waste potting soils left at WQ 5, staff did not observe water quality issues associated with spoils management.

Photo 20—Taken July 20, 2020, cannabis cultivation waste including soil-filled felt planting pots and a capped five-gallon bucket with unknown contents in the vicinity of WQ 5.
