Inspection Memorandum

Subject: Inspection Report 1-21EX-00634-SON, CalRecycle Utility Right of Way Exemption

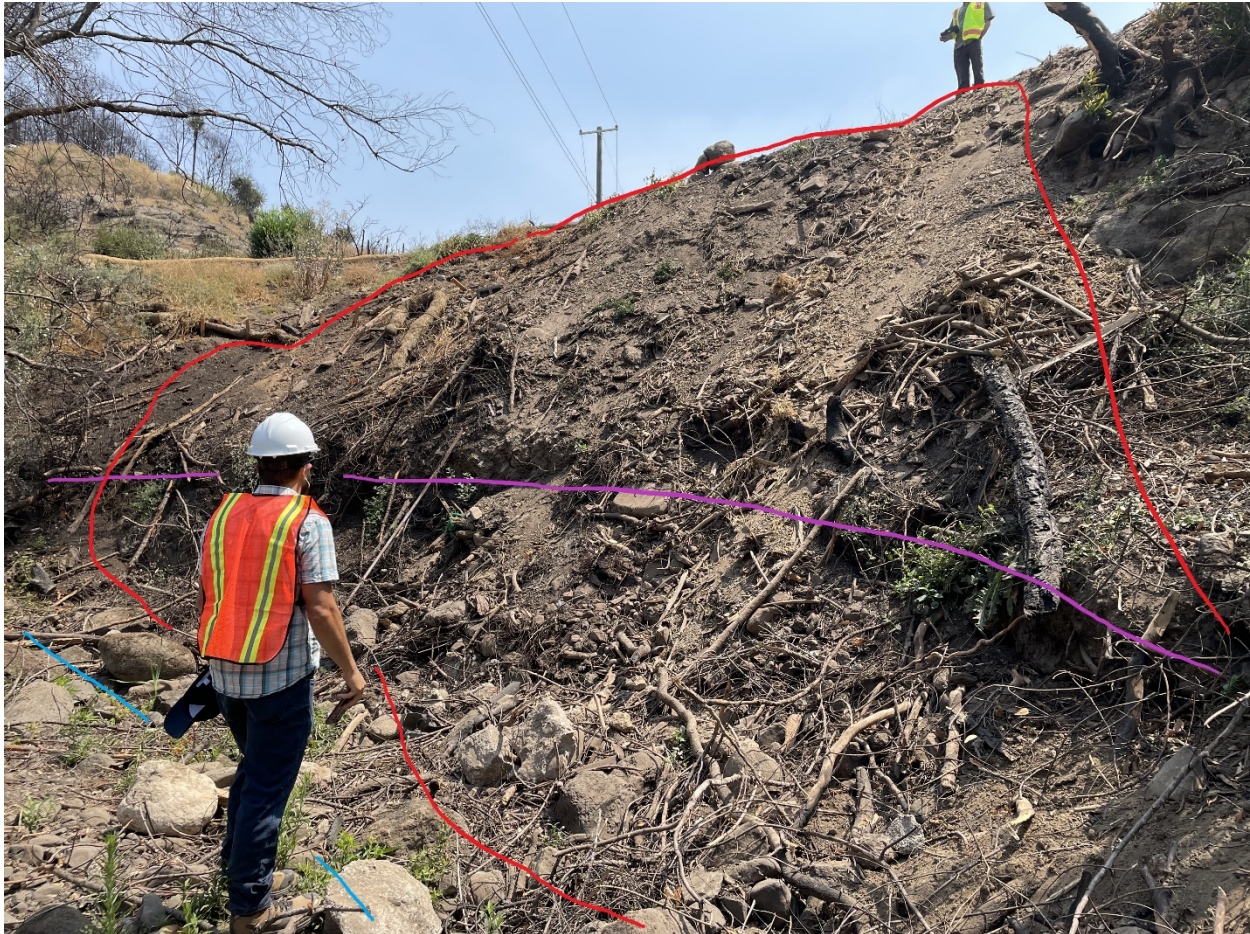
As reported, approximately 3 cubic yards of mixed timber slash, soil, and rocks were pushed over the edge of the embankment towards the unnamed tributary to Mark West Creek. The majority of the material seemed to be still perched on the steep slope above the bankfull channel. Approximately 1 cubic yard of material had made it down to the bankfull channel bed, though no material was observed in the currently active, flowing channel. The area of the channel bed the material was deposited on appeared to be an overflow channel of the main channel during higher flows and there were a few areas of standing water and wet bed material in the vicinity of the discharge, though the area directly under the discharge appeared to be dry at the time of our inspection. Subsurface flow is likely occurring beneath the discharged material.

Figure 1. View of discharge from within channel of unnamed tributary. Red line: approximate extent of discharge. Purple line: approximate bankfull. Blue line: Approximate path of side channel during higher flows.

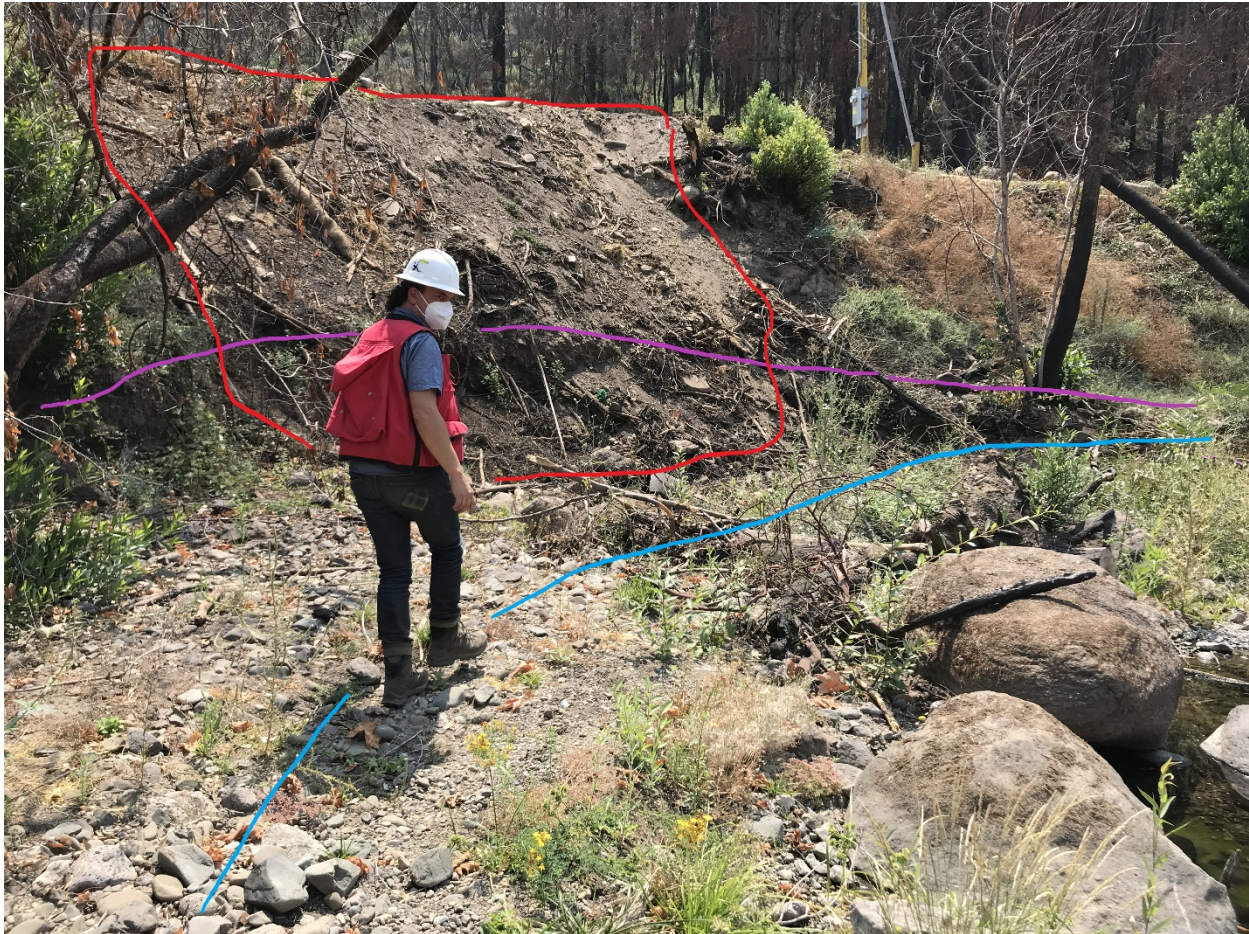
Figure 2. View of discharge from within channel of unnamed tributary. Red line: approximate extent of discharge. Purple line: approximate bankfull. Blue line: Approximate path of side channel during higher flows.

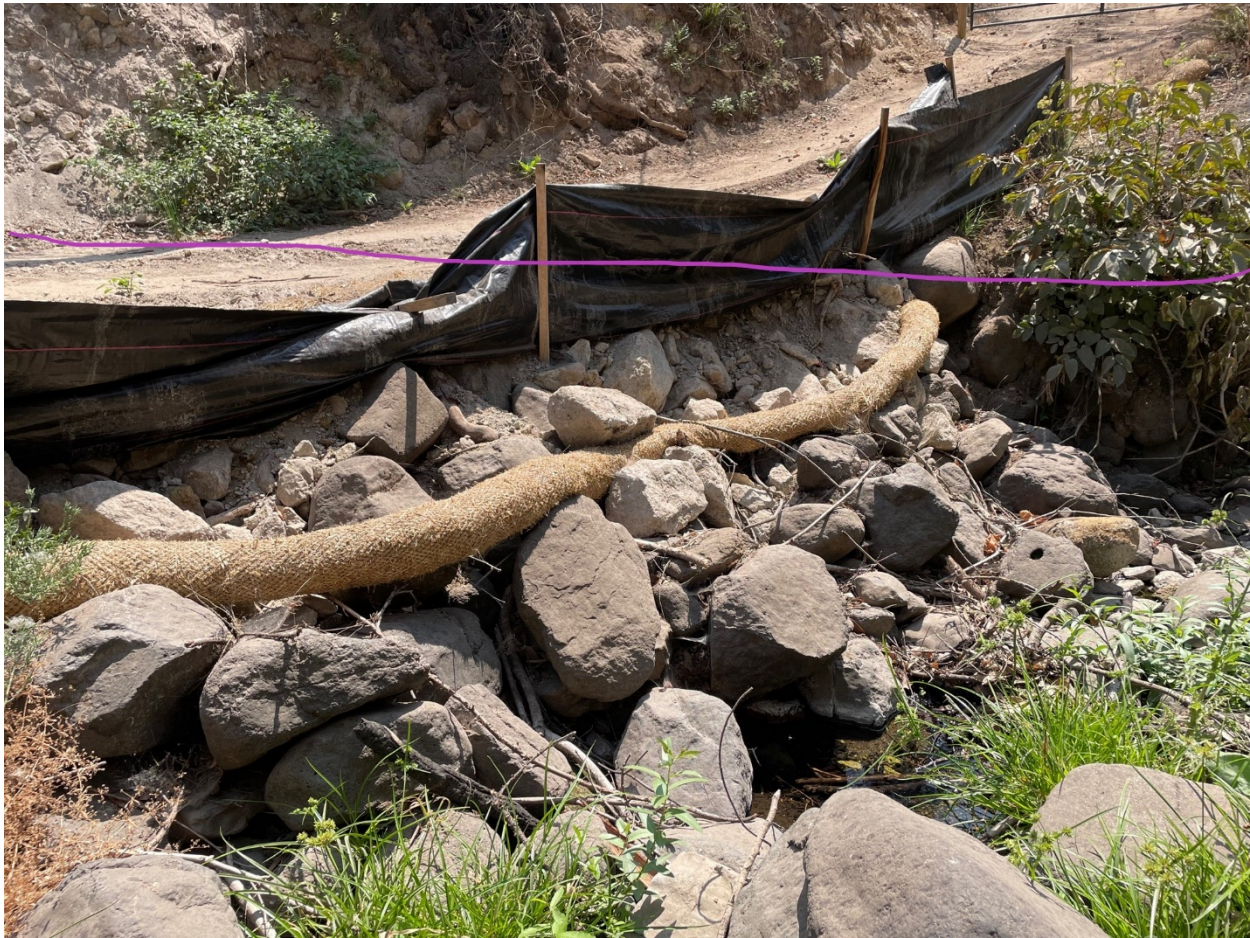
The crossing itself consists of steel plates, underlain by plastic sheeting to prevent soil falling through into the watercourse, laid across several logs spanning the watercourse. The road crossed the channel at an angle here and roughly one to two cubic yards of fill material, consisting of large cobbles to fine soil were placed in the channel in order to align the road. The fill material was removed from the bank above the road on the east side of the crossing. Biologist Rebecca Spranger with MBI showed us pre-construction photos of the site that showed a fallen tree with its root ball at the site the filled material was taken from. The contractor on site stated that in removing the tree, the bank material came down on its own and material was not intentionally removed.

Figure 3. View of east side of crossing taken from the west side of crossing. Purple line shows approximate location of bankfull depth of channel.

Although the debris cleanup work beyond the bridge had already been completed, the CalRecycle and CalOES representatives were conducting a separate and additional incident report for the site because of the contractor's activities. Removal and stabilization of the watercourse crossing site must occur at the site in advance of the upcoming rainy period. CalRecycle and CalOES representatives informed Regional Water Board staff that the current contract to conduct work in the vicinity is scheduled to expire at the end of September 2021, so the authorization to remove the bridge and associated fill activities necessitate expedited permitting.

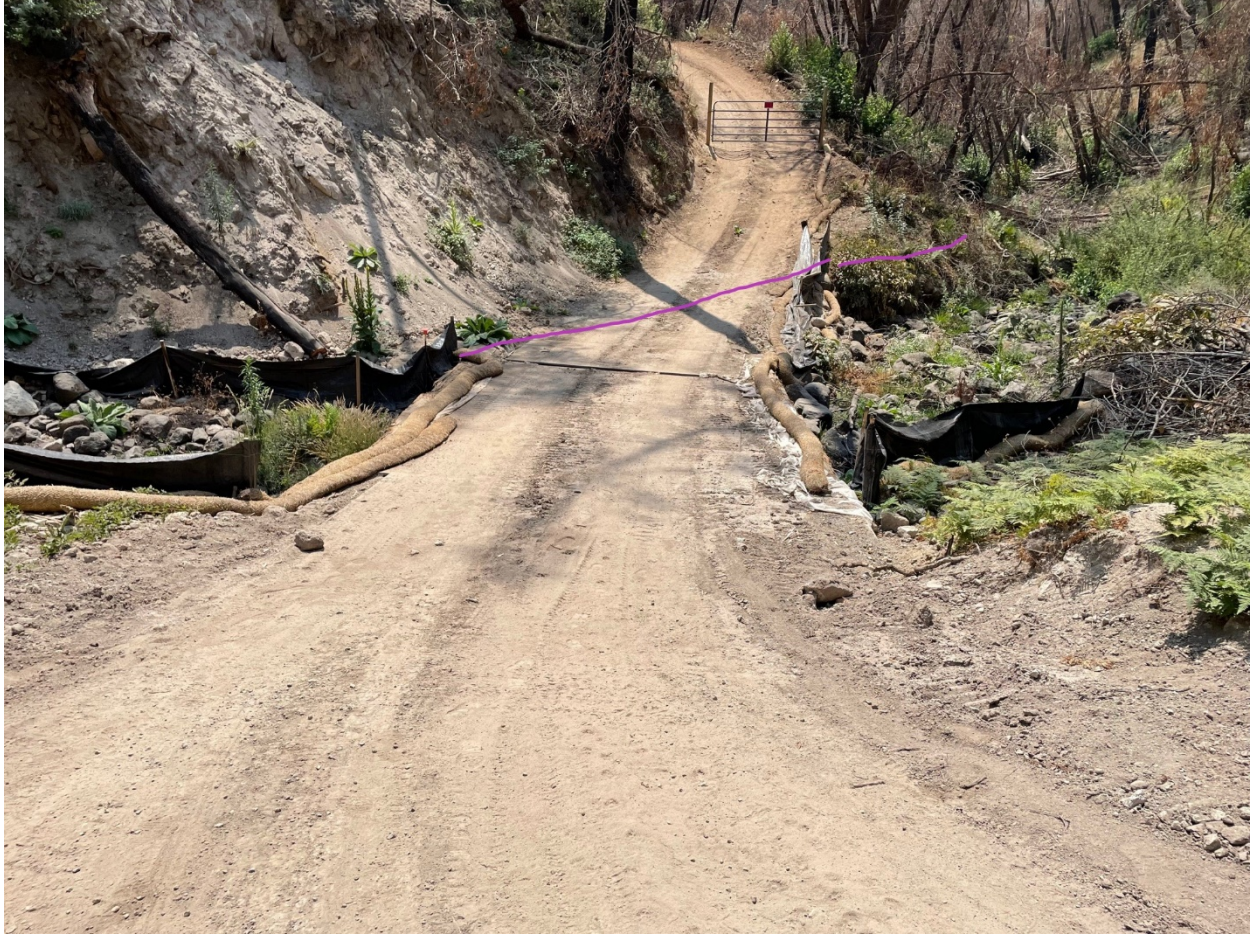
Figure 4. View of crossing taken from the west side of crossing. Purple line shows approximate location of bankfull depth of channel.

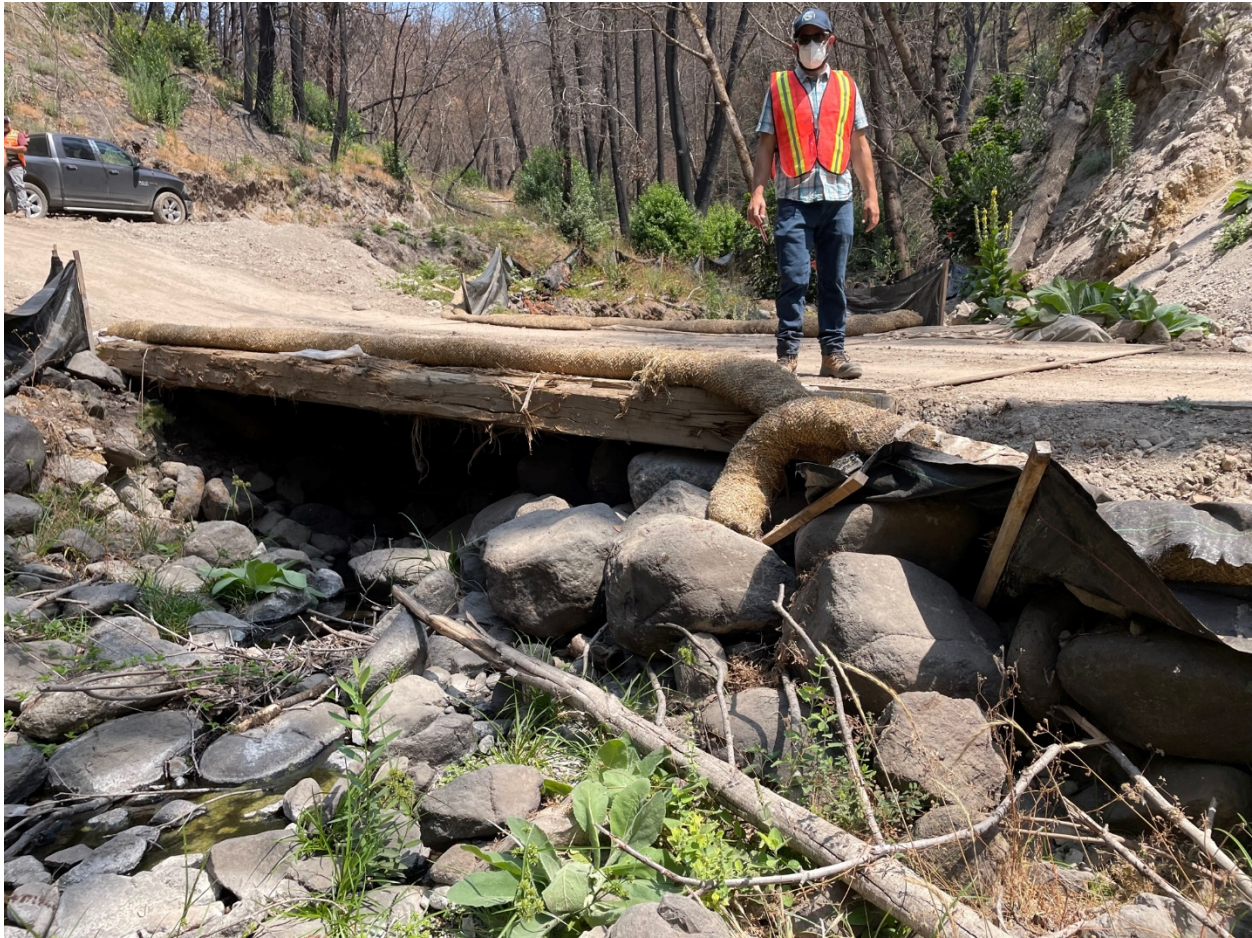
Figure 5. View of crossing from within channel, looking upstream
