North Coast Regional Water Quality Control Board

Subject: **Notice of Violation** of State Water Resources Control Board Order No. 2014-0057- DWQ *General Permit for Storm Water Discharges Associated with Industrial Activities* (Industrial General Permit)

File: Arcata Scrap and Salvage Inc., 192 South G Street, Arcata, CA
Humboldt County, WDID # 1 121028461

Attachment A – November 17, 2020 Facility Stormwater Inspection Report

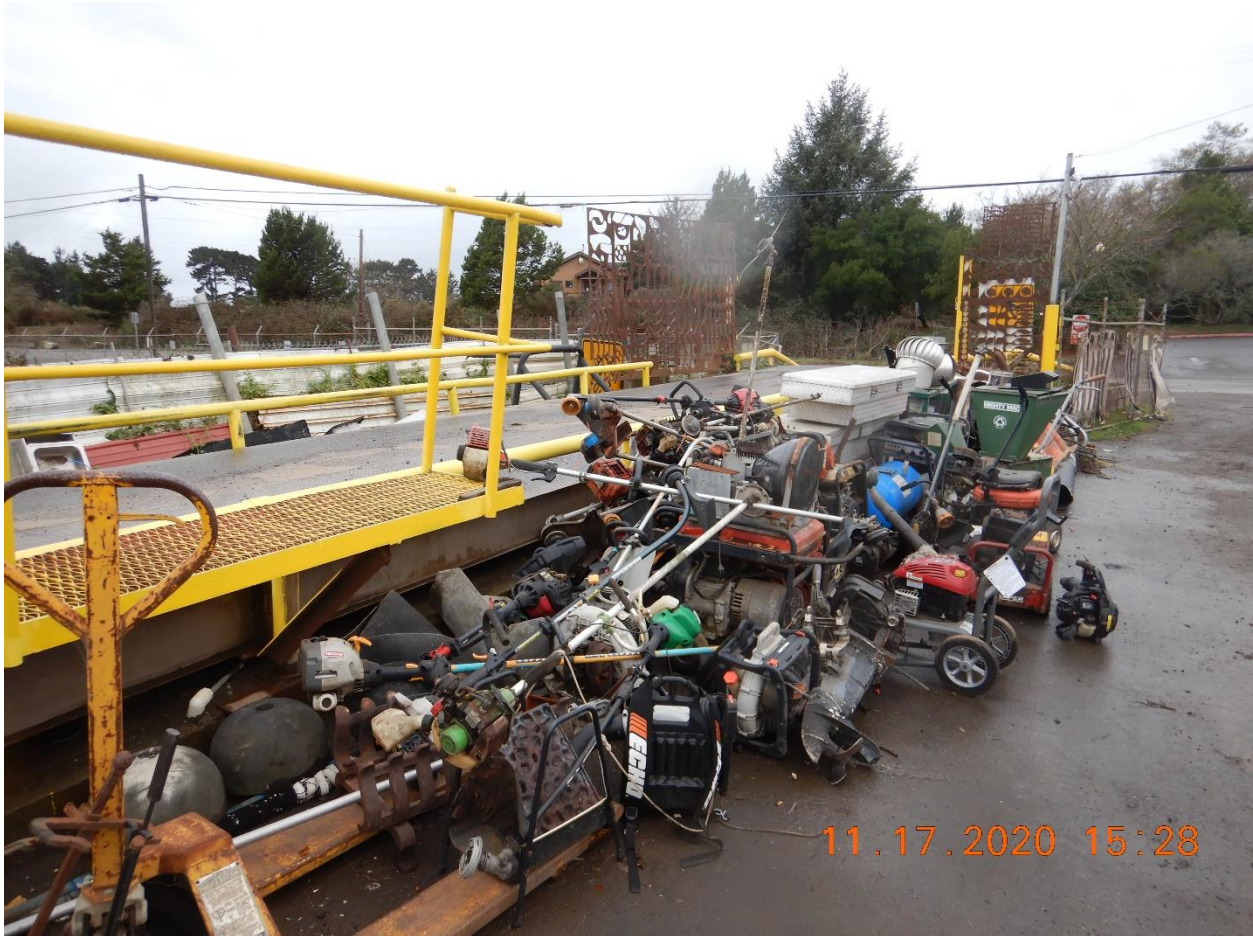
Picture 1- View of the equipment stored outside adjacent to the truck scale and exposed to rain.

- Ensure that the impervious areas are free of sediment and debris.
- Provide overhead coverage for all containers (bins and dumpsters) containing scrap materials.

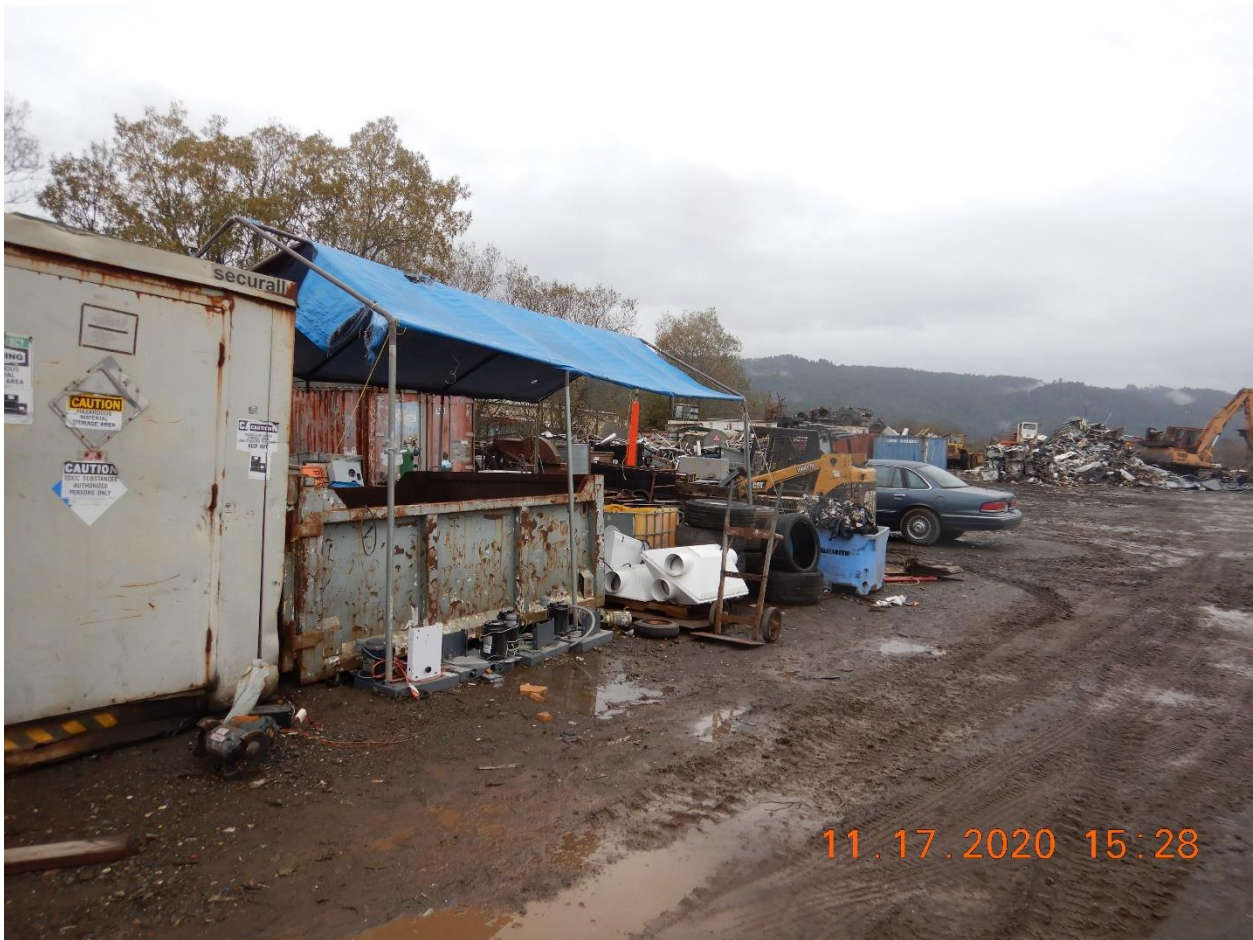
Picture 2 – View of non-watertight dumpster that is being placed on the ground with an inappropriate cover. Picture taken by Farzad Kasmaei.

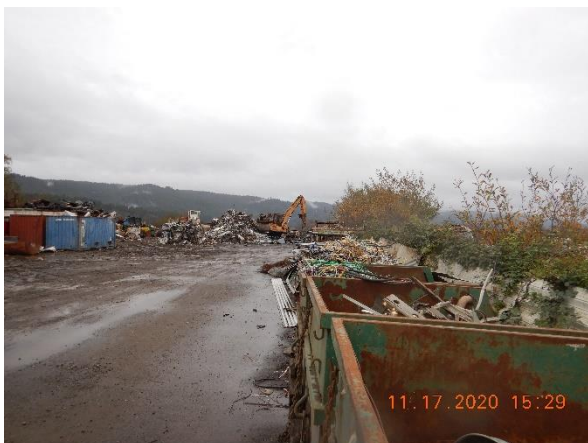
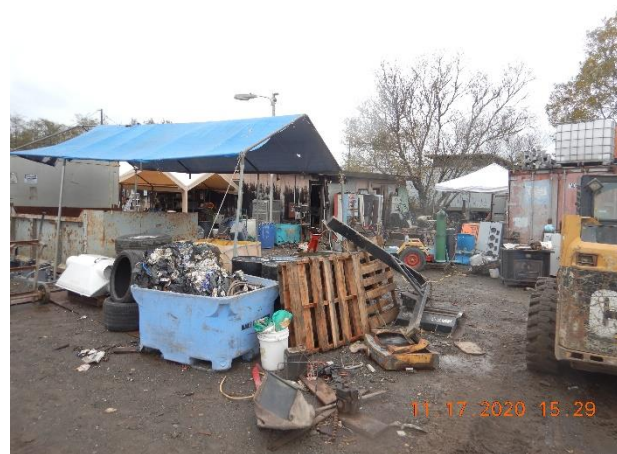
Pictures 3a, 3b – View of metal parts that are stored outside in the bins with no covers (lids) and exposed to rain. Source control is not implemented. Pictures taken by Farzad Kasmaei.

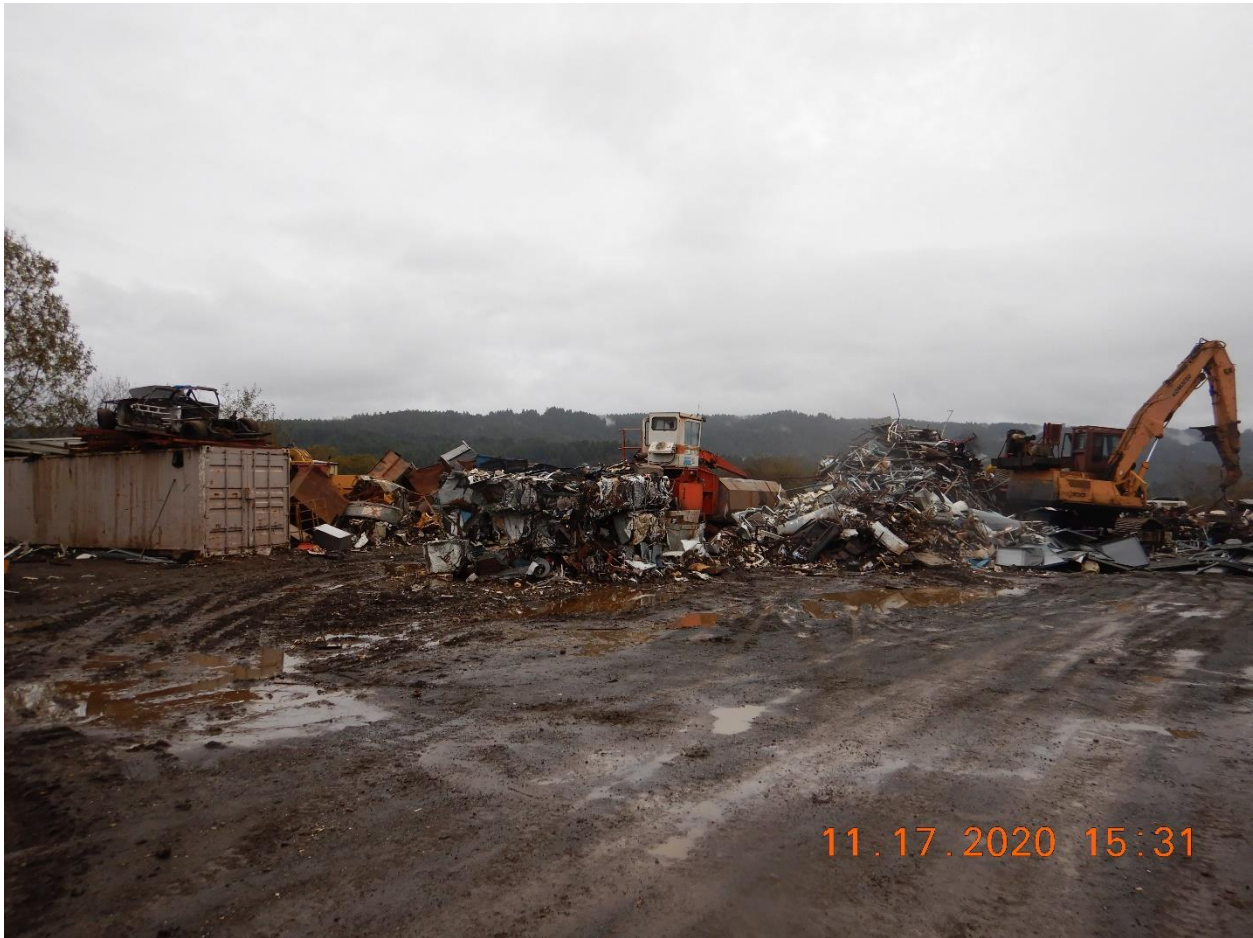
Material Handling and Waste Management	No	There is a significant amount of scrap metals and junk materials stored outside on the ground exposed to rain with no BMPs.	Section X.H.1.d	4, 5, 6, 7 & 8

Picture 4 – View of a huge scrap metal stockpile stored directly on the ground and exposed to rain. No BMPs implemented/installed throughout the facility to eliminate or at least minimize the exposure of industrial material/equipment to rain.

- Ensure that housekeeping practices are implemented throughout the facility. All outdoor areas associated with industrial activity; including storm water discharge locations, drainage areas, conveyance systems, waste handling/disposal areas, and perimeter areas impacted by off-facility materials must be evaluated to determine housekeeping needs. Any identified debris, waste, spills, tracked materials, or leaked materials shall be cleaned and disposed of properly.

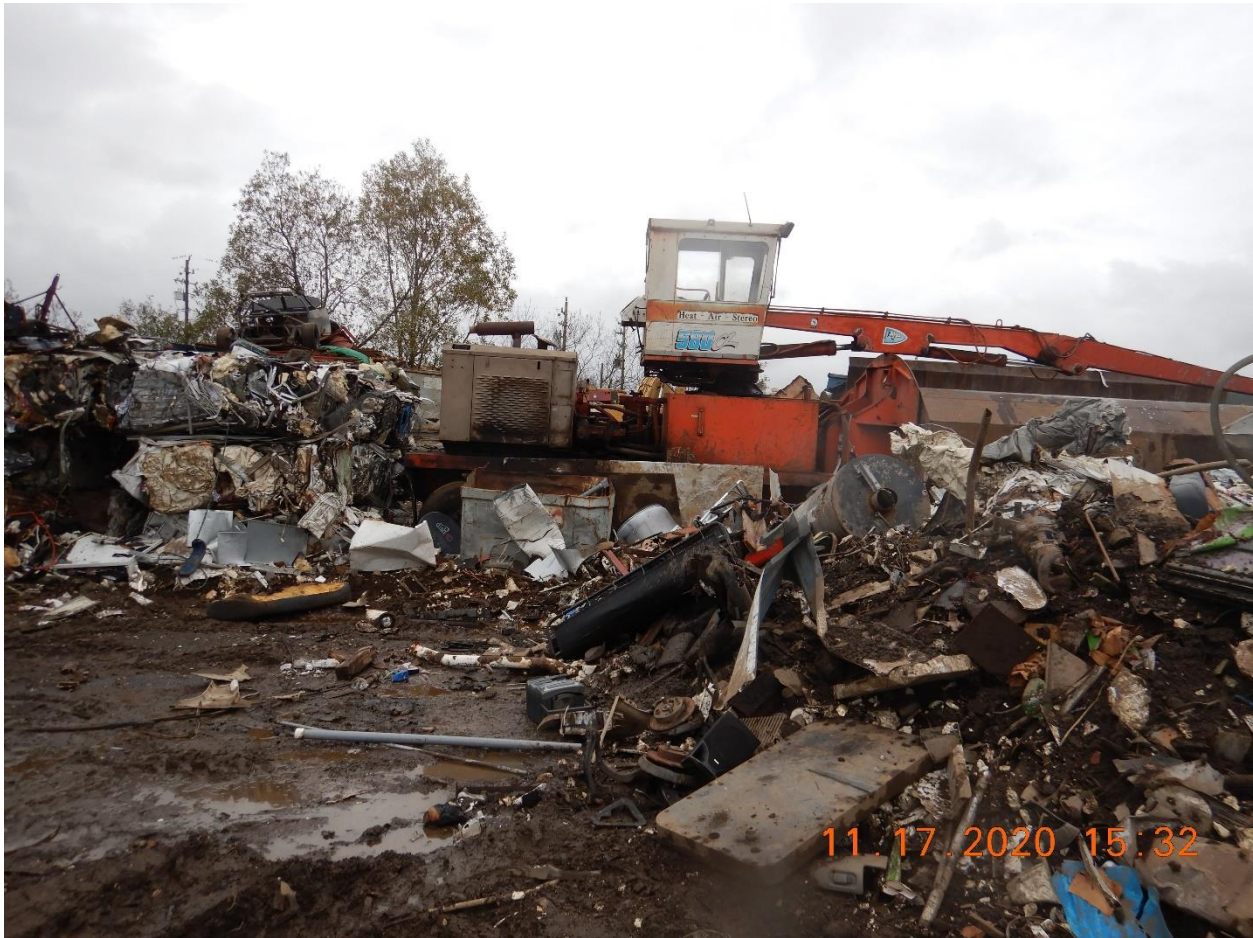
Picture 5 – View of debris, trash and scrap metals stored outside directly on the ground with no cover. Source control and housekeeping practices are not implemented throughout the facility. Picture taken by Farzad Kasmaei.

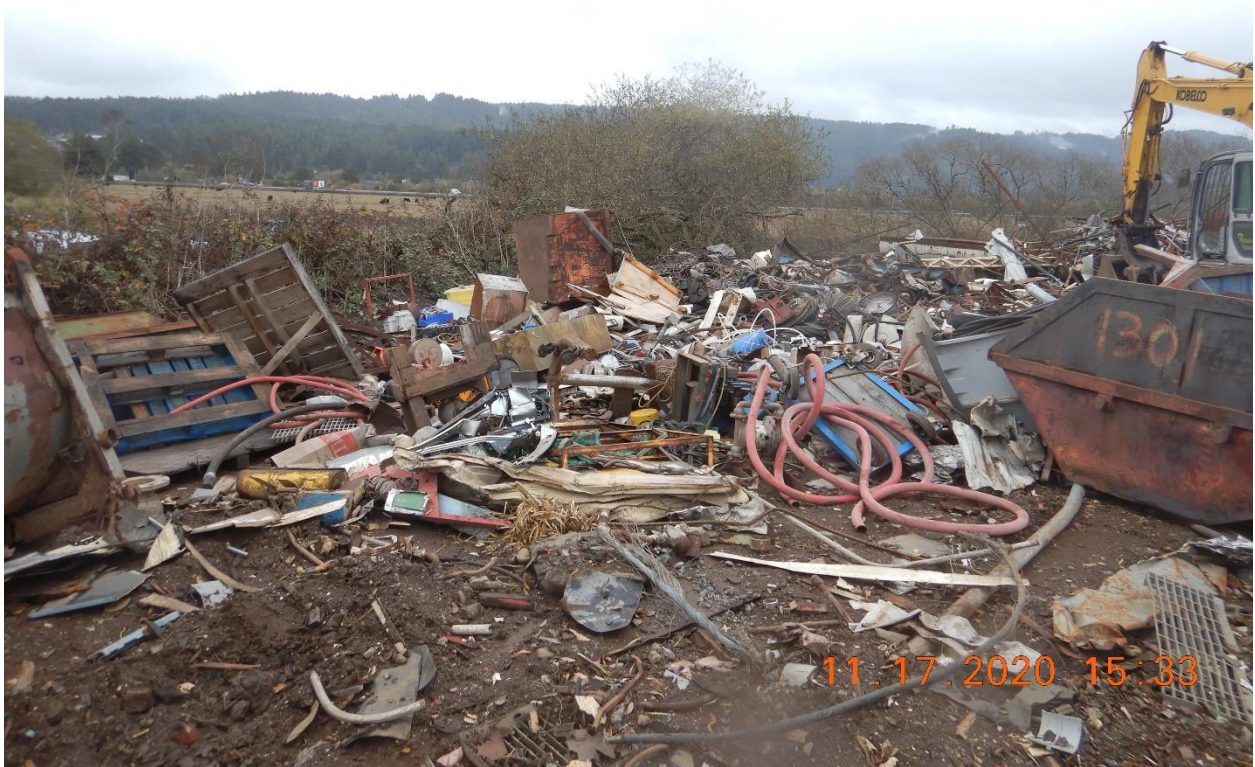
Picture 6 – View of wood, plastic wastes and scrap metals at the northeast side of the facility. Picture taken by Farzad Kasmaei.

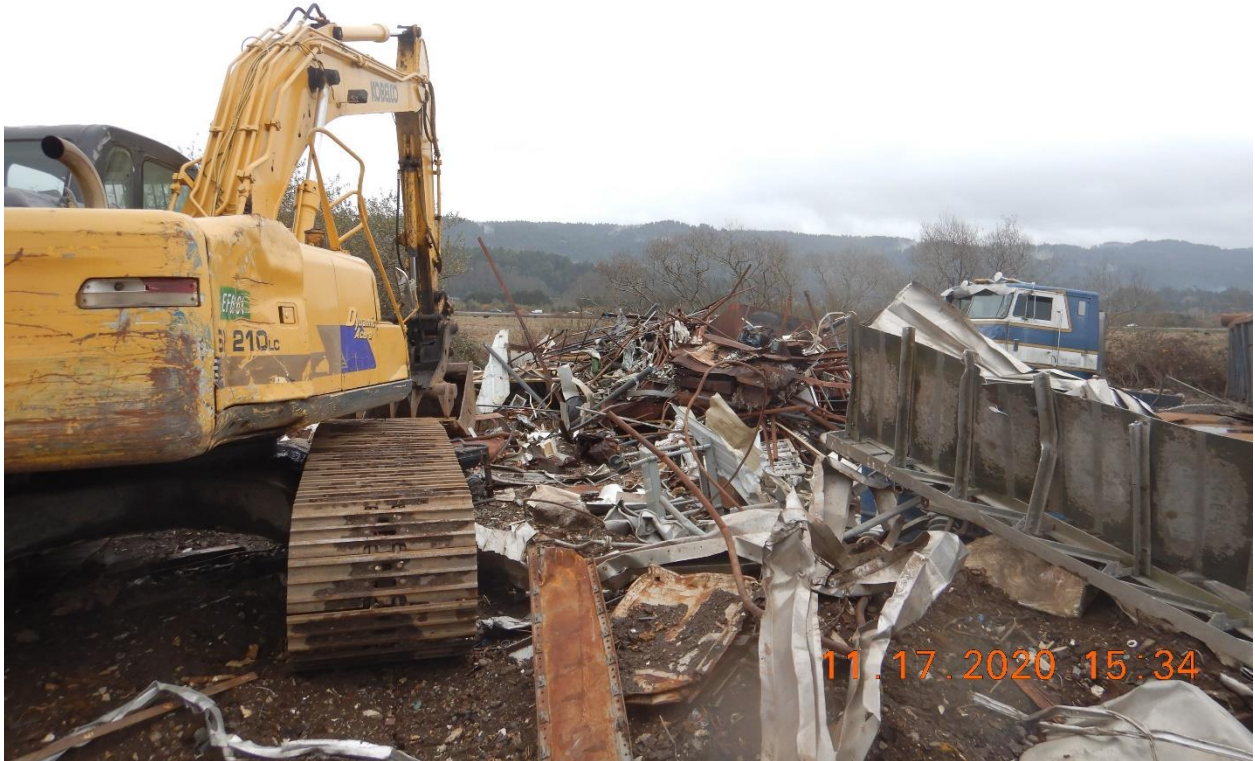
Picture 7 – View of the stored rusty metals by the parked excavator.

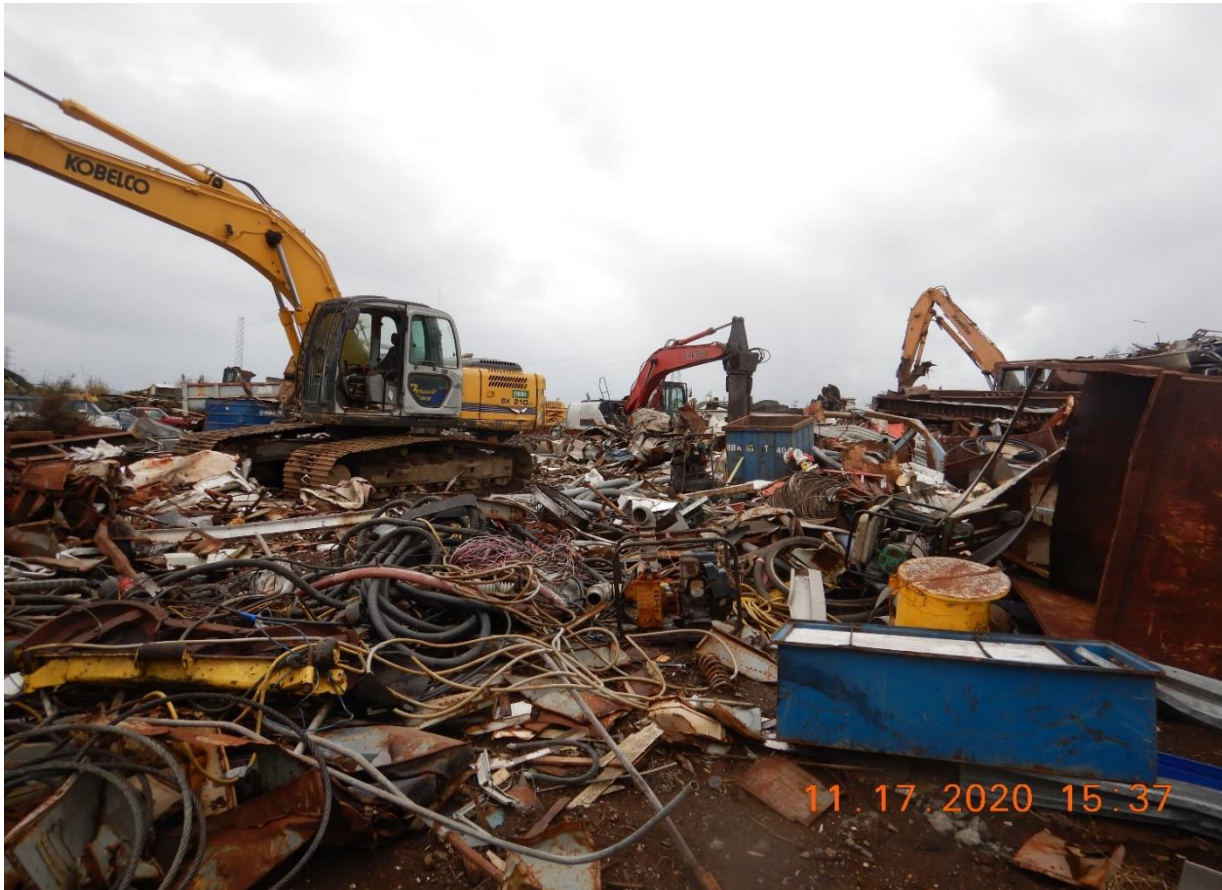
Picture 8 – View of junk materials exposed to rain with no BMPs. No material handling, waste management and housekeeping practices are implemented throughout the facility. Picture taken by Farzad Kasmaei.

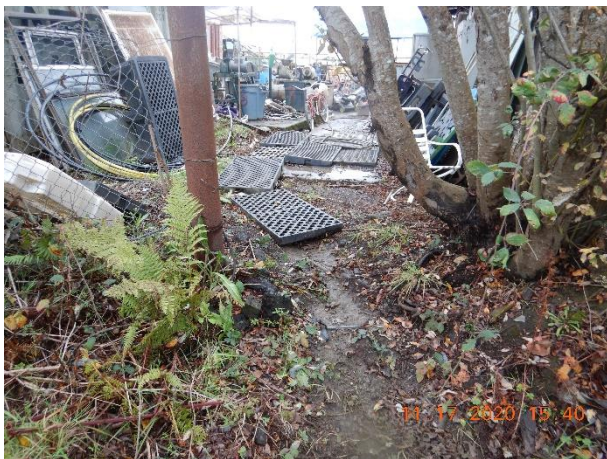
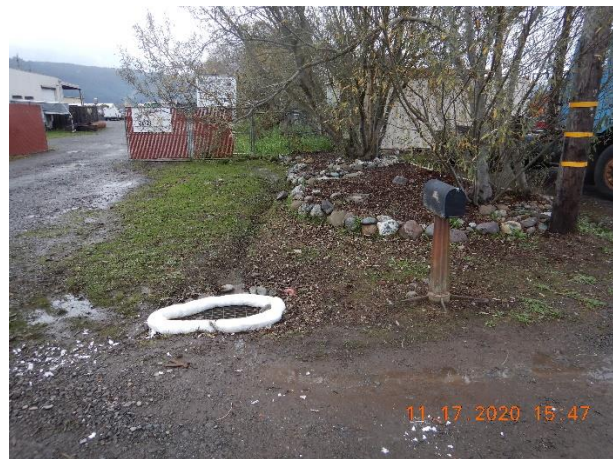
Pictures 9a, 9b – Views of sampling point on the northwest side of the facility adjacent to the main office. The samples are collected from a shallow trench where the runoff leaves the site on its way being discharged into an off-site drop inlet (DI). DI is protected with an absorbent sock. **Site Map:**

- Ensure that adequate sediment and erosion control BMPs are implemented/installed throughout the facility to address the sedimentation issue.
- Establish a designated sampling point within the Drainage Area B. Reassess the facility to ensure all drainage areas are monitored and the sampling point(s) provide a good representation of storm water runoff from the site. Also, Update the SWPPP for any new changes and submit a SWPPP amendment via SMARTS.
