Subject: Notice of Violation, Directive to Obtain Regulatory Coverage for Cannabis Cultivation, and Transmittal of Inspection Report for Sonoma County Assessor's Parcel Number (APN): 084-210-001-000

Report of November 4, 2020 Consent Inspection of Sonoma County Assessor's Parcel Number (APN): 084-210-001-000

File: Cannabis Program Inspections, Sonoma County, 2020,
CIWQS Place ID: 842542

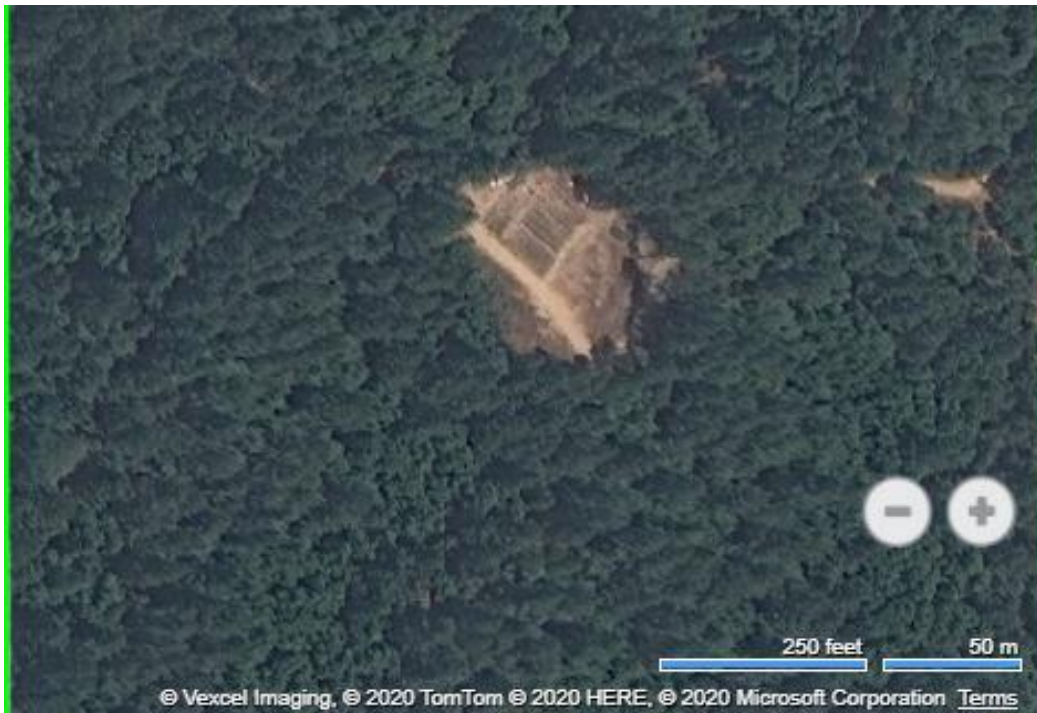
and August 2019 (Aerial Image 3). An additional 2 acres were cleared by June 27, 2020 (Aerial Image 4).

Aerial Image 3—August 6, 2019 aerial image showing the southern part of the property, accessed with Digital Map Products' Land Vision service.

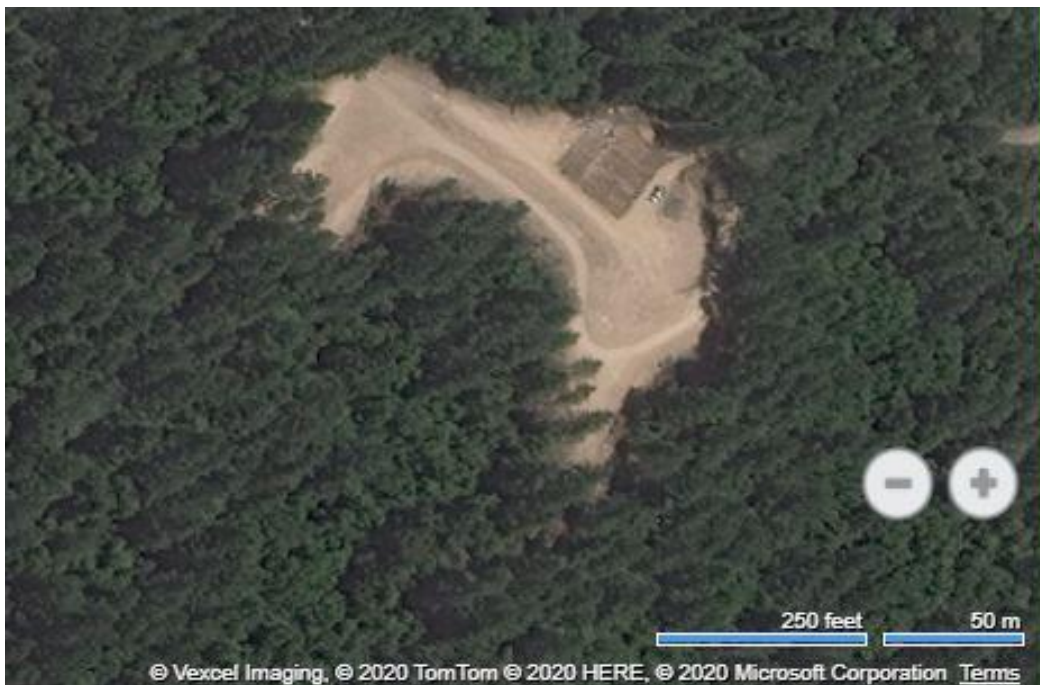
Aerial Image 4—June 27, 2020 aerial image showing the southern part of the property, accessed with Digital Map Products' Land Vision service.

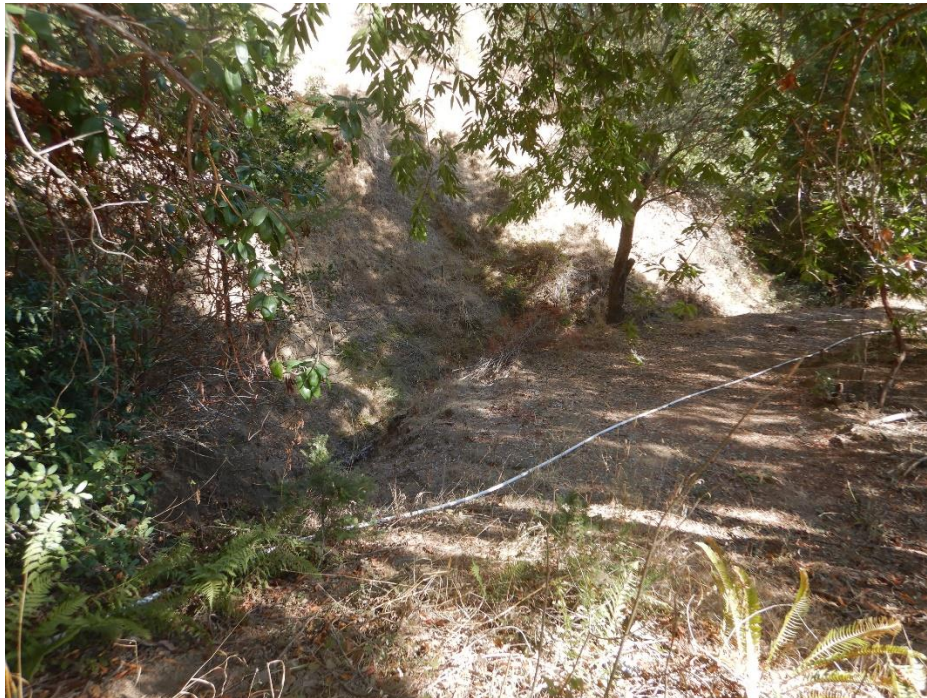
We did not observe any active cannabis cultivation areas during the inspection. The road at WQ 1 encroaches on a watercourse.

Photo 1—Historical road encroaching on a watercourse at WQ 1.

1. Retain a licensed professional to inventory, assess, and develop a workplan and schedule to implement measures to ensure that all developed features, roads, watercourse crossings, and cultivation areas throughout the Property are corrected, restored, and/or maintained in conditions that prevent or minimize erosion, sediment transport/delivery, and adverse impacts to water quality and beneficial uses. Include measures to ensure that unstable features caused or affected by onsite development and operations are removed or otherwise protected so as to minimize the potential for these features to cause adverse impacts to water quality and beneficial uses. Dispose of all development and restoration-related earthen spoils in a manner to prevent/minimize transport and delivery to receiving waters.

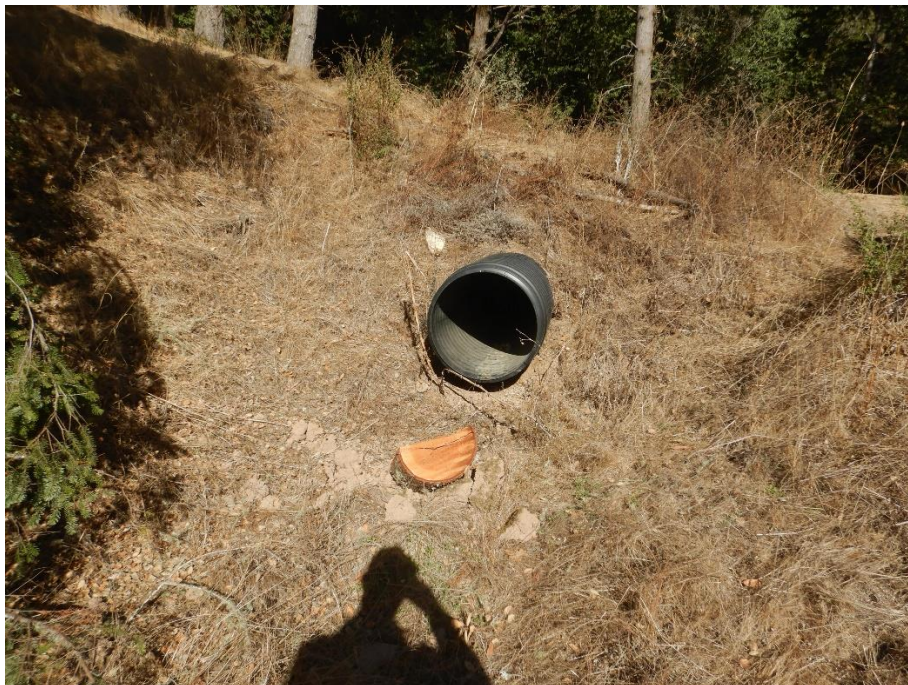
Photo 2—Inlet to reservoir outfall at WQ 2.

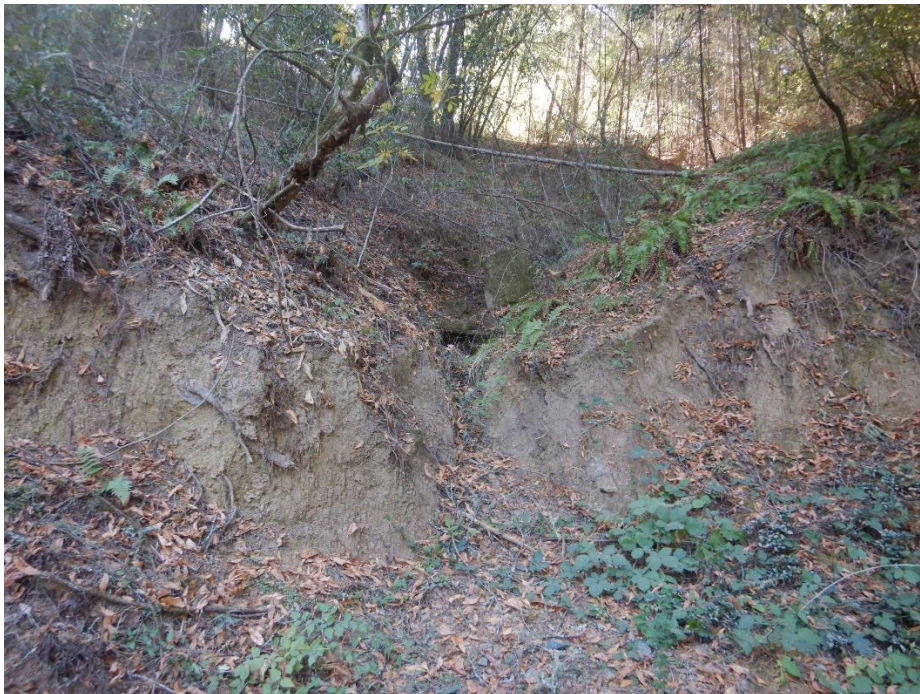
Along the road I observed two locations, WQ 4 and WQ 5, where watercourses crossed the road without a culvert or other stable conveyance feature (Photo 4 and Photo 5). At the top of the hill, I observed an approximate three-acre graded area. At the southern edge of this area, near WQ 6, I observed earthen spoils that had been pushed or placed over slash (Photo 6 and Photo 7) at a location where it could enter or be transported into a tributary to Green Valley Creek (see Figure 1). At the southwestern edge of the expanded graded area, at WQ 7, I observed a spoils pile that was about 10 feet tall, and with a circular base about 20 feet in diameter (Photo 8). On the western side of the spoils pile, I observed uncovered, uncontained potting soils (Photo 9).

Stream crossings at WQ 3, WQ 4 and WQ 8 lack culverts or other drainage features requiring water to flow over an unarmored road surface.

Photo 4—Looking upstream at watercourse from road at WQ 4.

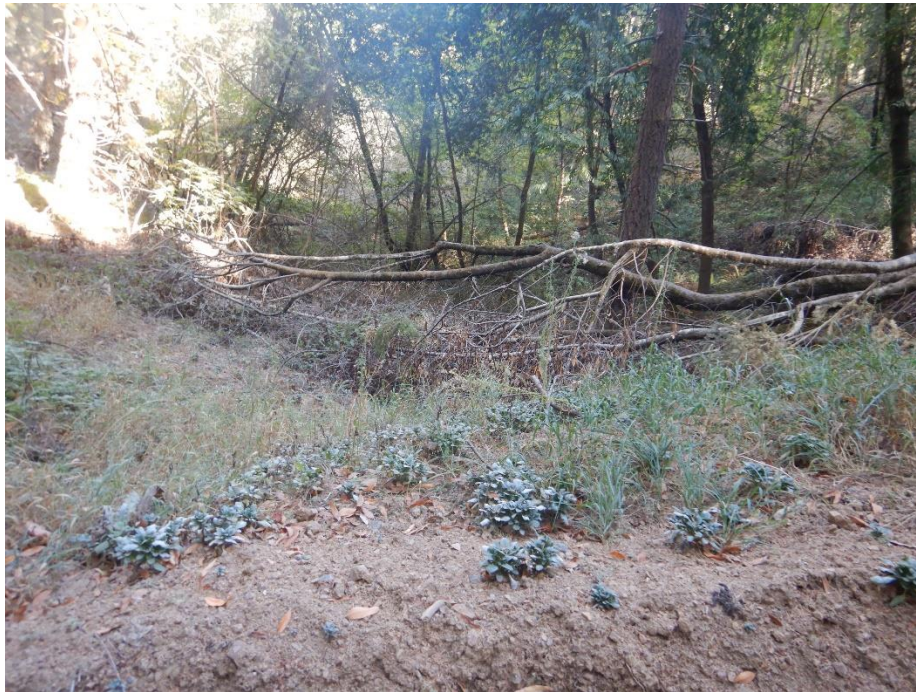
Photo 5—Looking downstream at watercourse from road at WQ 4.

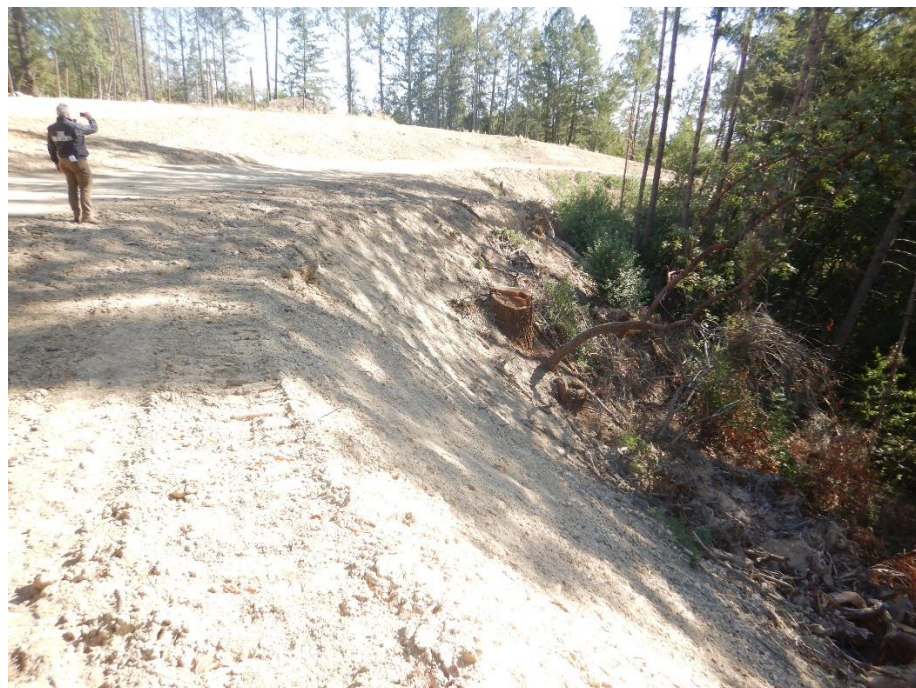
The recently graded pad at WQ 5 lacks any erosion control measures and earthen material at the edges of the graded pad are burying slash. I did not observe any erosion control supplies, such as wattles or silt fencing, onsite, though the wet-weather season had commenced.

Photo 6— Looking east in the vicinity of WQ 5.

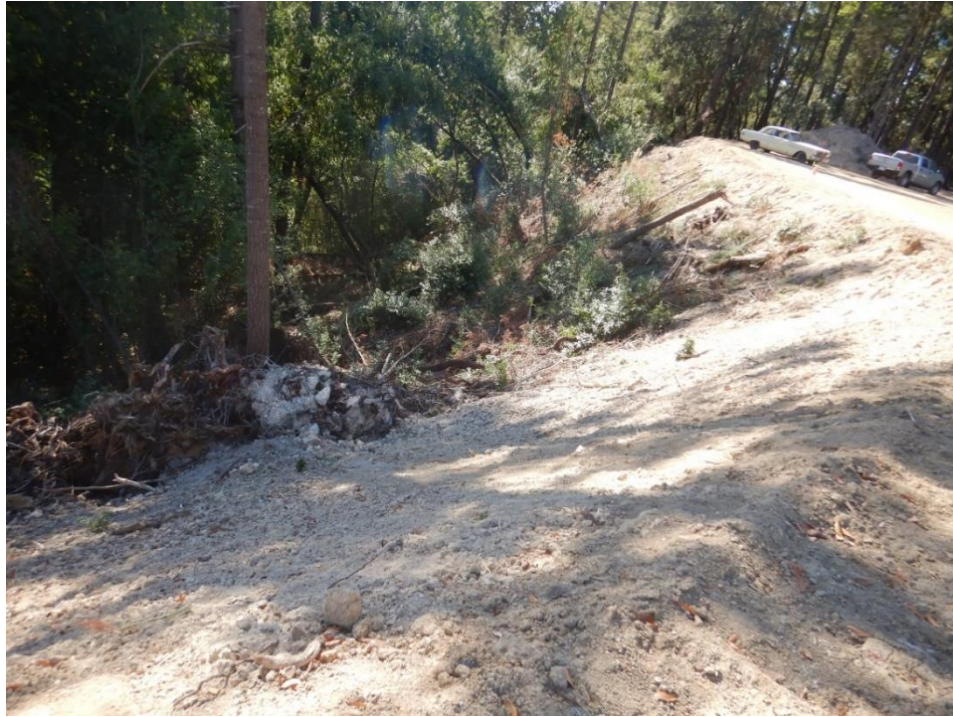
Photo 7—Looking west in the vicinity of WQ 5. Spoils pile at WQ 6 is visible in the back right of the image.

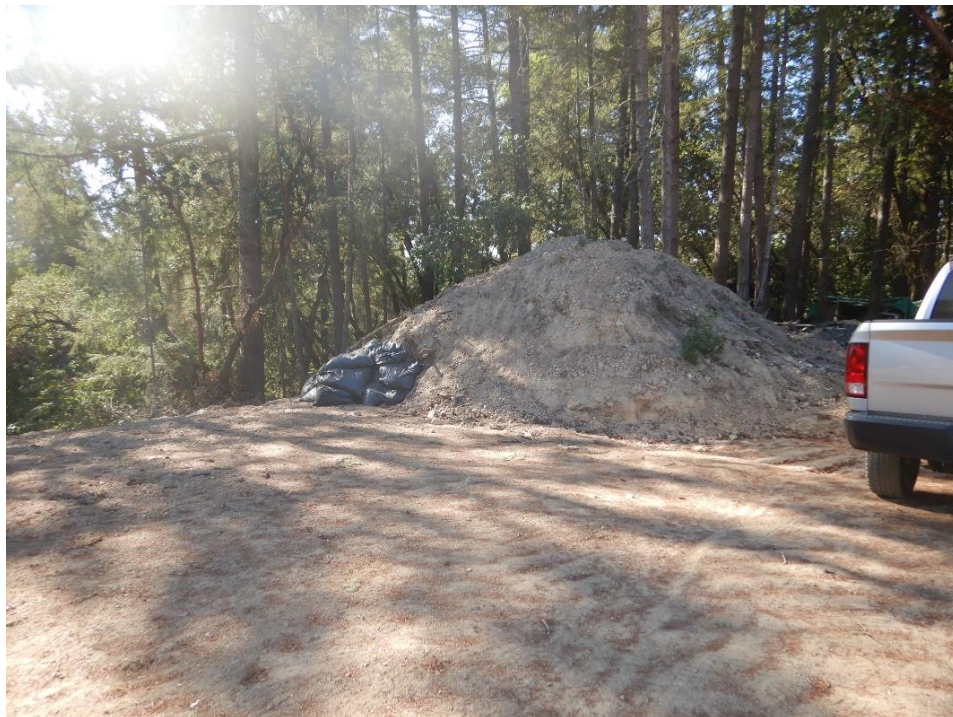
Earthen spoils were uncontained and without cover at WQ 6.

Photo 8—Looking west at uncovered spoils pile located at WQ 6.

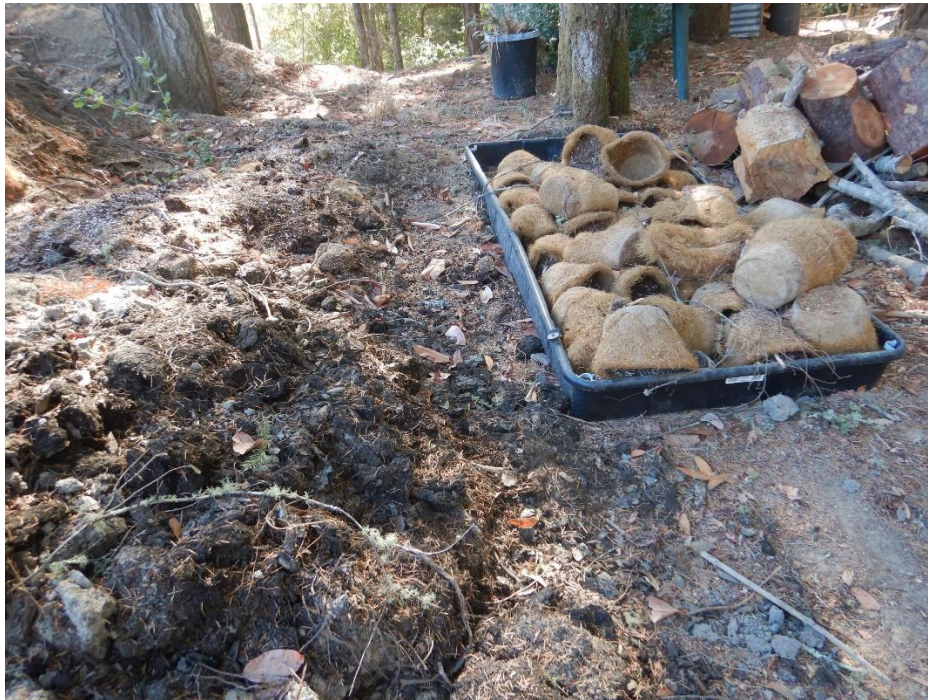
I observed potting soils among inadequately contained spoils at WQ 6.

Other than the potting soils at WQ 6, I did not observe cultivation related waste.

Photo 9—Potting soil spoils and other wastes on the western side of the spoils pile located at WQ 6.

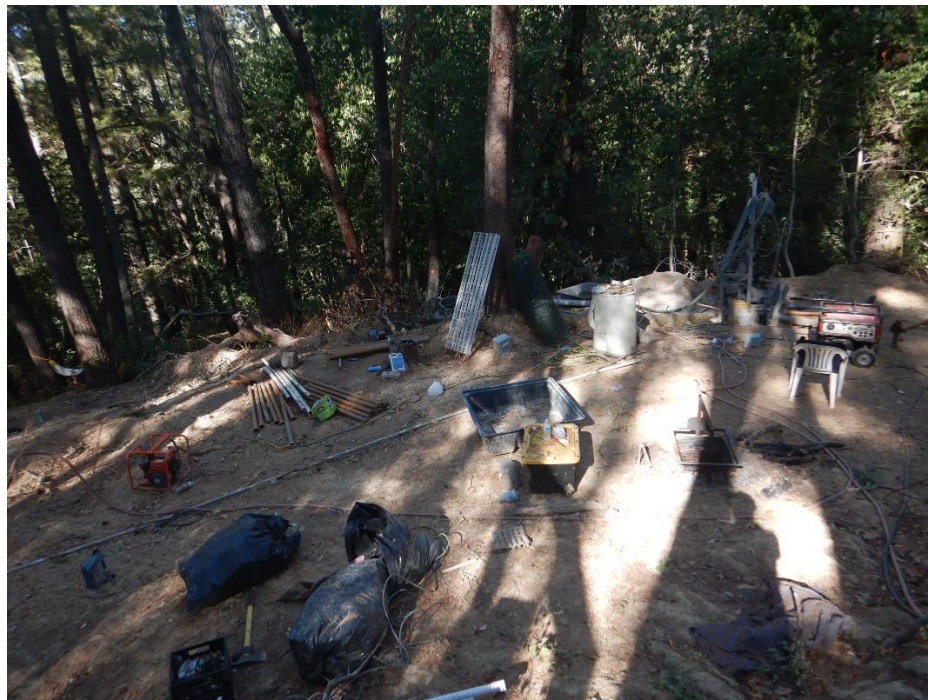
Photo 10—Showing work area for uncompleted groundwater well at WQ 7.

4. Complete all groundwater wells at WQ 7 in accordance with Sonoma County requirements.
5. Store and contain all chemicals, including petroleum, fertilizer and/or pesticides properly to prevent spillage and discharge to receiving waters. Provide secondary containment for all petroleum products.
6. Comply with requirements/directives from CDFW and the Division of Water Rights with respect to appropriate permitting/licensing for water source(s), diversion(s), storage, and use, and ensure that water storage features are modified/maintained so as to minimize the potential for adverse impacts to water quality and beneficial uses

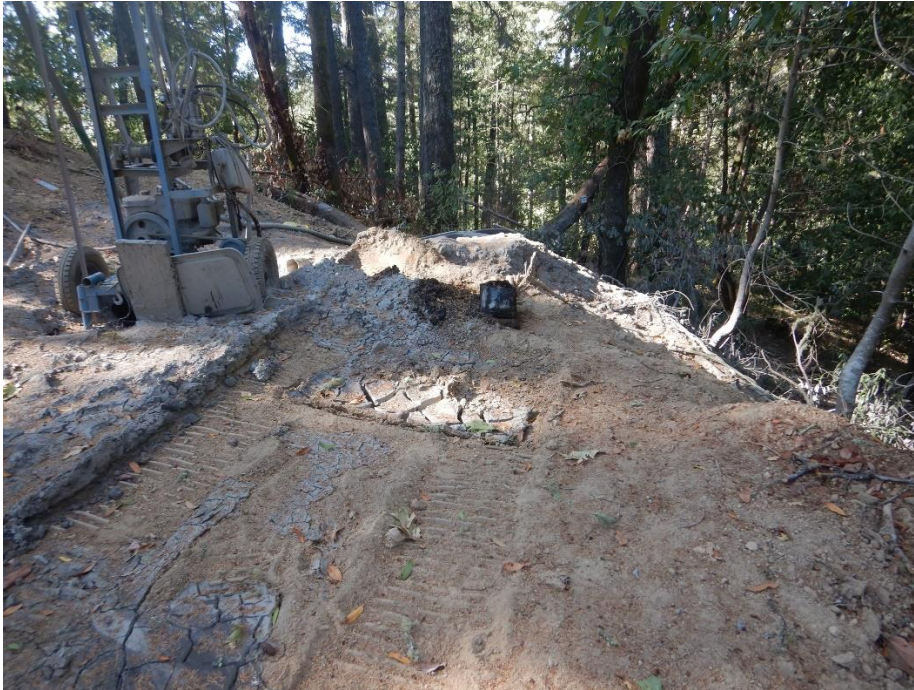
Photo 11—Drill rig and open bucket with black substance at WQ 7.

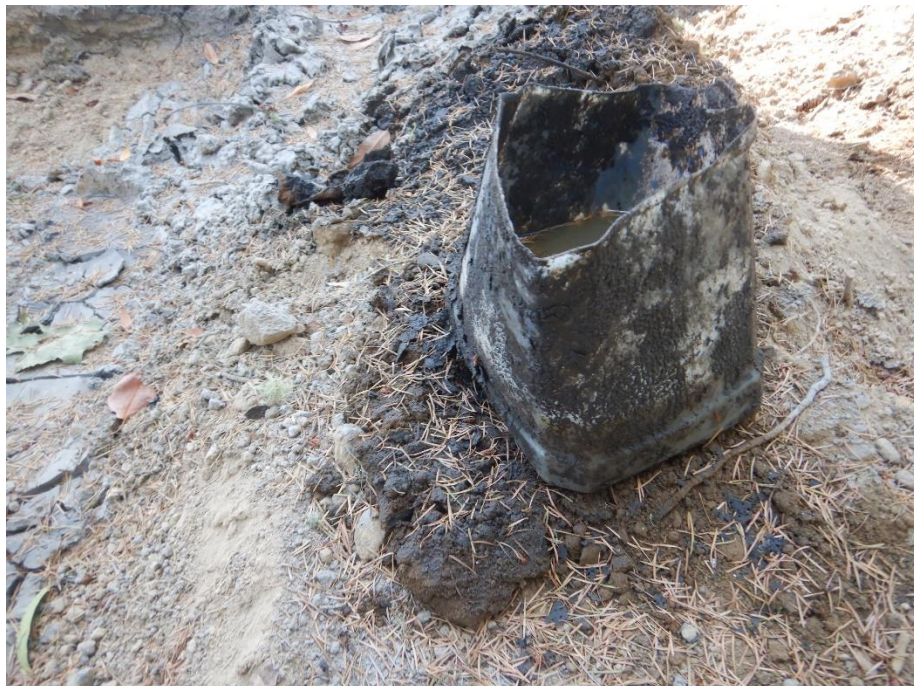
Photo 12— Closer view of bucket with black substance at WQ 7 that is pictured in previous image.

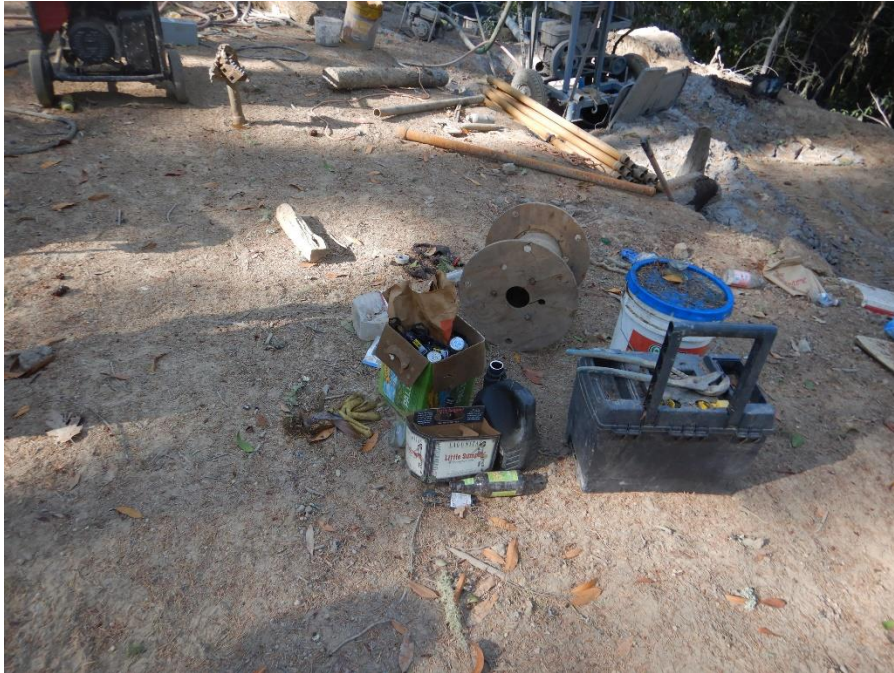
I observed hydraulic fluid, open and uncovered among other chemicals at the groundwater drill site located at WQ 7.

Photo 13—Uncapped gallon jug of hydraulic fluid, among other equipment and materials at WQ 7.

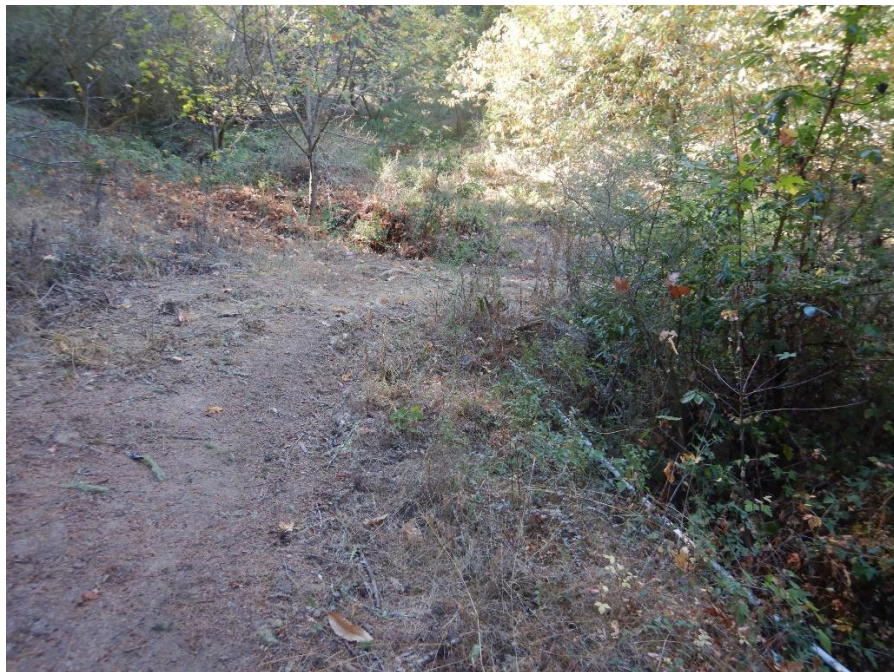
Photo 14—In the vicinity of WQ 8, a watercourse, visible in the top left of the image, crosses the road in the middle of the image and continues downstream to the location pictured in the following image.

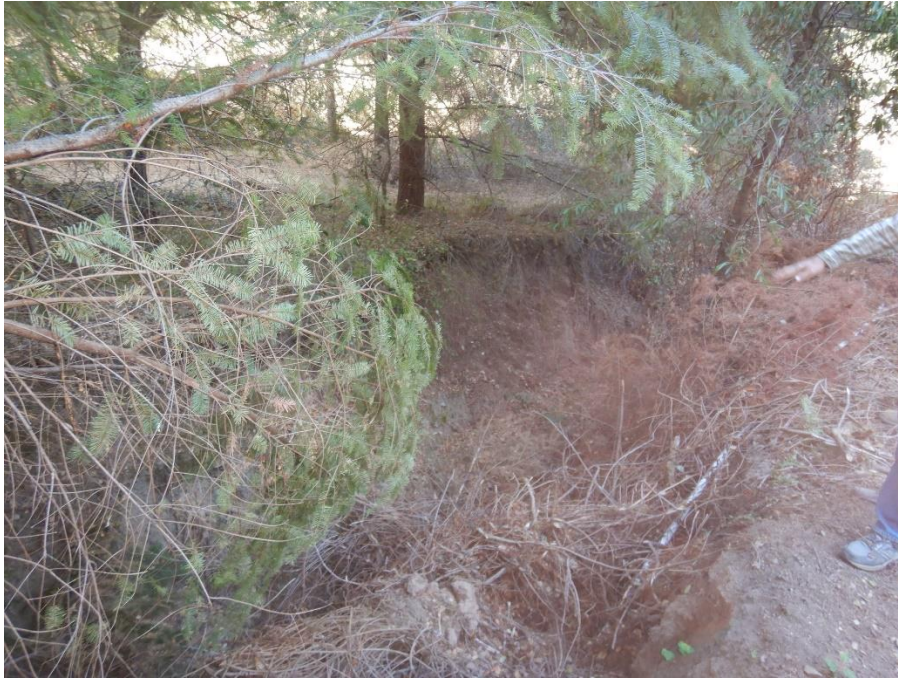
Photo 15—Watercourse filled with slash in the vicinity of WQ 8.

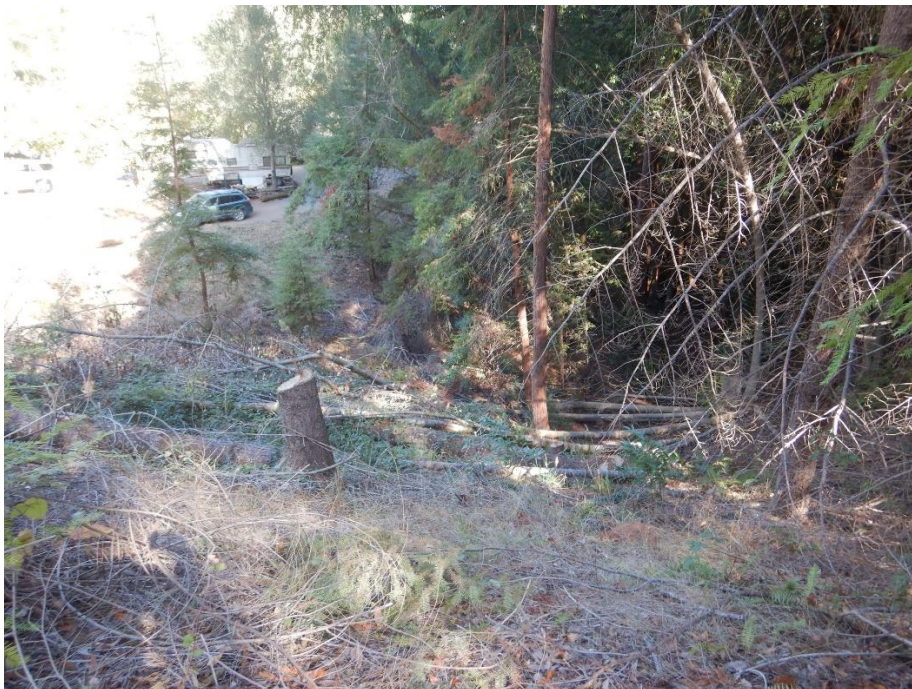
Photo 16—Looking towards WQ 9 from dam embankment.

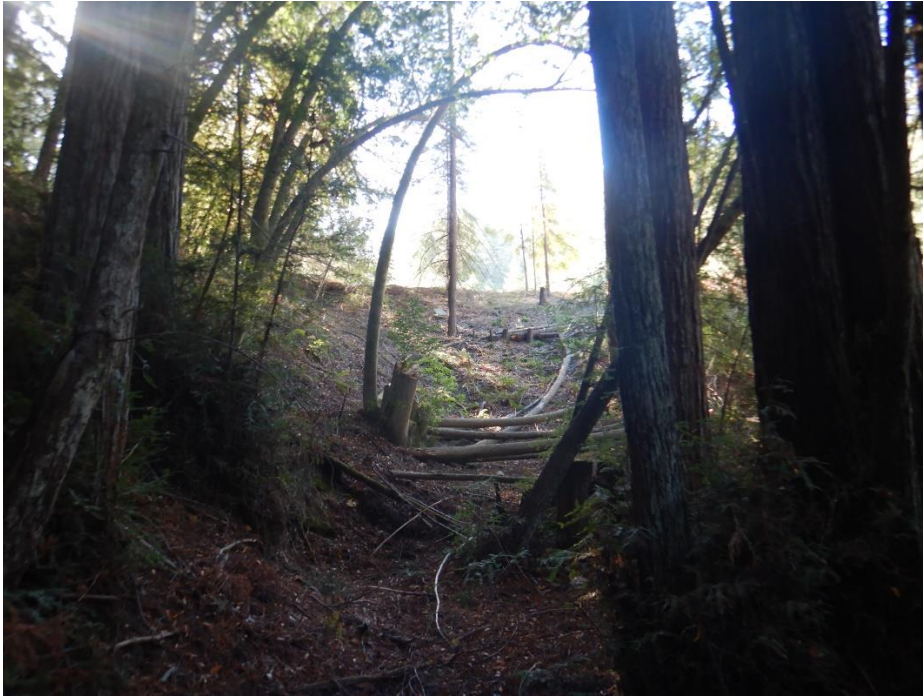
Photo 17—Looking towards dam embankment where previous photo was taken from. Cistern at WQ 9 is to the back of the photographer.

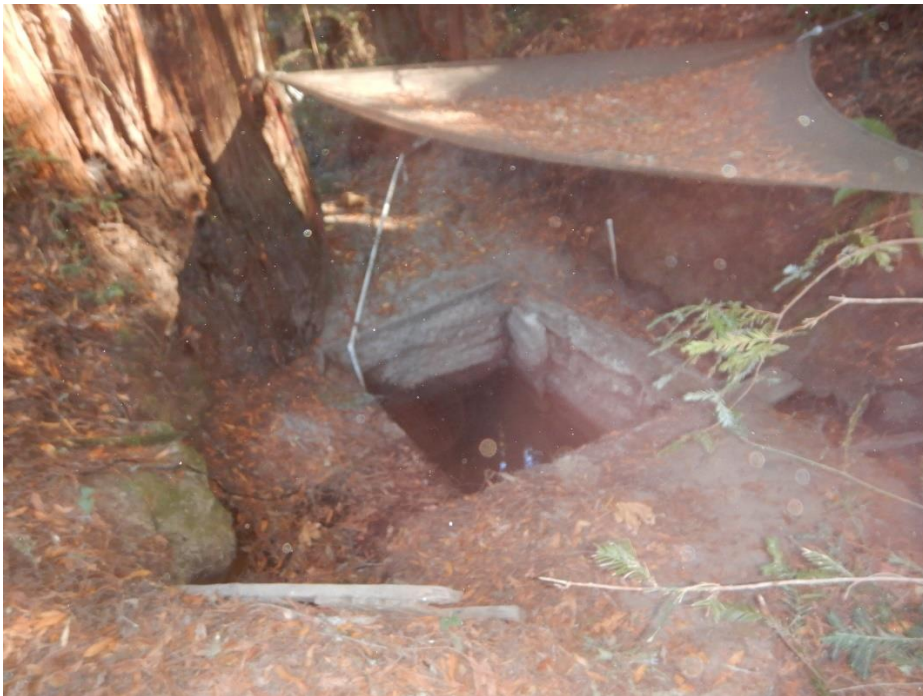
Photo 18—Instream cistern located at WQ 9.
